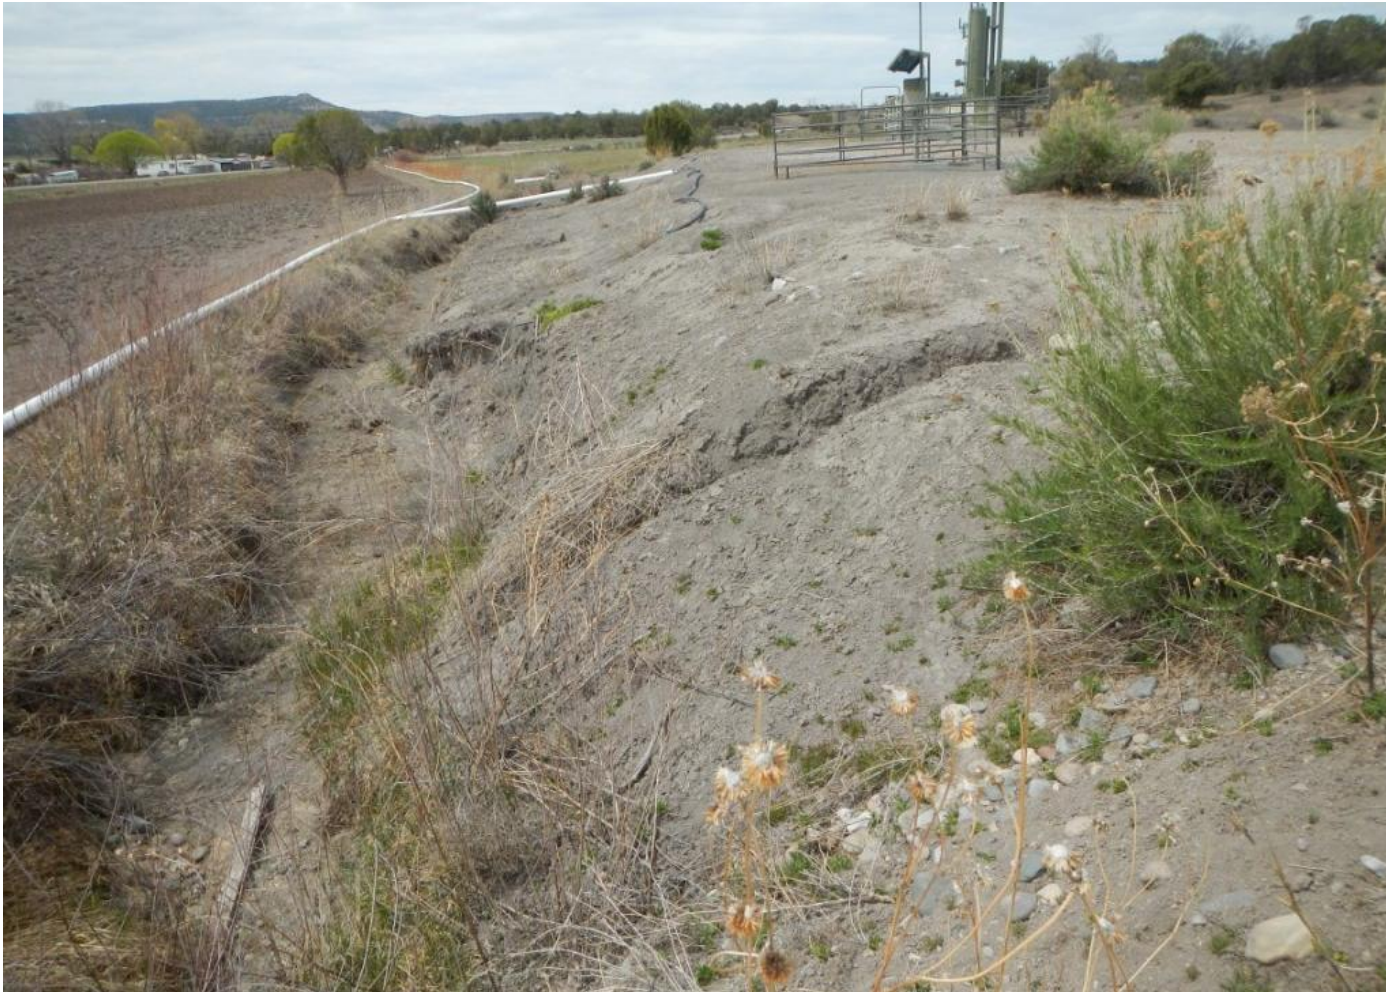
Photo 1. View of the southern portion of the project area from the well pad entrance facing westward. Little vegetation is growing here and several erosion channels are present and flow directly into adjacent irrigation ditch.

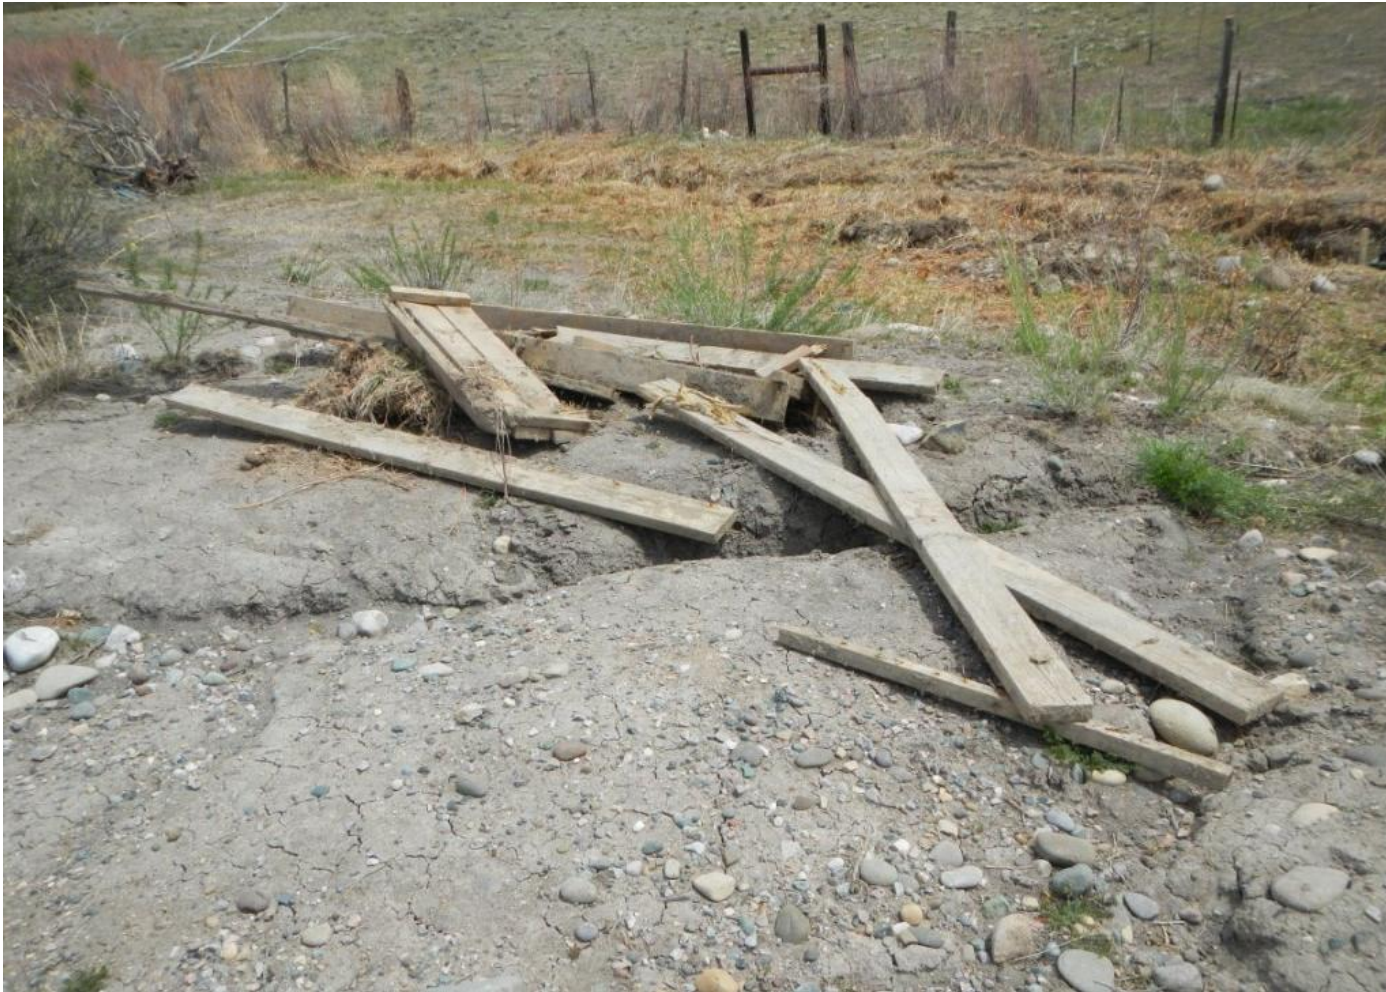
Photo 2. View of erosional channels and woody debris in the eastern portion of the project area. Erosional channels flow toward an irrigation ditch that flows along the eastern fenceline.

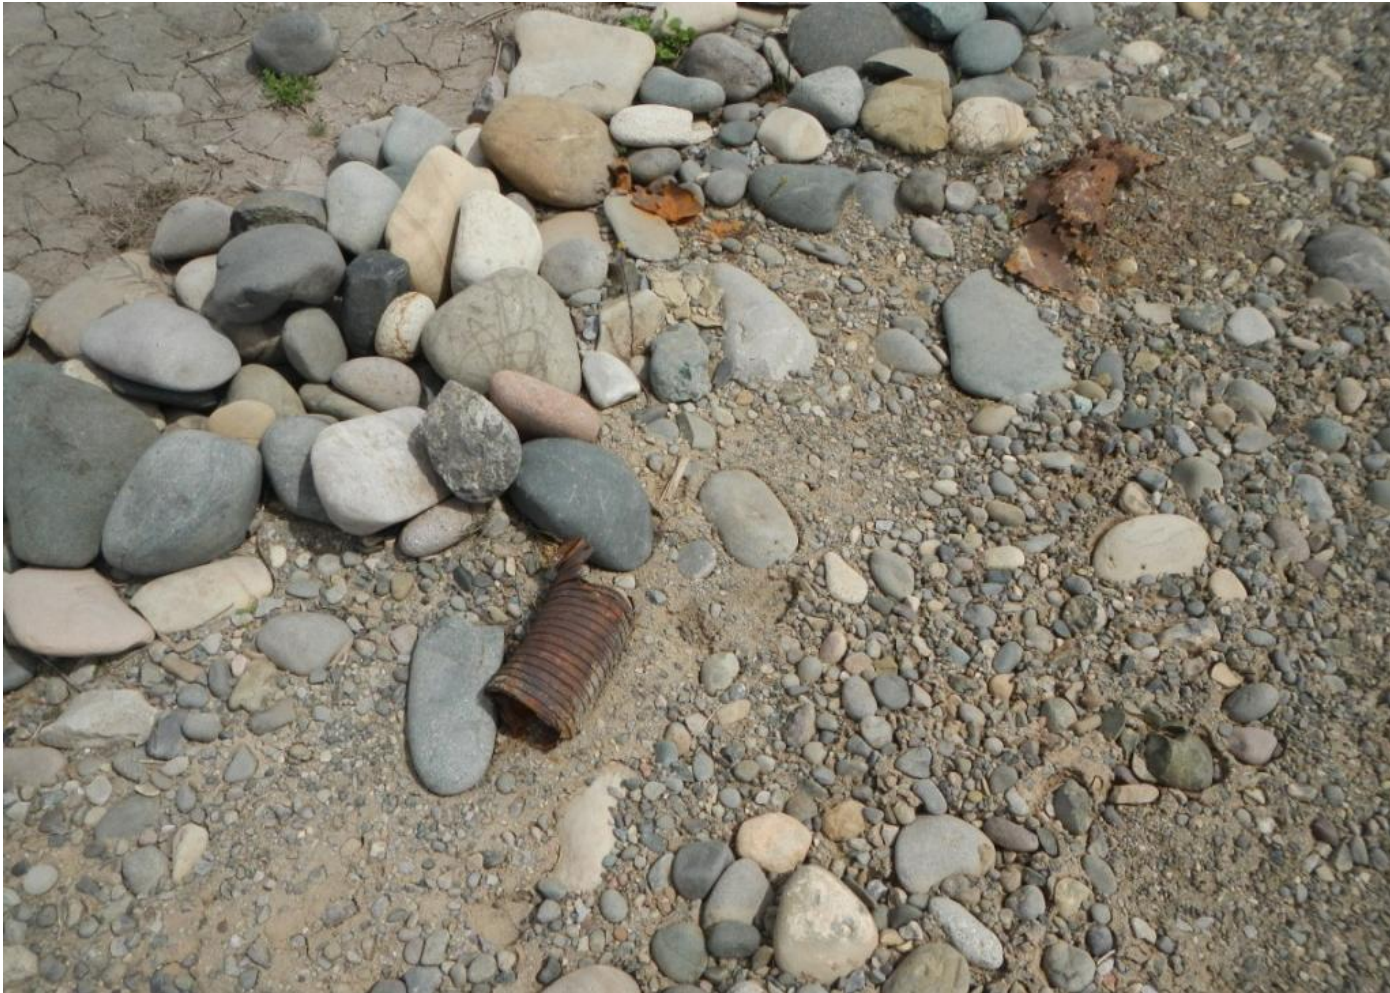
Photo 3. View of rusty trash in the eastern portion of the project area.

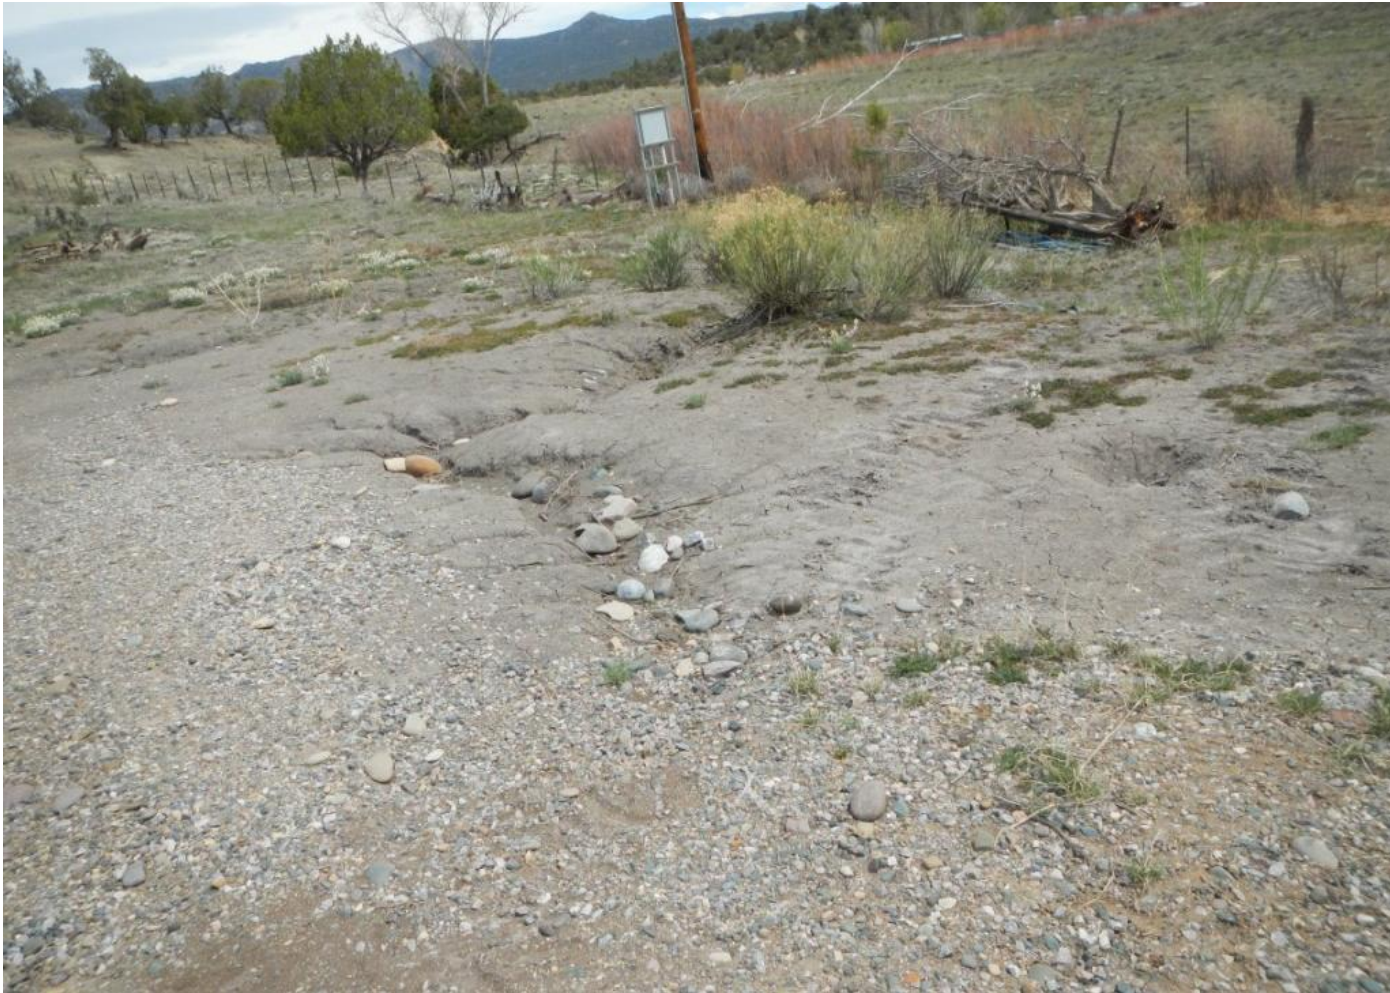
Photo 4. View of more erosional channels up to two feet deep in the eastern portion of the project area flowing toward the eastern irrigation ditch.

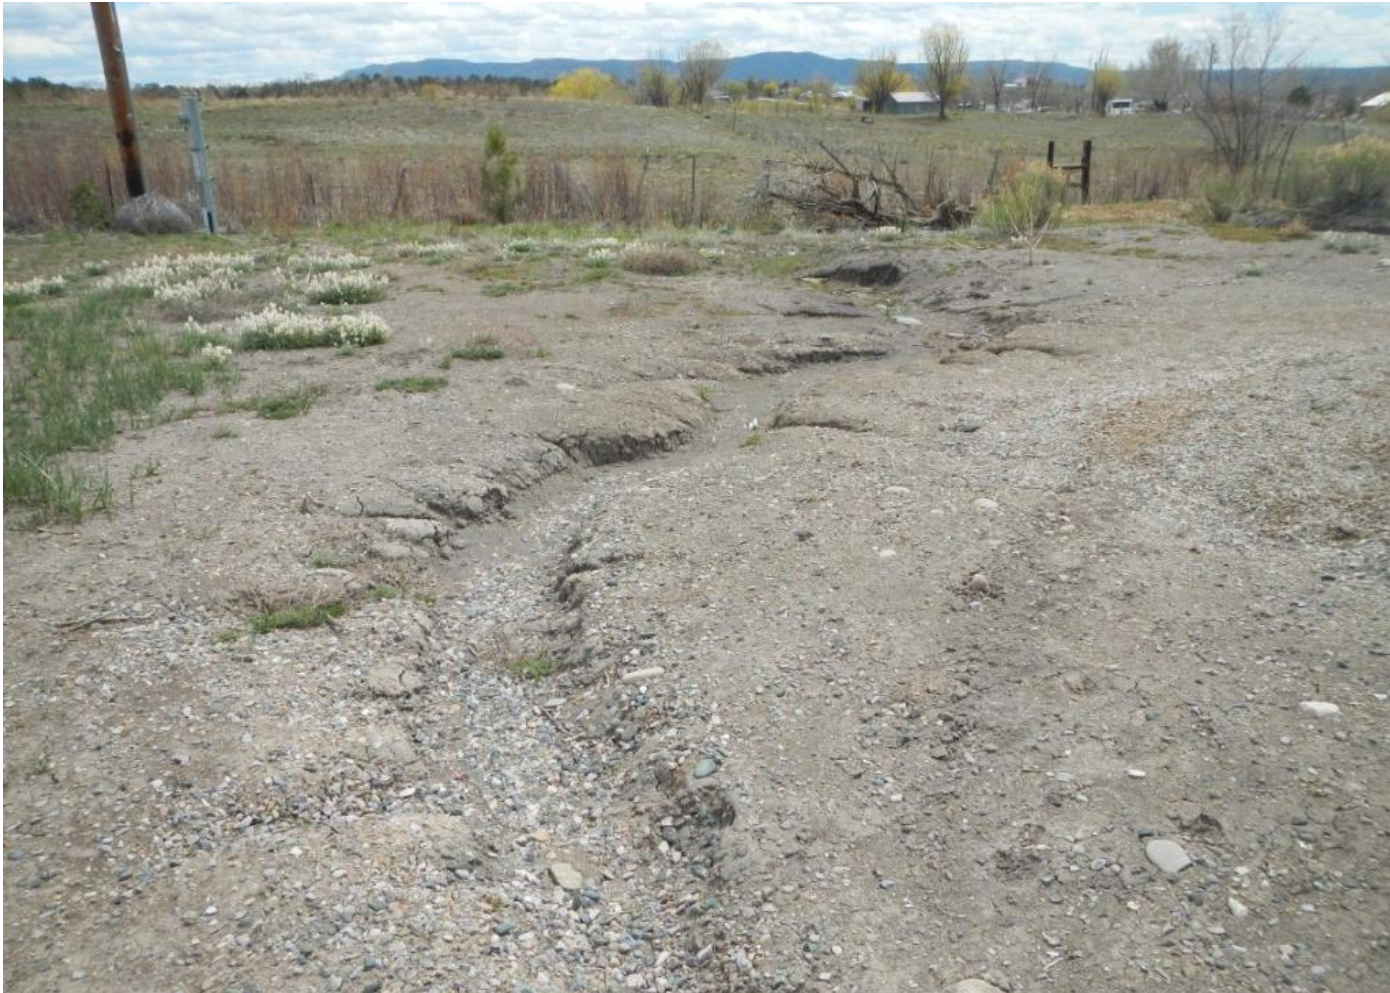
Photo 5. View of an erosional channel approximately 2 feet wide and deep in the northeastern portion of the project area.

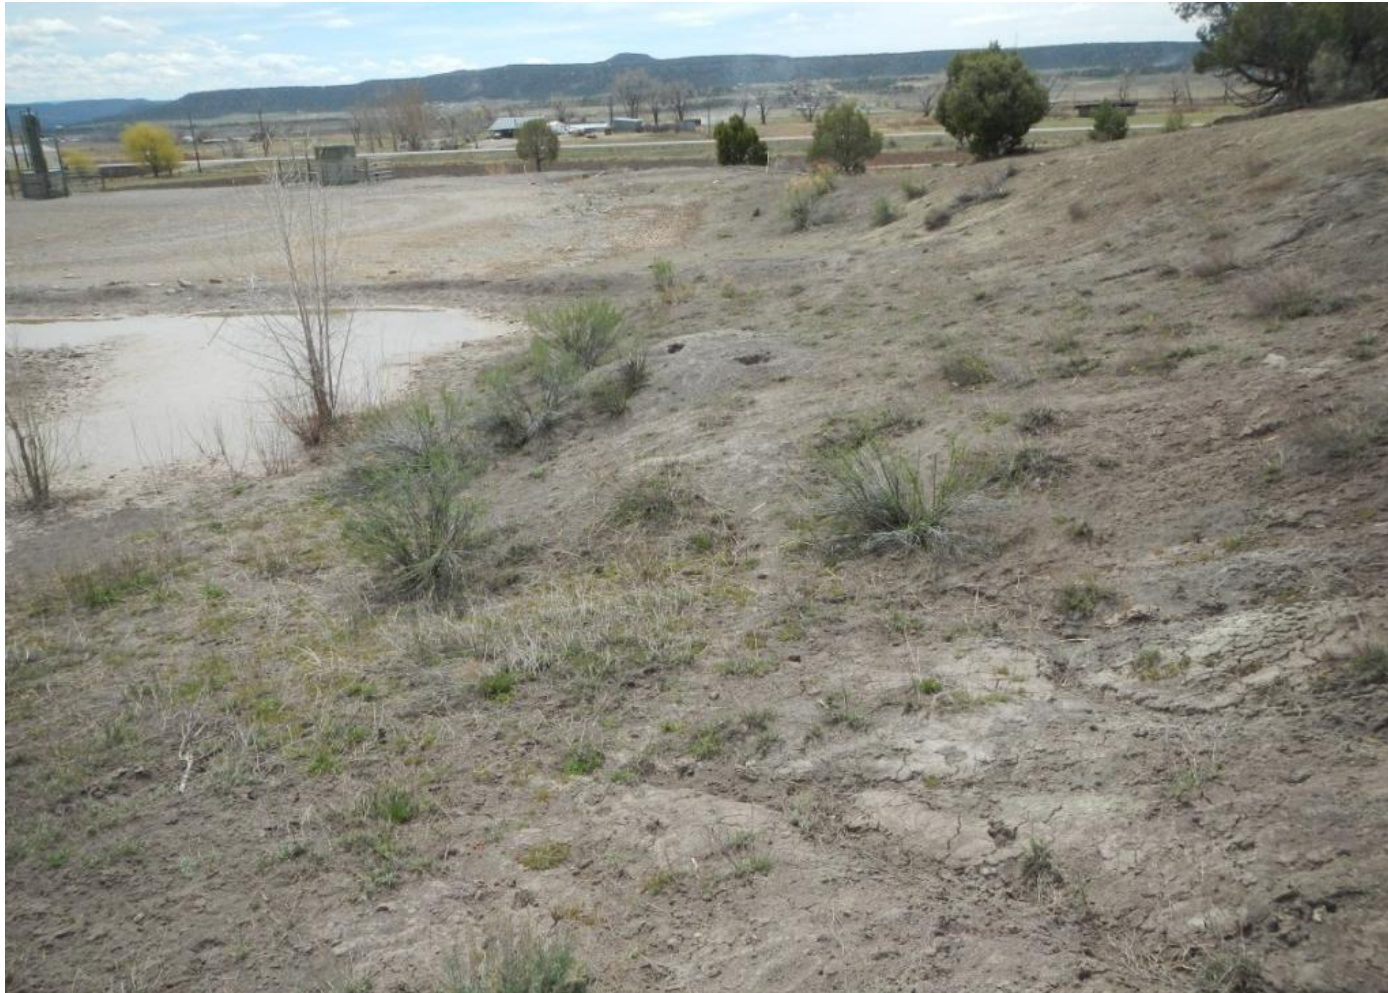
Photo 6. View of the western portion of the project area from the northwestern corner facing southward. Revegetation is largely comprised of rubber rabbitbrush (*Chrysothamnus nauseosus*), an unidentifiable aster, *Astragalus* sp., and cottonwood (*Populus* sp.).

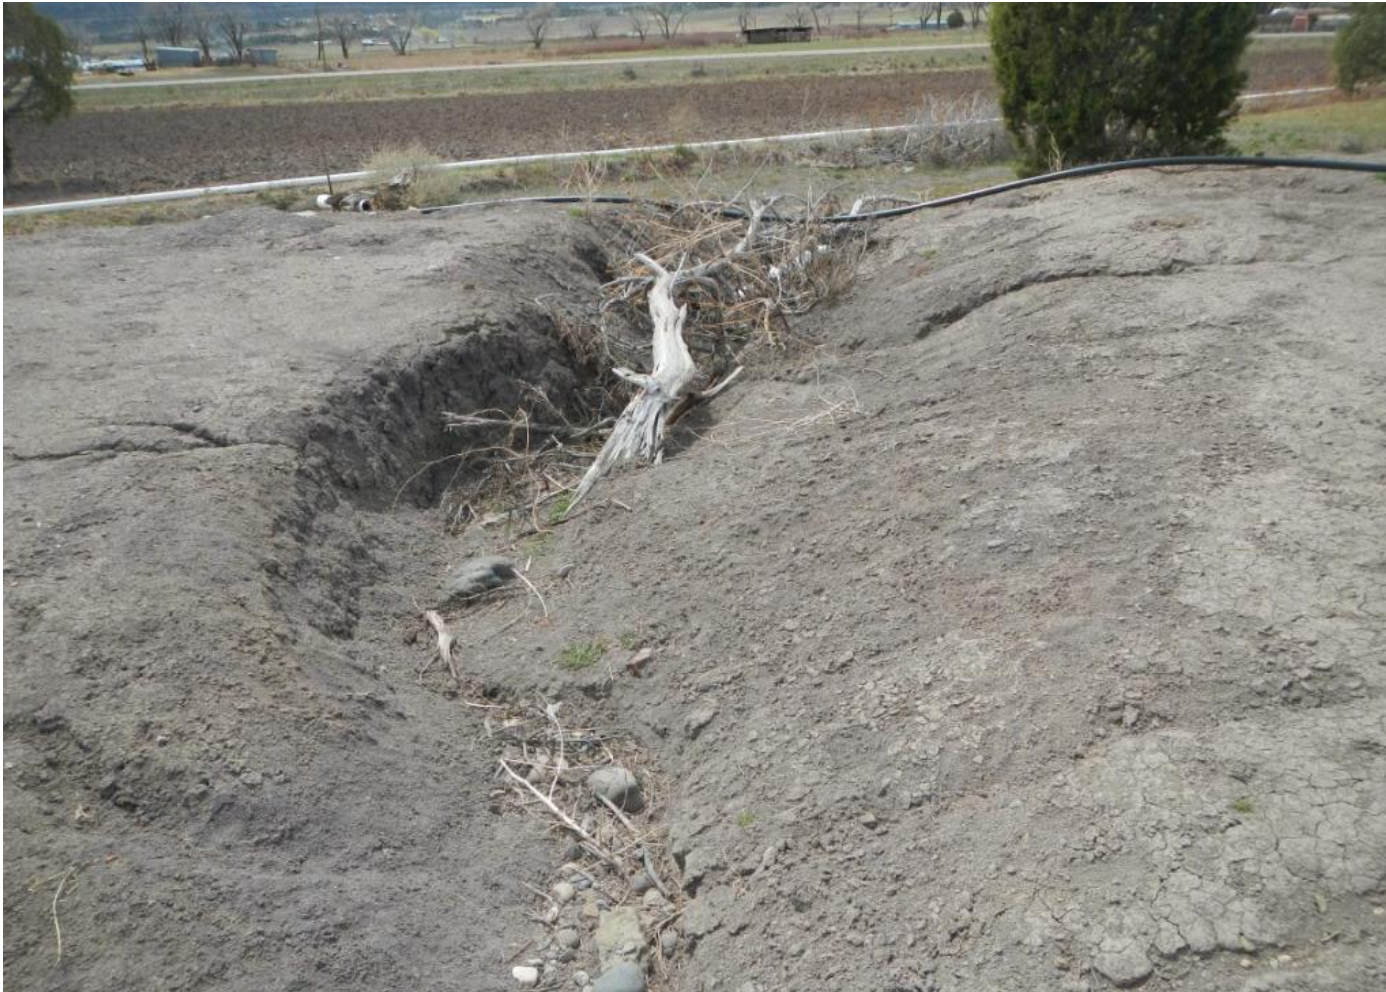
Photo 9. View of erosional channel in the southwestern portion of the project area approximately 4 feet wide and deep.

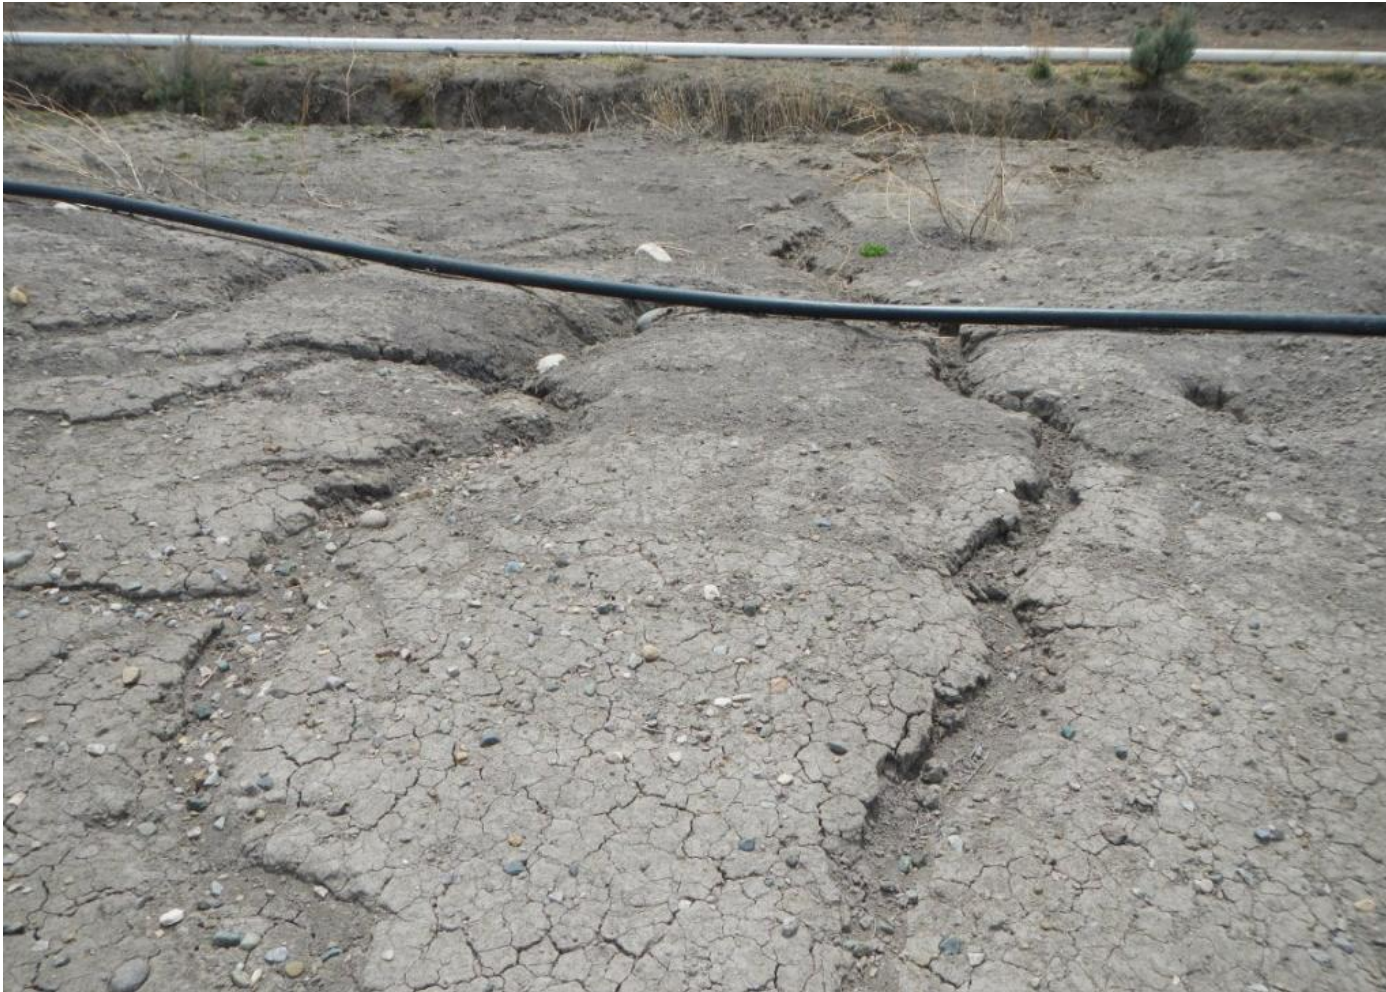
Photo 10. View of more erosional channels in the southern portion of the project area, flowing toward and irrigation ditch adjacent to the southern edge of the project area. Little vegetation present on southern slope.

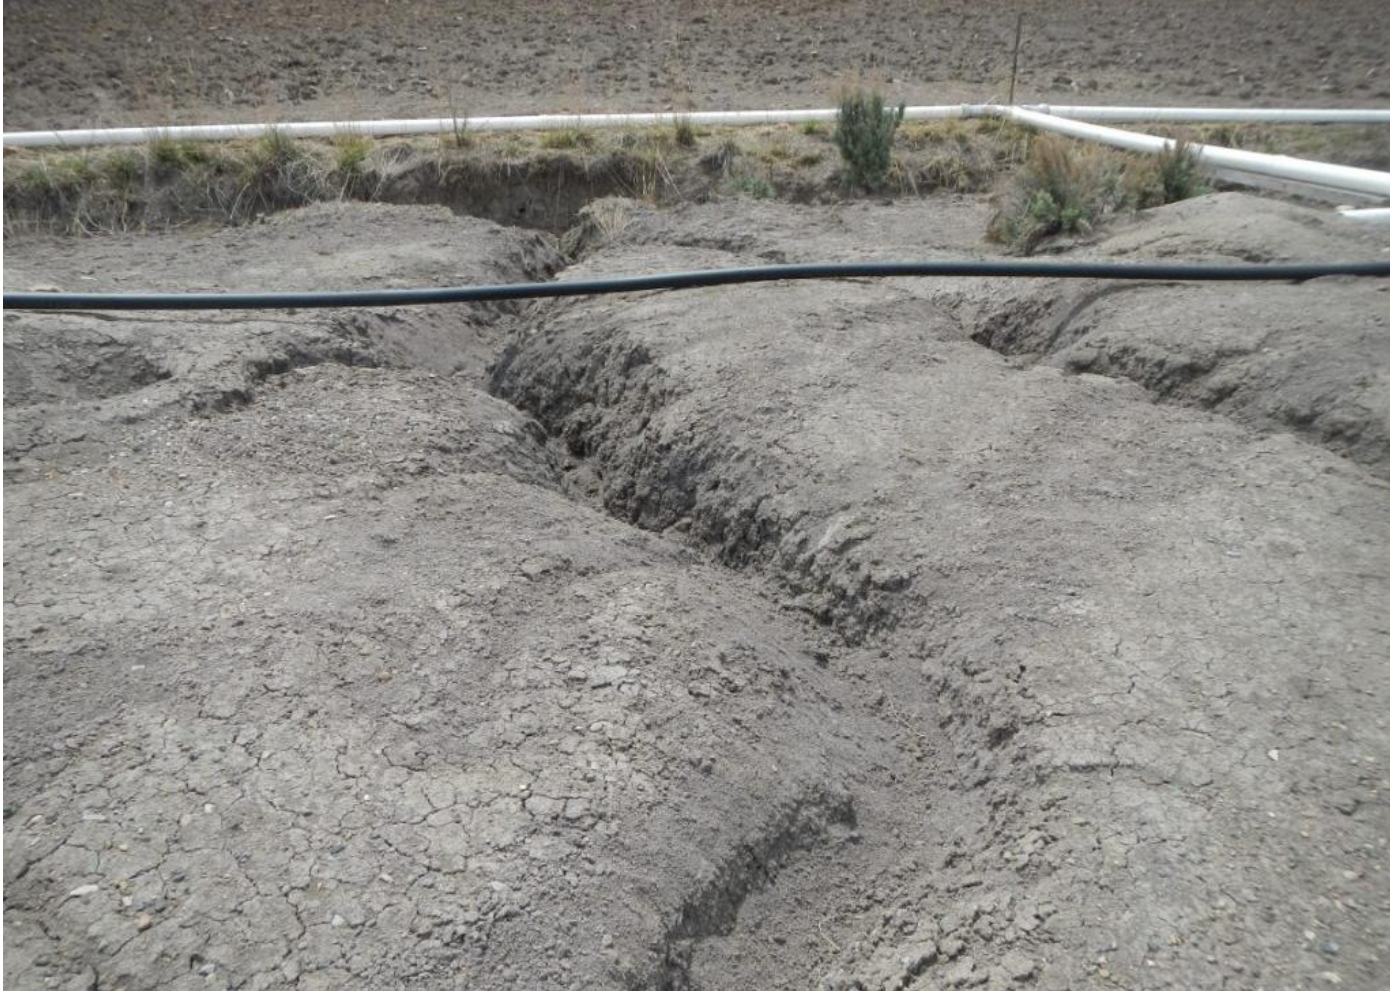
Photo 11. Another view of more erosional channels in the southern portion of the project area that flow directly to the southern irrigation ditch.
