Inspection Photos API# 123-10760

COLORADO
Oil & Gas Conservation
Commission
Department of Natural Resources

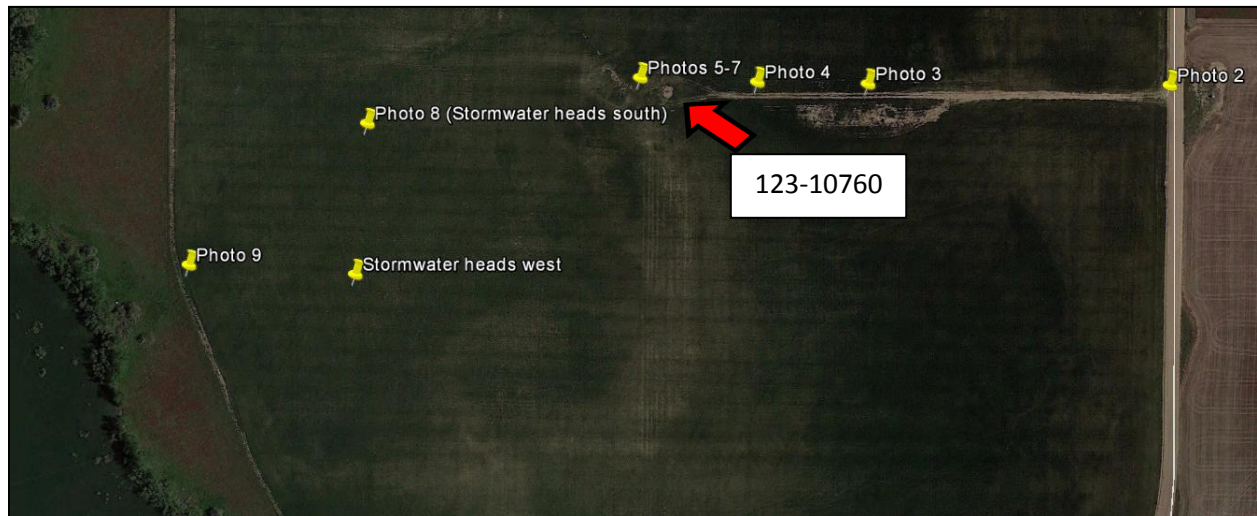
Photo 1: Aerial photo referencing locations of field photos taken on 4/19/16. Refer to Document# 682400502 for complete field photos from the 3/8/16 inspection.

Google Earth aerial photo illustrating that erosion and transport of sediment initiates on the lease road used for API# 123-10760, then travels west onto cropland and into Horse Creek Reservoir.

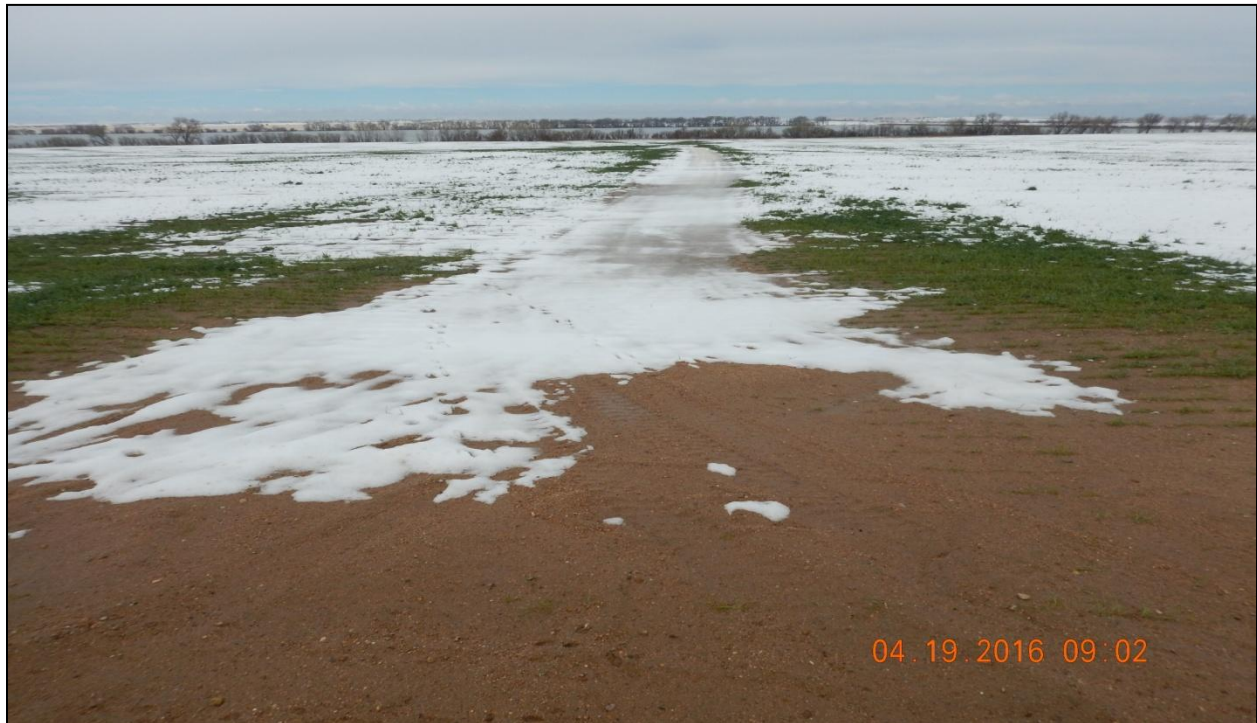
Photo 2: Photo taken 4/19/16 from the lease road entrance off CR53, facing West. Erosion and transport of sediment initiates on the lease road used for API# 123-10760.

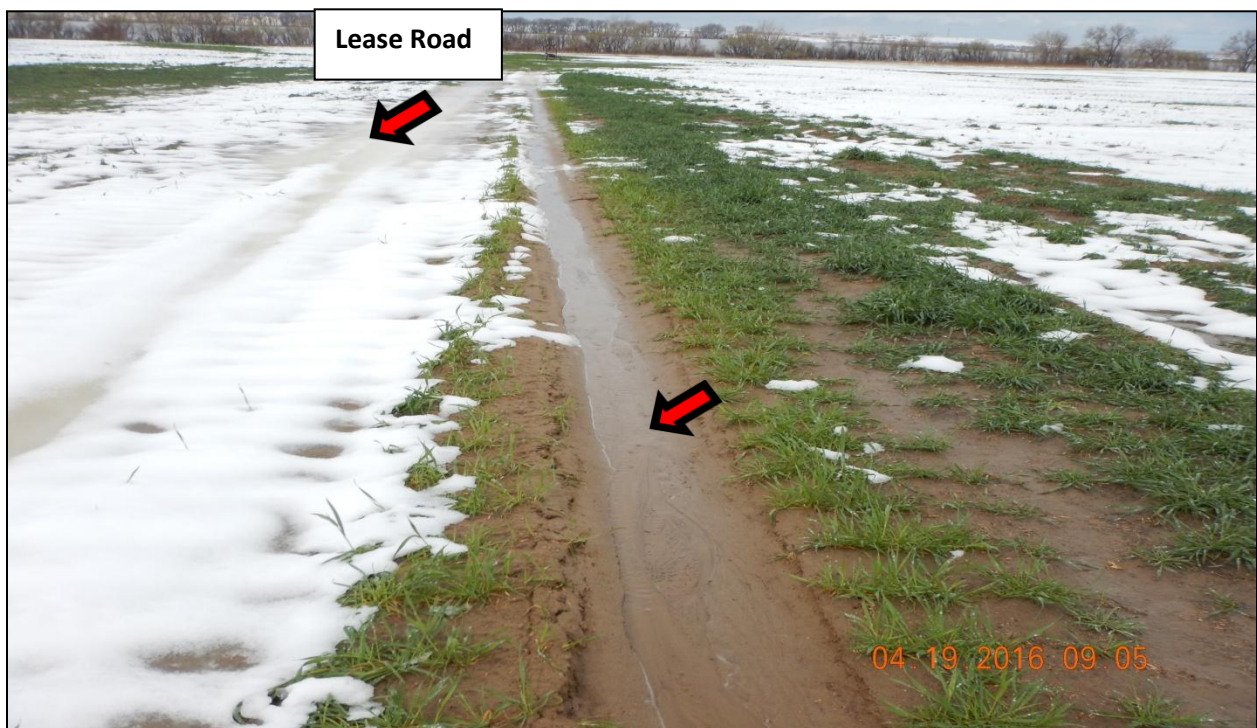
Photo 3: Photo taken 4/19/16 along the lease road, facing West. This photo illustrates stormwater traveling in the path of the lease road and along a vehicle rut adjacent to the lease road. Need to comply with Rule 1002.e.(4) and restrict vehicle traffic to lease road.

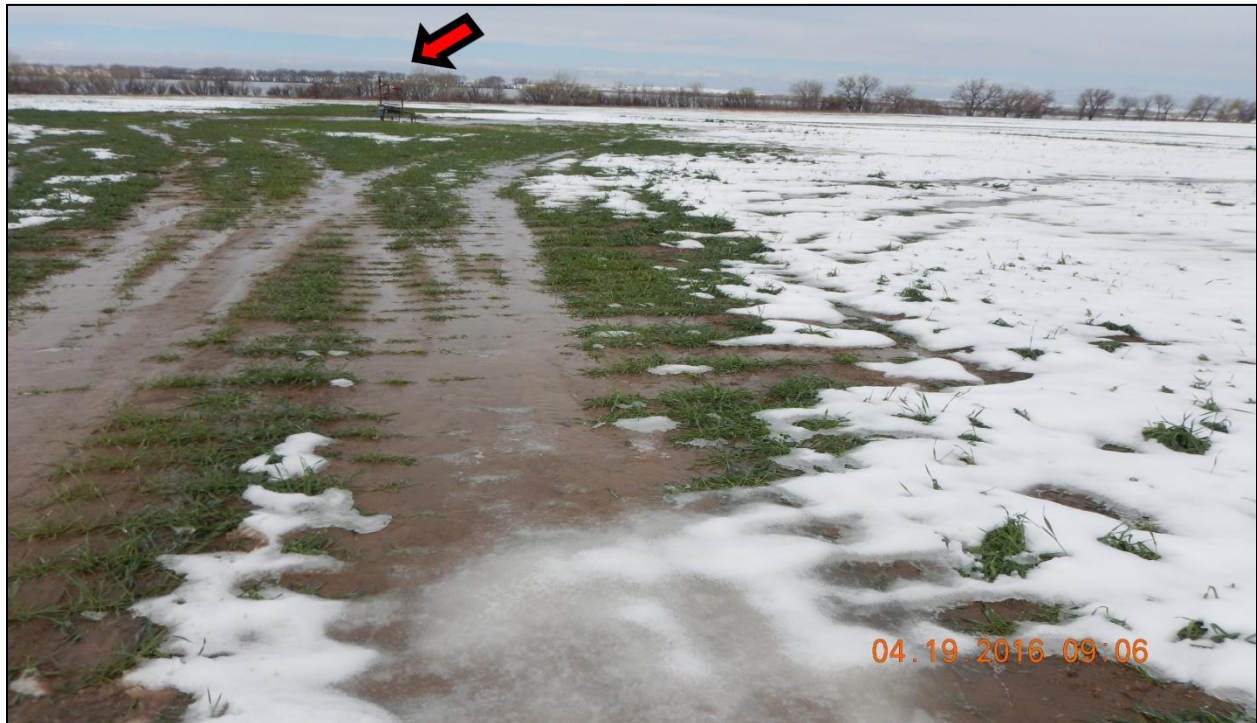
Photo 4: Photo taken 4/19/16 east, before the wellhead along the lease road, facing West. This photo illustrates stormwater traveling along the path of the lease road.

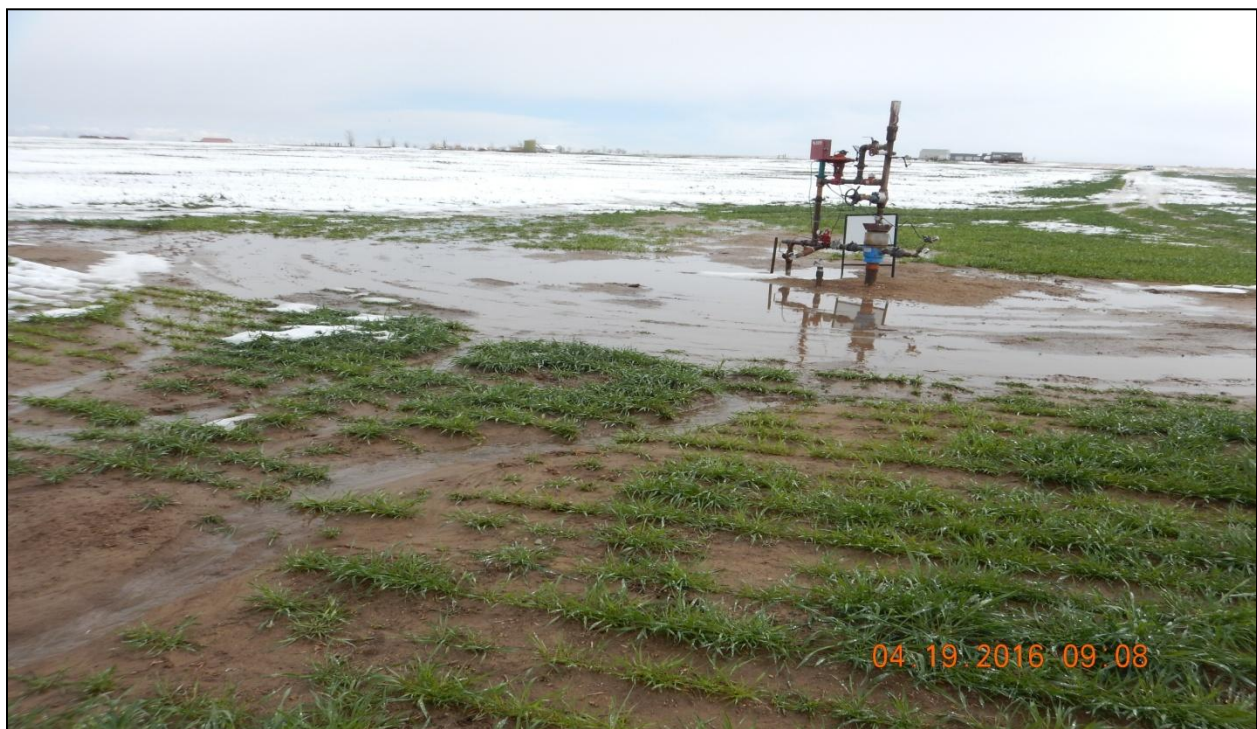
Photo 5: Photo taken 4/19/16 west of wellhead, facing East. This photo illustrates stormwater leaving the location, then traveling west onto crop and eventually Horse Creek Reservoir.

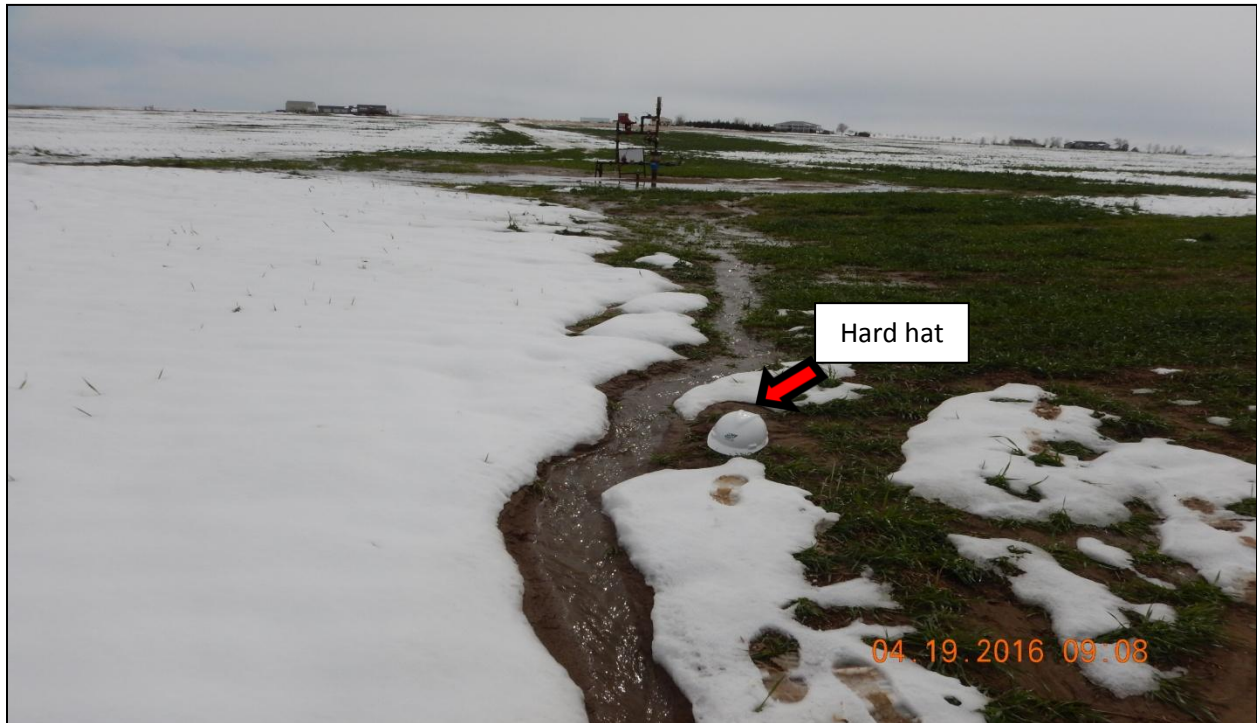
Photo 6: Photo taken 4/19/16 west of wellhead, facing East from cropland field. This photo illustrates stormwater traveling west onto cropland.

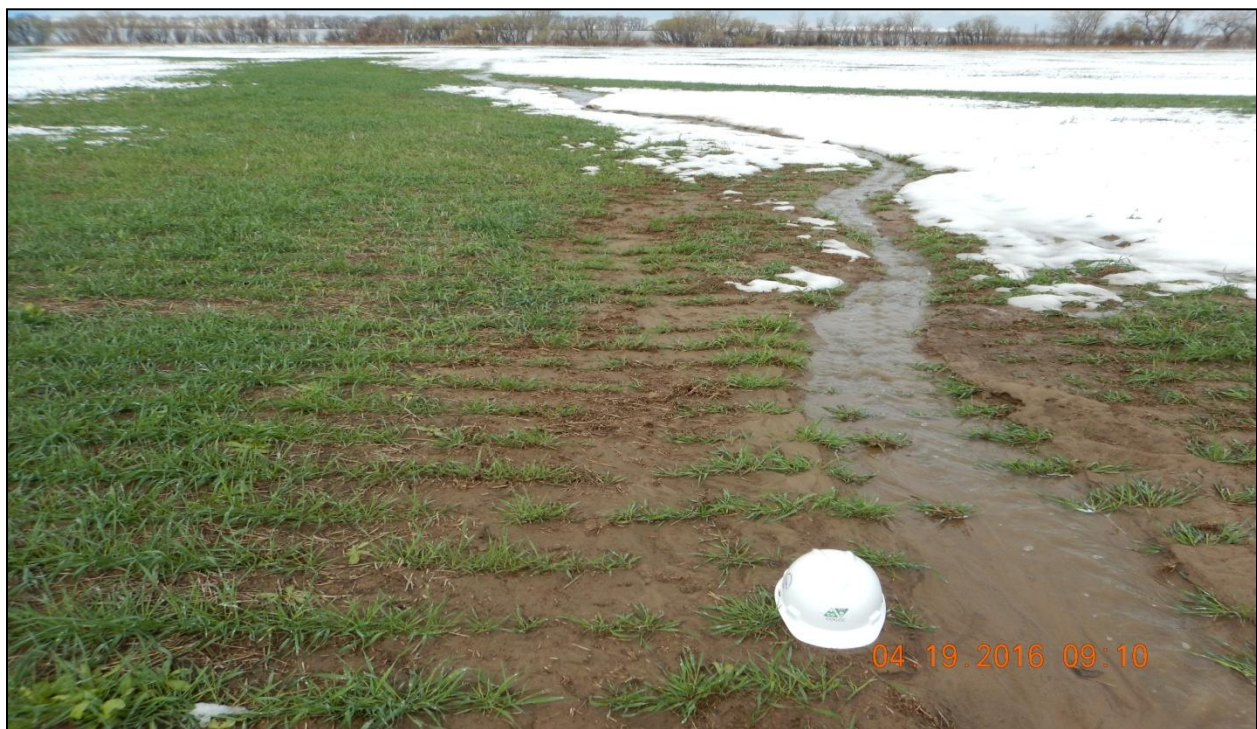
Photo 7: Photo taken 4/19/16 from the same location as the previous photo, facing West. This photo illustrates stormwater traveling west onto cropland.

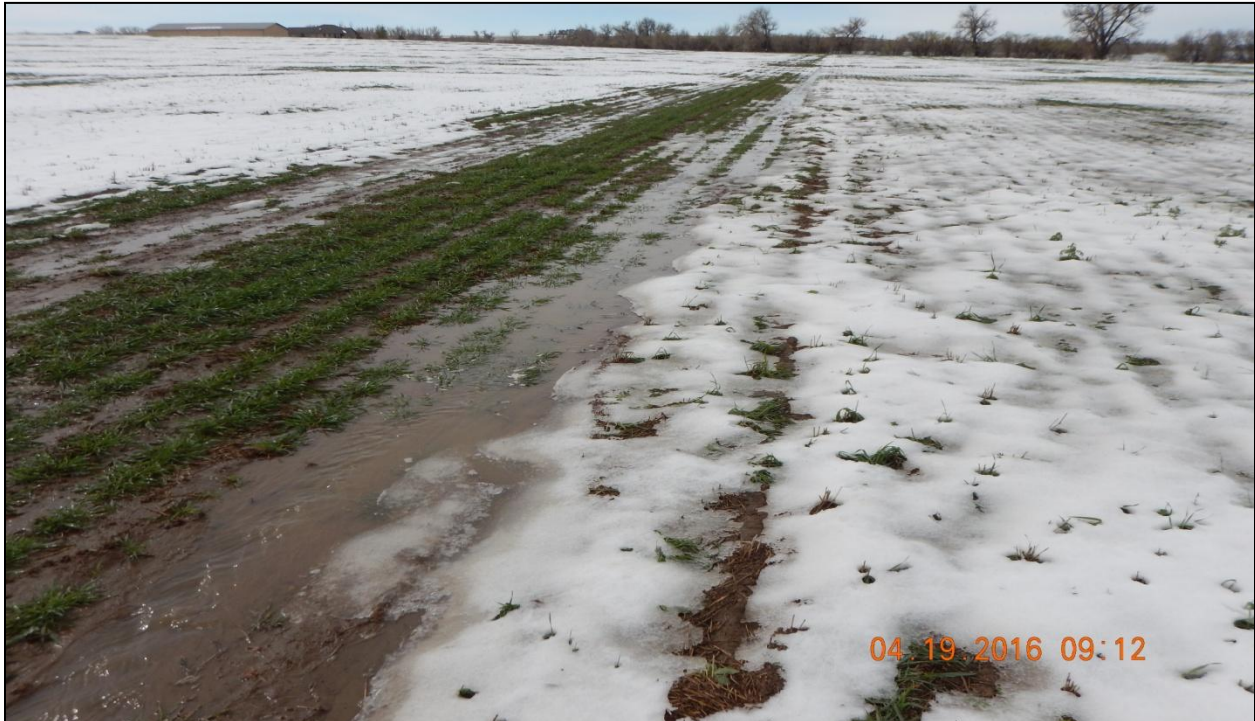
Photo 8: Photo taken 4/19/16 west of location, facing South. This photo illustrates stormwater traveling onto cropland. At this point, the stormwater heads south approximately 300 feet, then heads back west towards the reservoir.

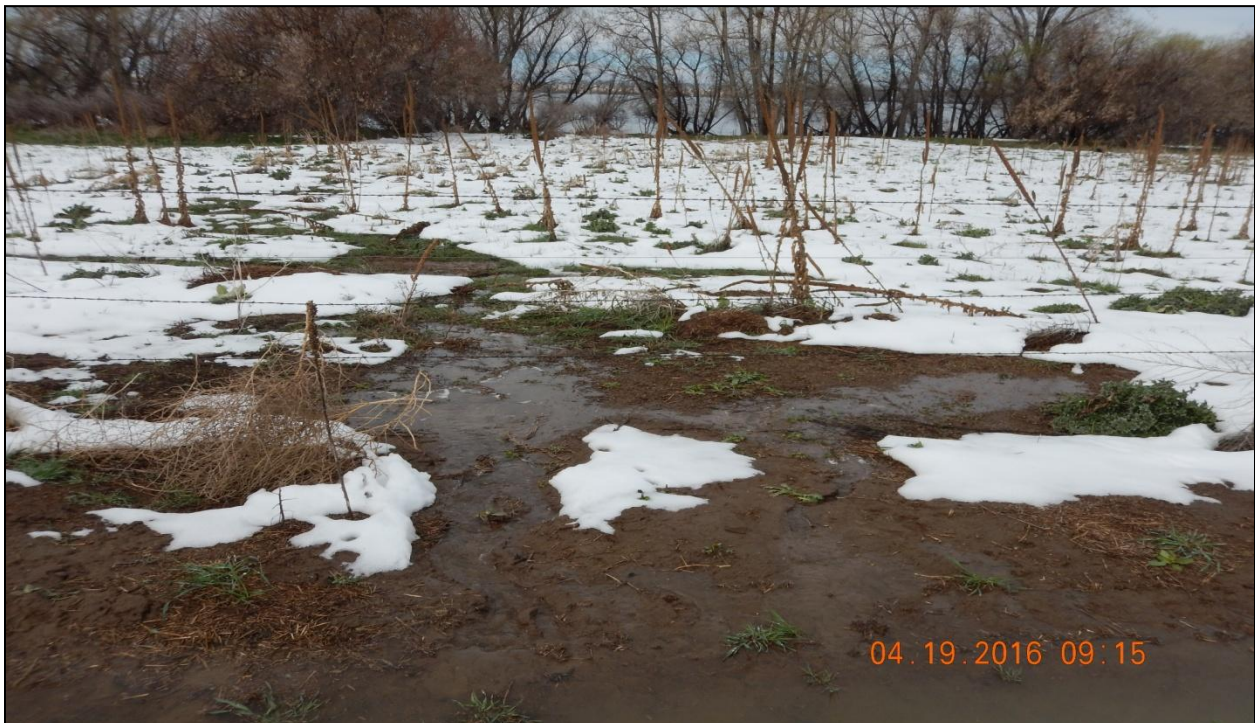
Photo 9: Photo taken 4/19/16 approximately 200 feet east of the reservoir where stormwater continues to travel west towards the reservoir, facing West.

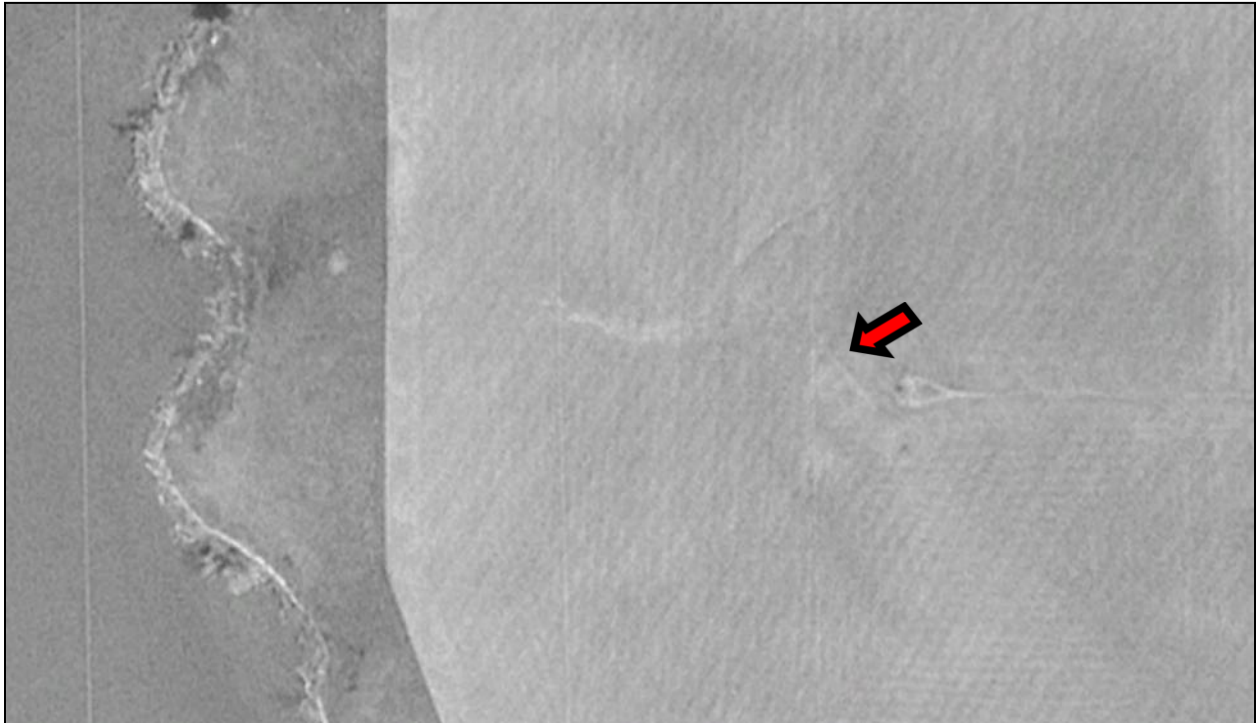
Photo 10. Google earth aerial imagery taken 1999. Slight evidence of erosion coming off the well location.

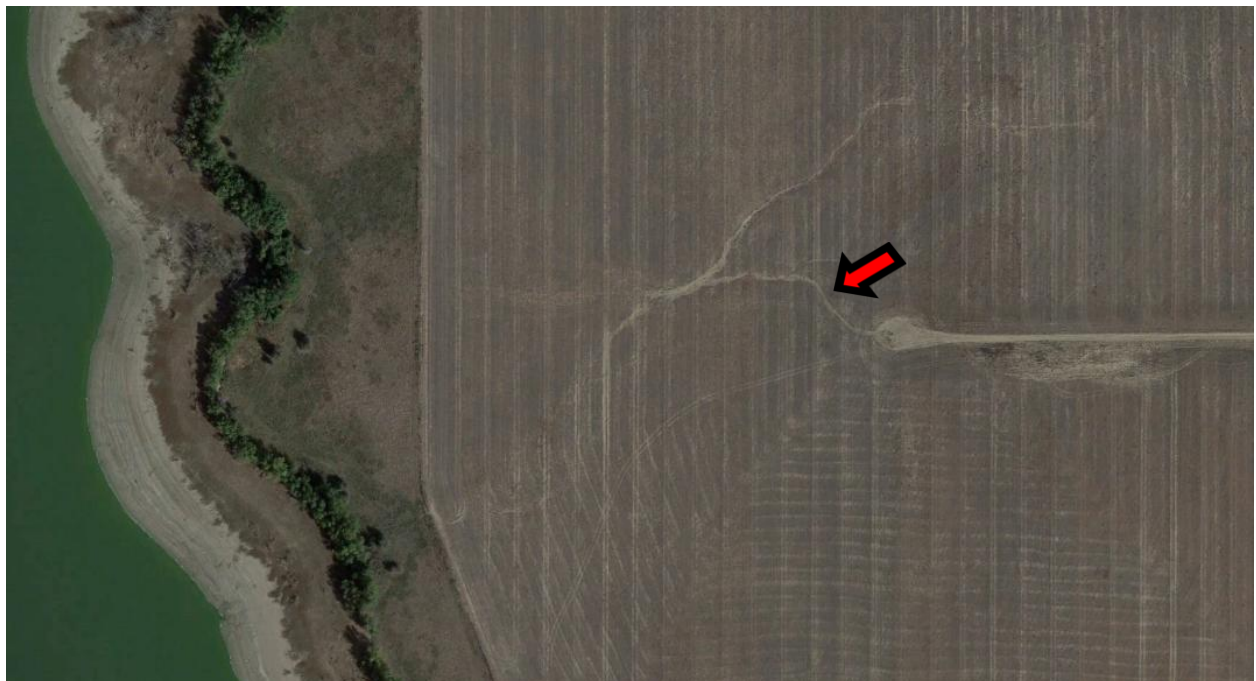
Photo 11. Google earth aerial imagery taken 2015. Apparent evidence of erosion coming off the well location.

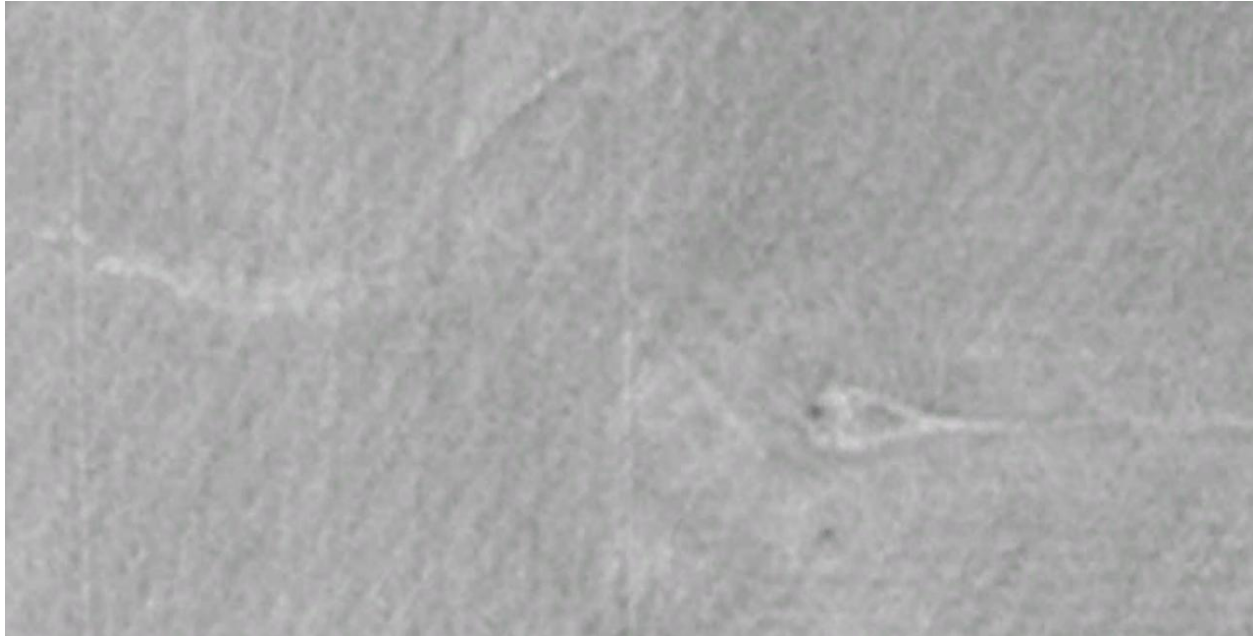
Photo 12. Google earth aerial imagery taken 1999. Slight evidence of erosion coming off the well location.

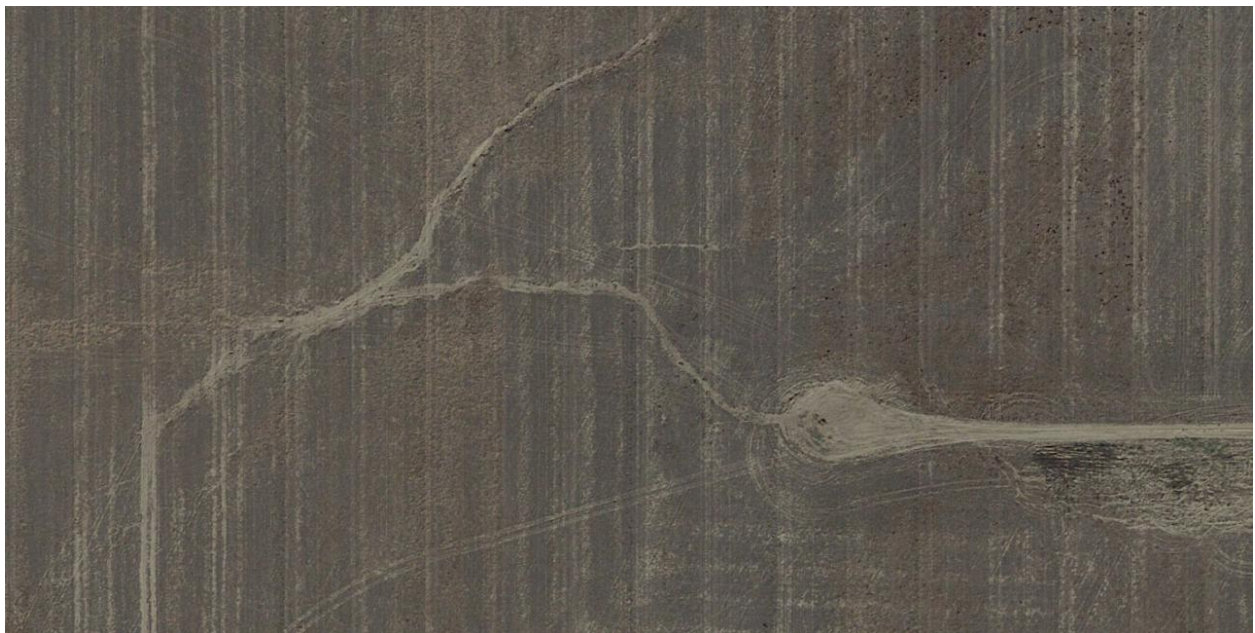
Photo 13. Google earth aerial imagery taken 2015. Apparent evidence of erosion coming off the well location. Appears erosion has increased overtime.
