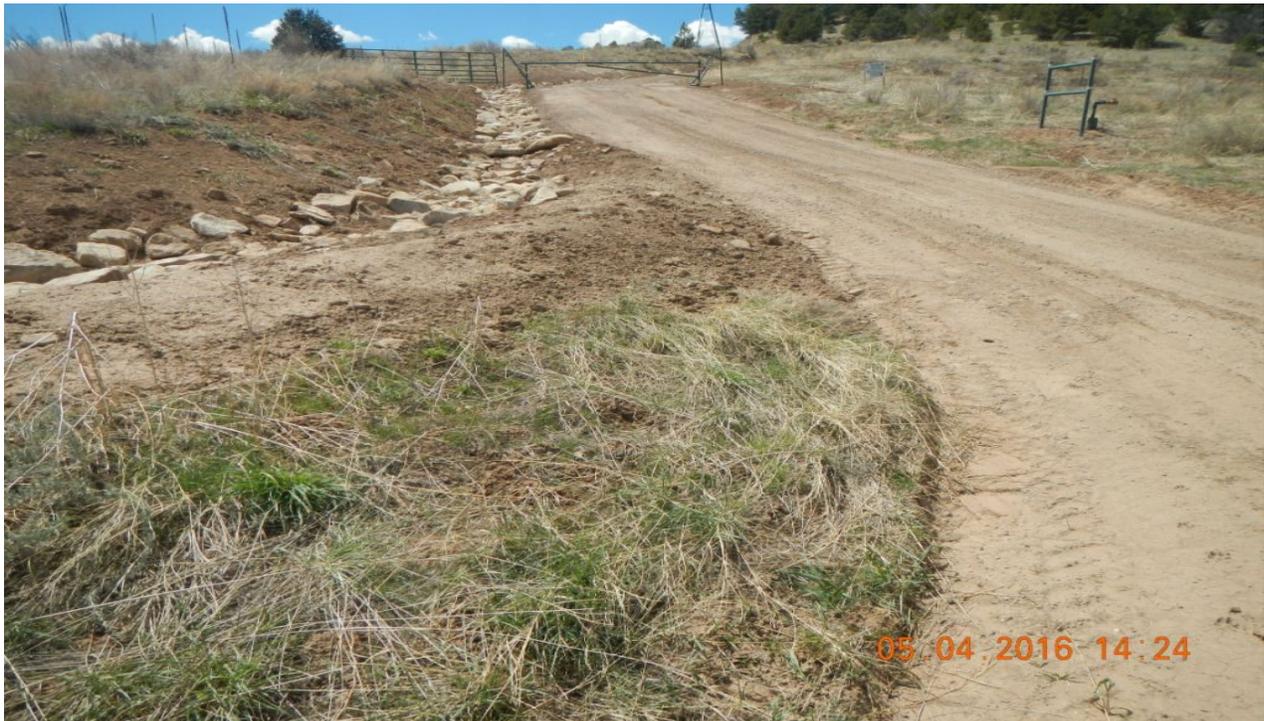
photo 1: Facing west along the access road. A diversion ditch with rock rip/rap has been installed.

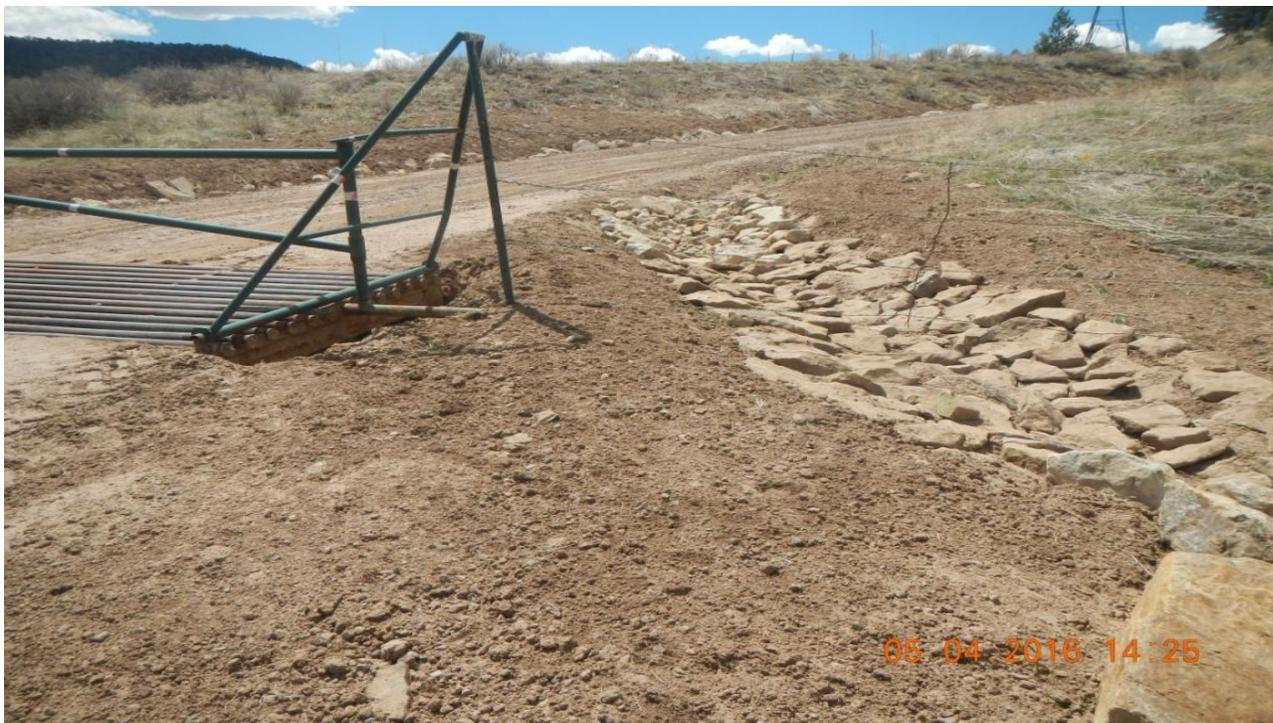
photo 2: A diversion ditch with rock rip/rap has been installed to direct stormwater away from the main access road.

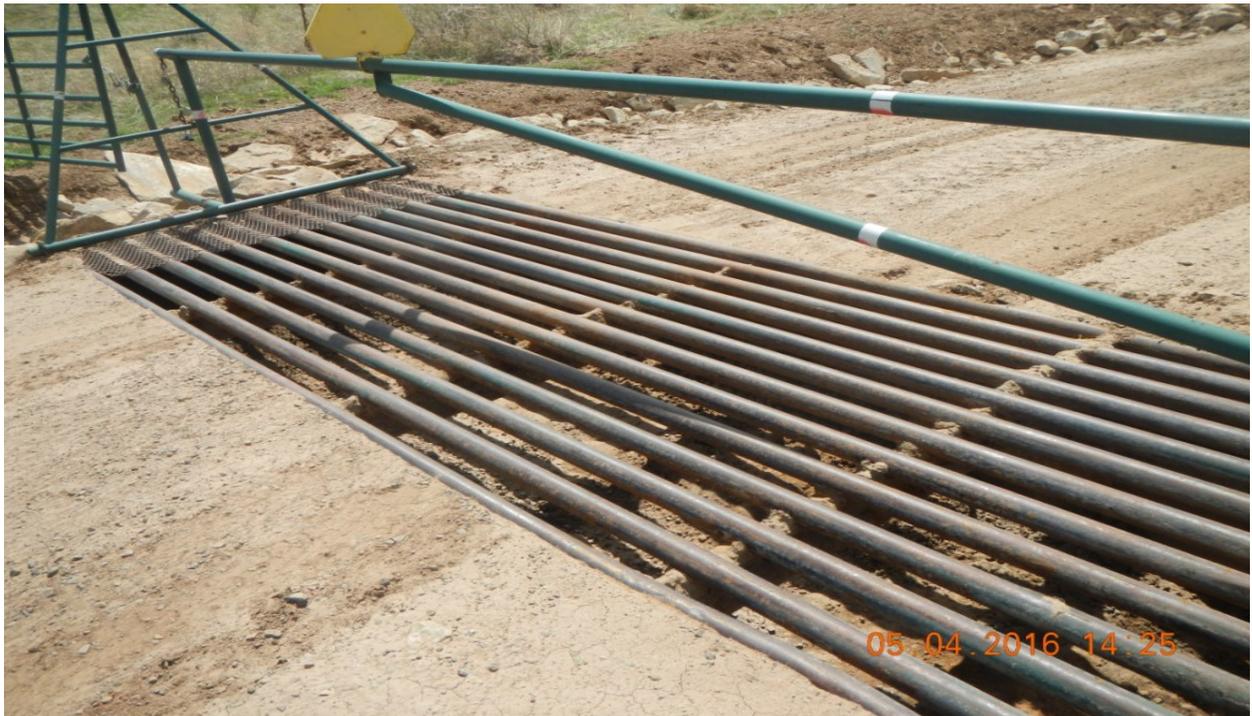
photo 3: Sediment has been cleaned out of the cattle guard.

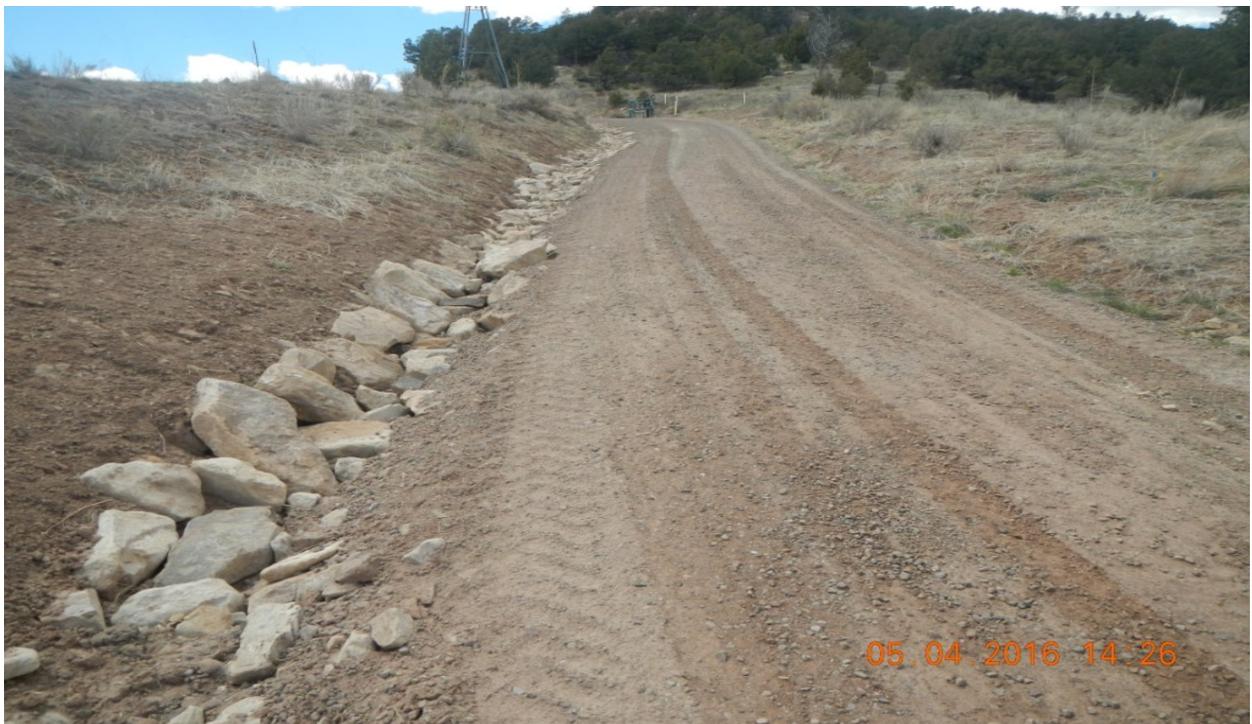
photo 4: Facing west along the access road.

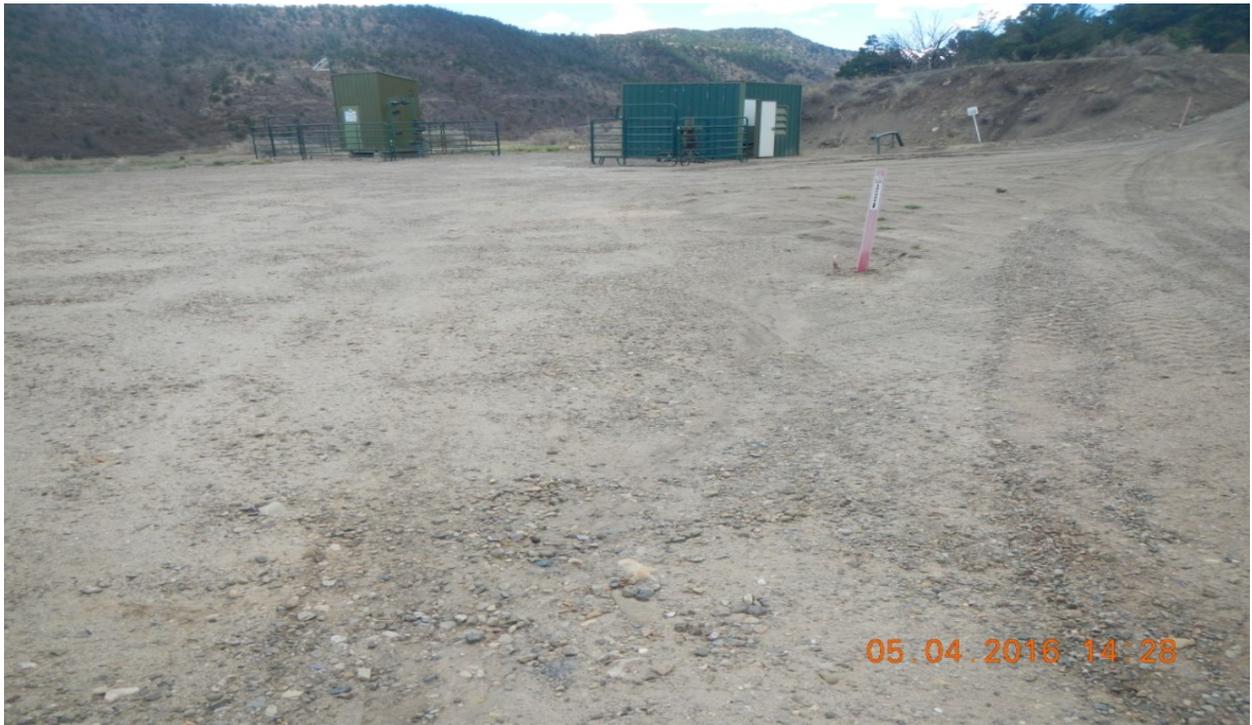
photo 5: Northeast side of the location facing southwest.

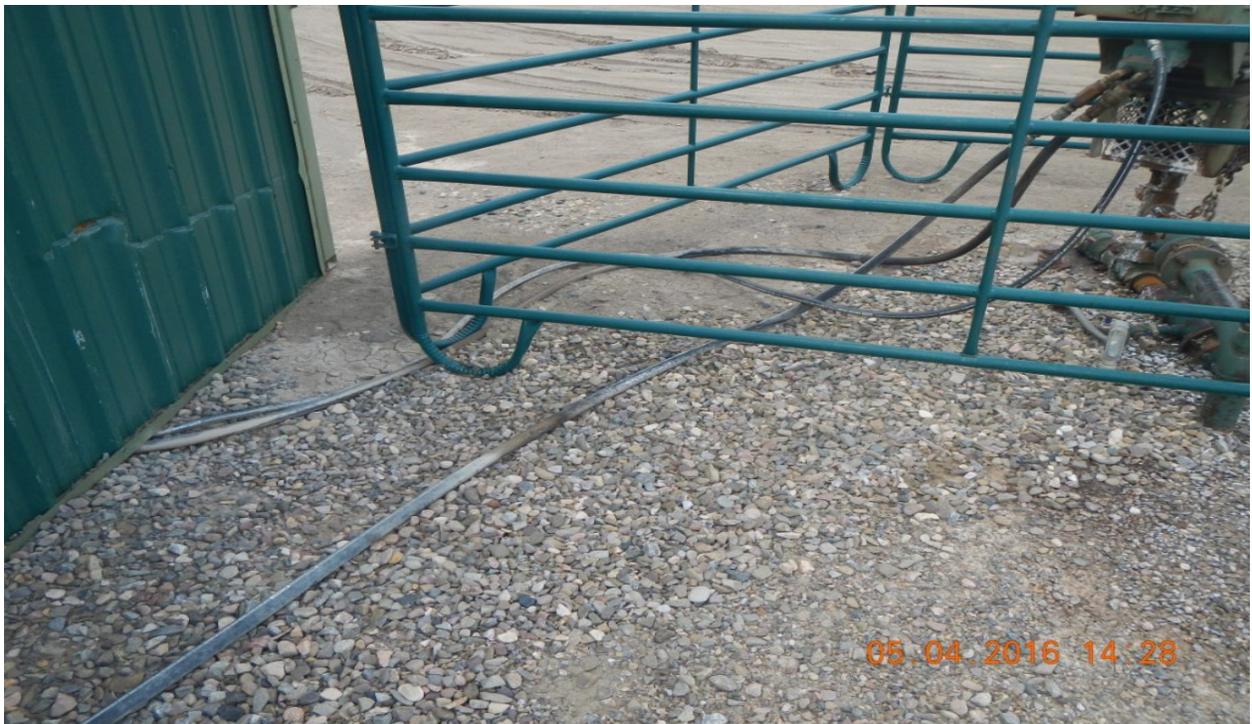
photo 6: Area near well head where oil stained surface was noticed appears to have been cleaned up.

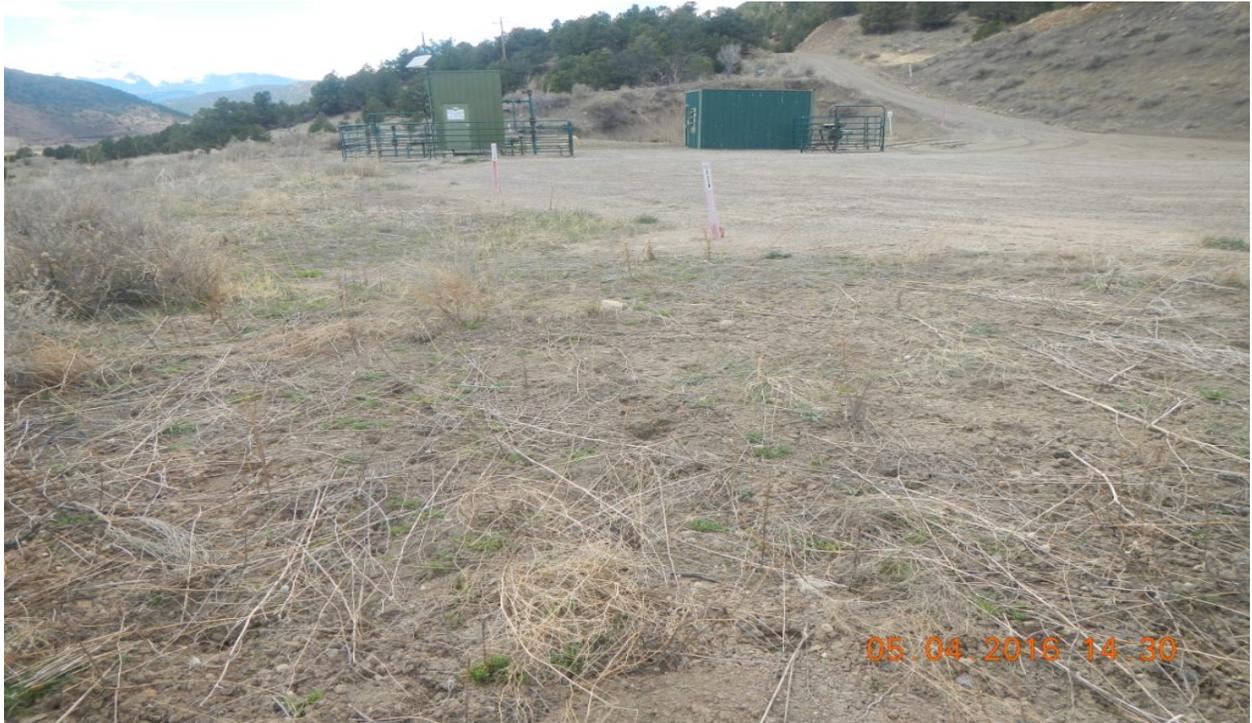
photo 7: Southeast side of the location facing west.

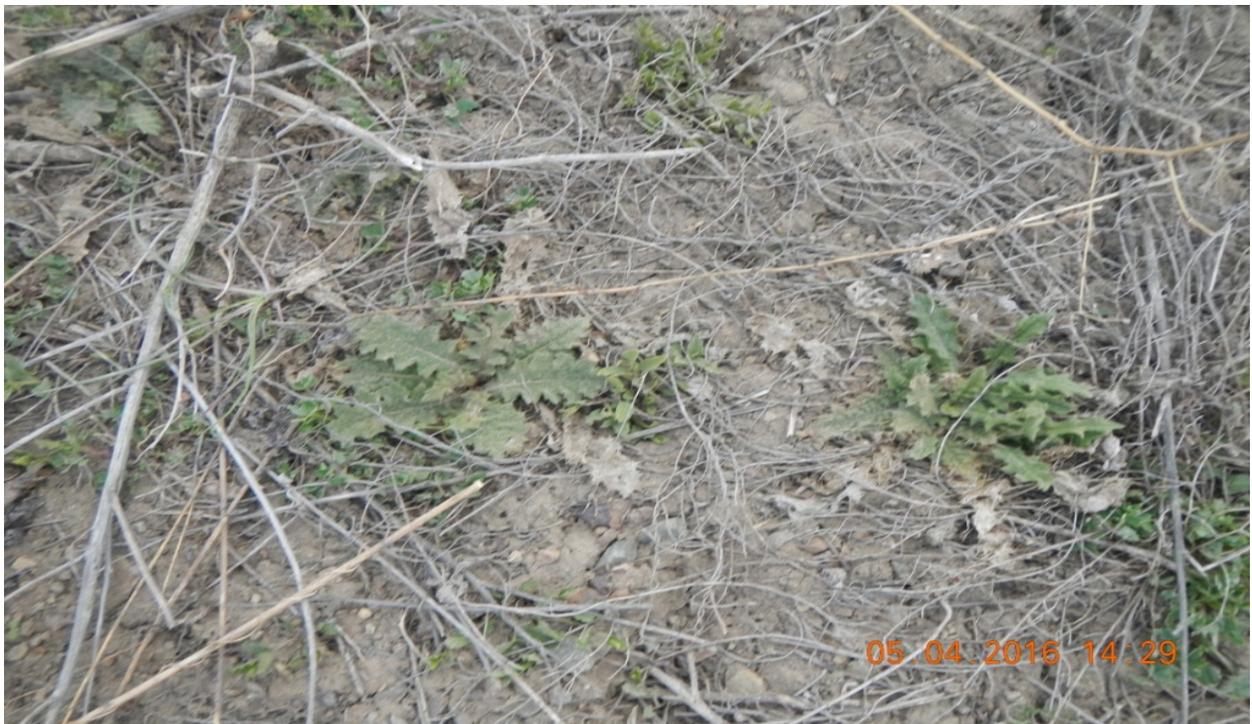
photo 8: Noticed Bull thistle beginning to germinate at the southeast side of the location.
