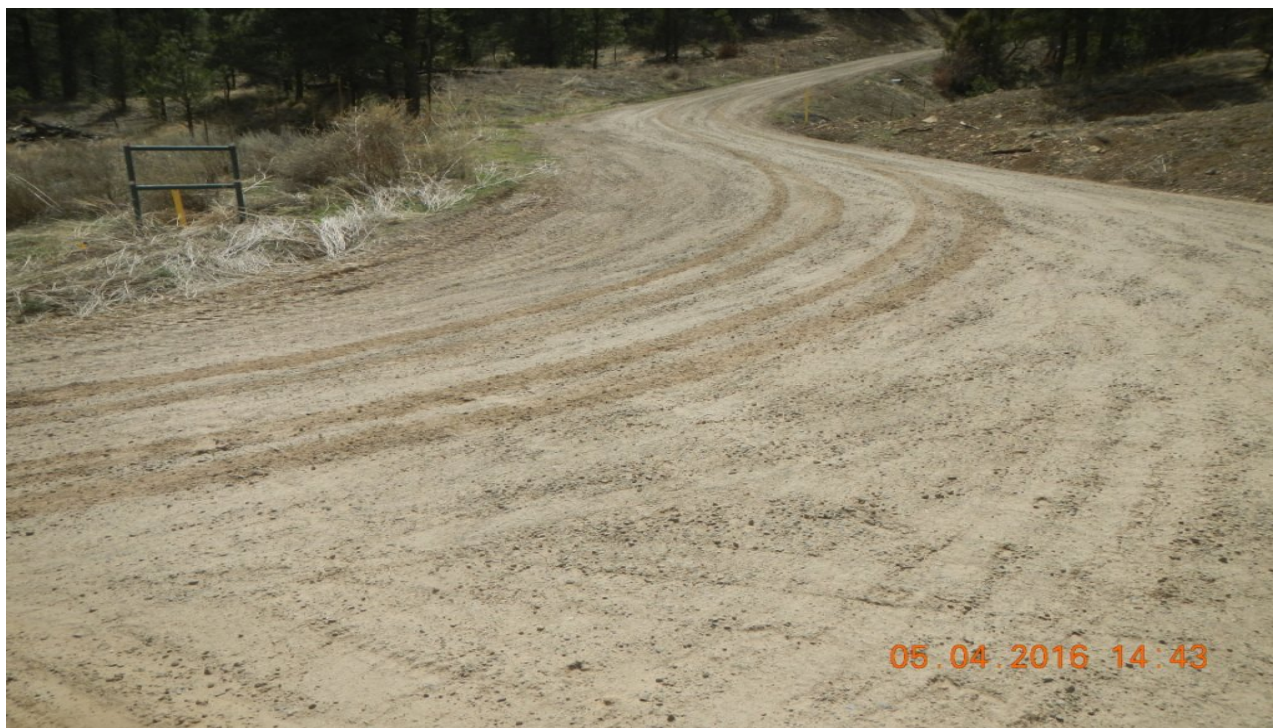
photo 1: Facing west toward the access road from the county road.

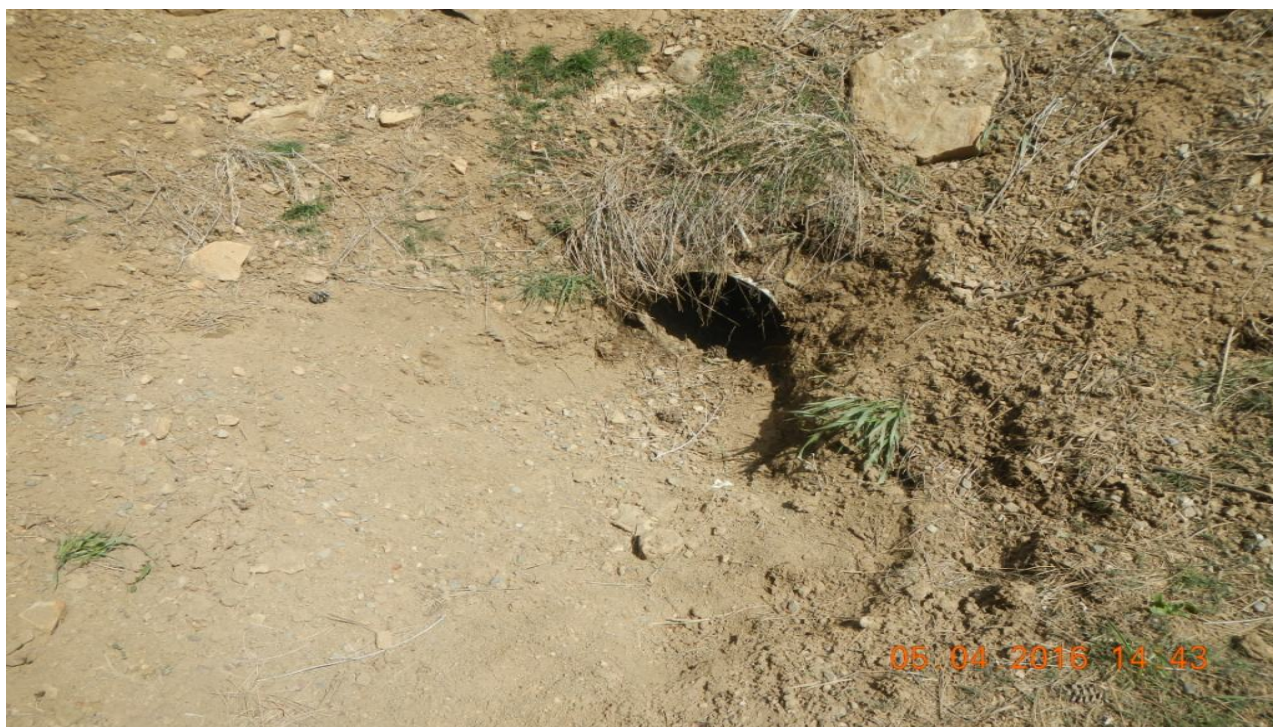
photo 2: Sediment around the culvert has been removed.

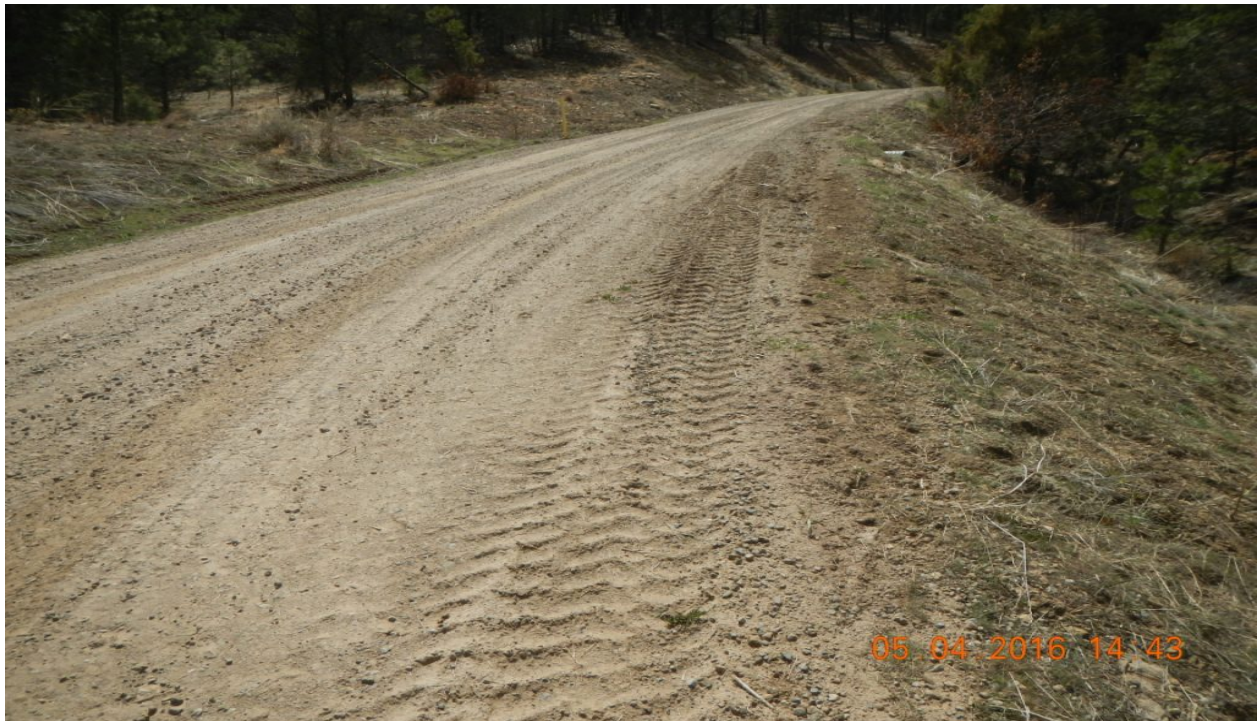
photo 3: Facing west toward the access road.

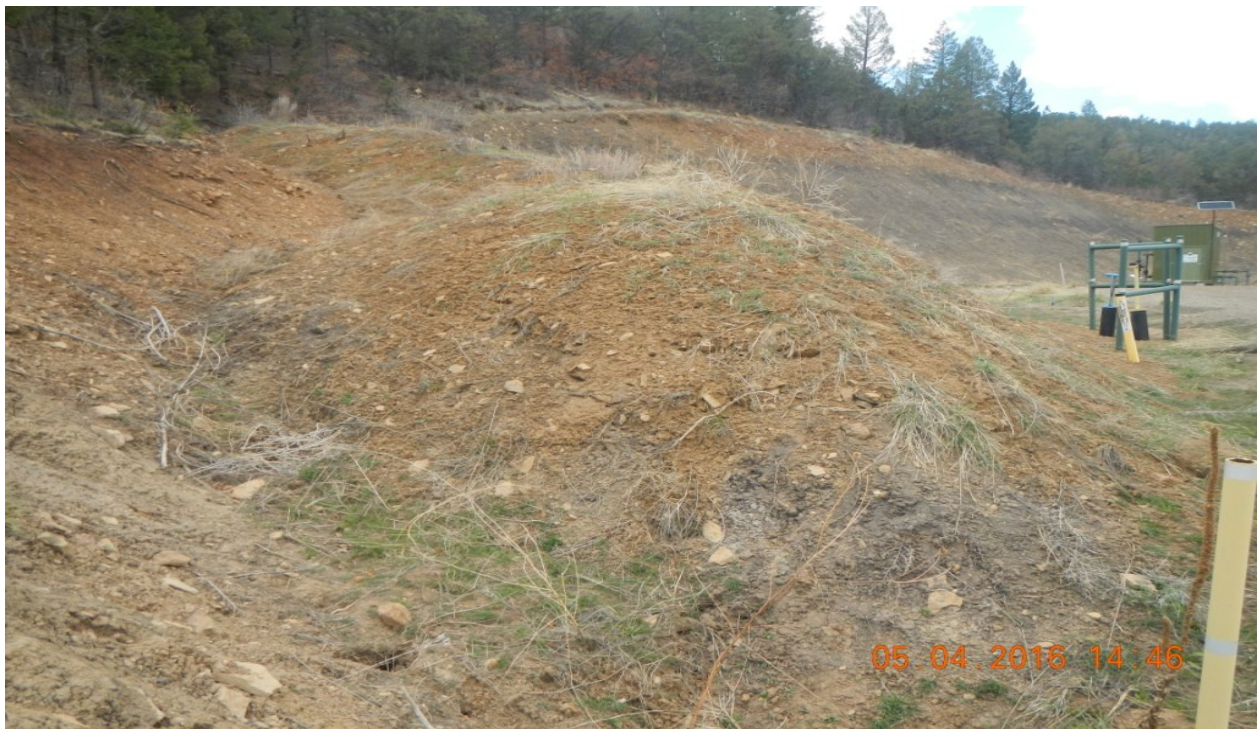
photo 4: Facing northwest toward location. Diversion ditch around the west side of the location.

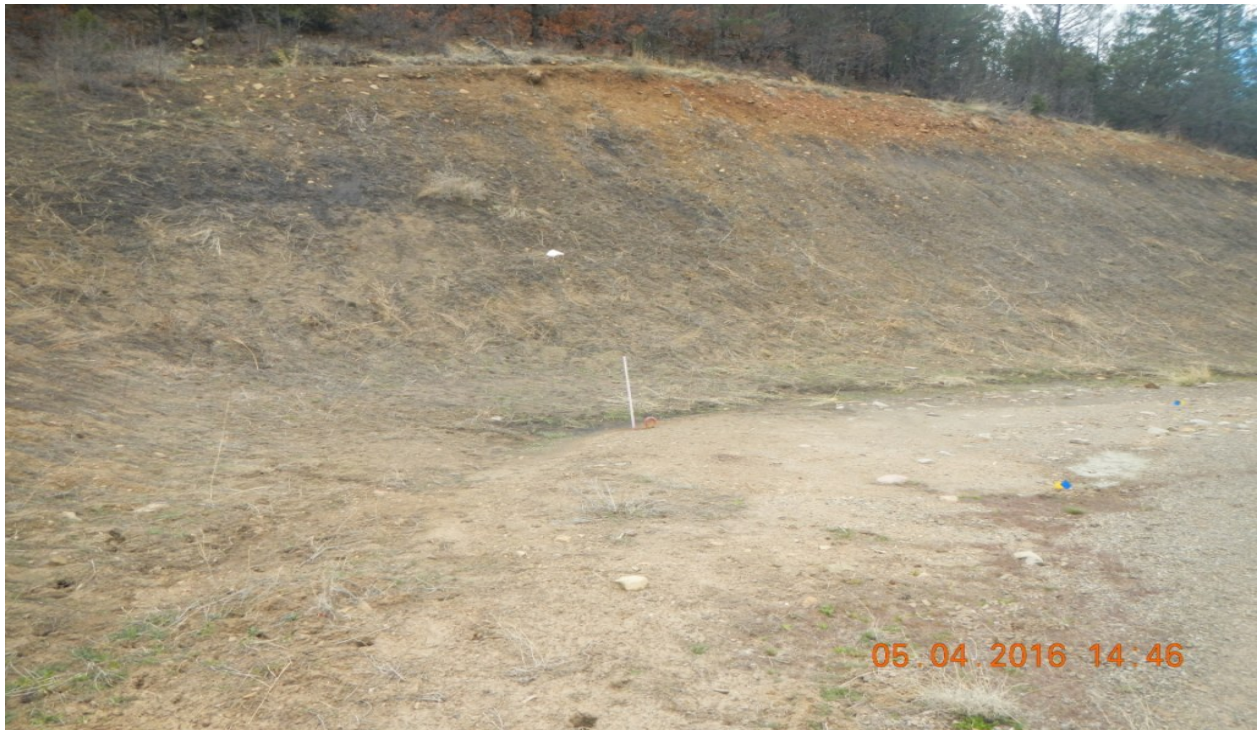
photo 5: Facing toward the cut slope at the west side of the location. Vegetation is not established along this area of the pad.

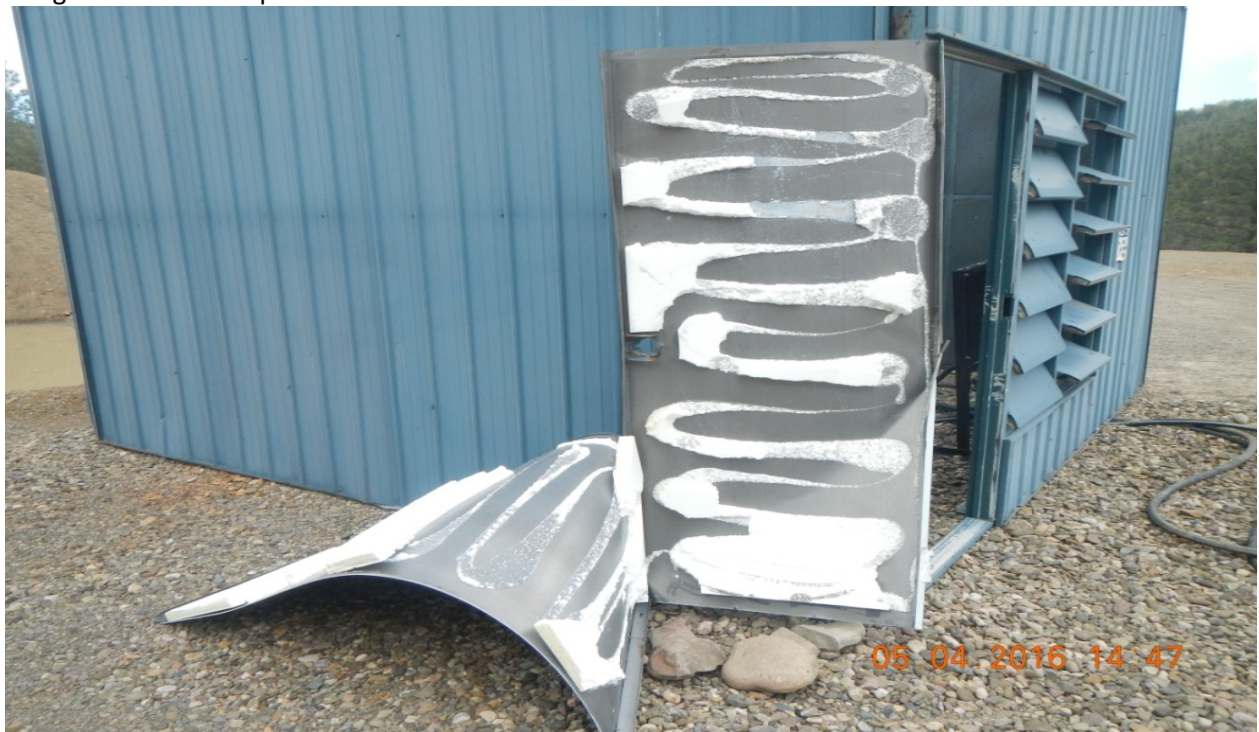
photo 6: Door of the shed is broken.

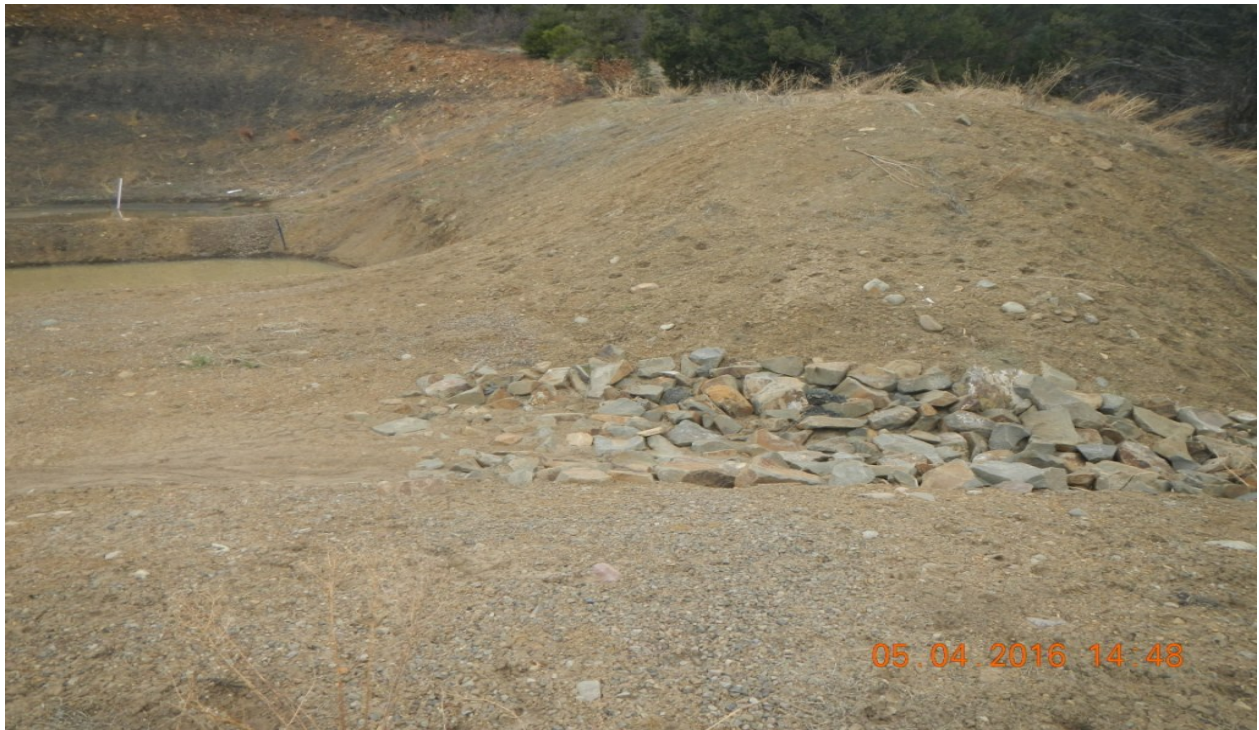
photo 7: Northeast side of the location facing west.

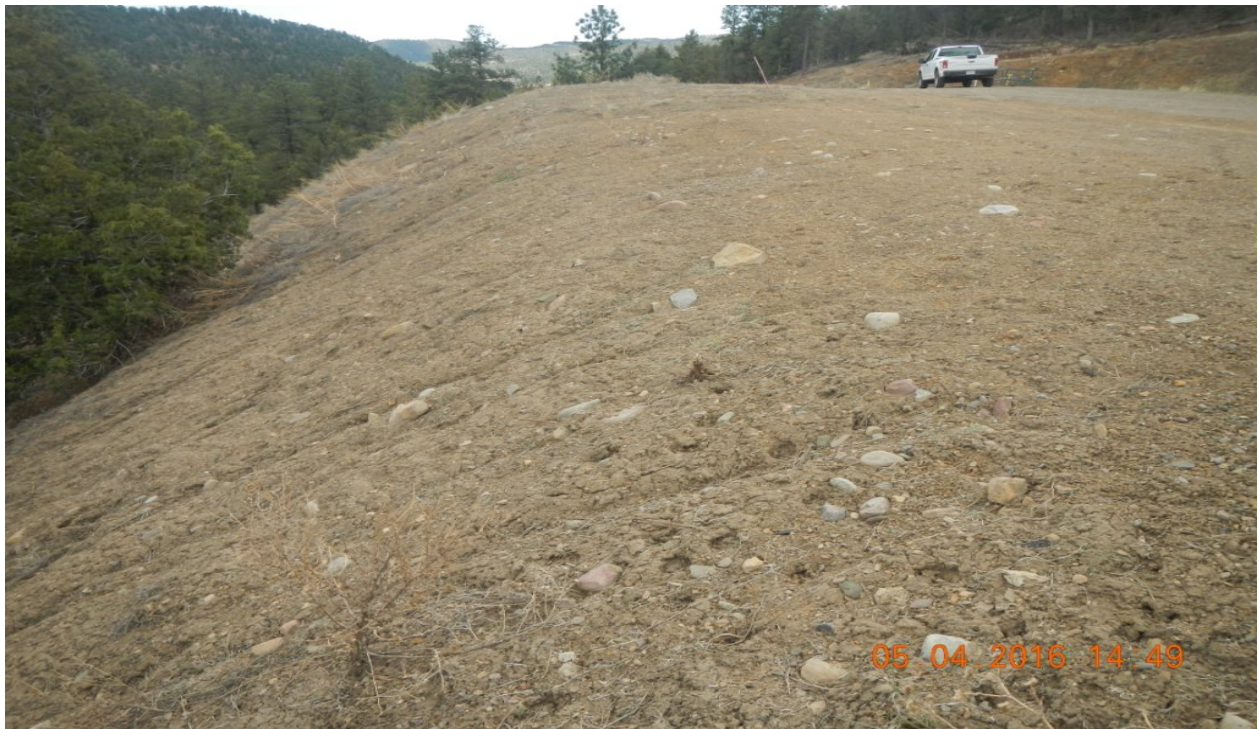
photo 8: Northeast side of the location facing south. Vegetation is not established along this area of the pad.
