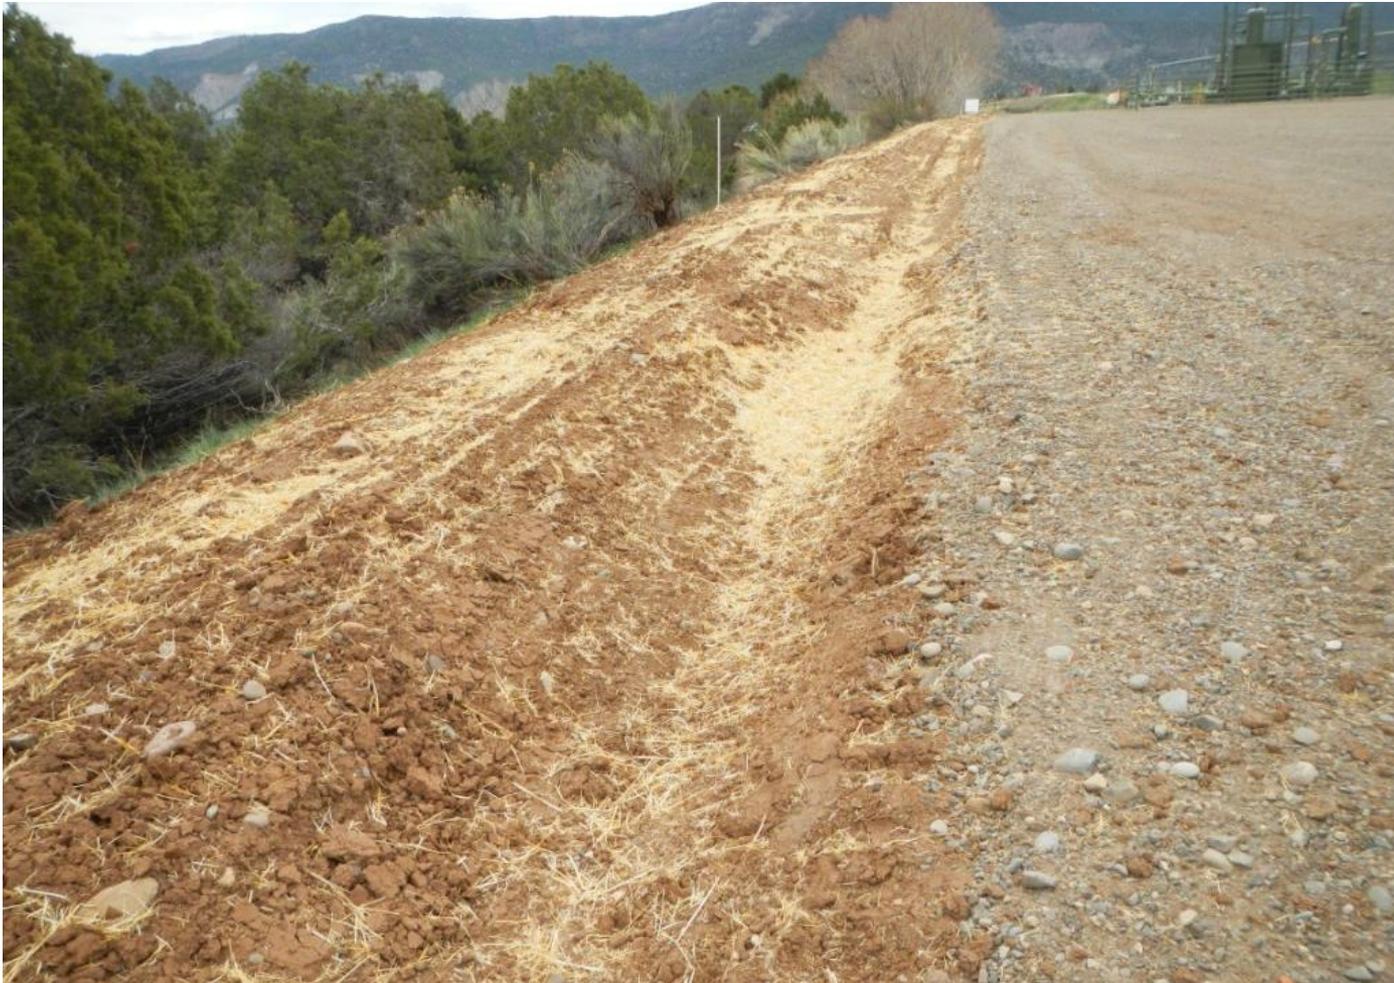
Photo 1. View of the eastern portion of the project area from the northeastern corner facing southward.

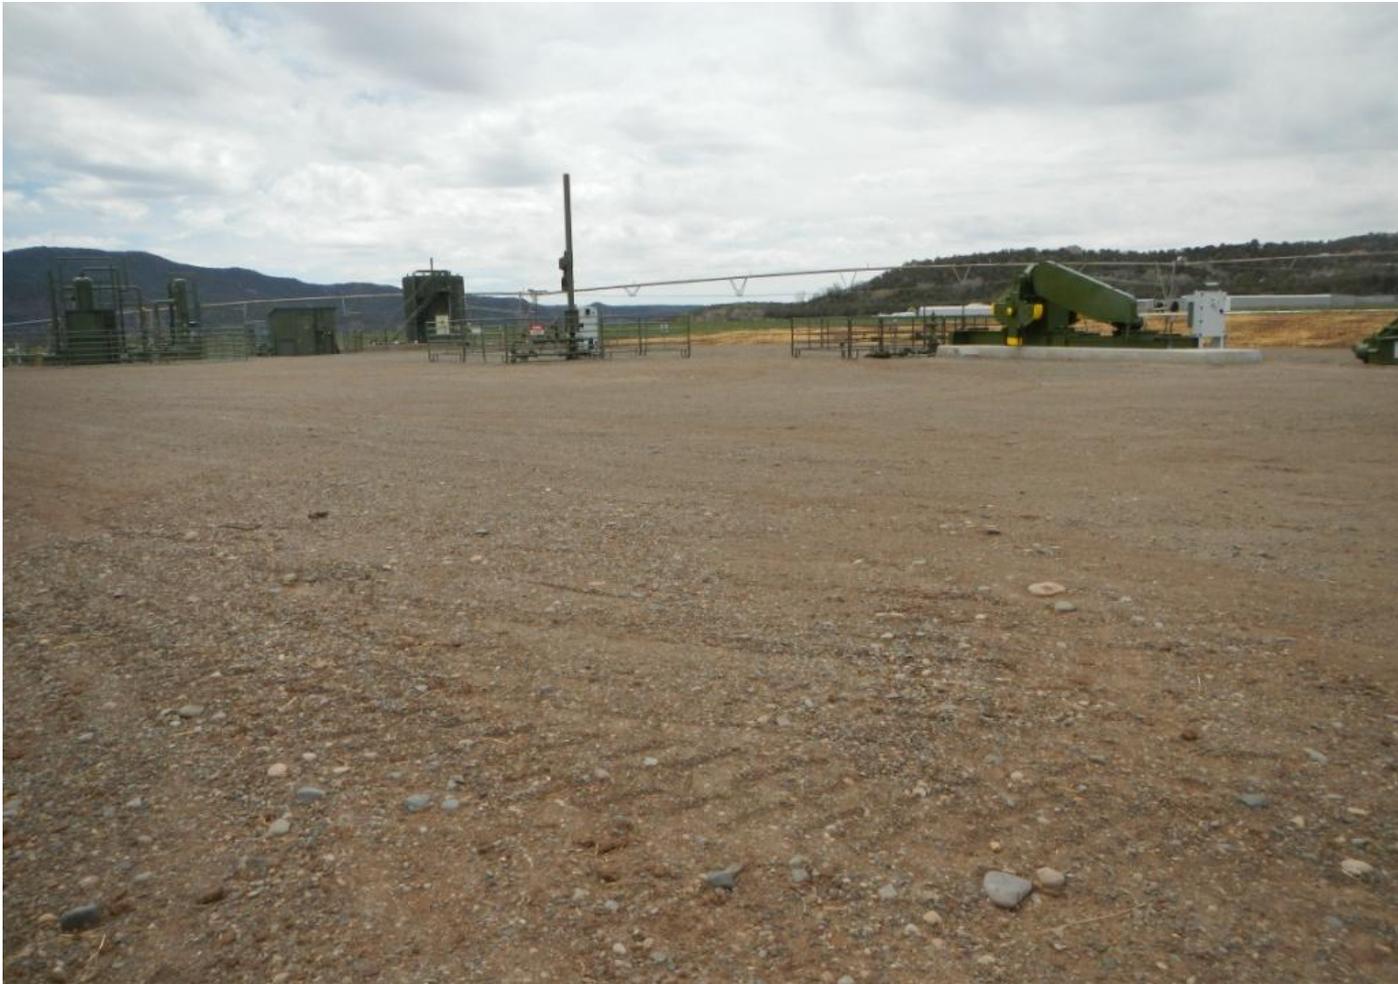
Photo 2. View of the project area from the northeastern corner facing center.

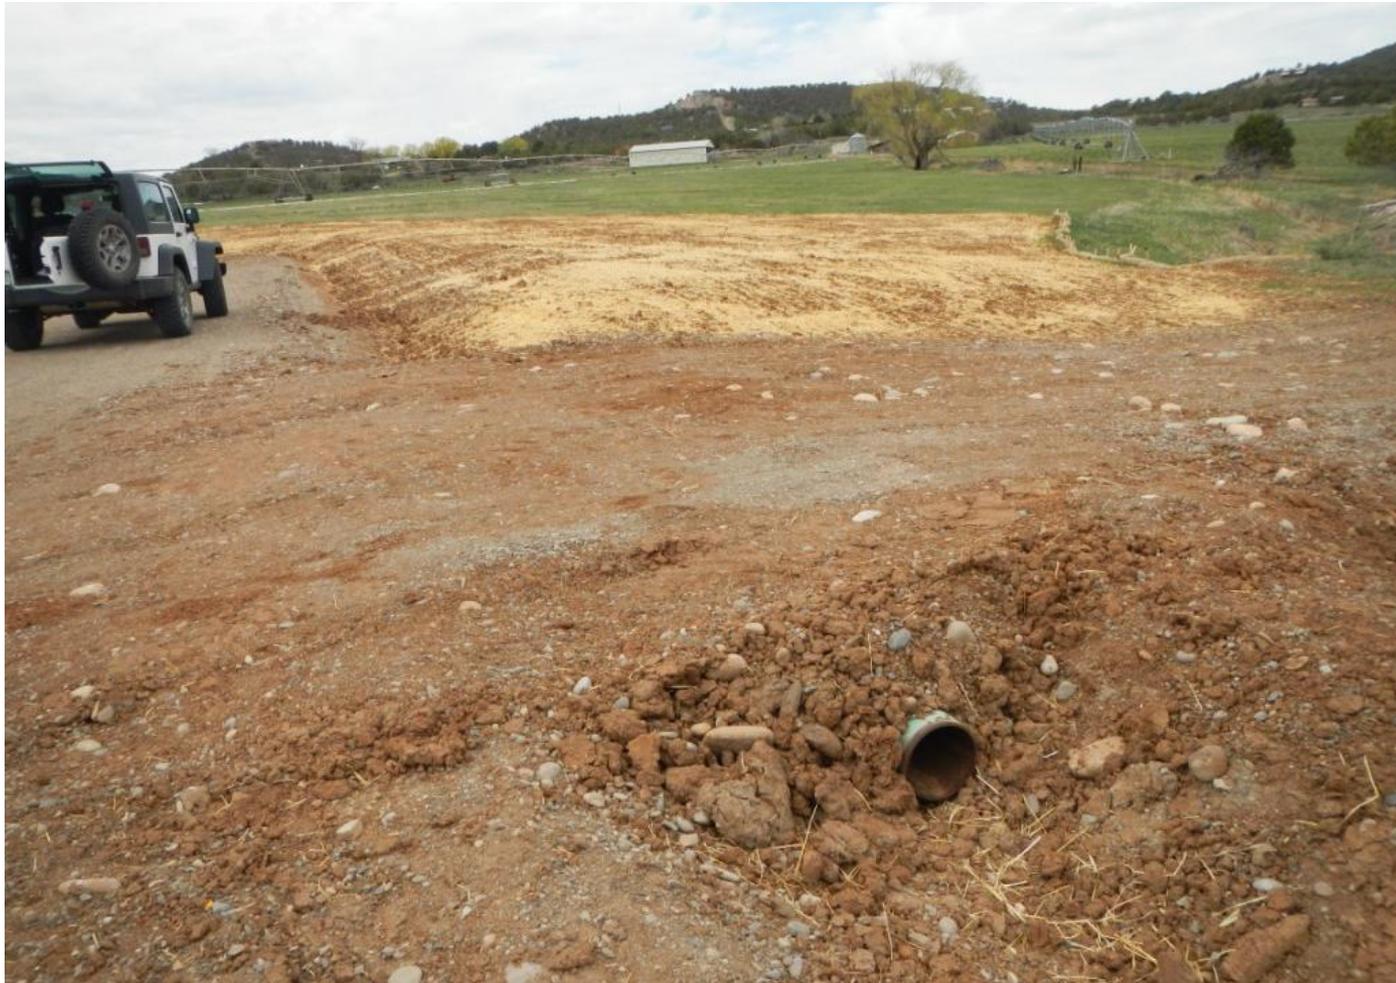
Photo 3. View of the northern portion of the project area from the northeastern corner facing westward. Stormwater is diverted into the culvert and off of the northeastern corner toward a drainage.

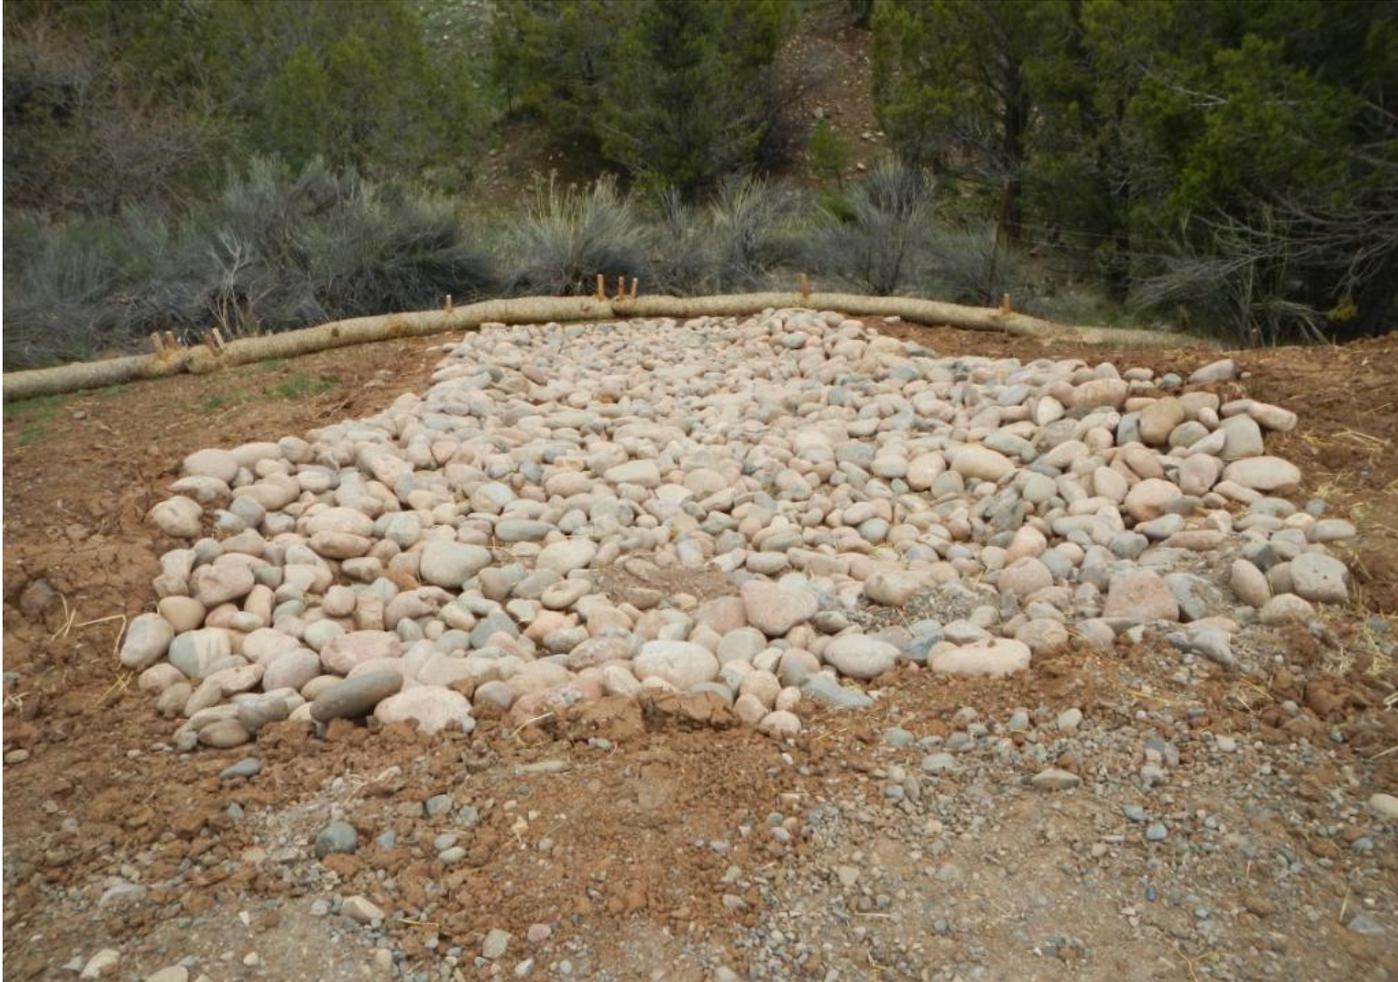
Photo 4. View of the armored drainage for diverted flows off of the well pad. This will need to be carefully monitored to ensure stabilization.

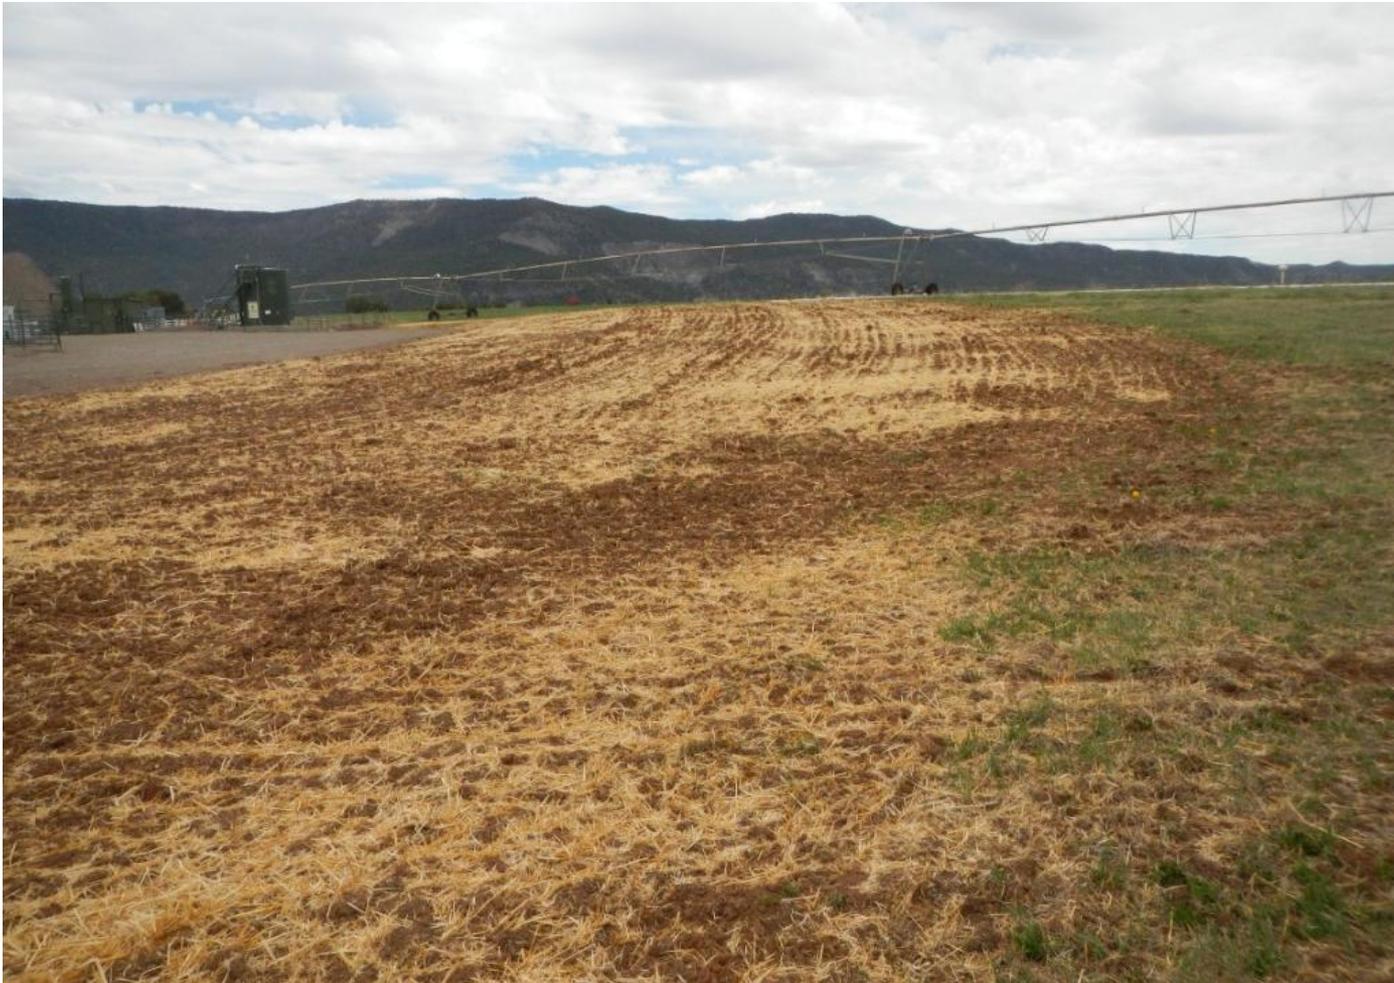
Photo 5. View of the western portion of the project area from the northwestern corner facing southward. Interim reclamation area appears to have been recontoured, decompacted, seeded and mulched with crimped straw. It is surrounded by and irrigated pasture.

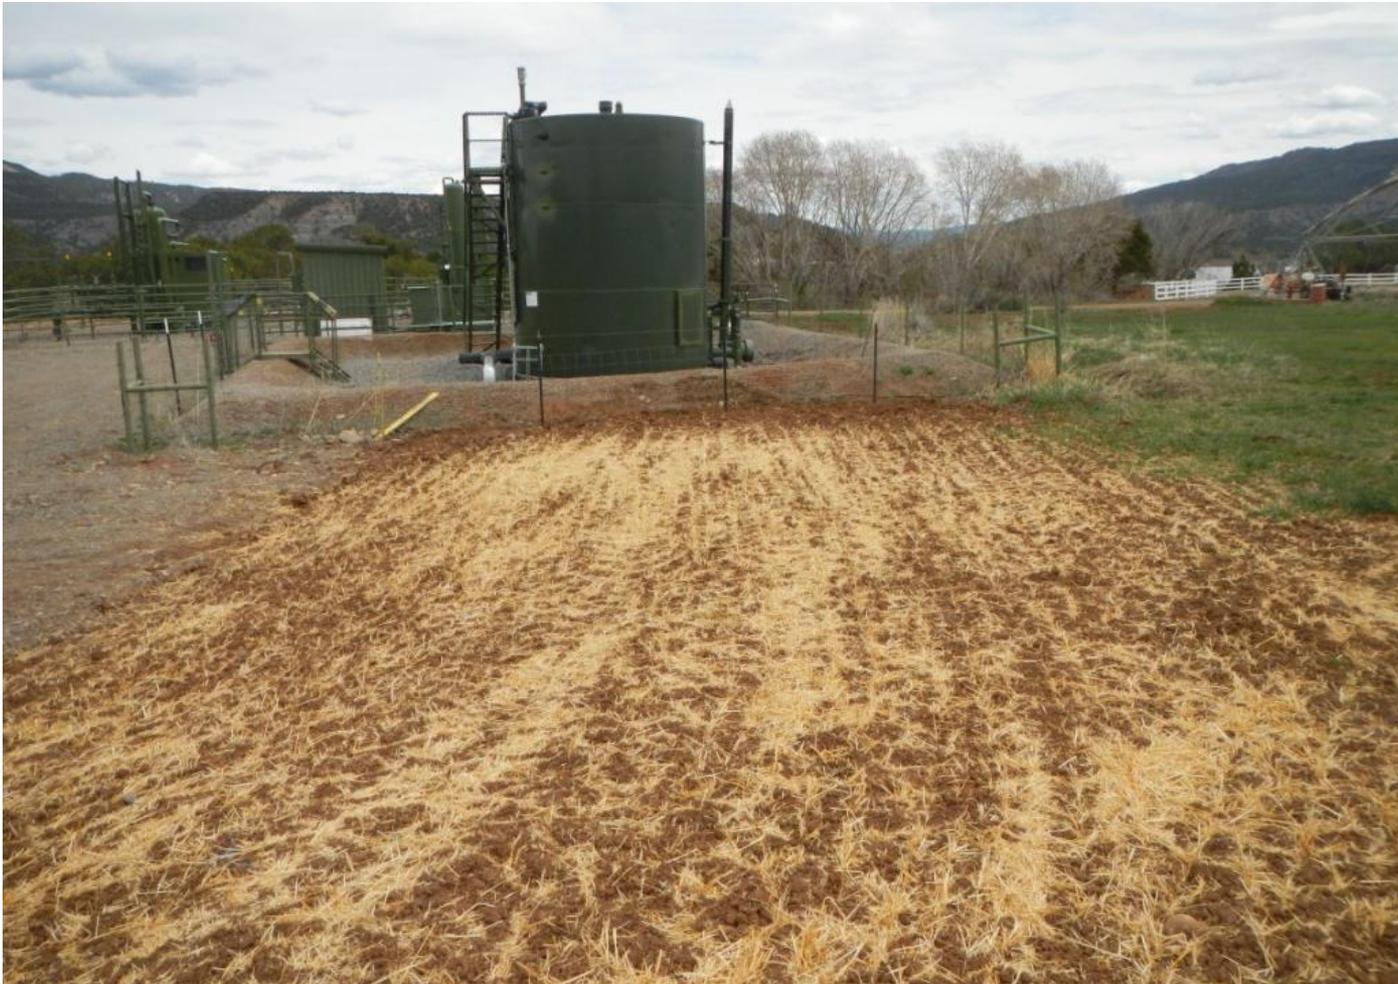
Photo 6. View of the southern portion of the project area from the southwestern corner facing eastward.
