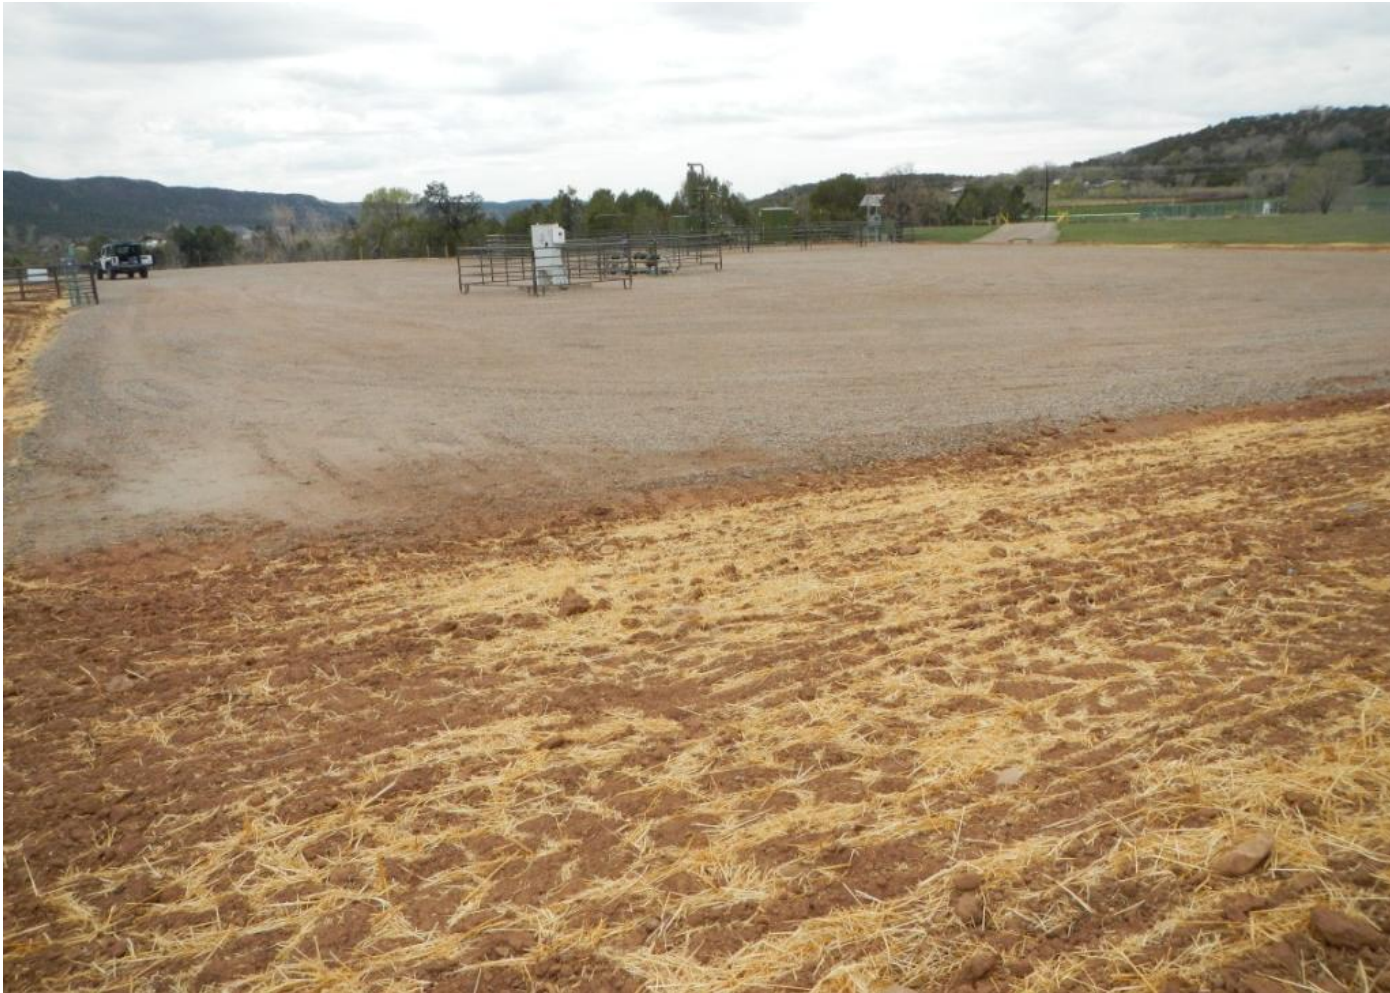
Photo 1. View of the project area from the northeastern corner facing center.

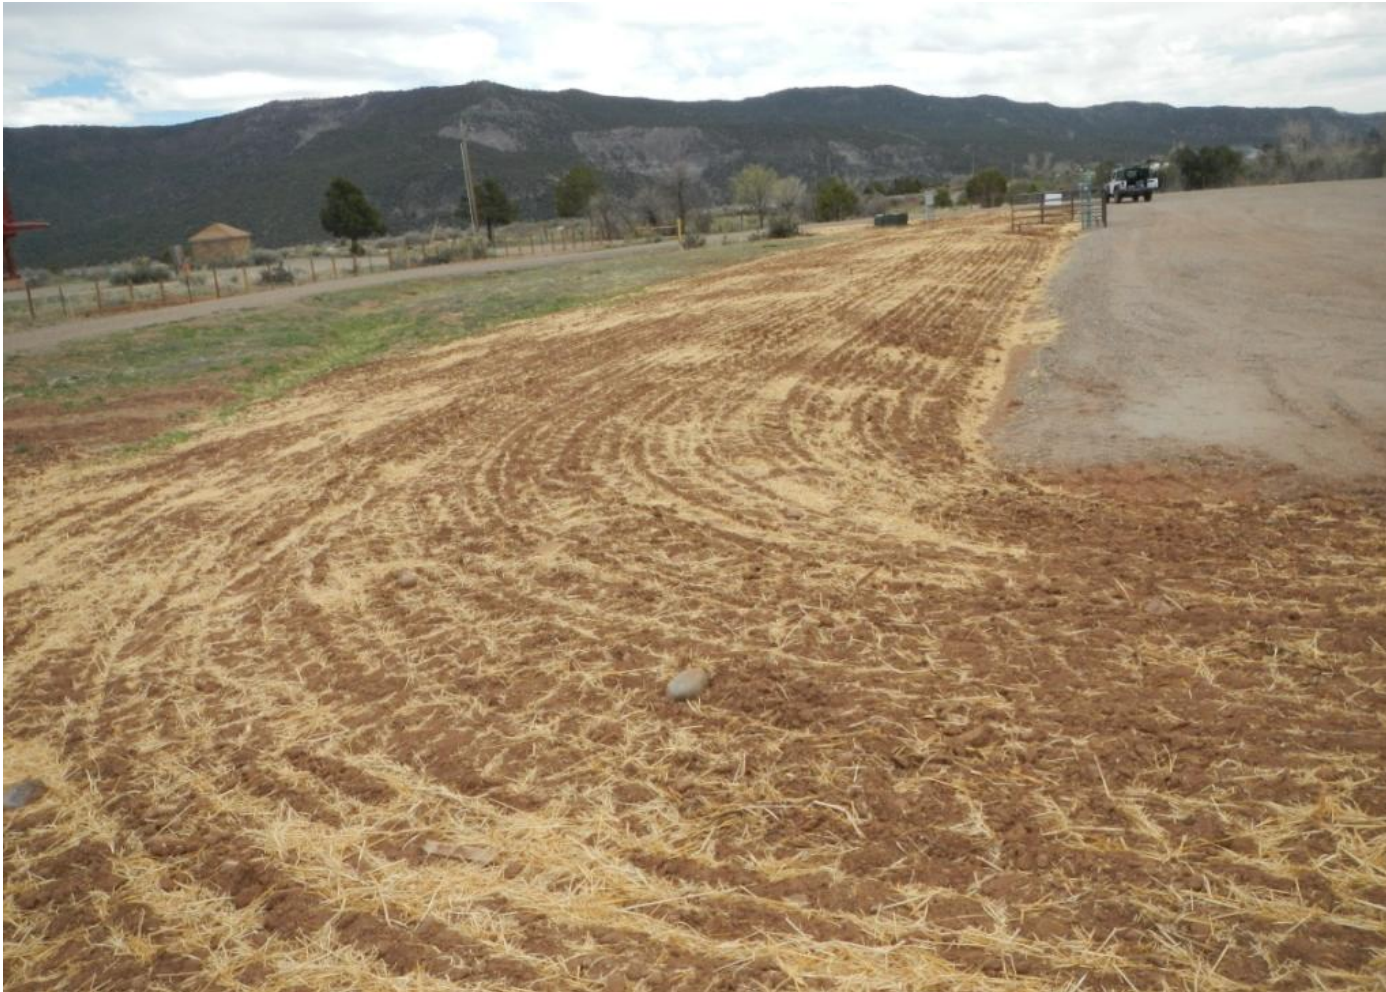
Photo 2. View of the eastern portion of the project area from the northeastern corner facing southward. Interim reclamation has commenced and outer portions of the well pad have been recontoured, decompacted, straw mulch crimped, and likely seeded.

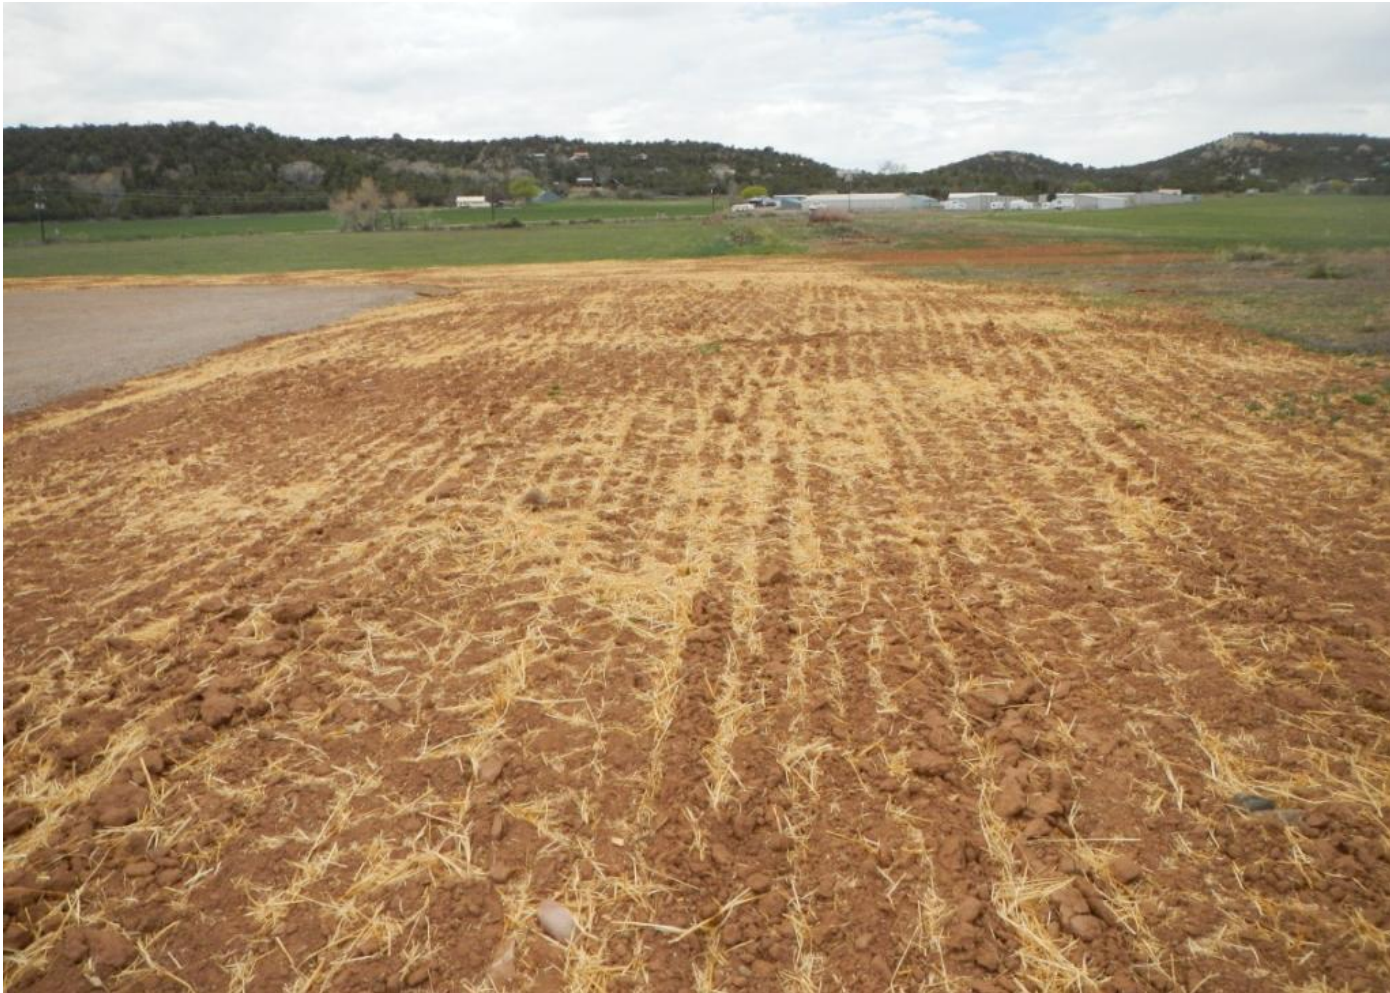
Photo 3. View of the northern portion of the project area from the northeastern corner facing westward.

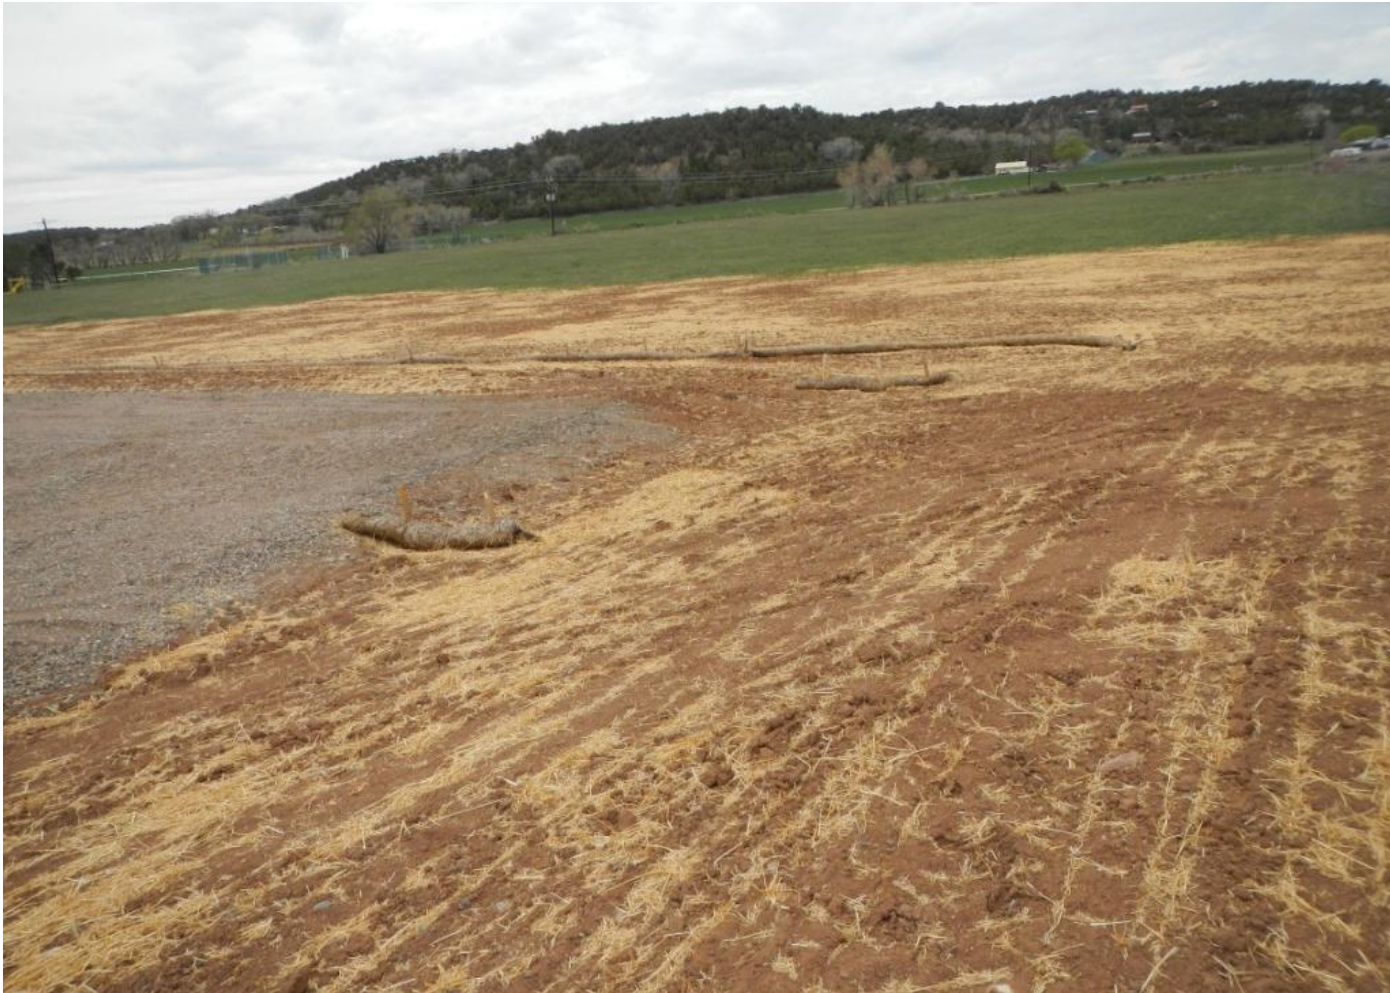
Photo 4. View of wattles and stormwater diversion in the northwestern edge of the working area and the interim reclamation area.

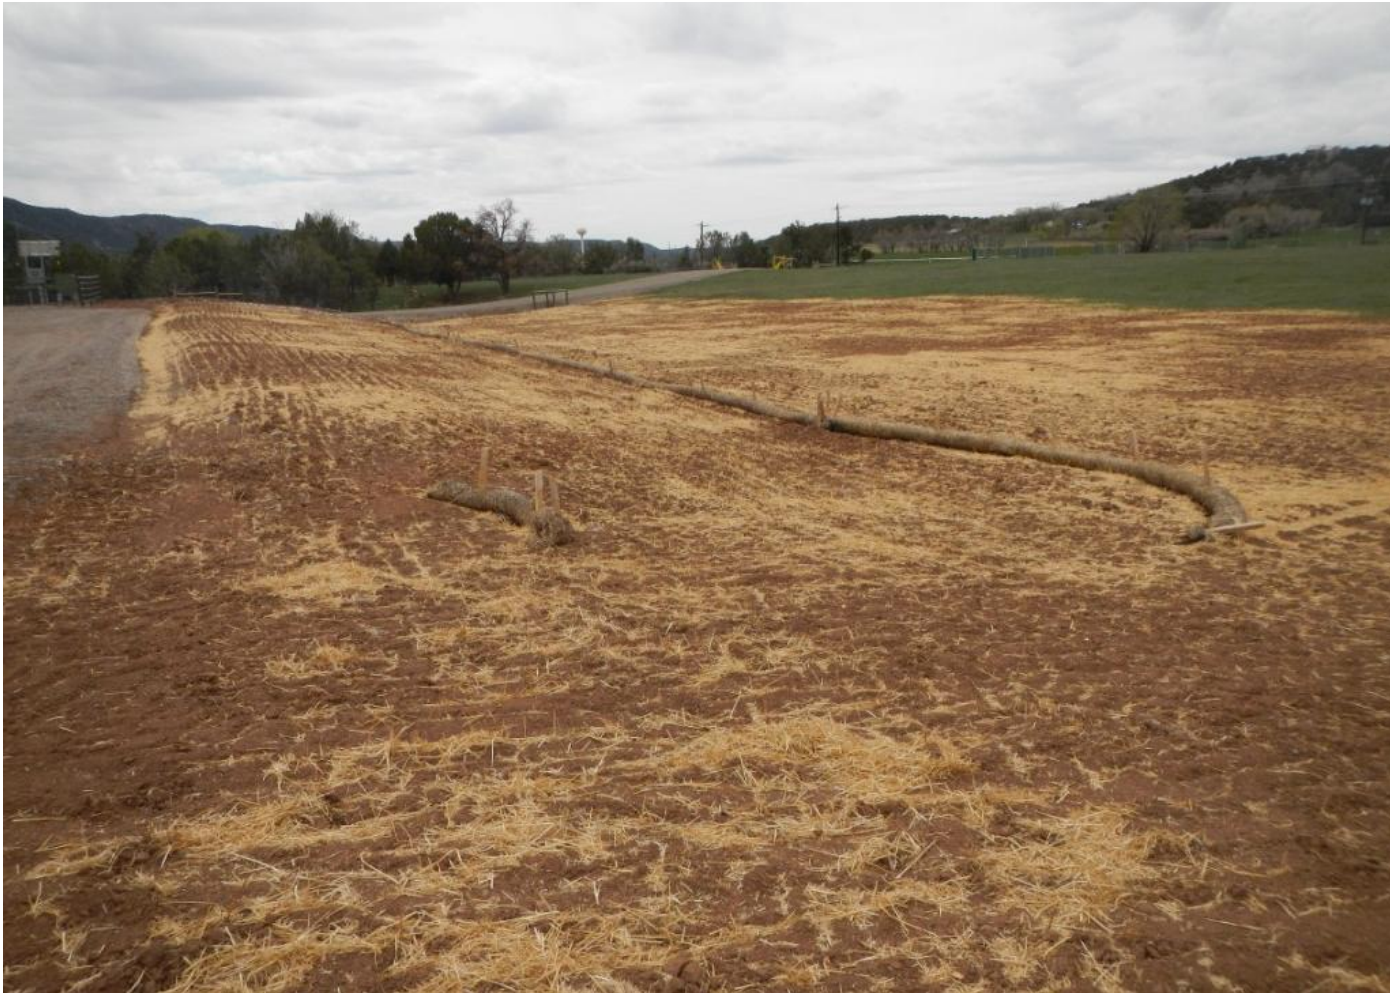
Photo 5. View of the western portion of the project area from the northwestern corner facing southward.

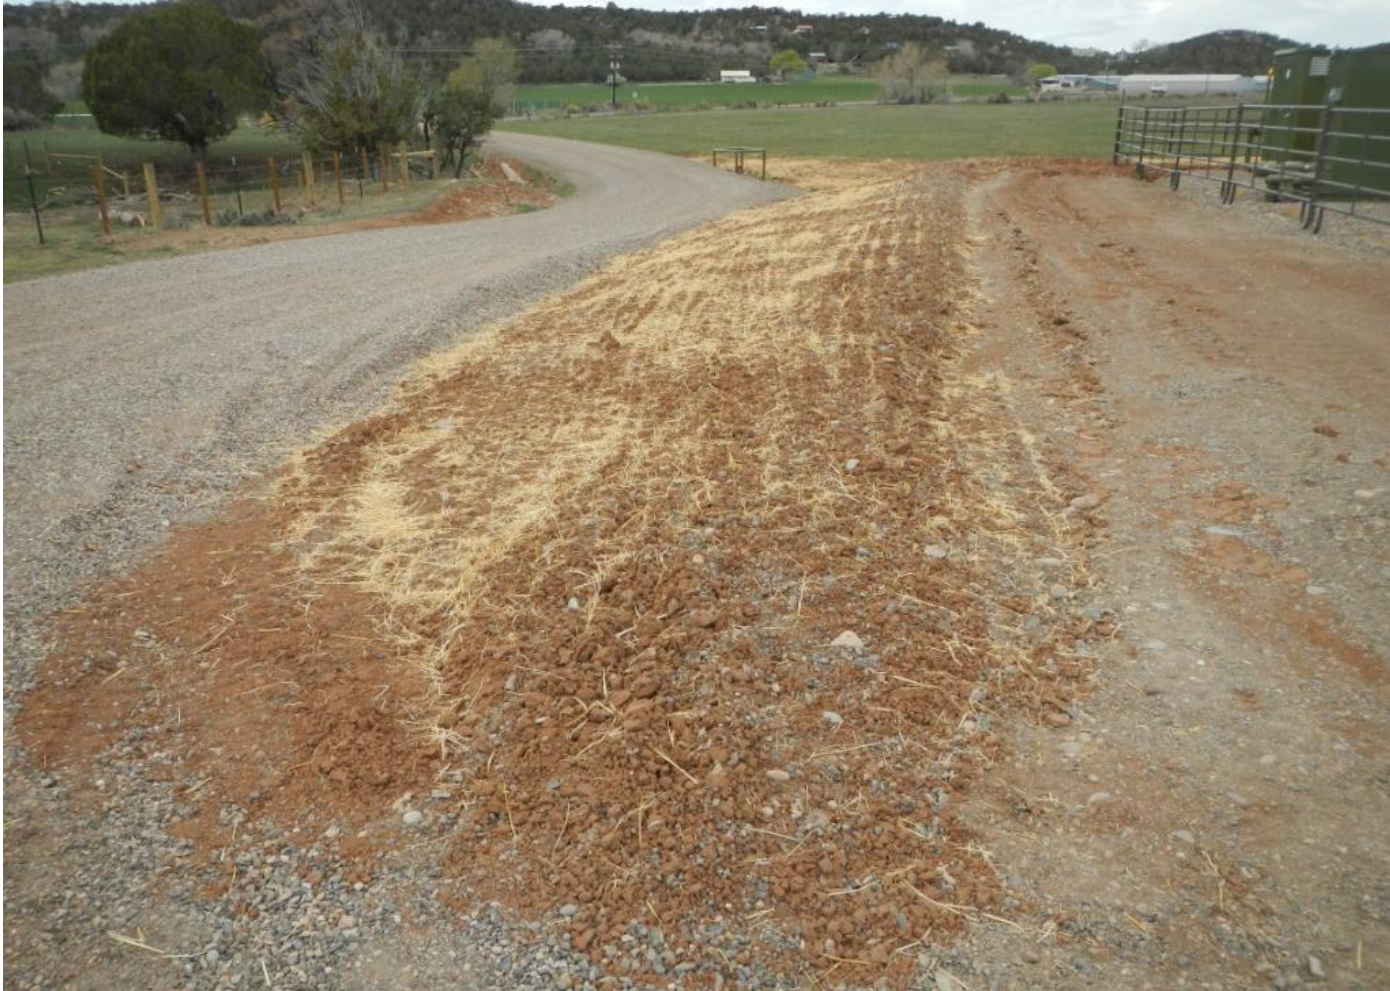
Photo 6. View of the southern portion of the project area from the well pad entrance facing westward

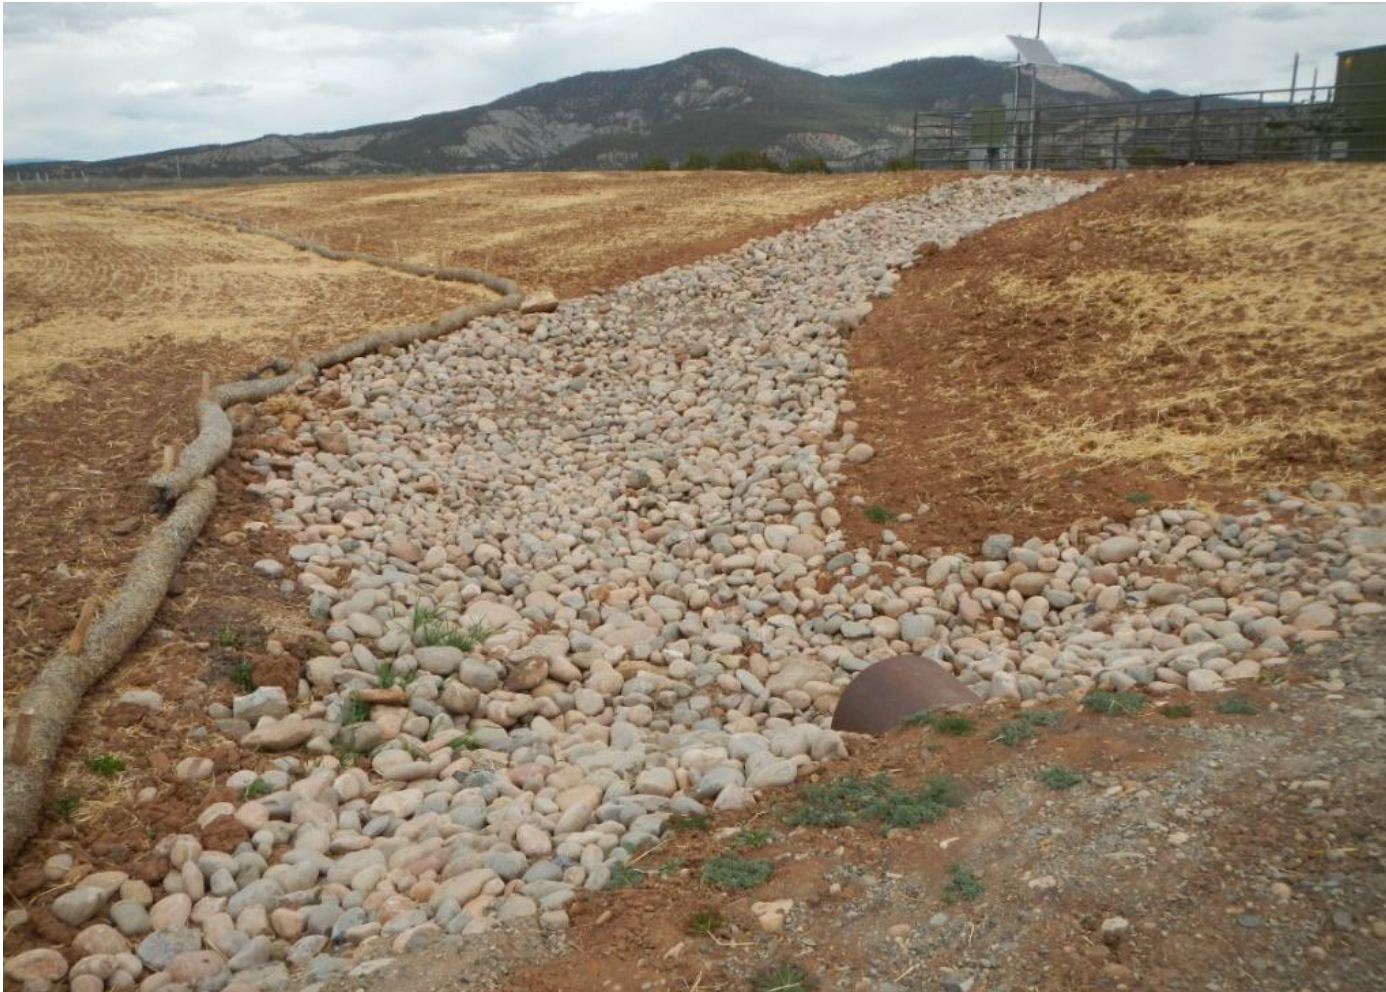
Photo 7. View of armored cobble run-down in the southwestern corner of the project area feeding toward culvert.

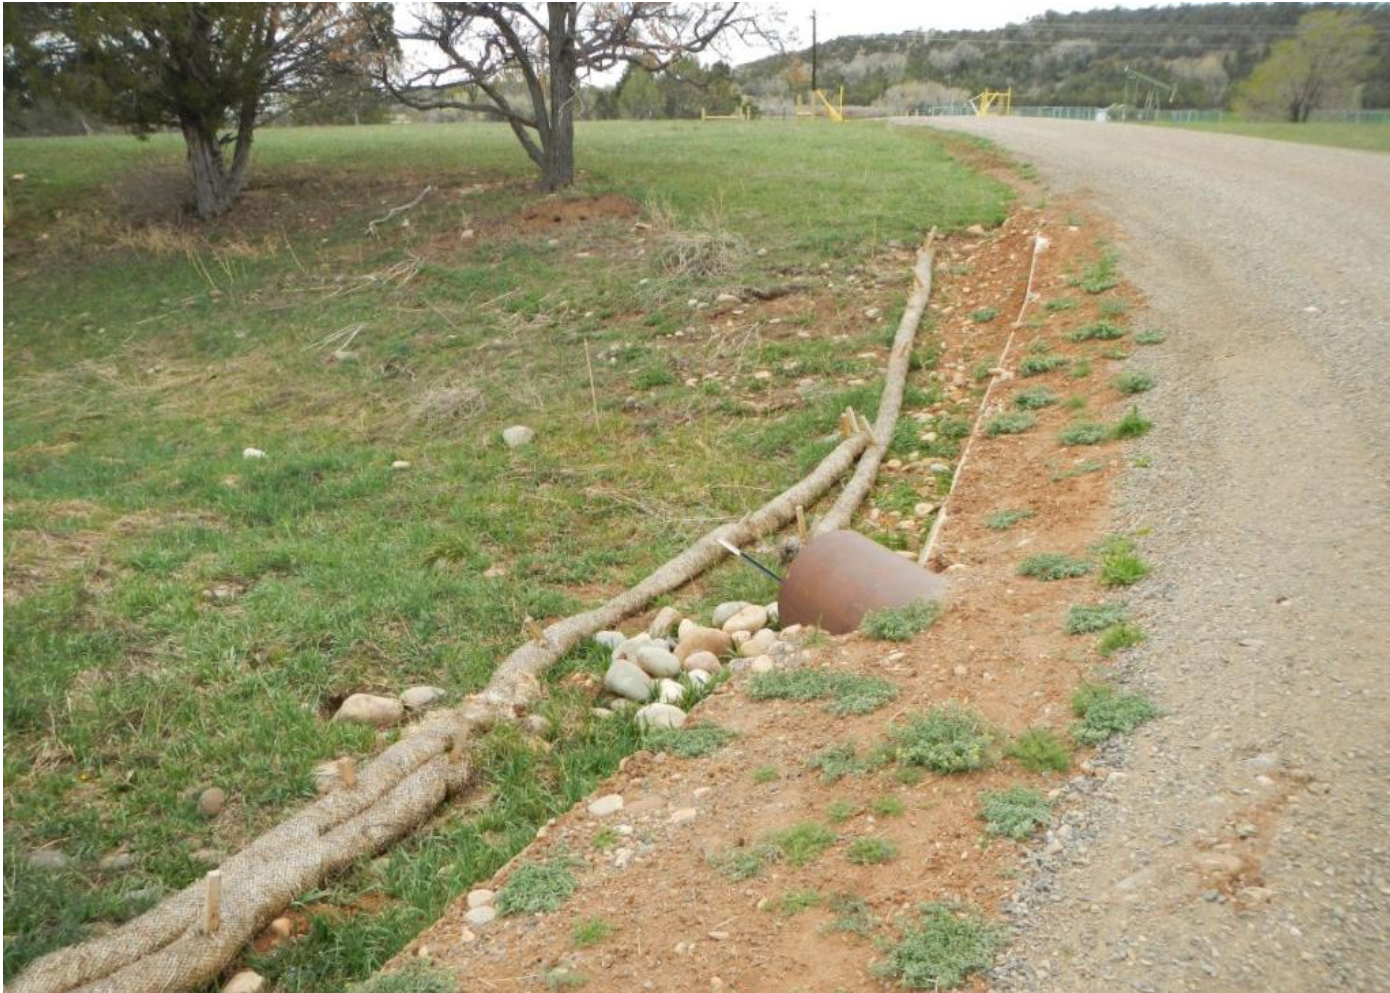
Photo 8. View of culvert outlet downstream from the project area. Does not appear that sediment has discharged from the project area at this time.
