Inspection Photos  
5/4/16  
API # 05-017-07727  
Pronghorn State 16-15-48 #1-H

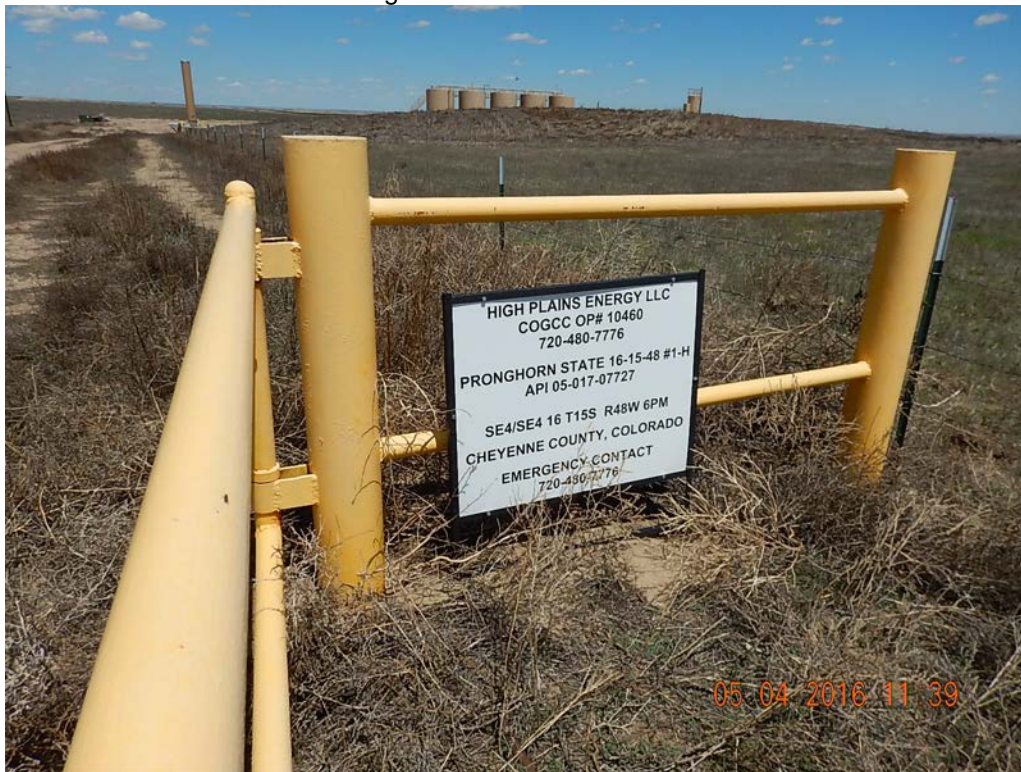
Figure 1 – Lease sign at gate.

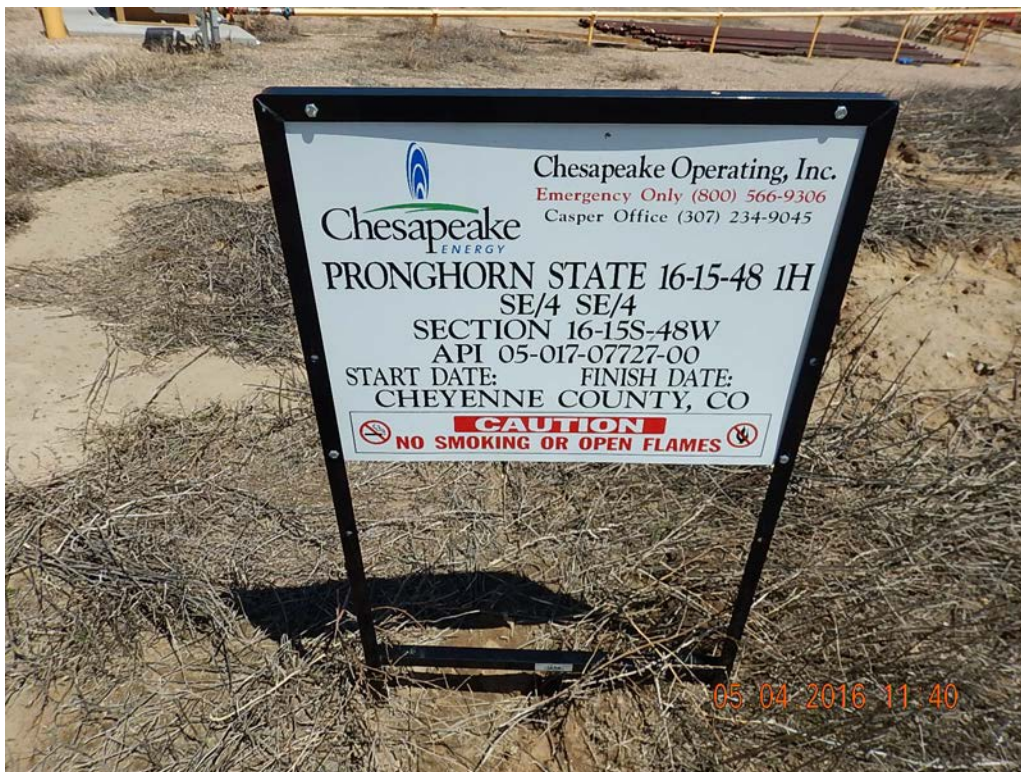
Figure 2 – Lease sign on well pad.

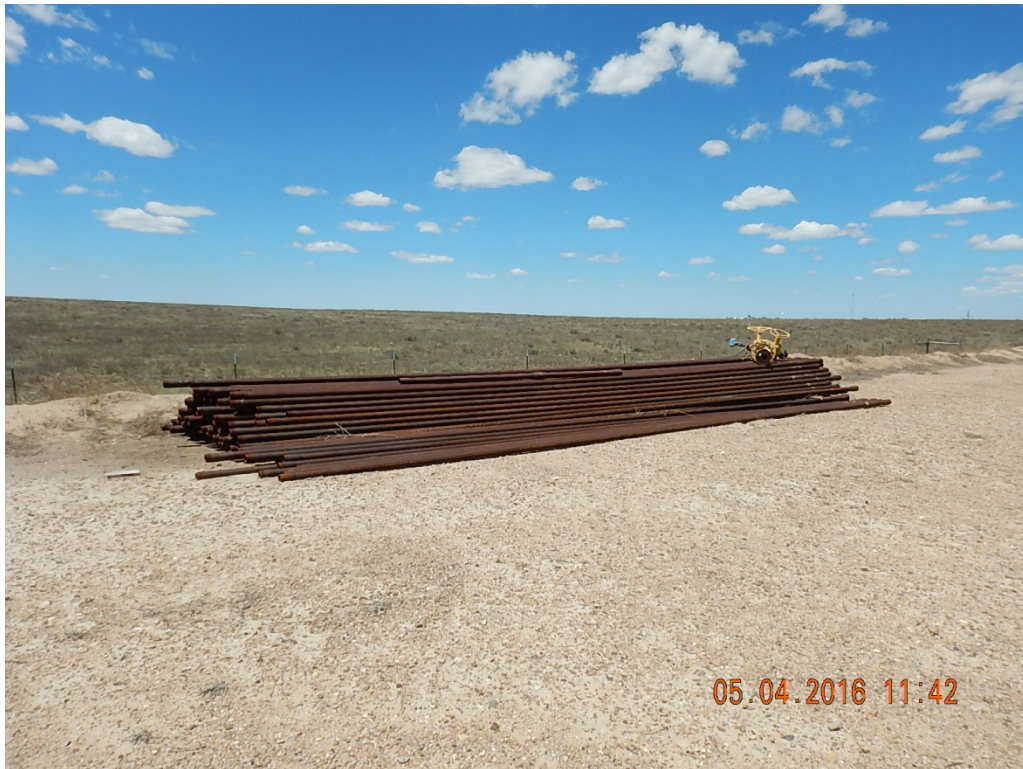
Figure 3 – Unused equipment stored on west side of location.

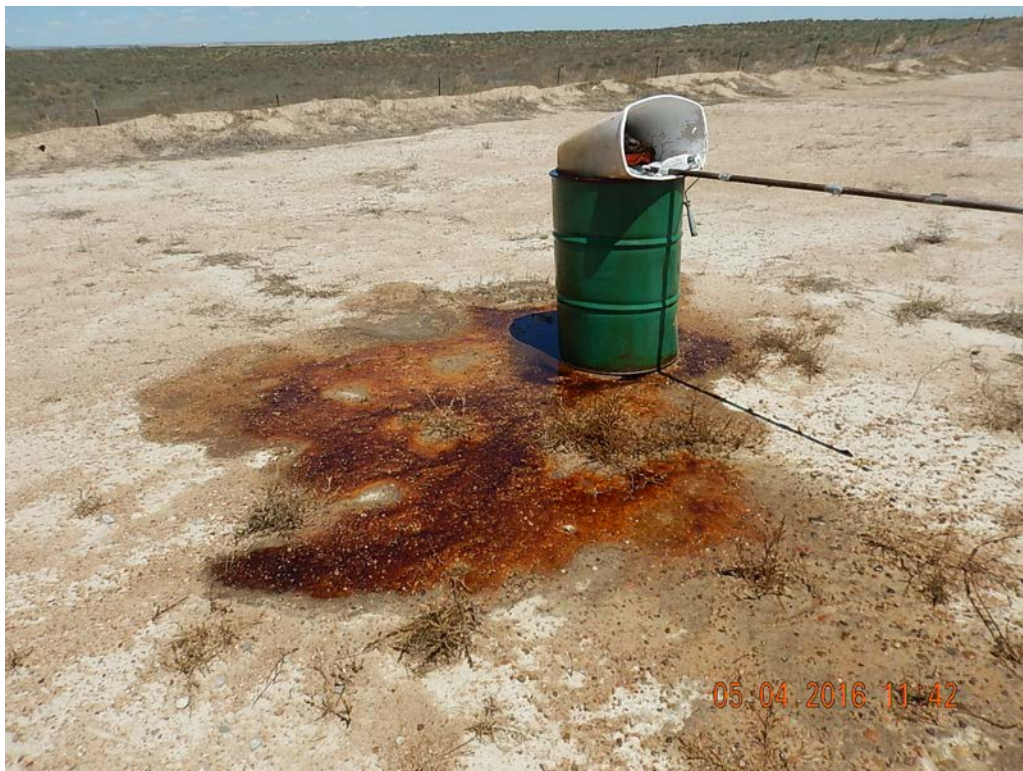
Figure 4 – Trash and stained soil on north side of pad.

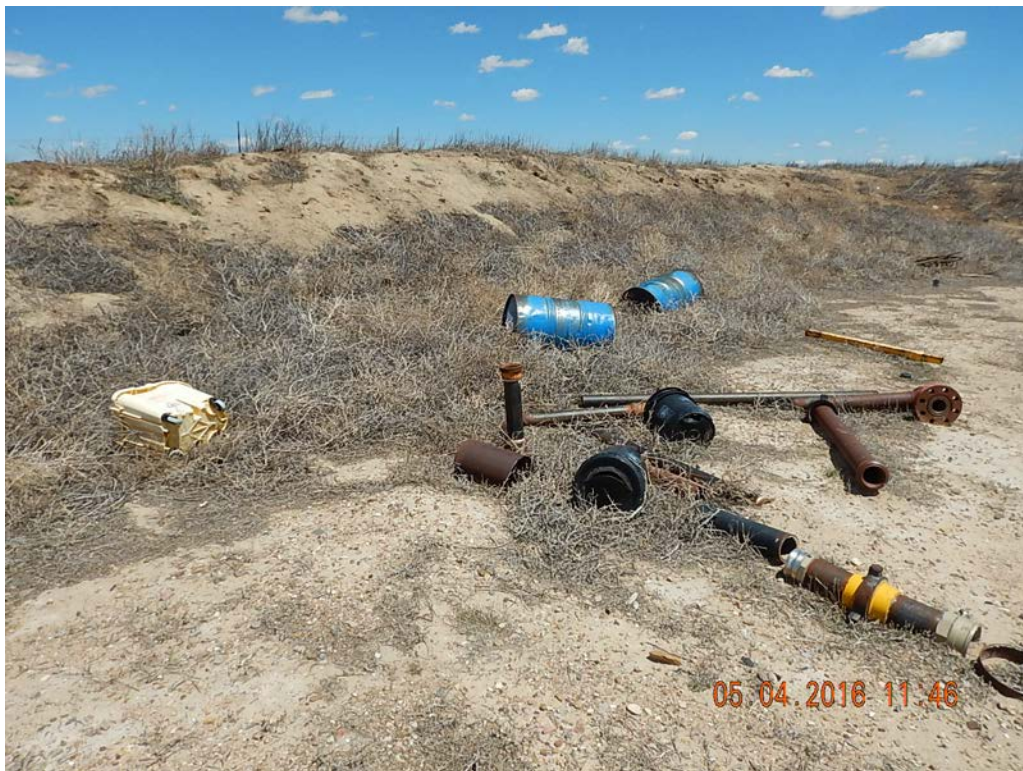
Figure 5 – Trash and unused equipment on pad.

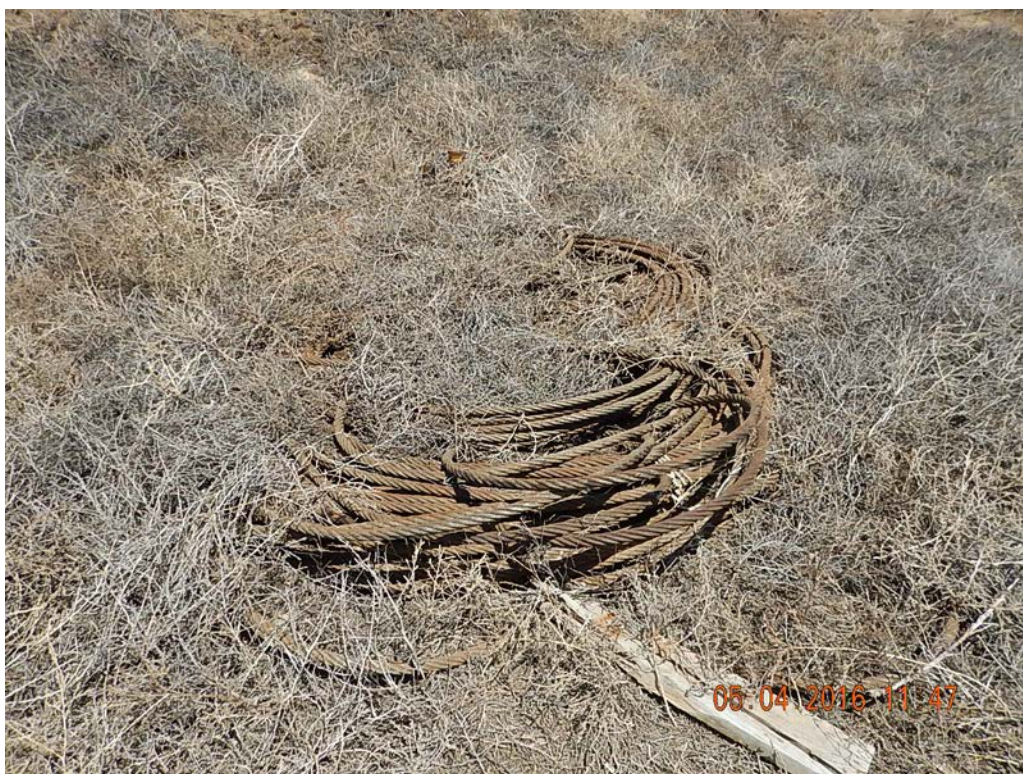
Figure 6 – Unused equipment and trash on pad.

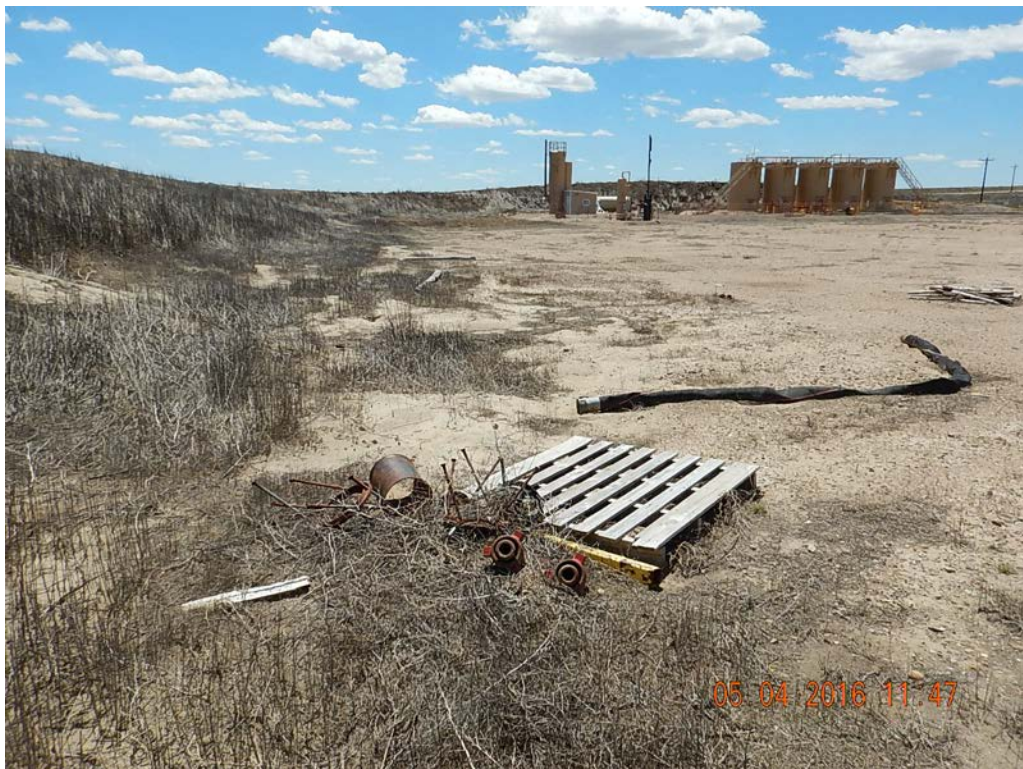
Figure 7 – Unused equipment and trash on pad.

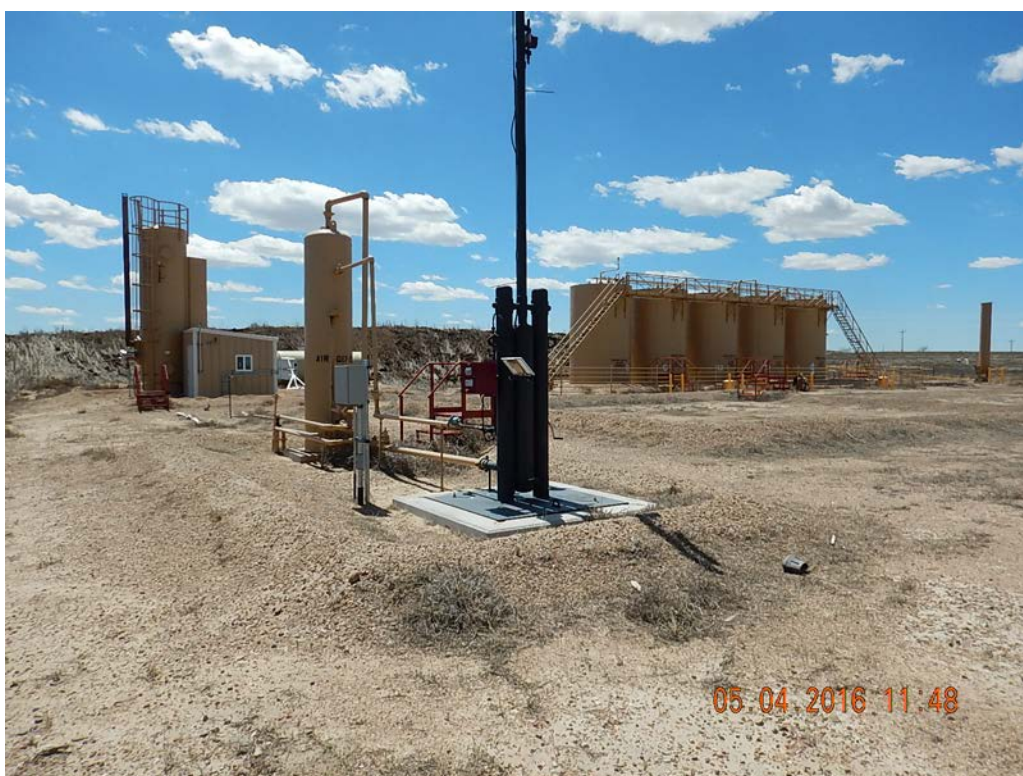
Figure 8 – Tank battery.

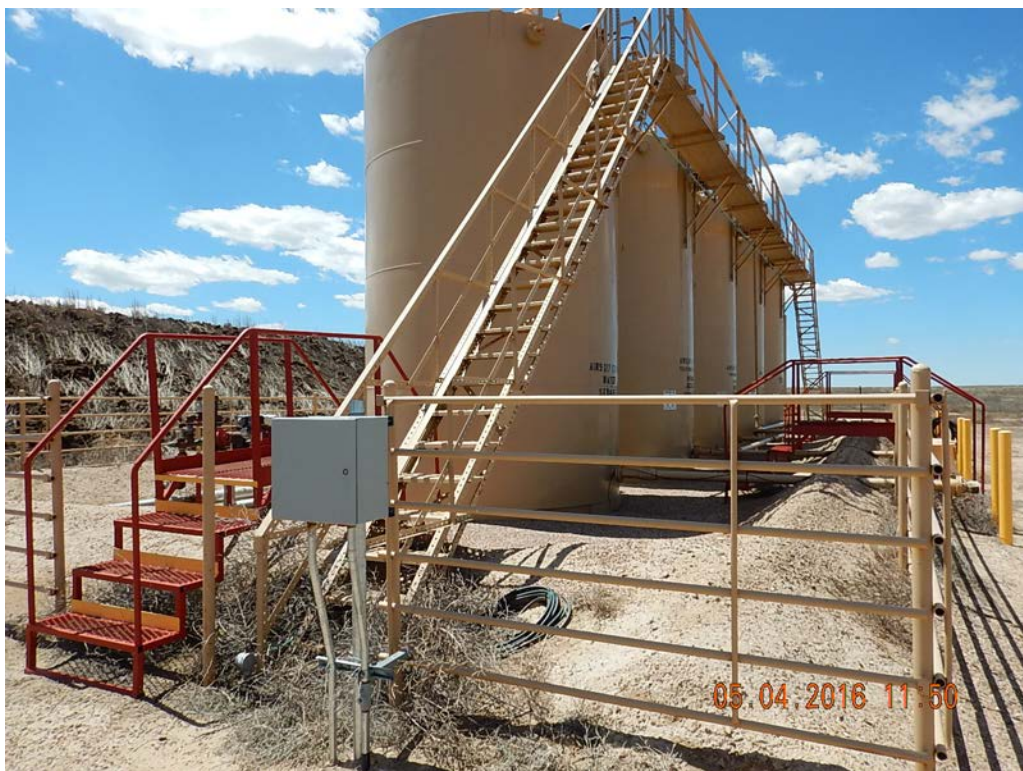
Figure 9 – Tank battery. Produced water (closest to stairs) is actively leaking.

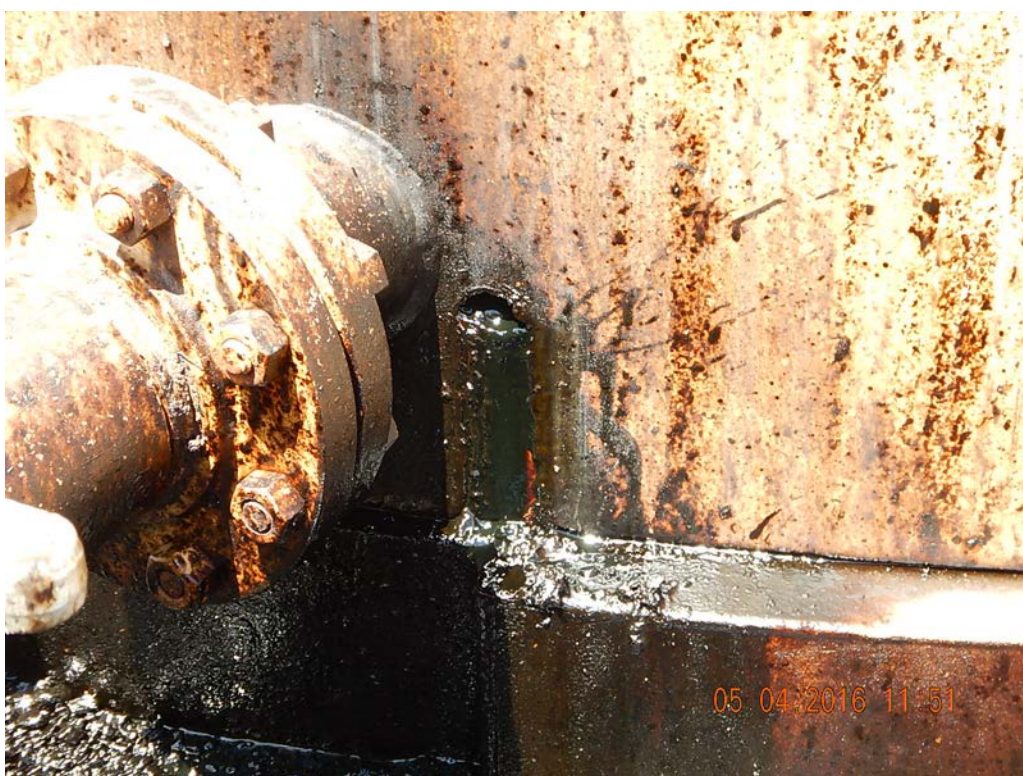
Figure 10 – Hole in tank causing leak.

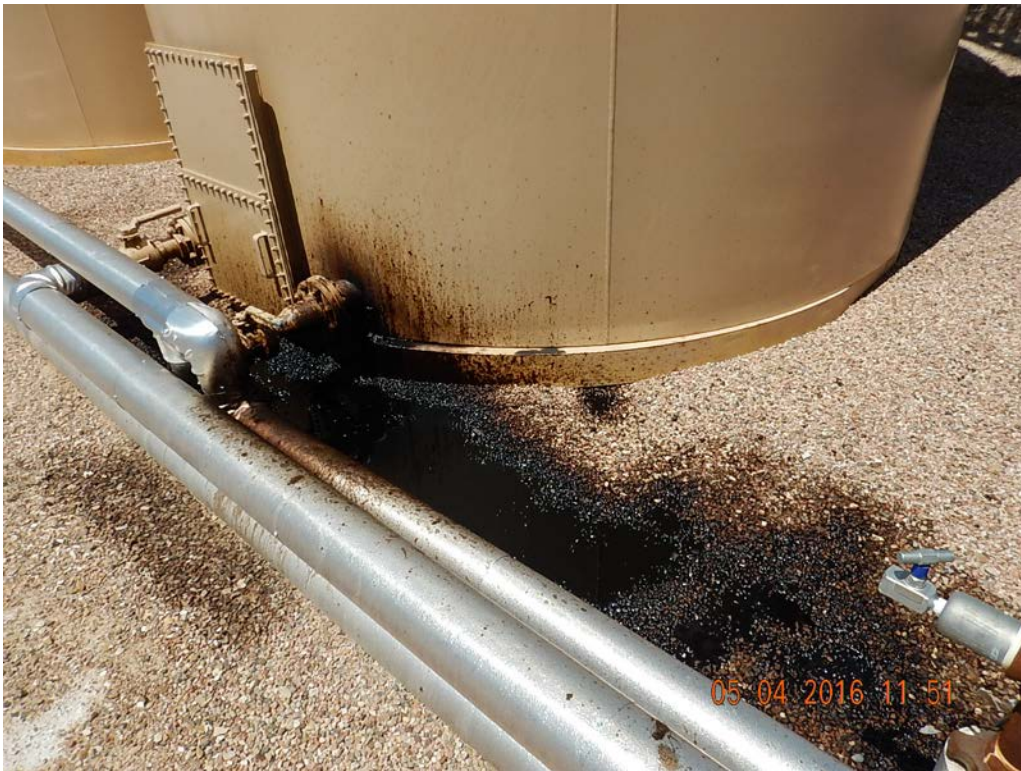
Figure 11 – Spill resulting from leak. Spill is entirely within secondary containment.

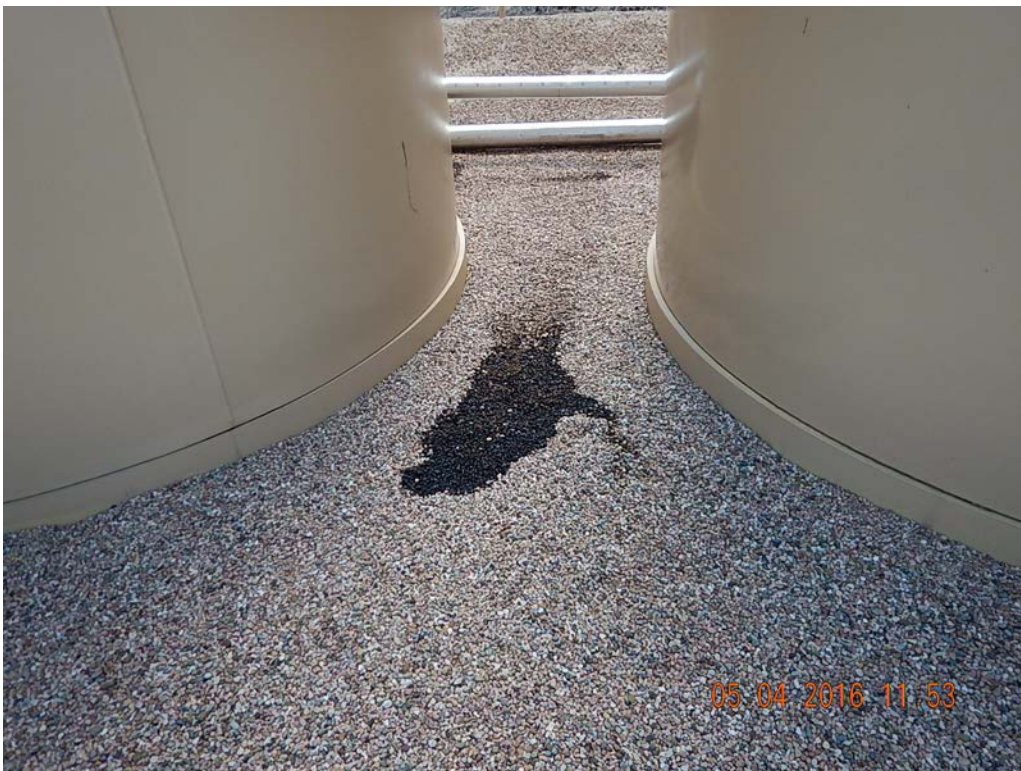
Figure 12 – Stained surface in between tanks.

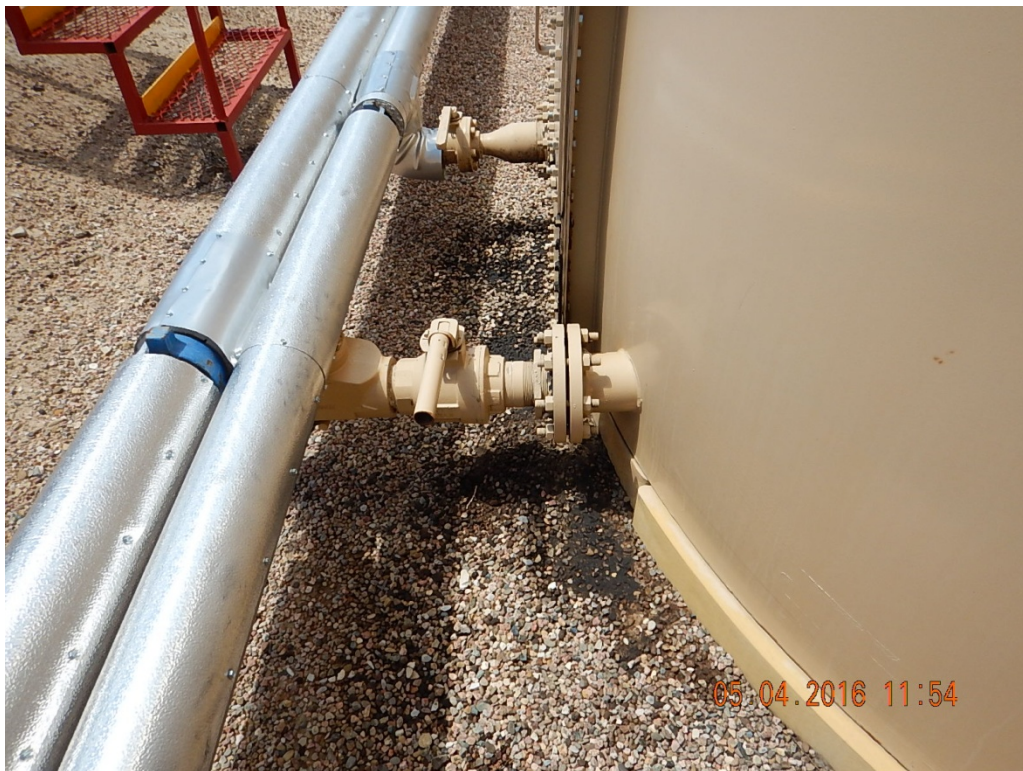
Figure 13 – Stained surface off produced water tank.

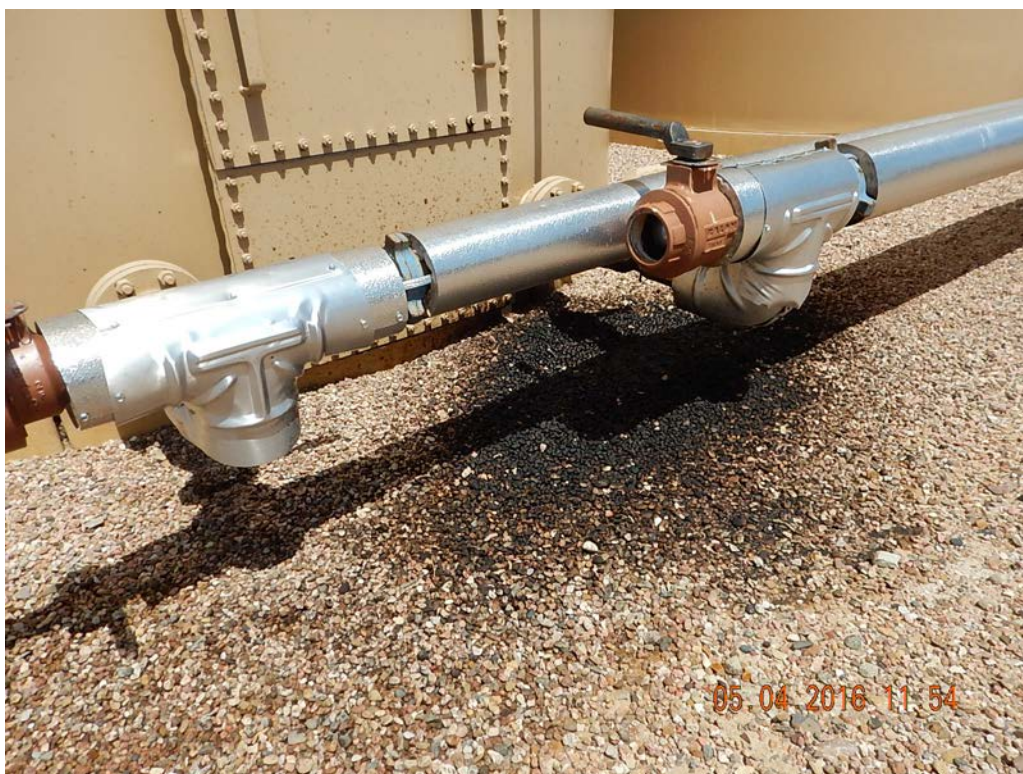
Figure 14 – Stained soil off crude oil tank.

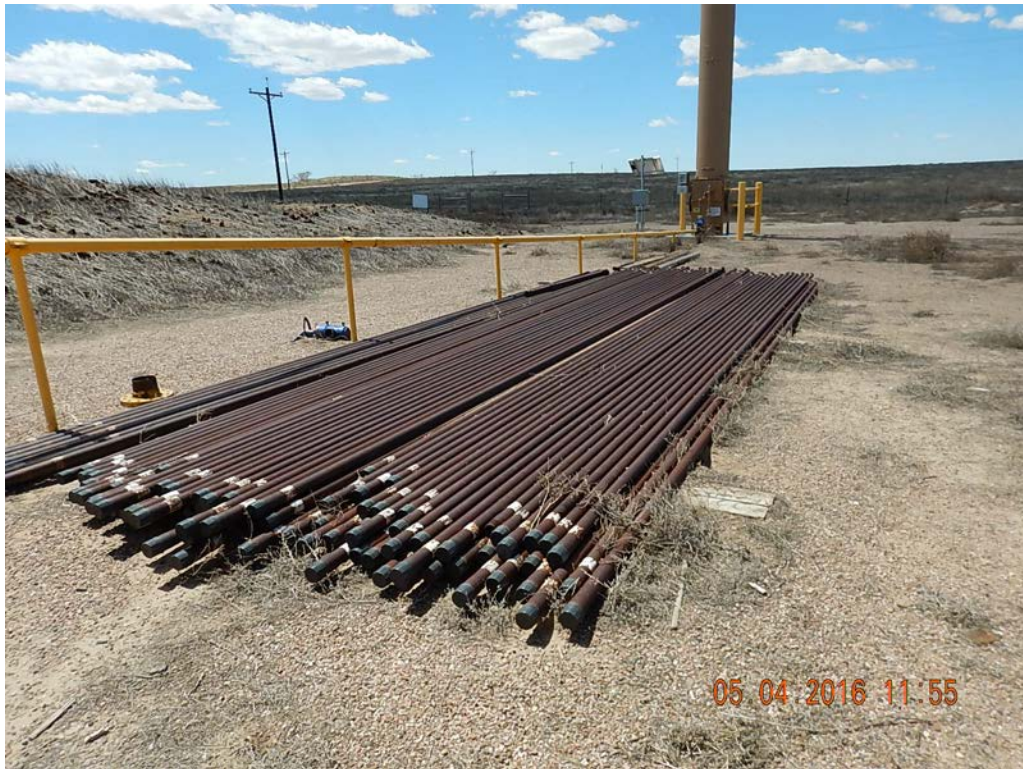
Figure 15 – Unused equipment stored on location.

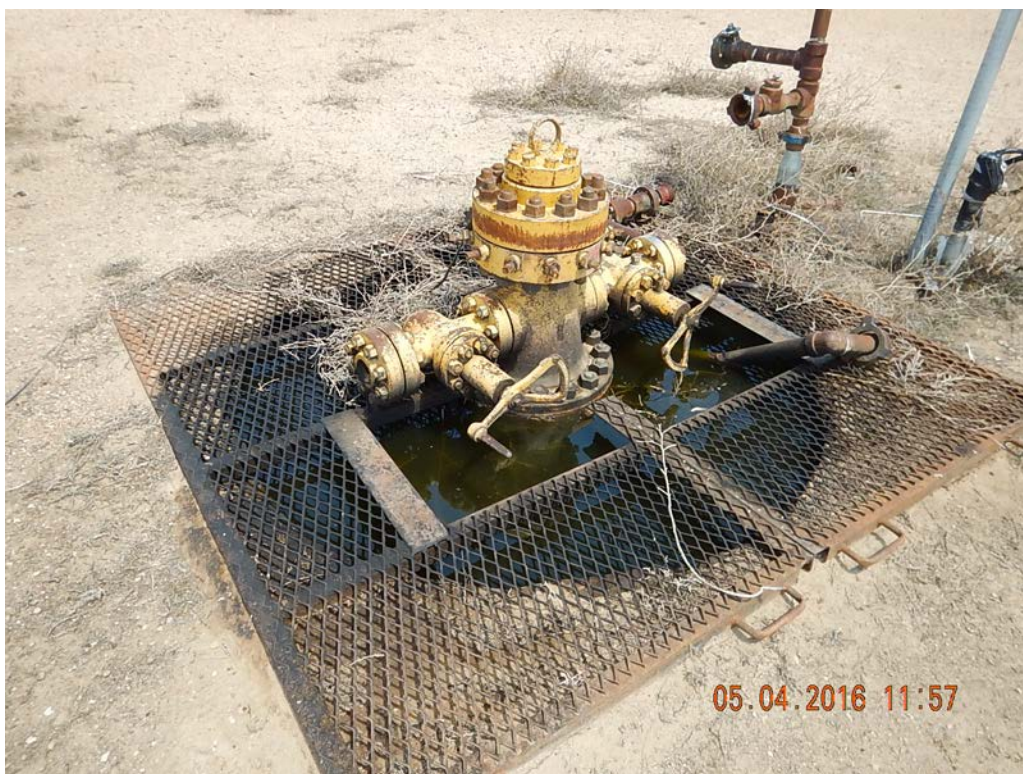
Figure 16 – Wellhead and cellar.

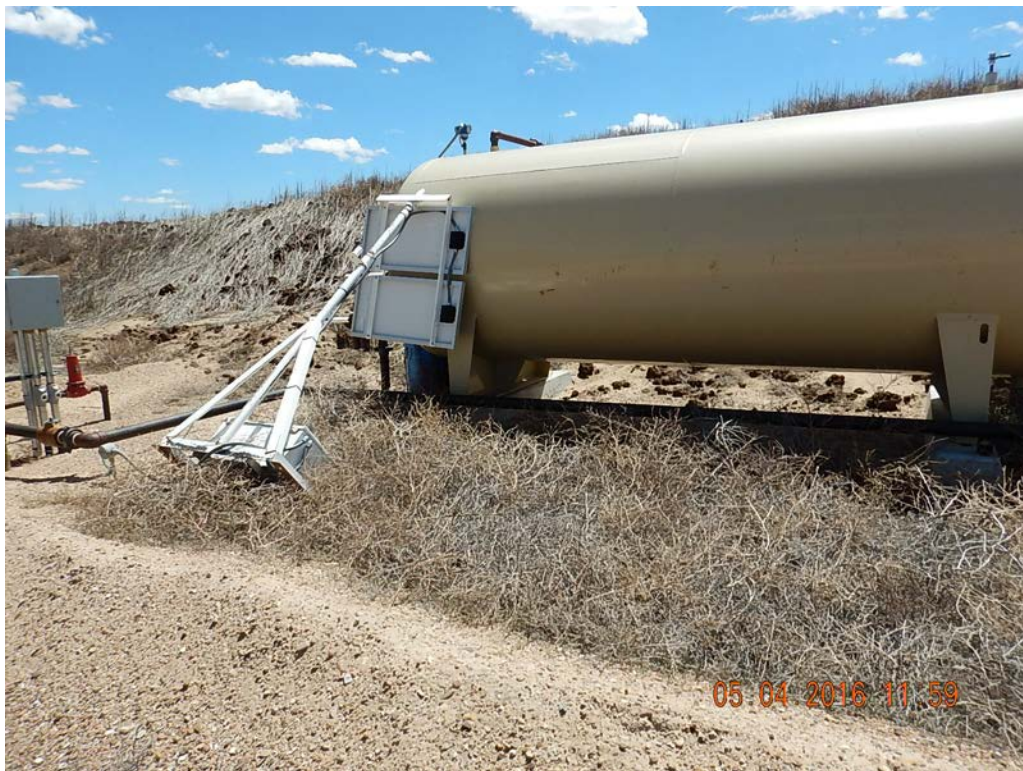
Figure 17 – Equipment fallen over and resting on tank.
