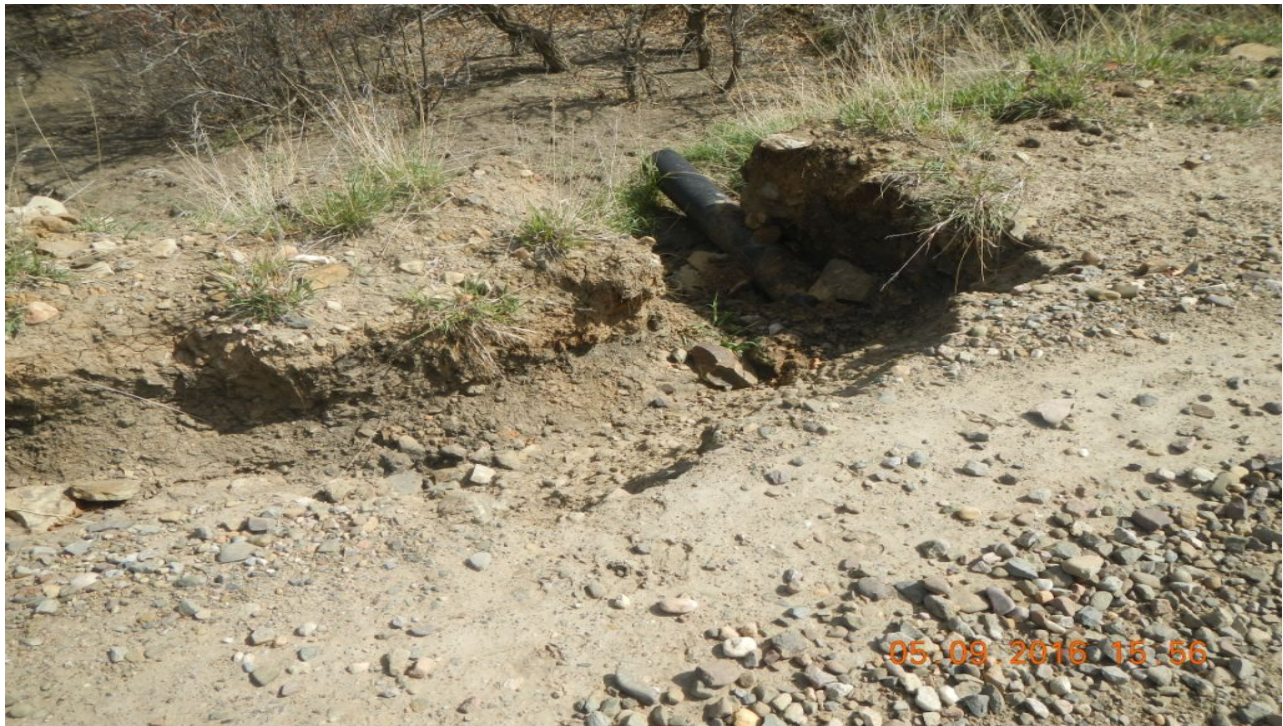
photo 1: Noticed areas of erosion along the access road.

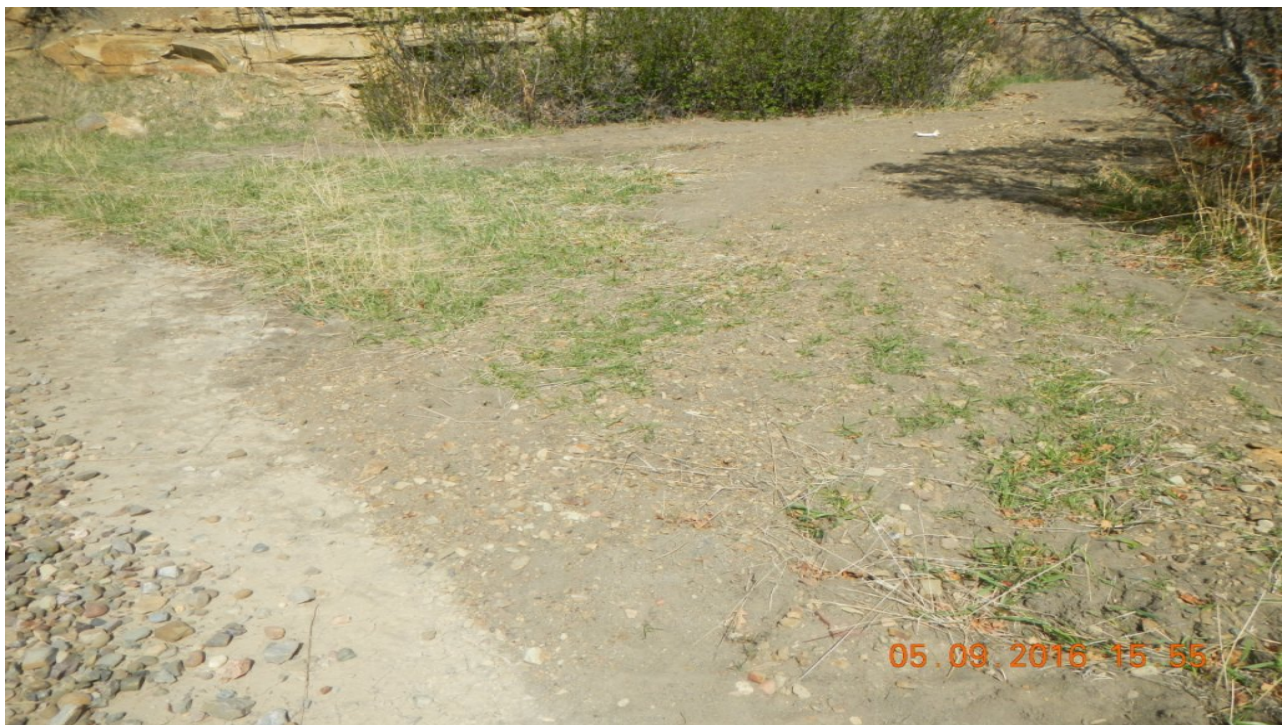
photo 2: Culvert appears to be filled with sediment at this area along the access road (Lat/Long:37.10380,-104.74803).

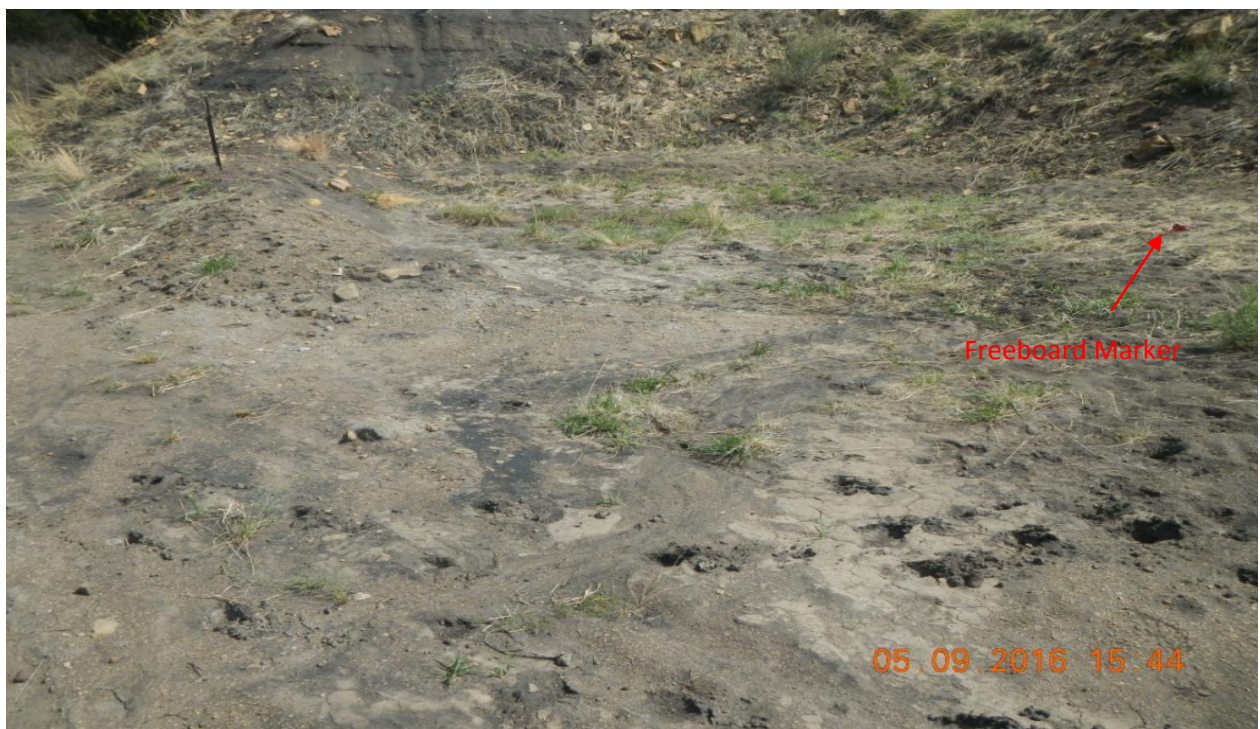
photo 4: Facing toward the pit at the south side of the location. There does not seem to be an adequate berm to allow for 2 feet of freeboard.

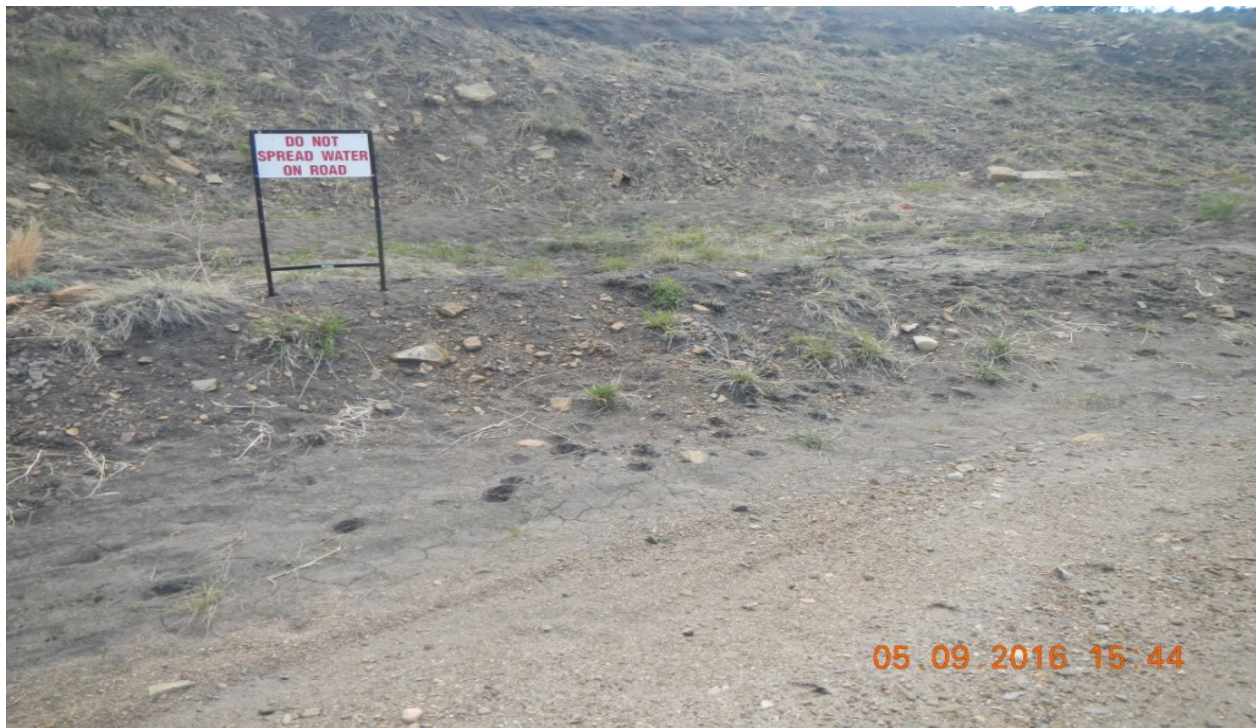
photo 5: Facing southwest toward the pit. There does not seem to be an adequate berm to allow for 2 feet of freeboard.

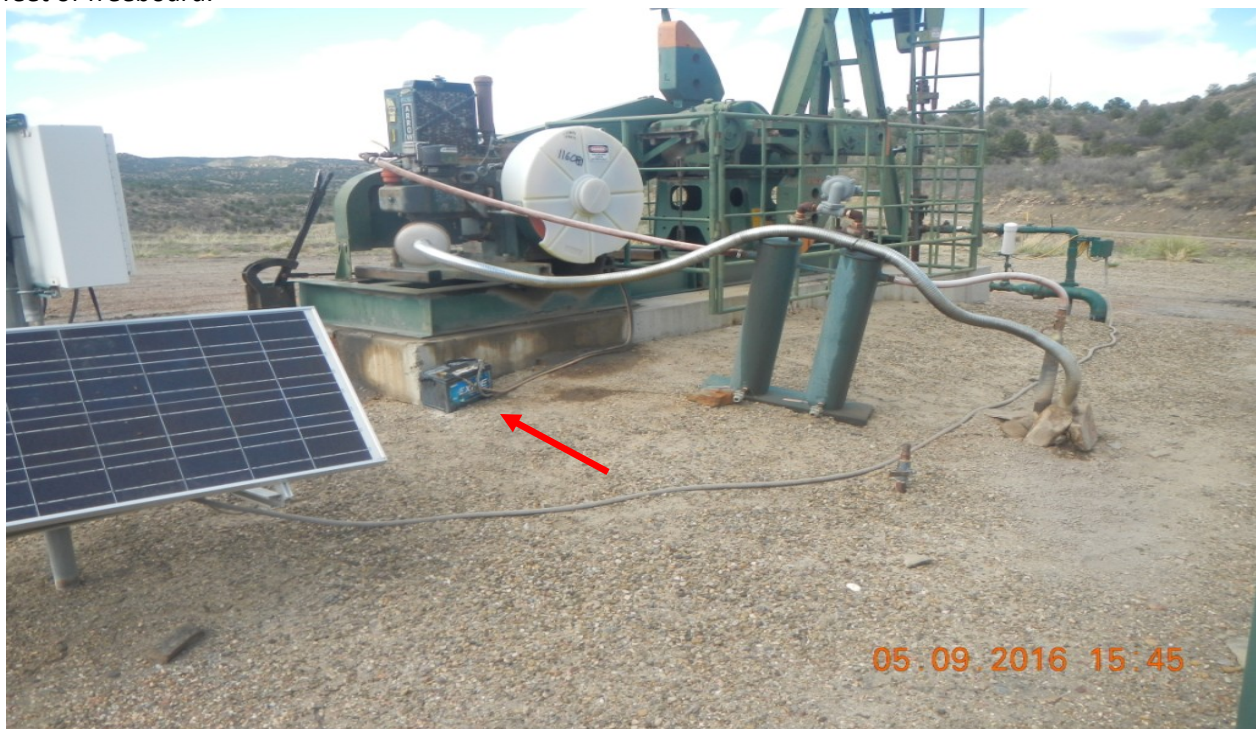
photo 6: Facing toward pump jack. Exposed battery on the ground and oil stains are a potential safety concern.

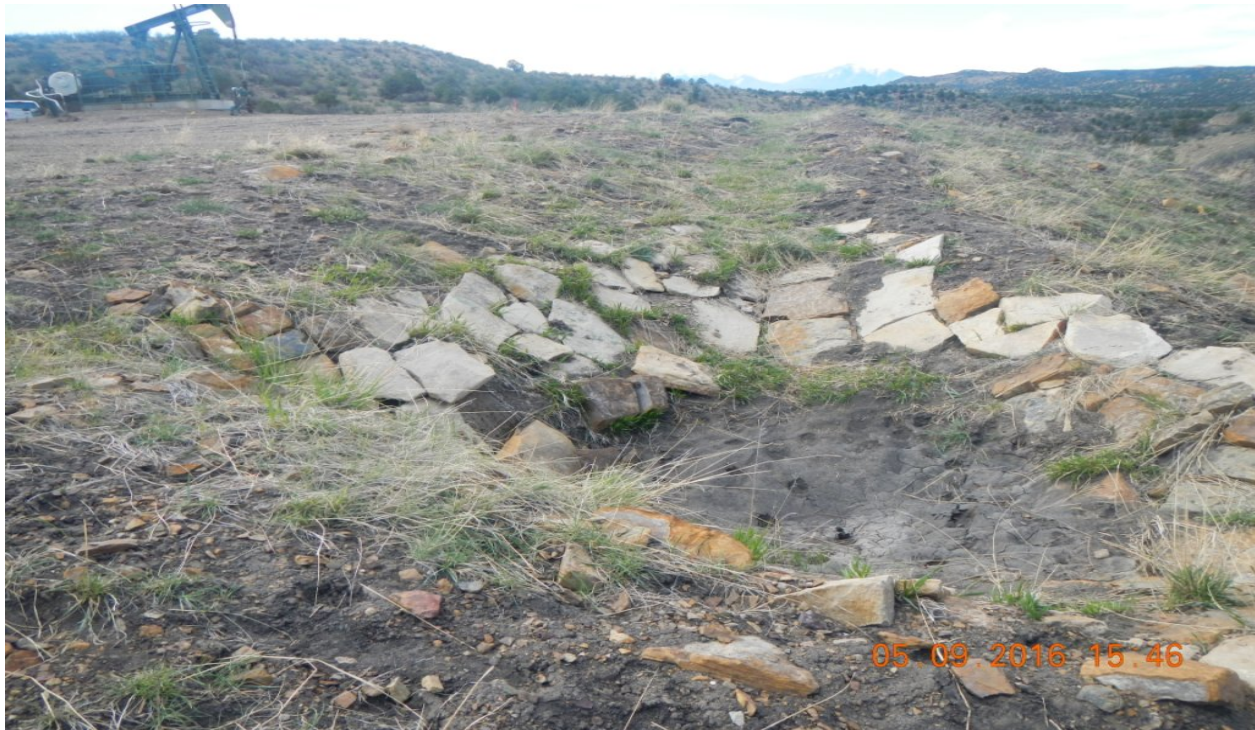
photo 7: Southeast side facing northwest. Sediment trap appears to be adequate.

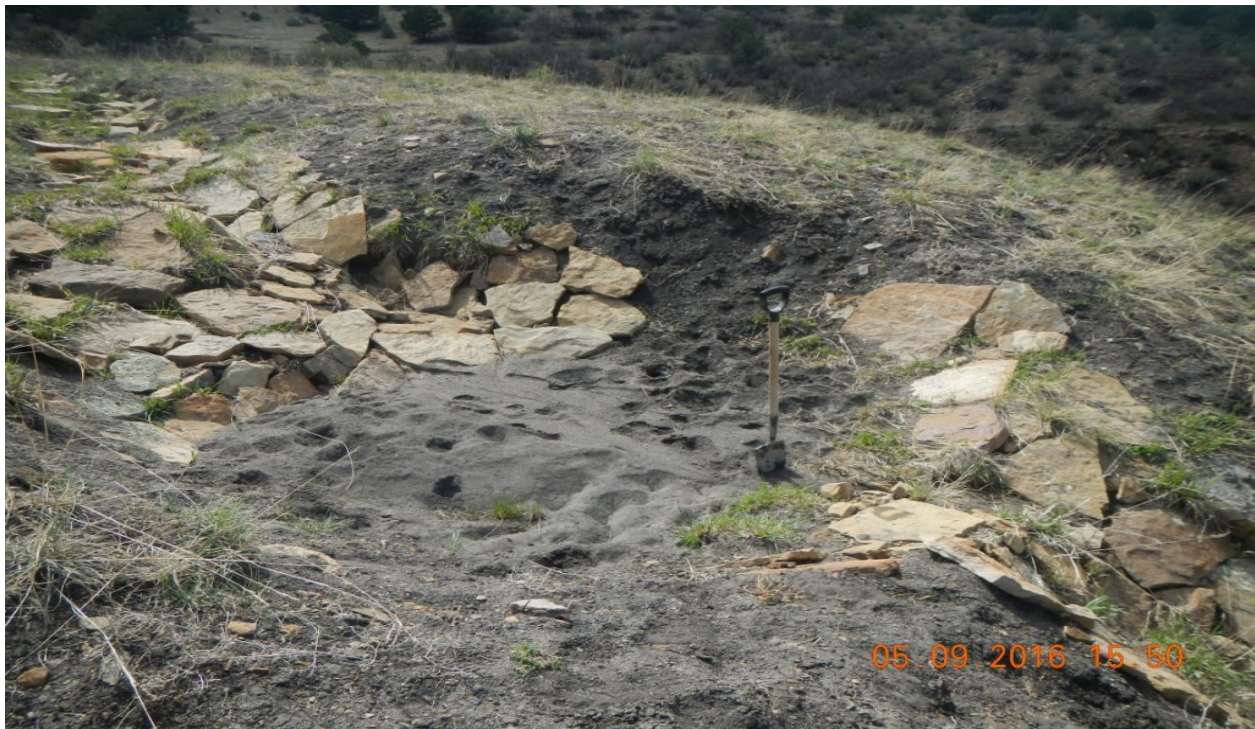
photo 8: Sediment trap at the northeast side, appears to be full of sediment.

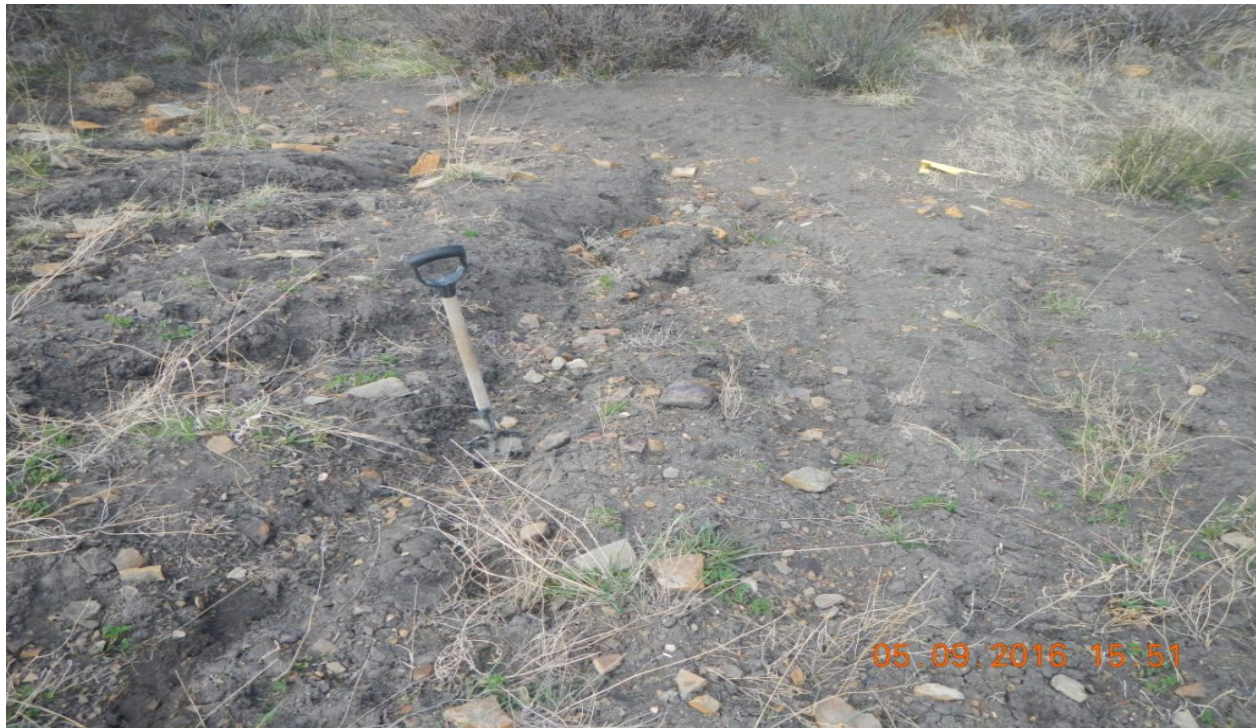
photo 9: Erosion channels have developed around the north side of the location.
