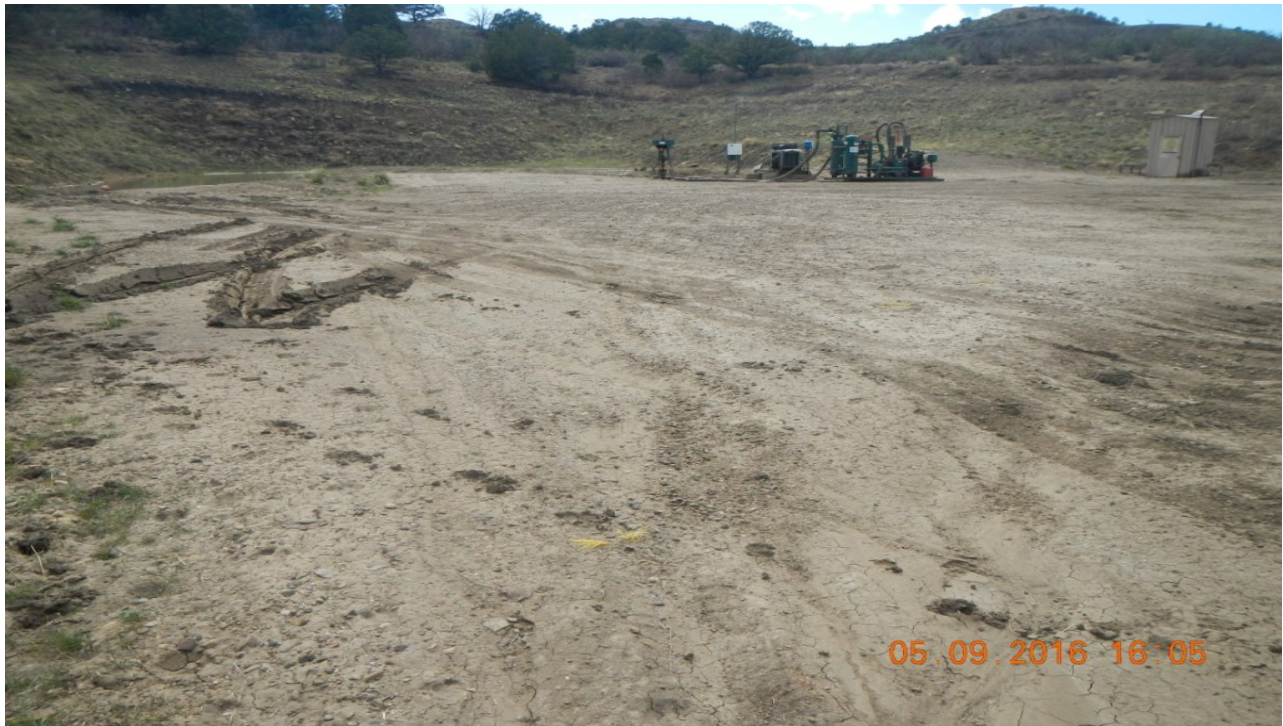
photo 1: Facing southwest toward the location.

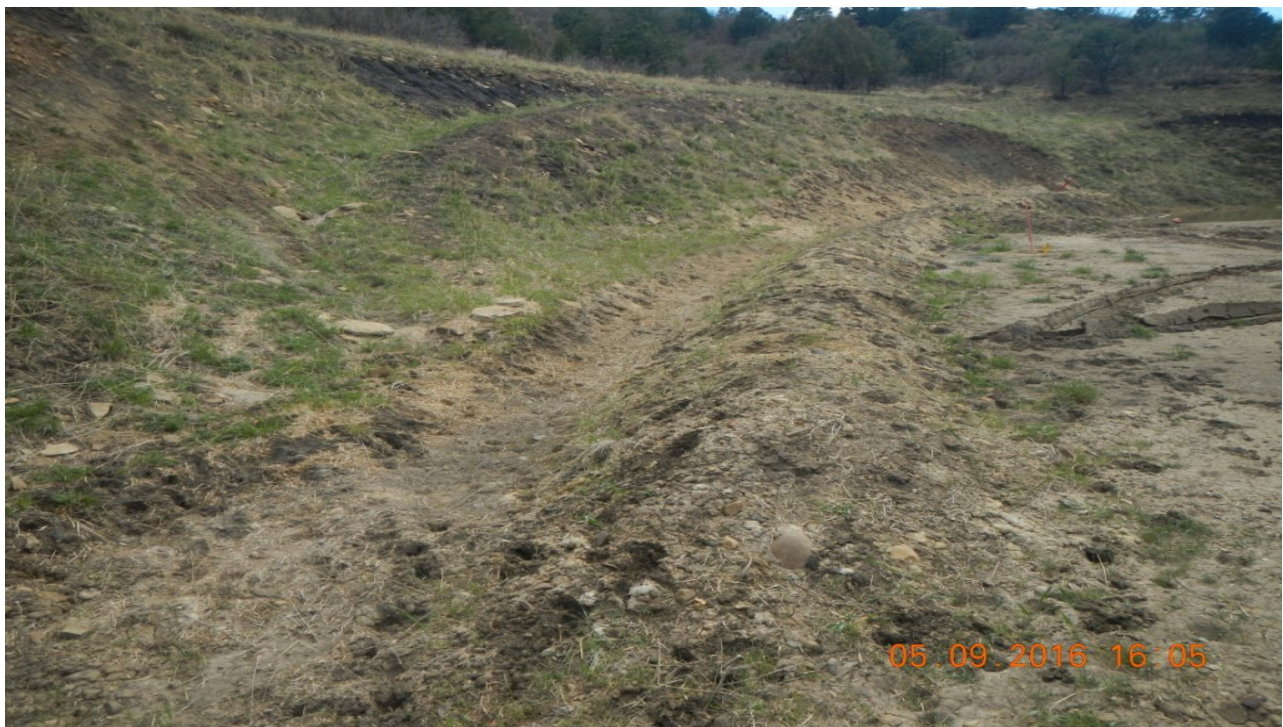
photo 2: Facing south at cut slope side of location.

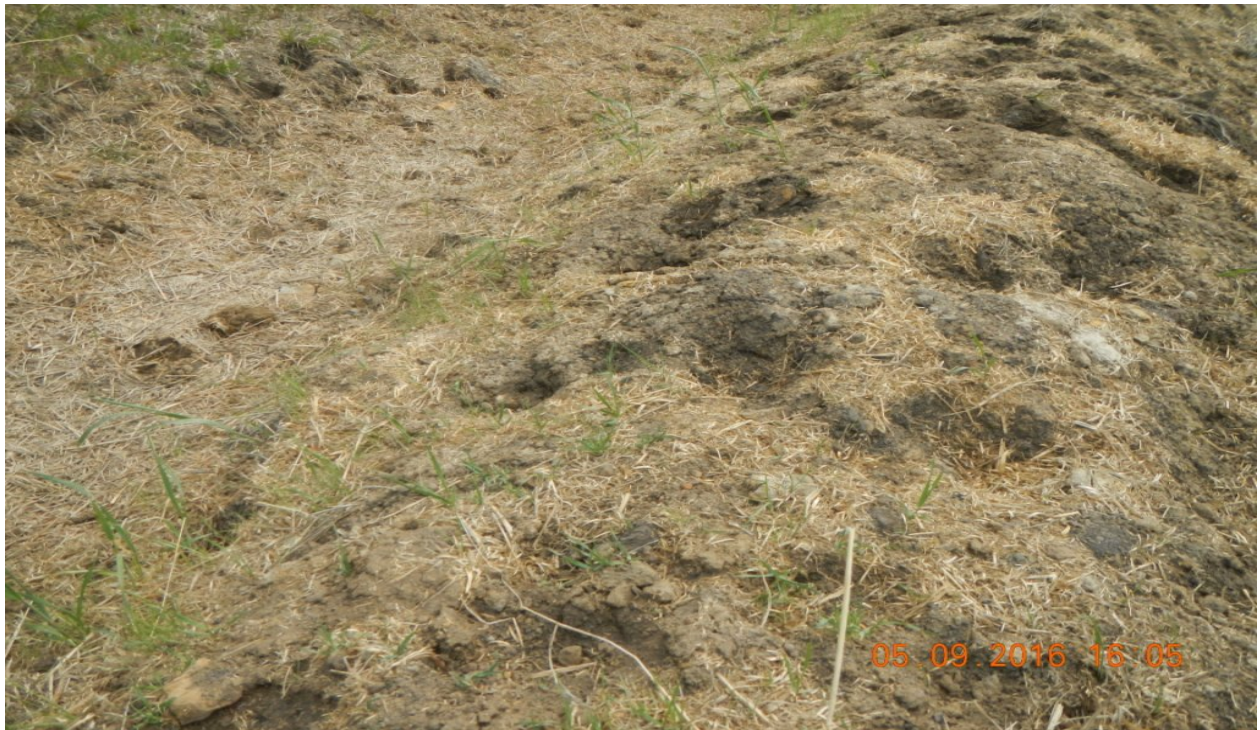
photo 3: Appears areas of the location have been reseeded and straw mulched.

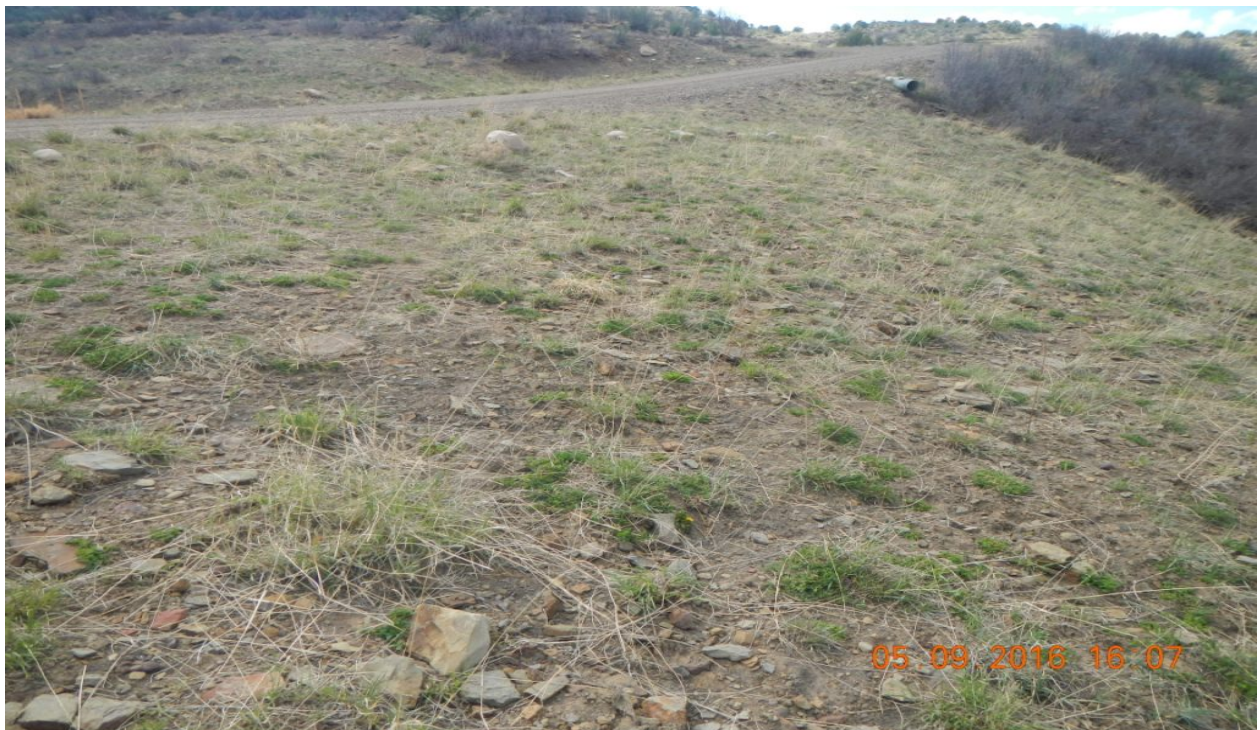
photo 4: Northeast side facing west.
