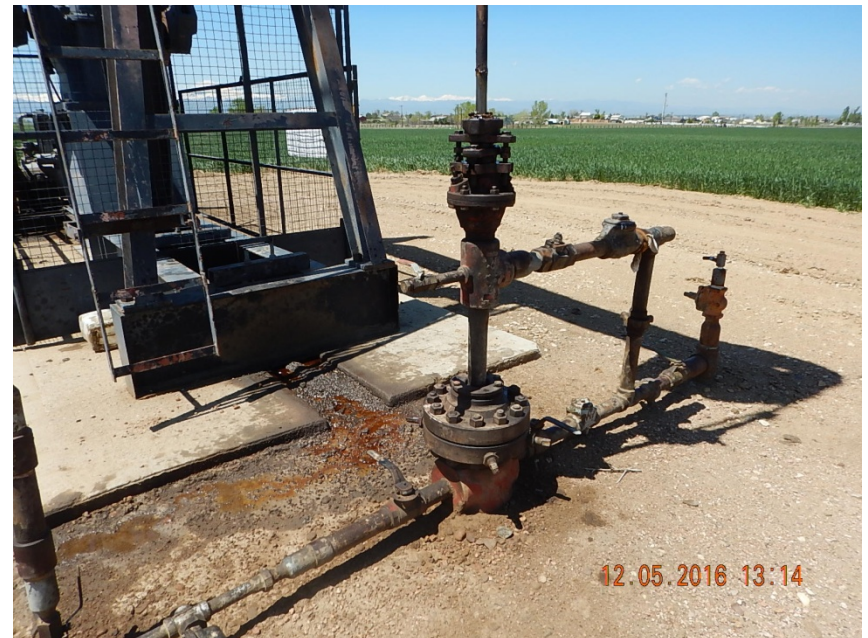
### Lube Oil Spill/ Release Observed at Wellhead

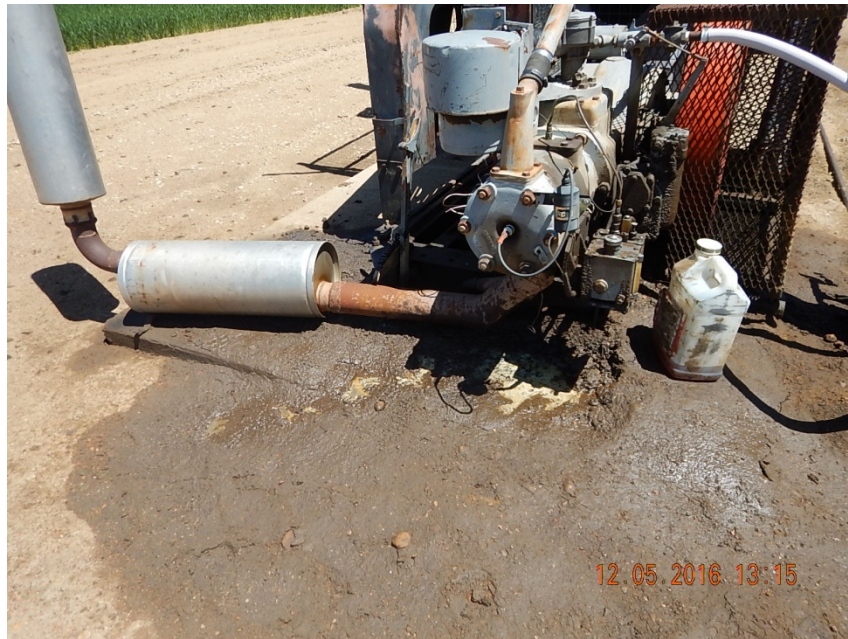
**Lube Oil Release Observed at Prime Mover**

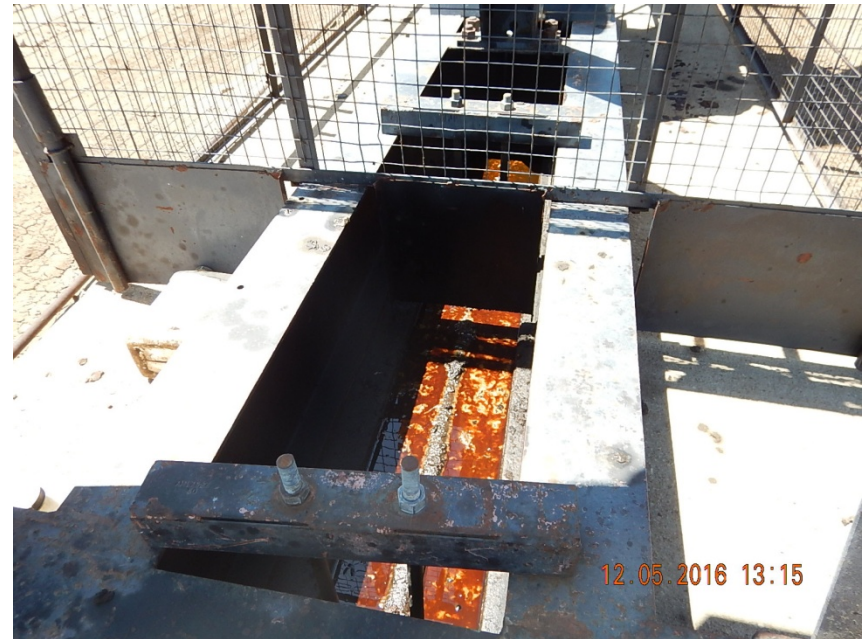
**Lube Oil Accumulations Observed Inside Frame Rails of Pump Jack**

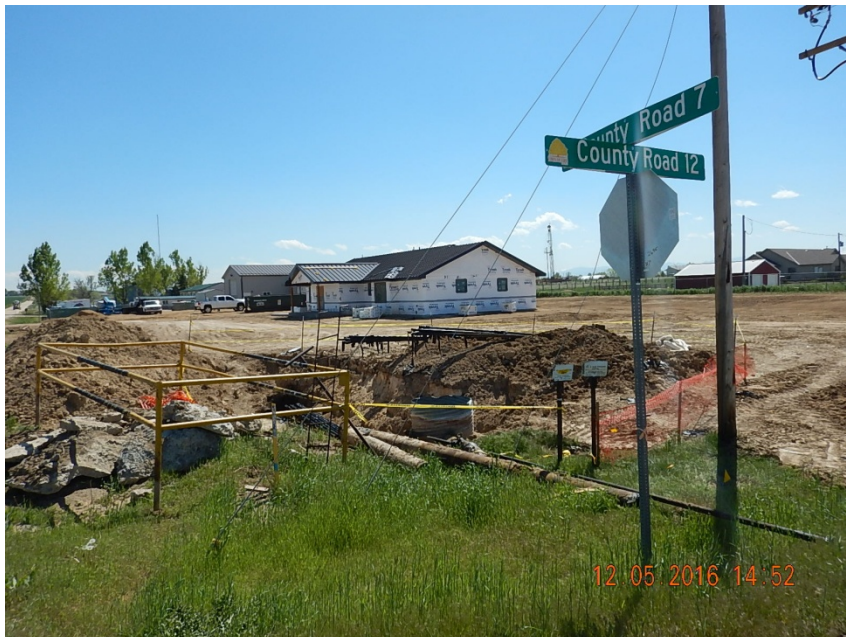
**Flowline Repair Excavation and Site of Spill  
Photo View Looking SW**

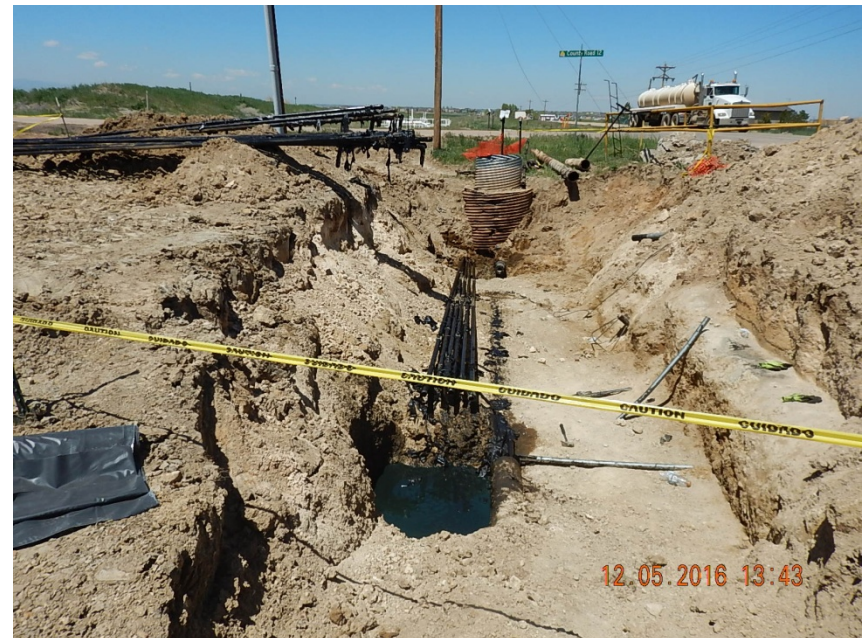
**Flowline Repair Excavation and Crude Oil Spill  
Photo View Looking North**

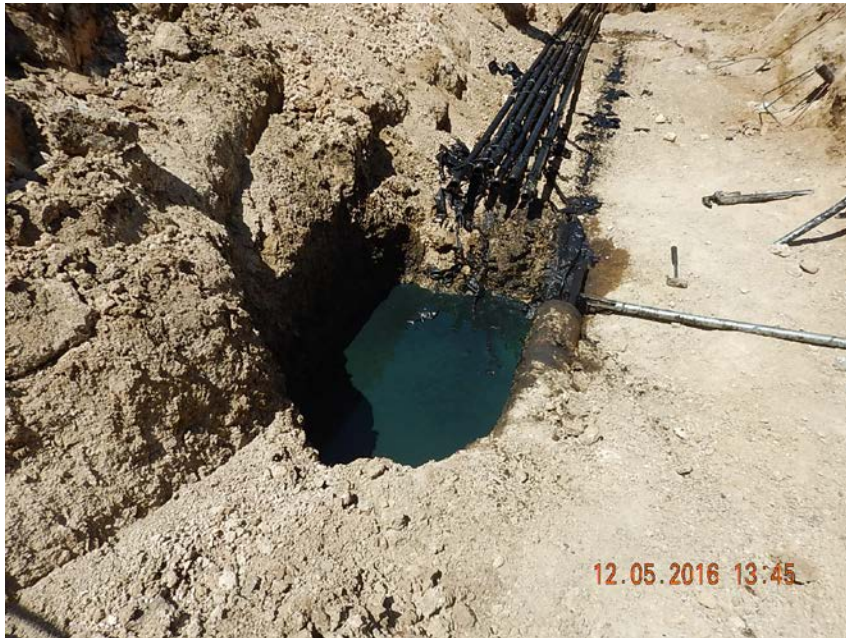
**Crude Oil Release in South End of Excavation  
(N End of Casing Pipe)**

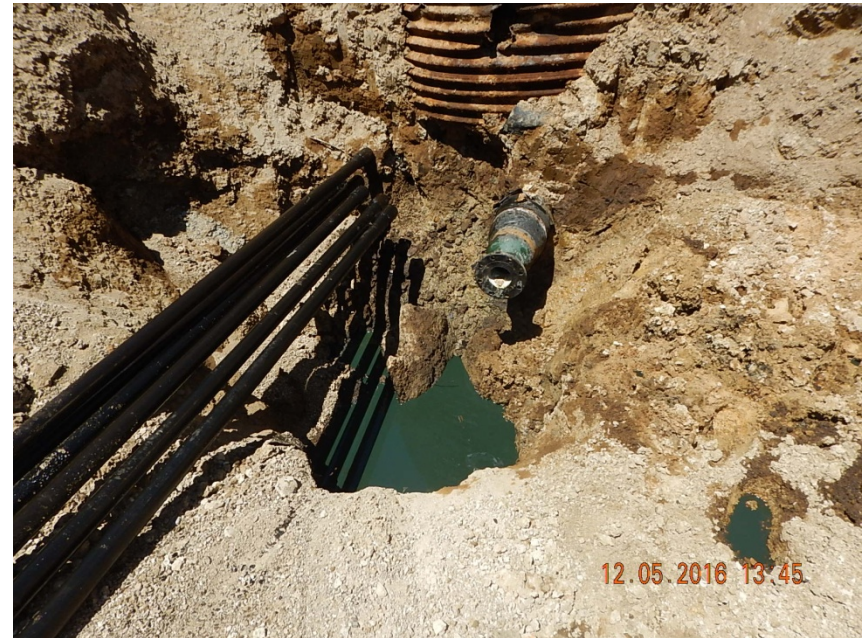
**Free Crude Oil Product at Valve Can  
(N End Excavation)**

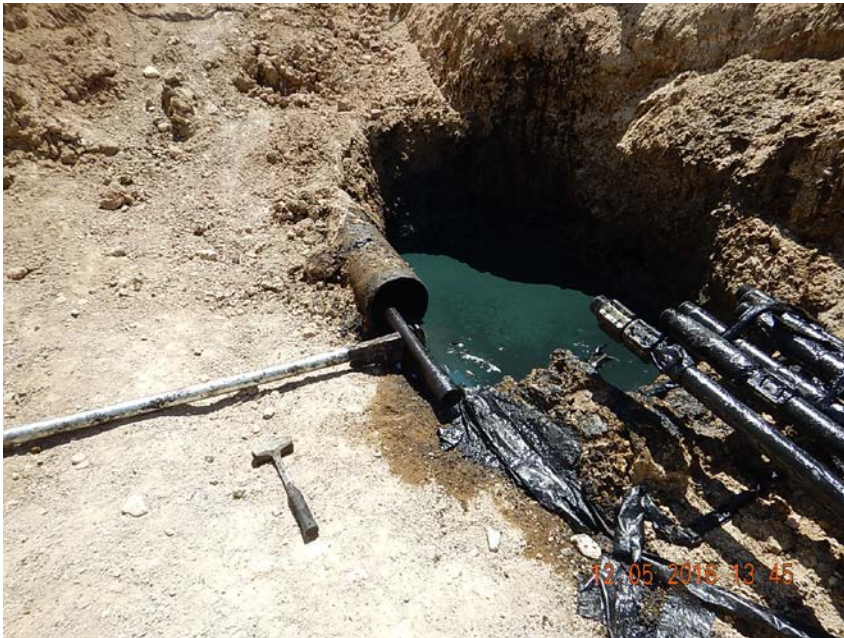
**Closer View of Free Crude Oil in Excavation  
Flowline Being Removed from Casing Pipe**

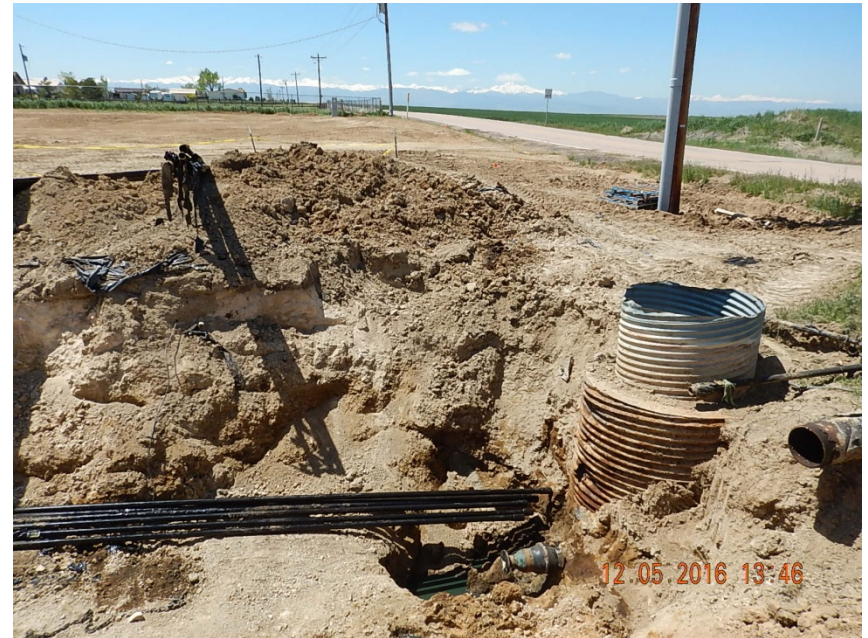
**View of Excavation/ Release looking West with  
Sections of Flowline Removed**

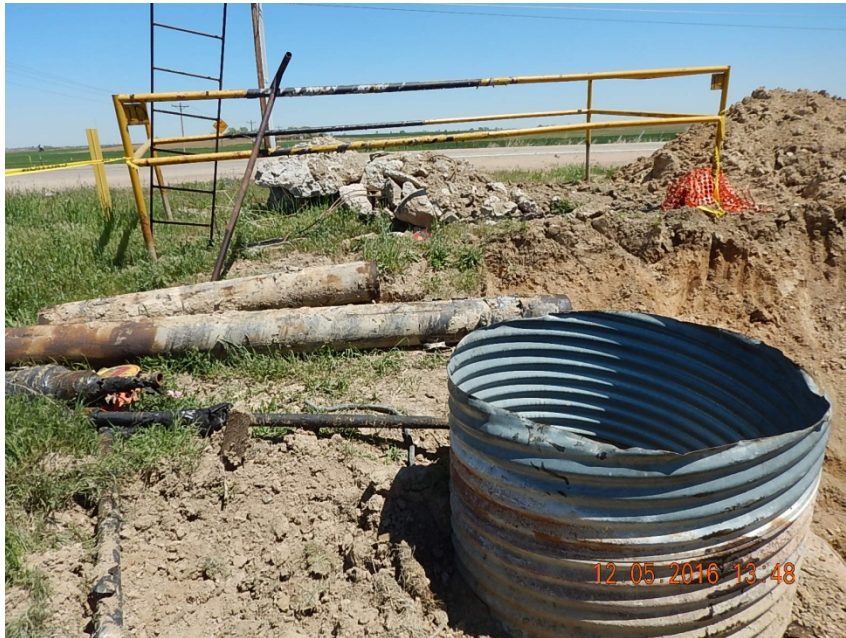
**Valve Can looking NE/ (No Existing Cover)**

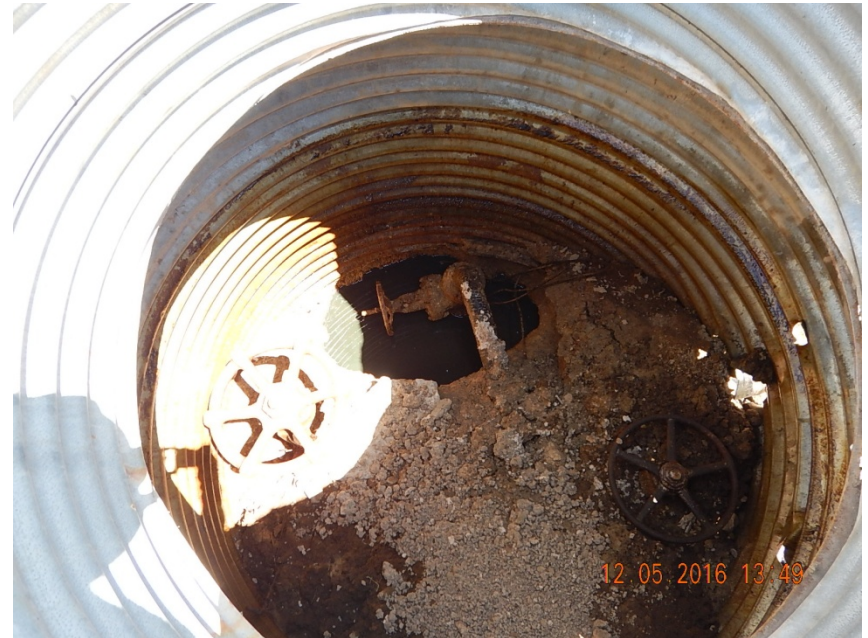
**Free Crude Oil in Bottom of Valve Can**
