## Final Reclamation Inspection

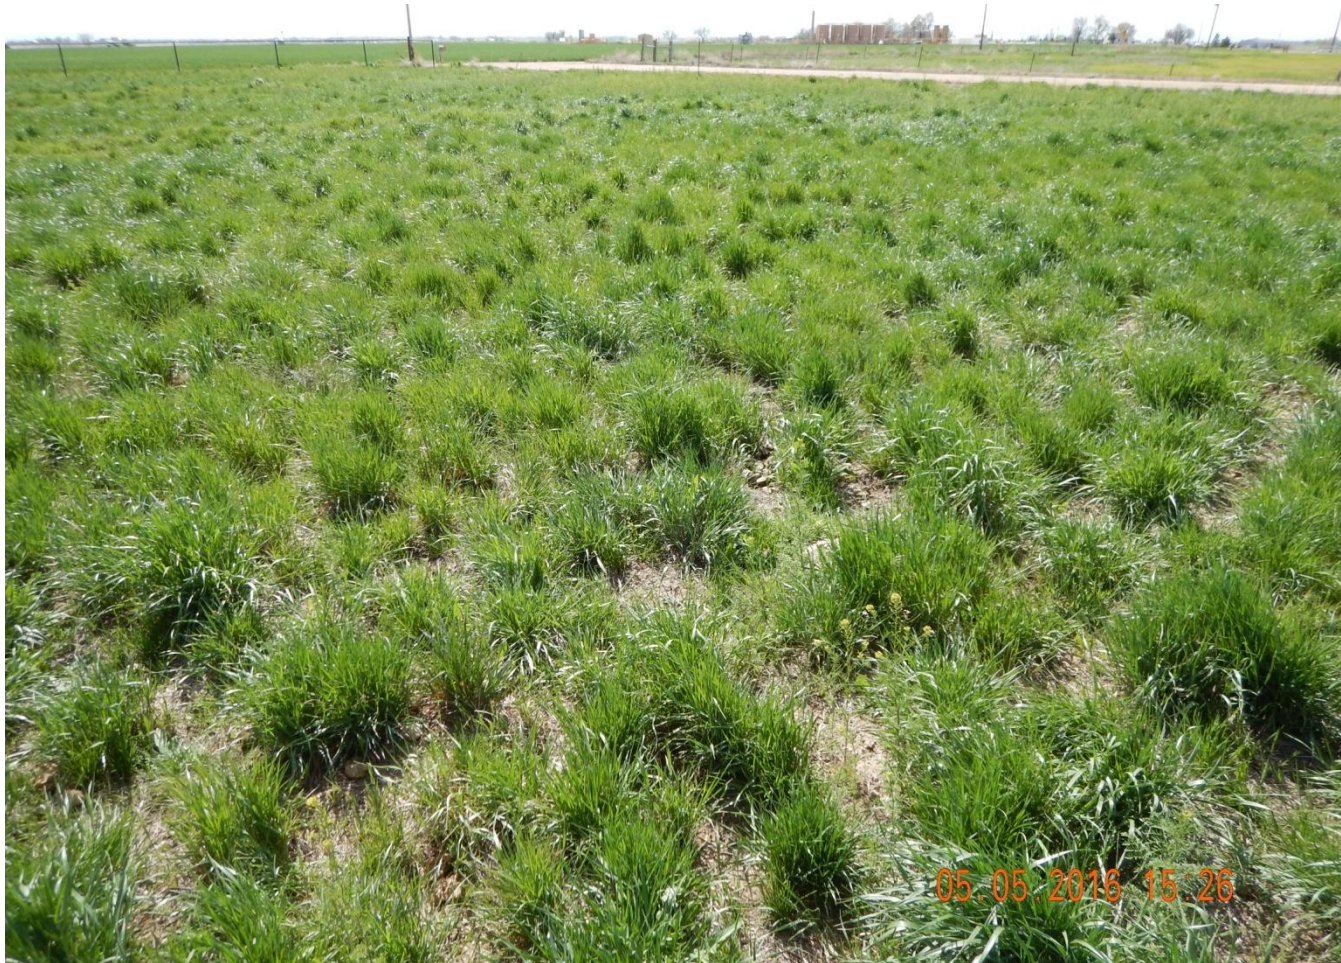
**Photo 1.** Photo taken from center of location, facing West. No evidence of wellbore or disturbance at location. Uniform vegetative plant cover throughout location.

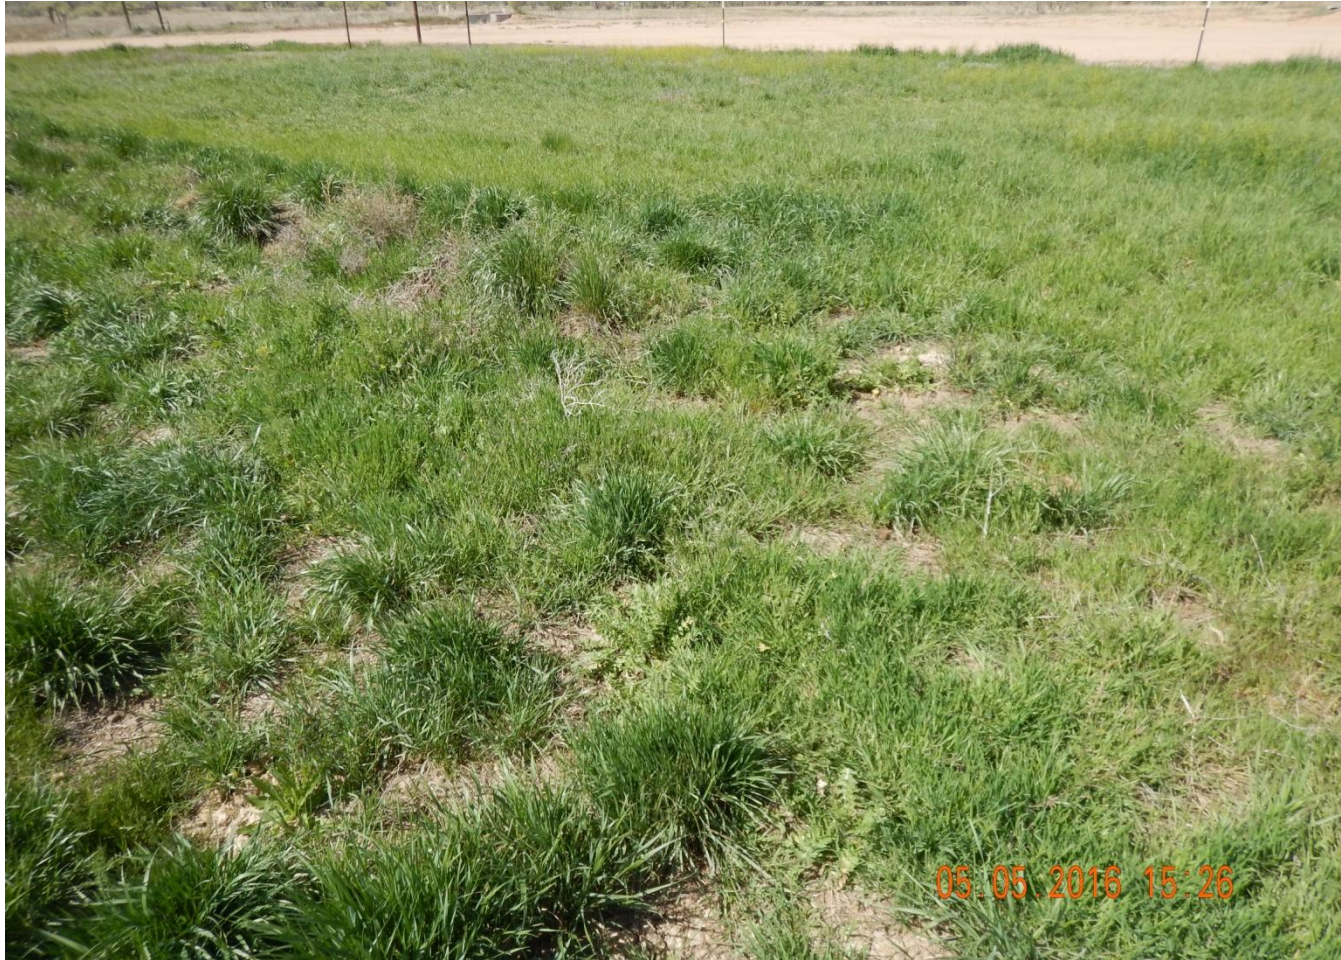
**Photo 2.** Photo taken from center of location, facing North. No evidence of wellbore or disturbance at location. Uniform vegetative plant cover throughout location.

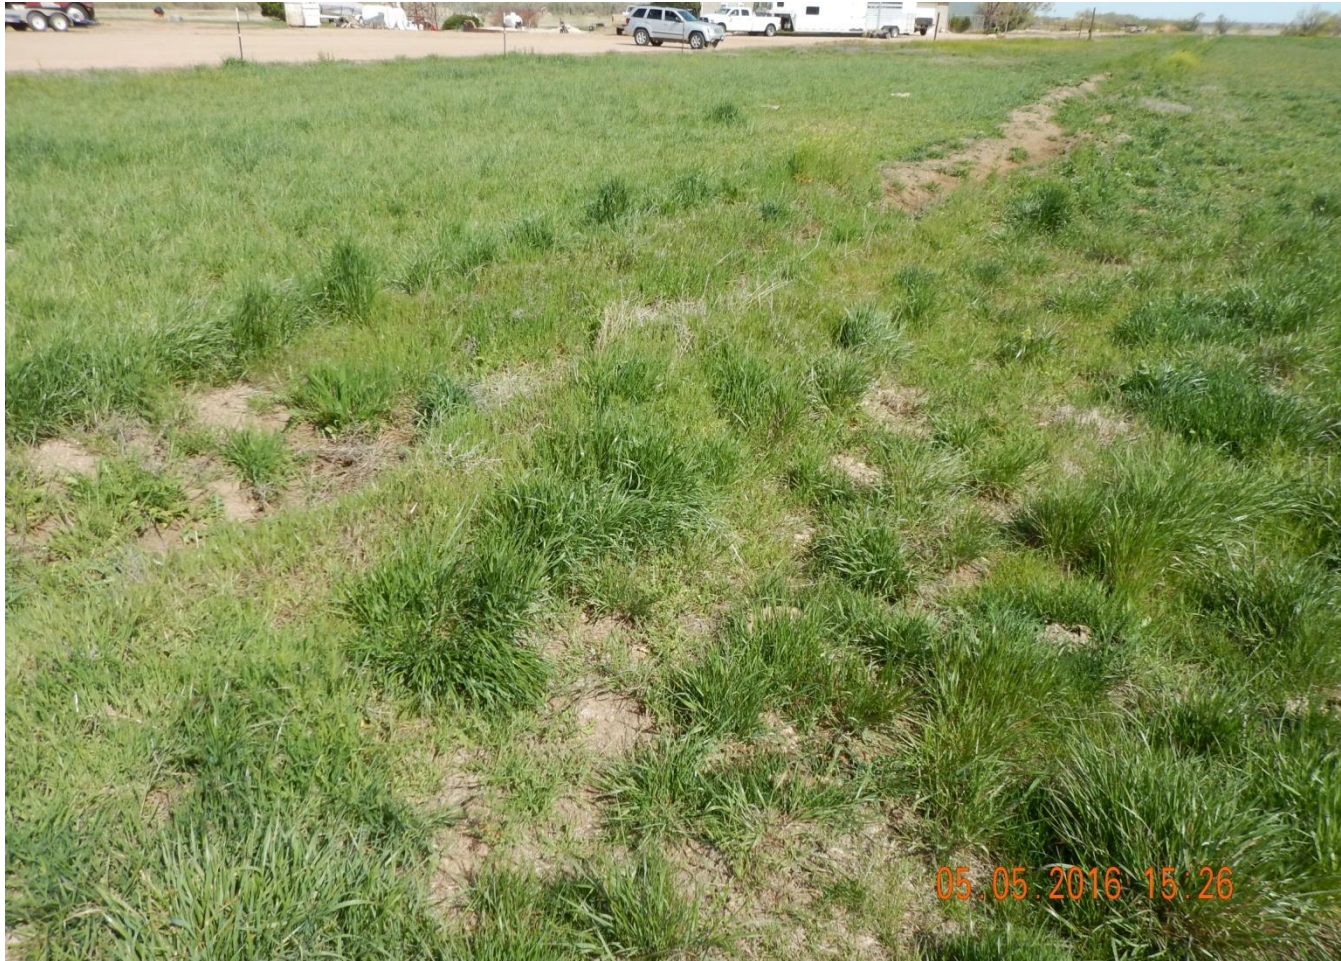
**Photo 3.** Photo taken from center of location, facing East. No evidence of wellbore or disturbance at location. Uniform vegetative plant cover throughout location.

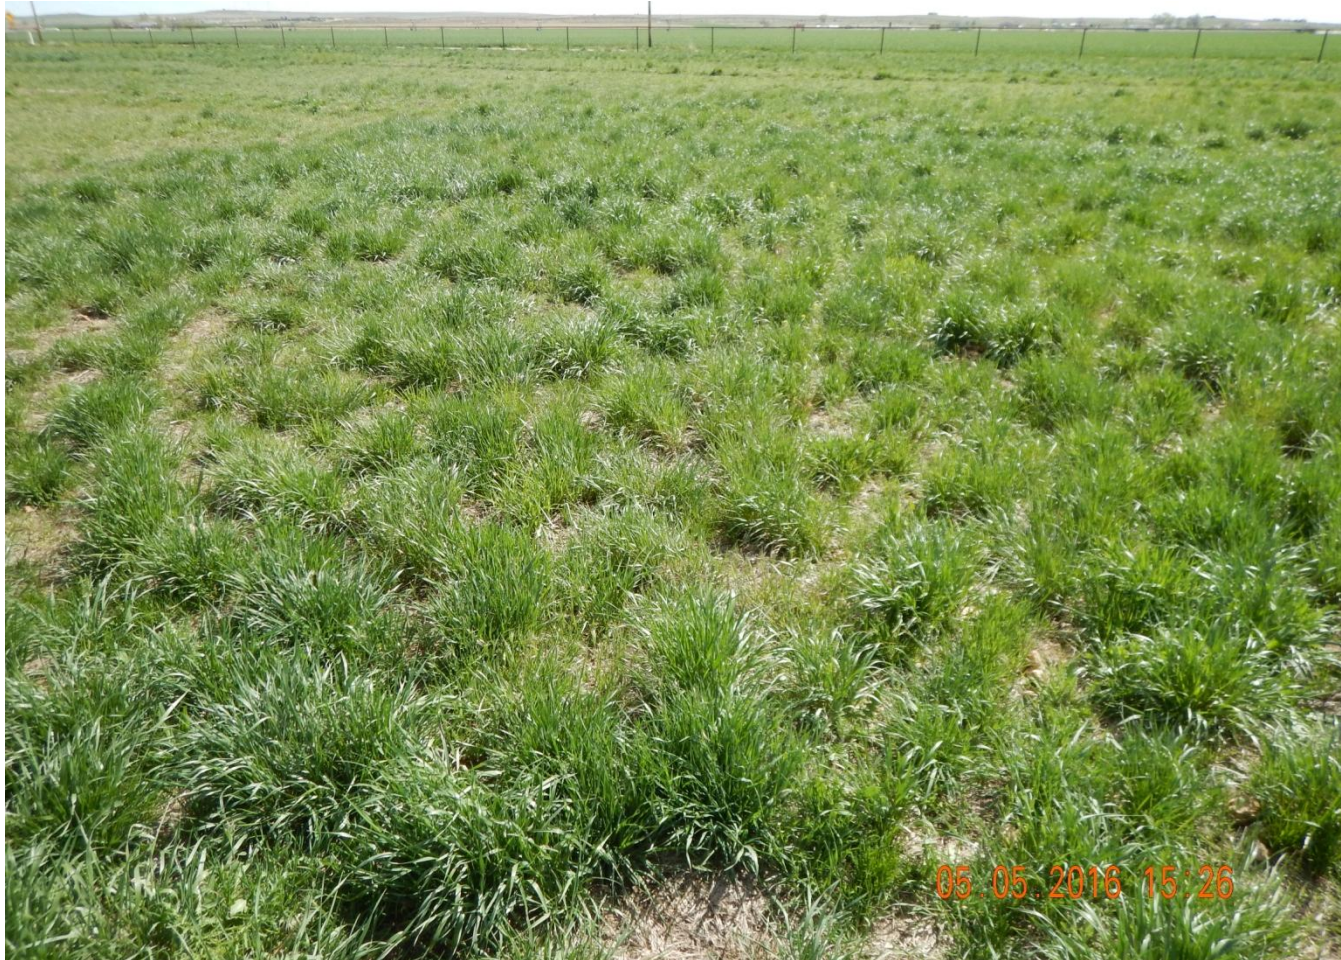
**Photo 4.** Photo taken from center of location, facing South. No evidence of wellbore or disturbance at location. Uniform vegetative plant cover throughout location.

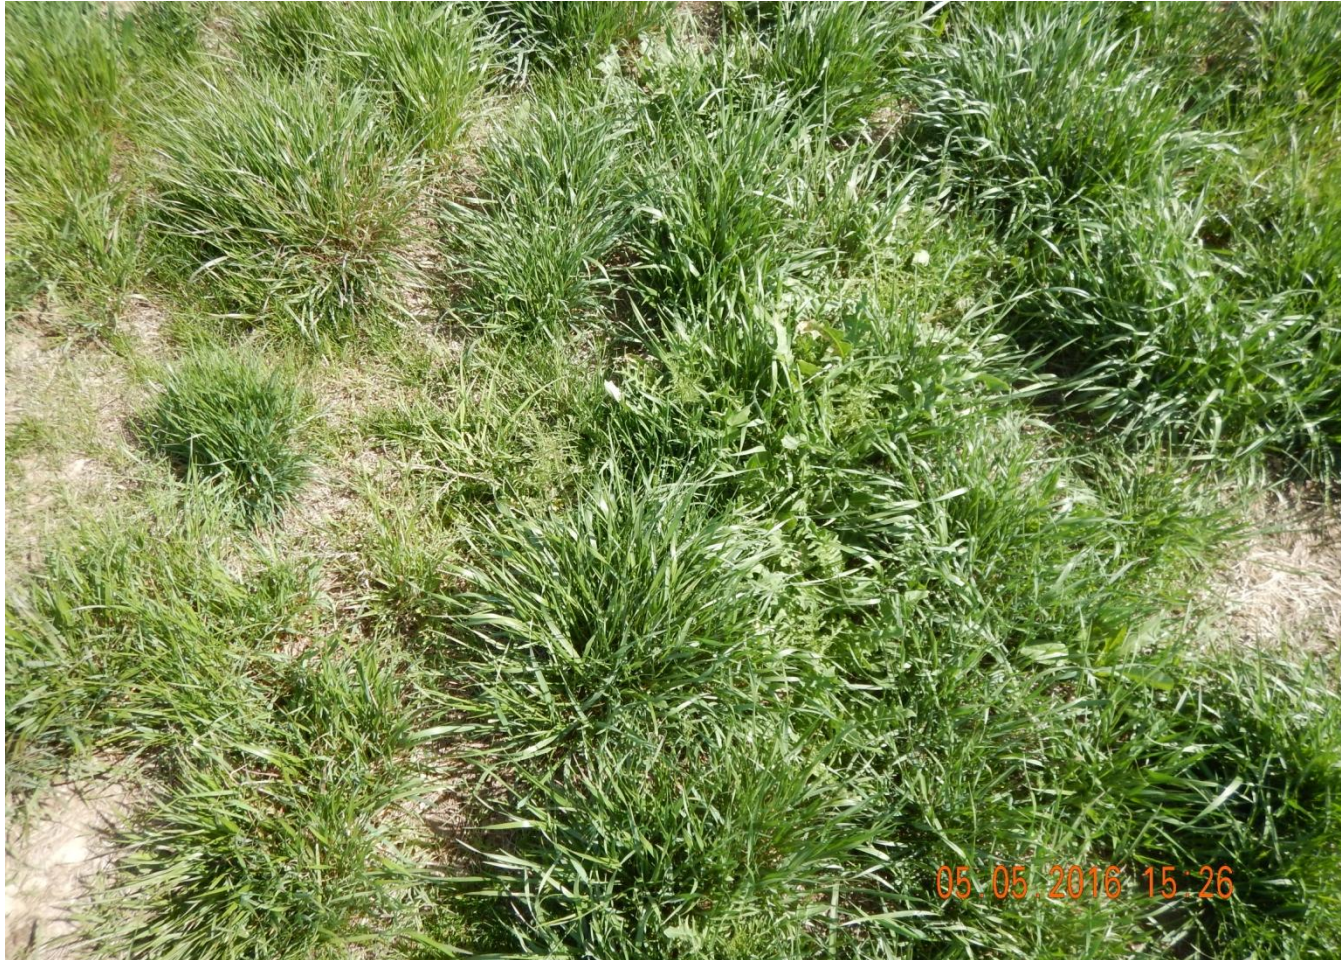
**Photo 5.** Photo taken from center of location. Birdseye view of total vegetative cover.
