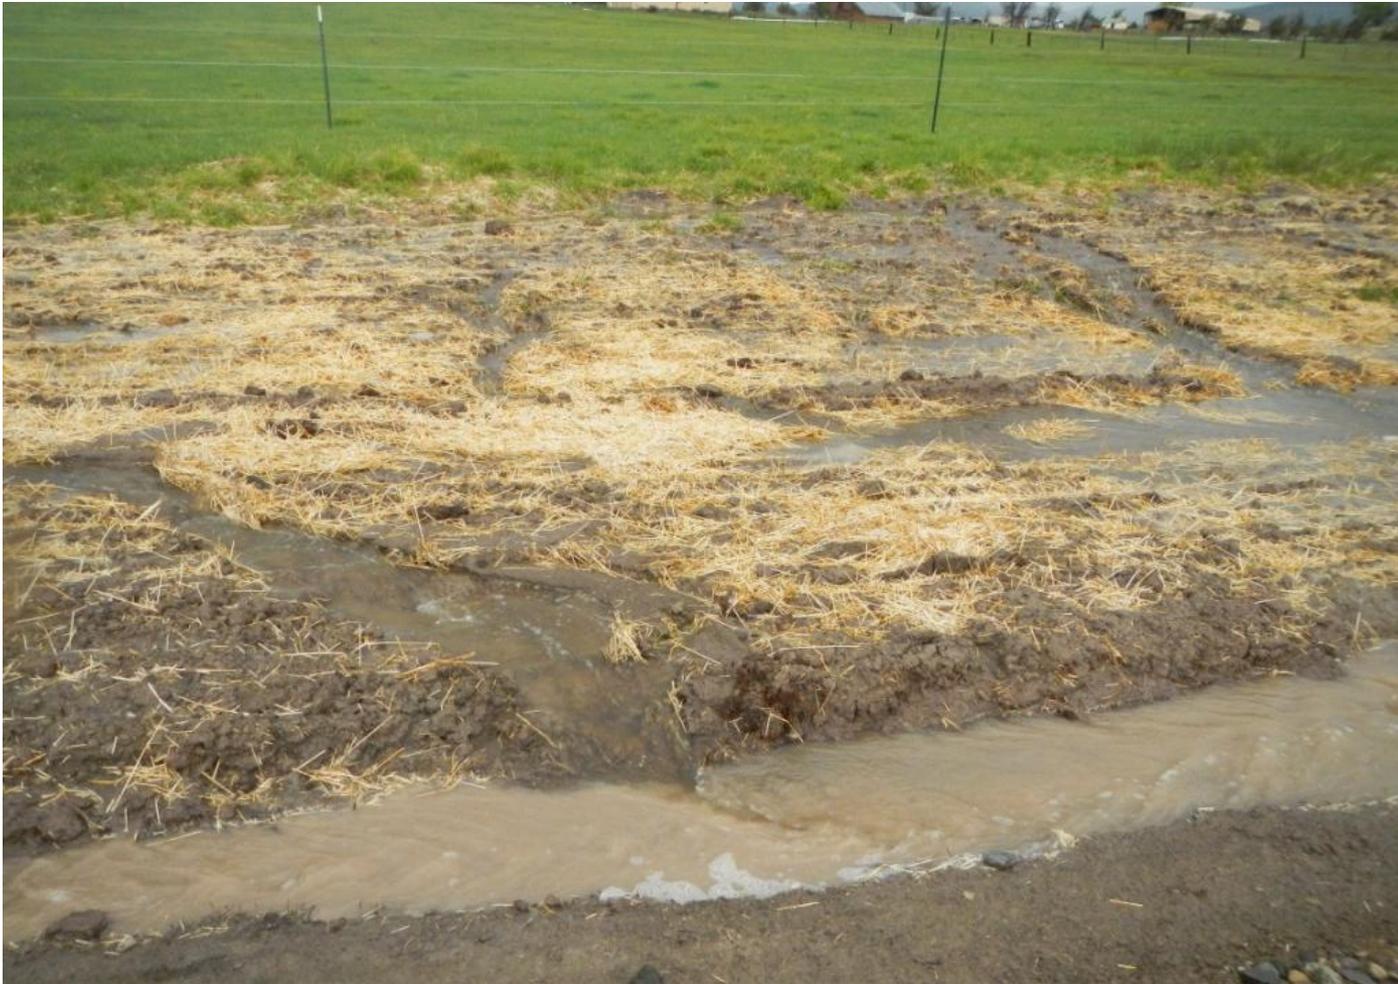
Photo 1. View of irrigation and stormwater run-on from adjacent field to roadside ditch on northern side of access road.

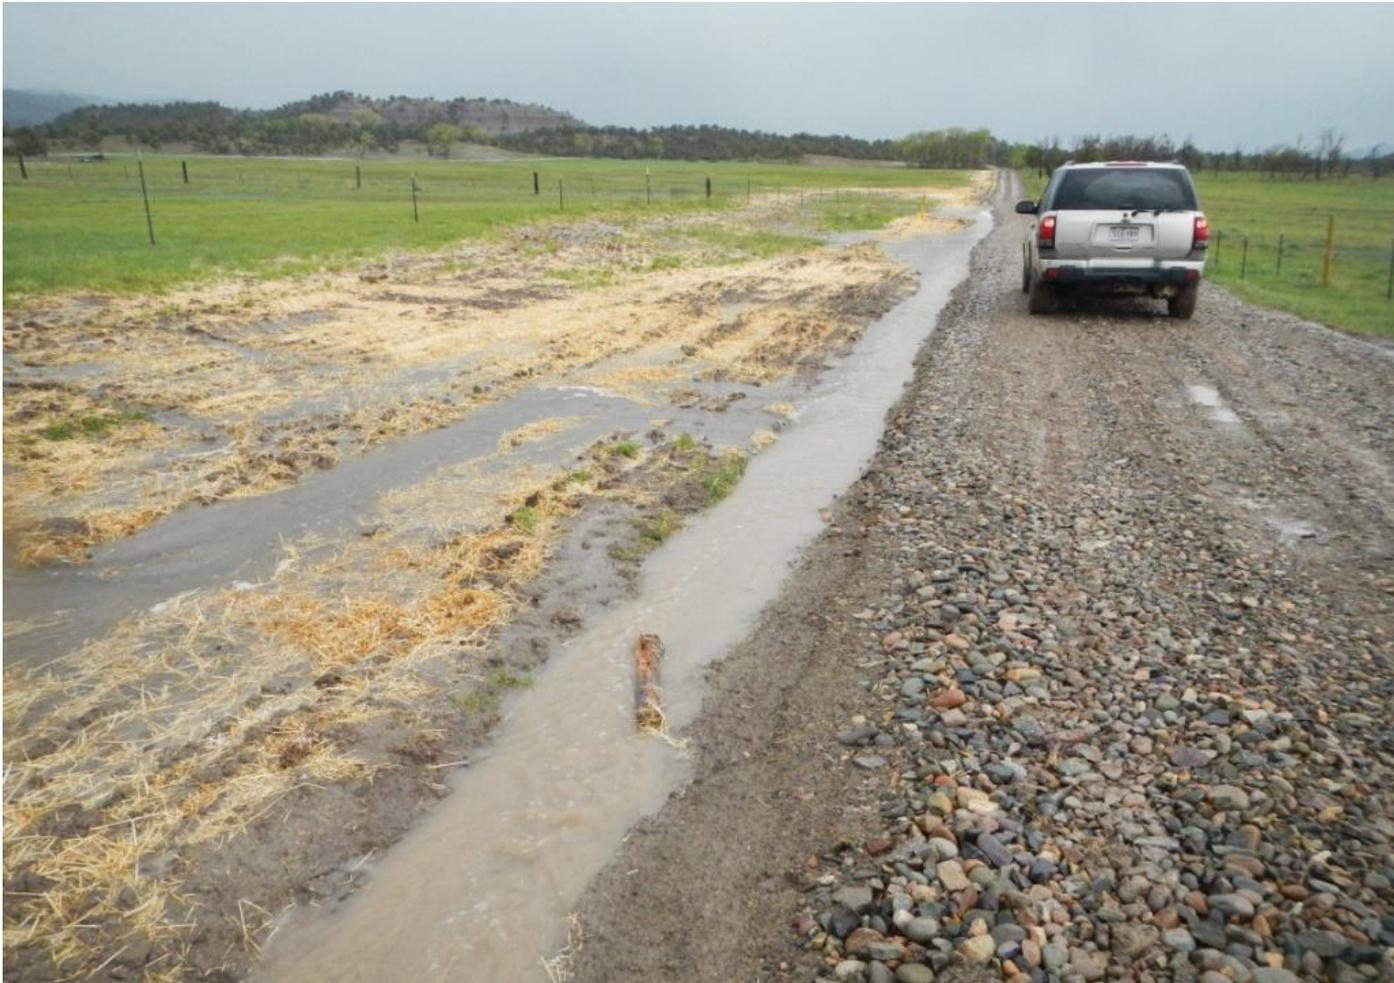
Photo 2. View of water flowing down roadside ditch toward culvert along access road facing eastward.

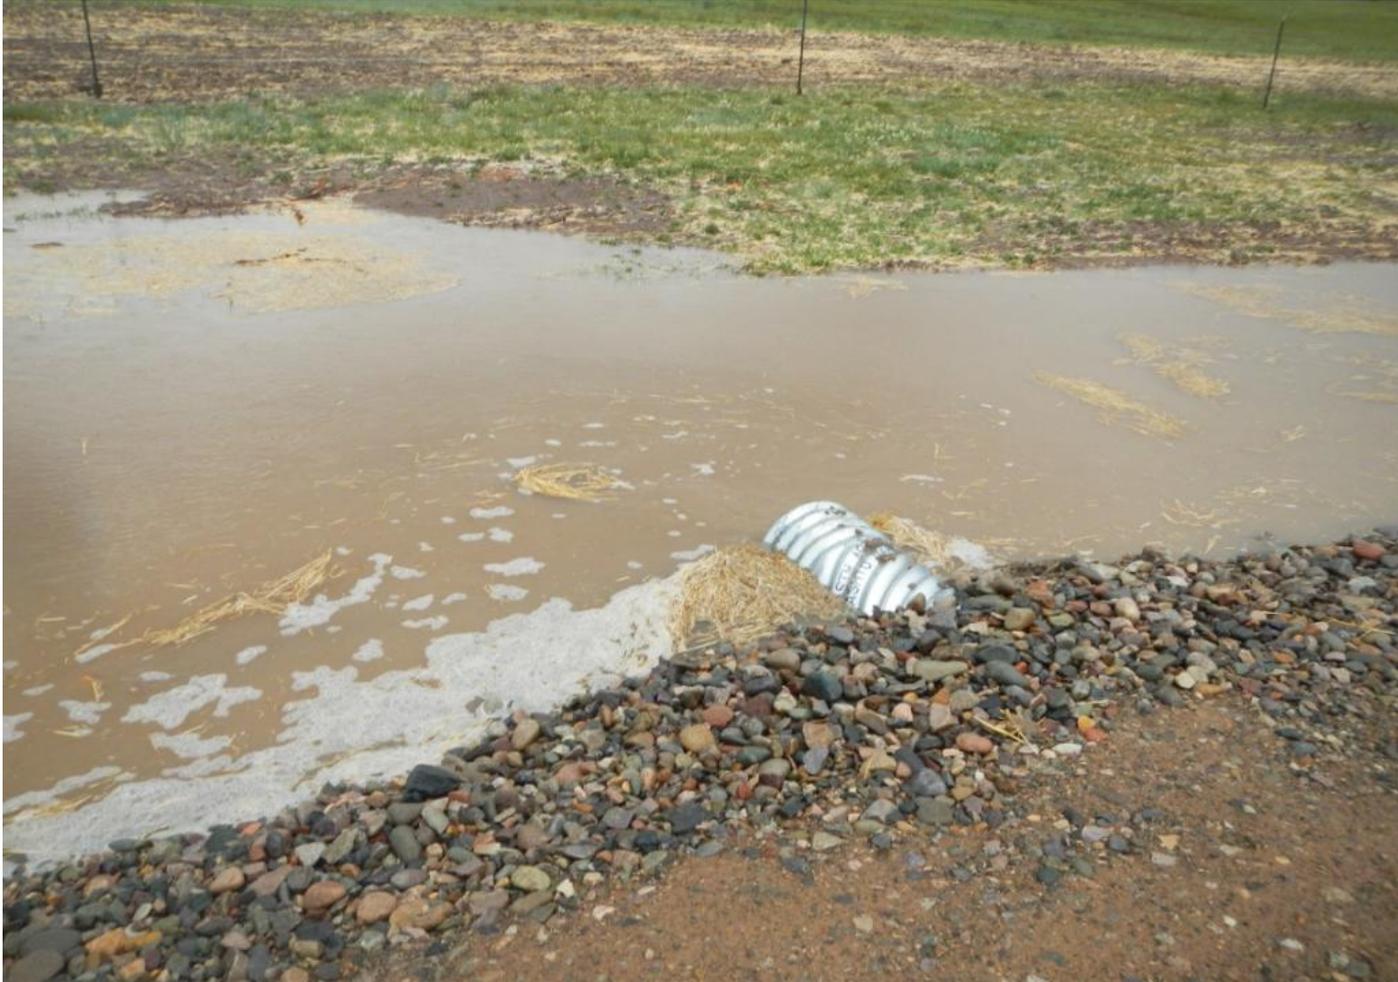
Photo 3. View of water pooling at culvert entrance along the access road.

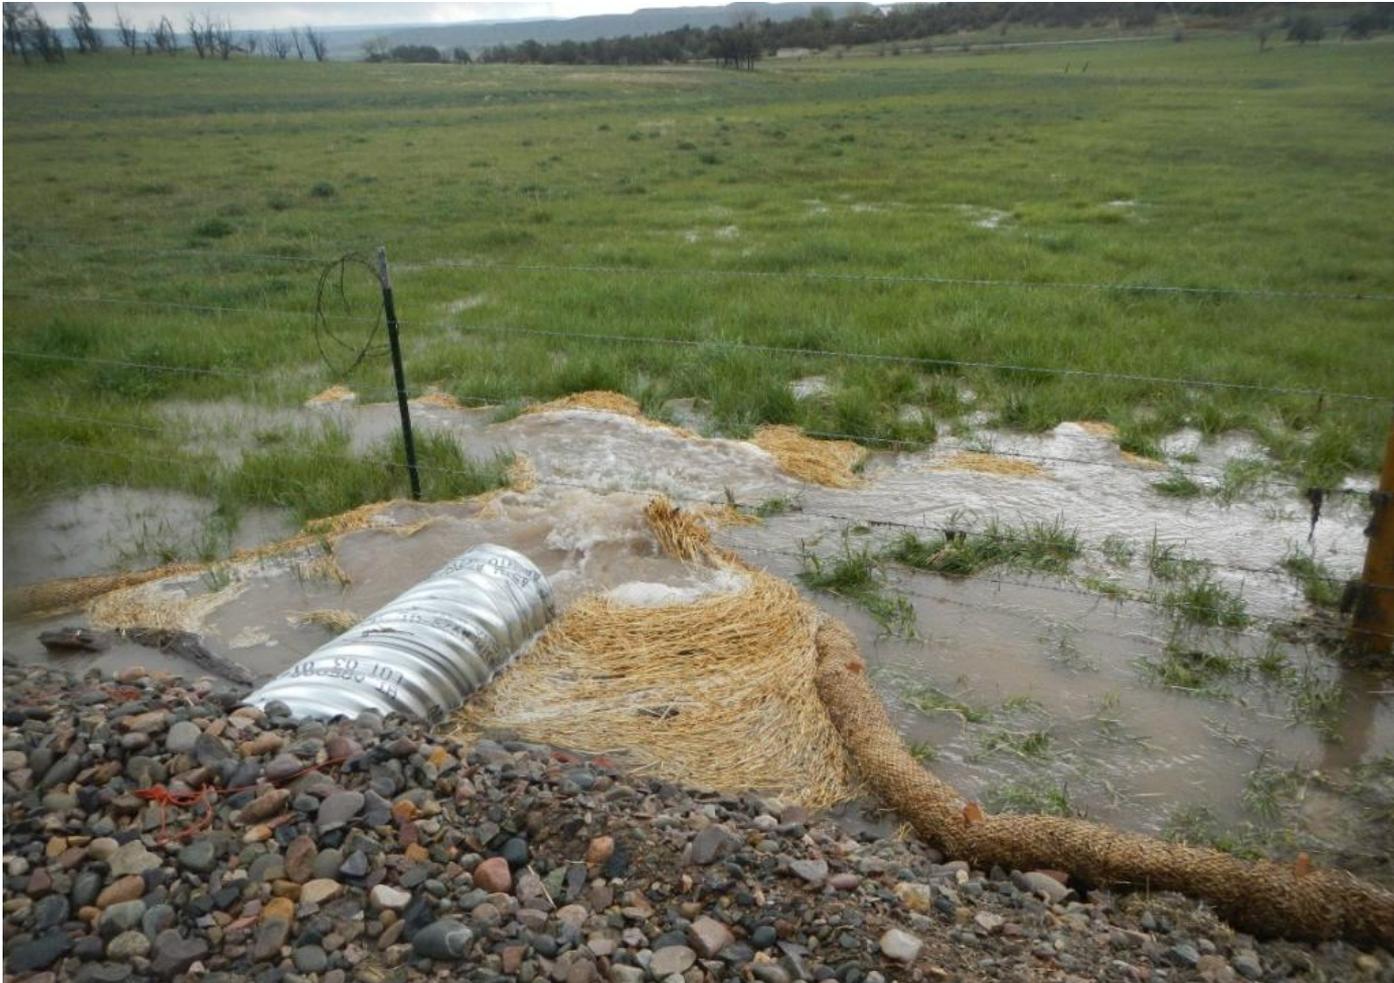
Photo 4. View of culvert outlet along access road where concentrated stormwater and irrigation flows into adjacent field. These concentrated flows will deposit sediment and damage adjacent field if not de-energized.

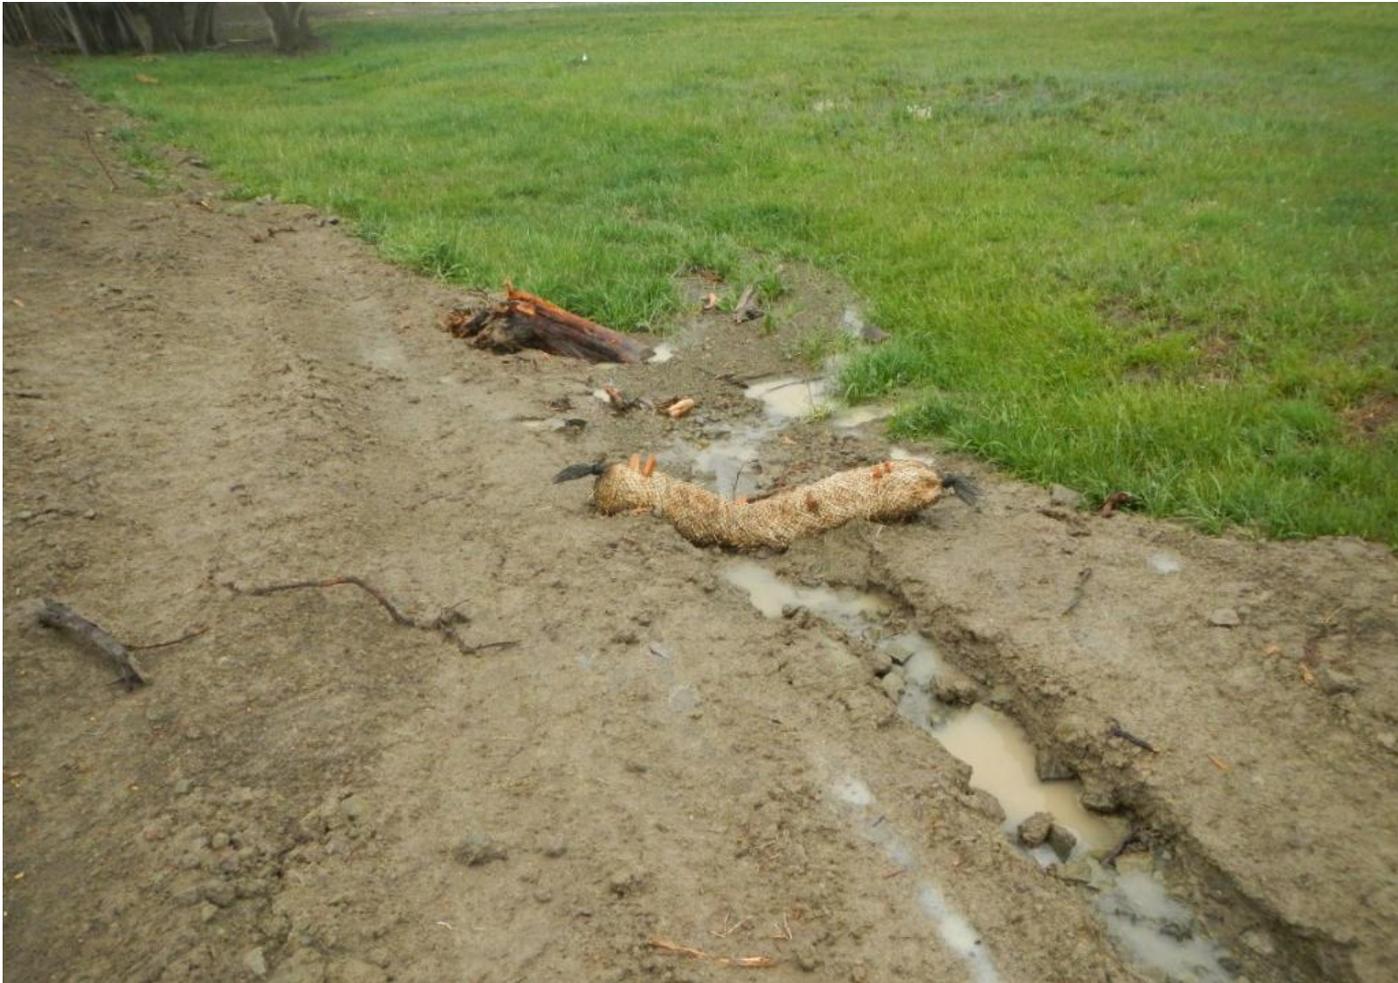
Photo 5. View of erosion and sediment deposition off of the western edge of the well pad. Straw wattle is not sufficient as the only BMP in this location.

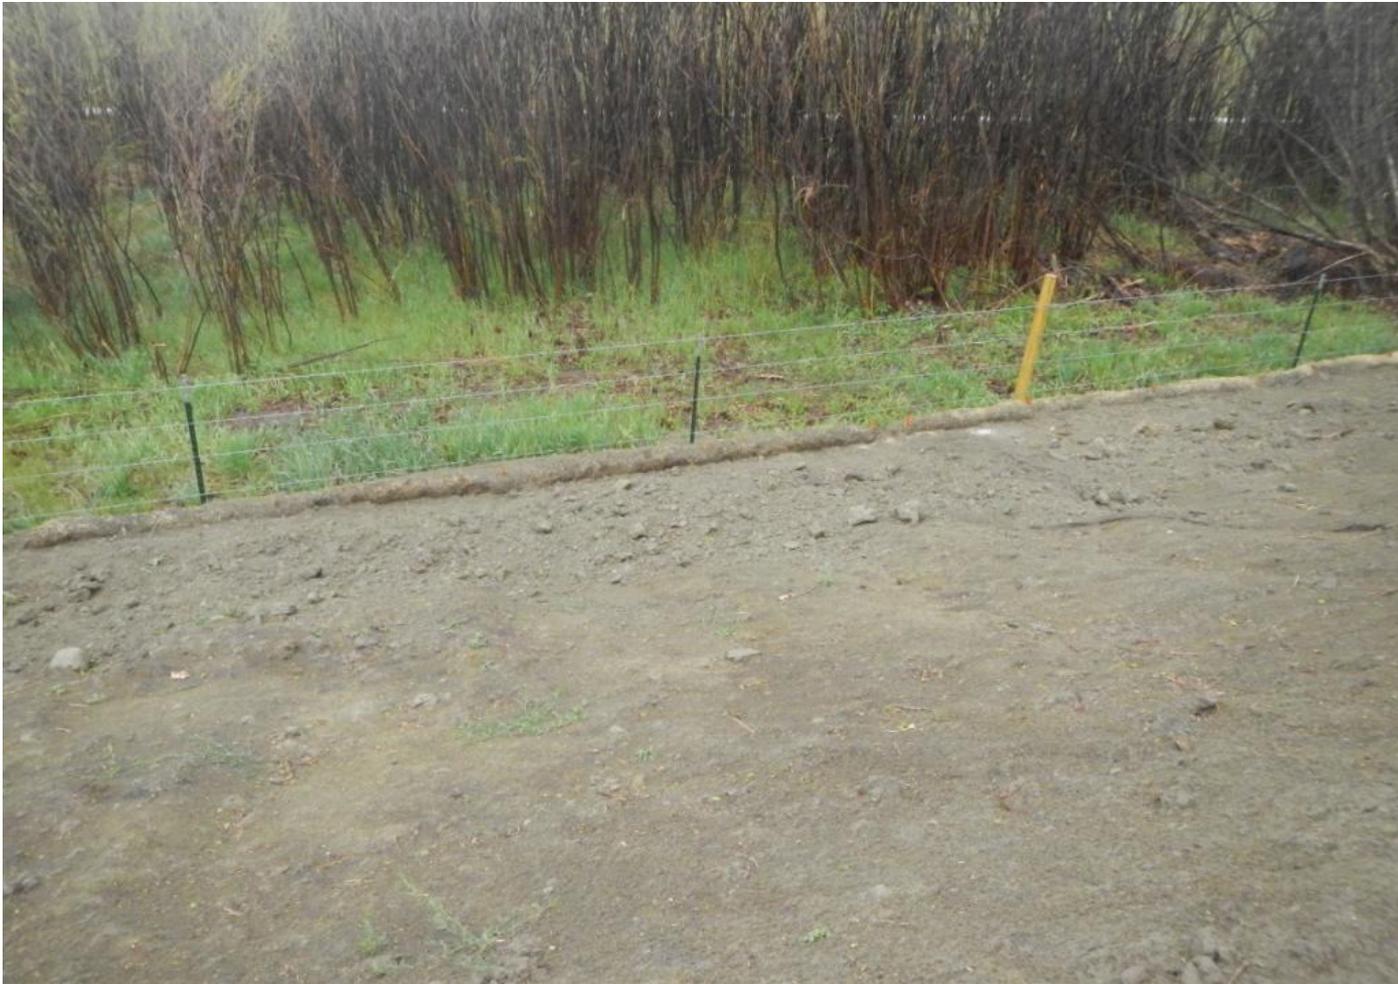
Photo 6. View of straw wattles on the southern edge of the project area that are full of sediment and need maintenance.

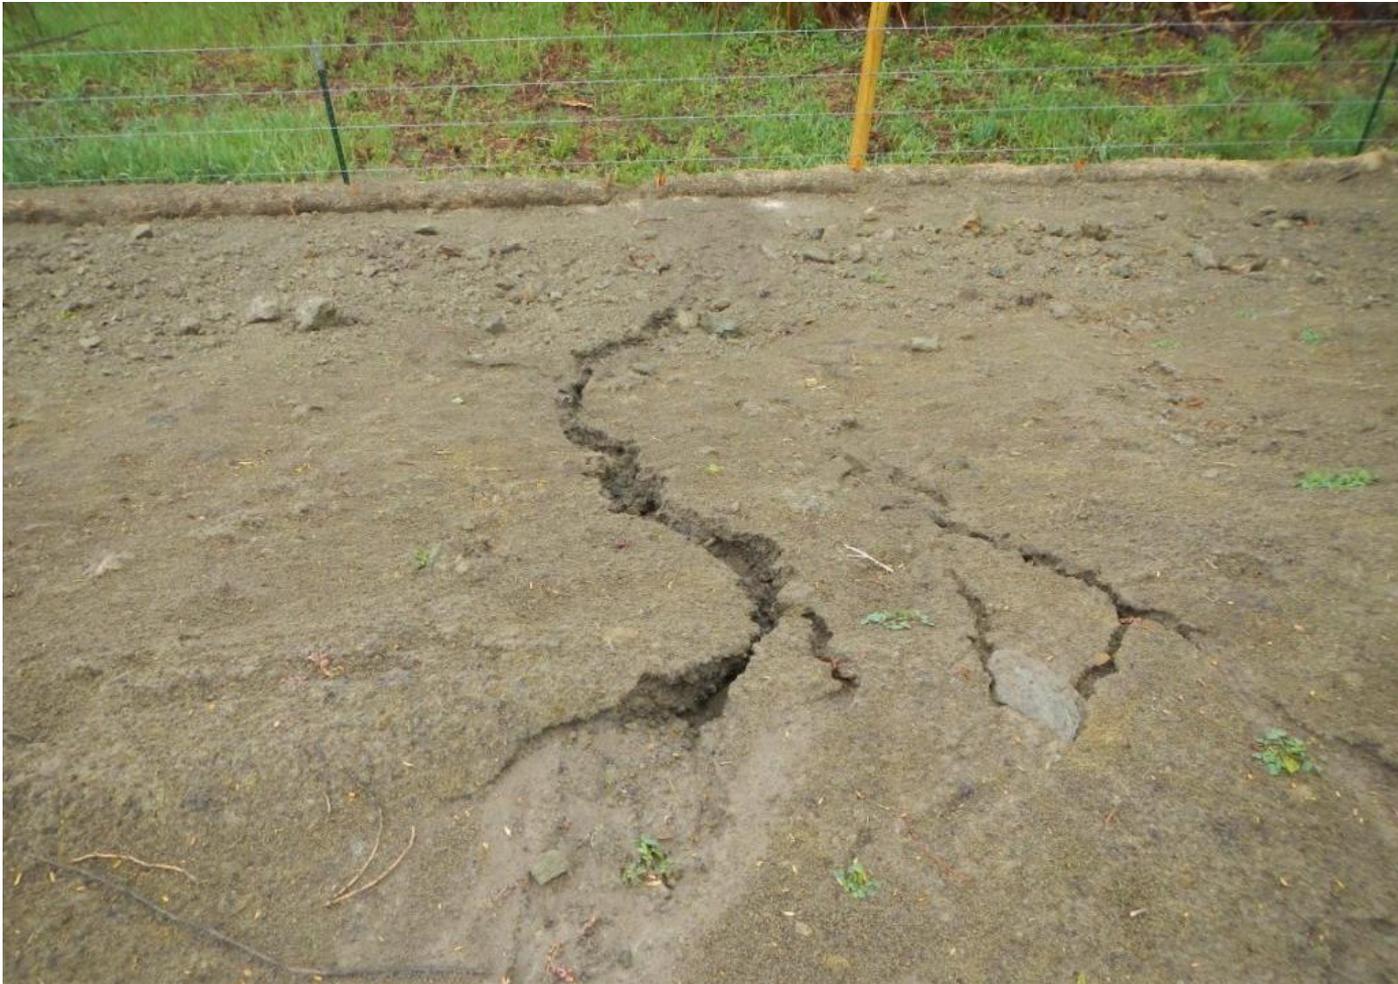
Photo 7. View of rill erosion occurring along southern fill slope.

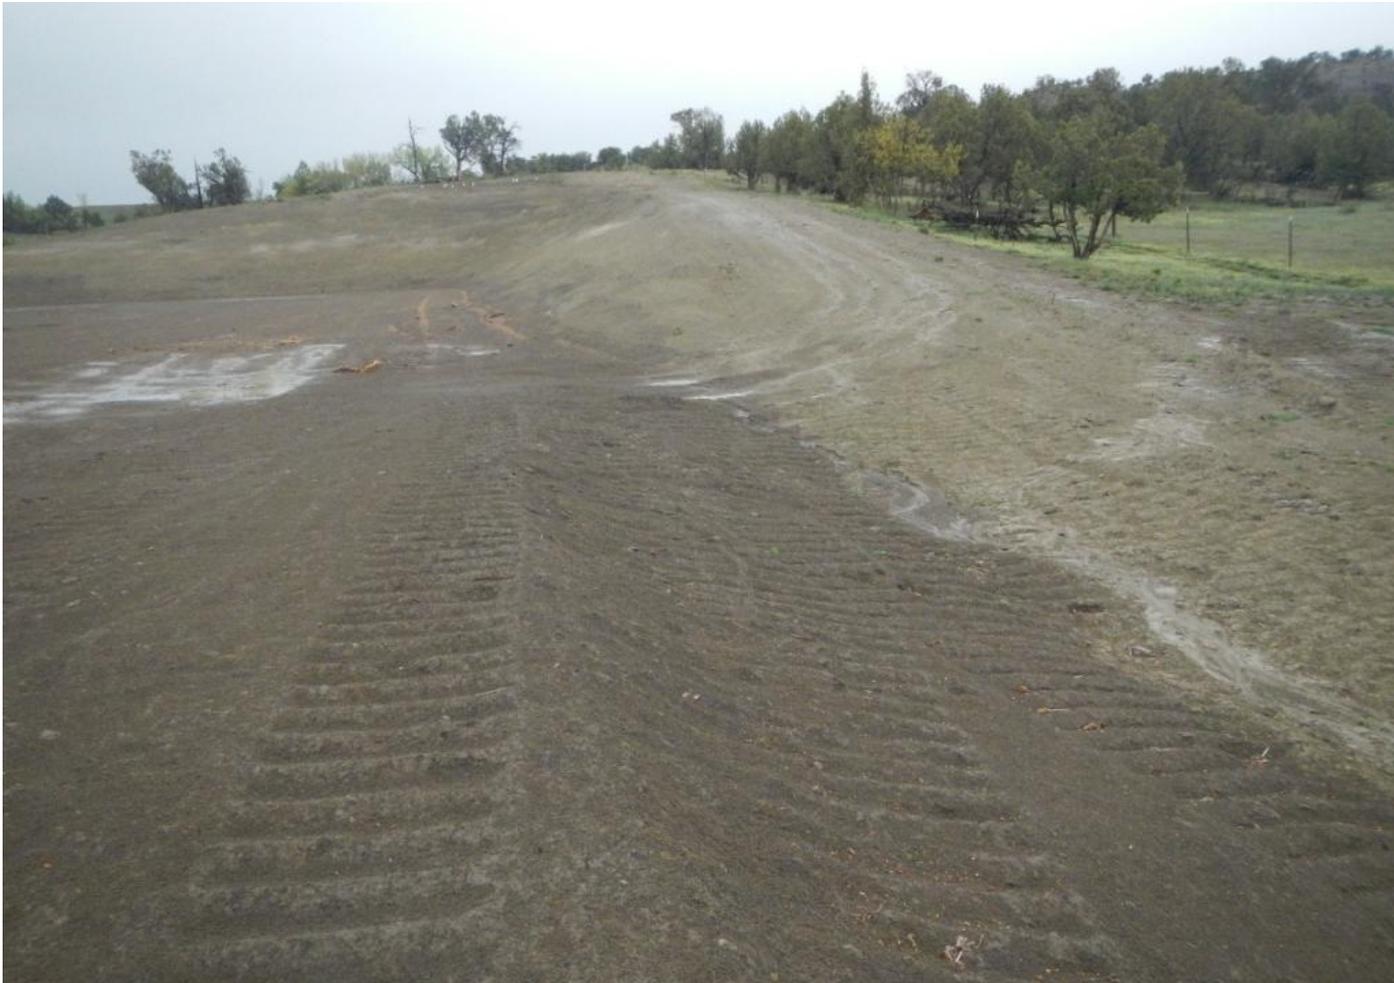
Photo 8. View of the eastern portion of the project area from the southeastern corner facing northward. Project area needs to be stabilized.
