May 6, 2016 COGCC Environmental inspection of Kerr McGee Strear Farms (Facility ID: 437129)

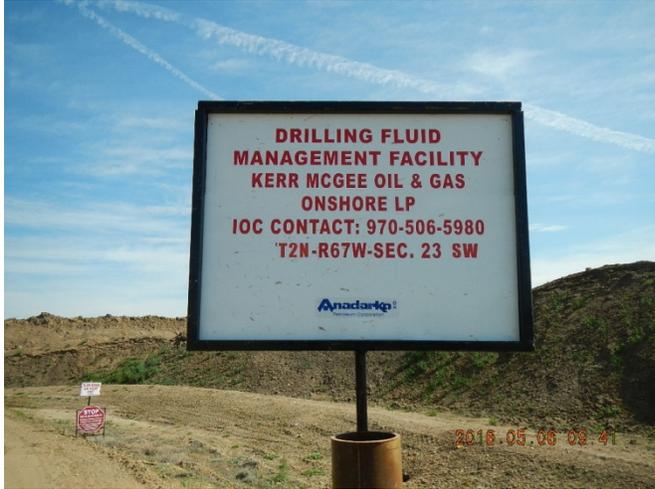
Sign at south entrance.

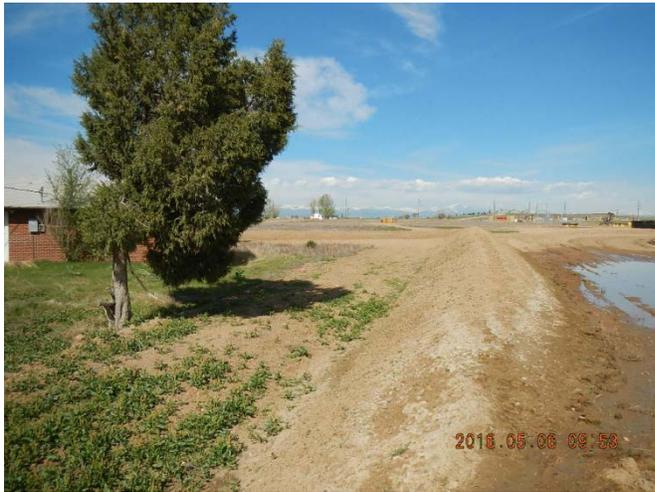
Berm along access road from south entrance.

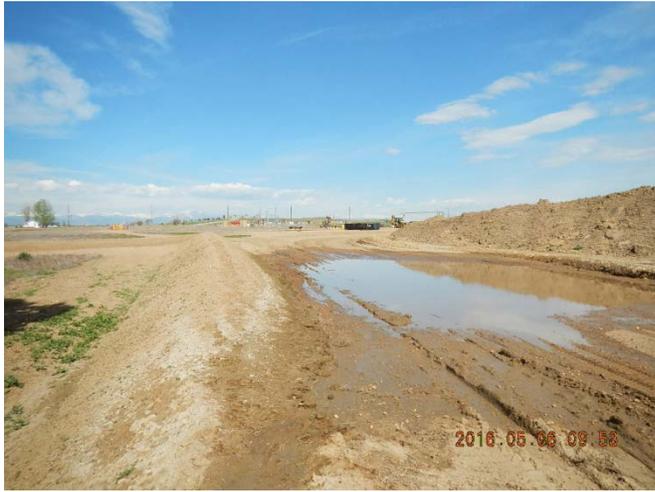
Berm along access road from south entrance.

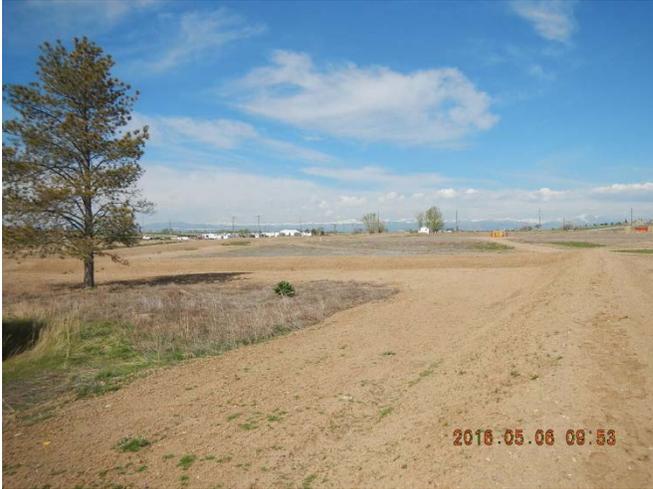
Berm along access road from south entrance.

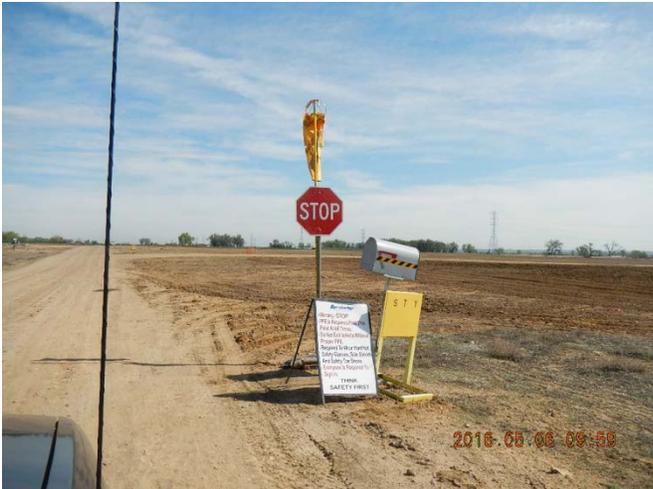
View looking north at land applied treatment area.

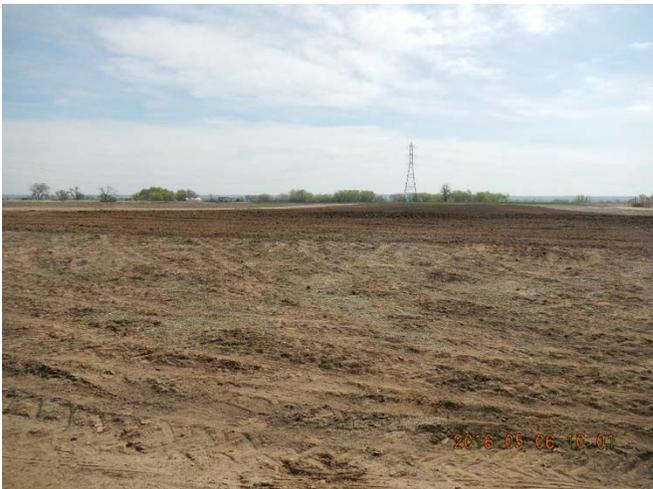
View looking east at land applied treatment area.

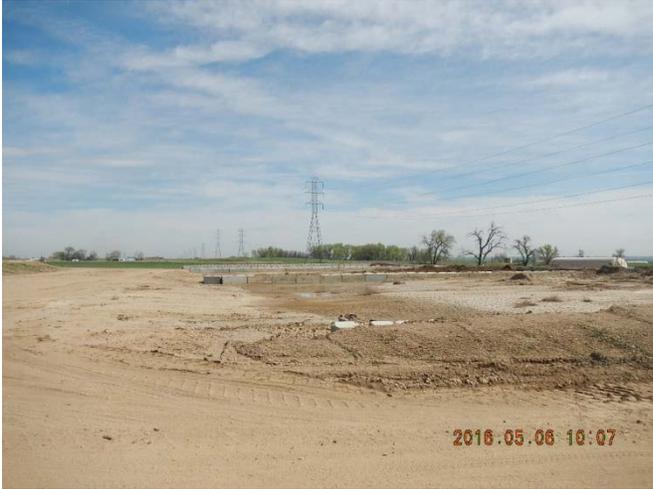
Concrete Liquids Handling cells.

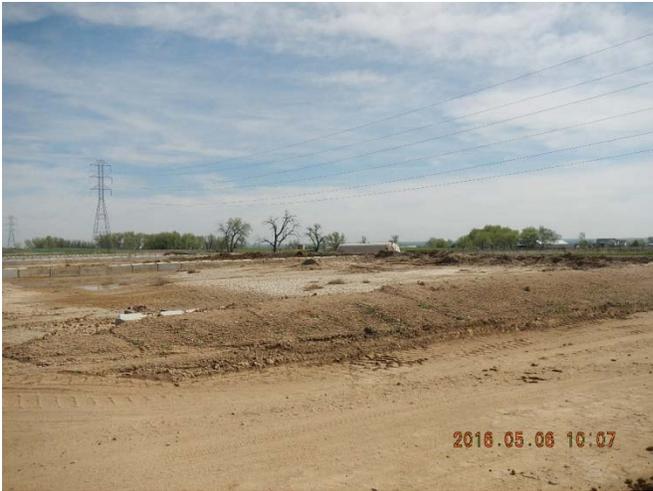
Concrete Liquids Handling cells.

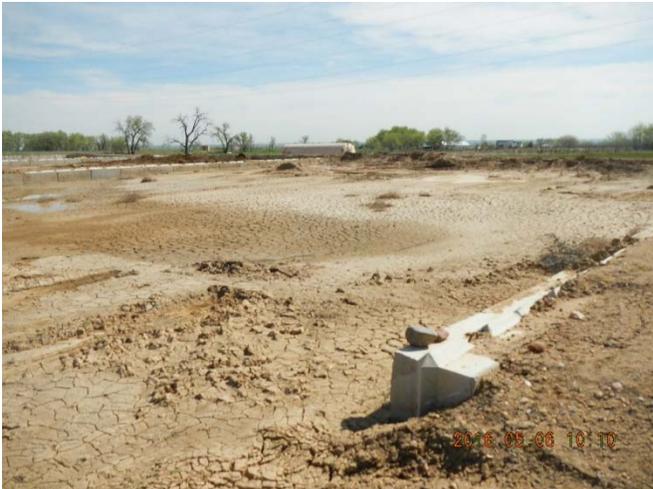
Concrete Liquids Handling cells.

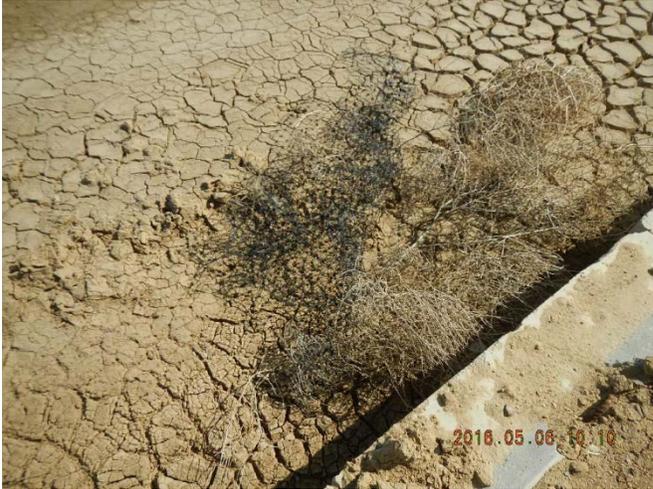
Debris in Concrete Liquids Handling cells.

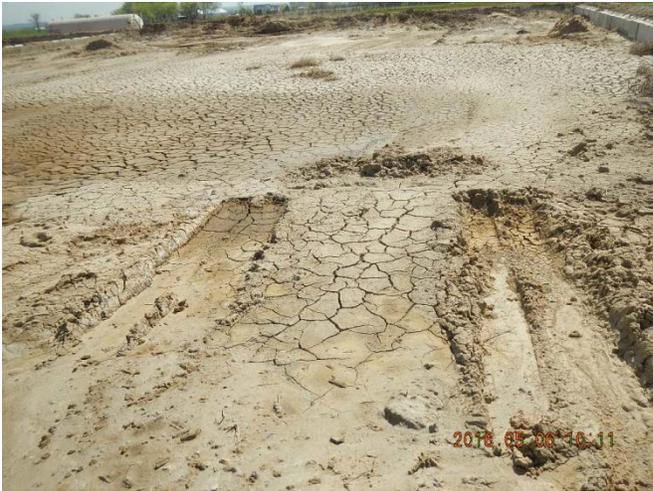
Concrete Liquids Handling cells.

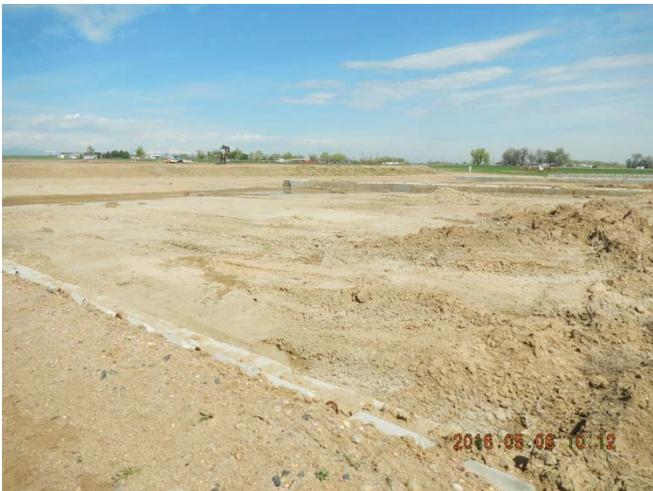
Concrete Liquids Handling cells.

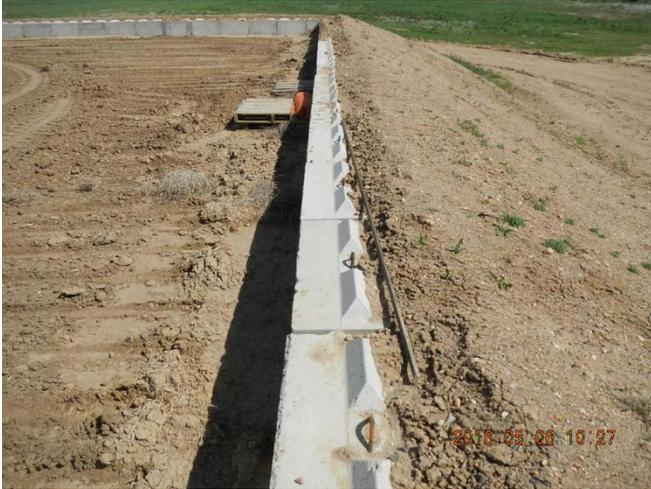
Concrete Liquids Handling cells with pallets.

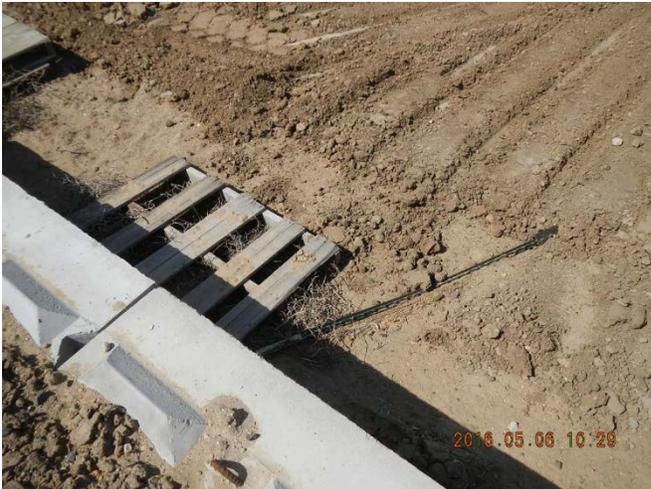
Concrete Liquids Handling cells with pallets post.

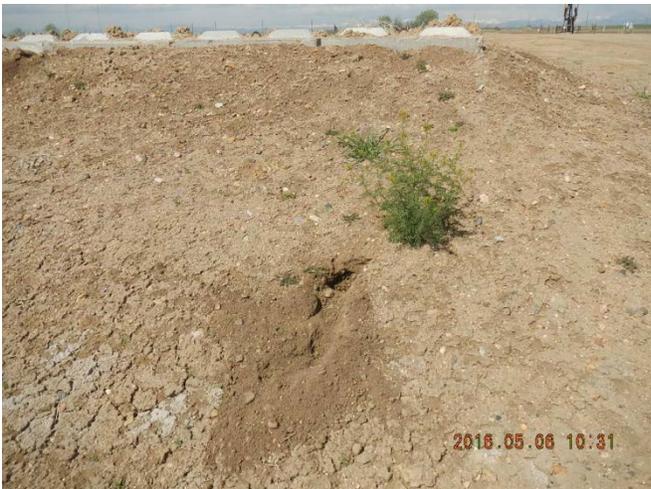
Burrows in berm of cell.

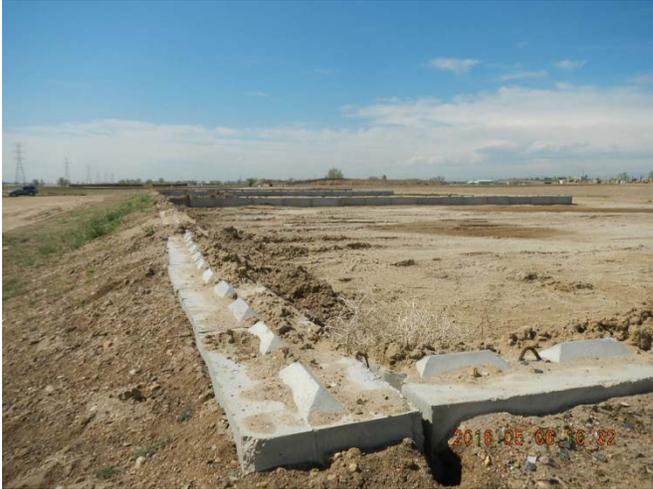
Burrows in berm of cell.

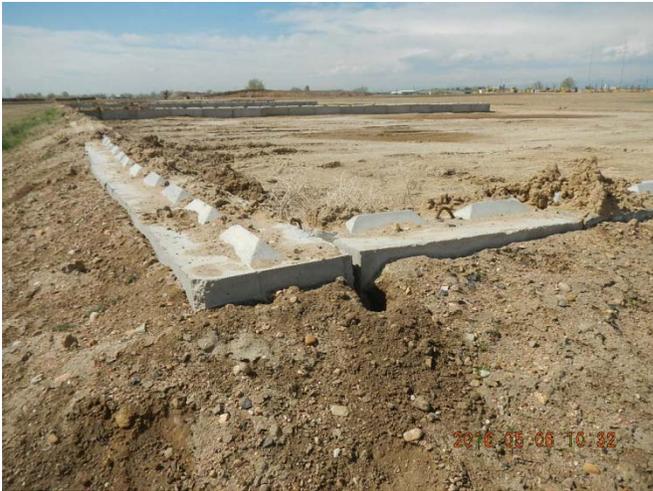
Burrows in berm of cell.

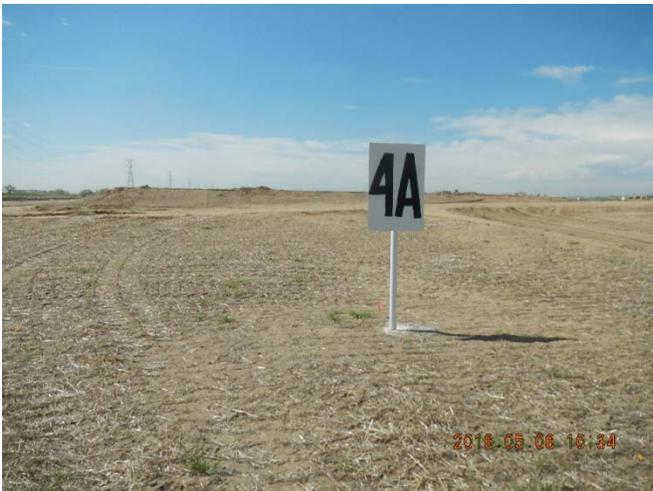
Land treatment area.

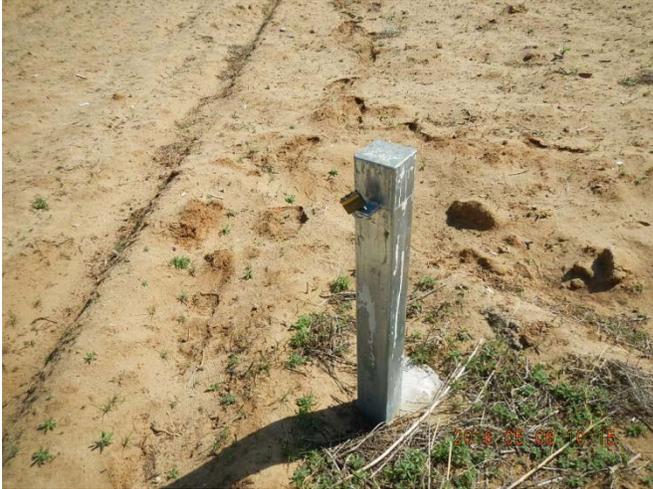
Monitoring well #4 locked.

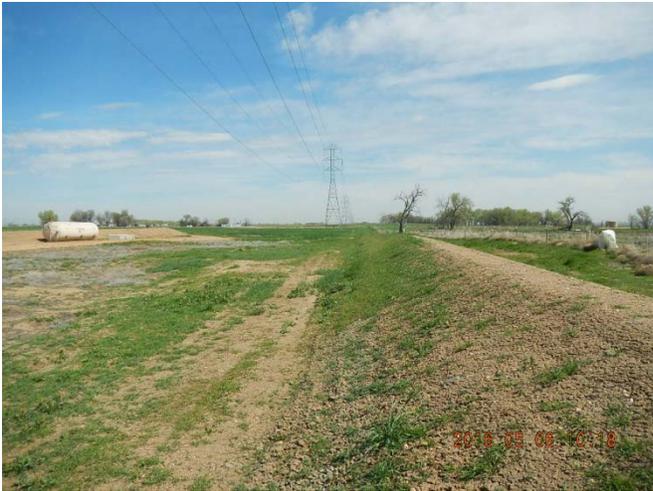
Berm along east side of facility.

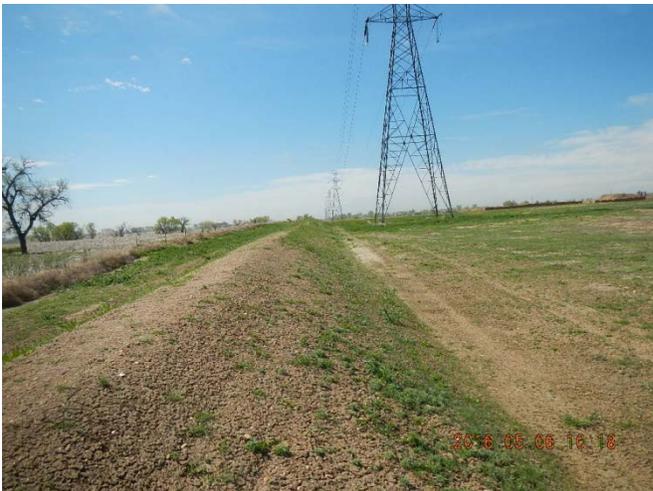
Berm along east side of facility.

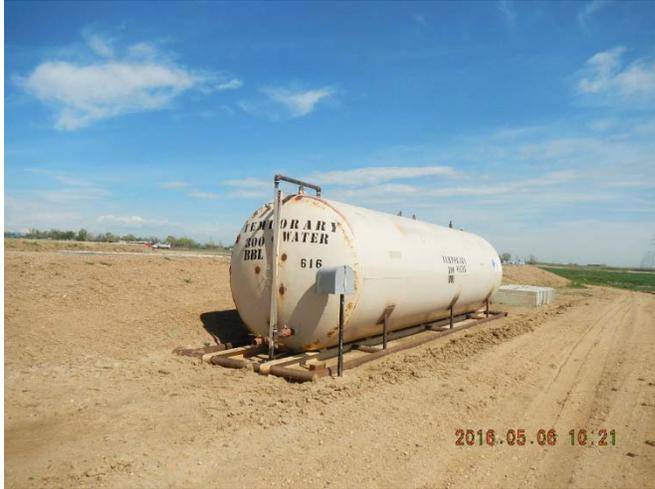
labeled.

300 bbl water tank not bermed, placard or properly

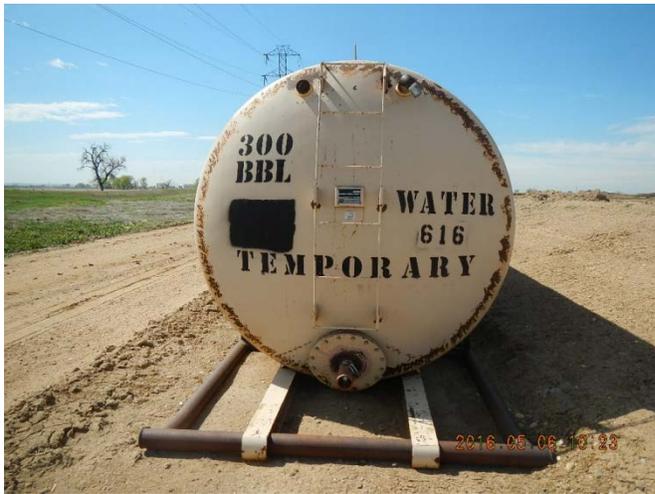
labeled.

300 bbl water tank not bermed, placard, or properly

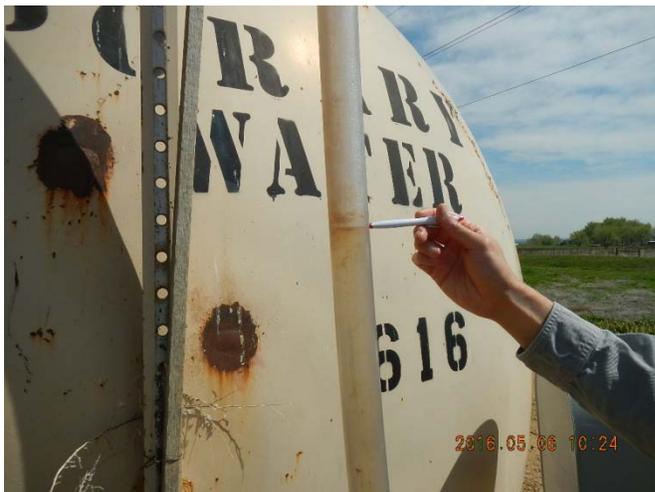
Tank app 3/4 full of fluids.

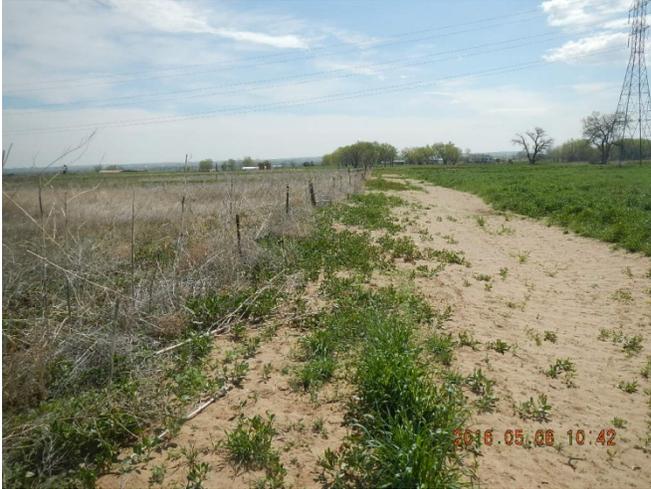
Berm and fence along north boundary of Facility.

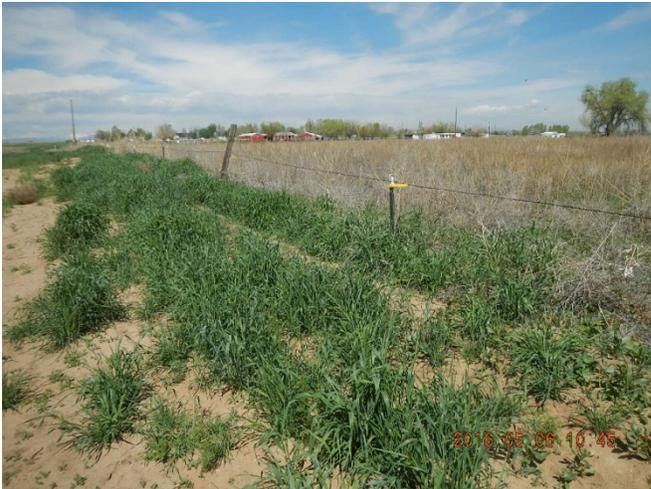
Berm and fence along north boundary of Facility.

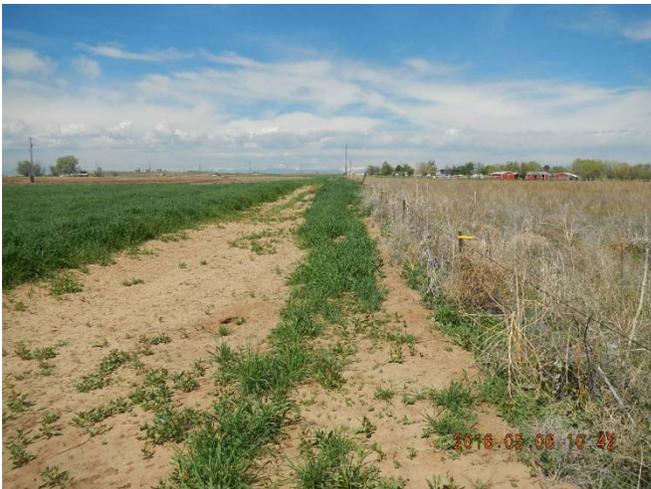
Berm and fence along north boundary of Facility.

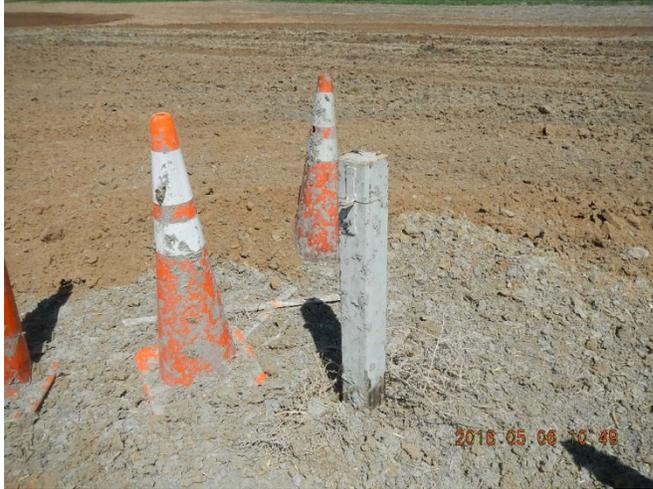
Monitoring Well #2 not secured.

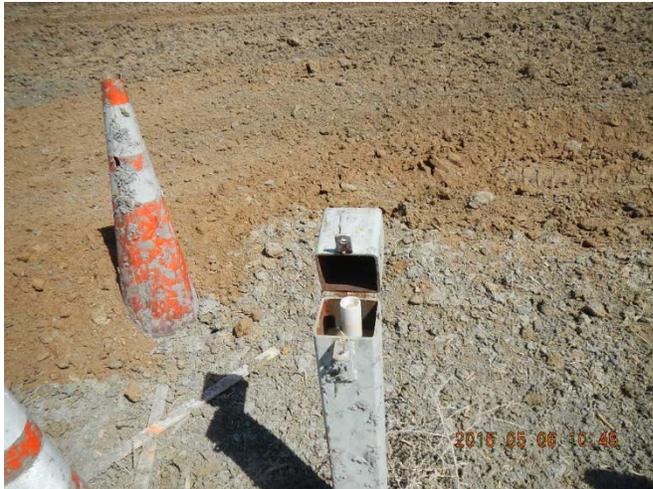
Monitoring Well #2 not secured.

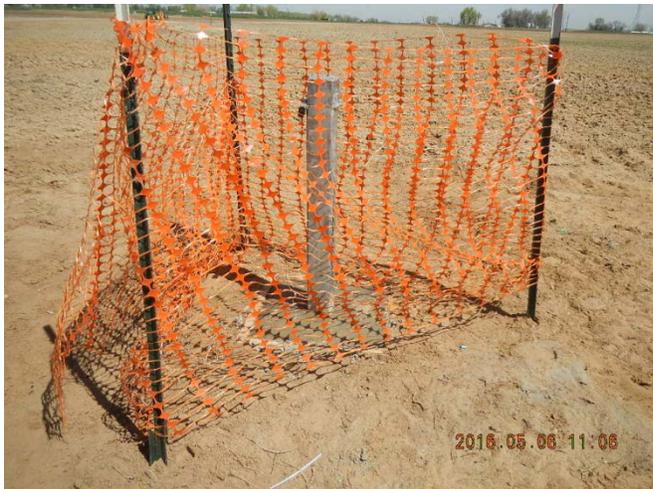
Monitoring Well #1 secured.

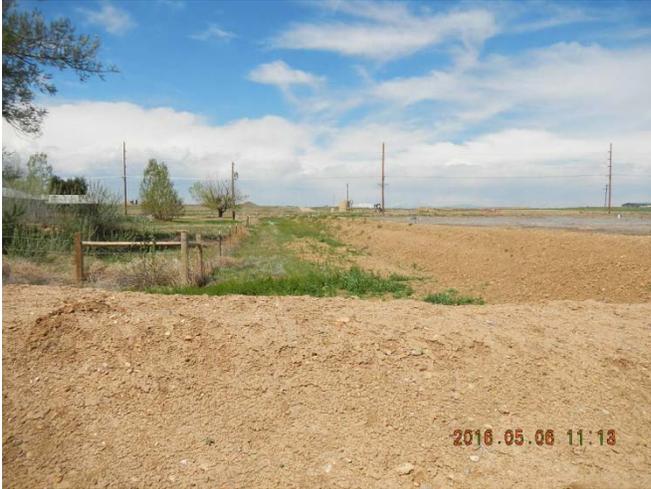
Berm along west side of Facility near residence.

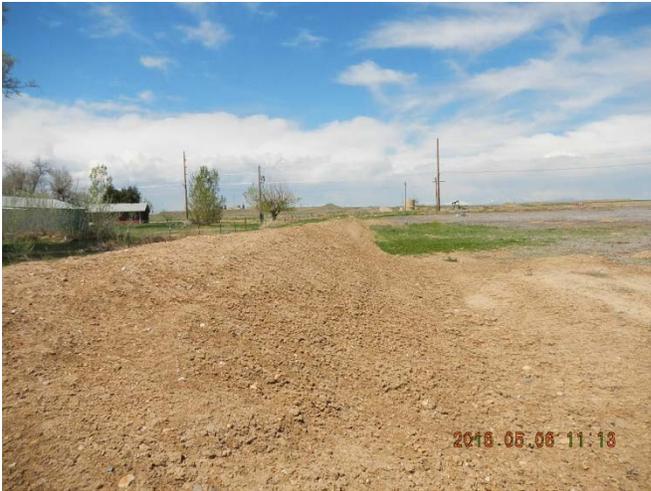
Berm along west side Facility near residence.

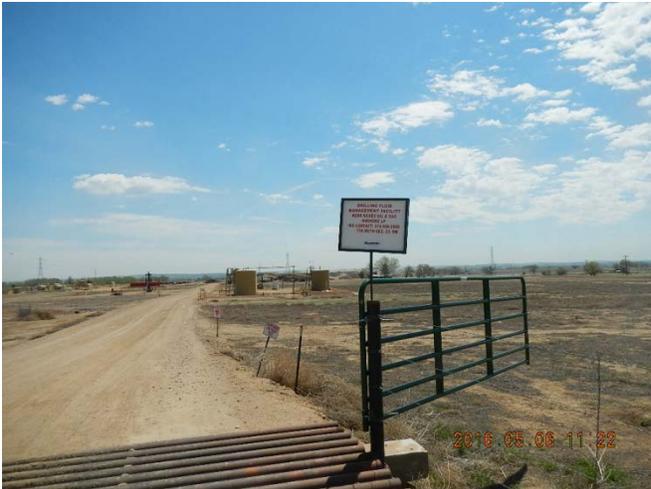
Entrance at west side of the Facility.

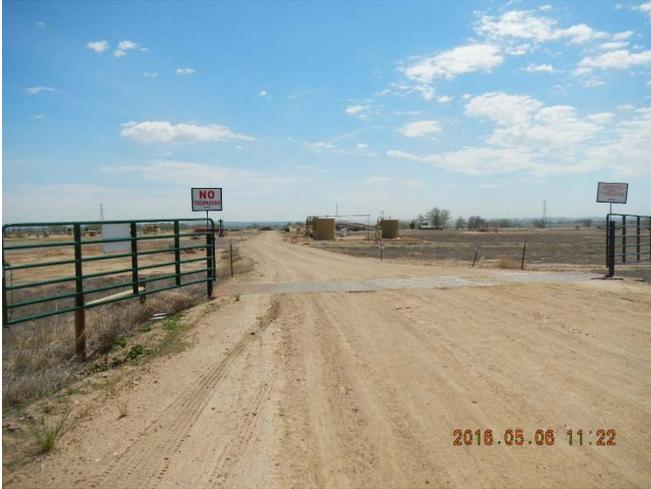
Entrance at west side of Facility.

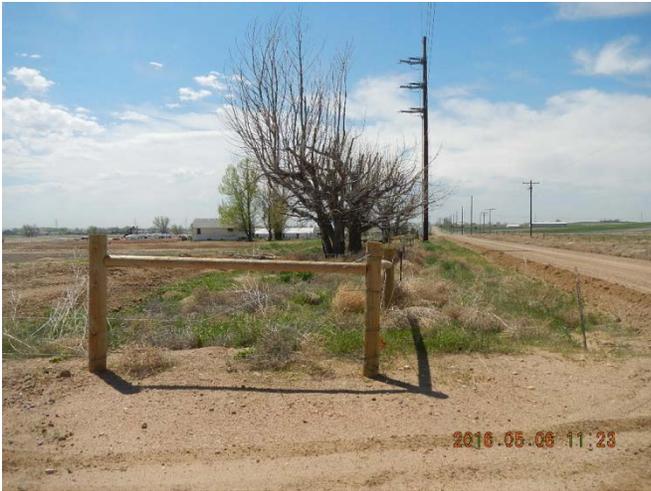
Fence along west side of Facility.

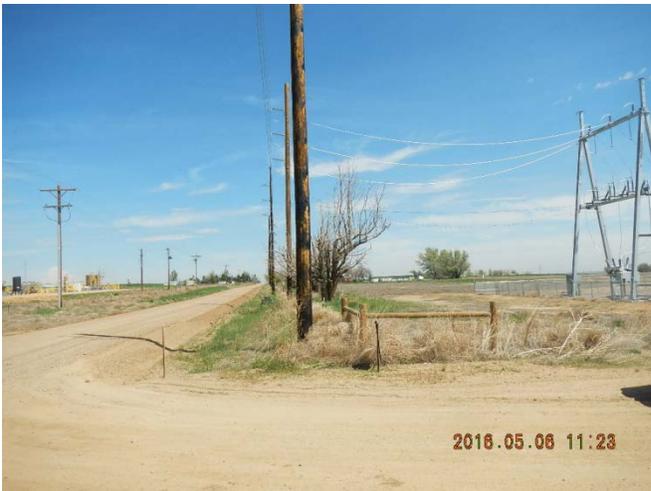
Fence along west side of Facility.
