Interim Reclamation Inspection

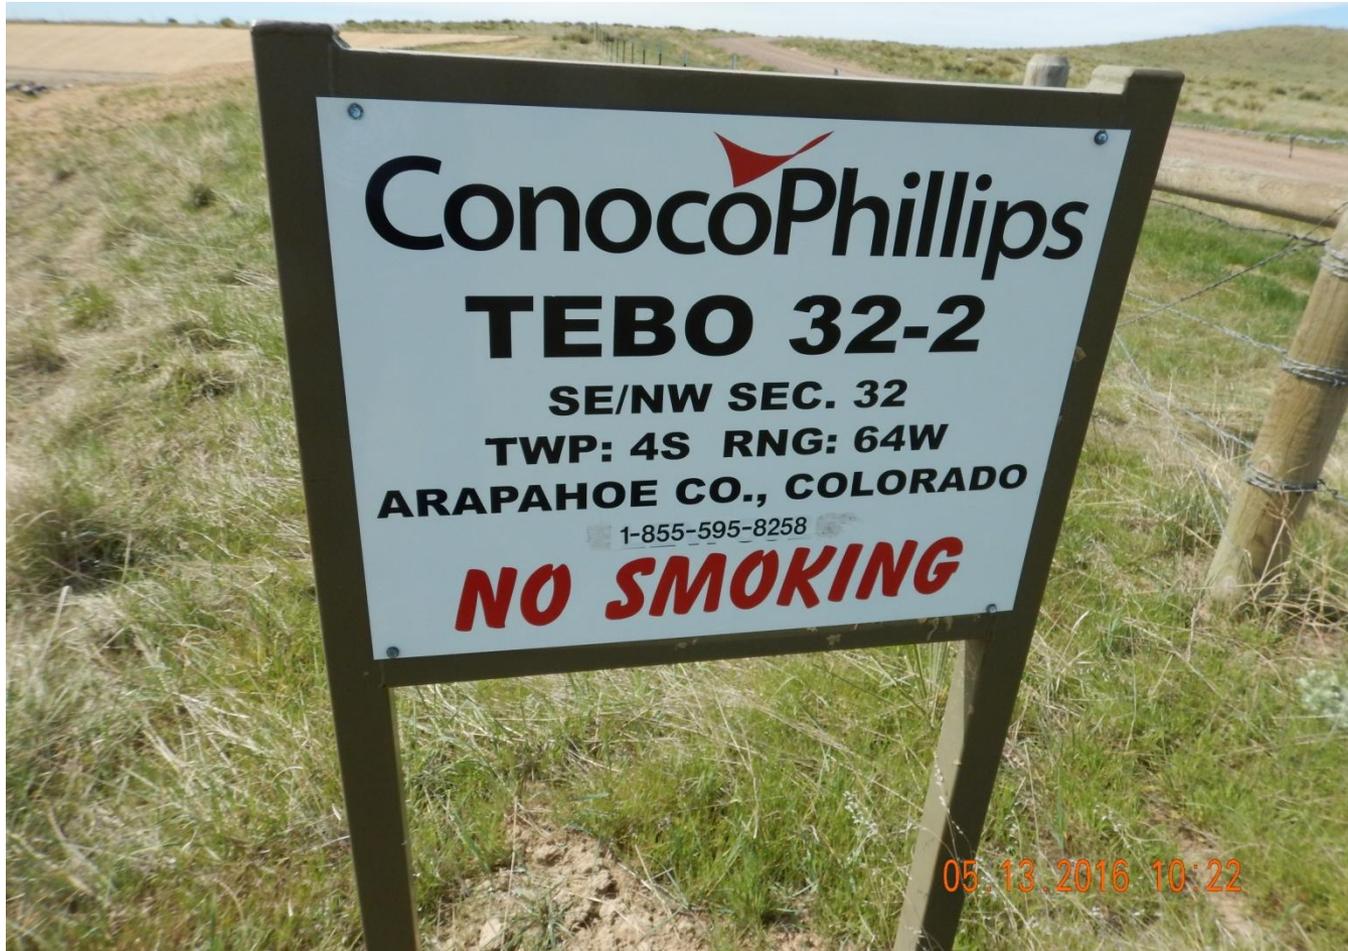
Photo 1. Photo taken of well sign for API #005-07177.

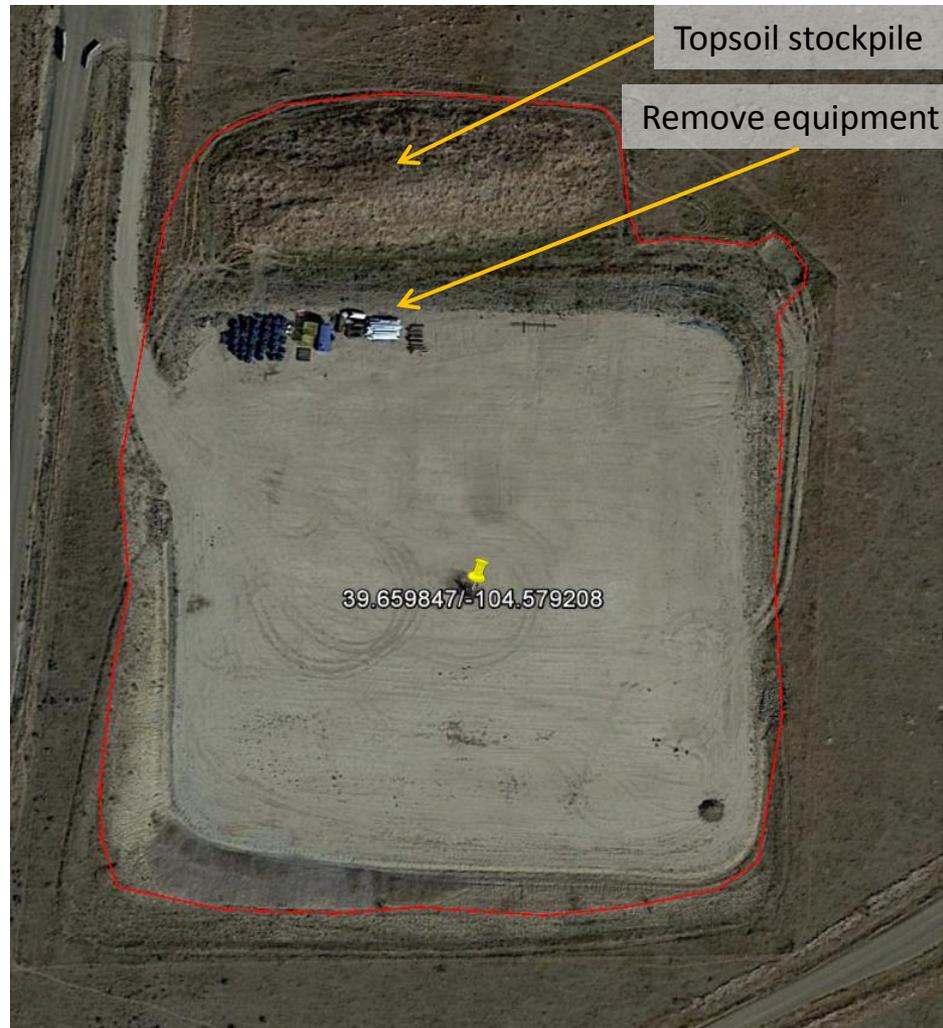
Photo 2. Google Earth aerial imagery taken 10/9/2015 indicating approximate total disturbance of 5.0 acres. As of 5/13/16, this is the extent of the current disturbance. Form 2A (Doc. #400218050) states total disturbance of 3.67 acres and size of location after interim reclamation of 1.2 acres.

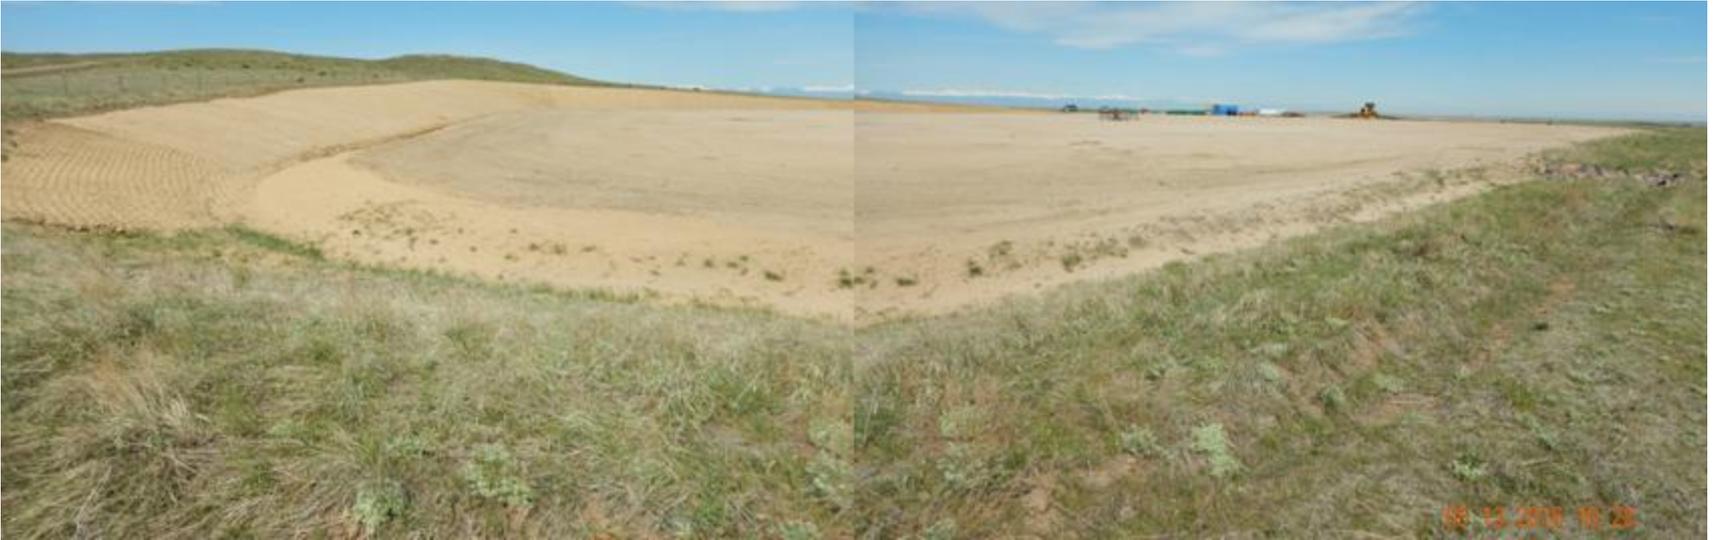
Photo 3. Photo taken from southeast location, facing West. Overview of total disturbance illustrating unused portions of location that have not been reduced in size per Form 2A .

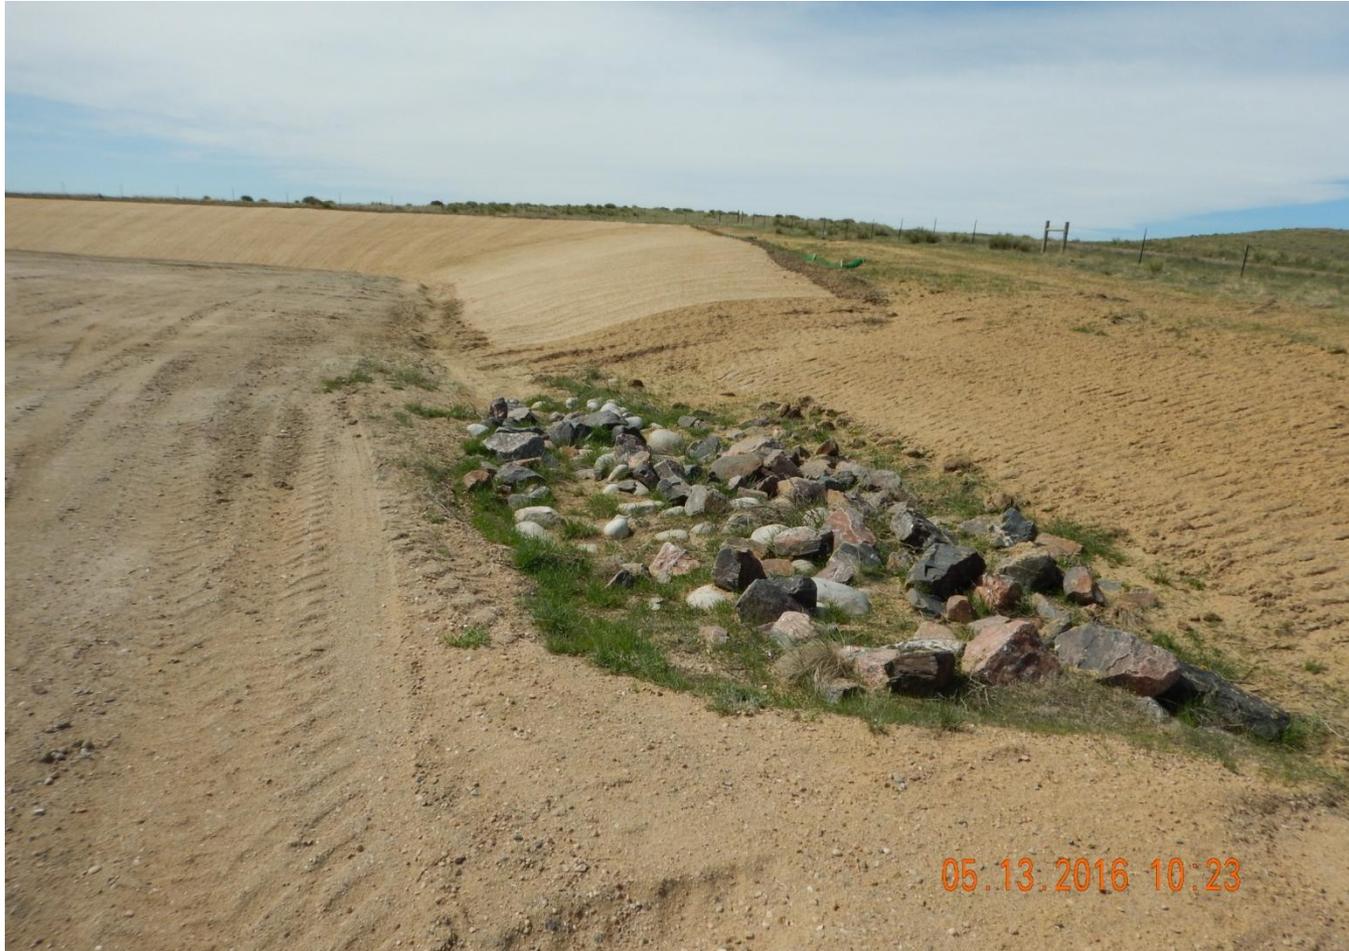
Photo 4. Photo taken from northwest location, facing South. Cut slopes stabilized with soil retention blankets and mulch tackifier.

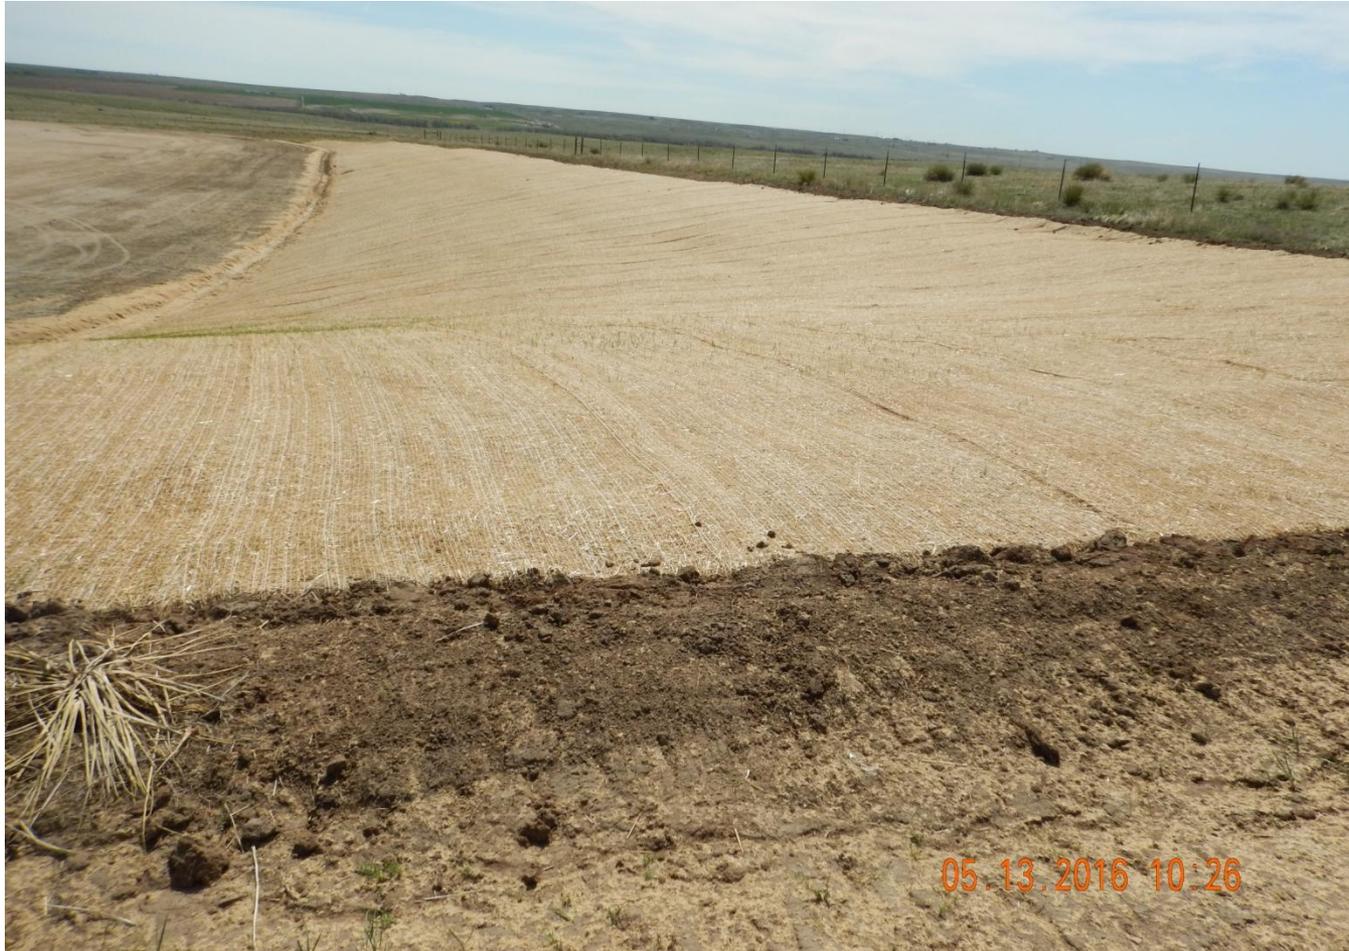
Photo 5. Photo taken from southwest location, facing East. Cut slopes stabilized with soil retention blankets and mulch tackifier.

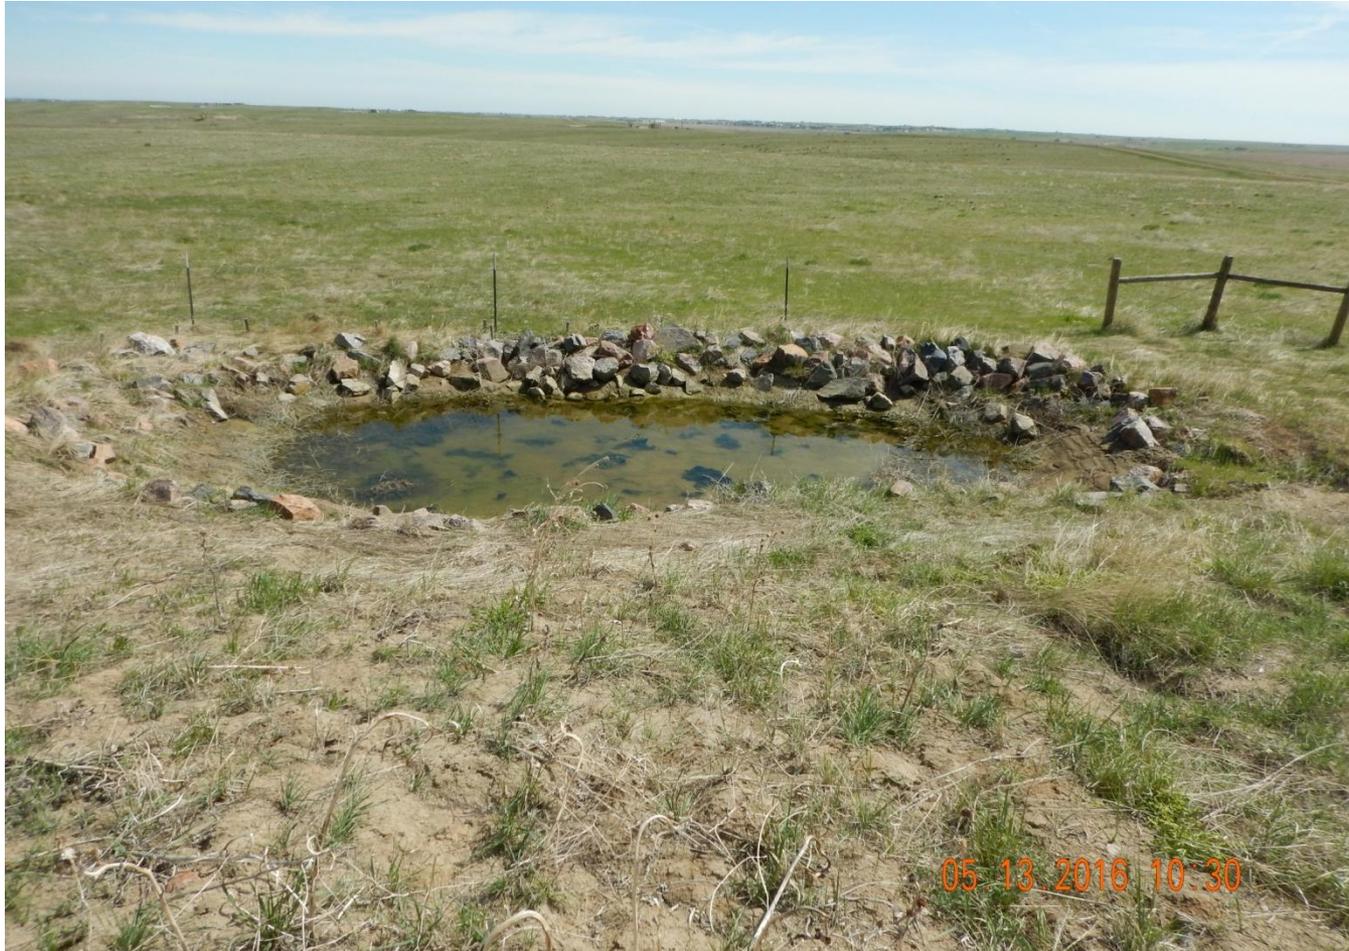
Photo 6. Photo taken from northeast location, facing East. Sediment trap installed to allow sediment to settle out of stormwater runoff.

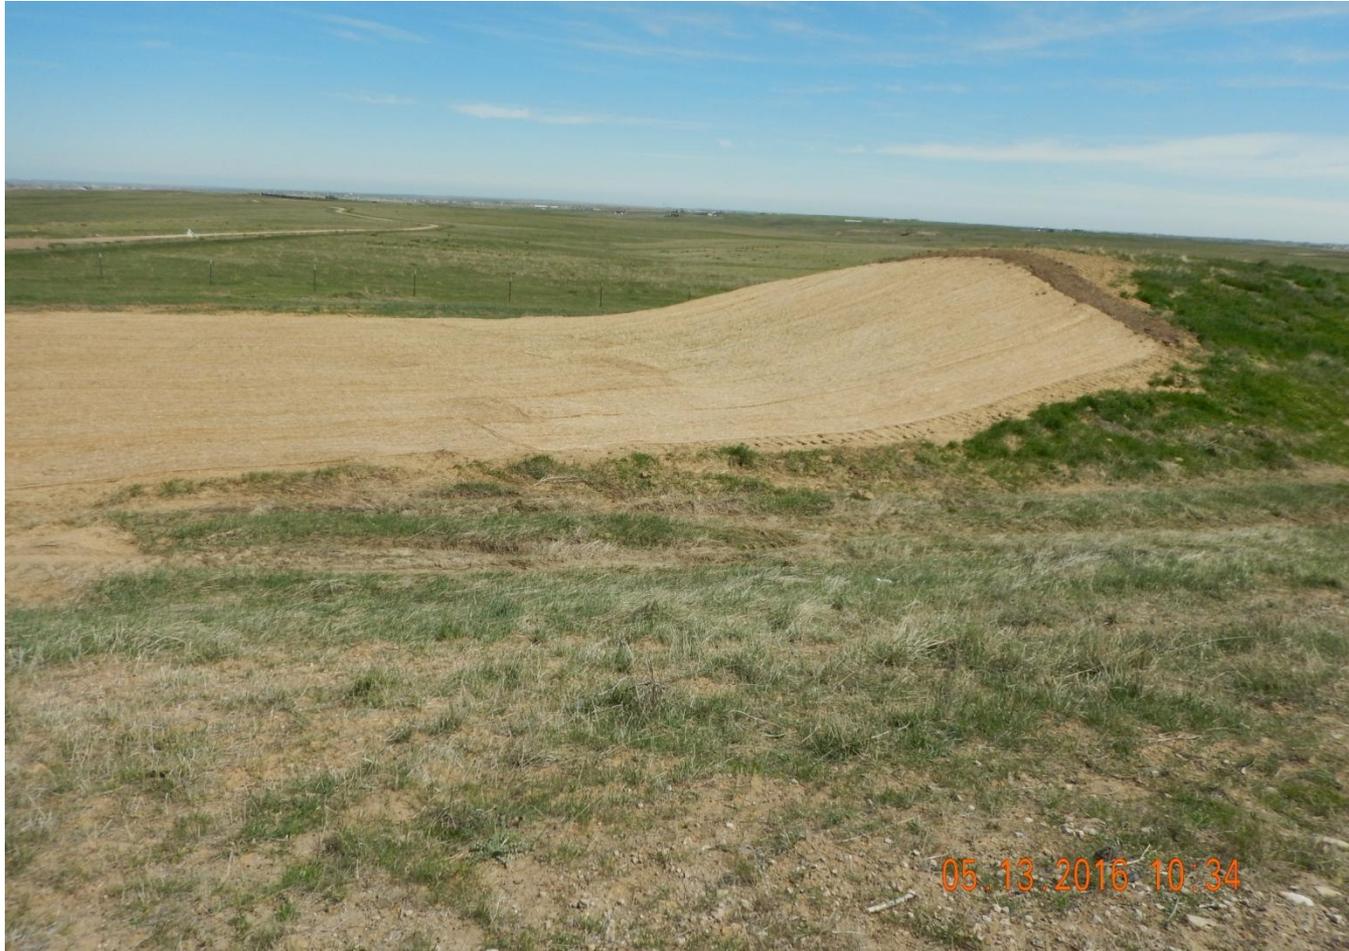
Photo 7. Photo taken from northern location, facing North. Topsoil stockpile stabilized with soil retention blankets and the other portion of the topsoil stockpile stabilized with perennial vegetation.

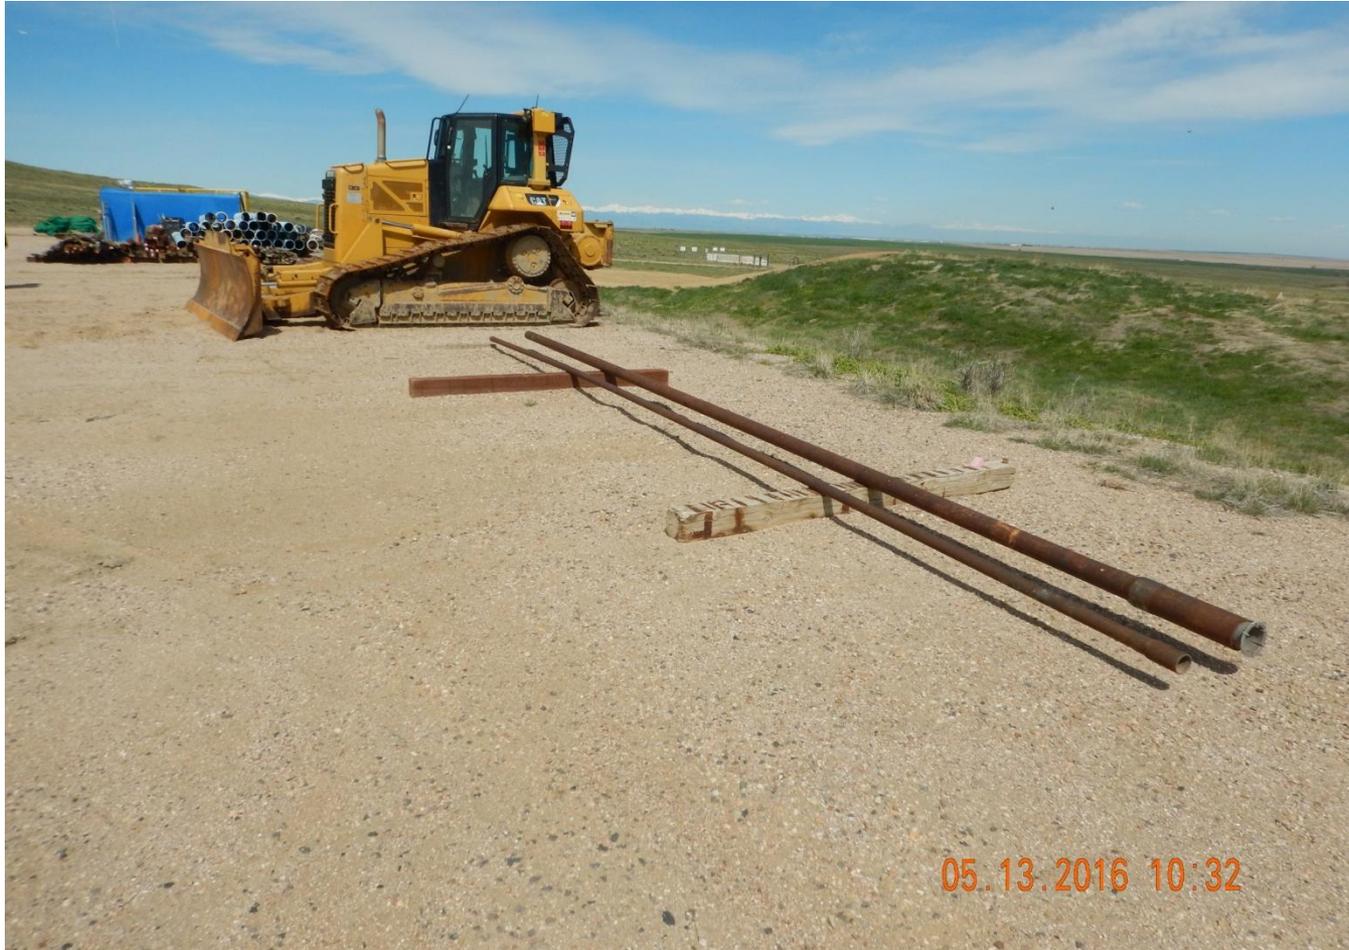
Photo 8. Photo taken from northern location, facing West. Per Rule 603.f oil and gas locations are to be kept free of serviceable equipment, vehicles, or supplies owned by the operator or any service or other third-party company performing work on behalf of the operator.

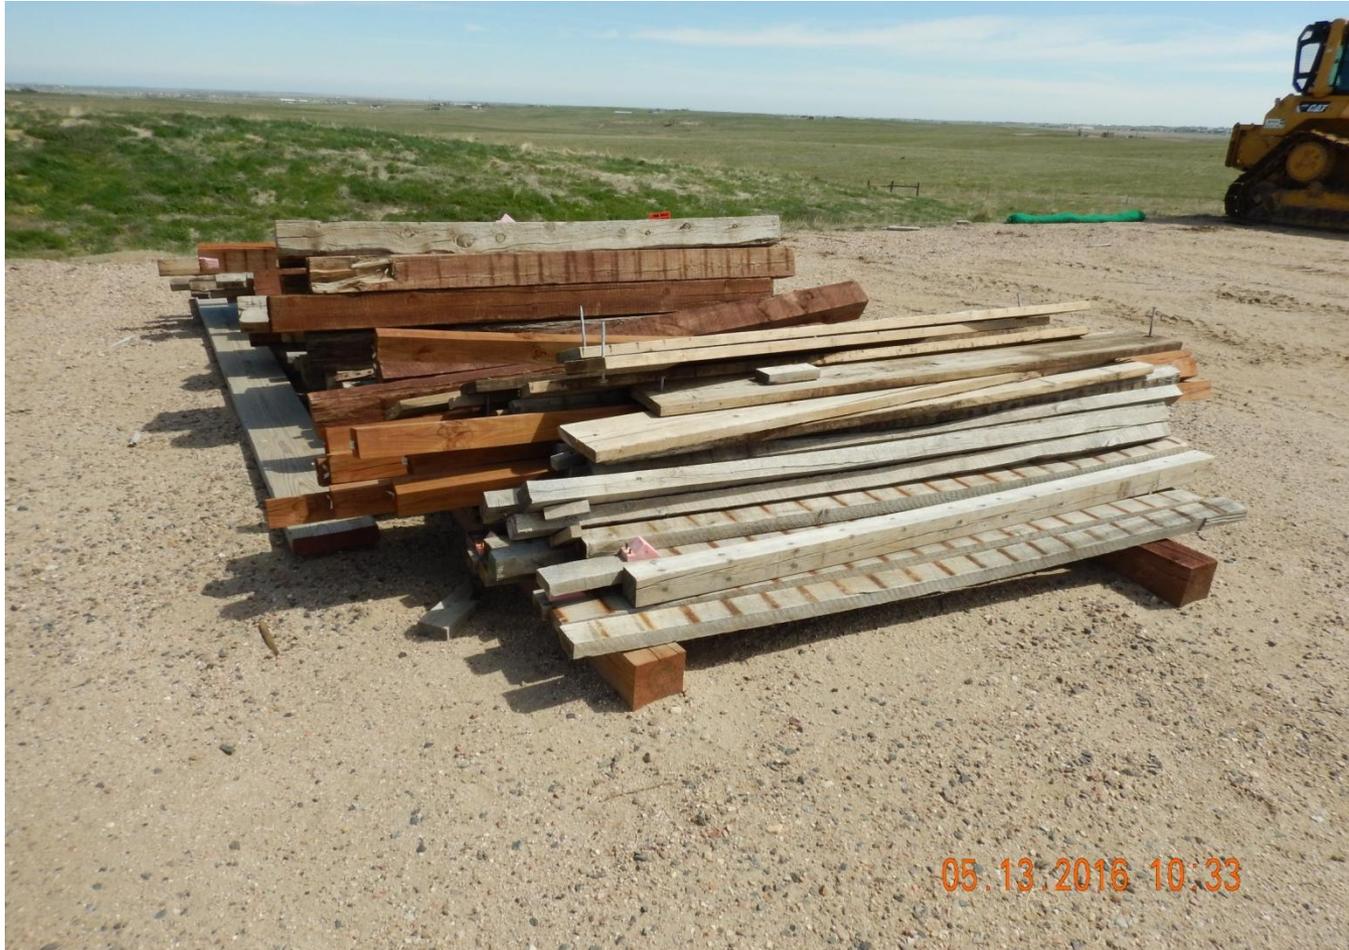
Photo 9. Photo taken from northern location, facing West. Per Rule 603.f oil and gas locations are to be kept free of serviceable equipment, vehicles, or supplies owned by the operator or any service or other third-party company performing work on behalf of the operator.

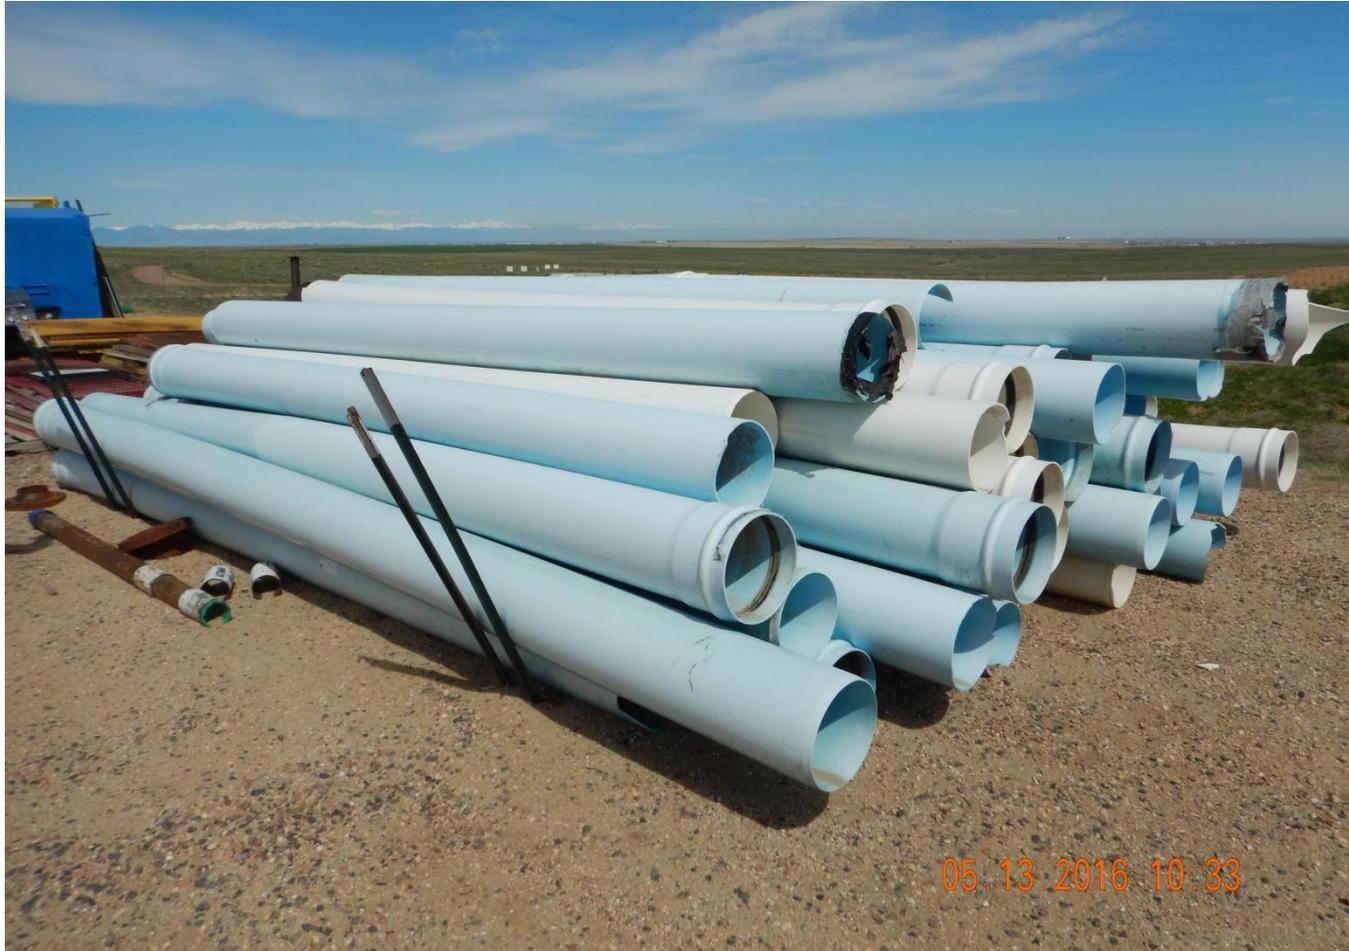
Photo 10. Photo taken from northern location, facing West. Per Rule 603.f oil and gas locations are to be kept free of serviceable equipment, vehicles, or supplies owned by the operator or any service or other third-party company performing work on behalf of the operator.

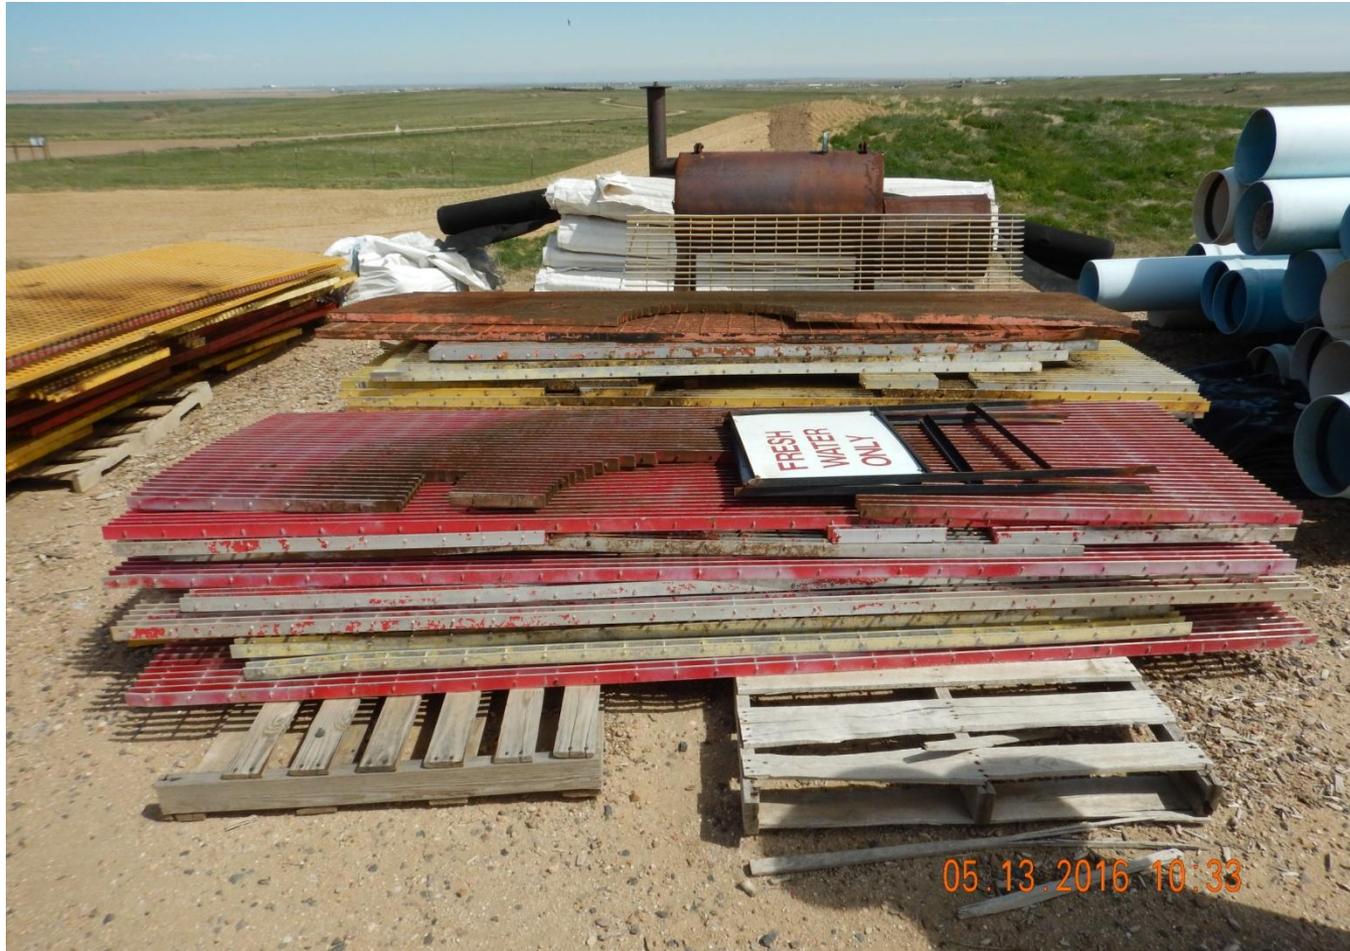
Photo 11. Photo taken from northern location, facing West. Per Rule 603.f oil and gas locations are to be kept free of serviceable equipment, vehicles, or supplies owned by the operator or any service or other third-party company performing work on behalf of the operator.

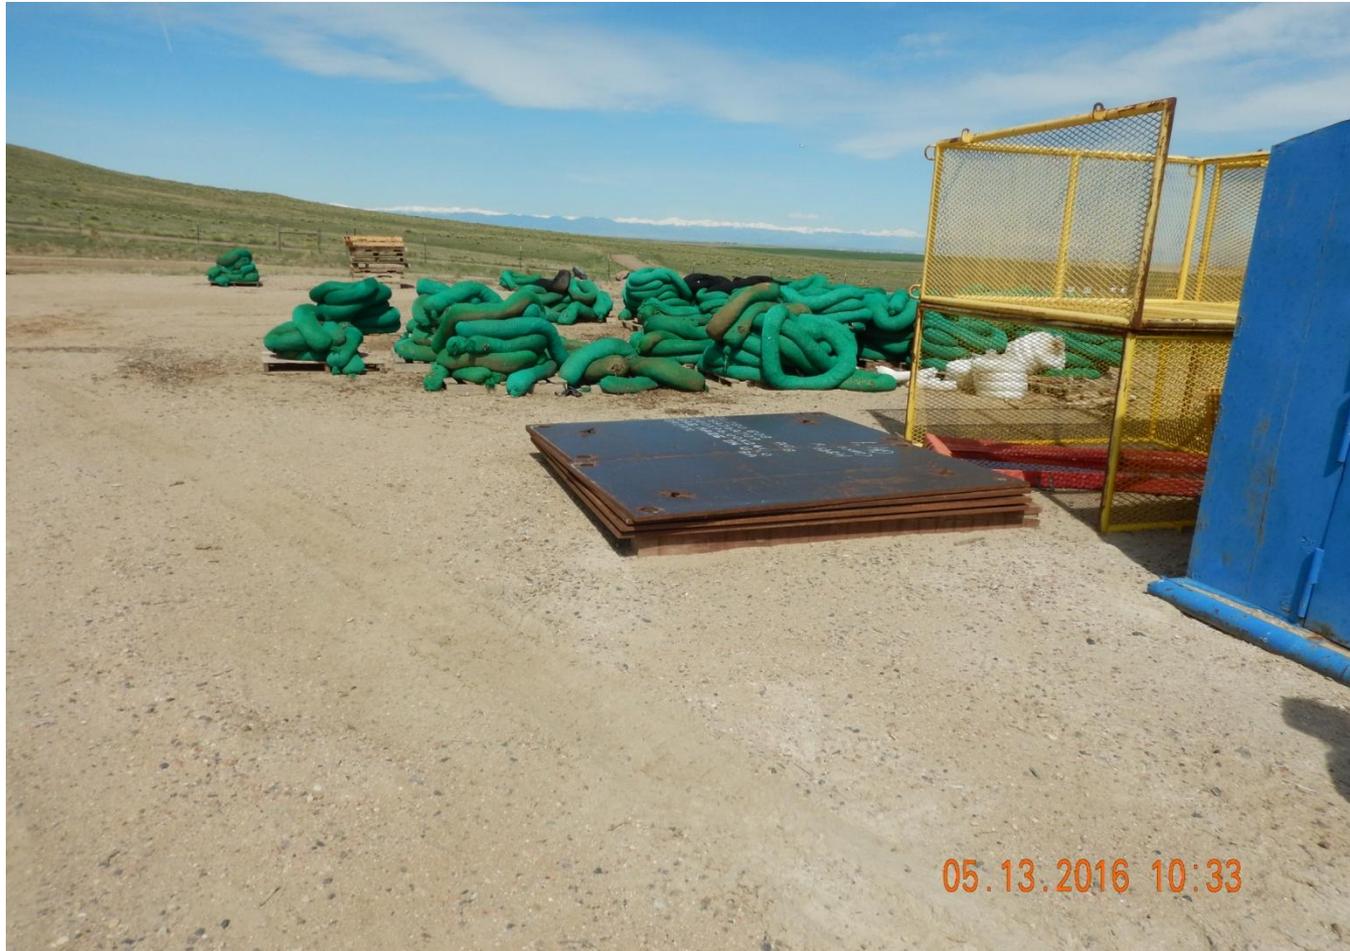
Photo 12. Photo taken from northern location, facing West. Per Rule 603.f oil and gas locations are to be kept free of serviceable equipment, vehicles, or supplies owned by the operator or any service or other third-party company performing work on behalf of the operator.

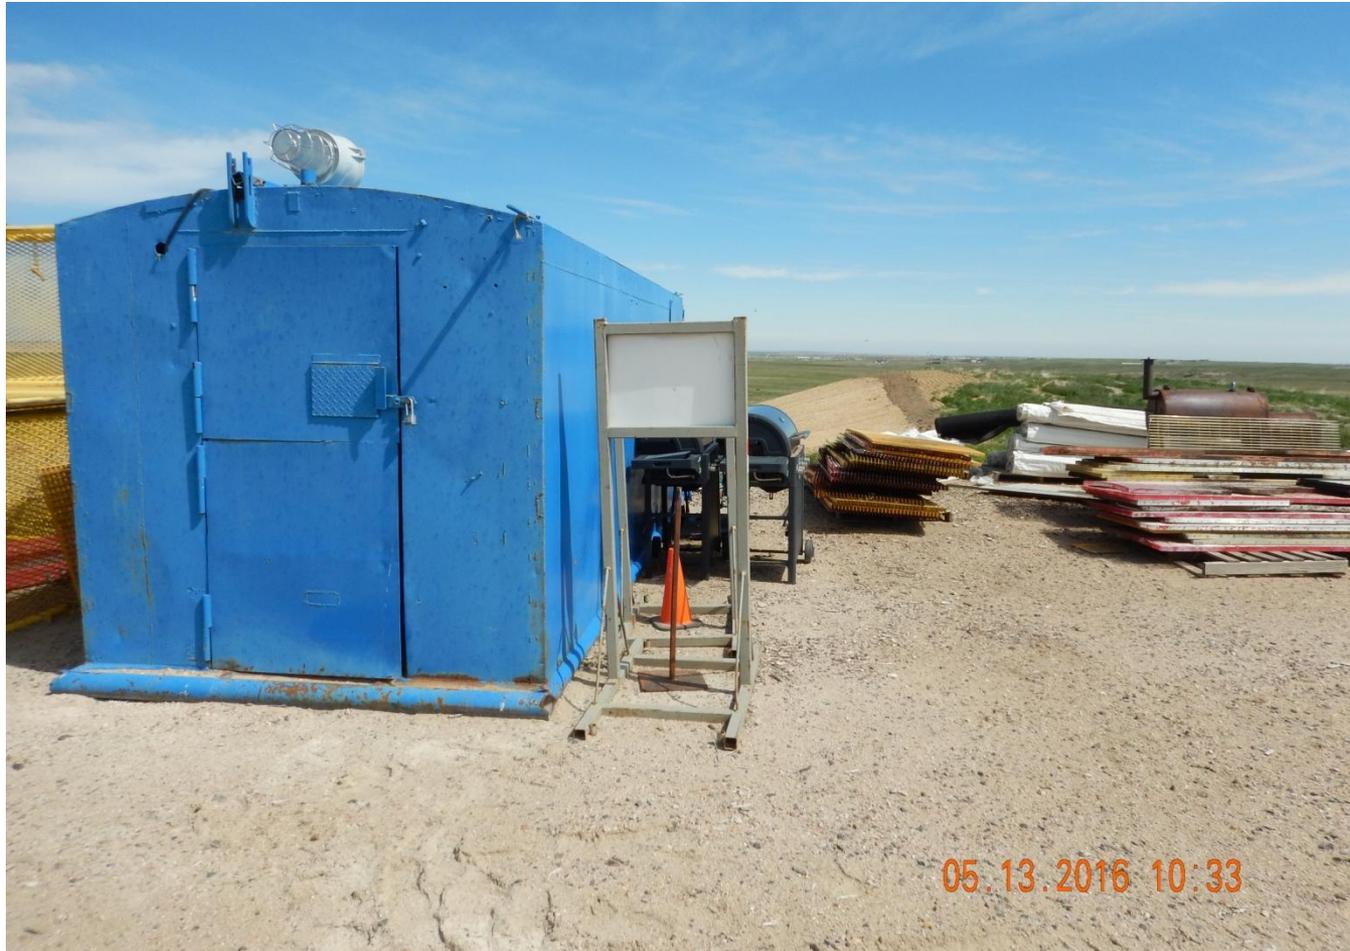
Photo 13. Photo taken from northern location, facing West. Per Rule 603.f oil and gas locations are to be kept free of serviceable equipment, vehicles, or supplies owned by the operator or any service or other third-party company performing work on behalf of the operator.
