May 12, 2016

Inspection Photos: Bayless #081-06436

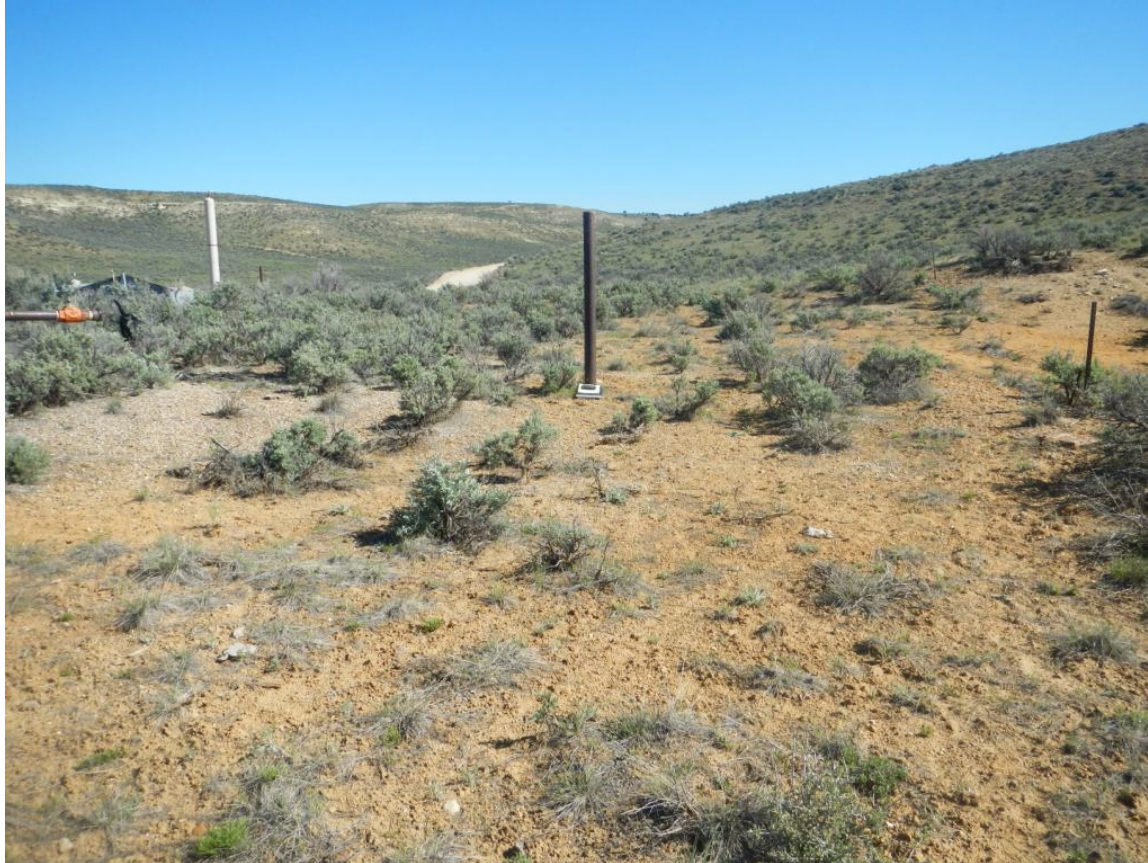
Photo#1: Overview of Location to North.

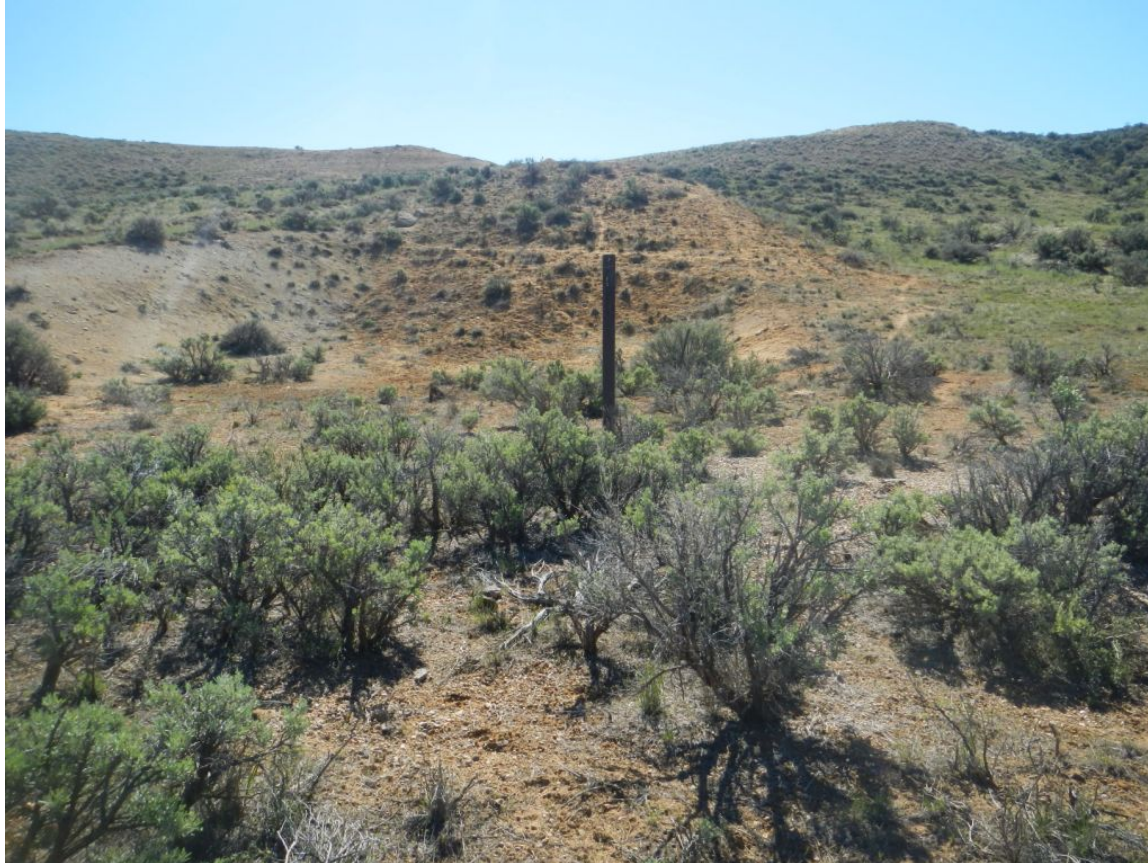
Photo#2: View to East; showing lack of Re-contouring.

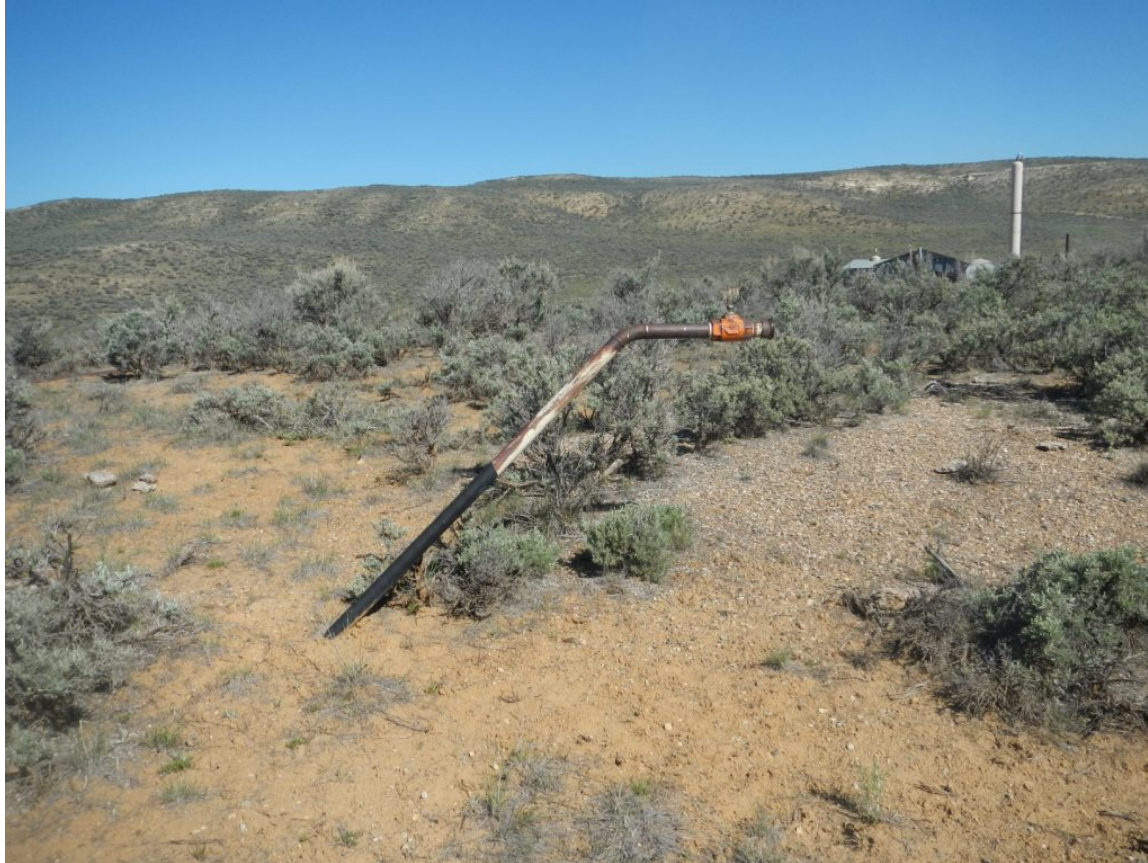
Photo#3: Flow lines, Associated Facilities not closed, removed.

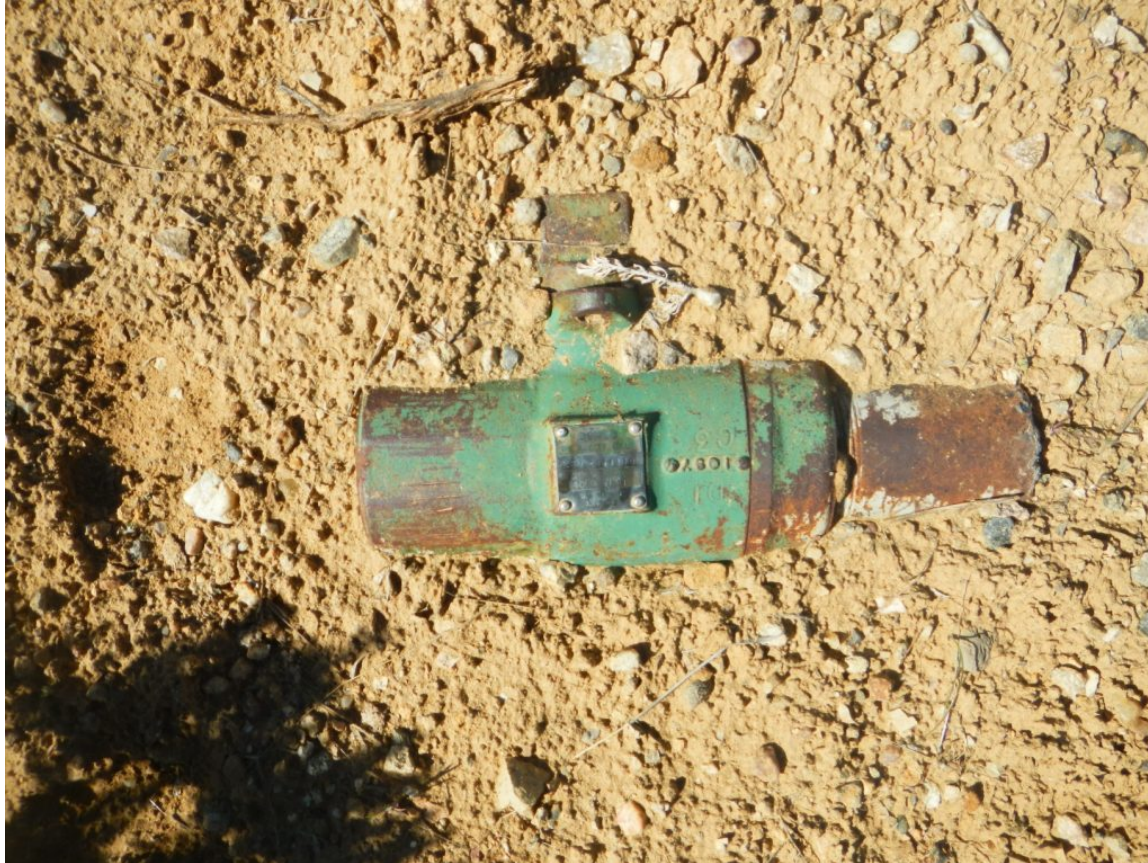
Photo#4: Debris left on Location.

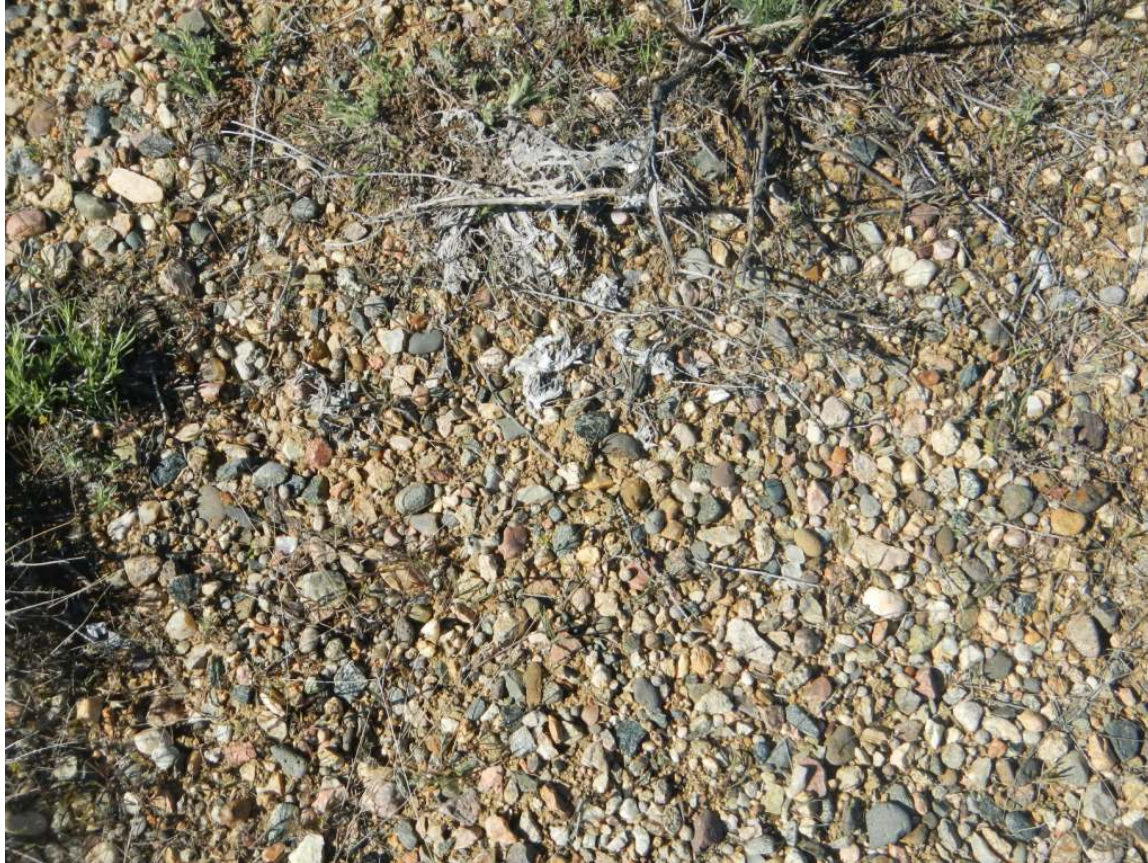
Photo#5: Gravel has not been removed.
