May 12, 2016

Inspection Photos: QuickSilver Alpha State #1-16

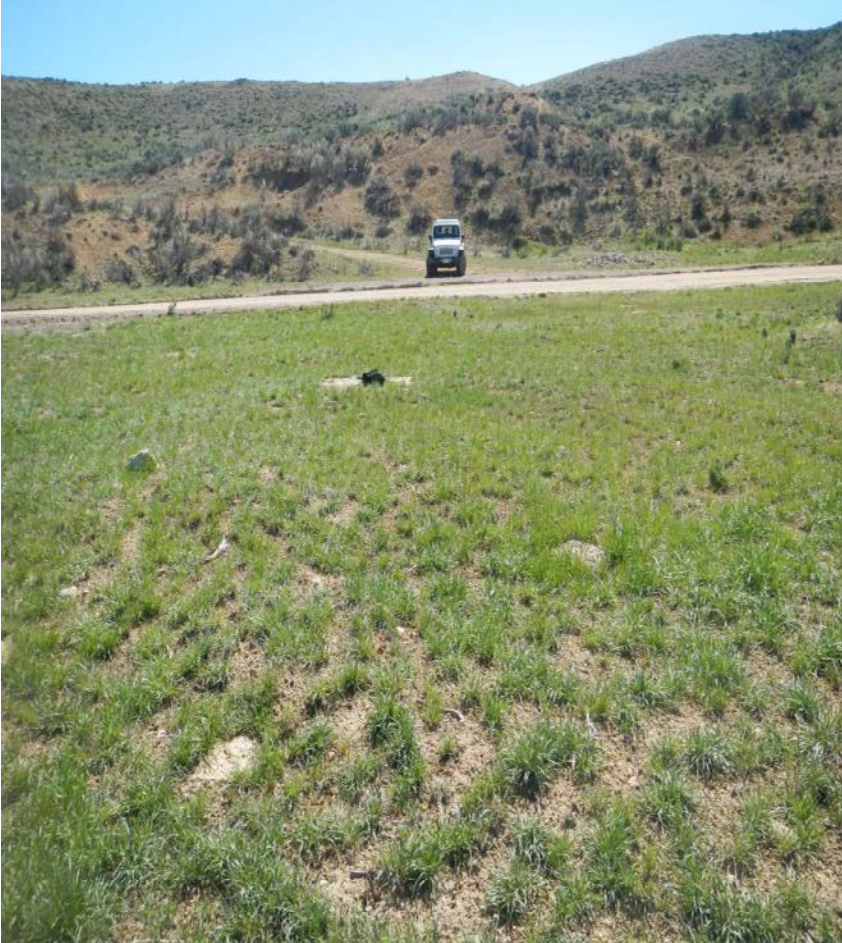
Photo#3:

View East over Location

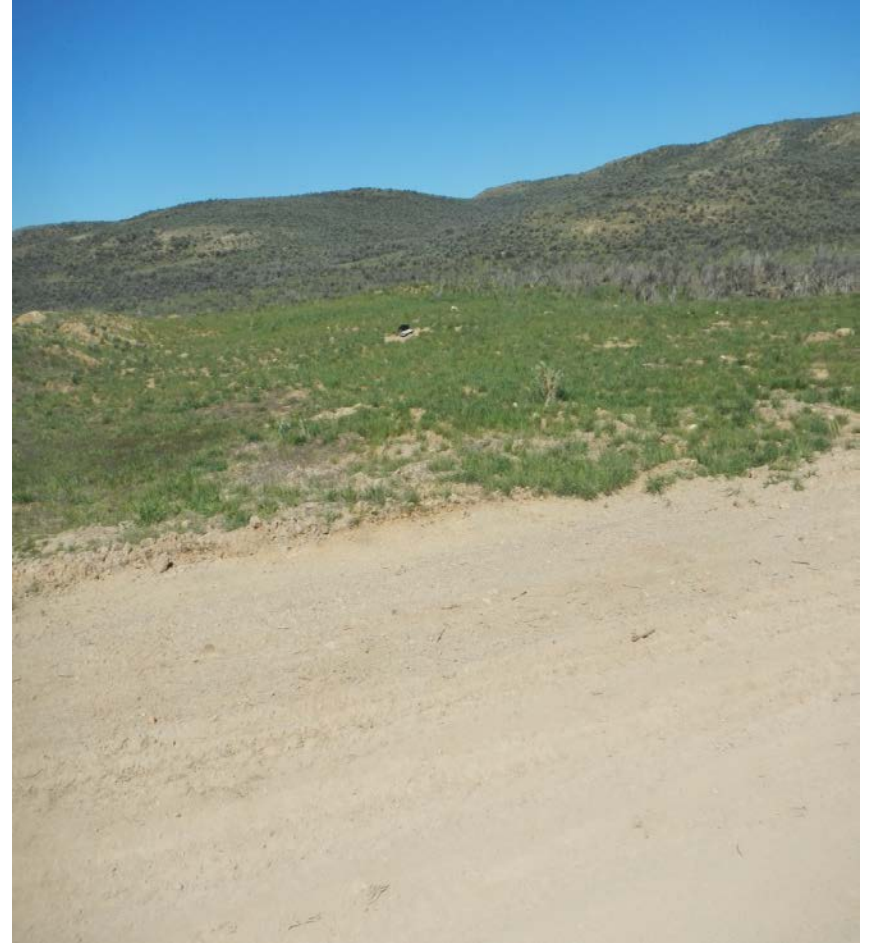
Photo#4:

View West over Location

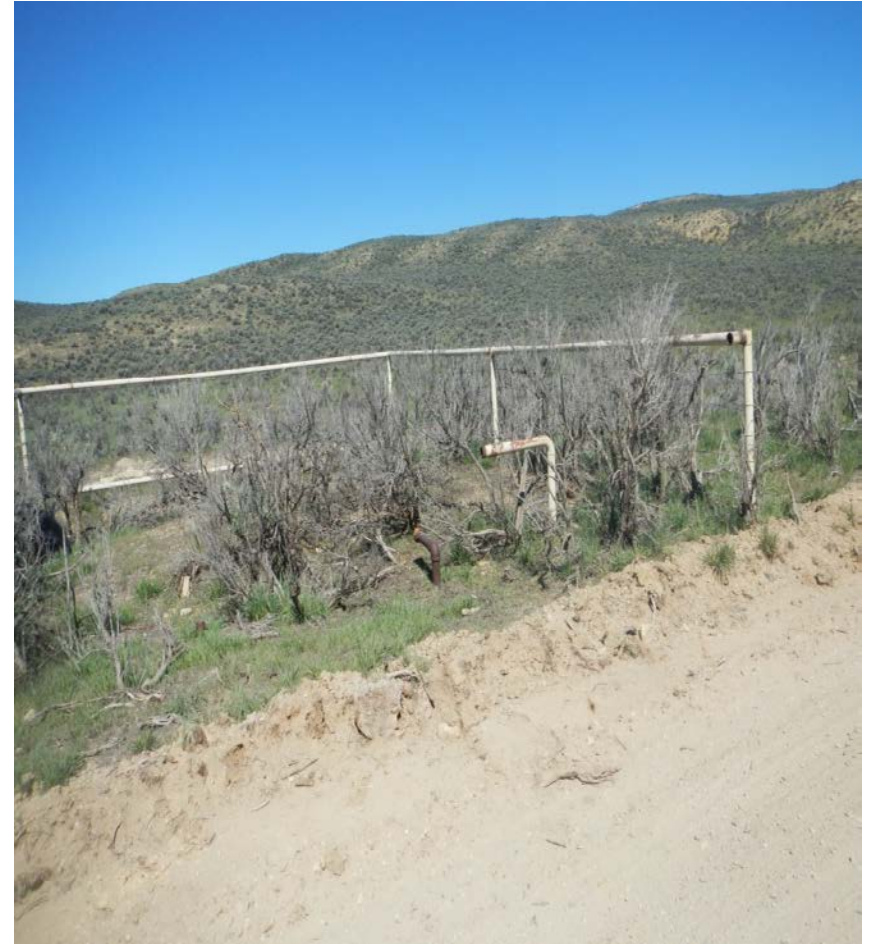
Photo#10:

View to West of same Facilities which appear to feed across Road East to Compressor Station (Photo #13)

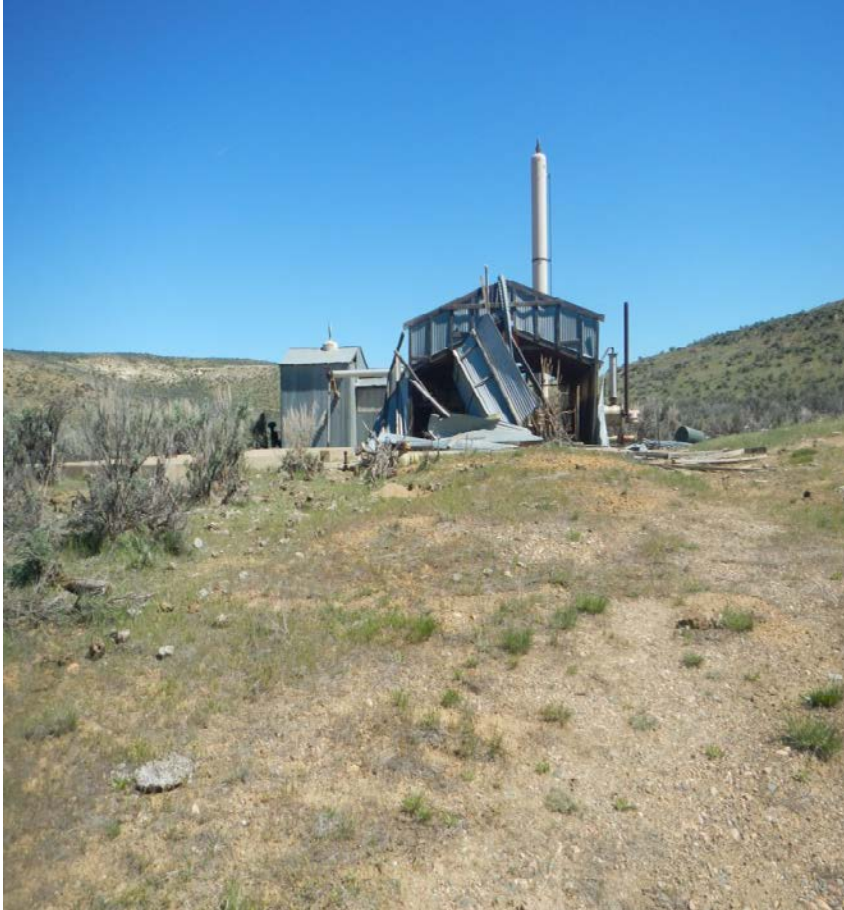
Photo#14:

View North at Compressor Station.

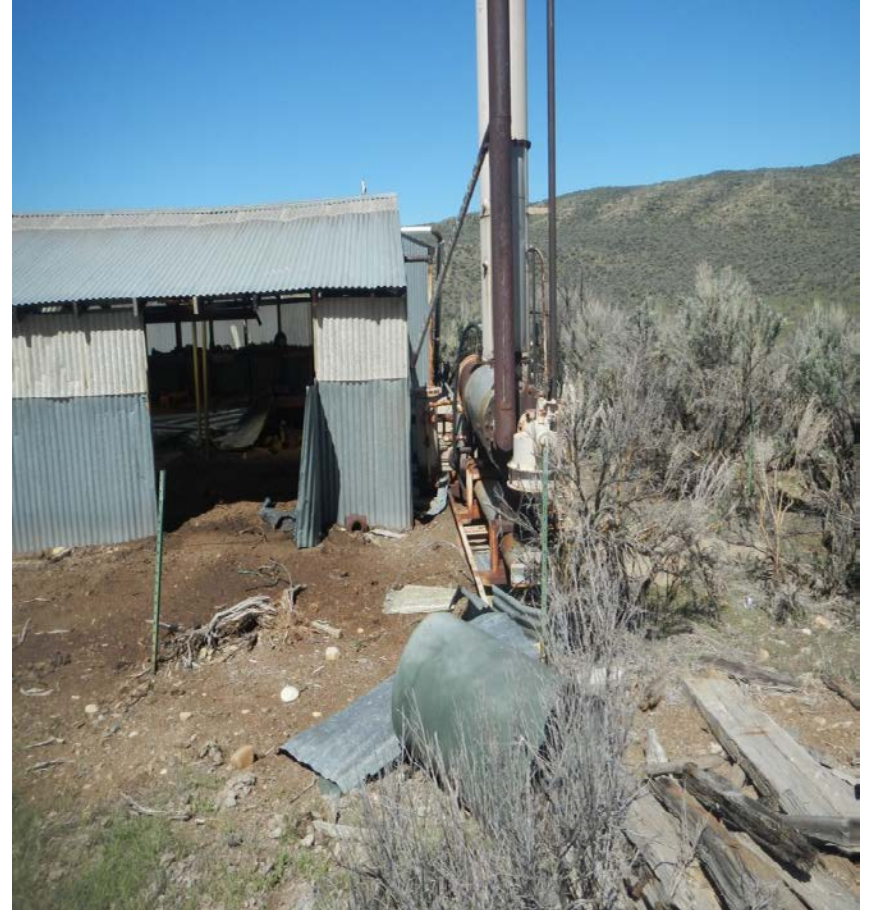
Photo#15:

View West at Compressor Station

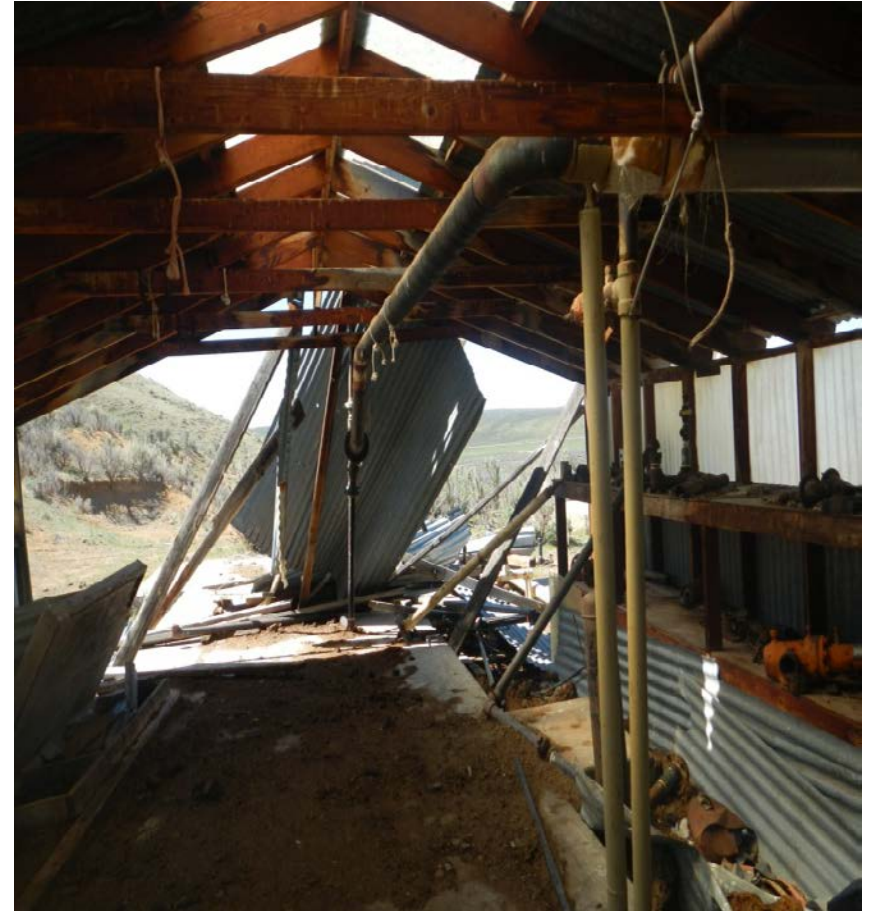
Inside Views of Compressor Station Building

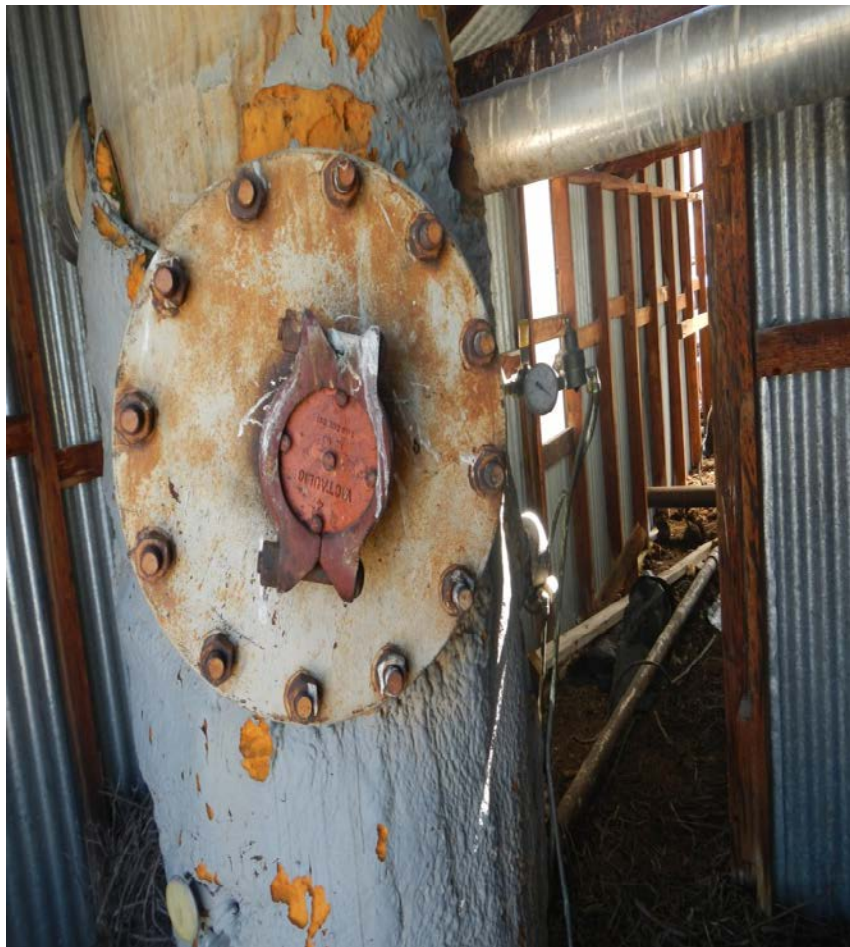
Photo#18:
Equipment inside Building

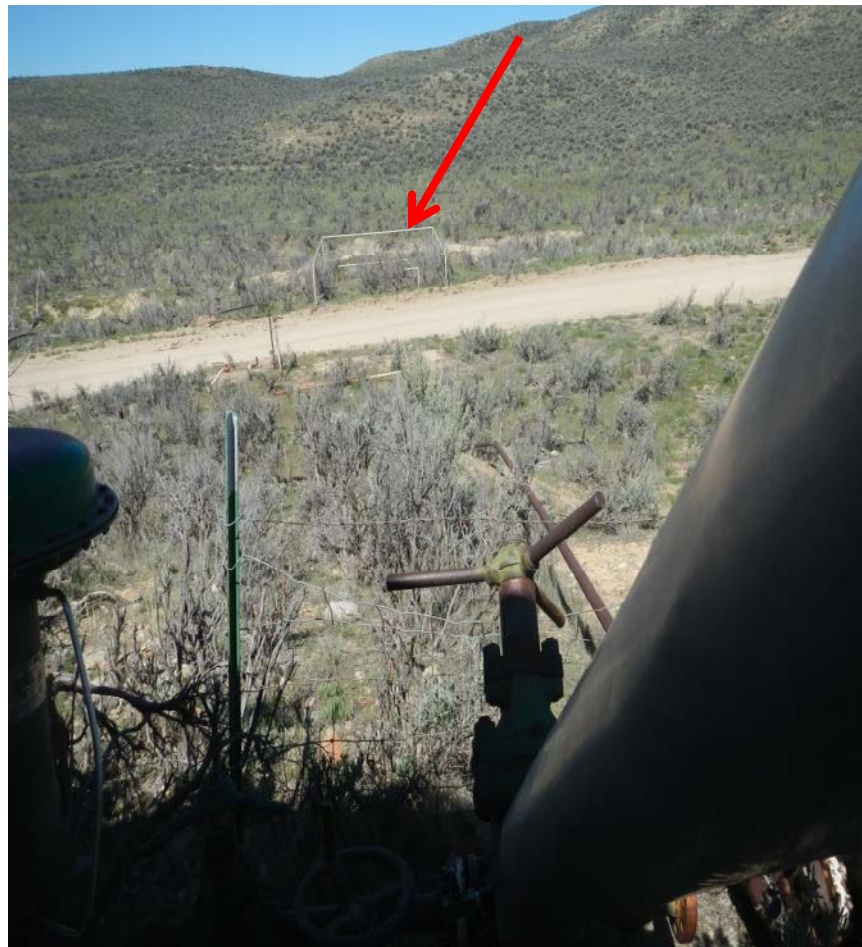
Photo#19:
View from Bldg to West; showing Facilities photo #9 & 10
