## Interim Reclamation Inspection

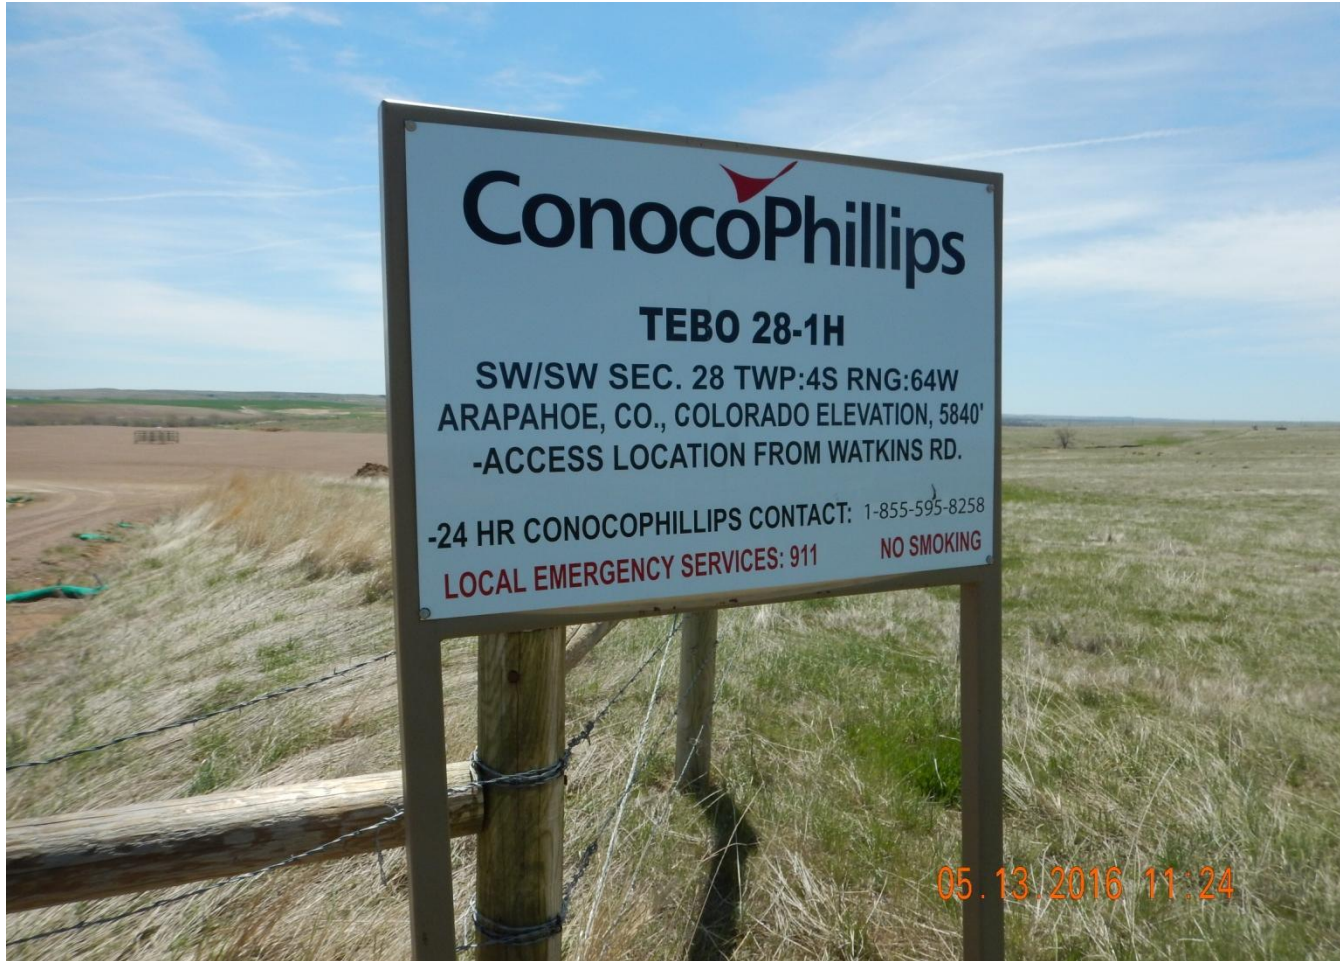
**Photo 1.** Photo taken of well sign for API #005-07206.

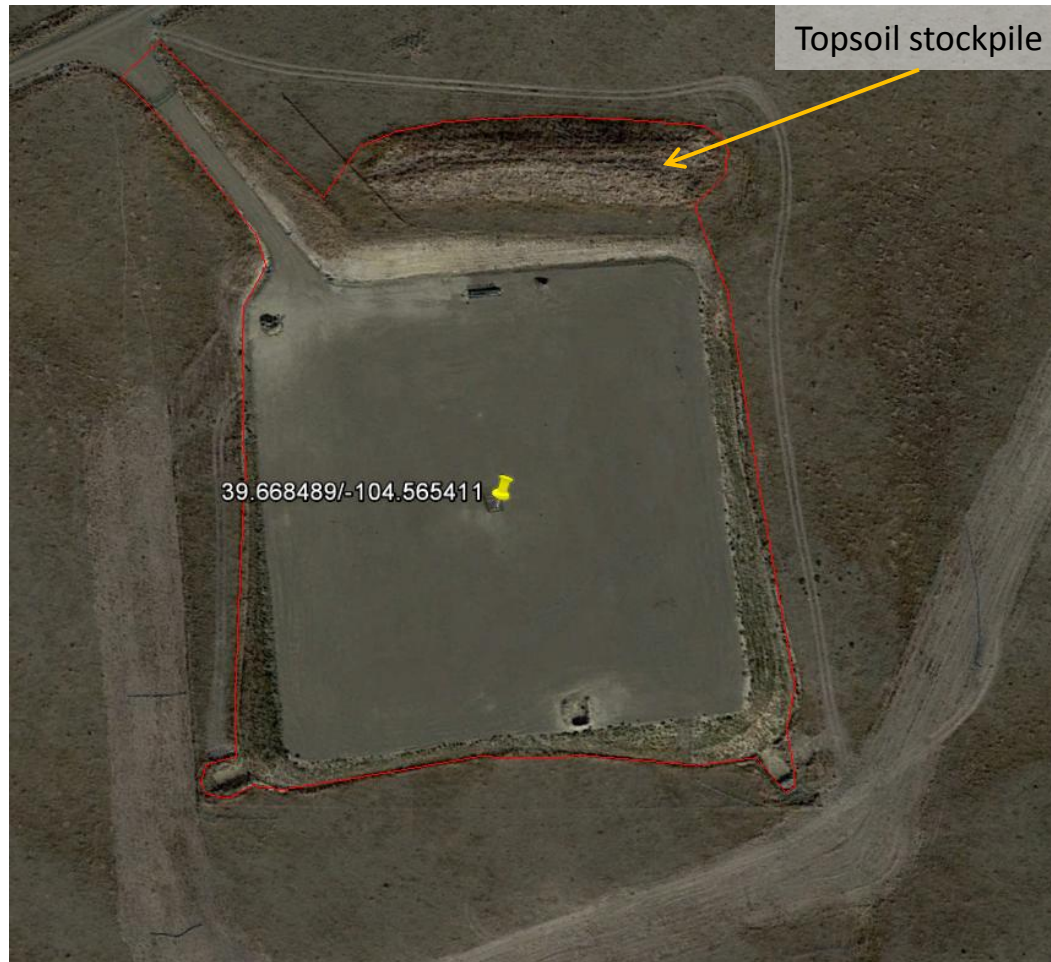
**Photo 2.** Google Earth aerial imagery taken 10/9/2015 indicating approximate total disturbance of 5.7 acres.

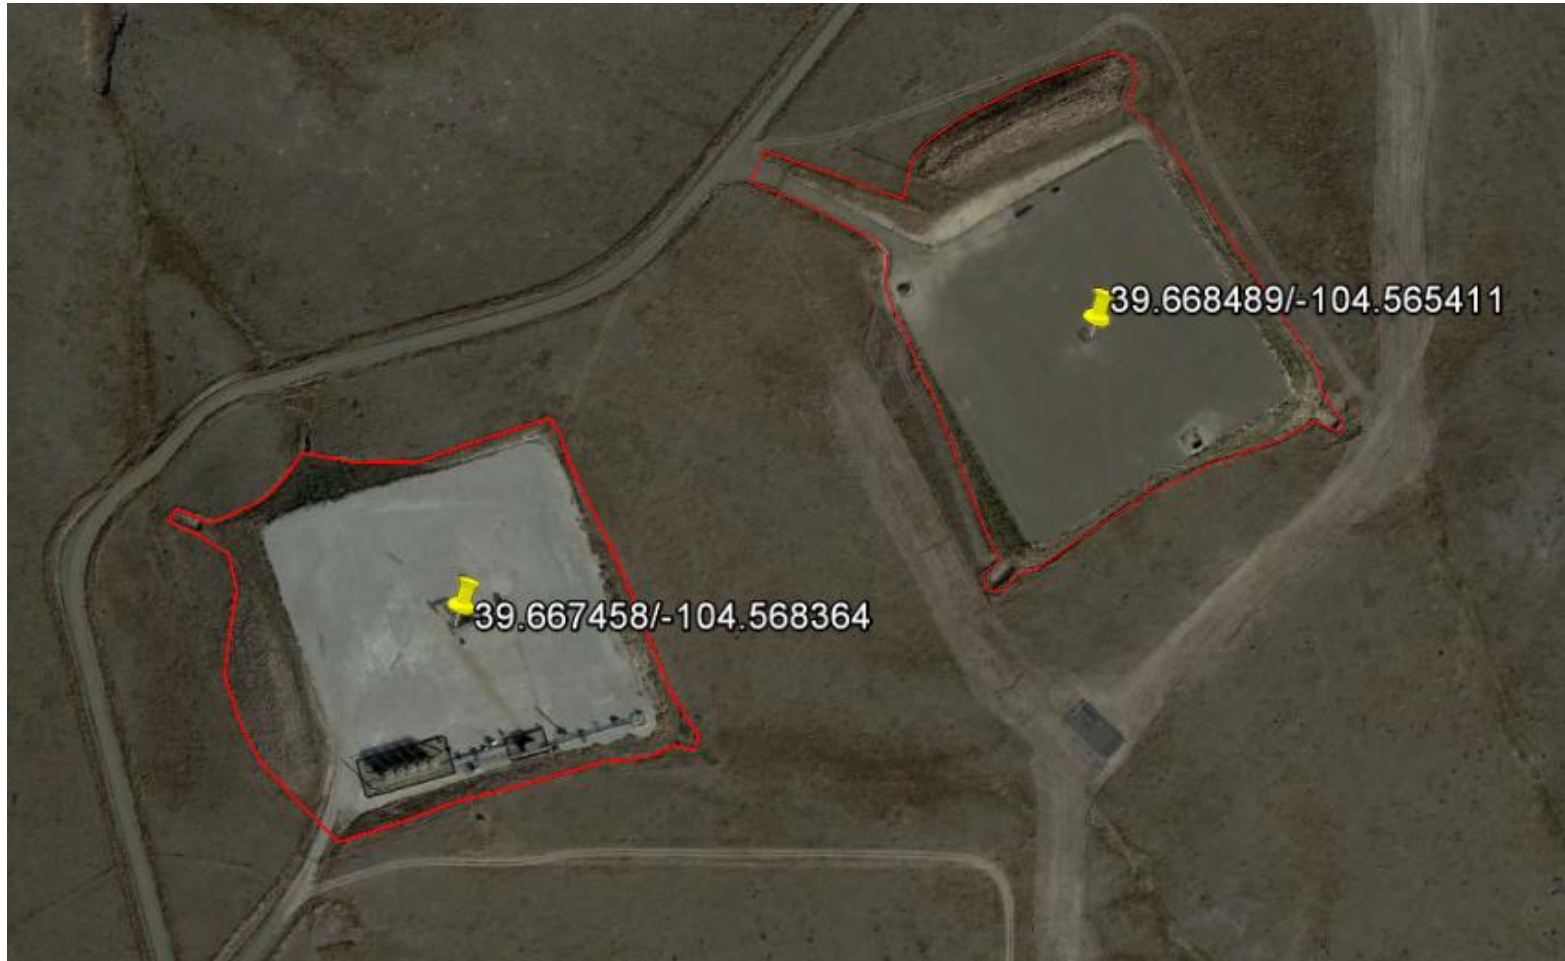
**Photo 3.** Google Earth aerial imagery taken 10/9/2015 indicating approximate distance of 450 feet from perimeter disturbance in relation to Tebo 29-1H (005-07165) and Tebo 28-1H (005-07206).

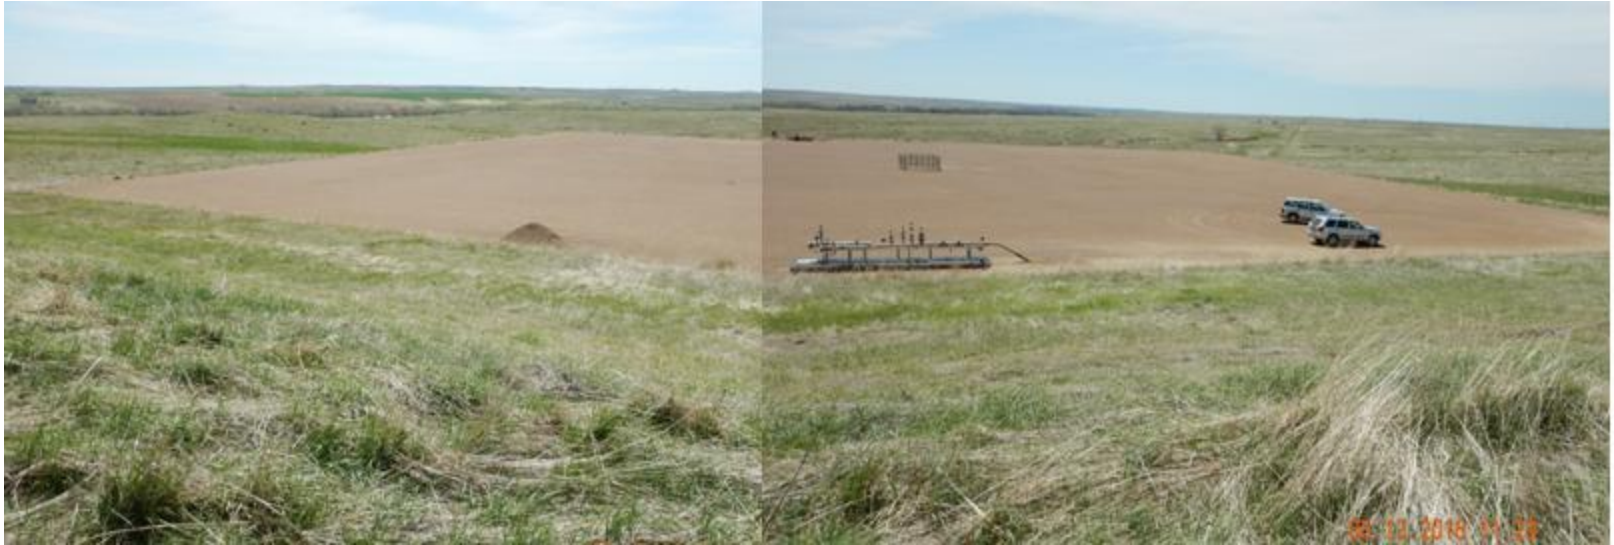
**Photo 4.** Photo taken from southeast location, facing West. Overview of total disturbance illustrating unused portions of location that have not been reduced in size per Form 2A .

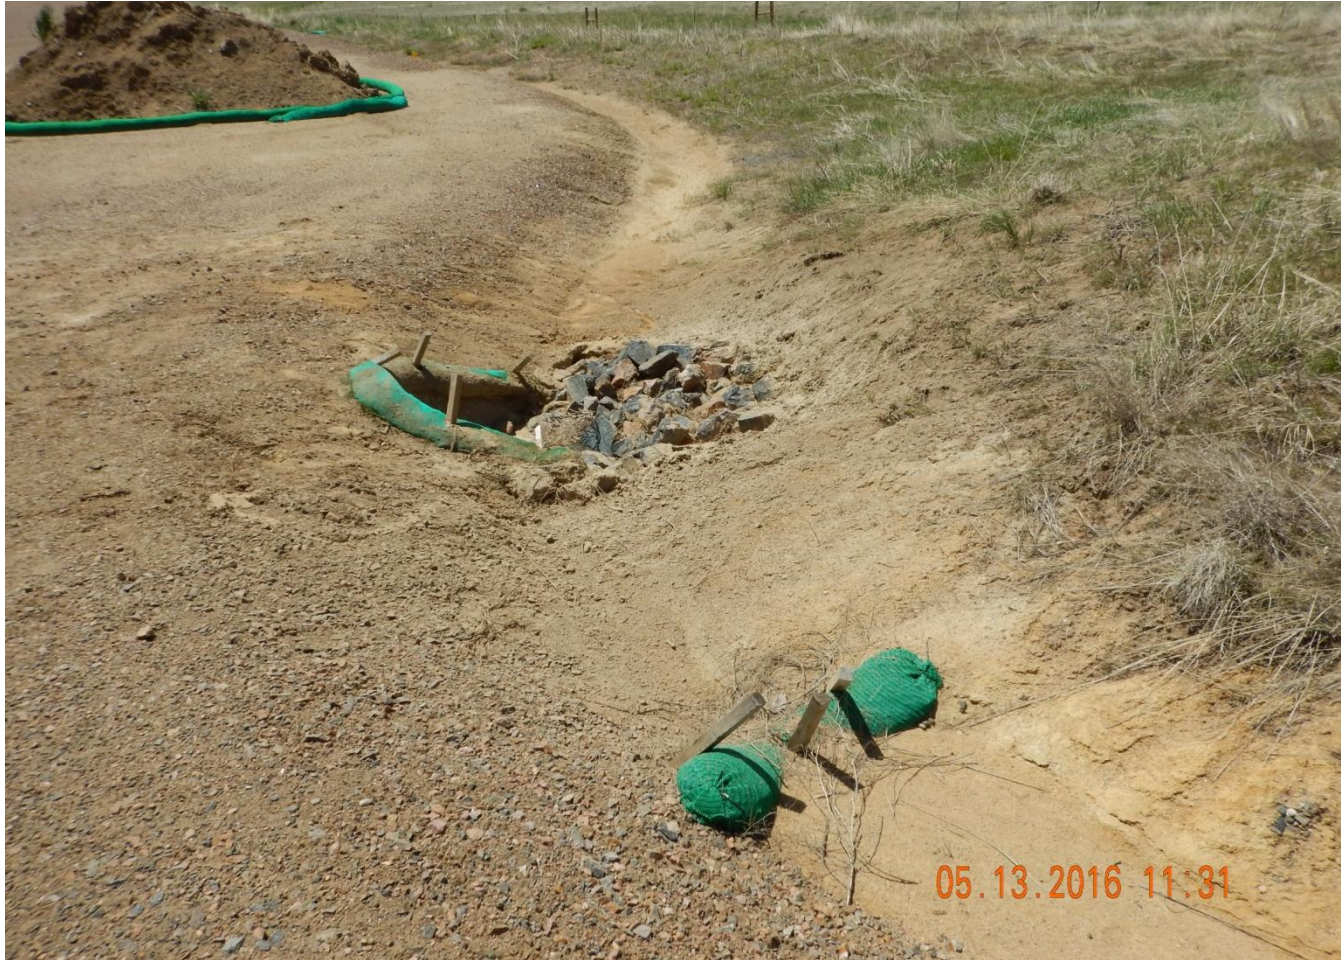
**Photo 5.** Photo taken from entrance of location, facing South. Need to maintain stormwater and sediment control BMPs.

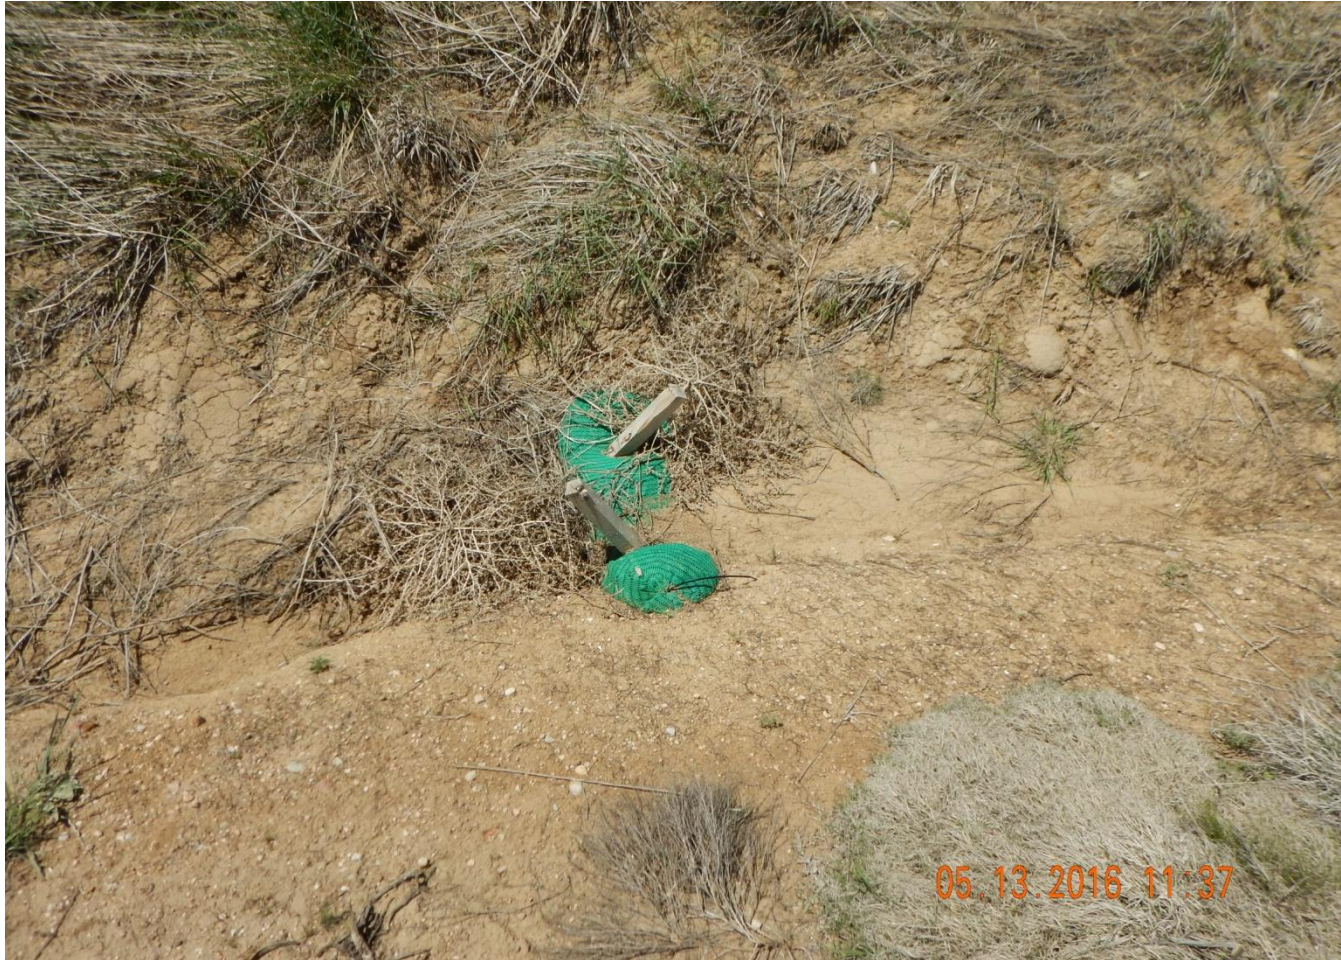
**Photo 6.** Photo taken from eastern of location. Need to maintain stormwater and sediment control BMPs.

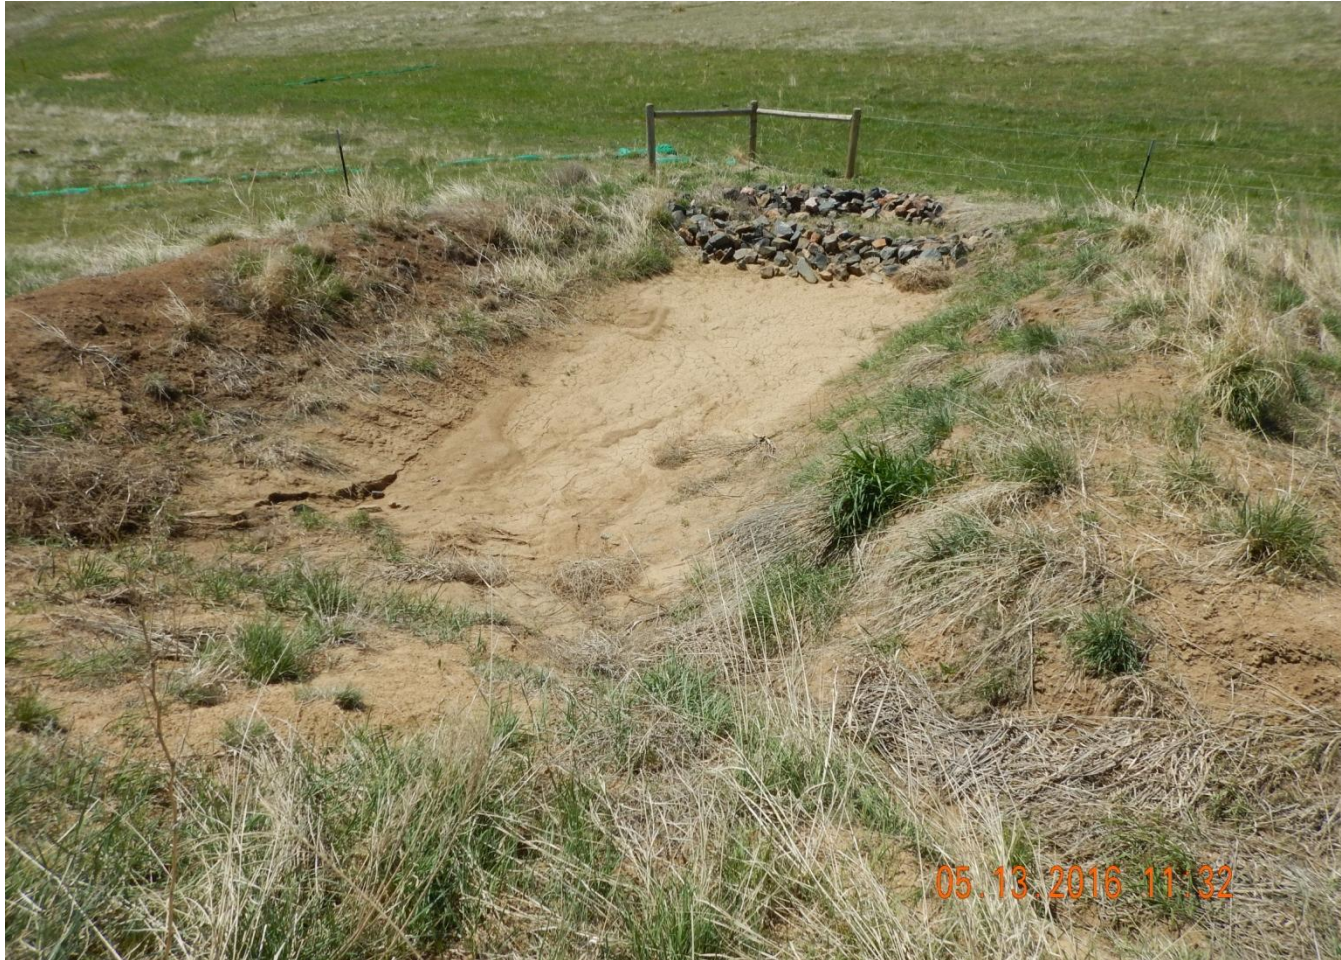
**Photo 7.** Photo taken from southwest location, facing South towards sediment trap. Sediment trap installed to allow sediment to settle out of stormwater runoff.

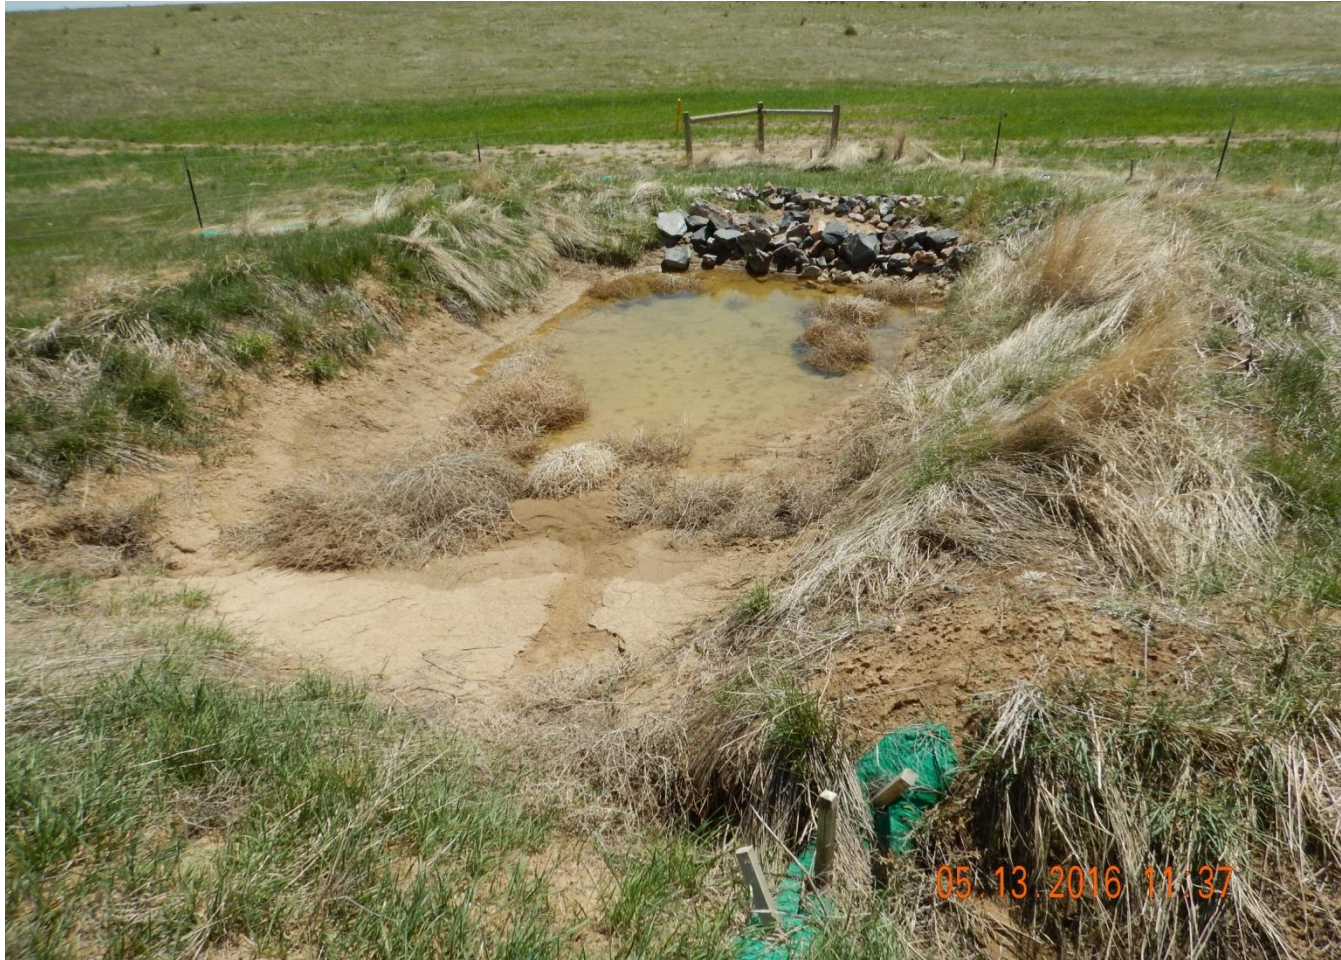
**Photo 8.** Photo taken from southeast location, facing South towards sediment trap. Sediment trap installed to allow sediment to settle out of stormwater runoff.

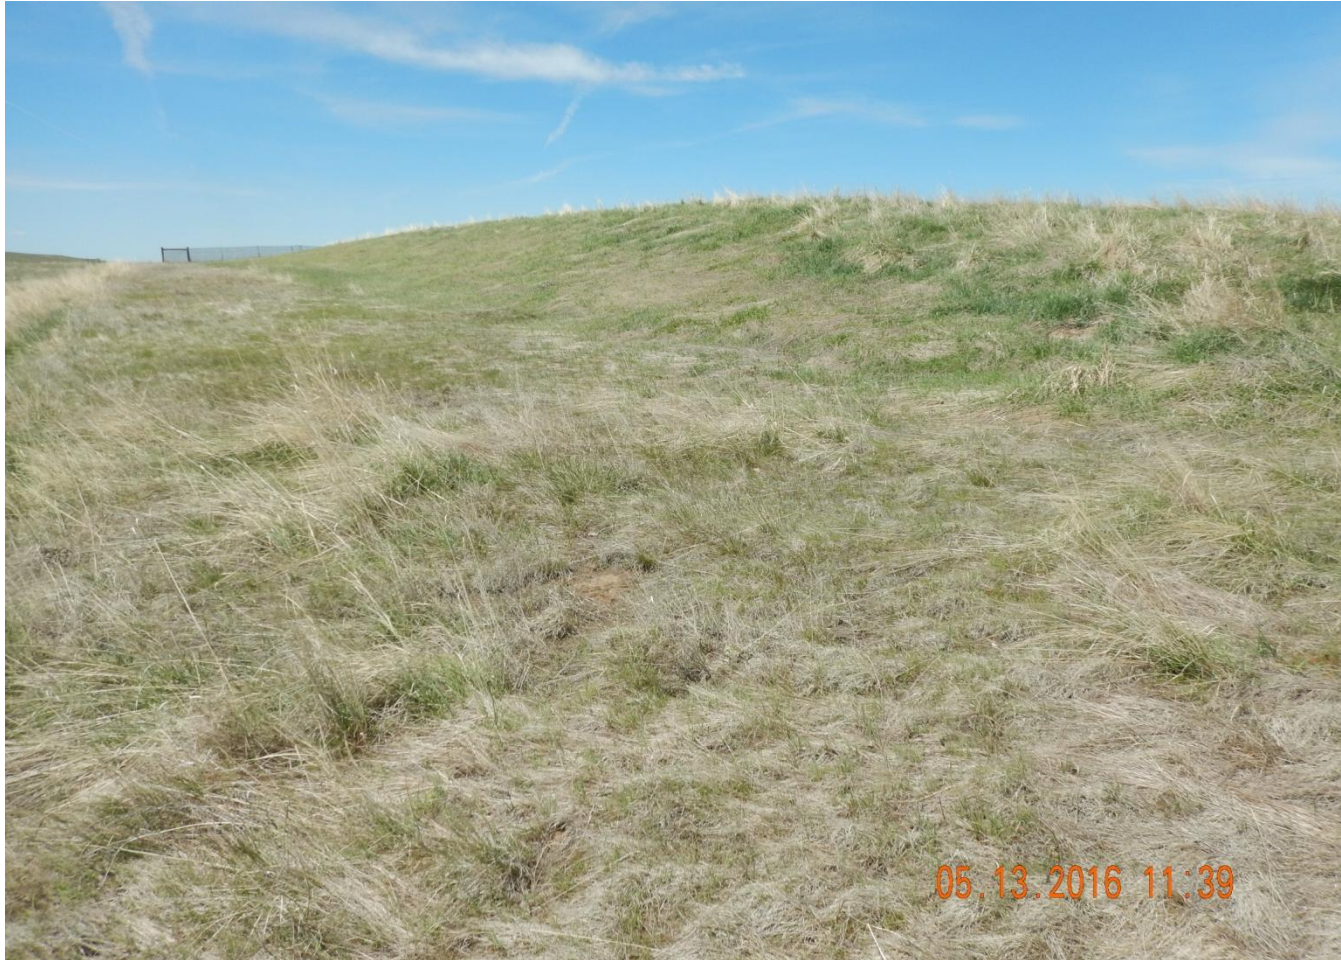
**Photo 9.** Photo taken from northern location, facing West. Topsoil stockpile stabilized with perennial vegetation.
