## Interim Reclamation Inspection

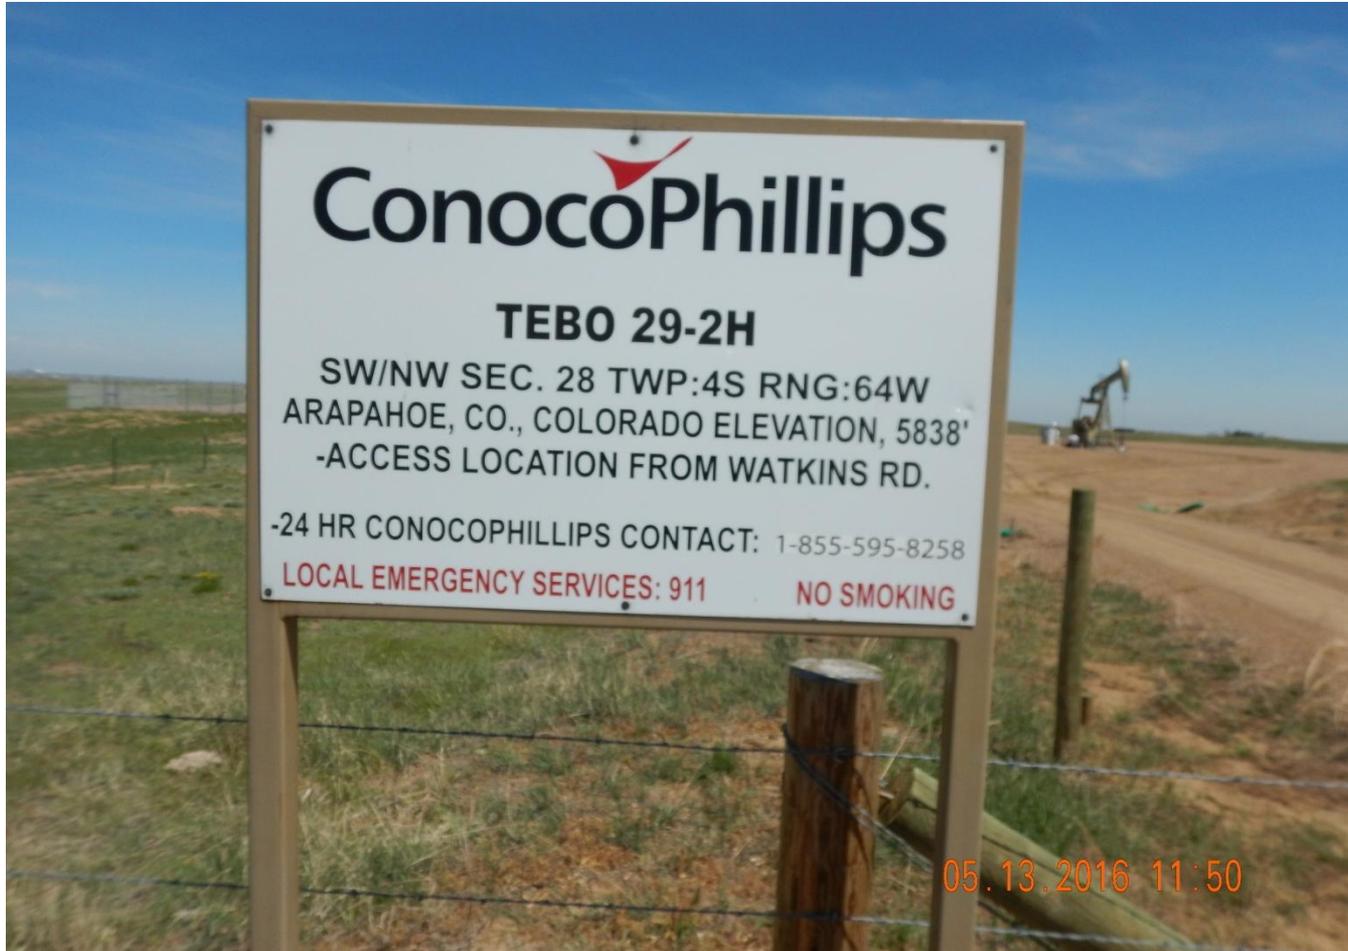
**Photo 1.** Photo taken of well sign for API #005-07209.

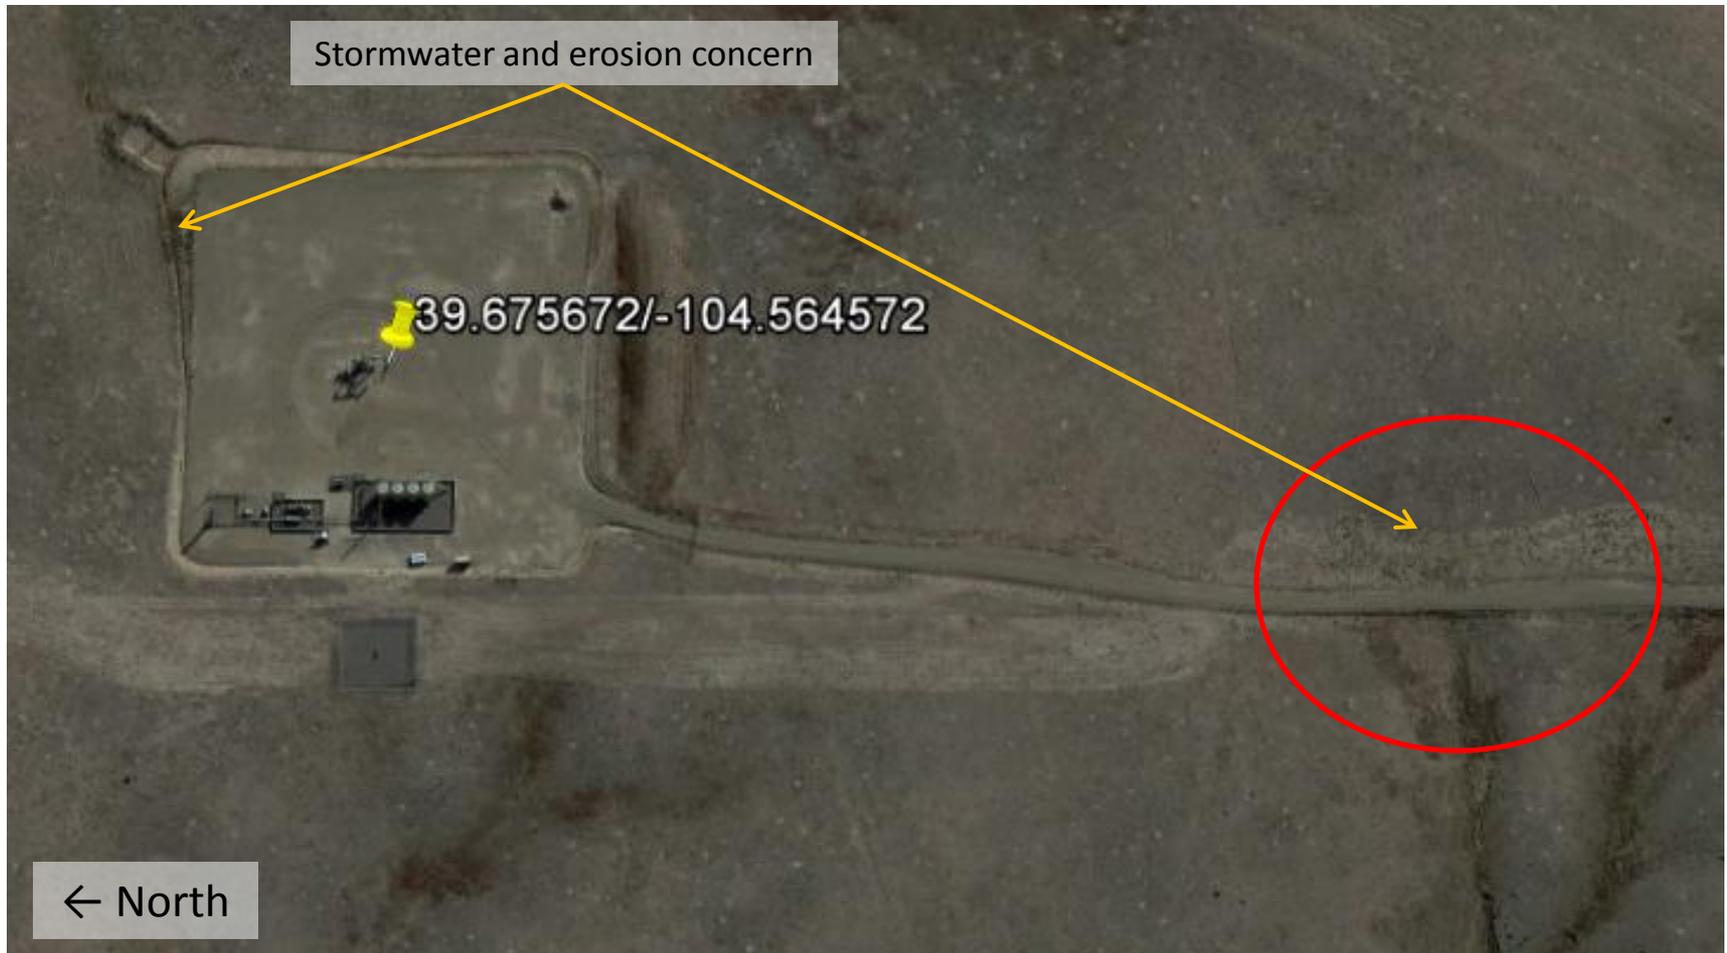
**Photo 2.** Google Earth aerial imagery taken 10/9/2015. Two areas of concern need to control stormwater and erosion. One area is located on the northeast well pad and the second area is approximately 800 feet south of the entrance on a pipeline.

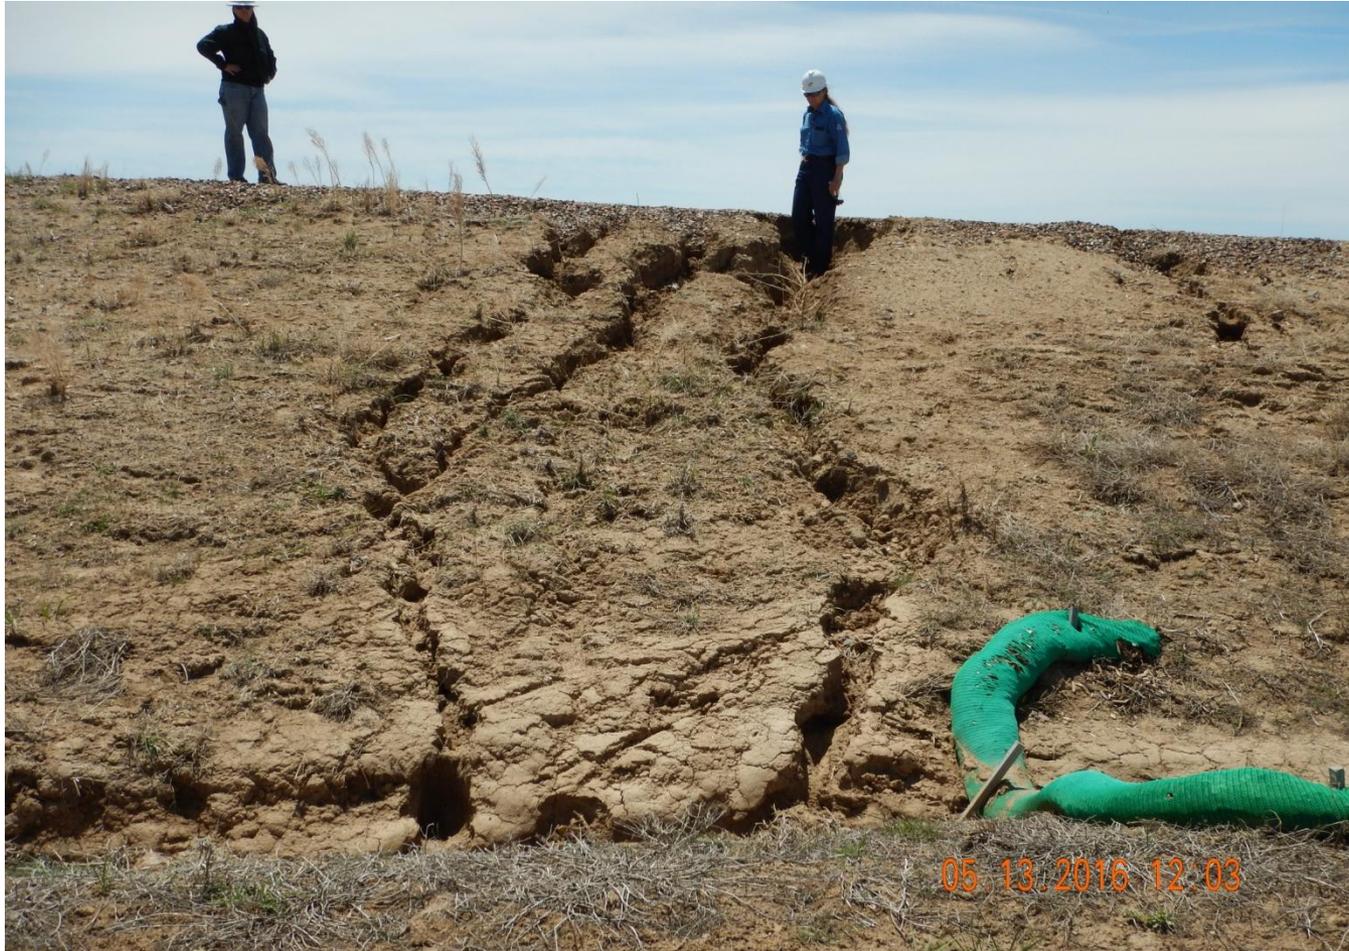
**Photo 3.** Photo taken from northeast location, facing South. Need to stabilize production area and prevent erosion.

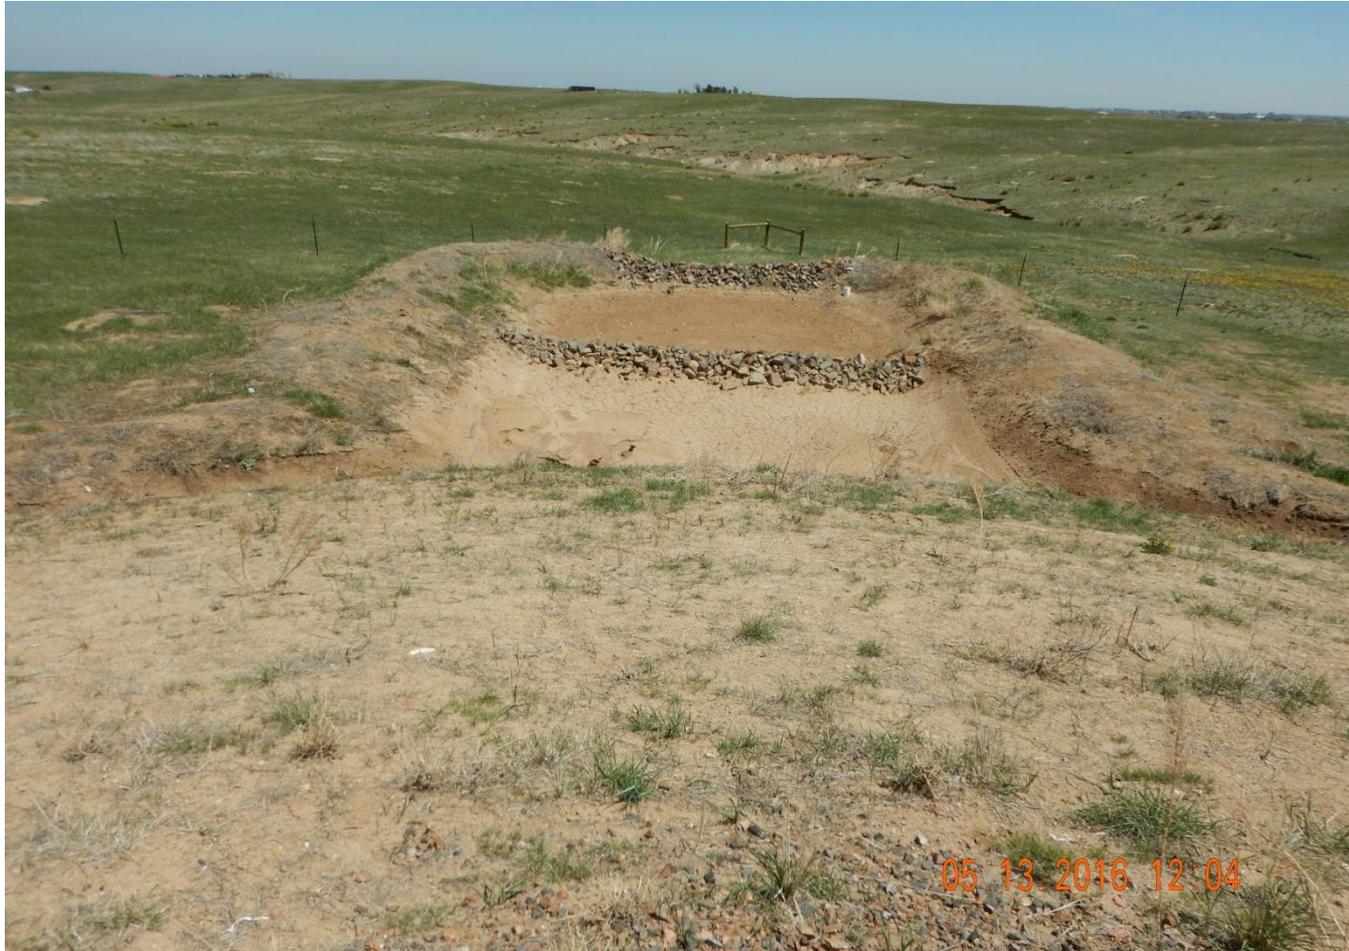
**Photo 4.** Photo taken from northeast location, facing Northeast towards sediment trap. Sediment trap installed to allow sediment to settle out of stormwater runoff.

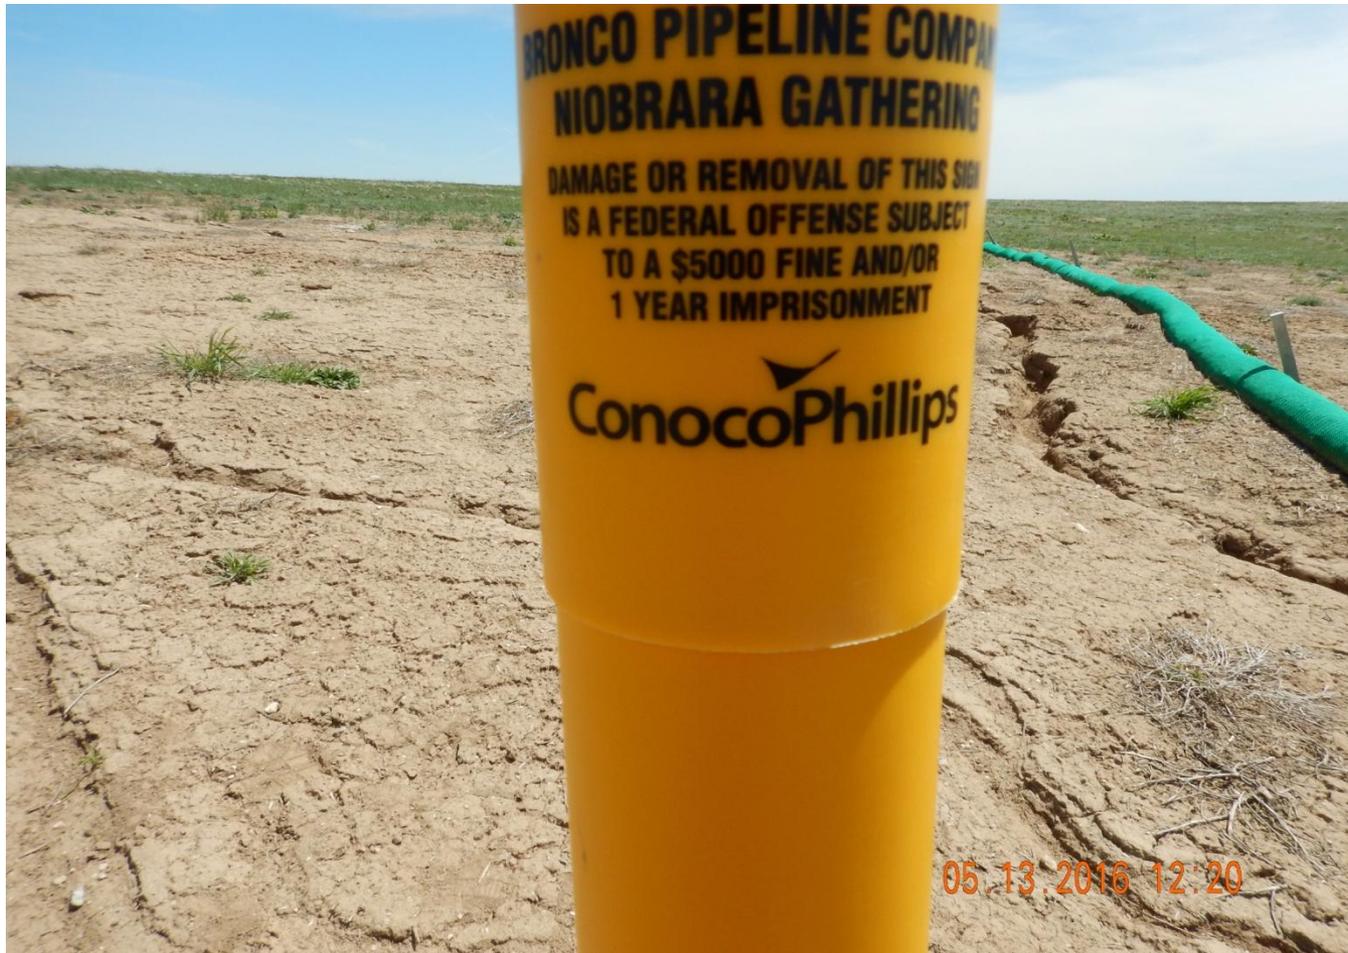
**Photo 5.** Photo taken from Conoco Phillips pipeline ROW. Refer to Photo 2.

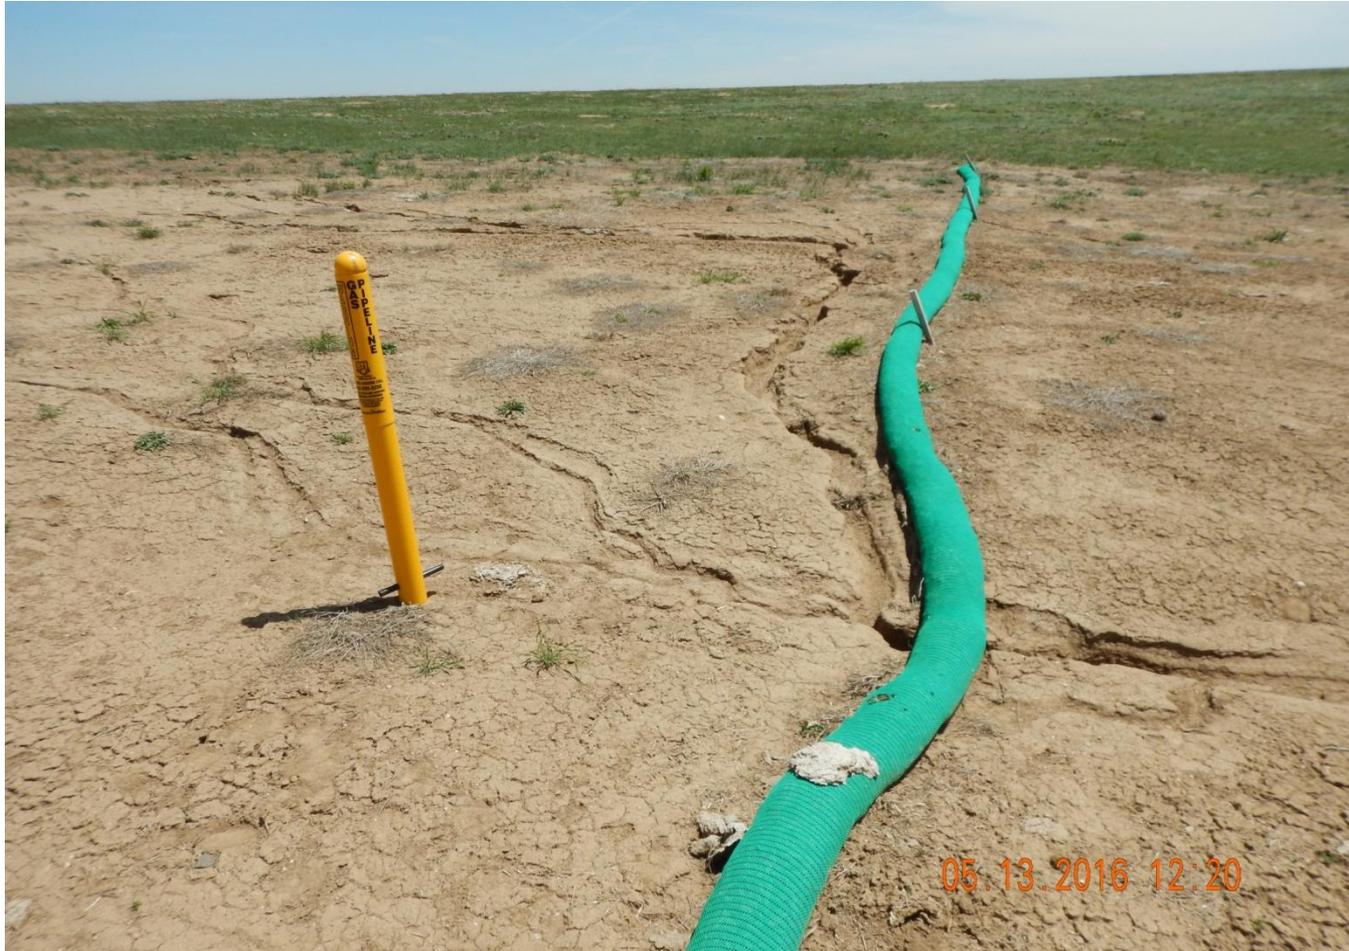
**Photo 6.** Photo taken from previous location, facing East. Need to control stormwater and erosion. Stormwater is cutting underneath wattle and transporting sediment.

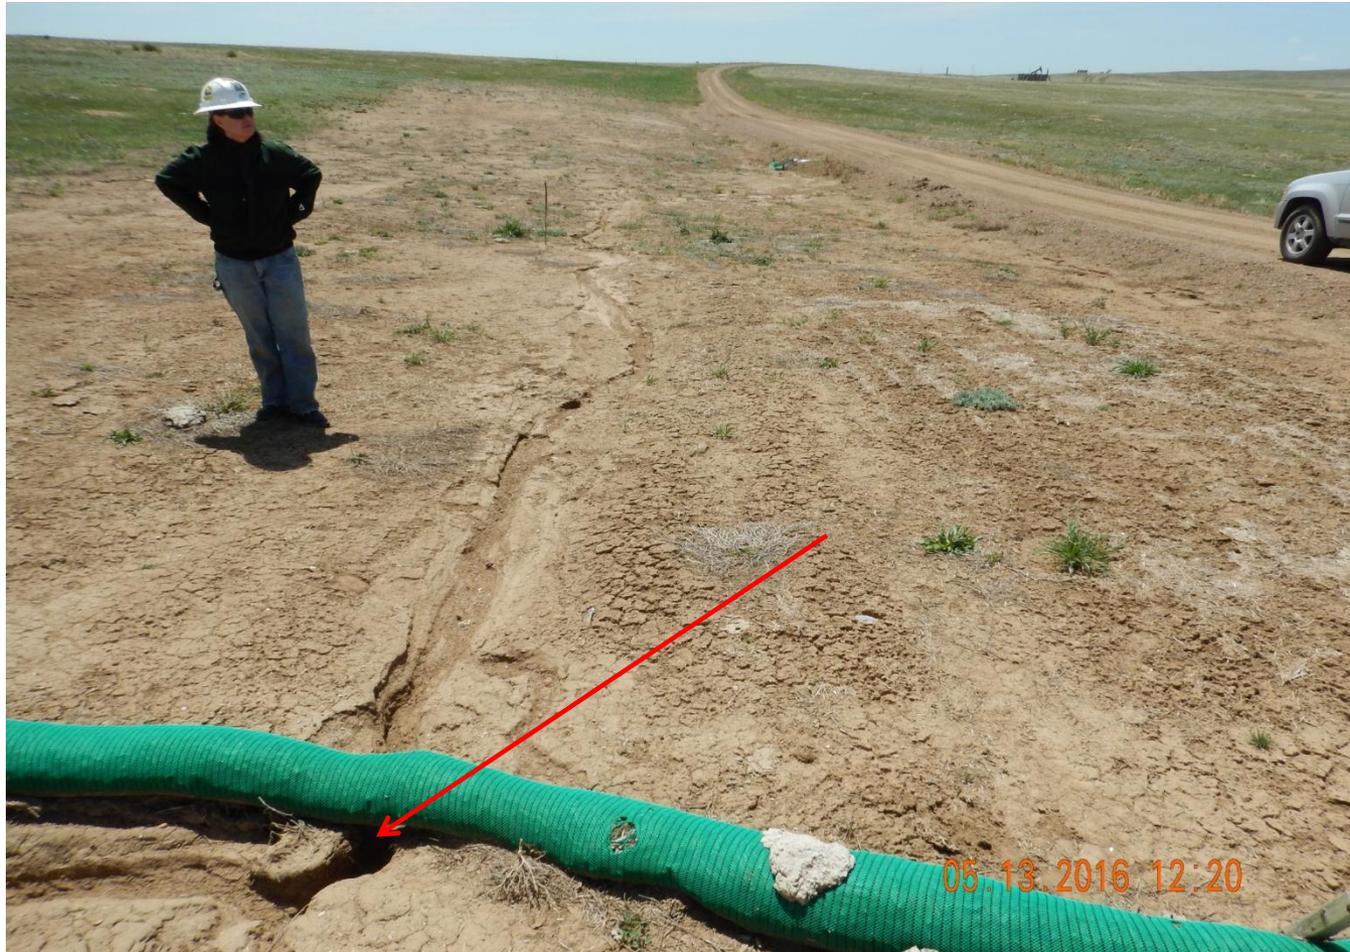
**Photo 7.** Photo taken from previous location, facing South. Need to control stormwater and erosion. Stormwater is cutting underneath wattle and transporting sediment.

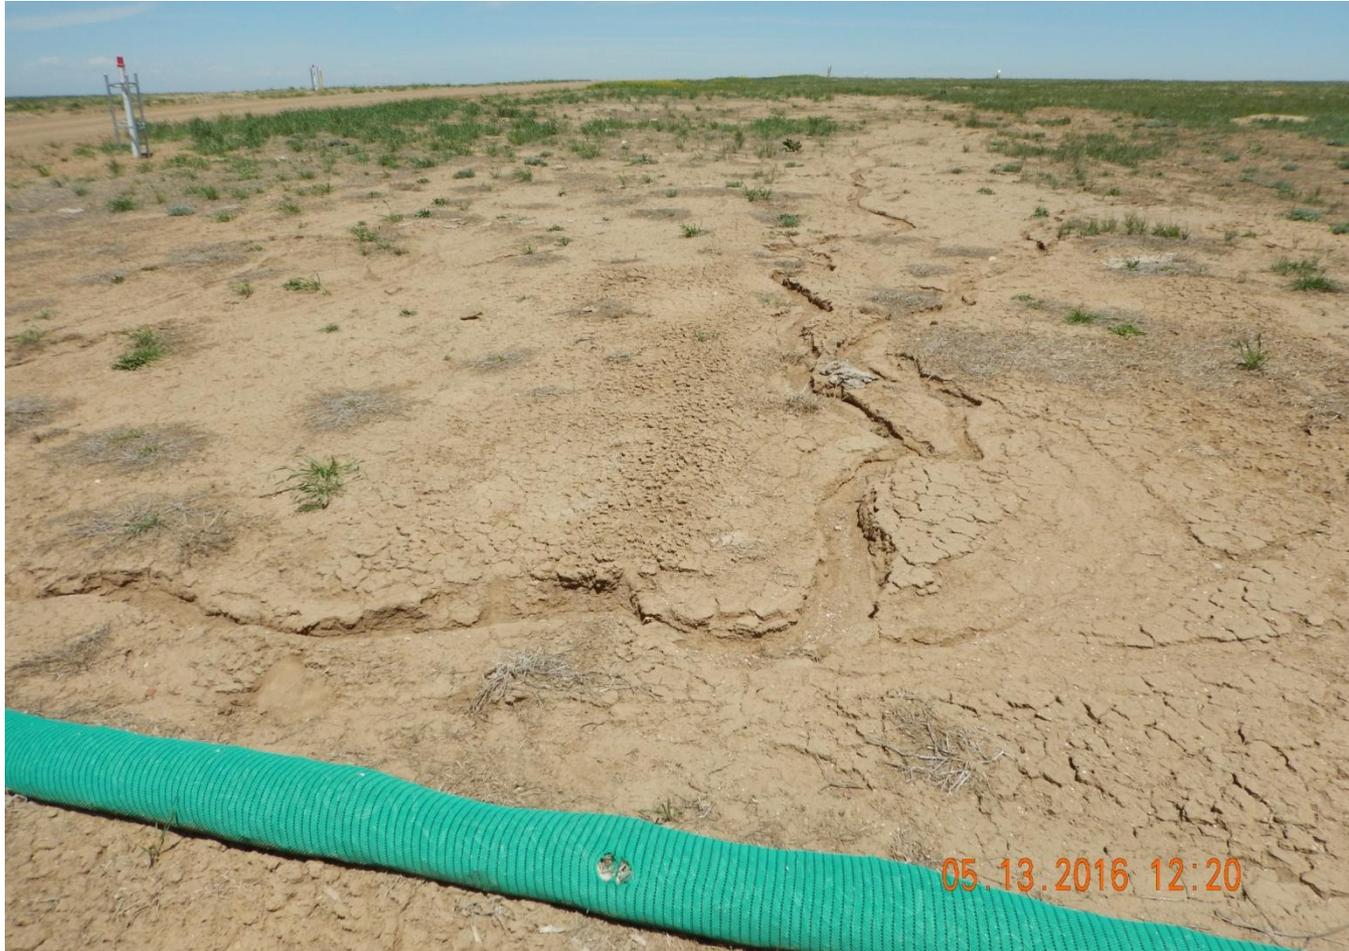
**Photo 8.** Photo taken from previous location, facing North. Need to control stormwater and erosion. Stormwater is cutting underneath wattle and transporting sediment.
