May 13, 2016

Inspection Photos: SWN API# 081-07737

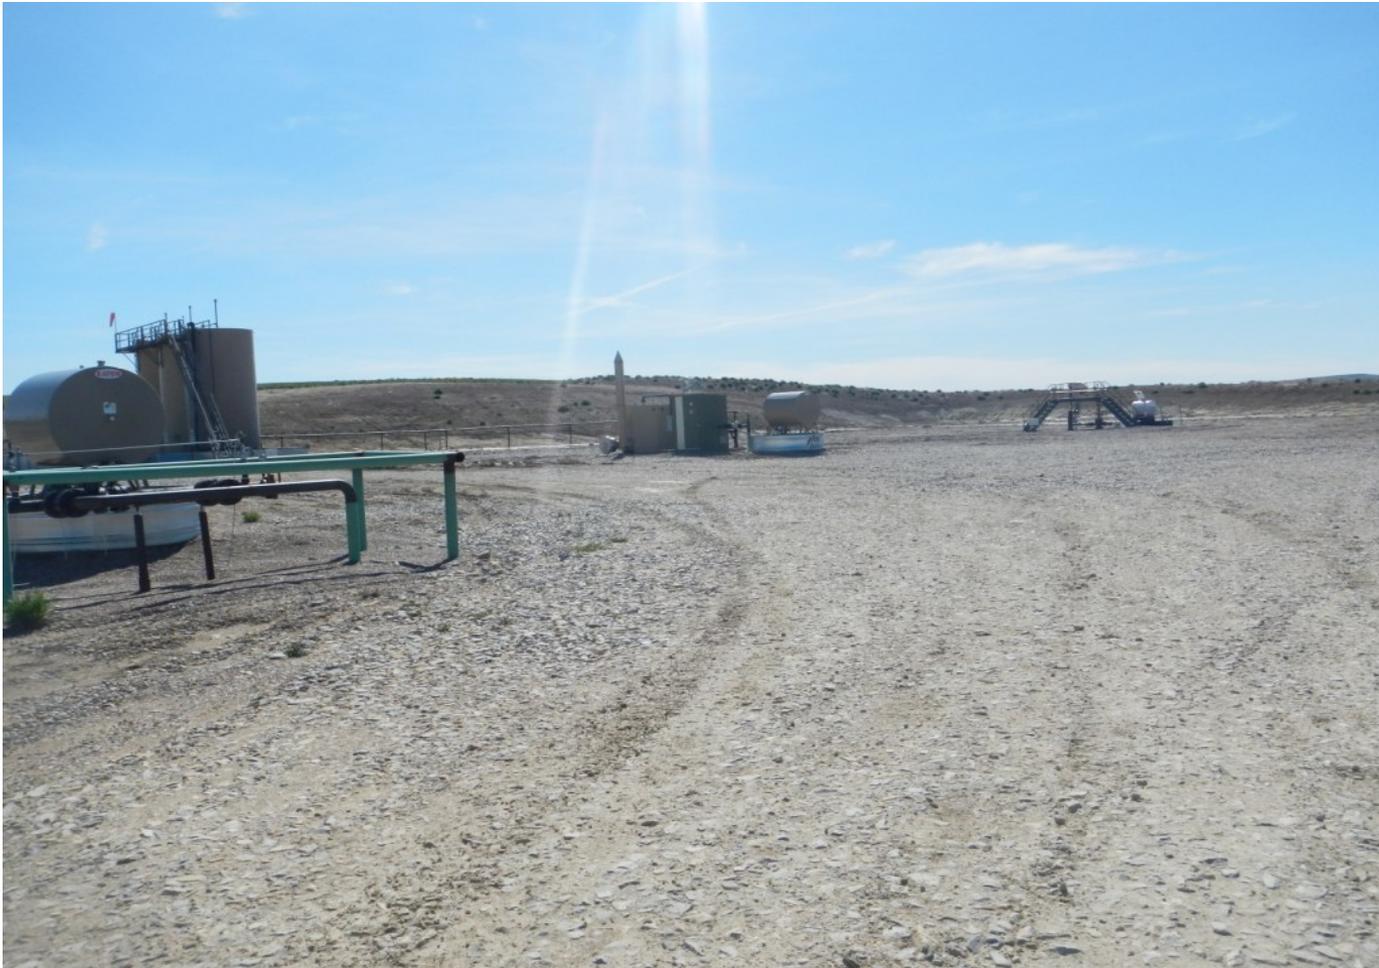
Photo#1: Overview of Location to SE

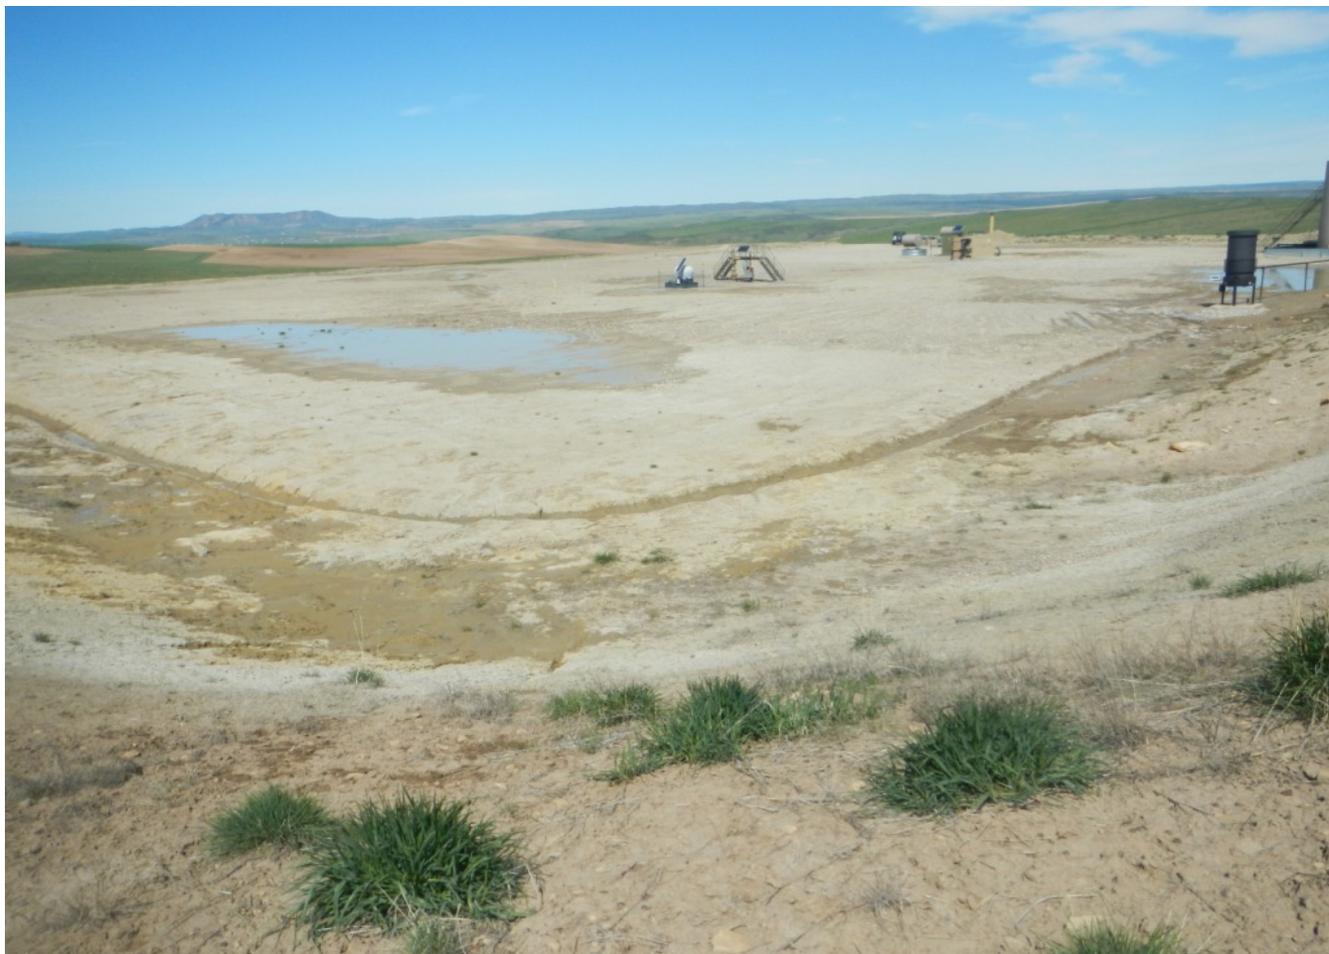
Photo#2: Overview of Location from SE Corner; showing Large Areas no Longer needed for Use or Production that need to be Reclaimed.

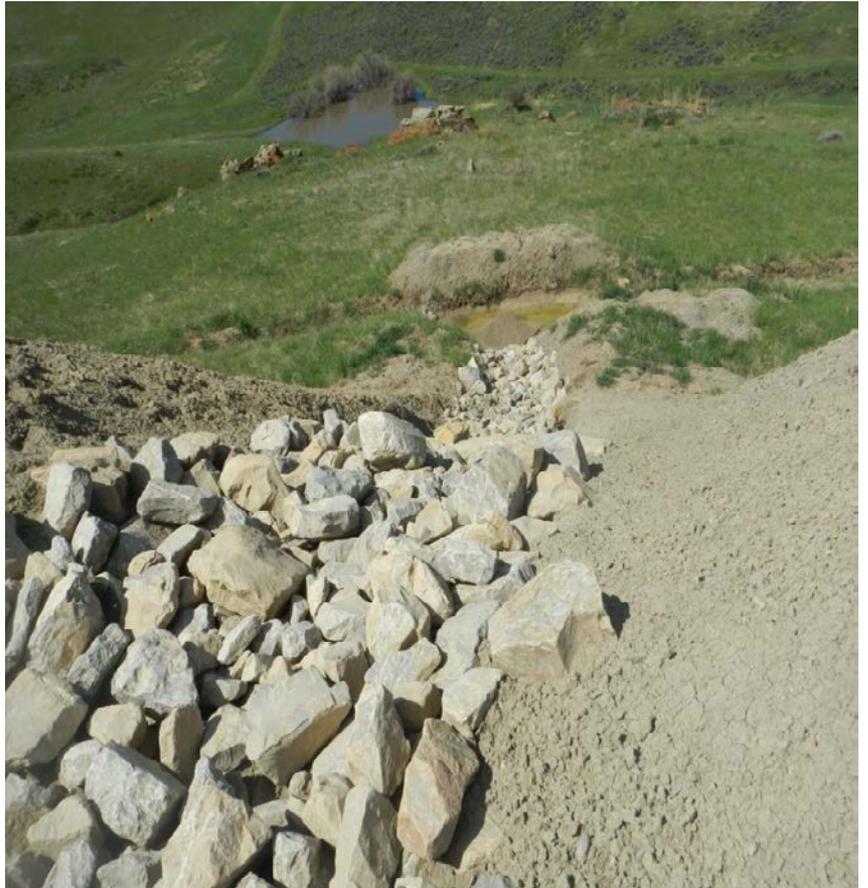
Photo#3:  
Drain Mid Fill Slope that needs BMPs Installed .

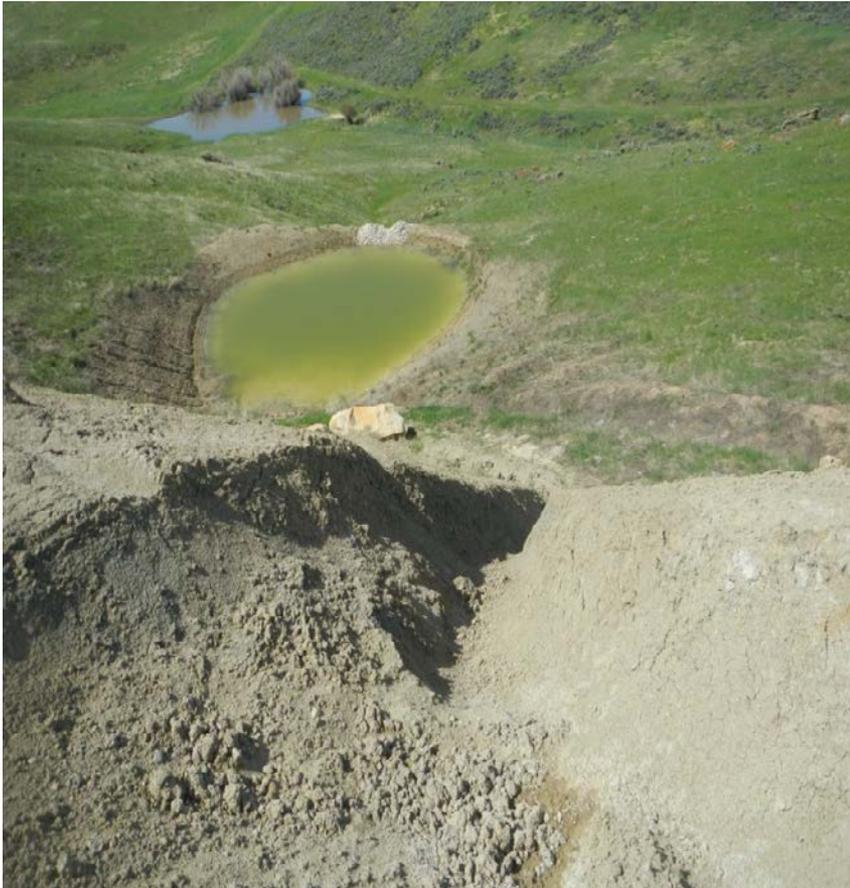
Photo#4:  
Drain, further South, adequately armored.

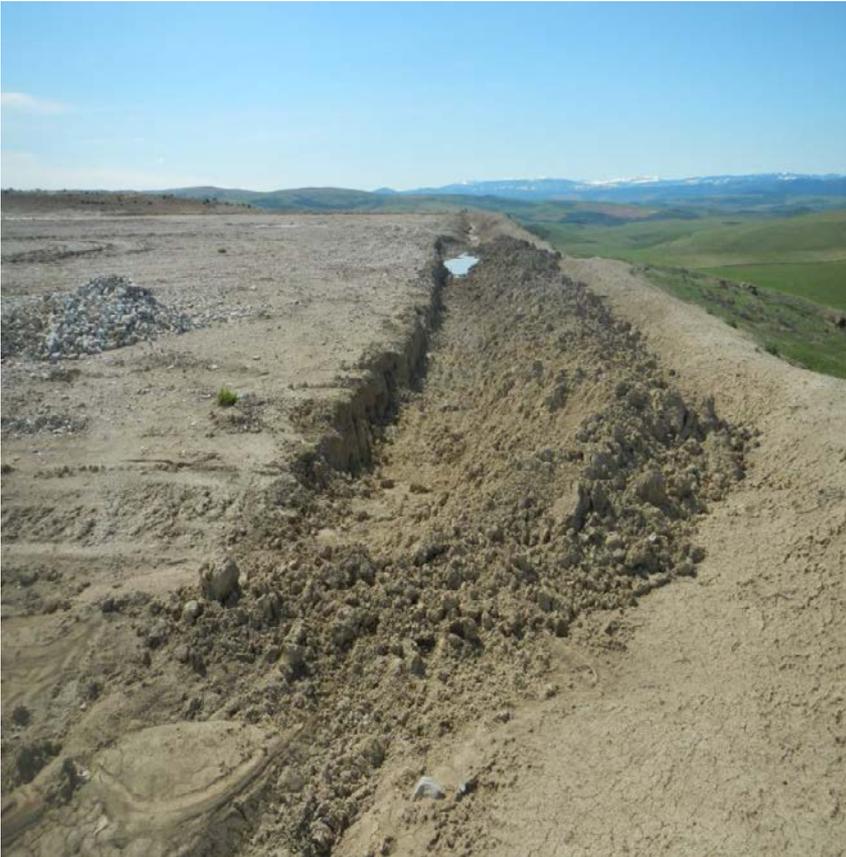
Photo#5:  
Ditch running N to S at West side of Location .

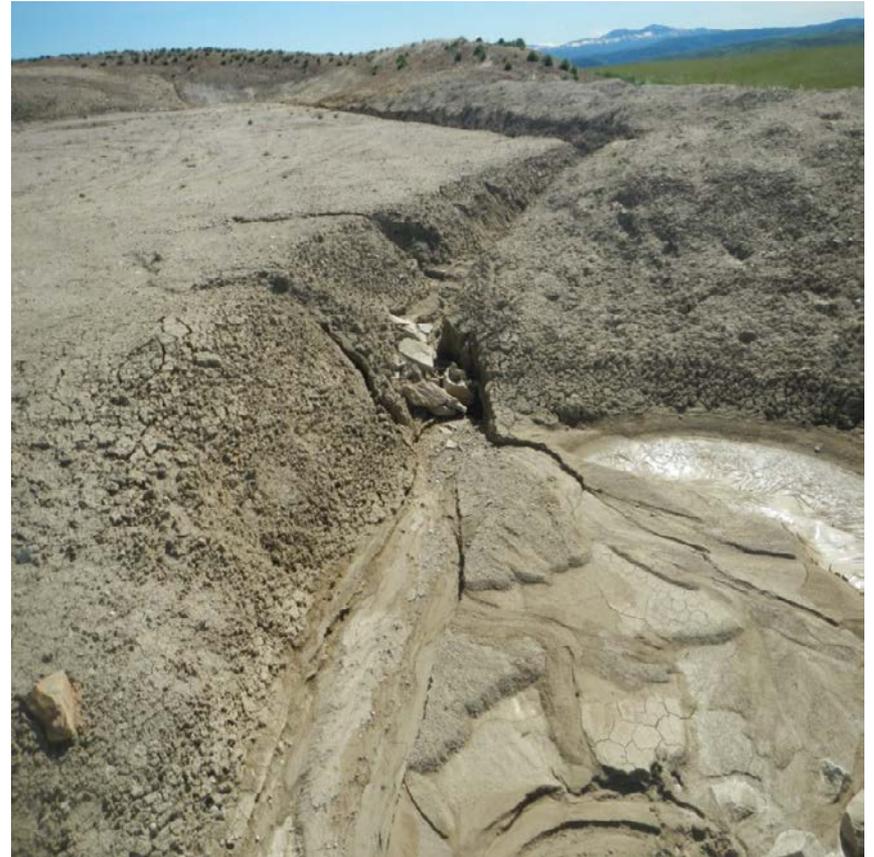
Photo#6:  
Sediment Run-Off from Pad to Ditch at SW corner

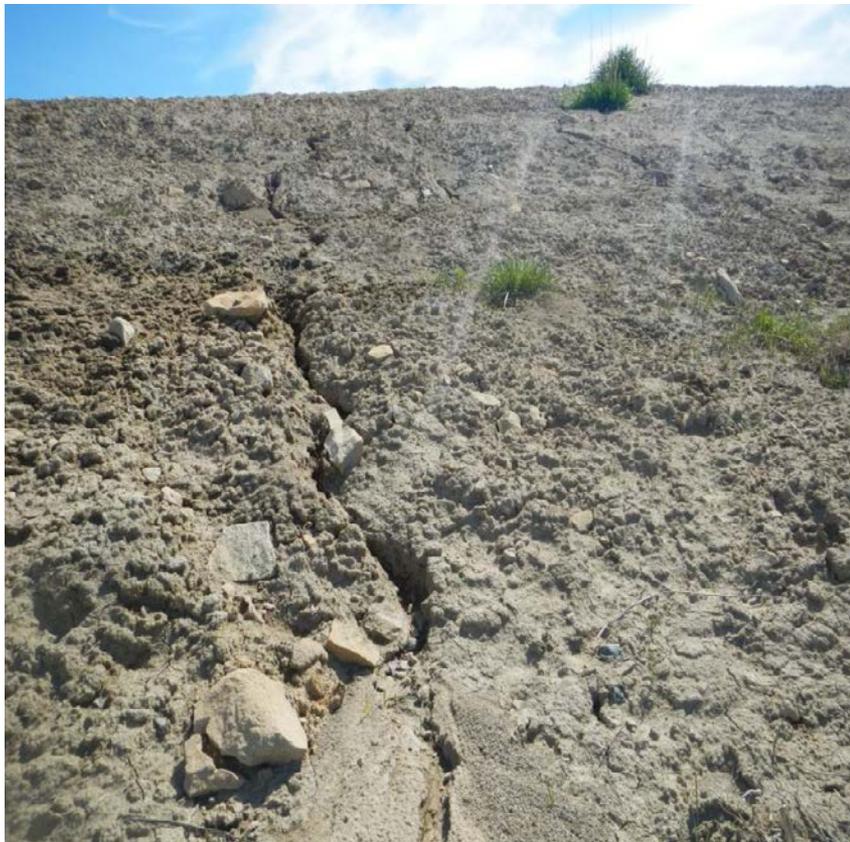
Photo#7:

Erosion commencing on Cut Slope

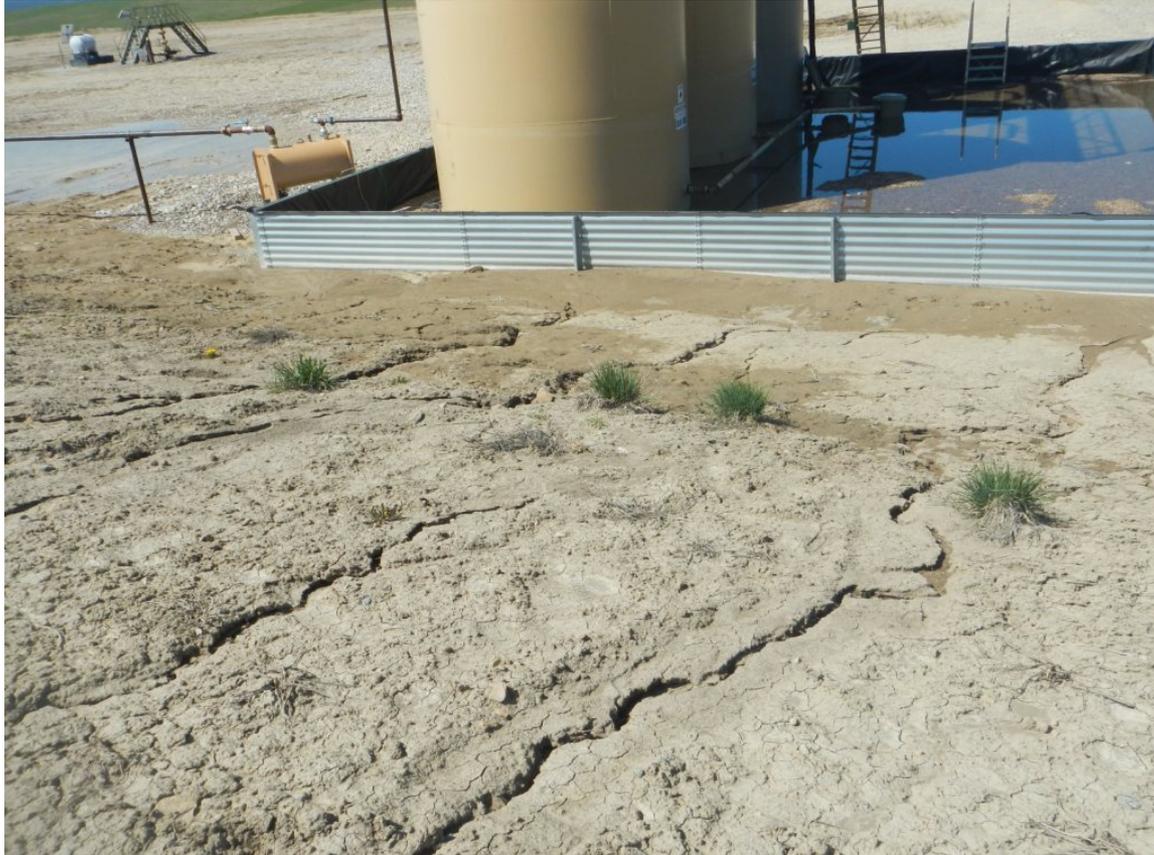
Photo#9: Erosion Rills and Run-On to Location from Cut Slope.

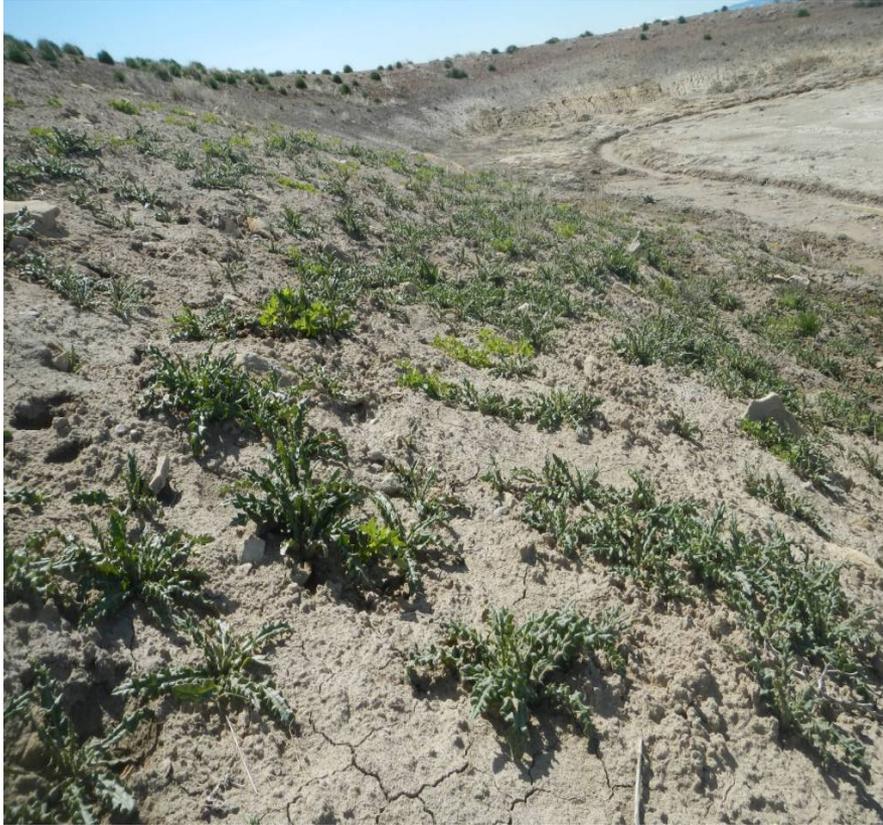
Photo#10:

Noxious Weed rosettes at Cut slope Area

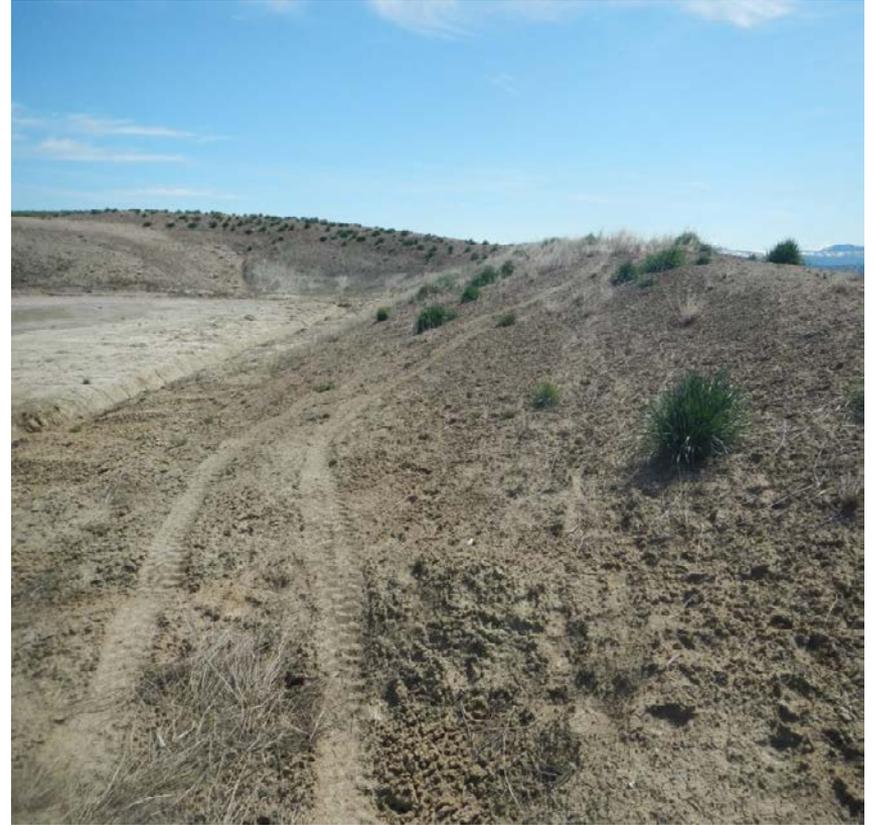
Photo#11:

ATV Incursion into Interim Vegetation areas.
