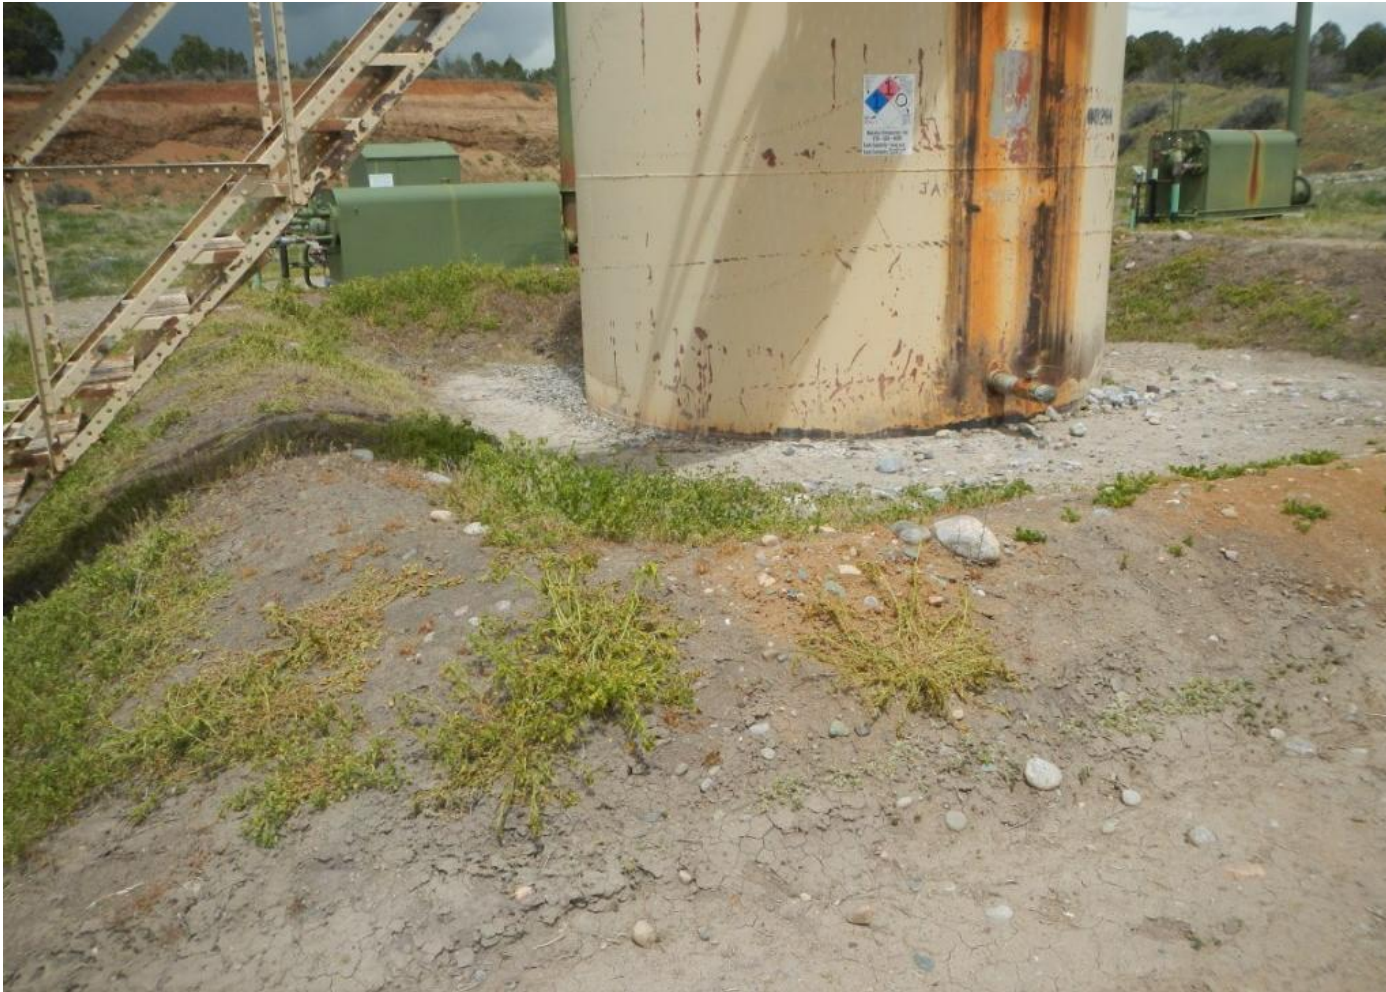
Photo 1. View of tank berm area. Weeds and pallet in the storage area have been removed. However weeds on the berm (some of which have recently been treated need to be removed).

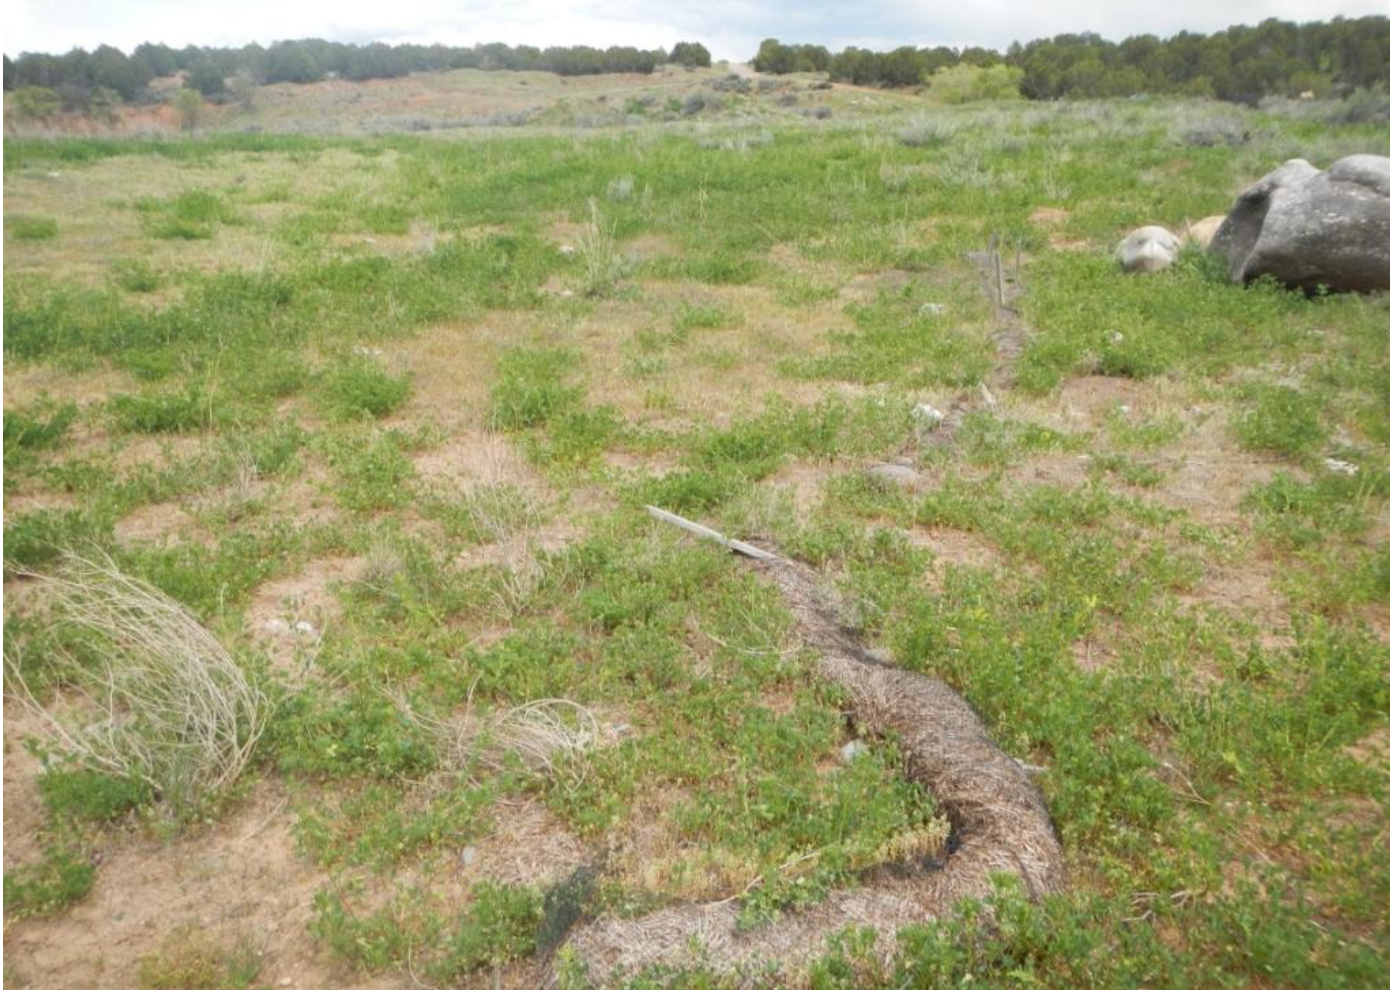
Photo 2. View of the southern portion of the project area from the southwestern corner facing eastward. Wattles are roughly the edge of the original disturbance on this edge.

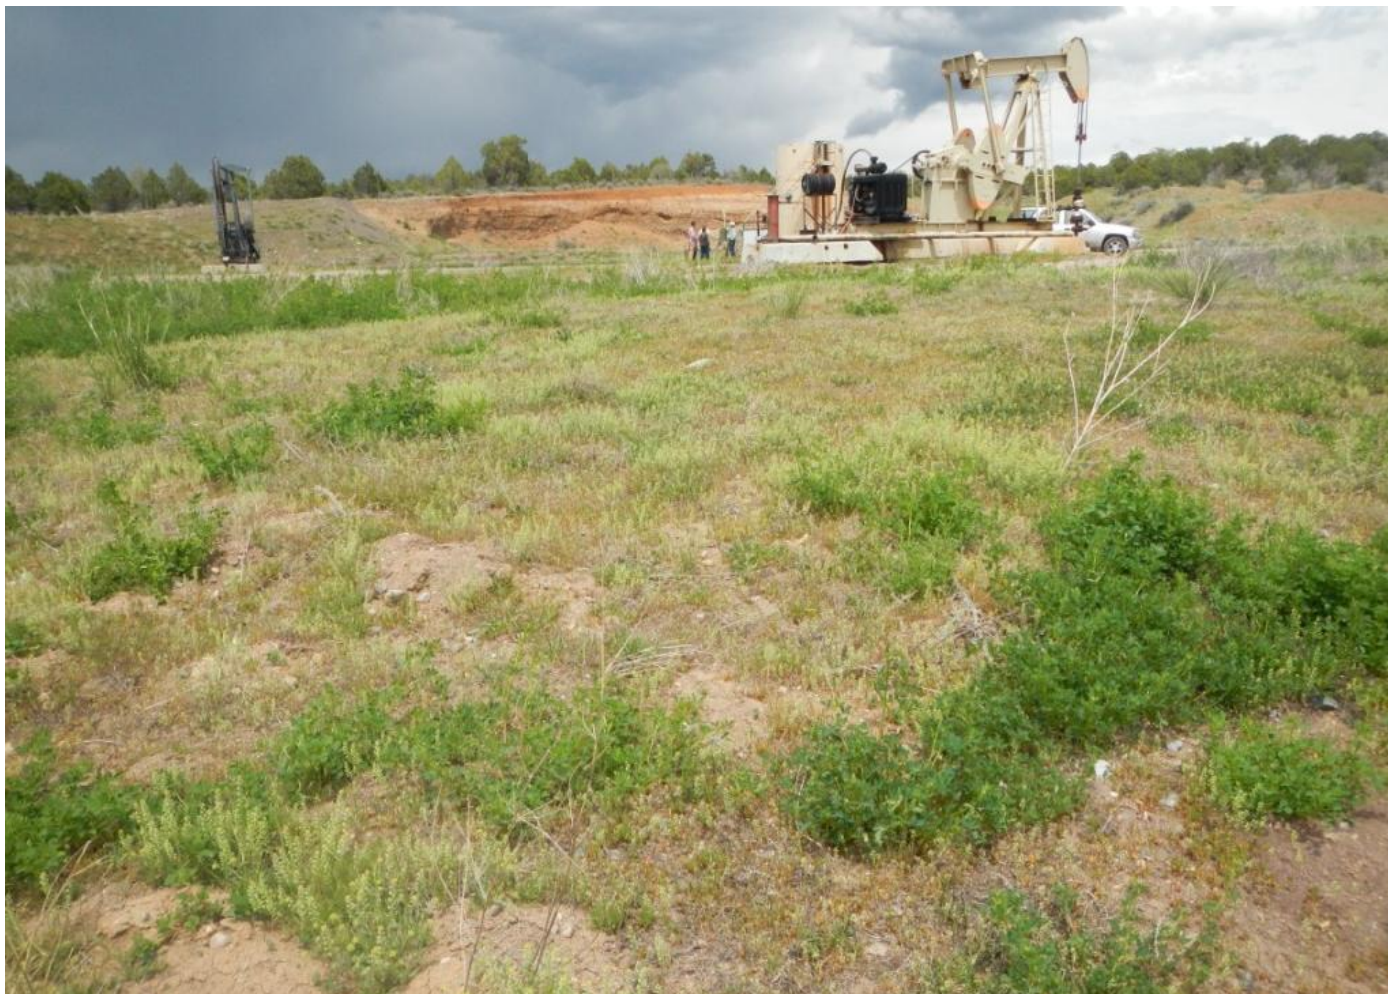
Photo 3. View of the project area from the southwestern corner facing center.

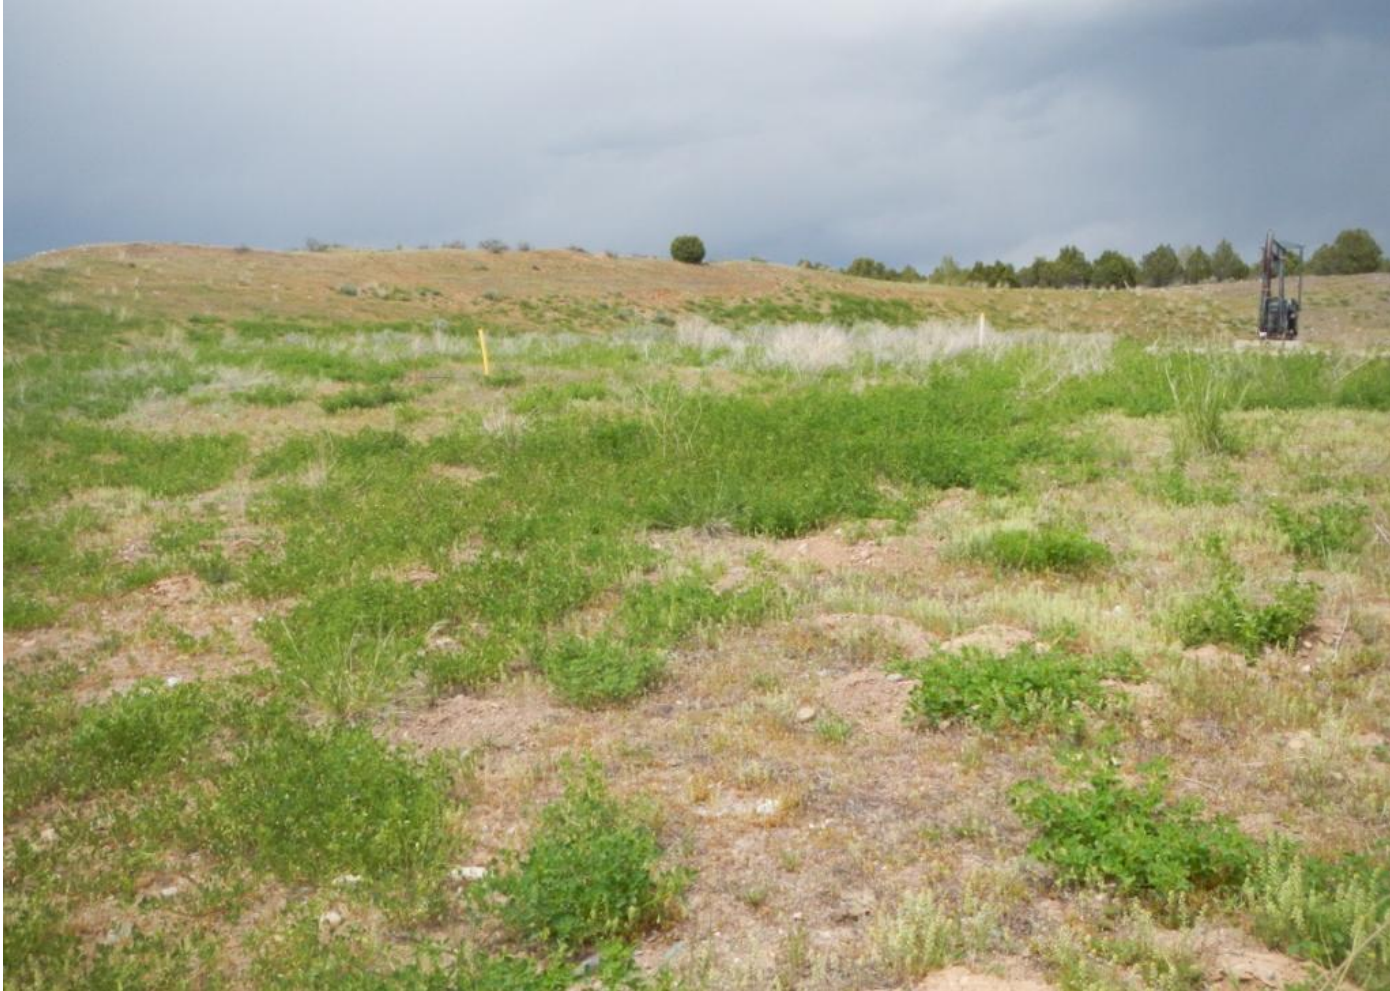
Photo 4. View of the western portion of the project area from the southwestern corner facing northeastward.

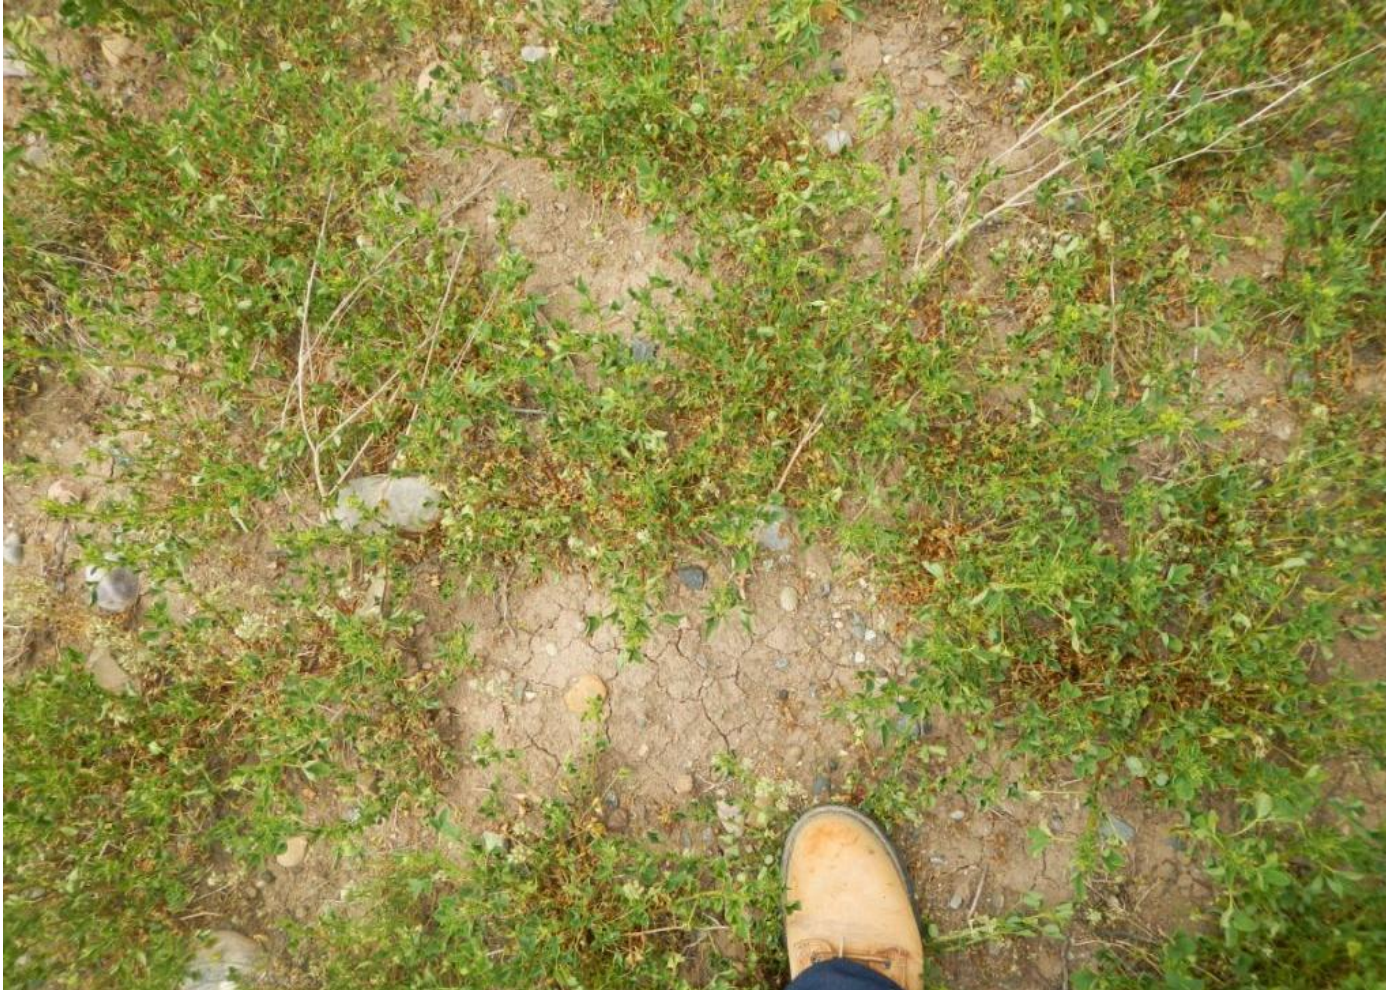
Photo 5. Typical birdseye view of vegetation within the interim reclamation area which is largely yellow clover (*Melilous officinalis*). Vegetation throughout the project area is largely weeds such as yellow clover, cheatgrass (*Bromus tectorum*), Russian thistle (*Salsola tragus*). Some sparse native vegetation such as rubber rabbitbrush (*Chrysothamnus nauseosus*), Indian ricegrass (*Achnatherum hymenoides*), and three awn (*Aristida* sp.) are also present
