May 13, 2016

Inspection Photos: Vaughn Orphan API#081-05332

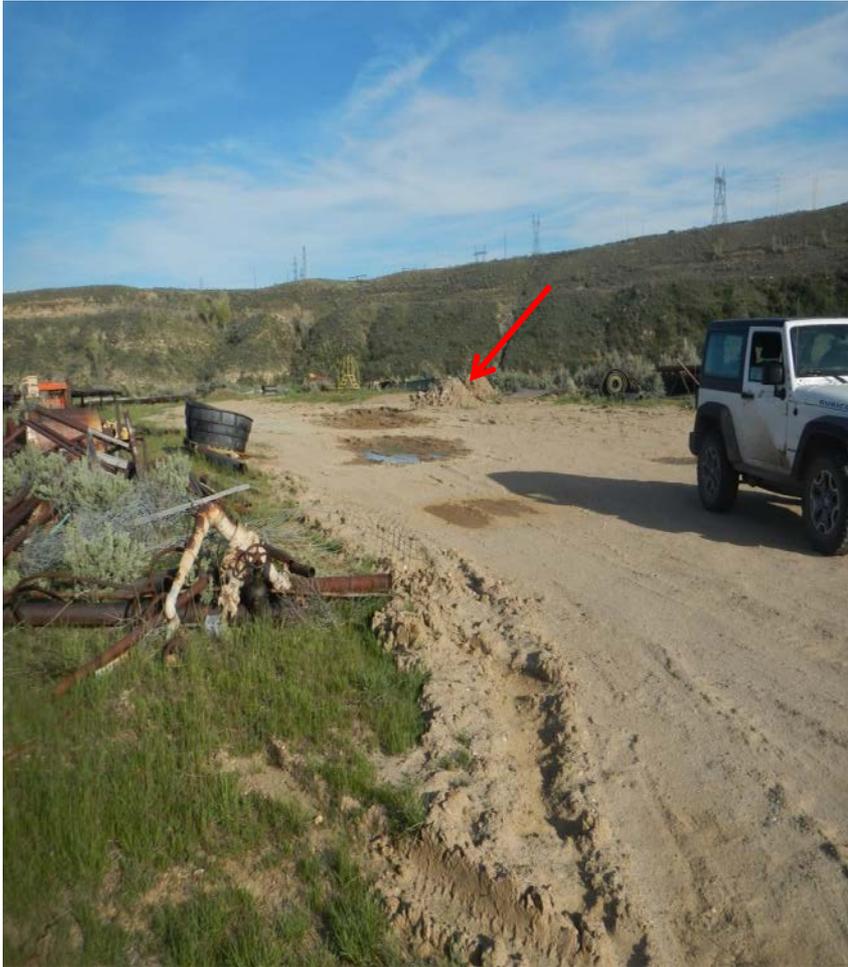
Photo#1:

View SE over Location.

Arrow marks site of plugging Procedures

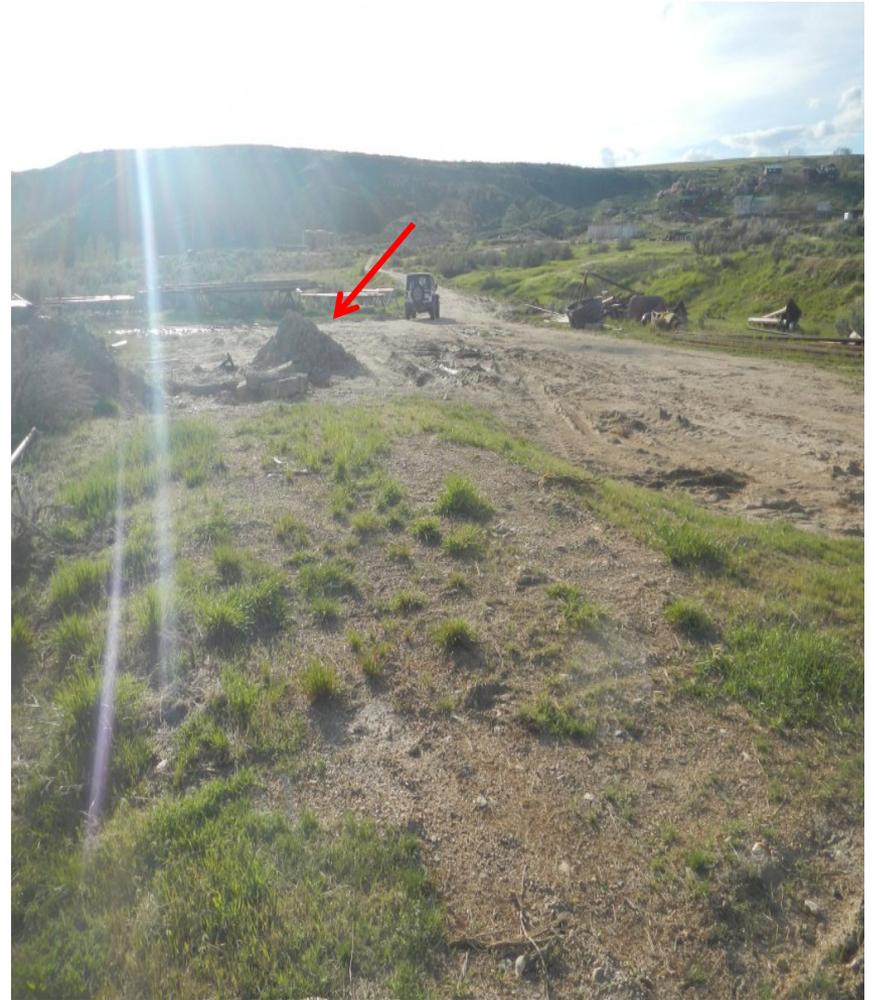
Photo#2:

View NW over Location .

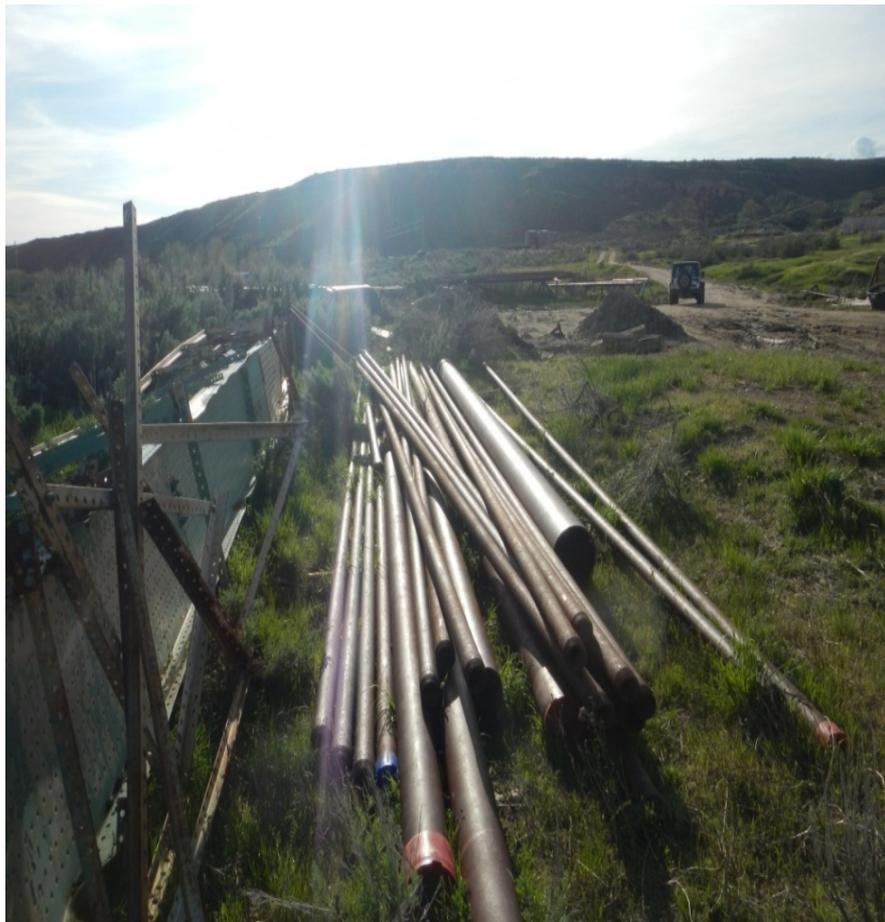
Photo#3:
View from SE Corner.

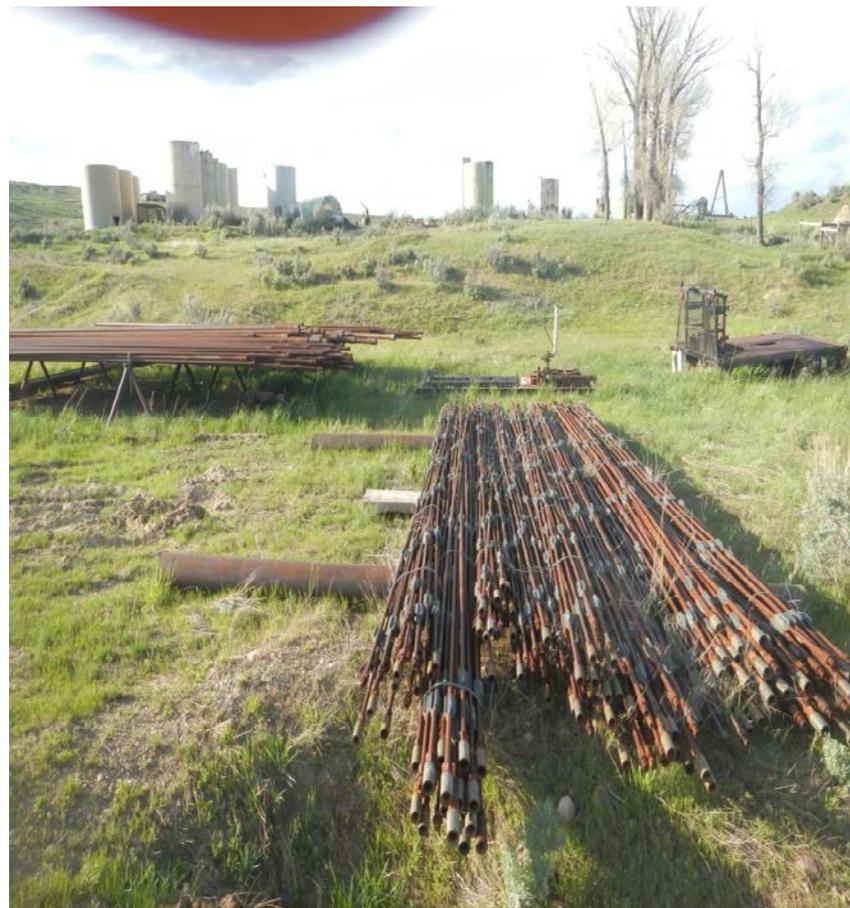
Photo#4:
View to NE from Location

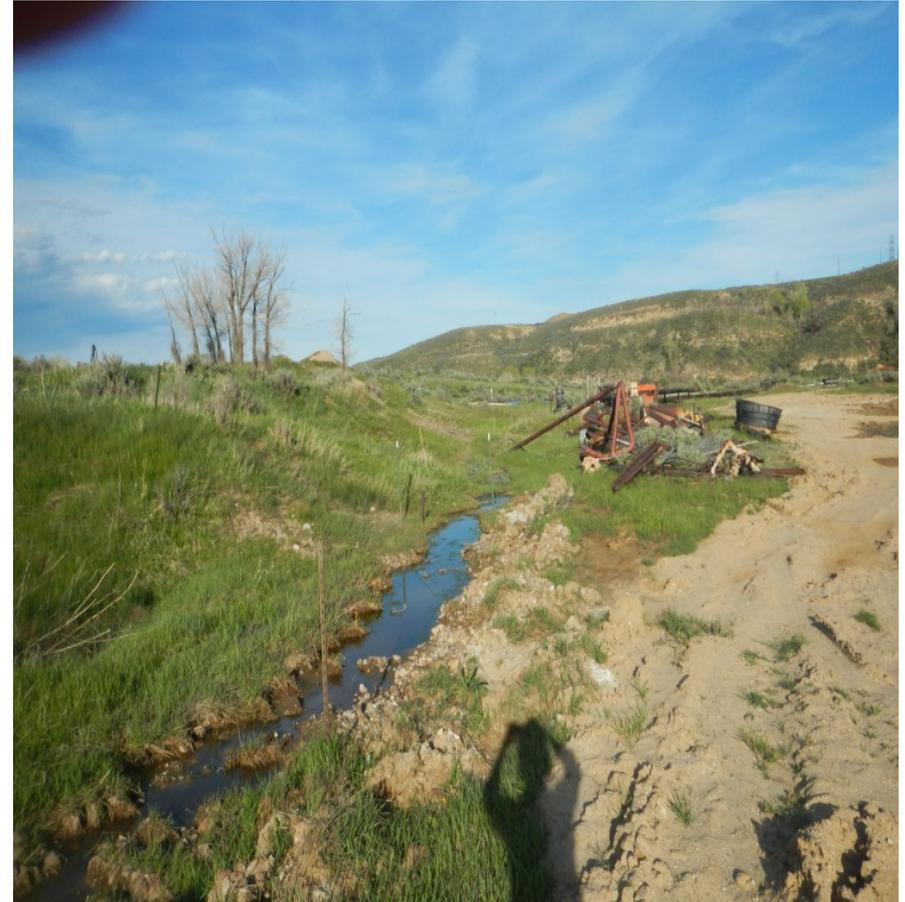
Photo#6:

Location receives run –off water from Gravel Pits /Irrigation.

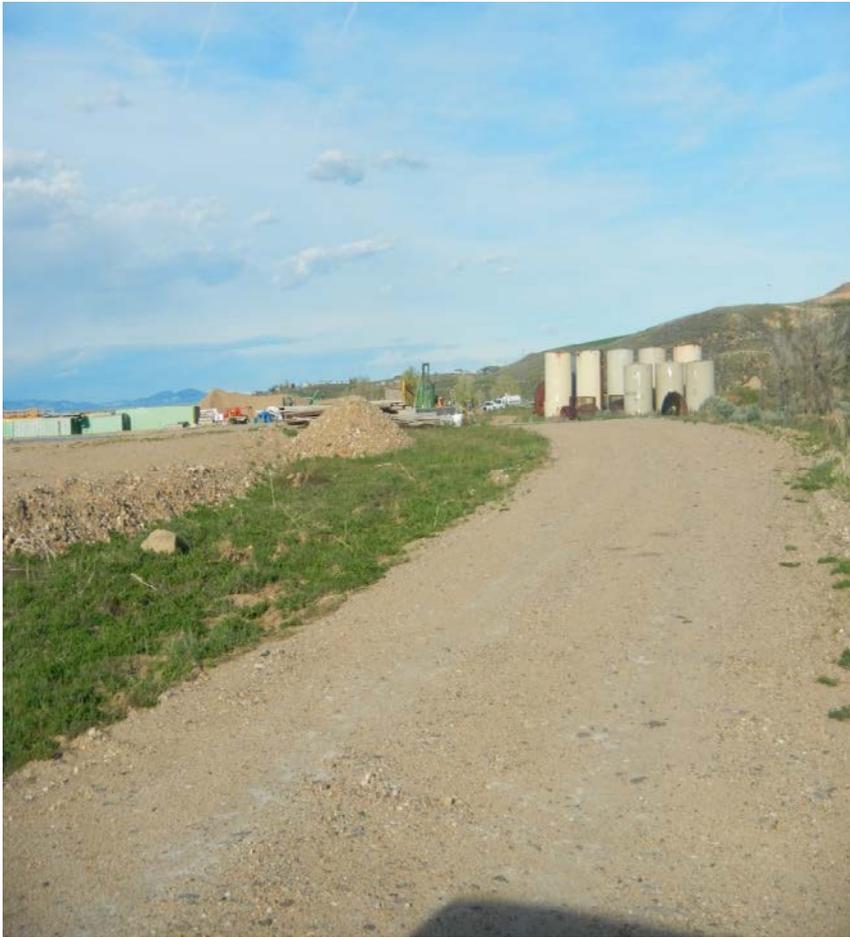
Photo#7:

Stored O&G Equipment surrounds Location.

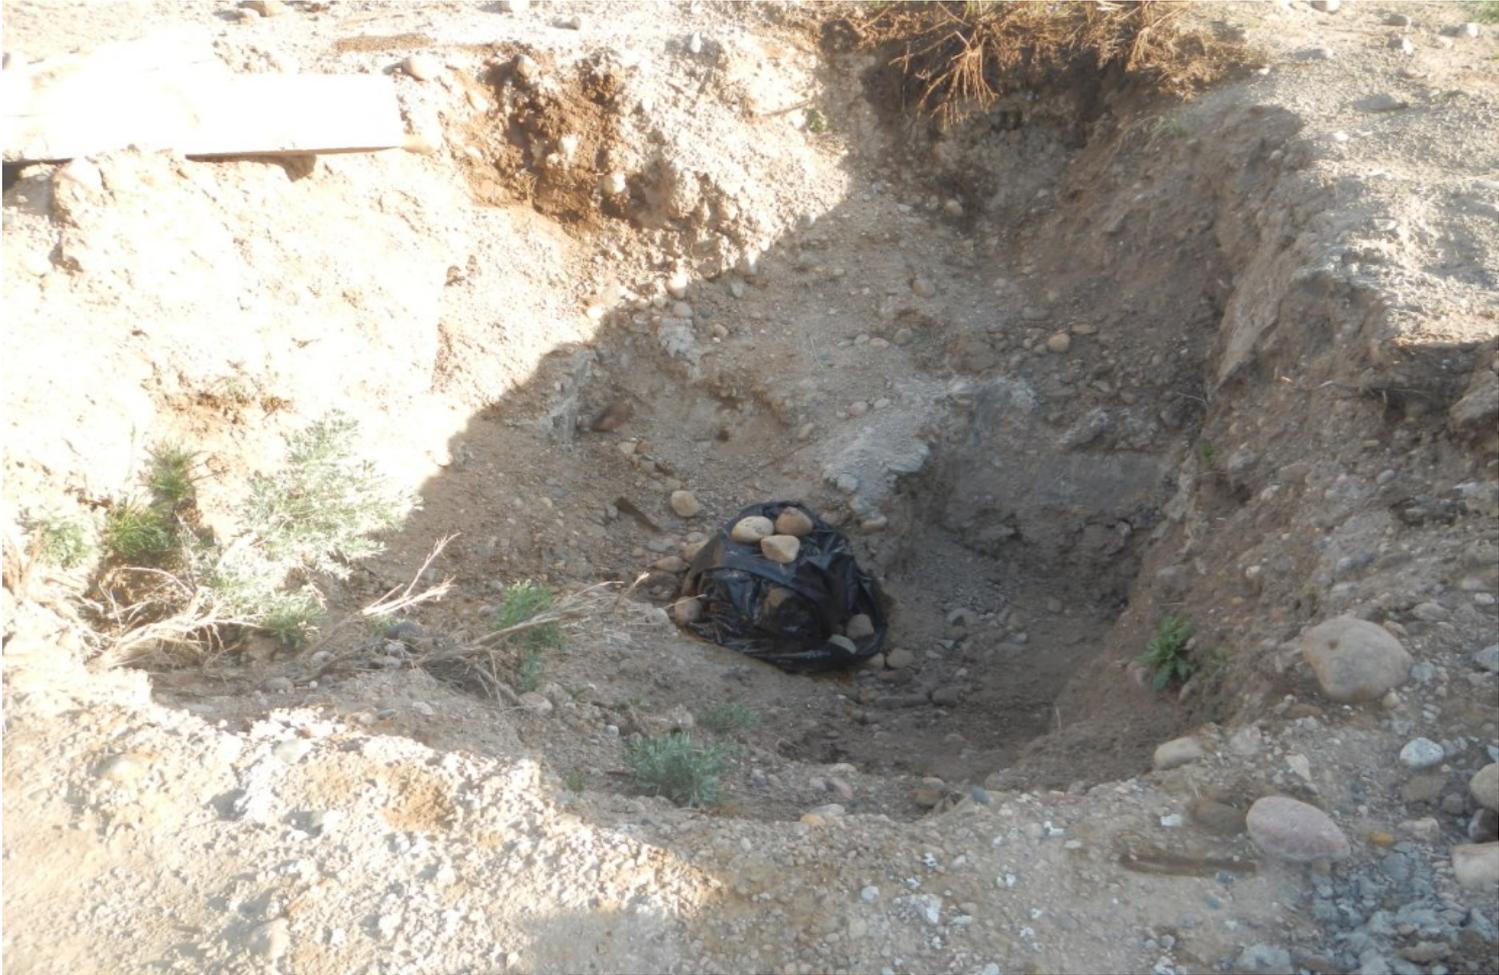
Well Condition 5/13/2016
