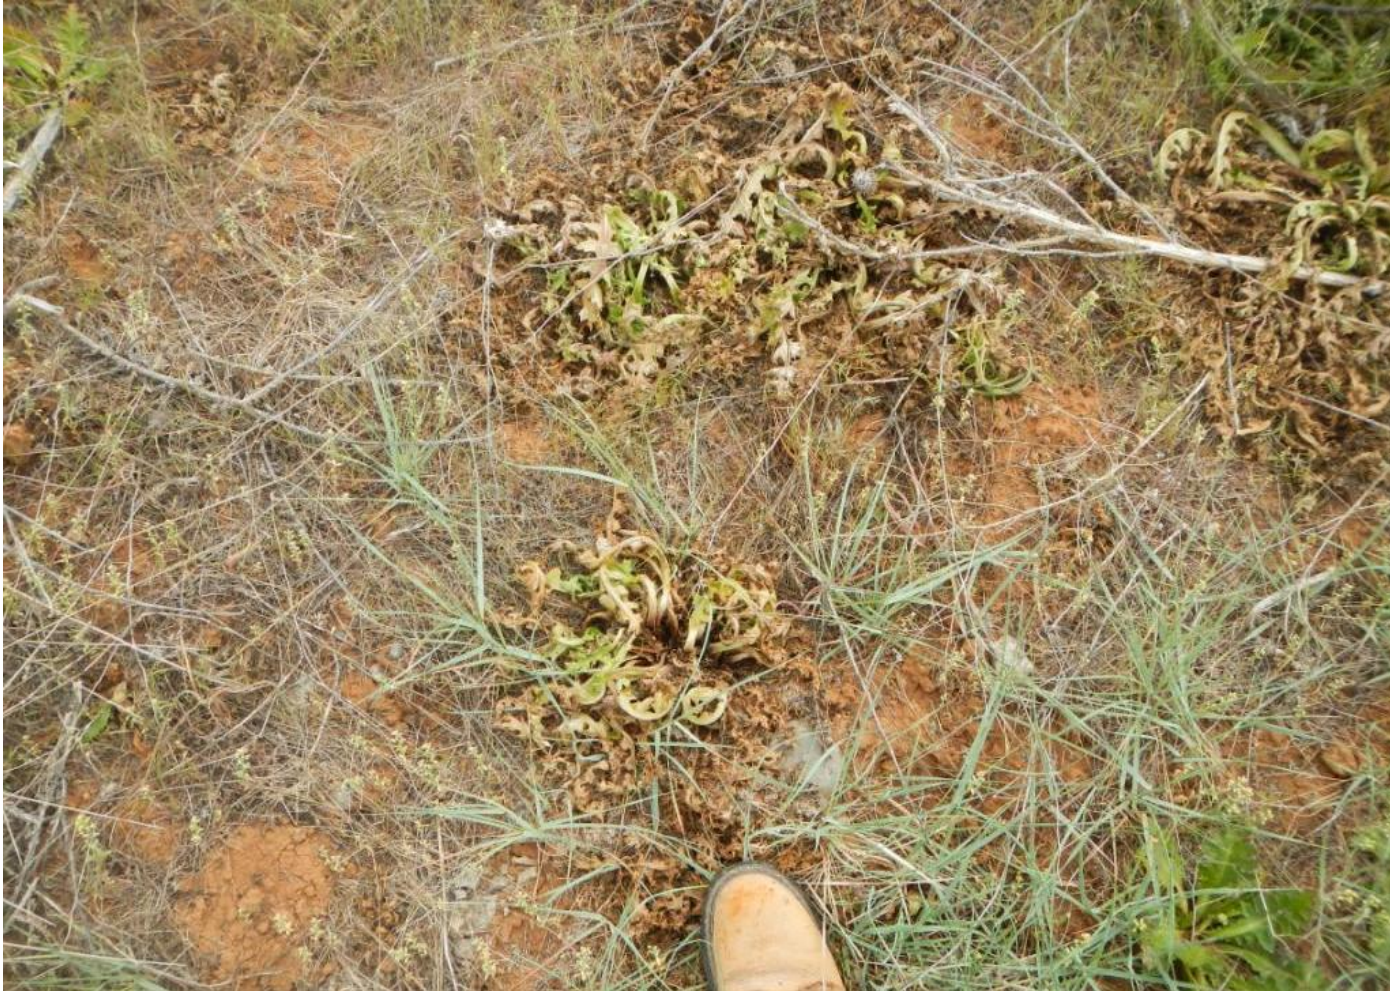
Photo 1. View of recently treated musk thistle within the interim reclamation area.

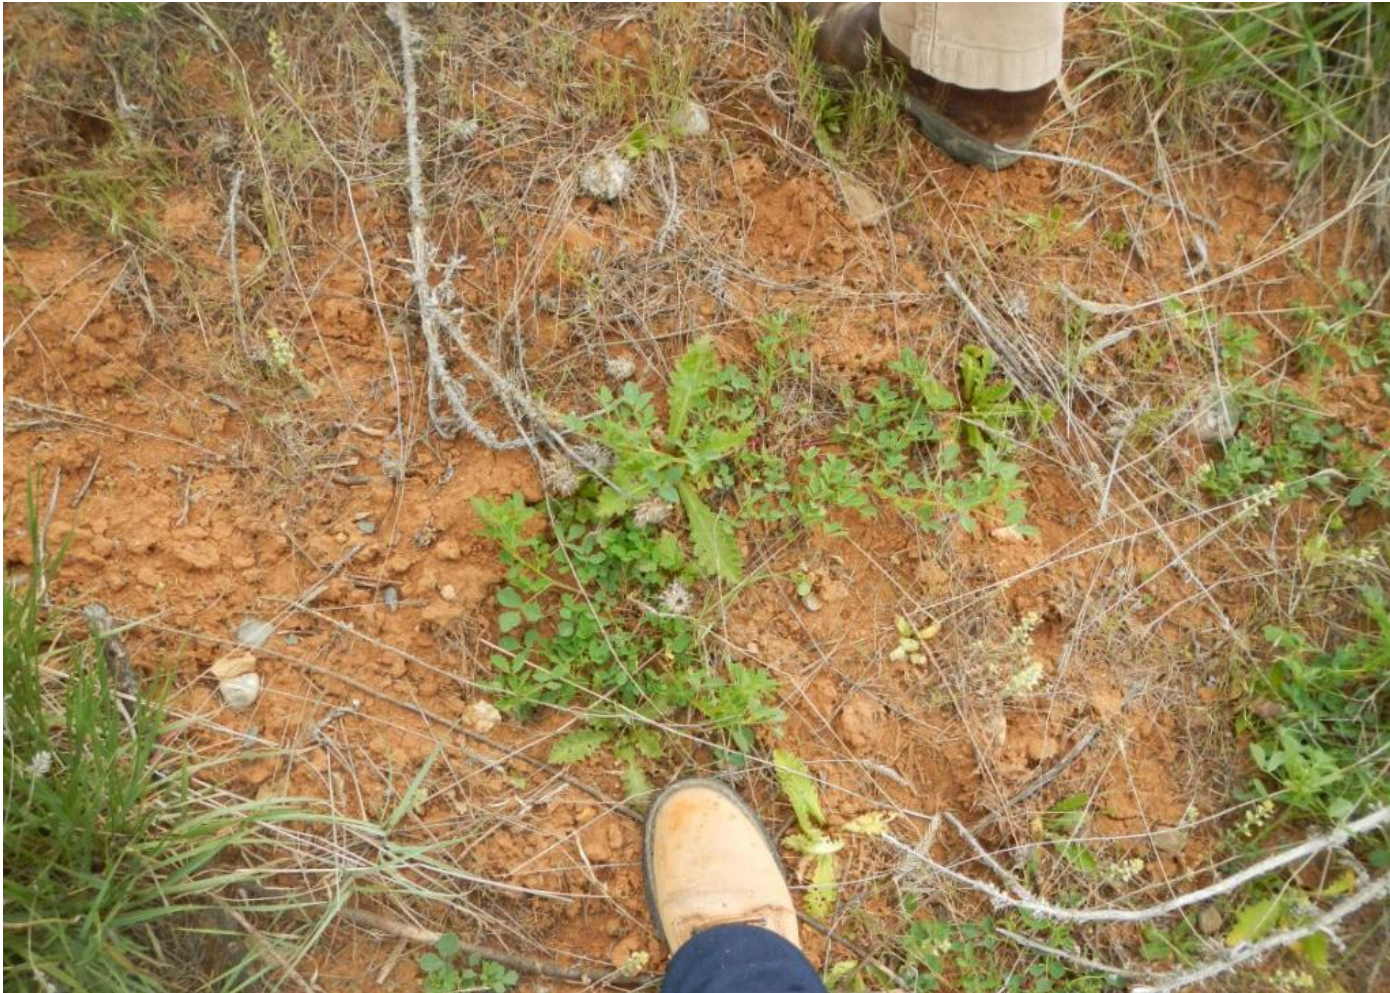
Photo 2. View of un-treated, young musk thistle plants within the interim reclamation area.

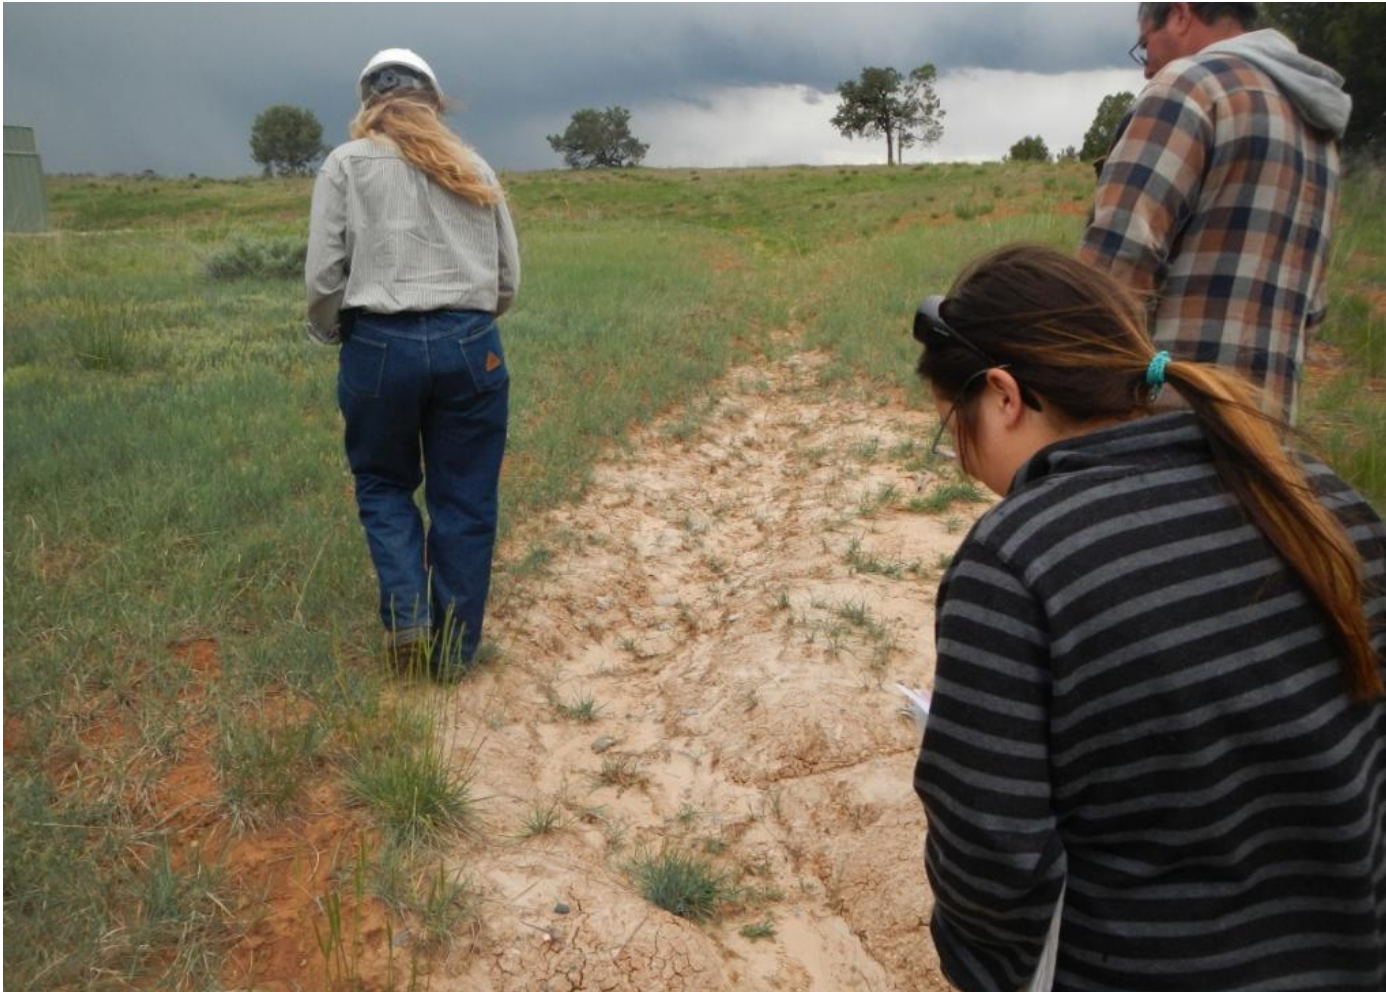
Photo 3. View of stormwater diversion along the western edge of the well pad that should have stormwater controls installed per 2015 inspection.

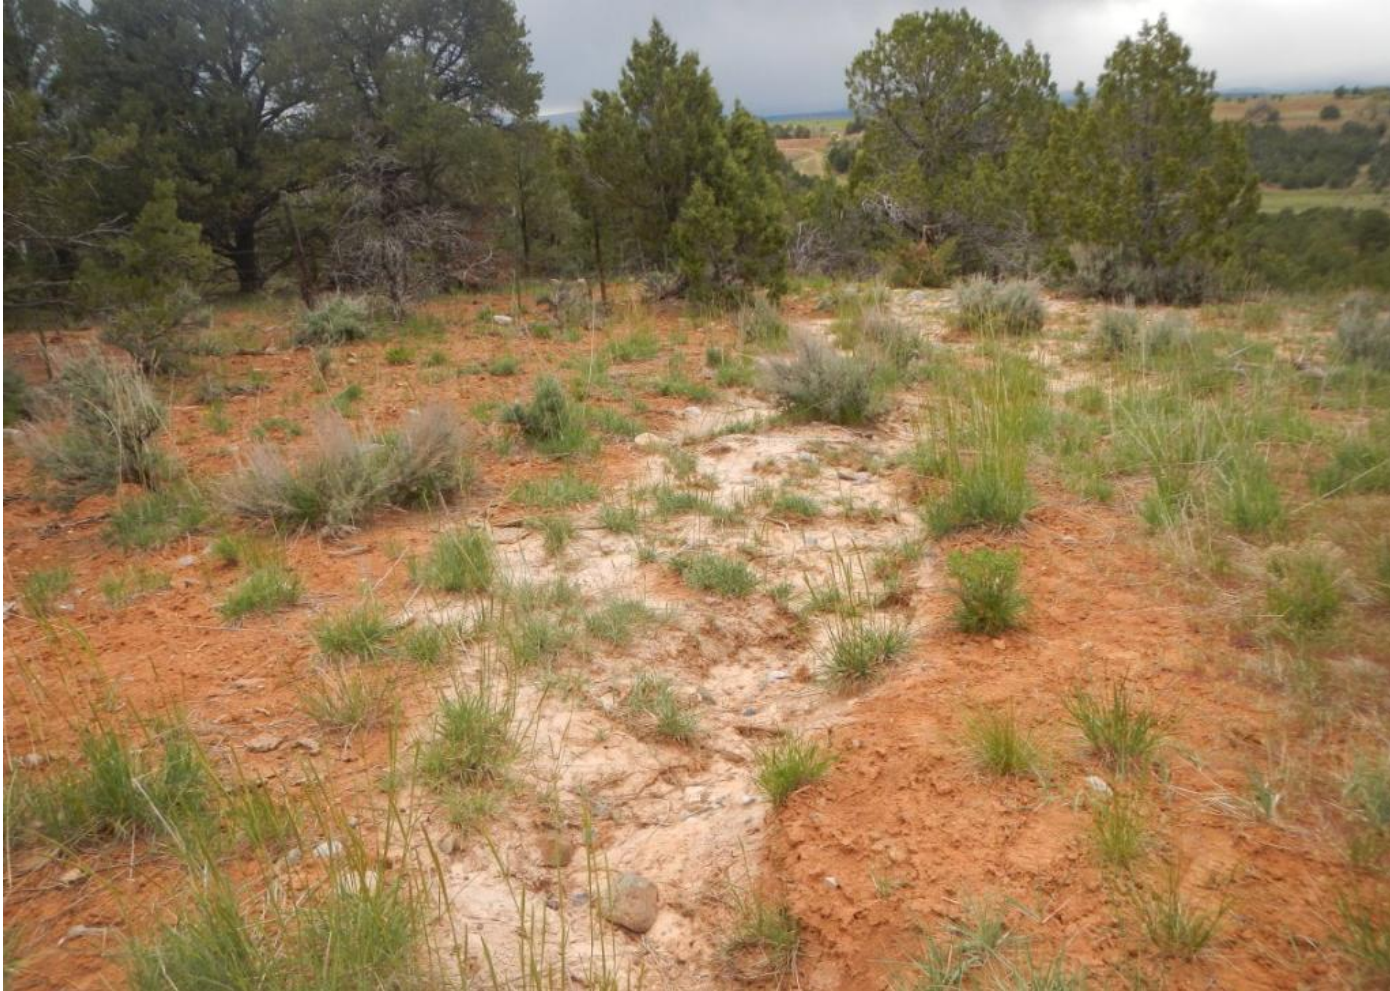
Photo 4. Downstream view of diversion channel where it flows off of the northwestern corner of the project area and stormwater controls are needed to de-energize flows.
