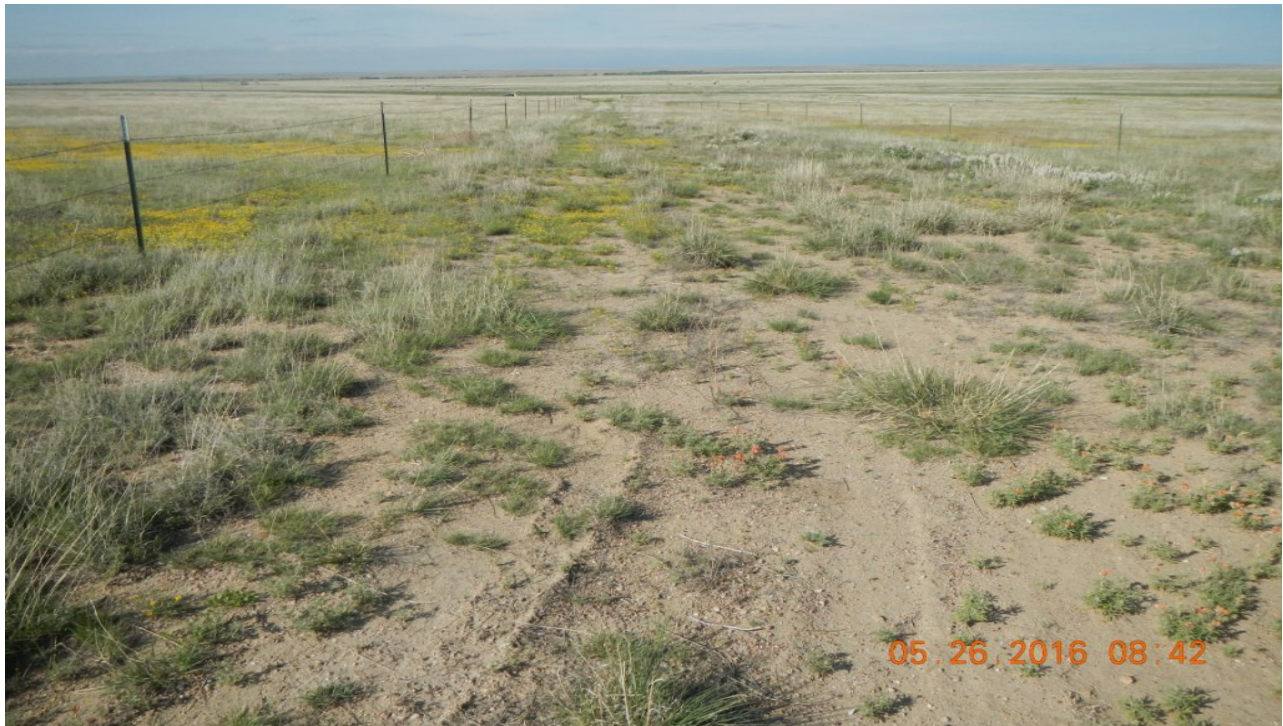
photo 1: Facing southwest along fence area of the former access road.

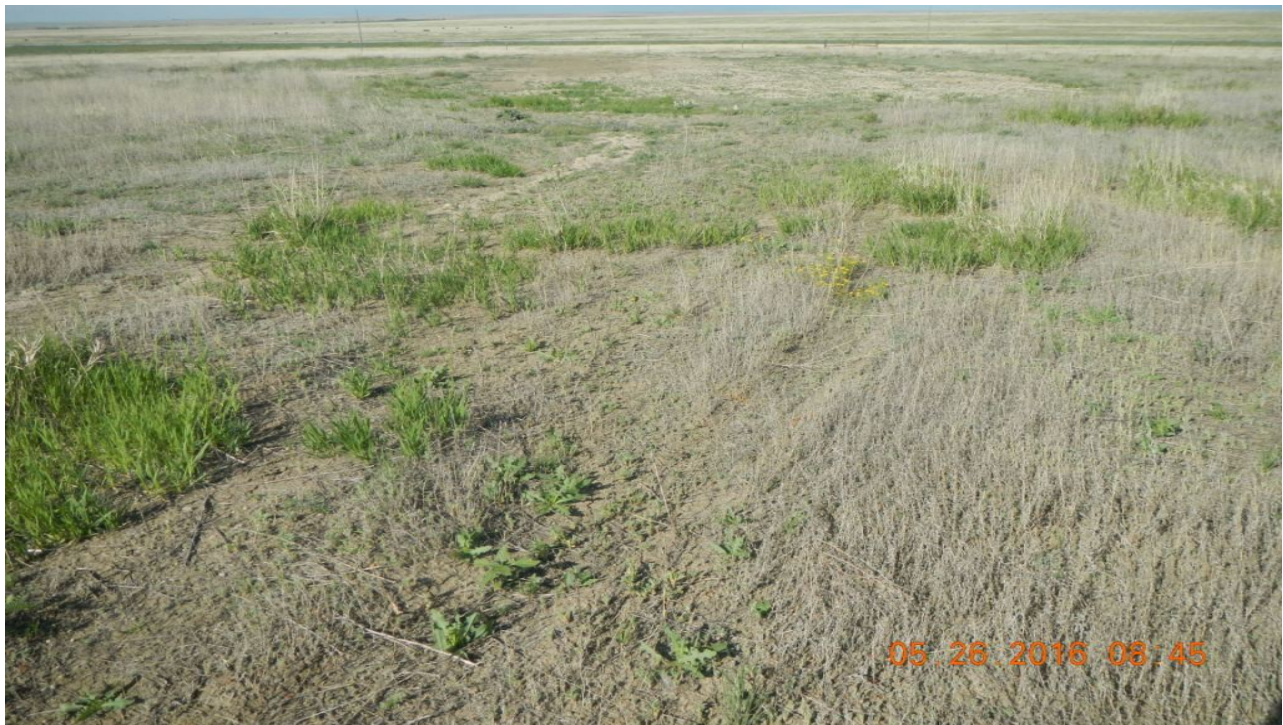
photo 2: Facing southwest at the location.

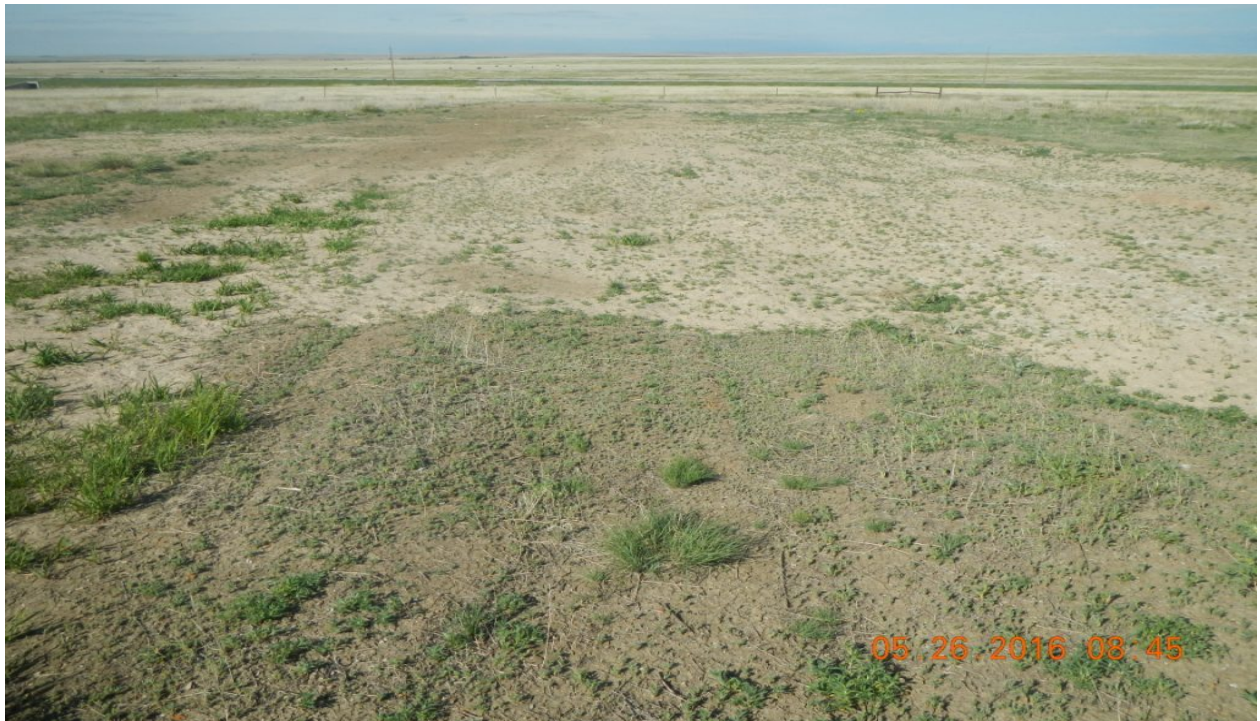
photo 3: The area at the center of the location where subsidence was observed in the previous inspection has been regraded.

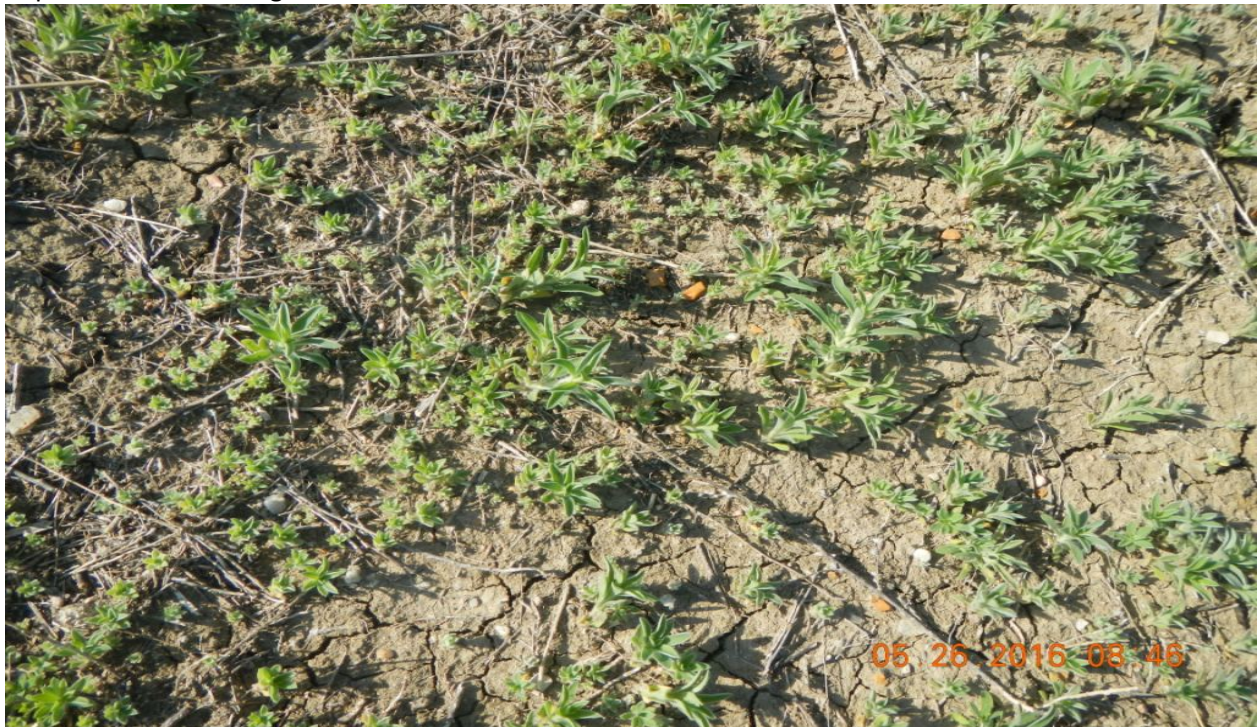
photo 4: Weed growth (Kochia) was noticed in areas of the location.

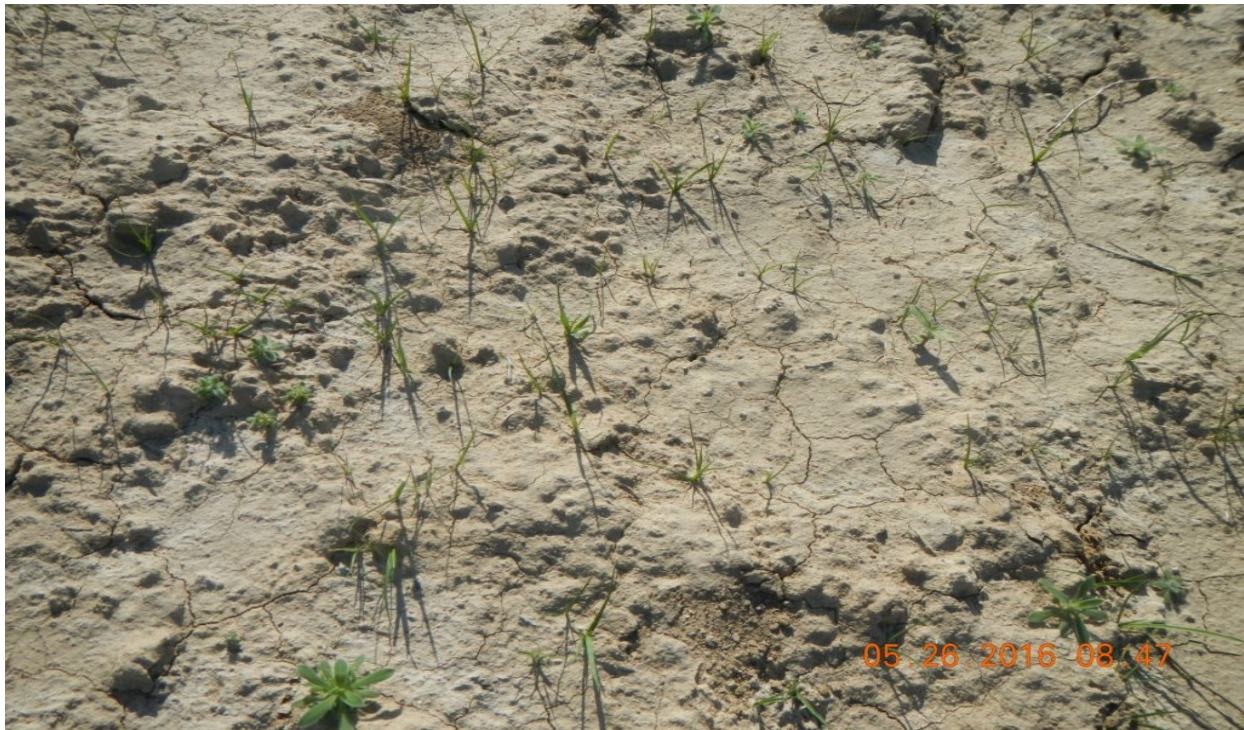
photo 5: There were areas where grass germination was noticed where the regrading occurred.

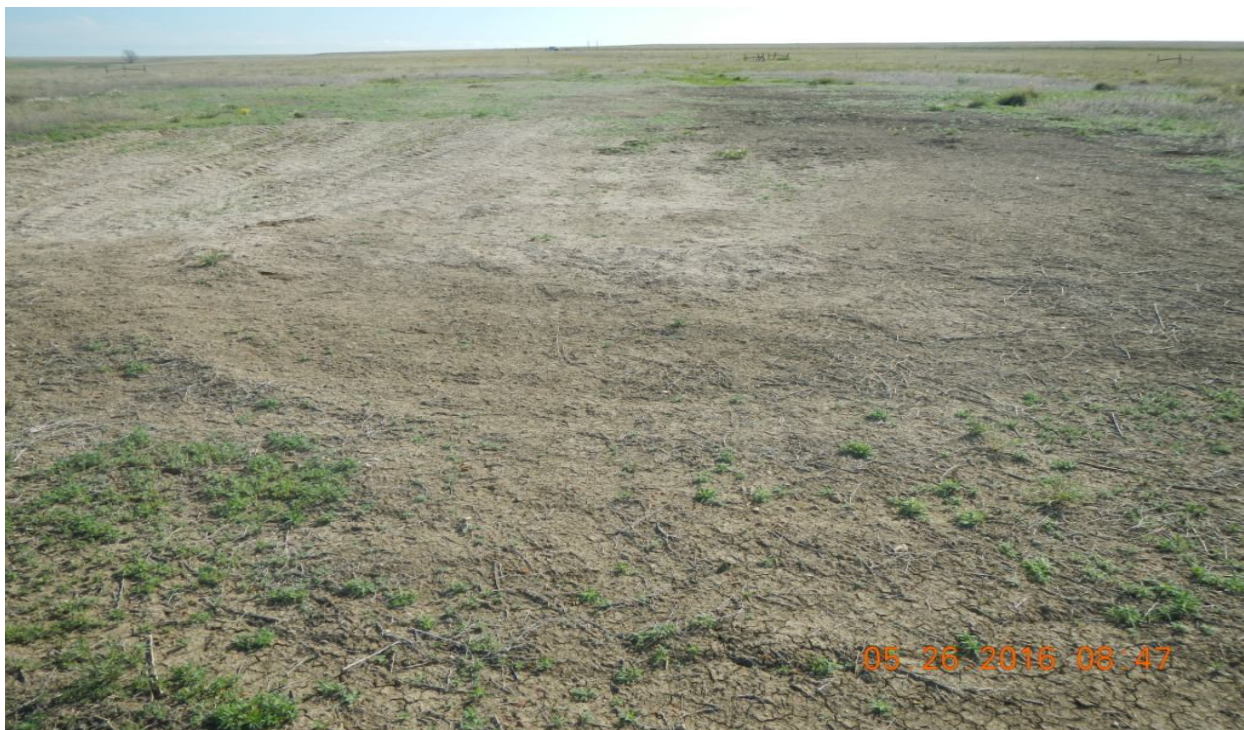
photo 6: Facing northeast toward the area which has recently been regraded.
