Interim Reclamation Inspection

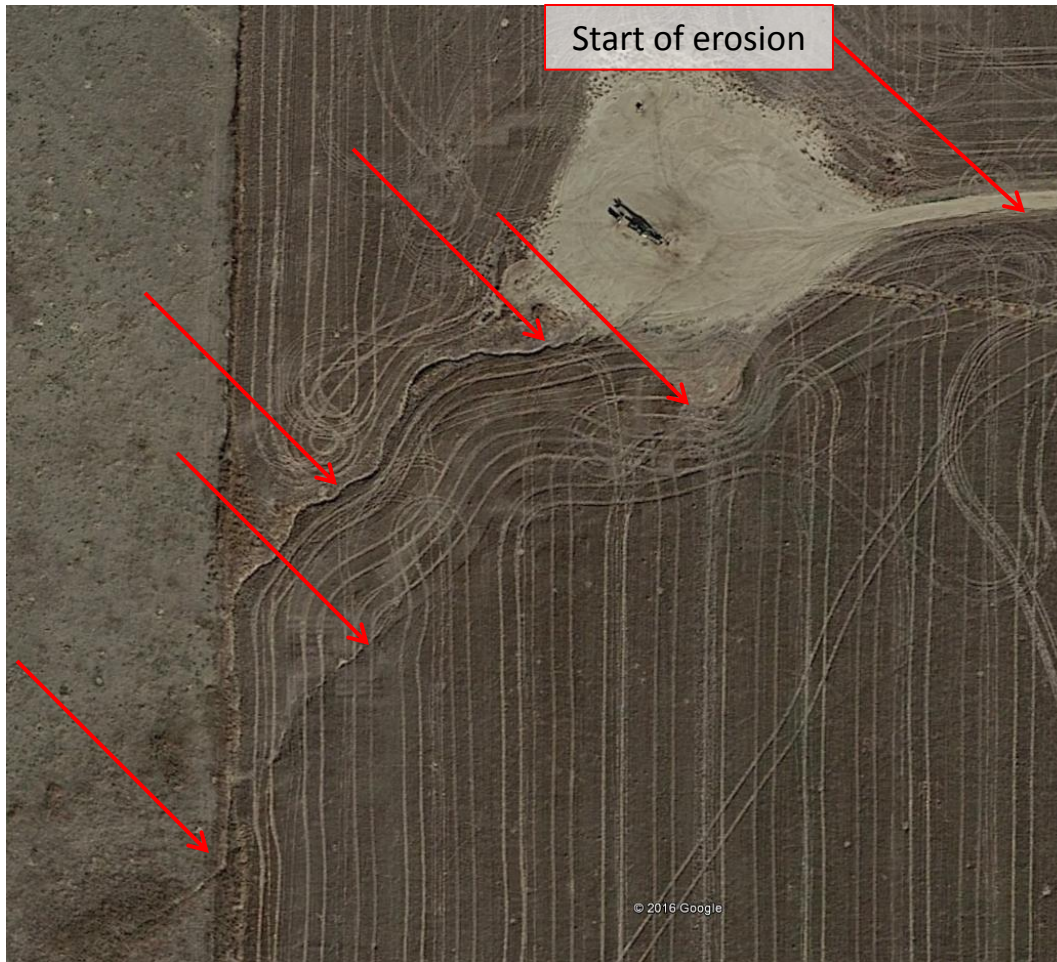
Photo 1. Google Earth aerial imagery taken 10/9/2015 illustrating erosion initiating from access road then continues onto well location and southwest onto adjacent lands.

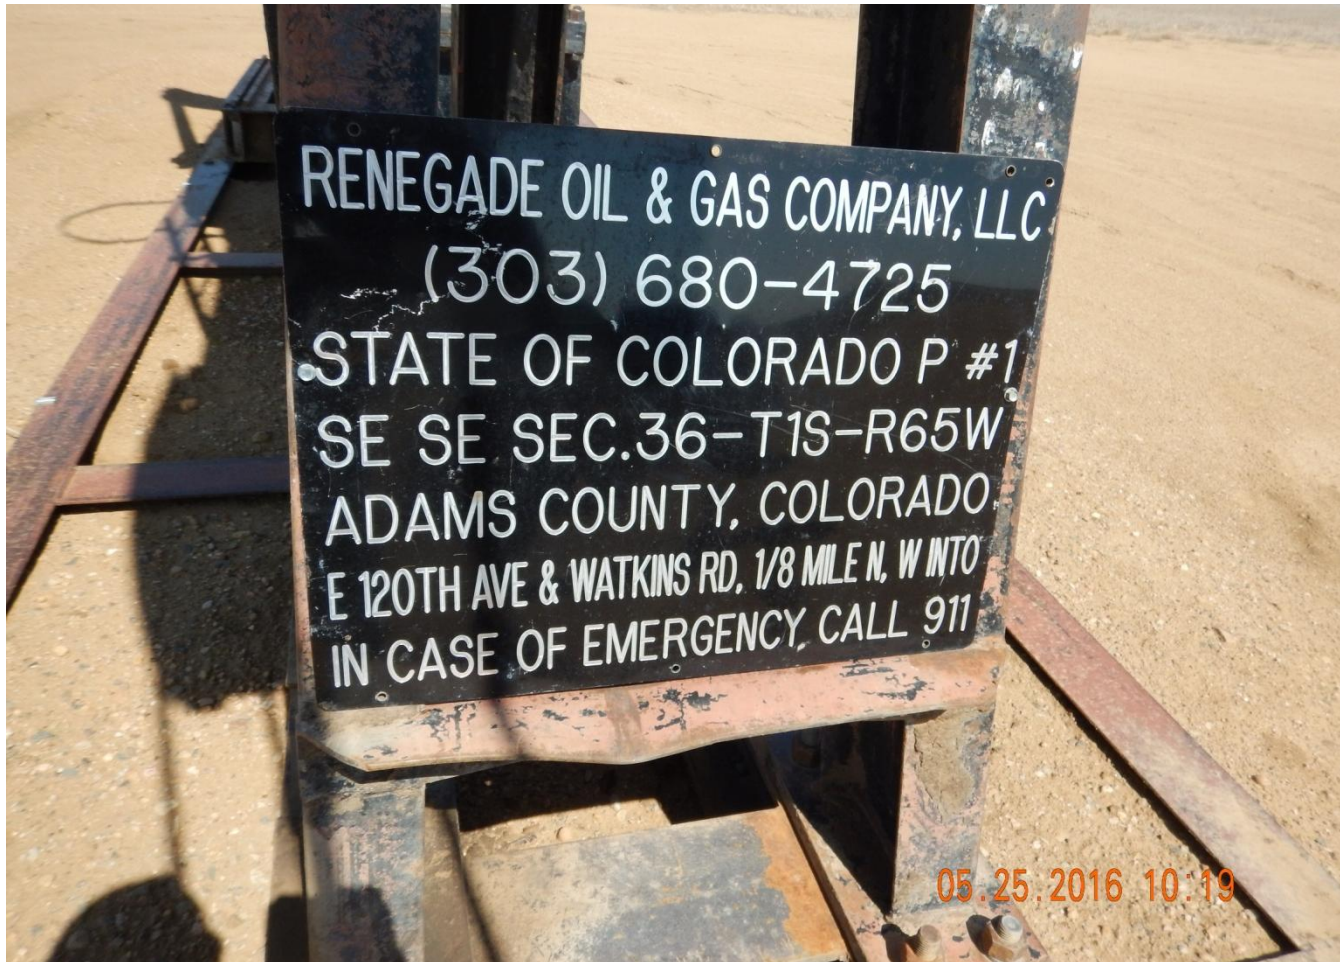
Photo 2. Photo taken of PR well sign for API #001-06321.

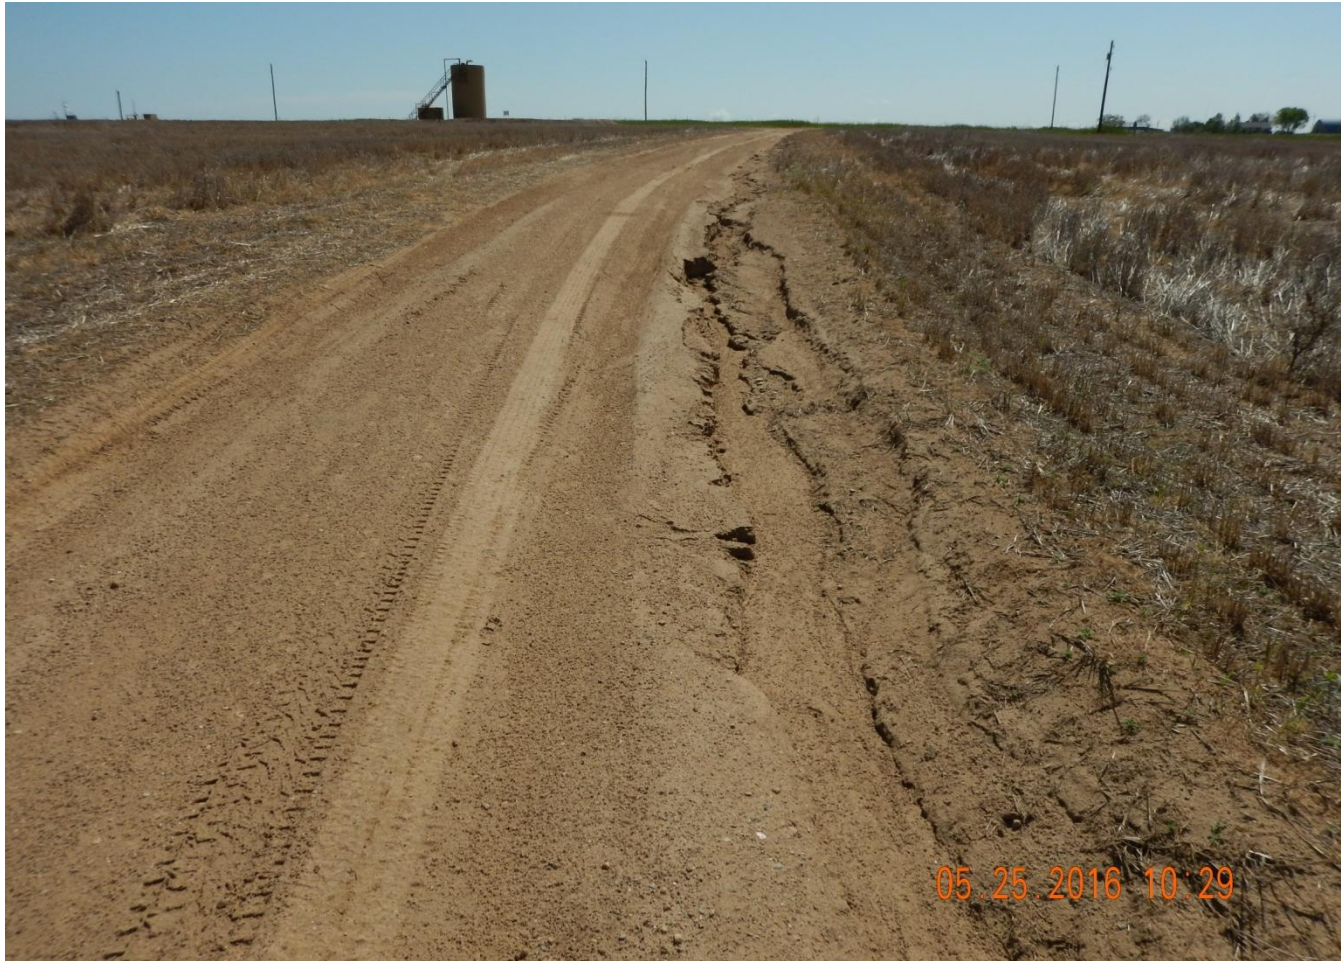
Photo 3. Photo taken from the well location, facing East along access road. Need to control stormwater runoff that minimizes erosion and transport of sediment offsite per Rule 1002. Erosion and transport of sediment initiates from access road then continues onto well location and southwest onto adjacent lands.

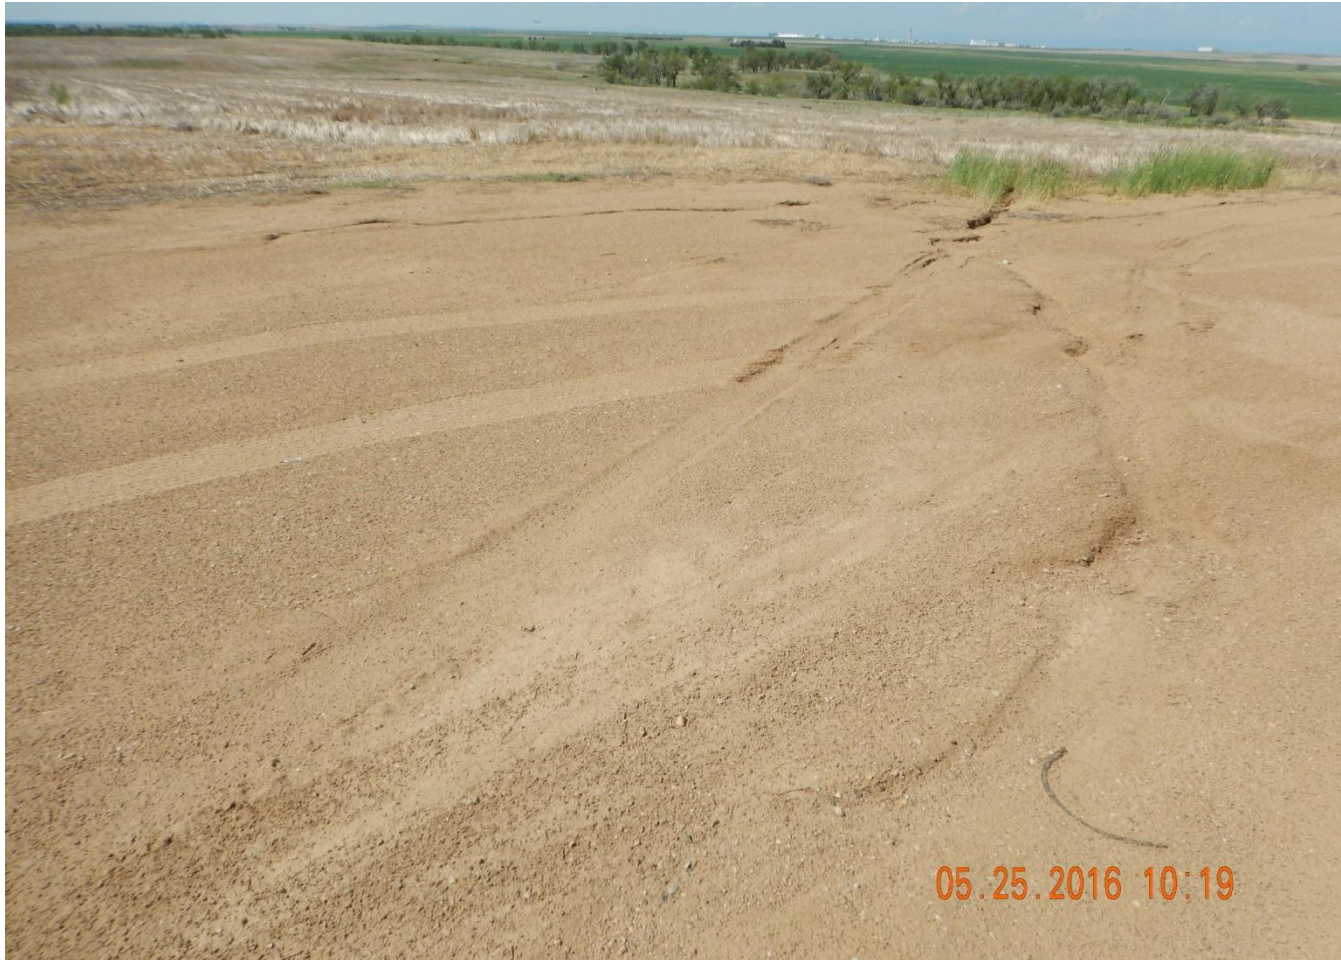
Photo 4. Photo taken from the well location, facing Southwest. Need to control stormwater runoff that minimizes erosion and transport of sediment offsite per Rule 1002. Erosion and transport of sediment initiates from access road then continues onto well location and southwest onto adjacent lands.

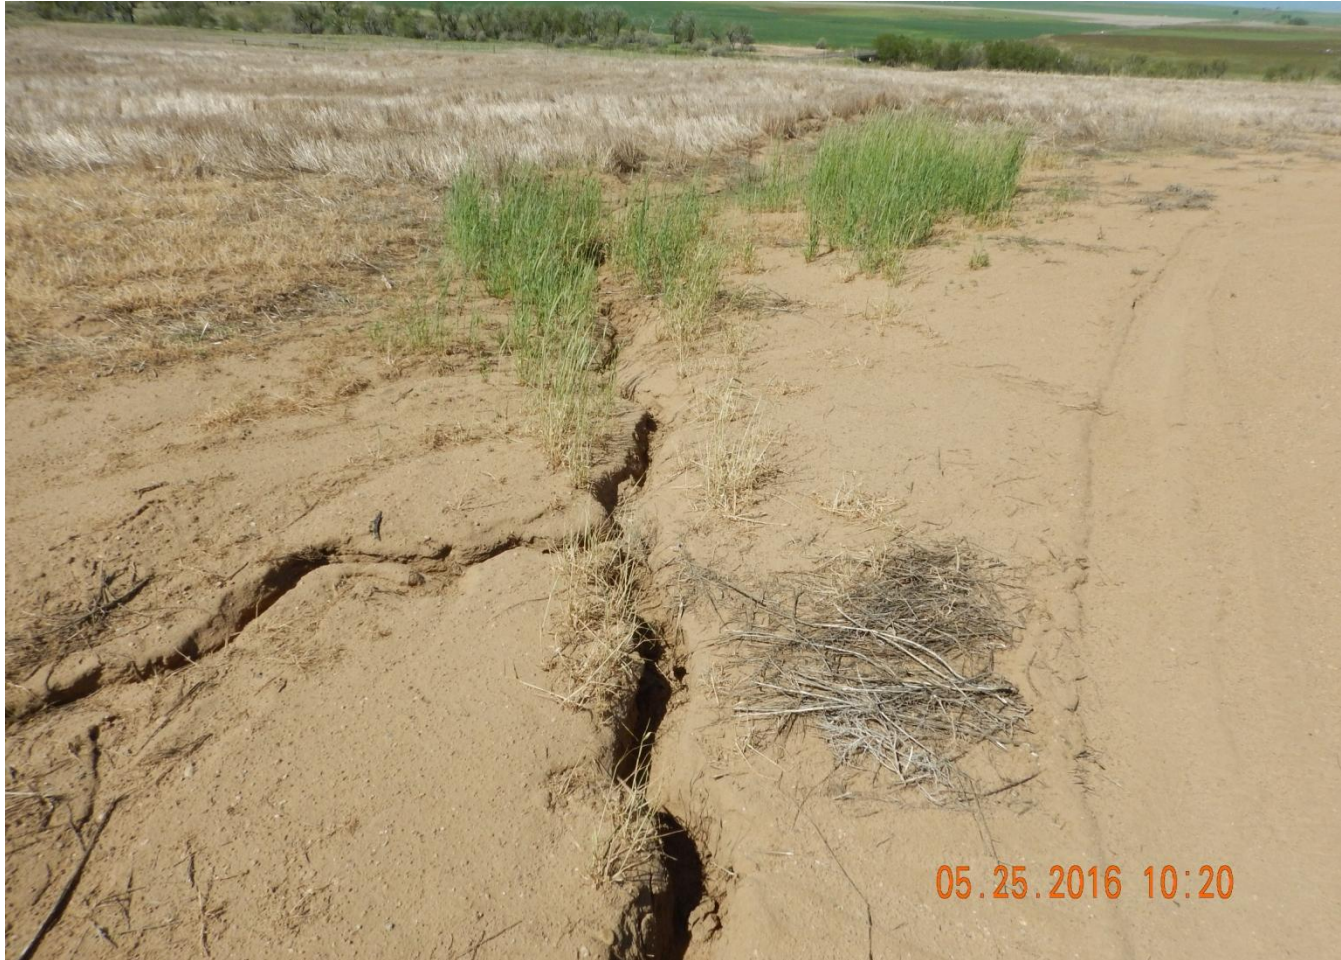
Photo 5. Photo taken from southwest well location, facing Southwest. Need to control stormwater runoff that minimizes erosion and transport of sediment offsite per Rule 1002. Gully erosion forming at well perimeter and continue to enlarge further southwest.

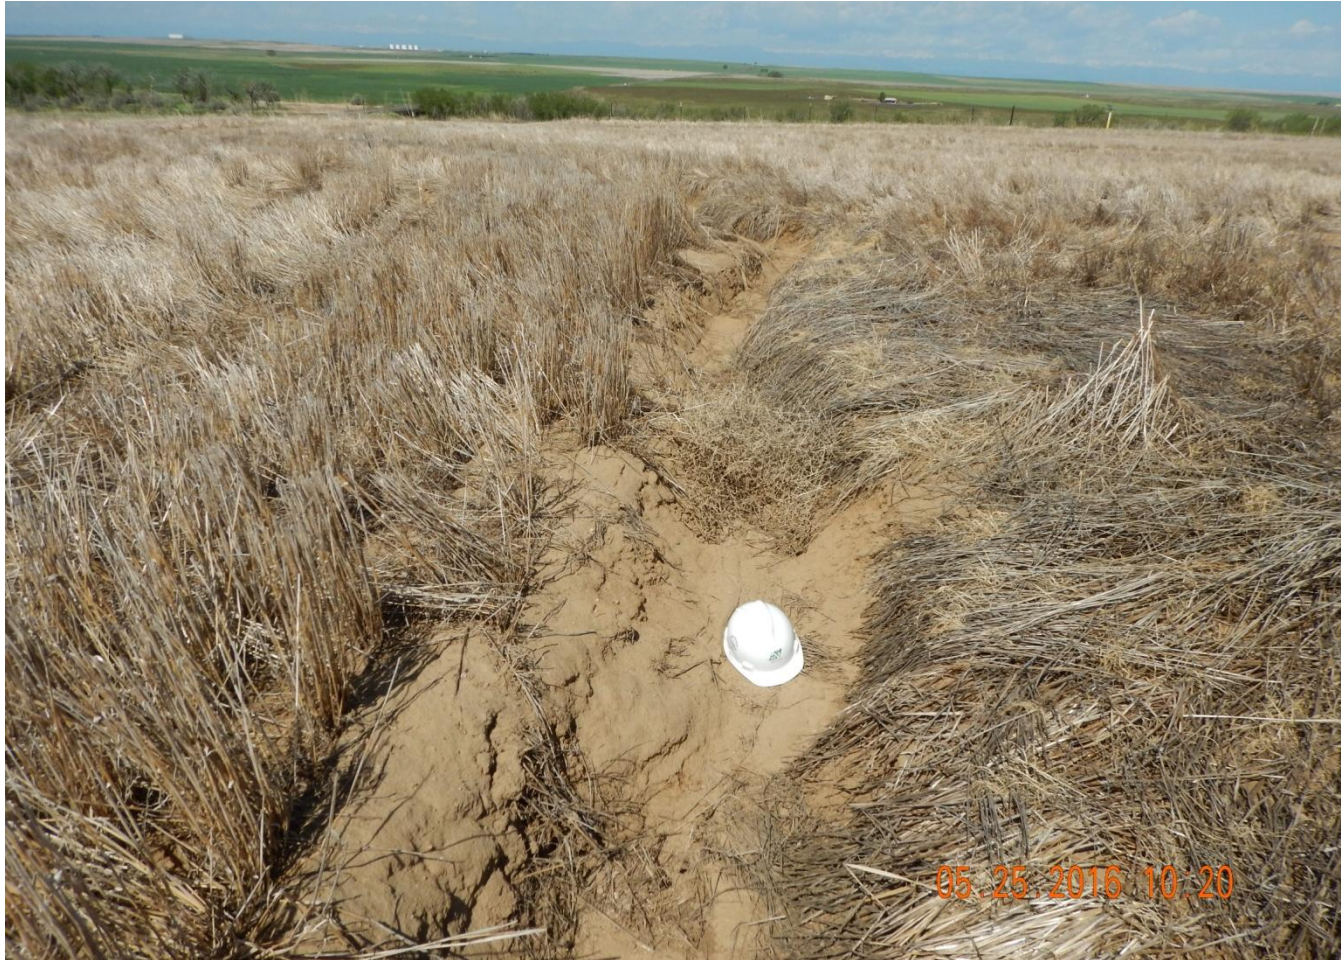
Photo 6. Photo taken southwest of well location, facing Southwest. Need to control stormwater runoff that minimizes erosion and transport of sediment offsite per Rule 1002. Gully erosion enlarging further southwest.

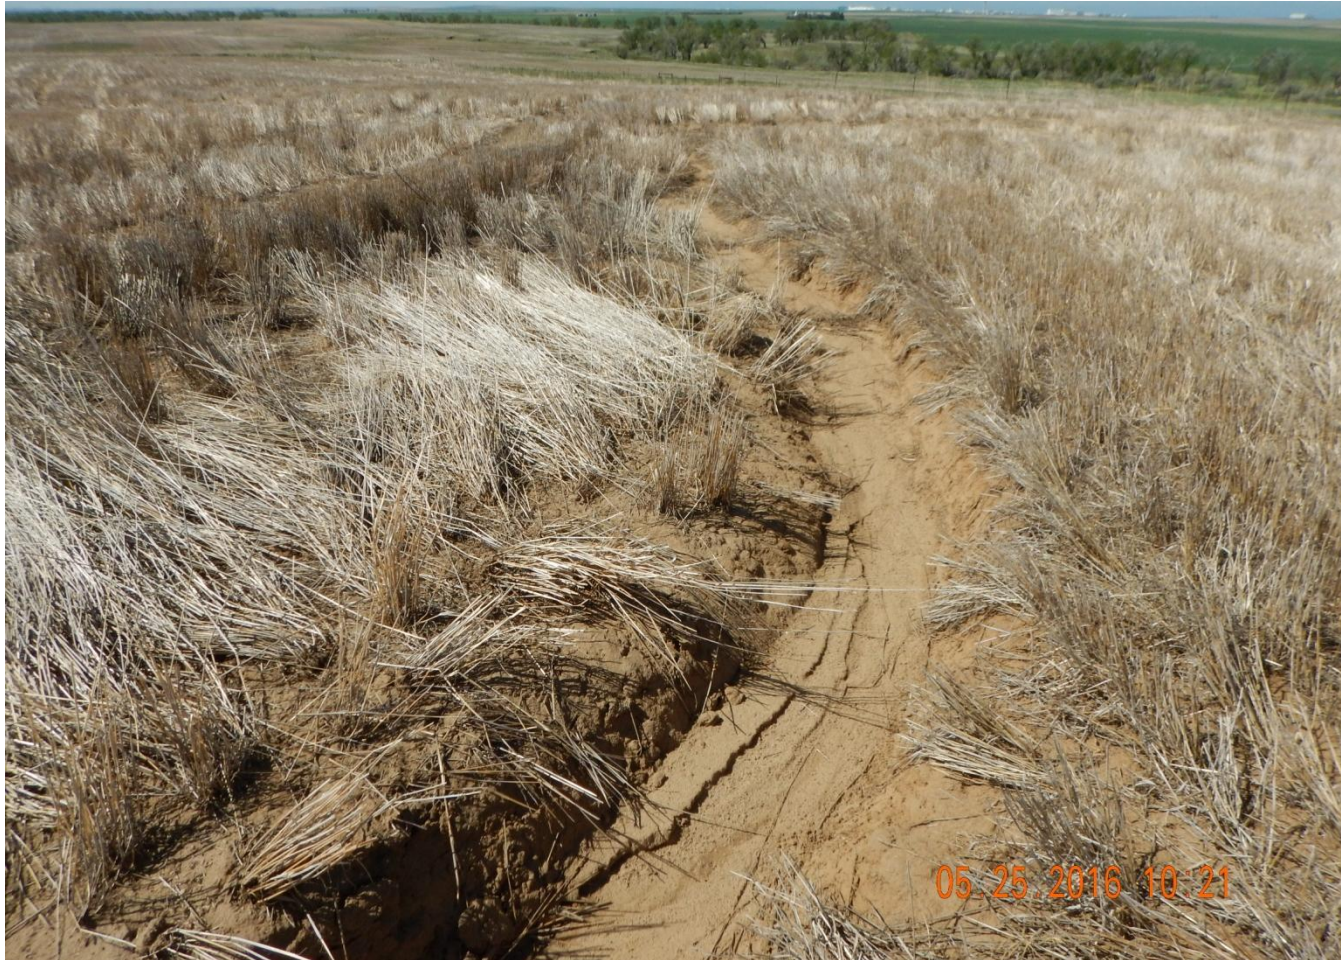
Photo 7. Photo taken southwest of well location, facing Southwest. Need to control stormwater runoff that minimizes erosion and transport of sediment offsite per Rule 1002. Gully erosion enlarging further southwest.

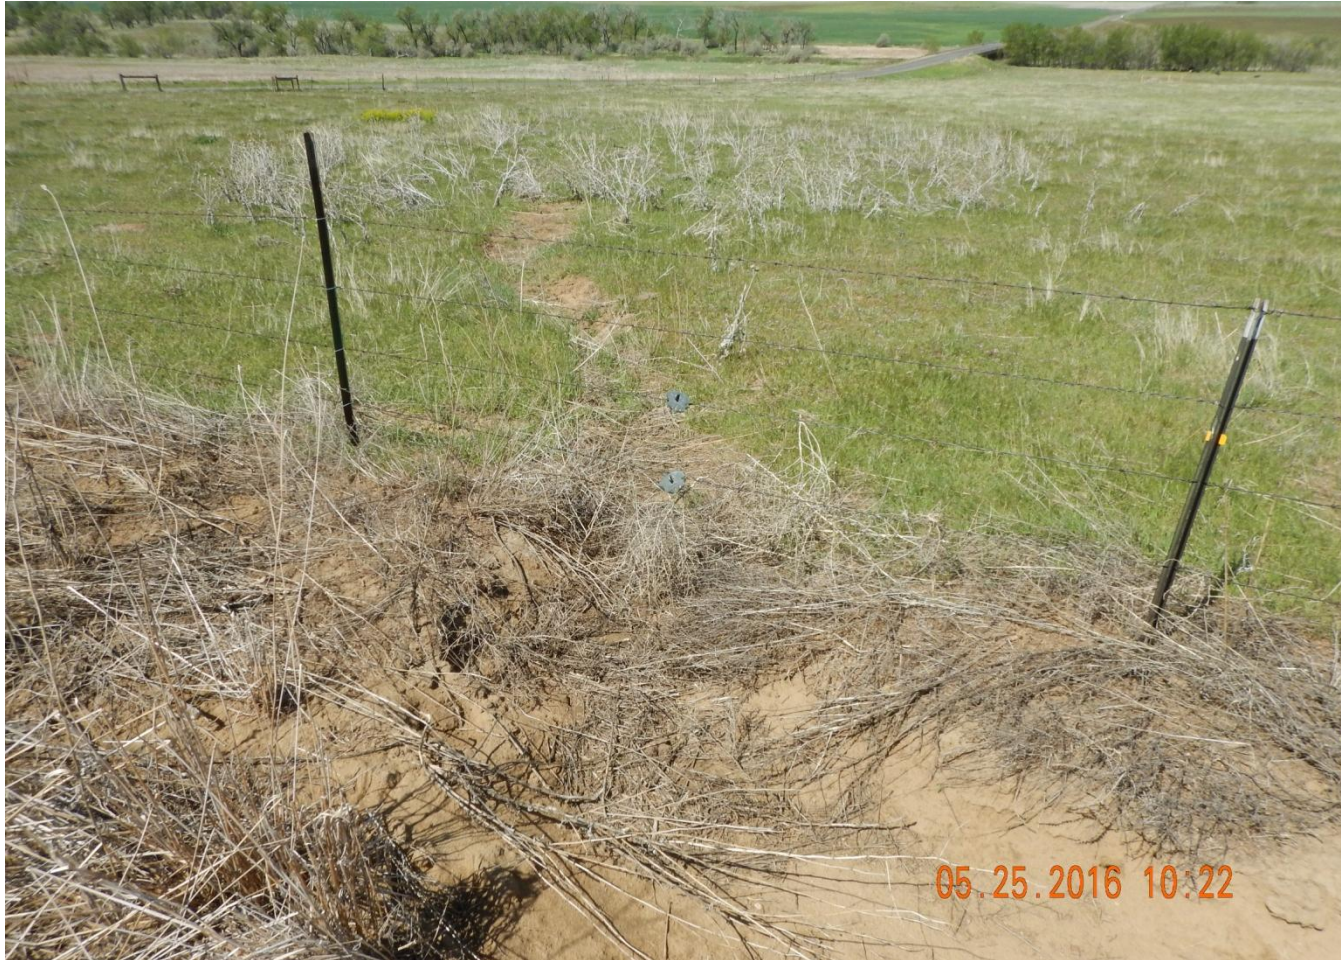
Photo 8. Photo taken southwest of well location, facing Southwest illustrating erosion occurring on adjacent lands. Need to control stormwater runoff that minimizes erosion and transport of sediment offsite per Rule 1002.

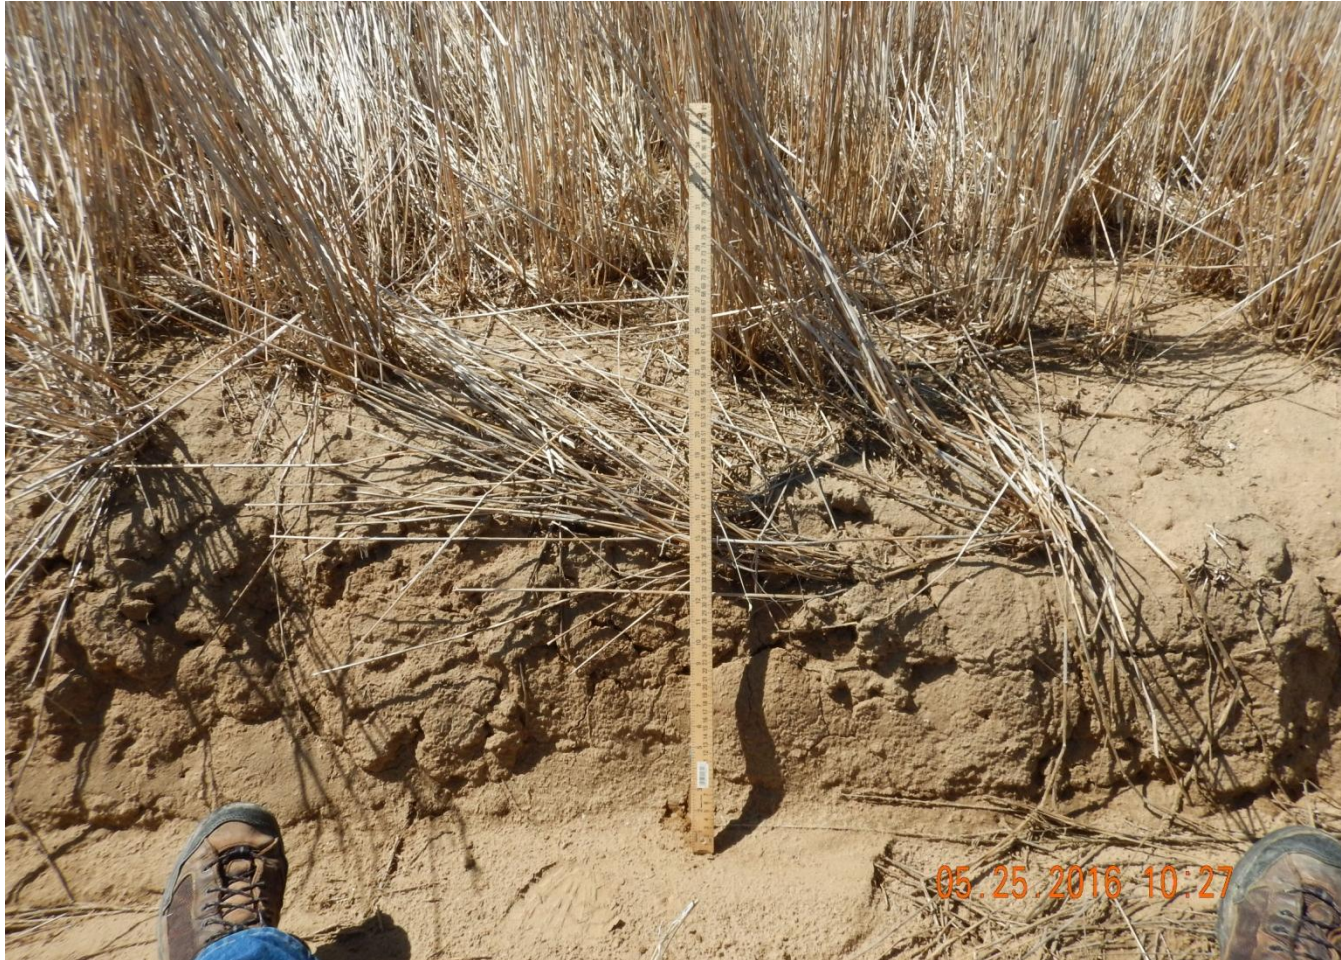
Photo 9. Photo taken from mid-way point of gully erosion measuring an average depth of 24".
