Construction Inspection

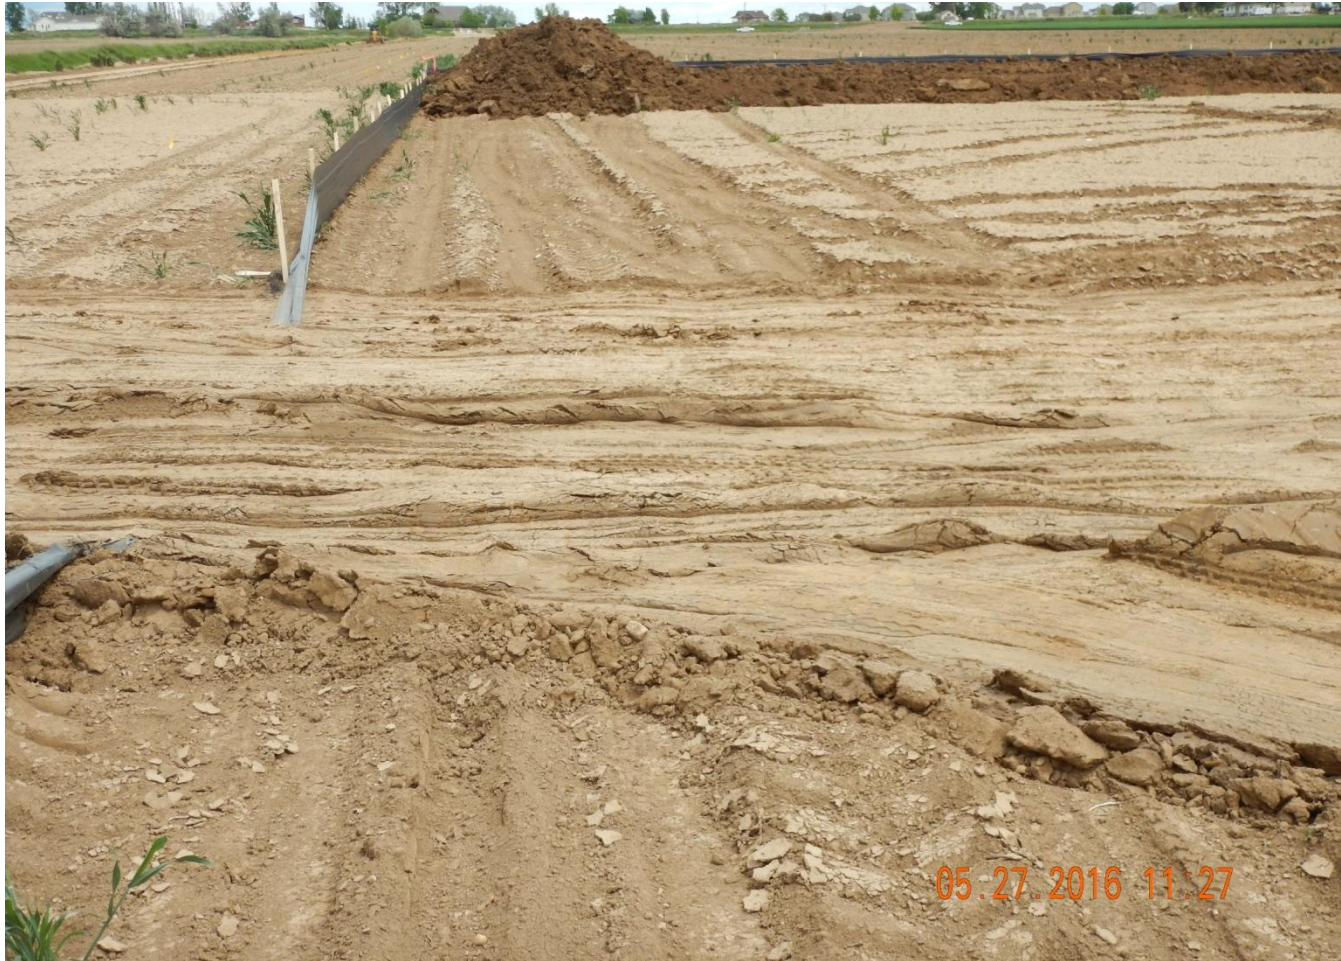
Photo 1. Photo taken from location entrance, facing North. Sediment control BMP installed around perimeter of location.

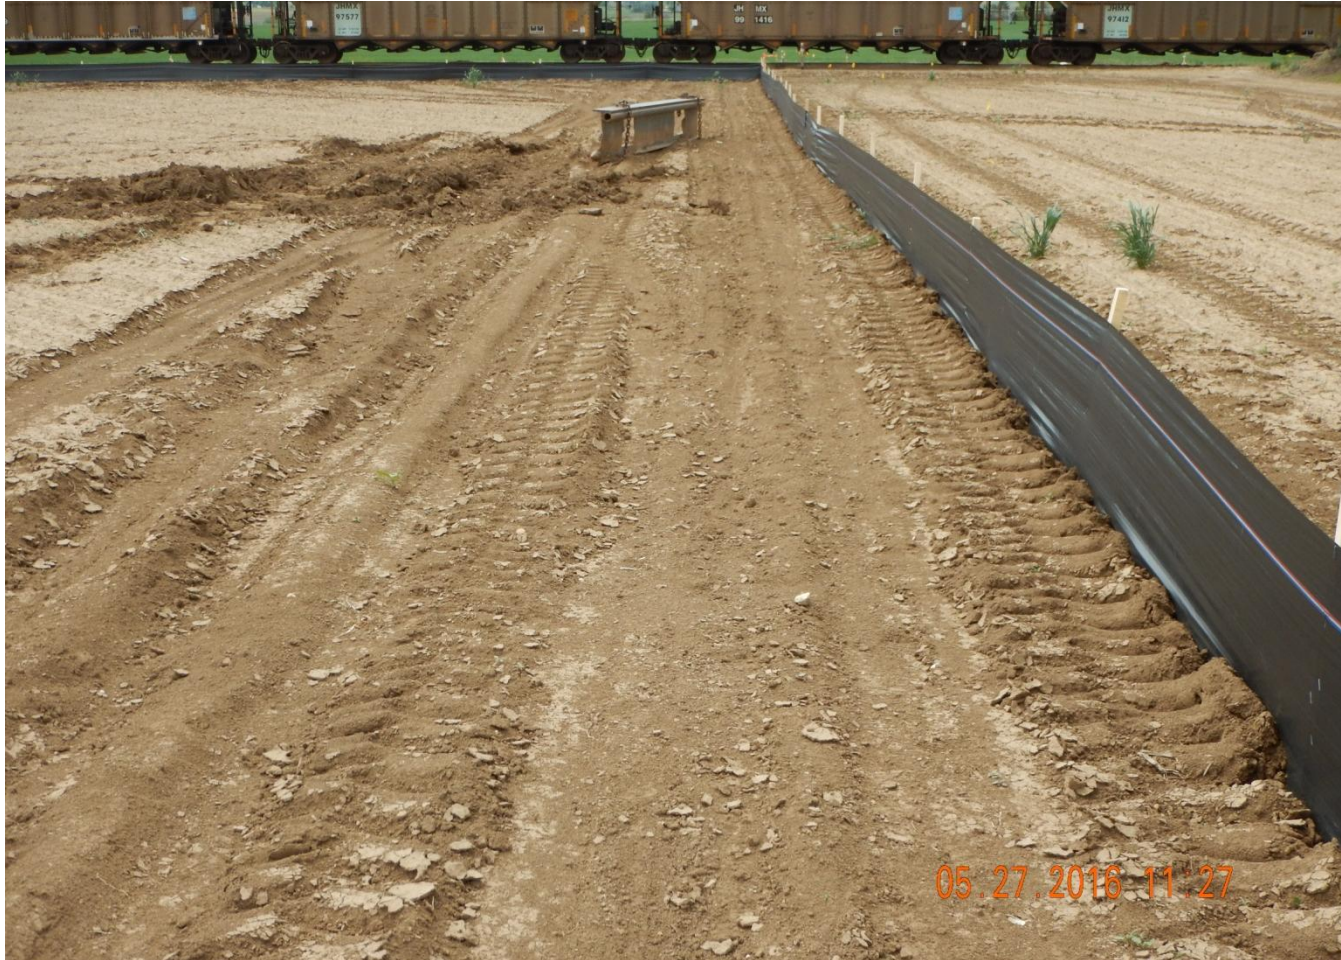
Photo 2. Photo taken from location entrance, facing South. Sediment control BMP installed around perimeter of location.

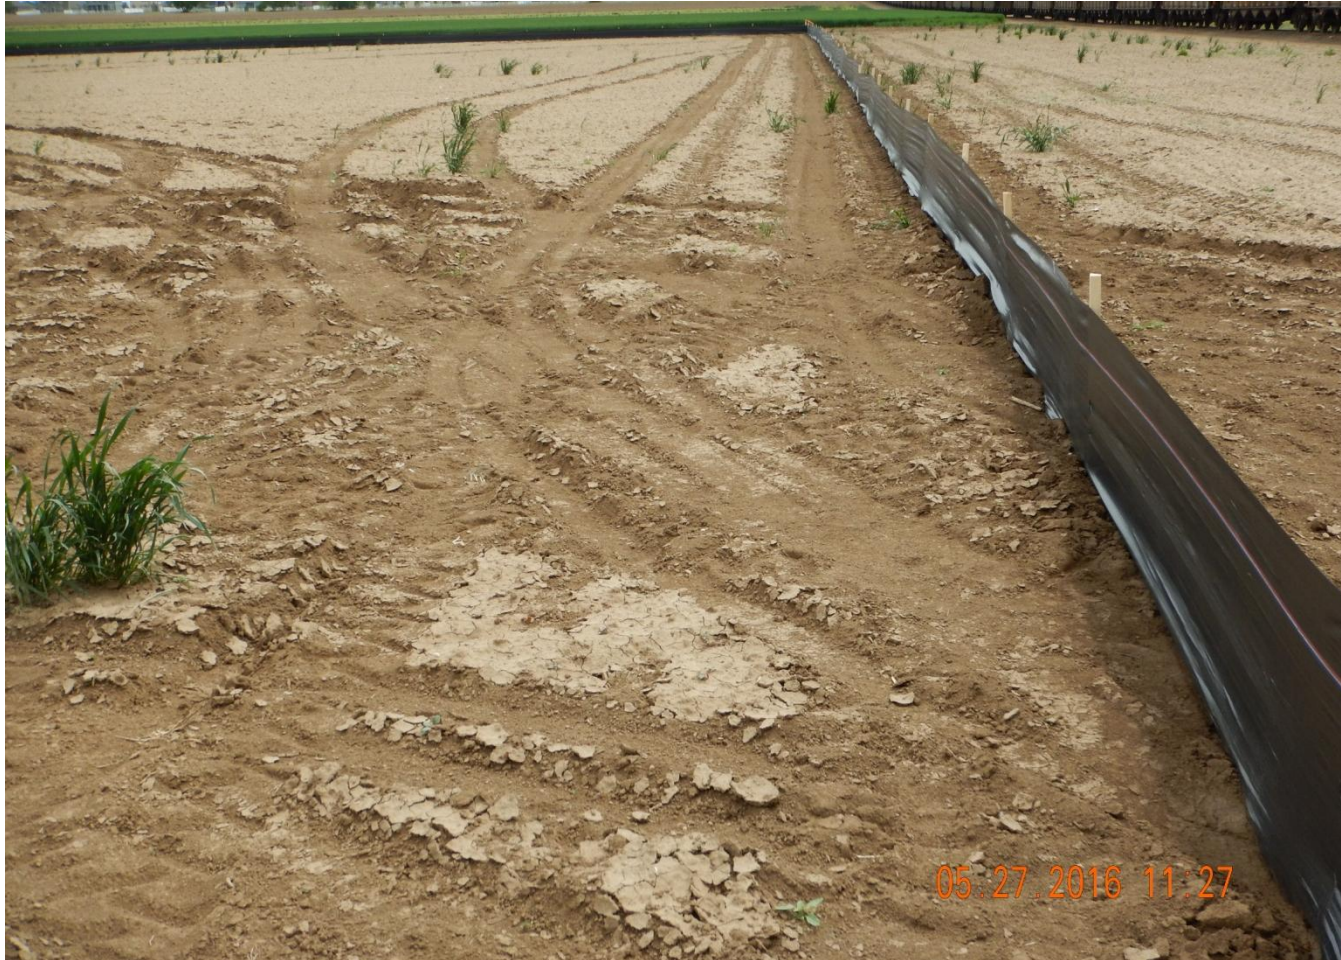
Photo 3. Photo taken from southwest location, facing East. Sediment control BMP installed around perimeter of location.

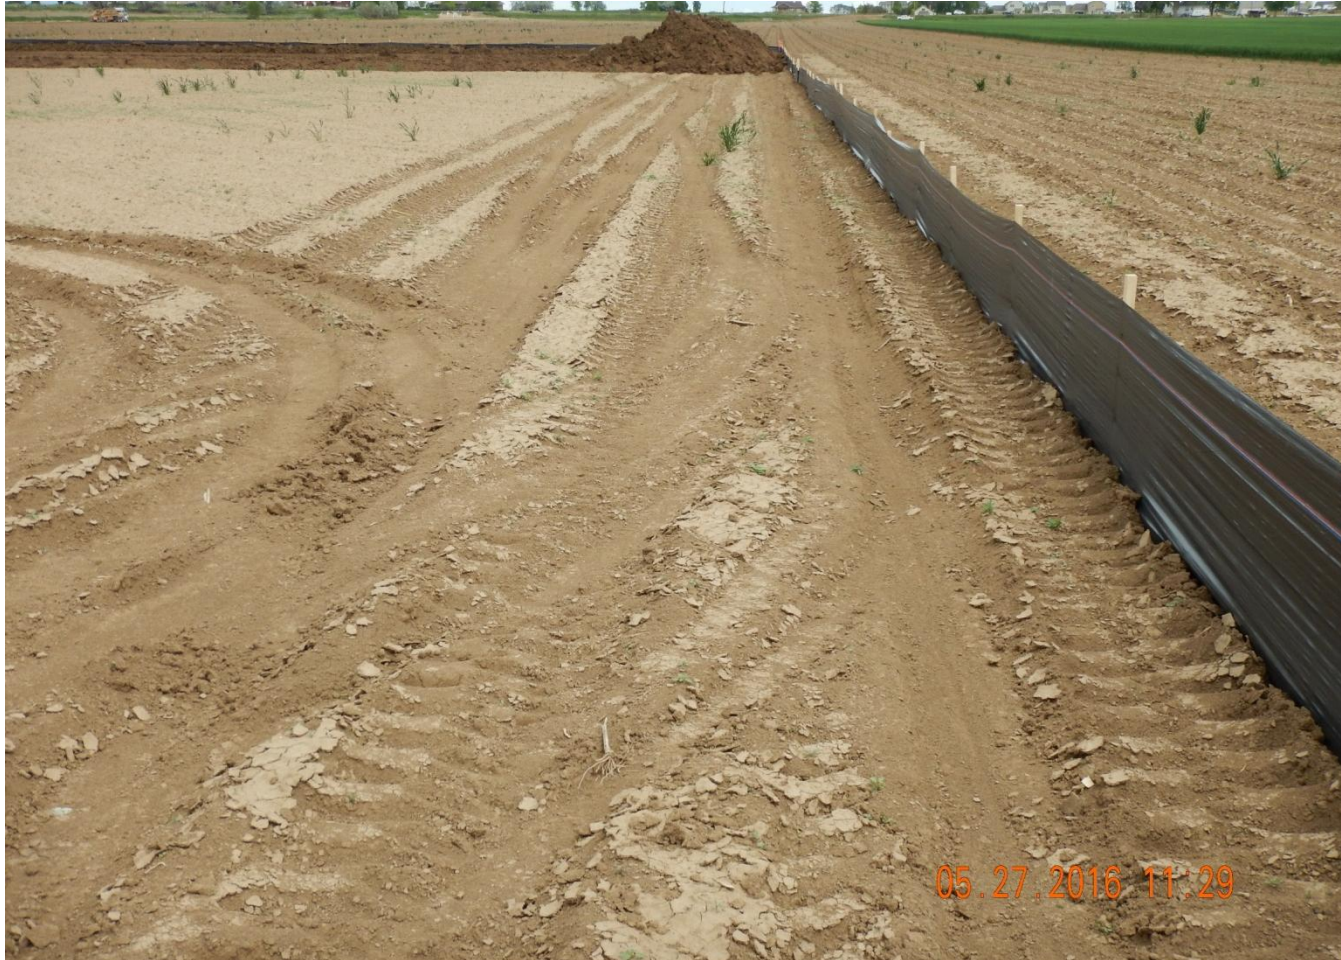
Photo 4. Photo taken from southeast location, facing North. Sediment control BMP installed around perimeter of location.

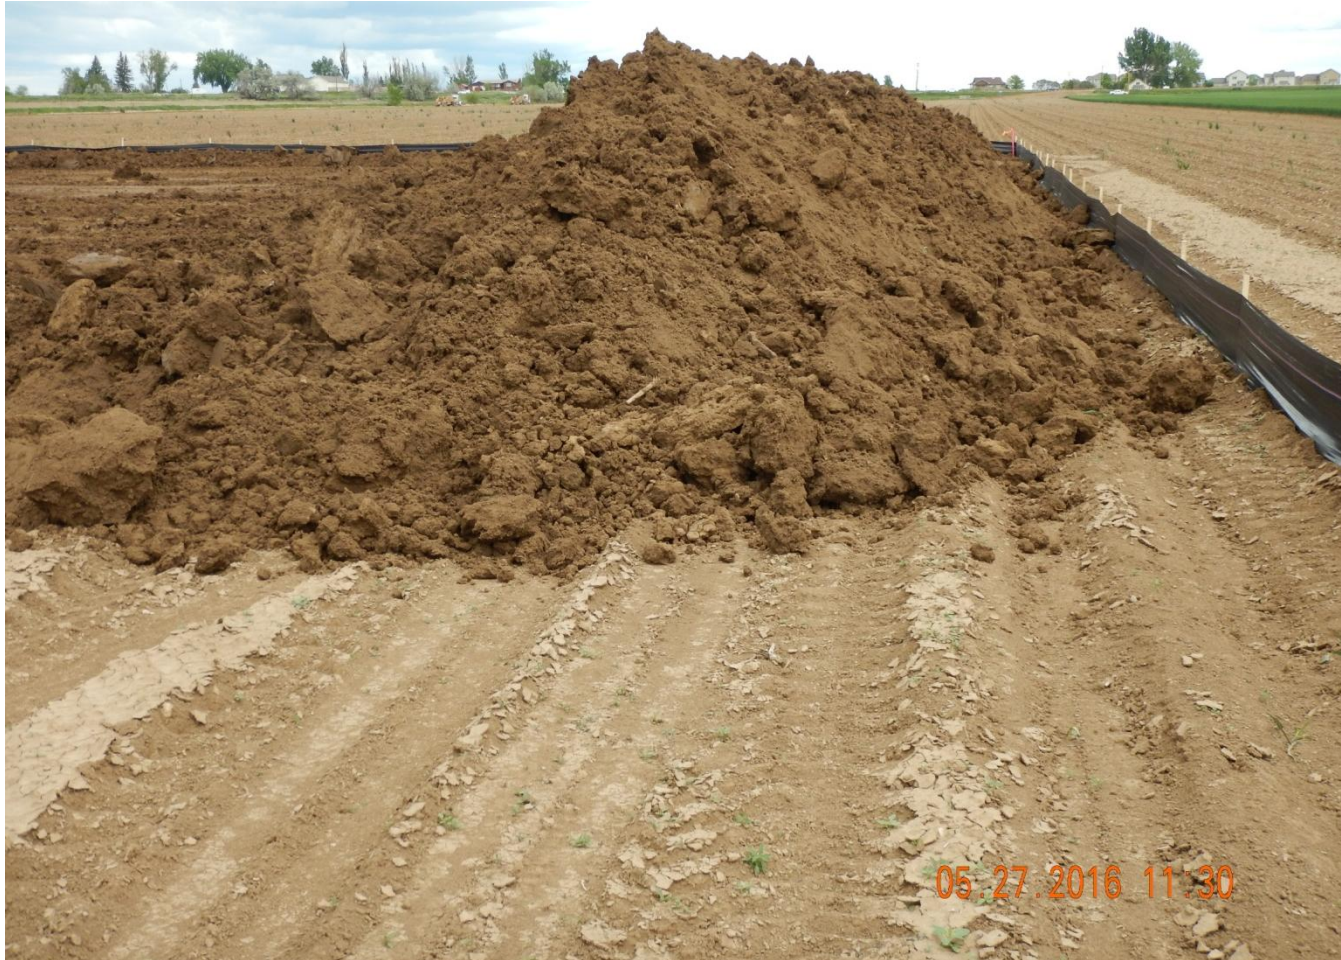
Photo 5. Photo taken from eastern location, facing North. Topsoil salvage in process. Need to stabilize topsoil stockpile upon completion of salvage process.

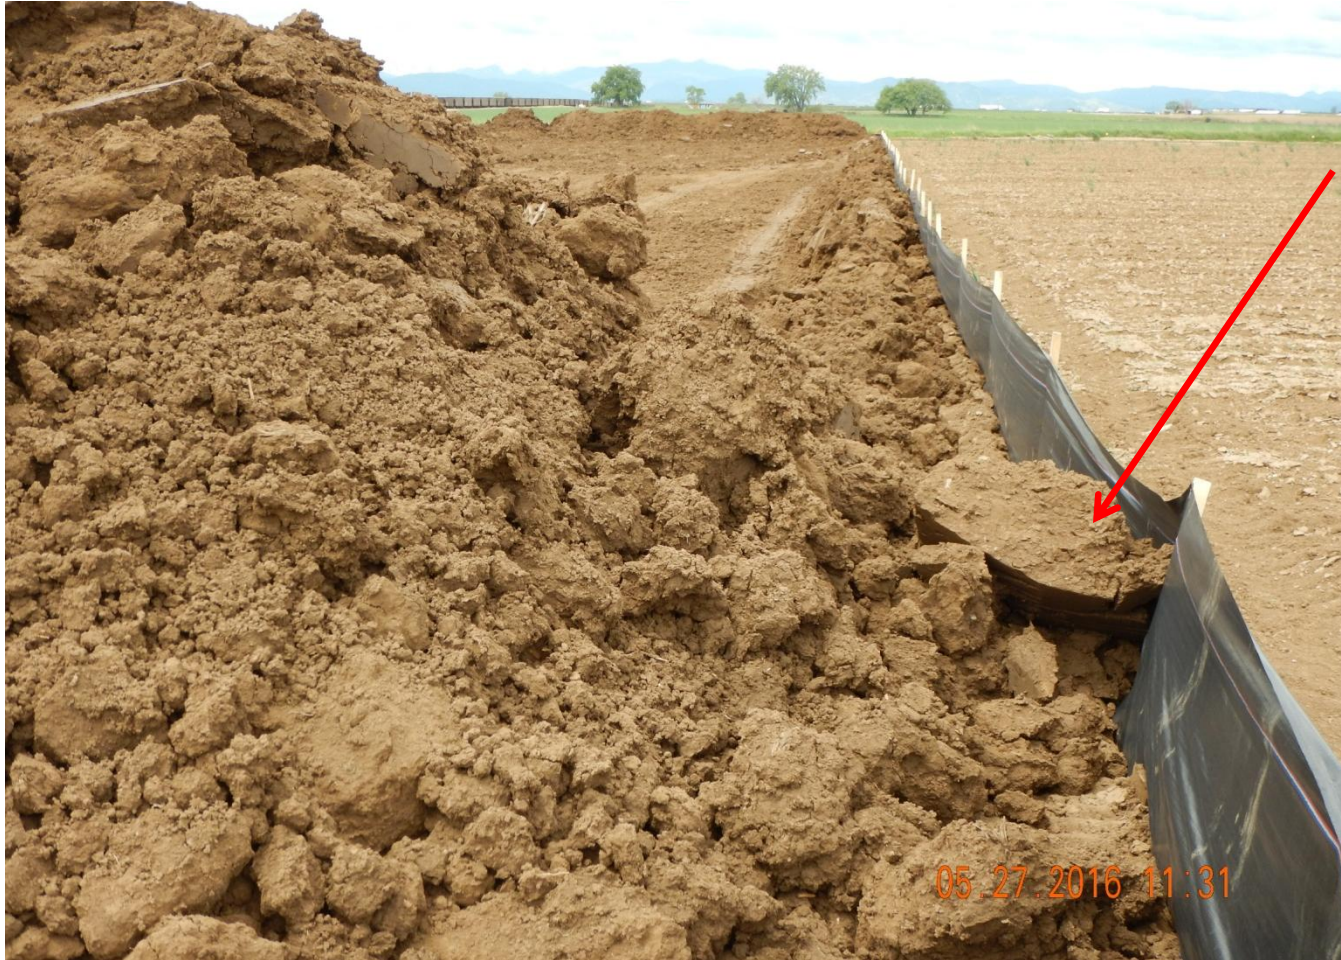
Photo 6. Photo taken from northeast location, facing West. Sediment control BMP installed around perimeter of location. Need to ensure BMPs are maintained throughout the life of the location. Silt fence will require routine maintenance, especially during construction operations.

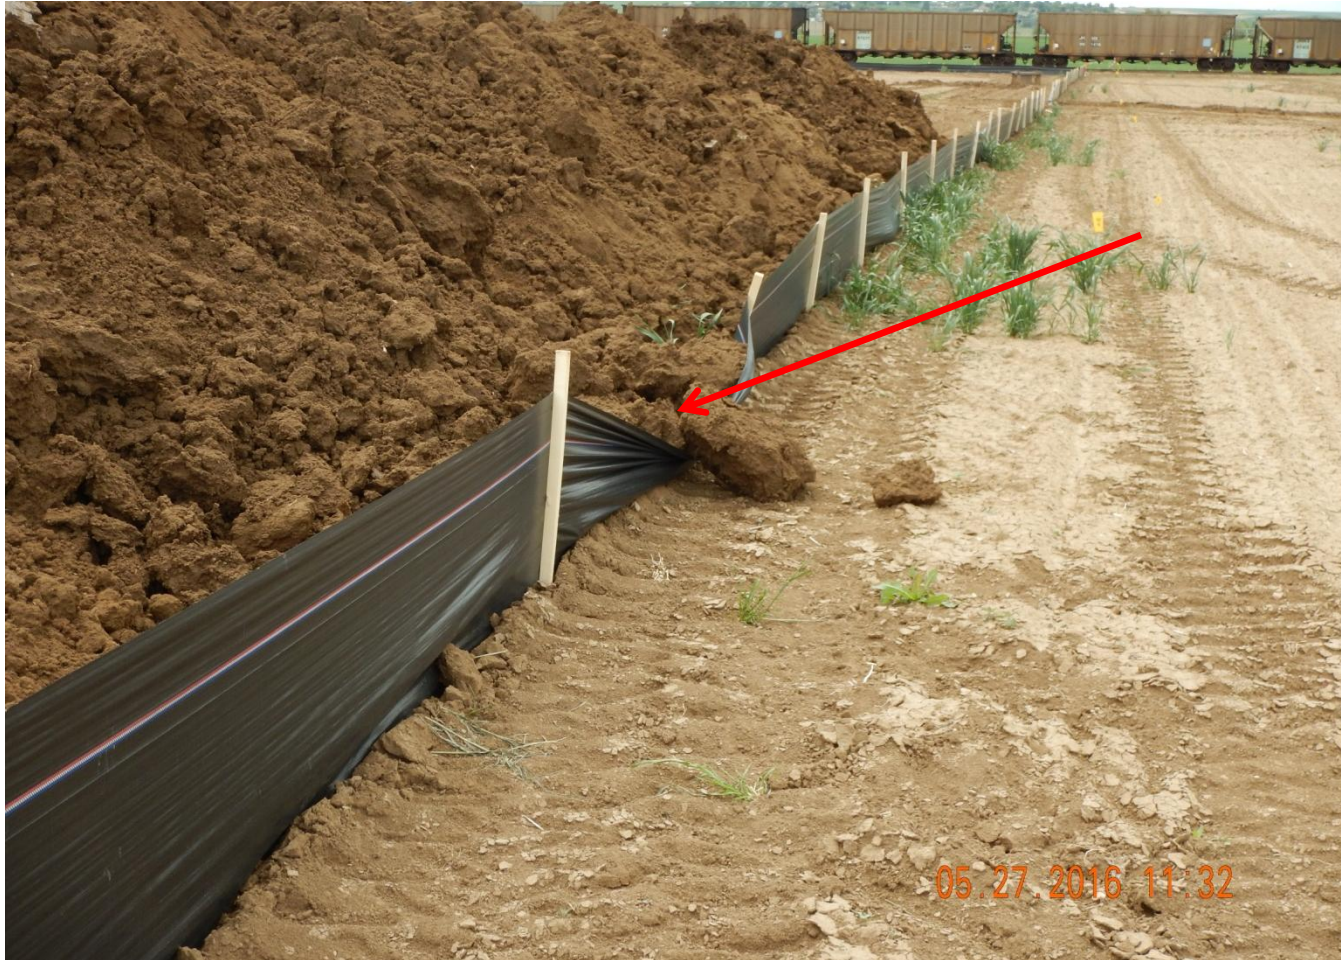
Photo 7. Photo taken from northwest location, facing South. Sediment control BMP installed around perimeter of location. Need to ensure BMPs are maintained throughout the life of the location. Silt fence will require routine maintenance, especially during construction operations.

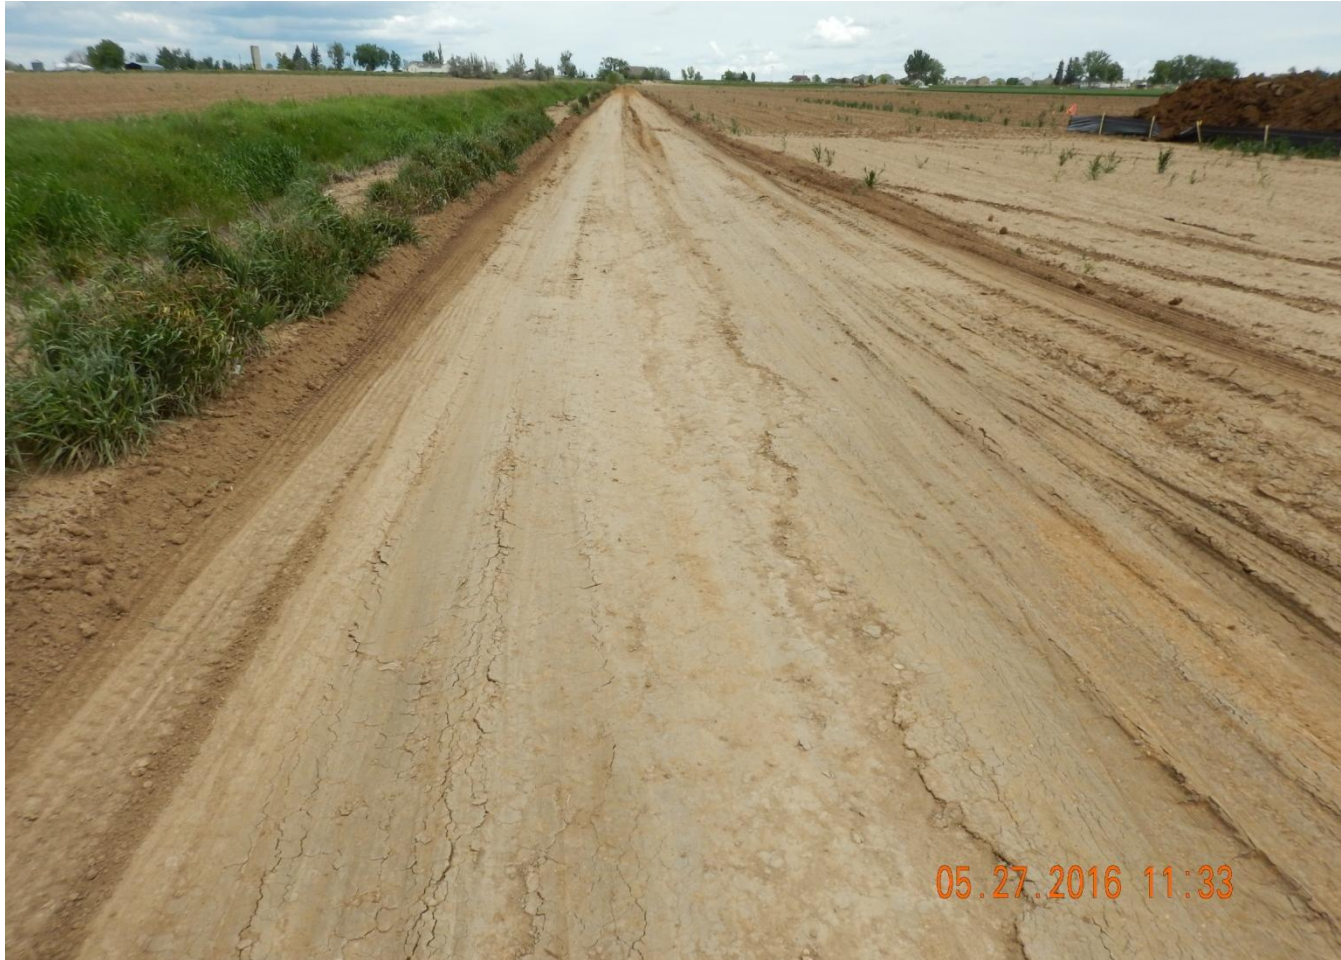
Photo 8. Photo taken from location entrance, facing North. Road base is currently being trucked in.

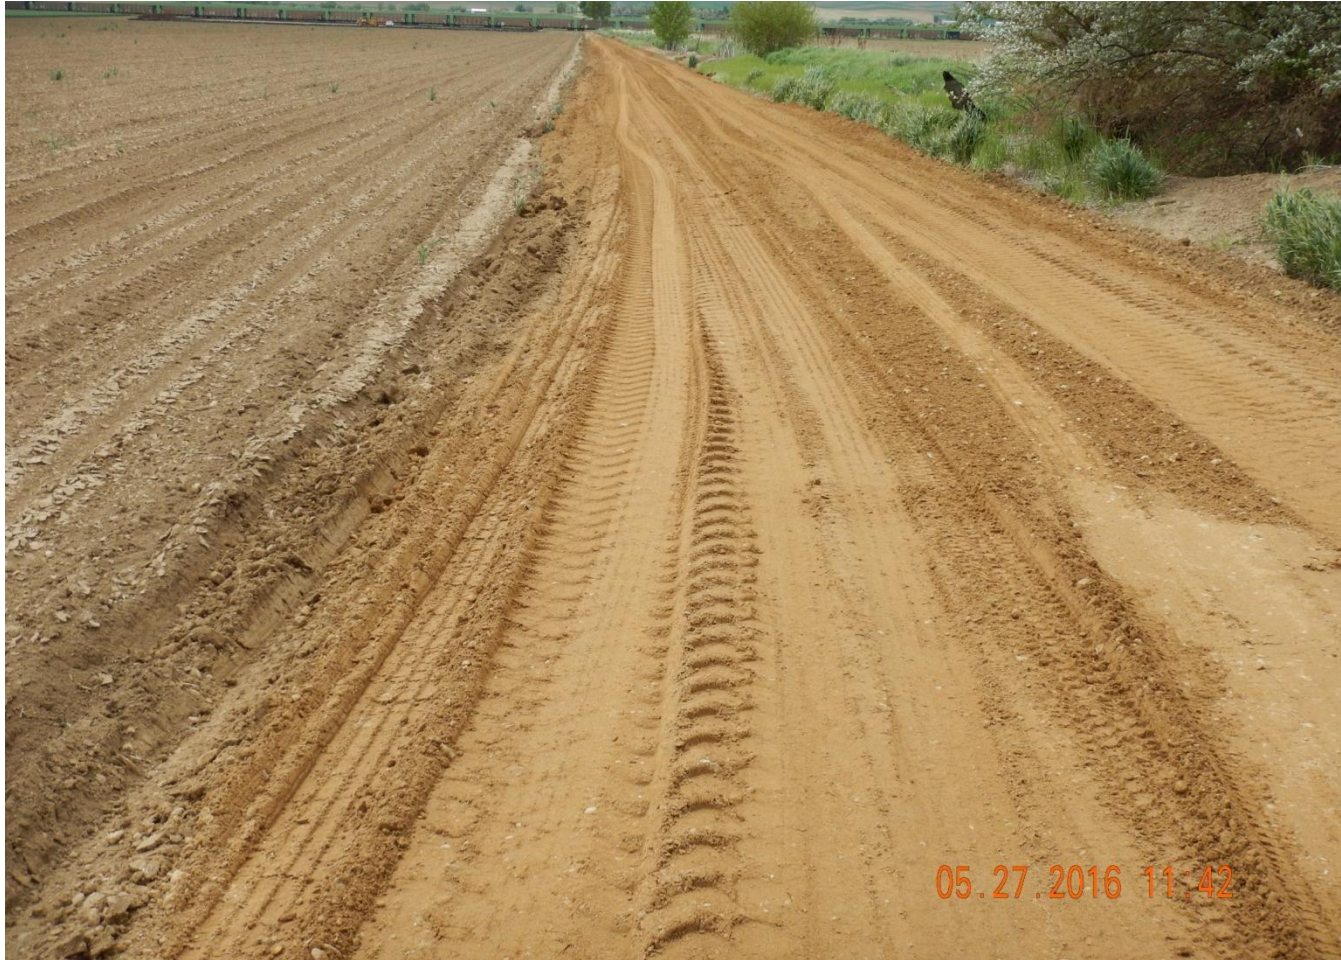
Photo 9. Photo taken from north of location, facing South. Road base is currently being trucked in.

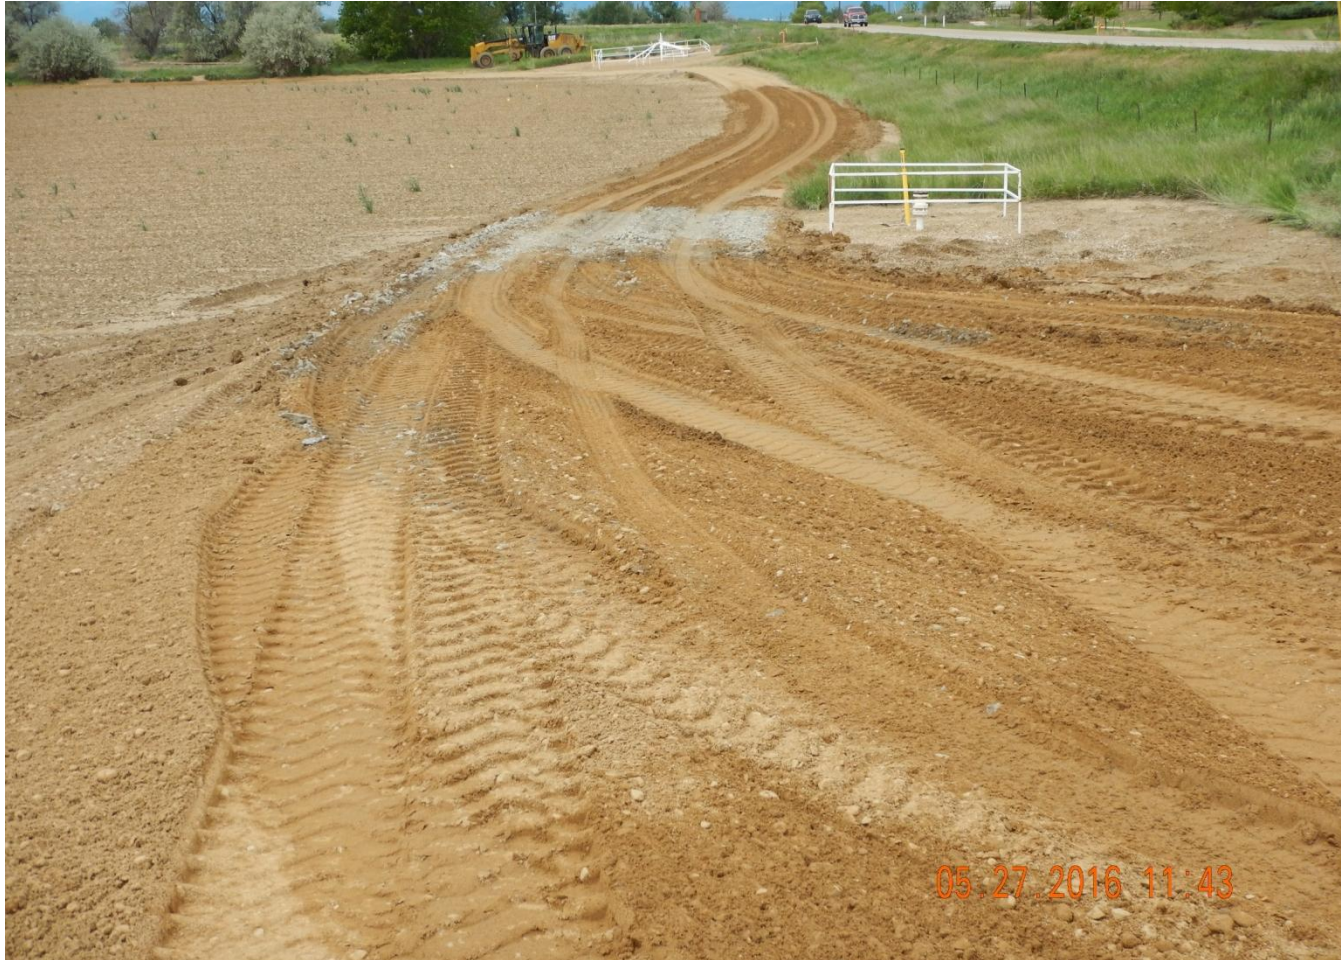
Photo 10. Photo taken from location entrance off Hwy 60, facing West. Road base being trucked and tracking pad being built.
