Inspector: Joe MacLaren
Operator: KP Kauffman
COGCC Field Inspection Doc #: 674602591
Spill Point ID # (if applicable):

Inspection Date: 6/14/2016 (Follow up inspection)
Facility Name and Number:
Well Name and Number: UPRR PAN AM I 27
API Number (if applicable): 123 - 09913

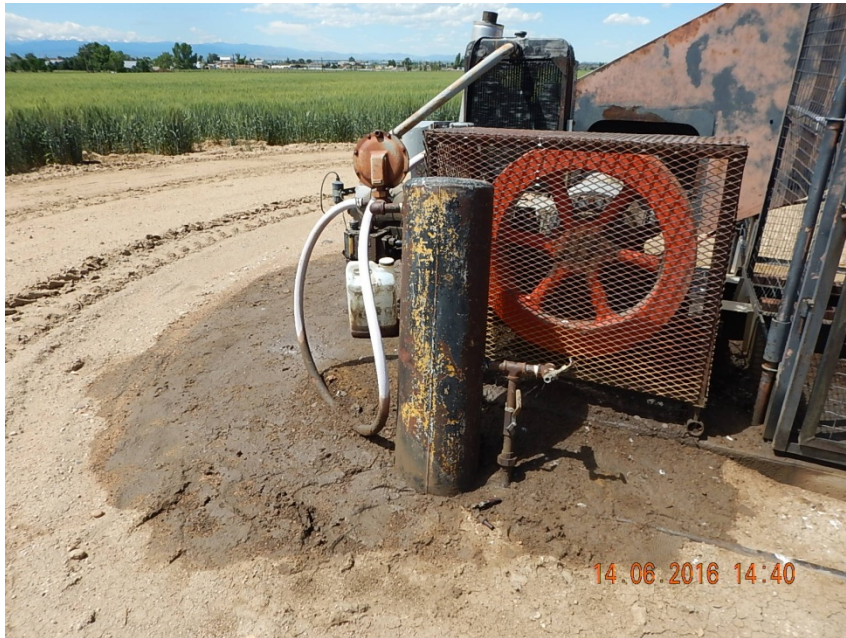
Lube Oil Release Observed at Prime Mover

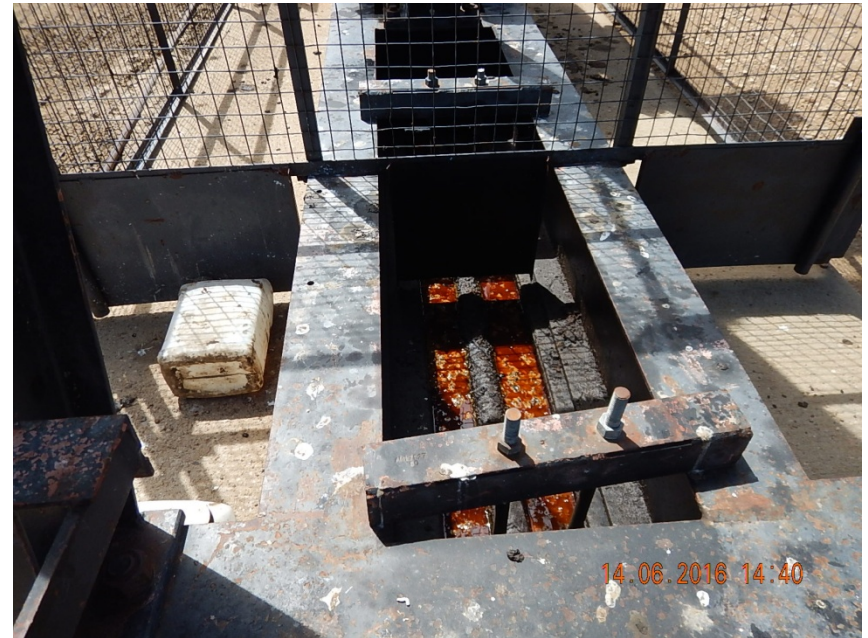
**Lube Oil Accumulations Observed Inside
Frame Rails of Pump Jack**

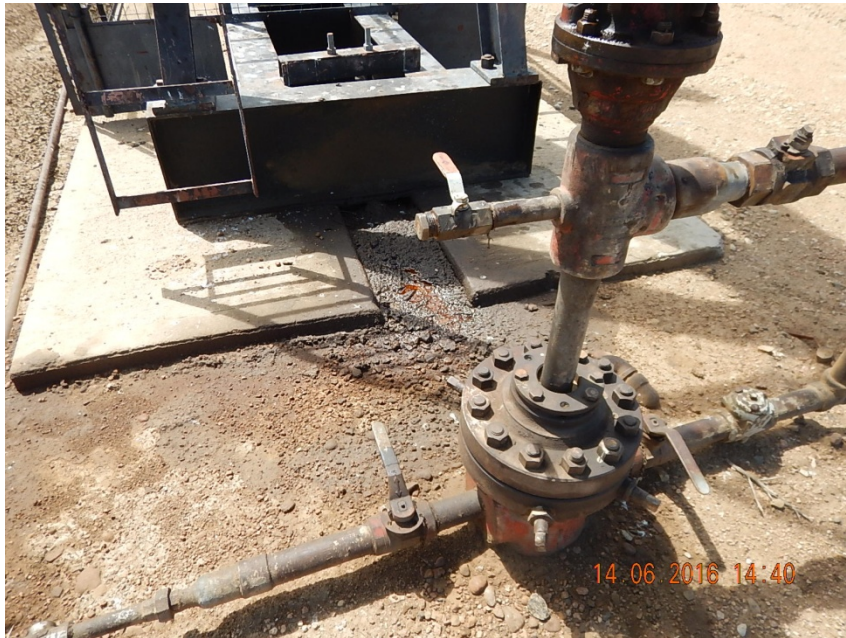
Lube Oil Spill/ Release Observed at Wellhead

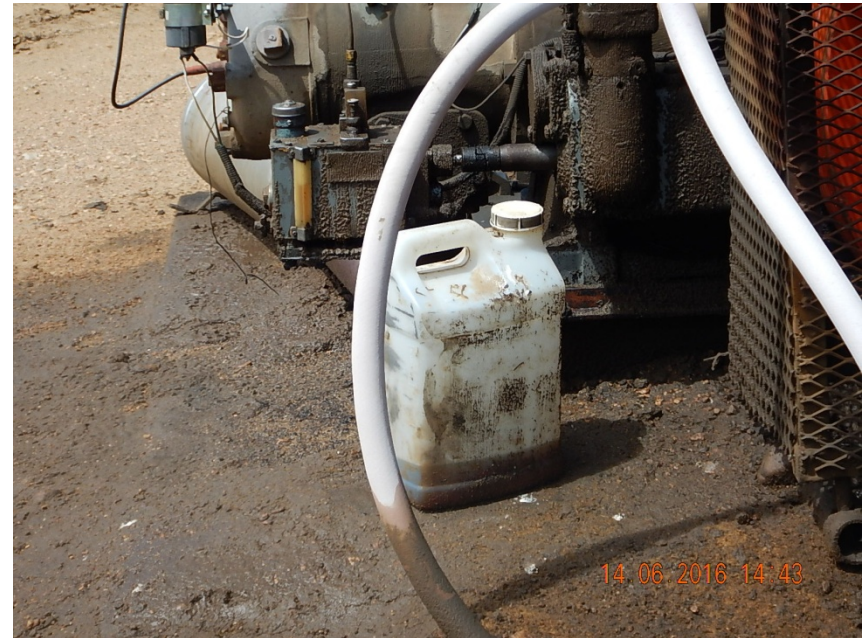
Unlabeled Container at Prime Mover

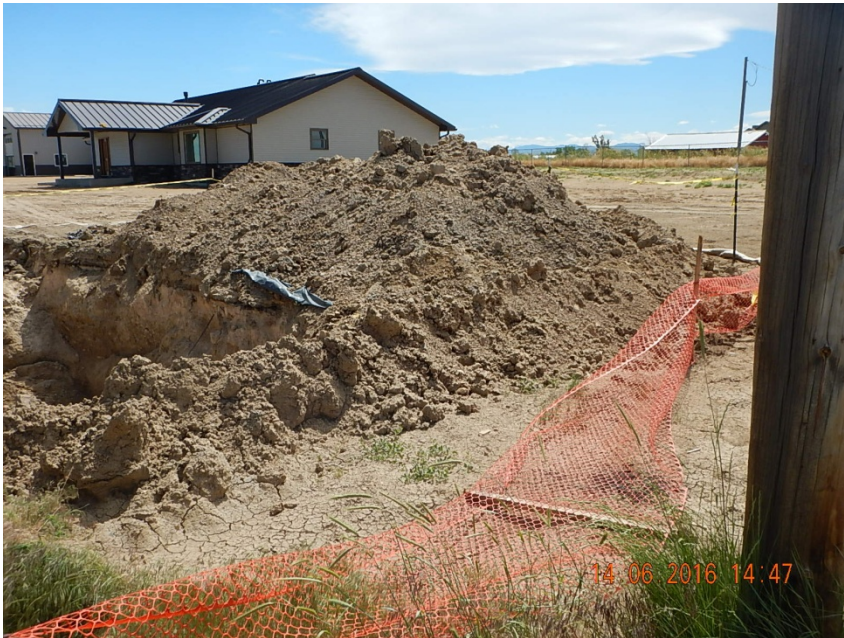
**E & P Waste Soils adjacent to excavation/
unmaintained fencing**

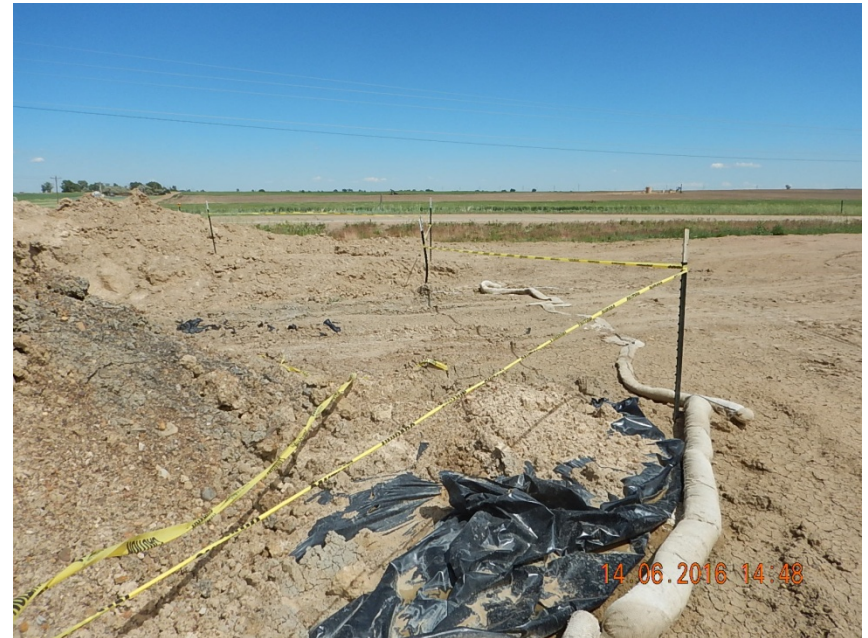
**Unmaintained BMP's adjacent to E & P Waste
soil pile**

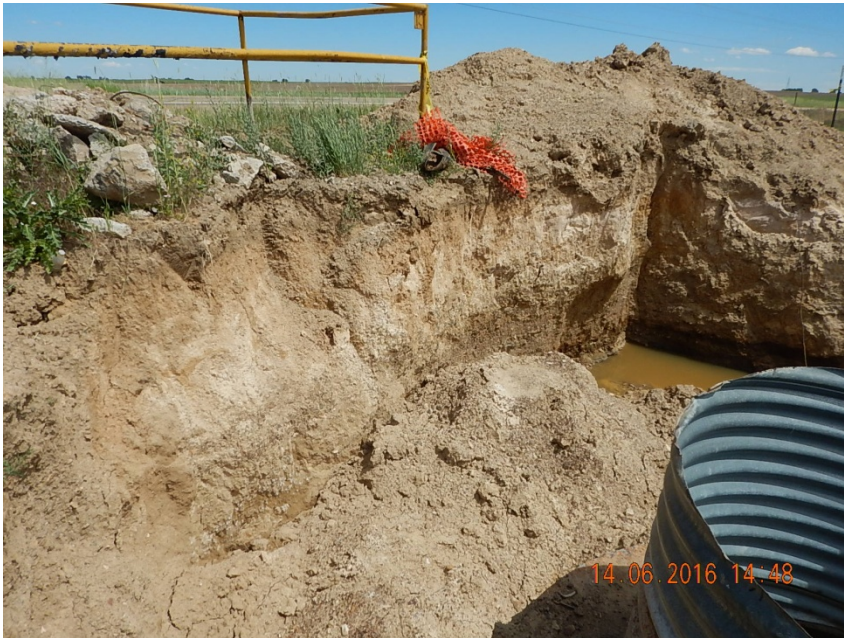
Stormwater accumulation and erosion at remediation / excavation

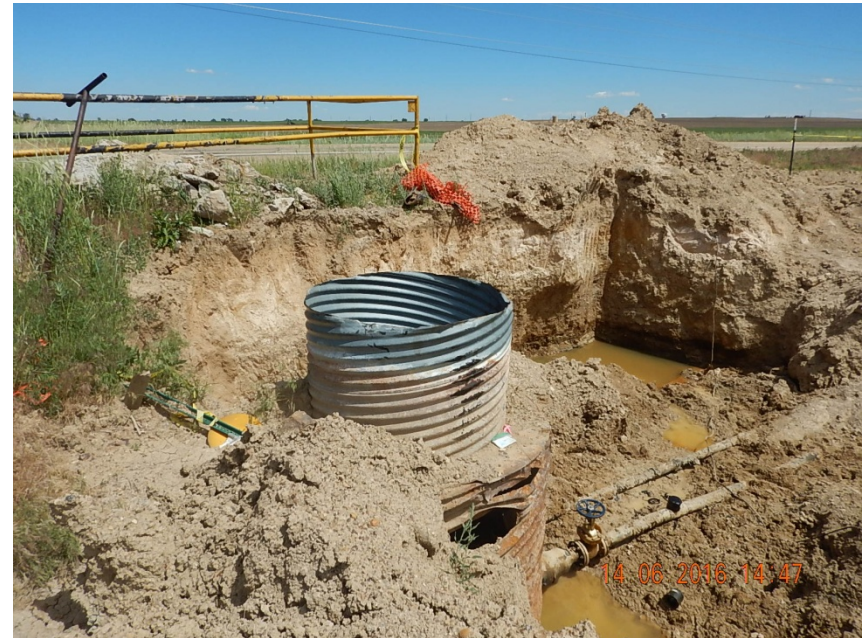
Uncovered valve can adjacent to excavation

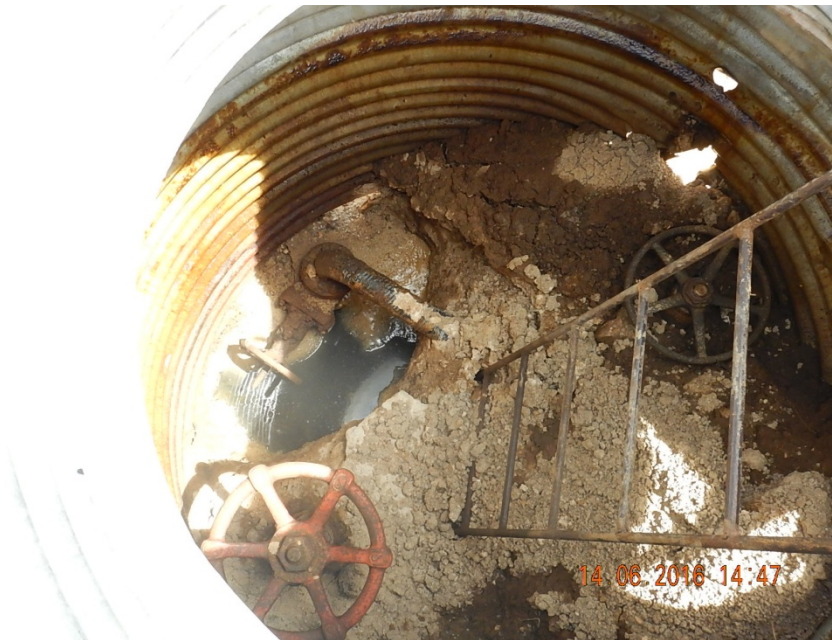
Free crude oil at bottom of valve can

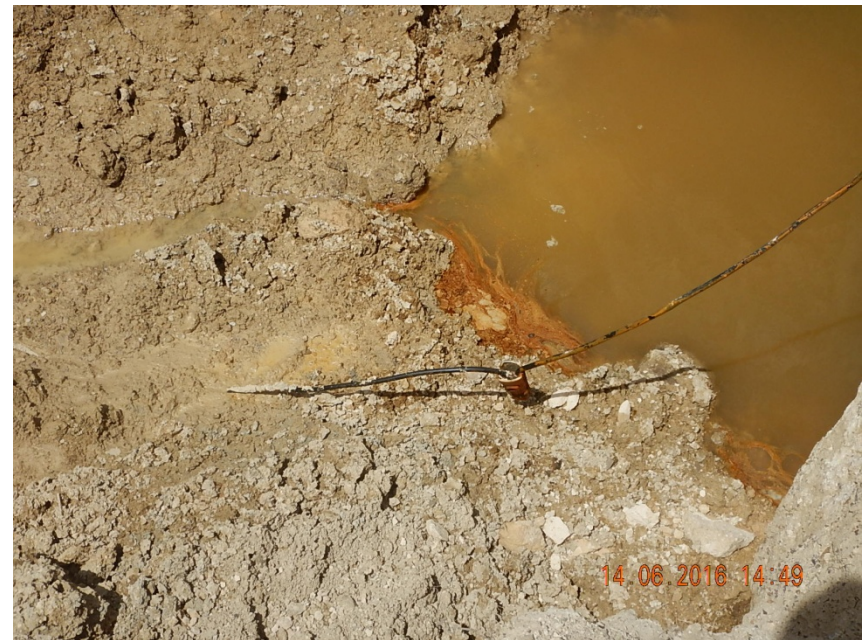
Crude oil residue in stormwater at bottom excavation
