Interim Reclamation Inspection

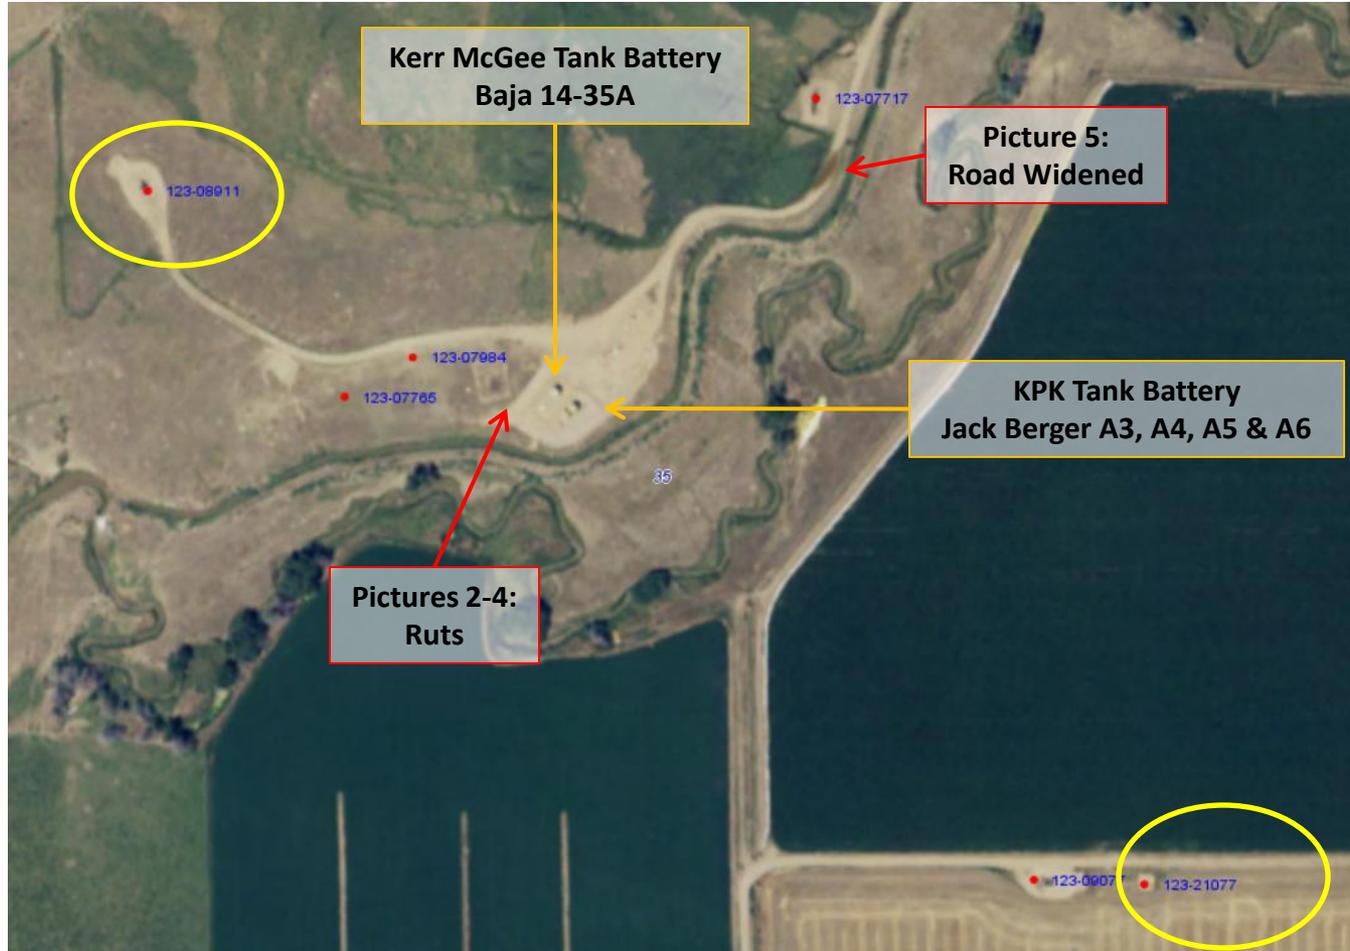
Photo 1. Aerial imagery using COGCC GISOnline database illustrating shared tank battery location with KPK and Kerr McGee in relation to corrective actions to fix ruts around southwest tank battery and widened access road.

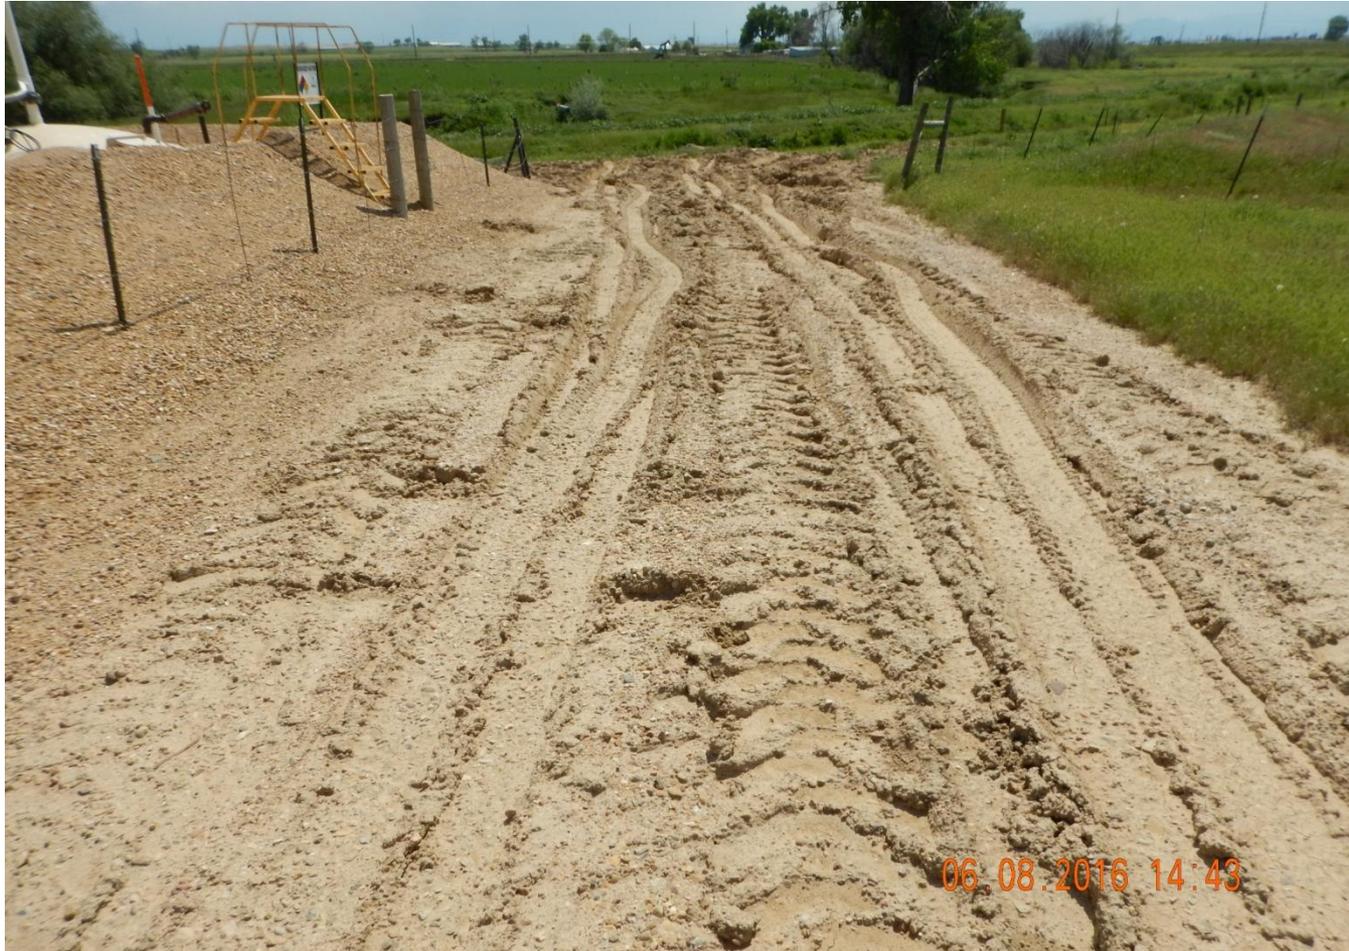
Photo 2. Photo taken from west of tank batteries, facing South. Need to maintain access road to prevent vehicle tracking and rutting.

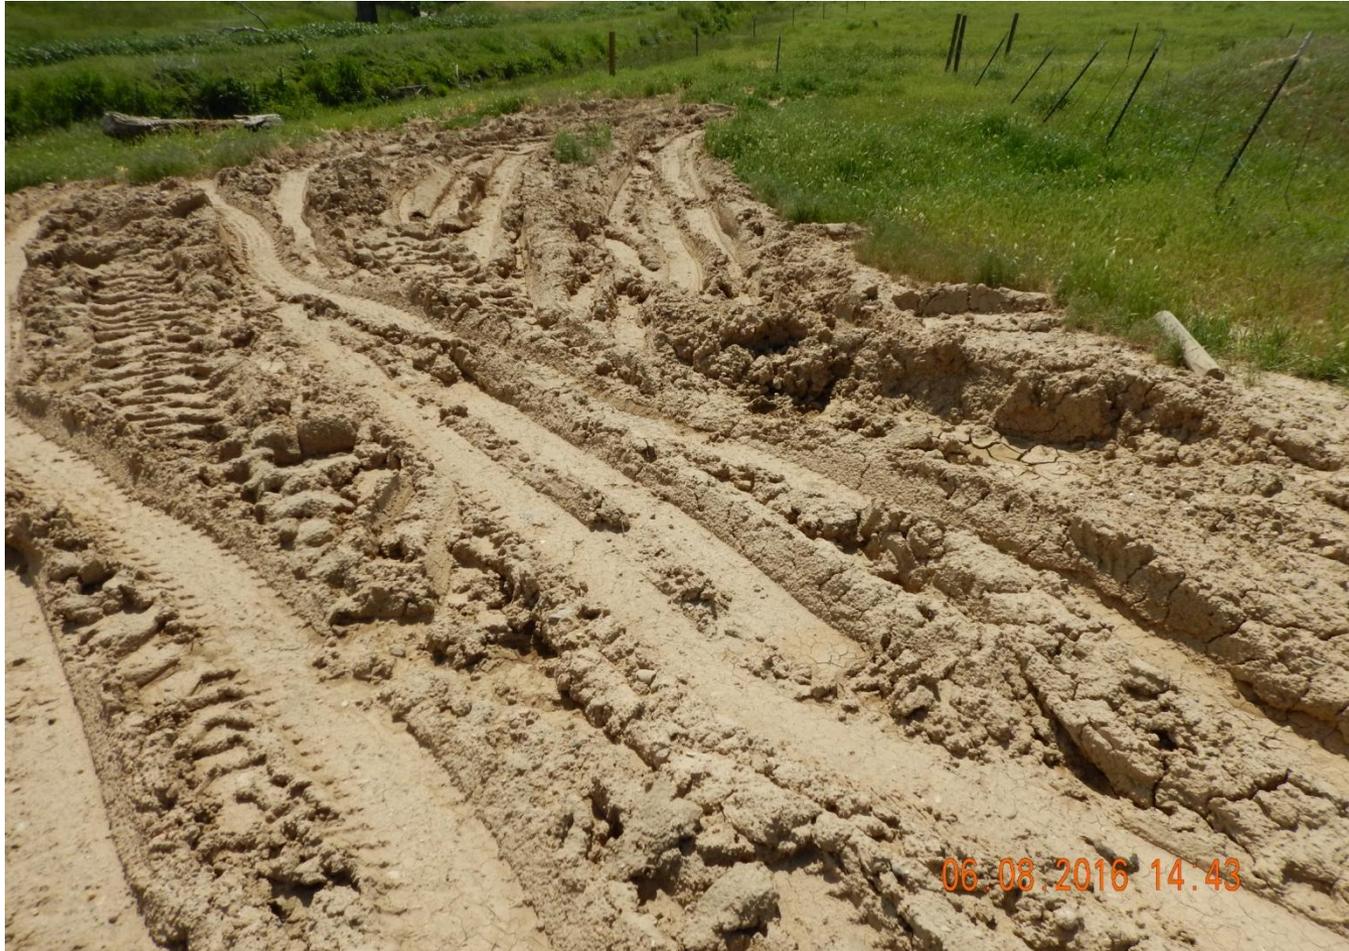
Photo 3. Photo taken from southwest of tank batteries, facing West. Need to maintain access road to prevent vehicle tracking and rutting.

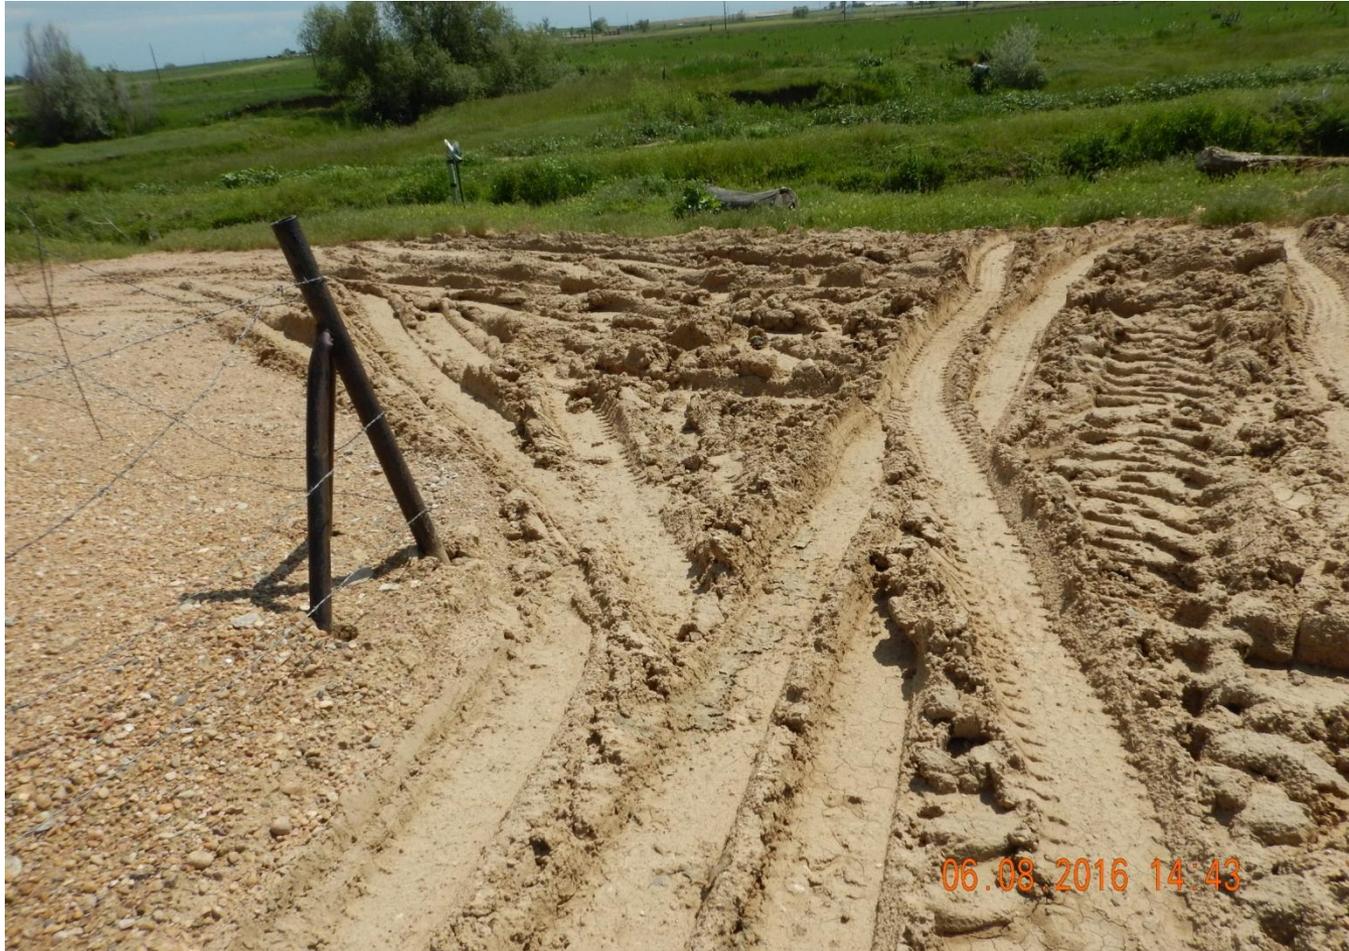
Photo 4. Photo taken from southwest of tank batteries, facing East. Need to maintain access road to prevent vehicle tracking and rutting.

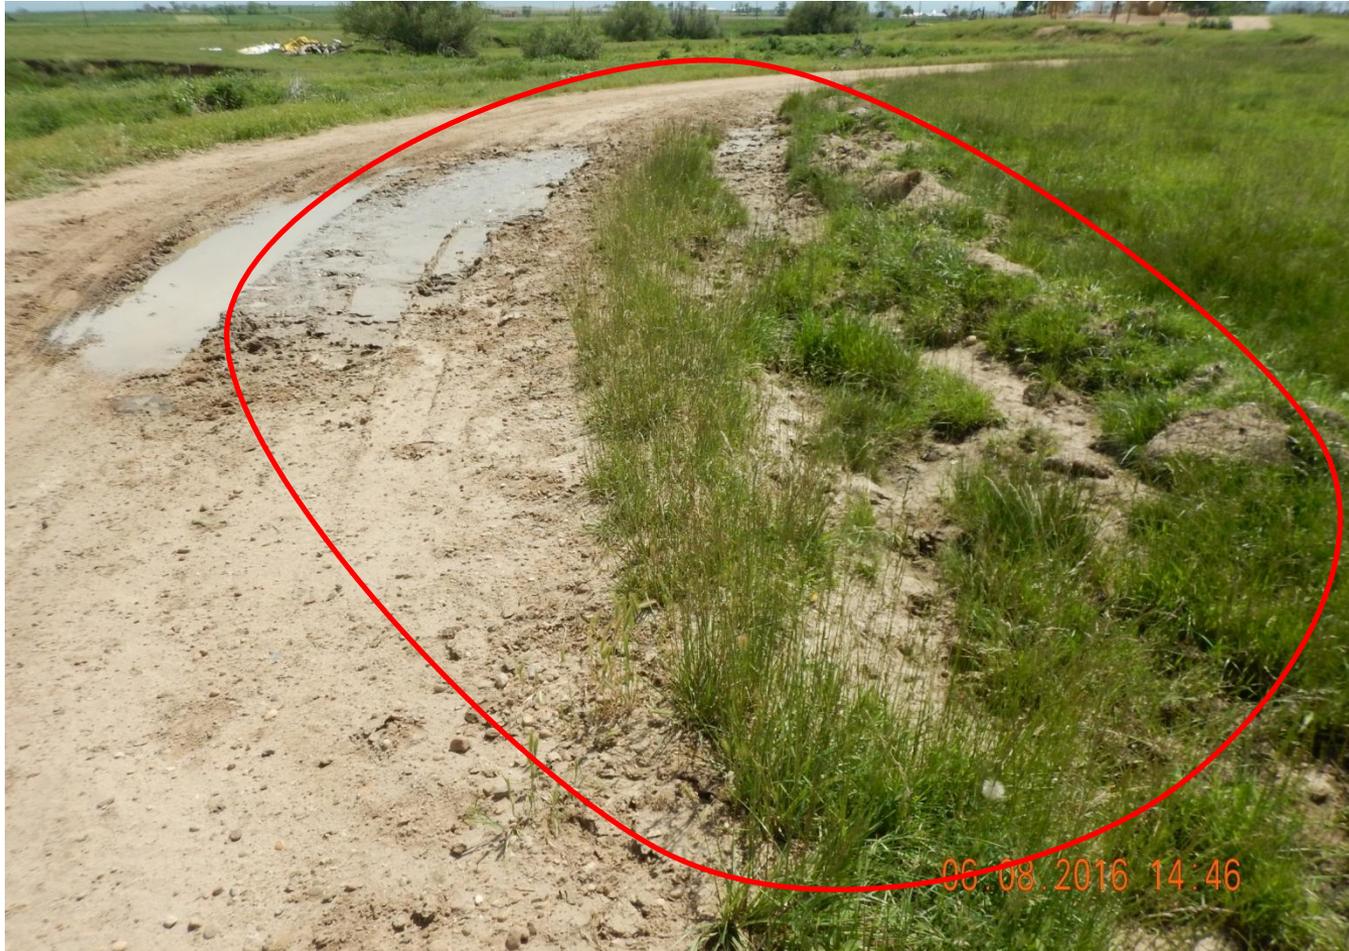
Photo 5. Photo taken north of tank batteries, facing South. Access road was widened. Need to repair access road and reseed portions that will be disturbed. Reseeding may have to wait until the Fall when more favorable conditions are permitted.
