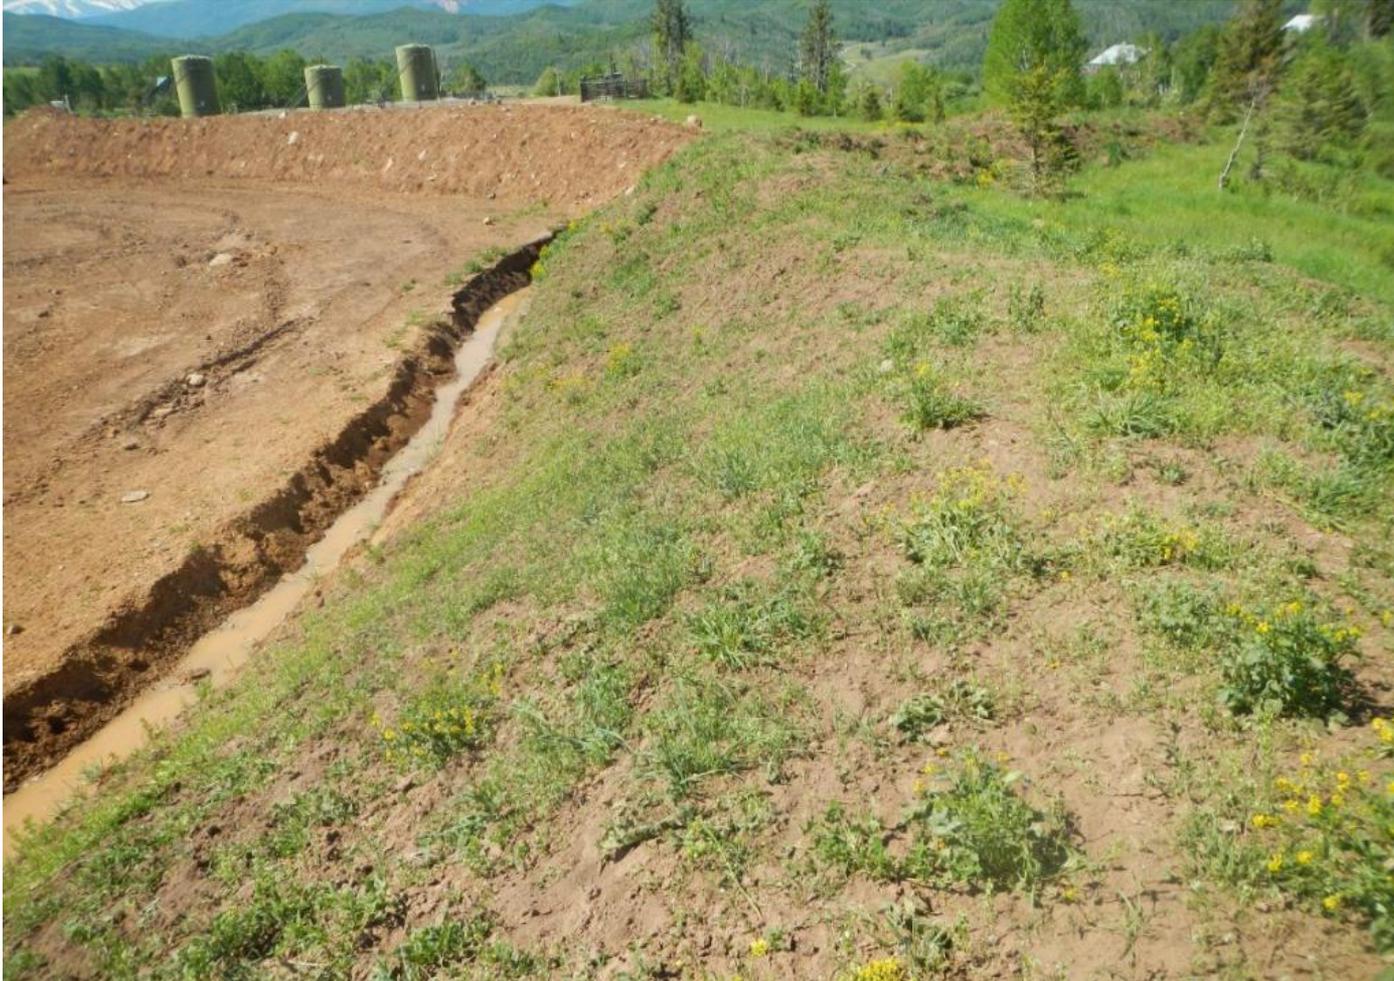
Photo 1. View of the northern portion of the project area from the northeaster corner facing westward. Soil stockpiles around the working area appear to have been seeded and are revegetating along with several ruderal weeds.

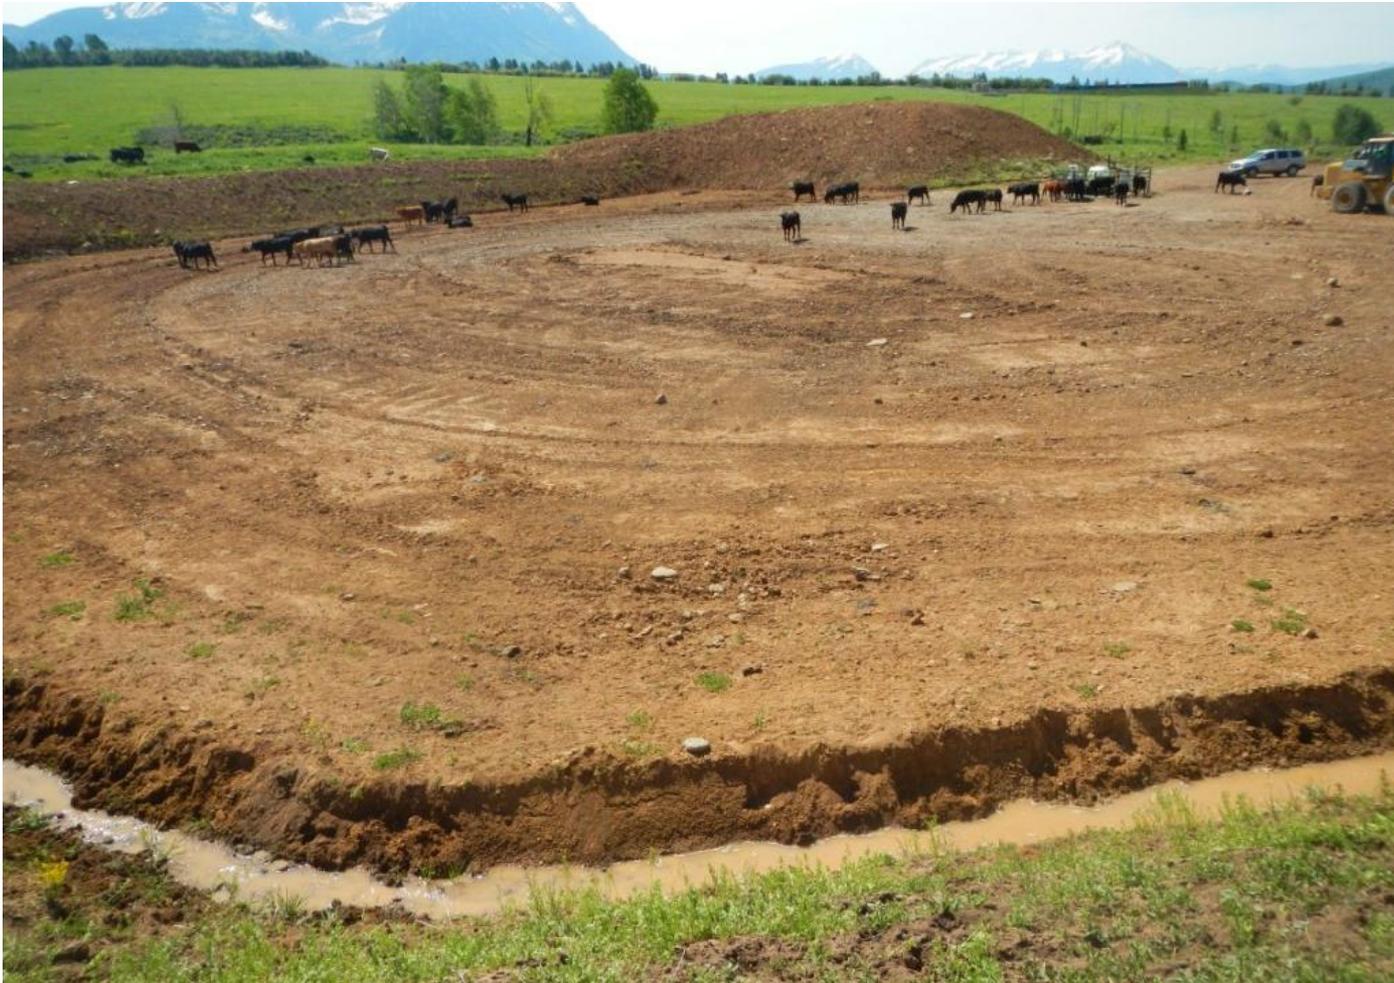
Photo 2. View of the project area from then northeastern corner facing center. Northern portion of the well pad does not appear necessary for production operations.

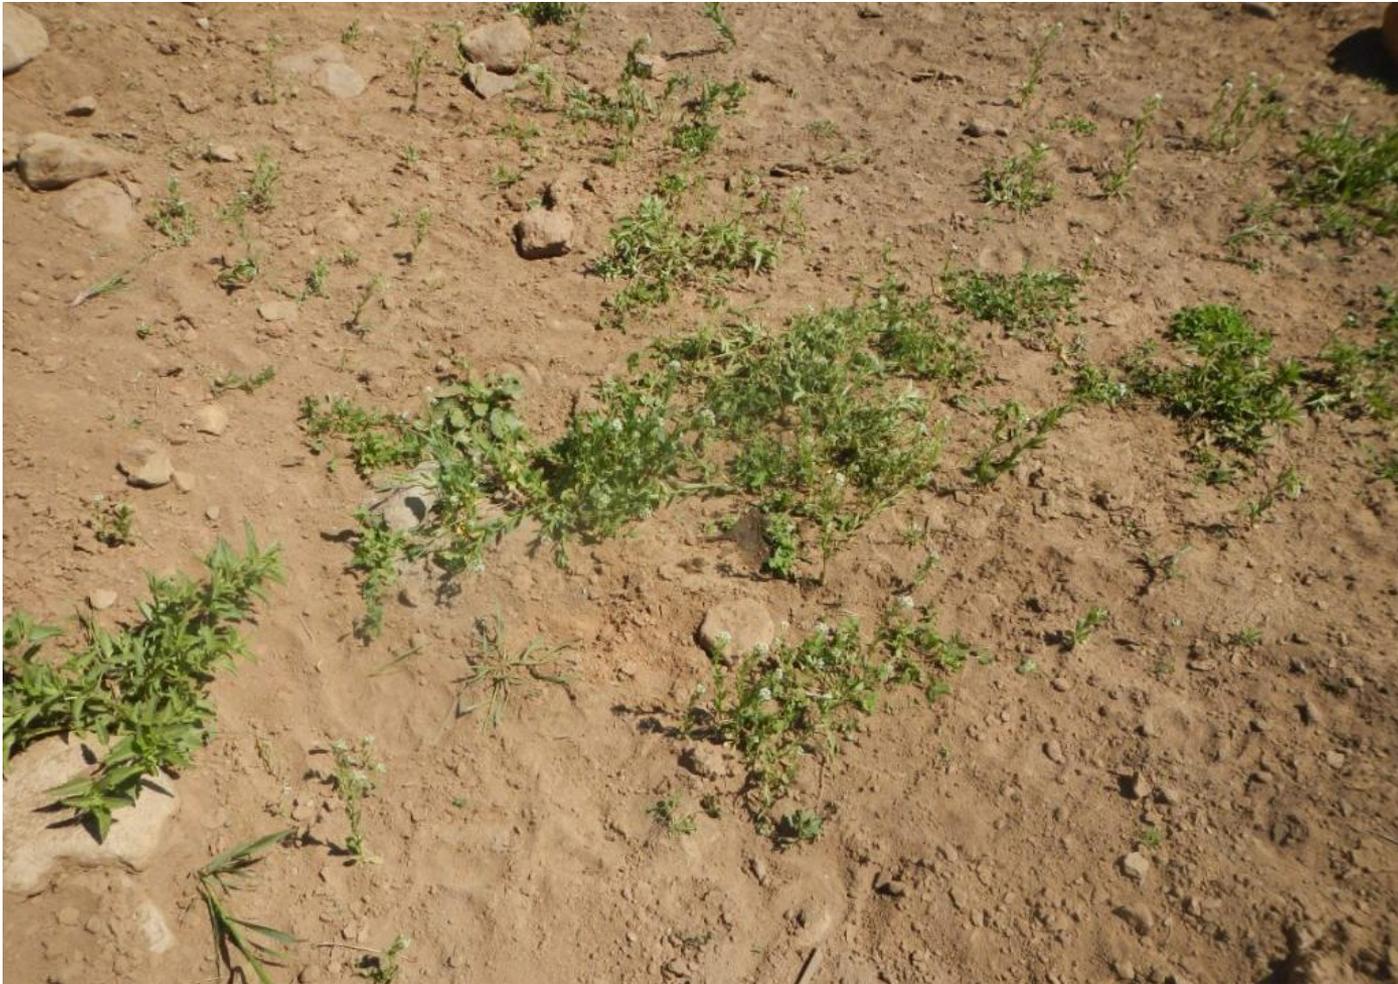
Photo 4. View of hoary cress (*Cardaria draba*) plants growing on the well pad.
