Cover Data

Date: 5/26/16 Inspected By: Ryan Costa
 Location/Operator: API # 073-06314 Running Fox Petro

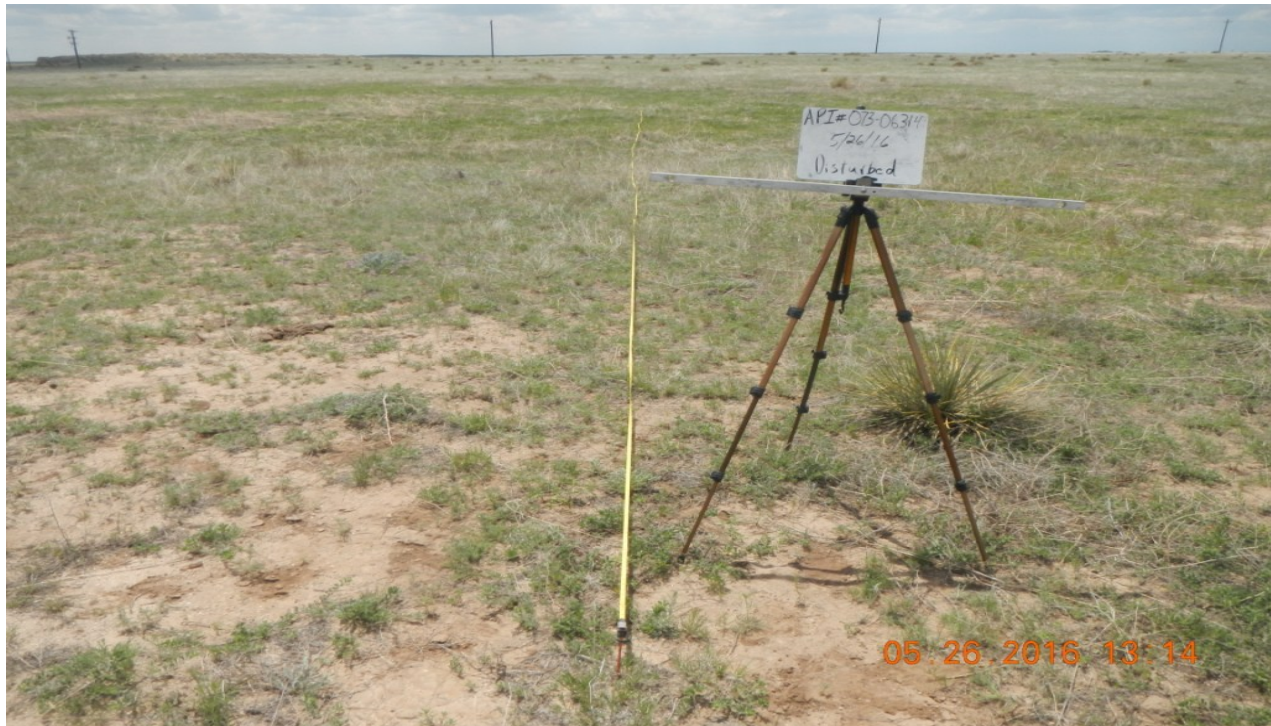
photo 1: Beginning of transect facing southwest at the location (disturbed).

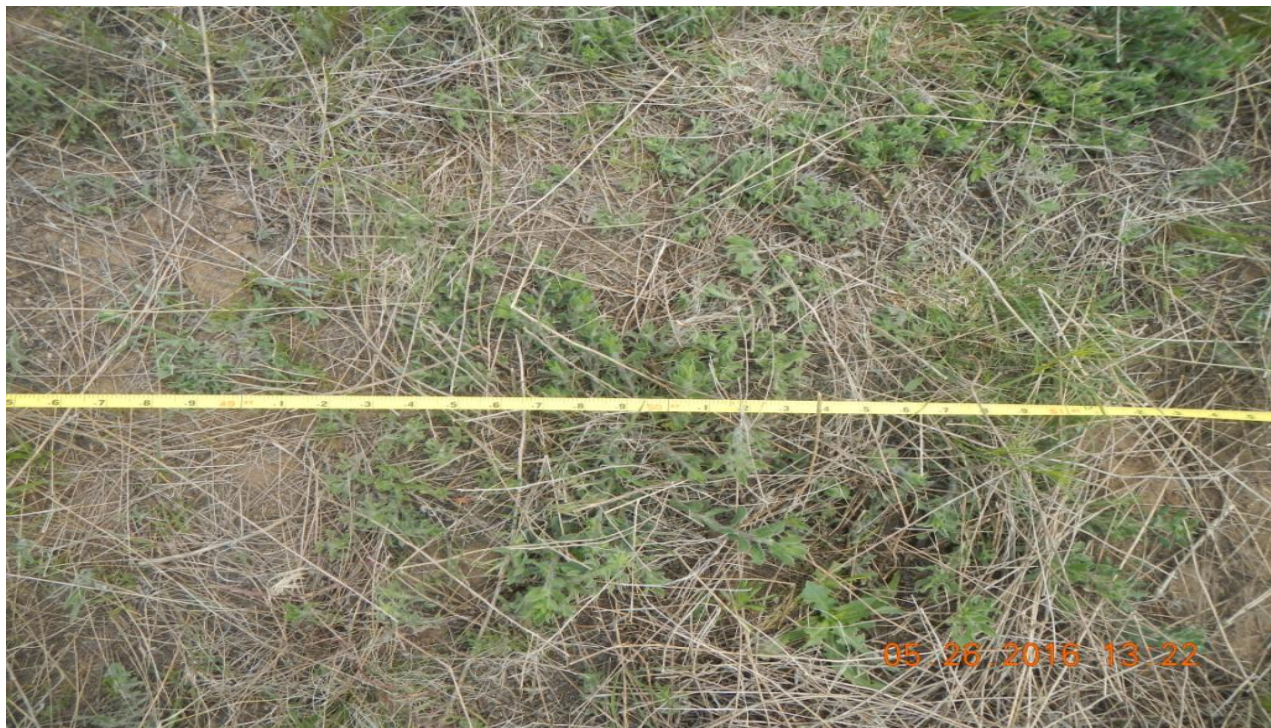
photo 2: View of groundcover at midpoint of transect at the location (disturbed).

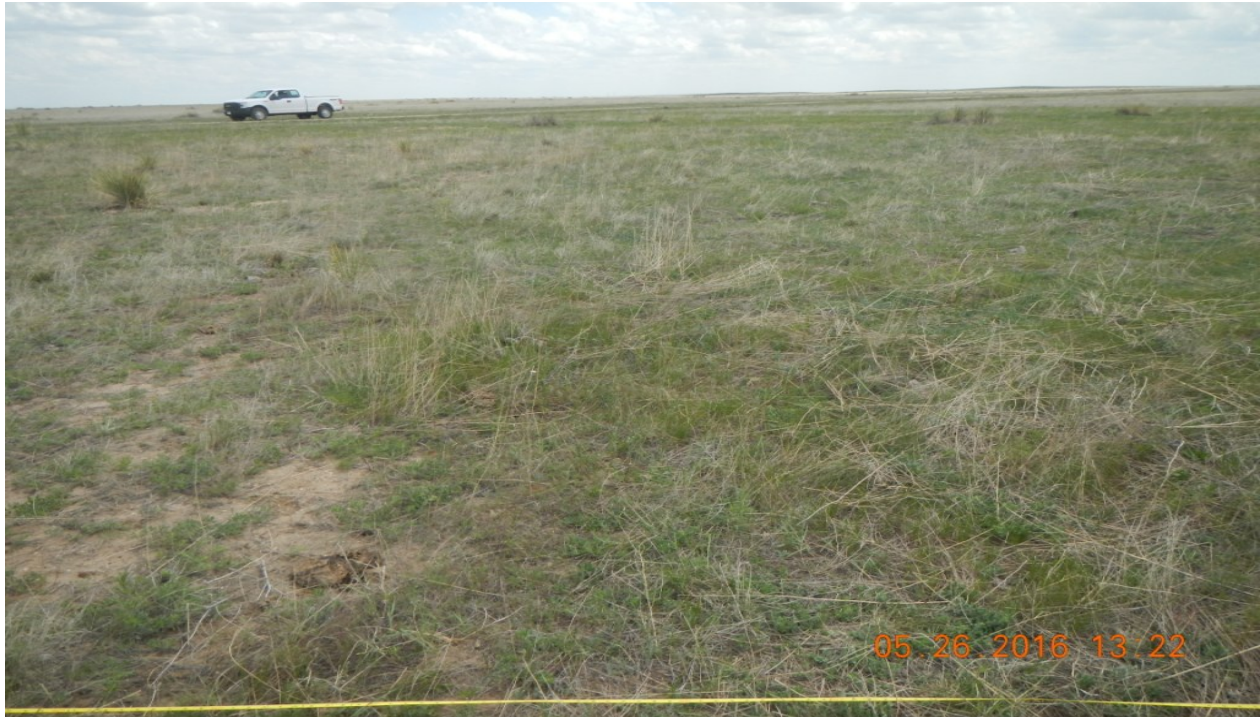
photo 3: Midpoint of transect facing southeast at the location (disturbed).

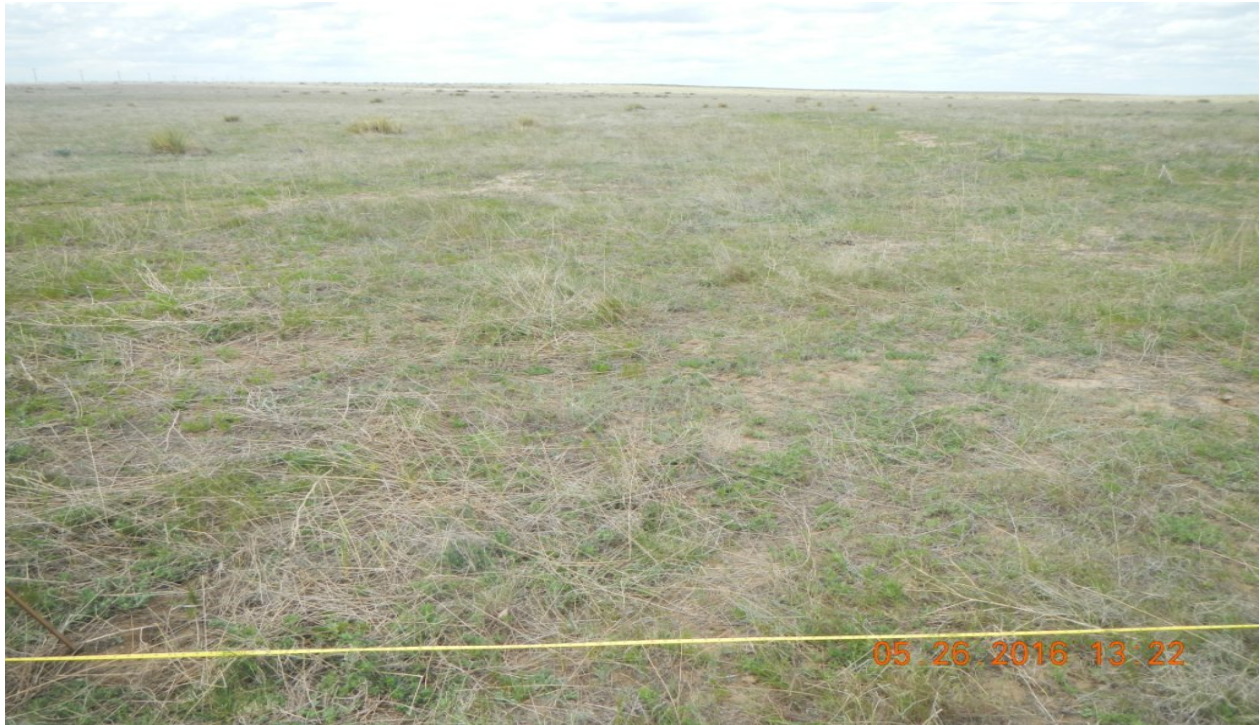
photo 4: Midpoint of transect facing northwest at the location (disturbed).

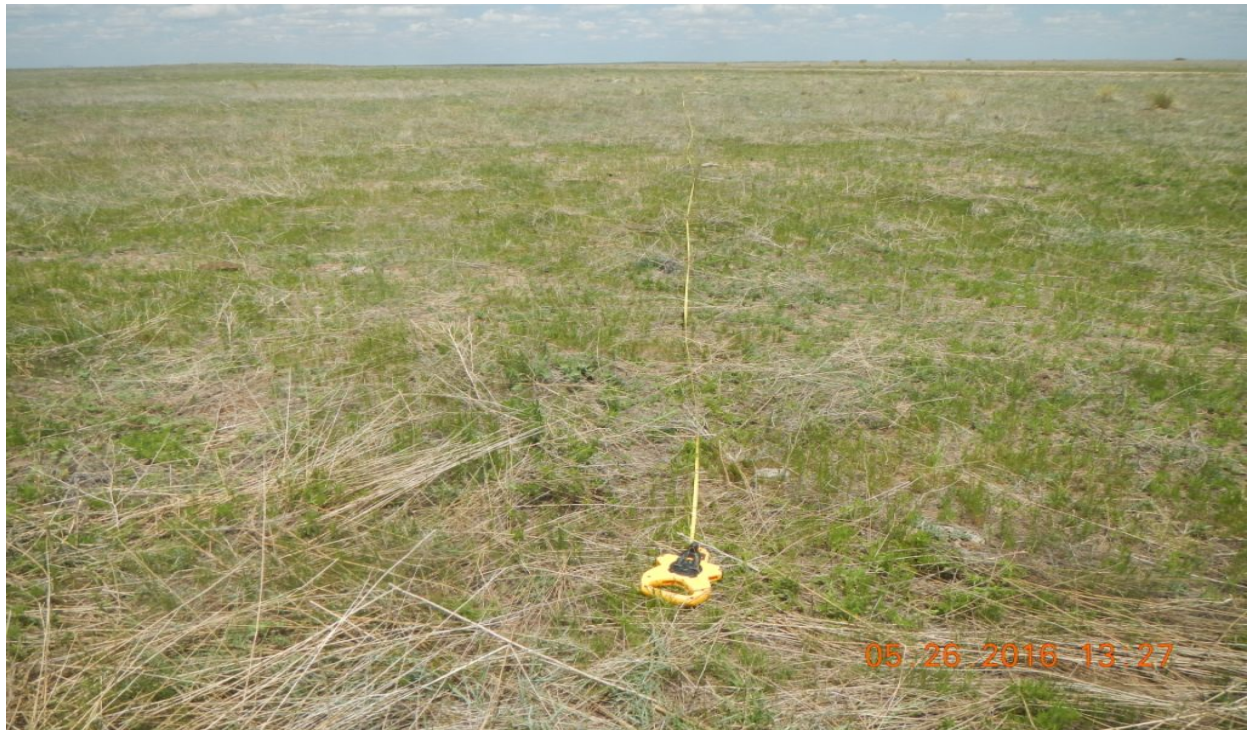
photo 5: End of transect facing northeast at the location (disturbed).

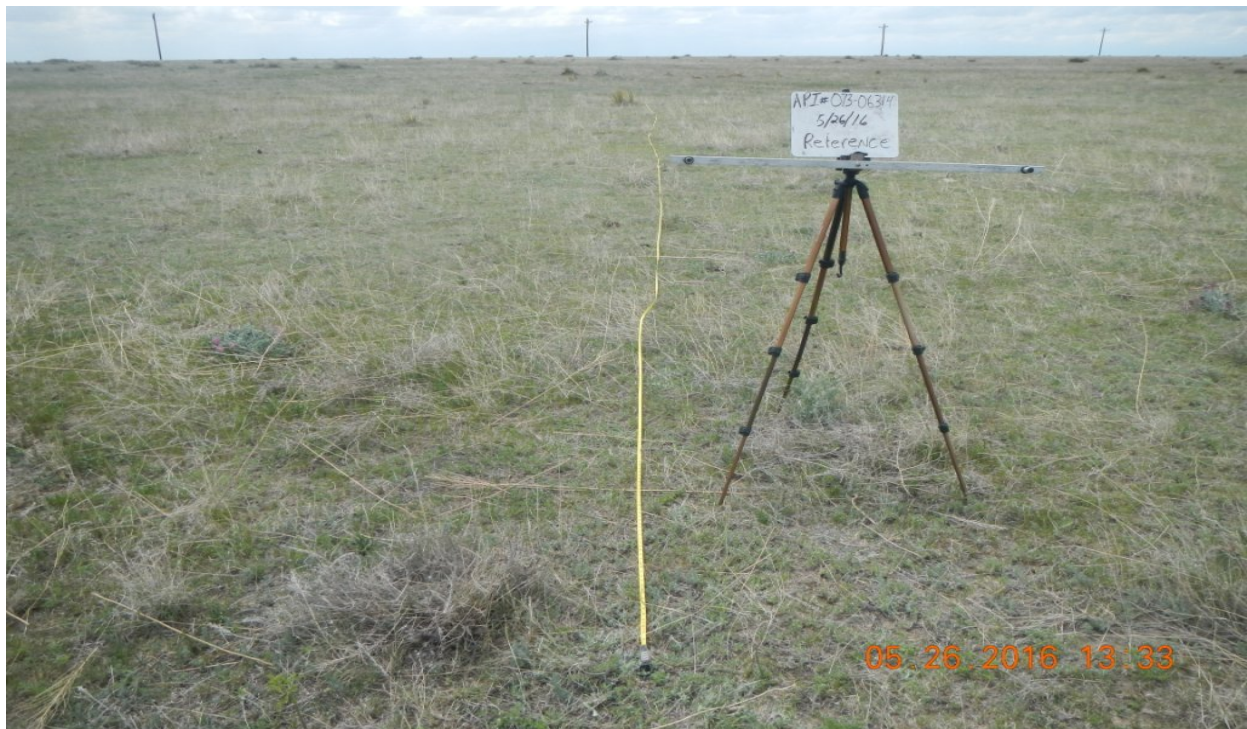
photo 6: Beginning of transect facing southwest at the reference area.

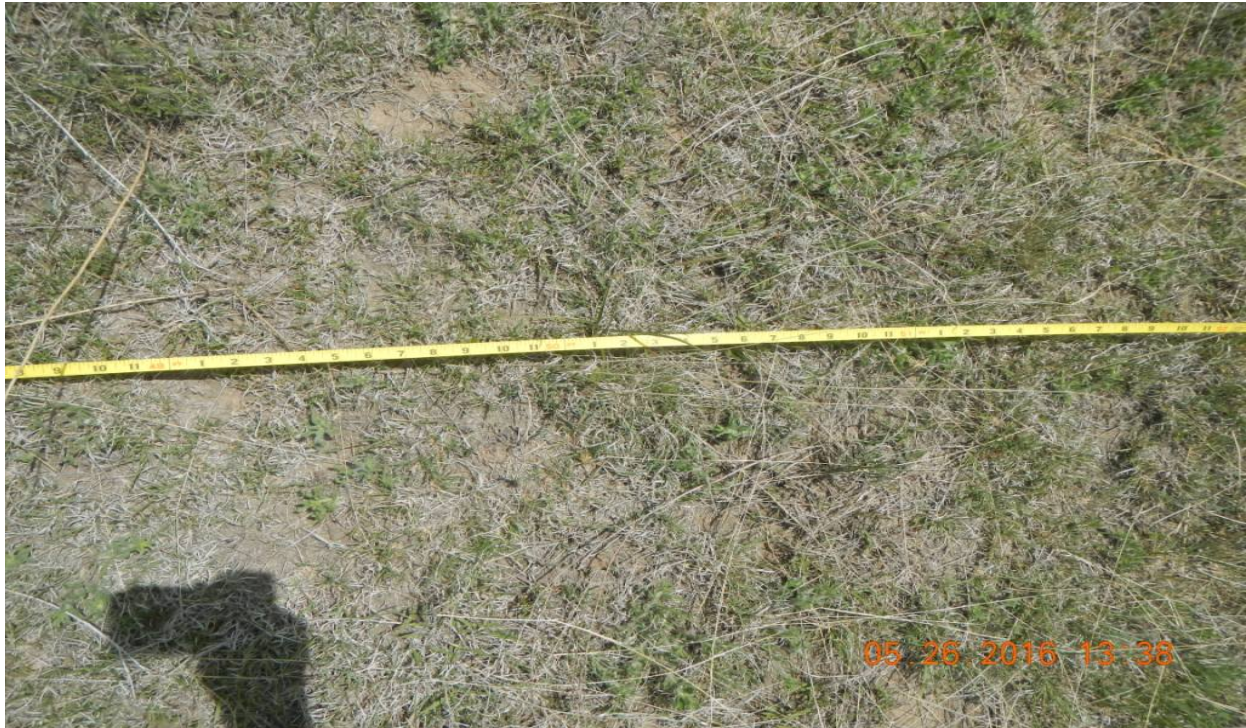
photo 7: View of groundcover at midpoint of transect at the reference area.

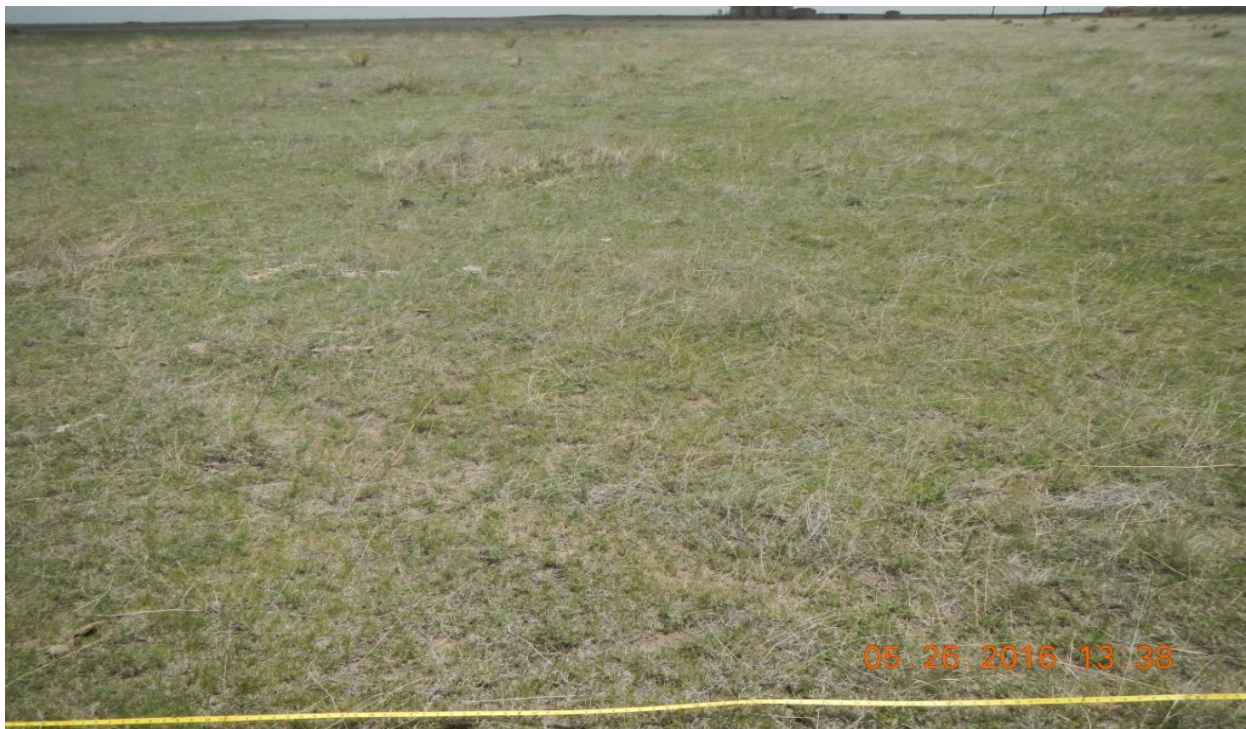
photo 8: Midpoint of transect facing southeast at the reference area.

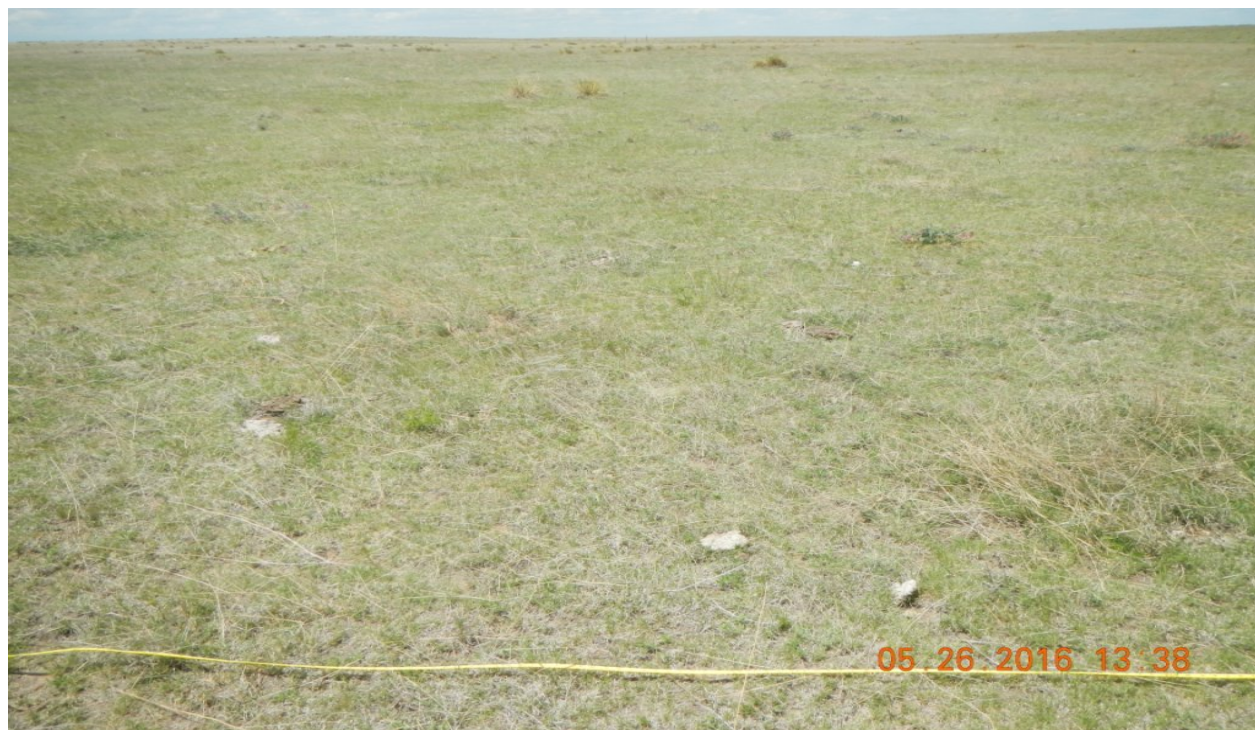
photo 9: Midpoint of transect facing northwest at the reference area.

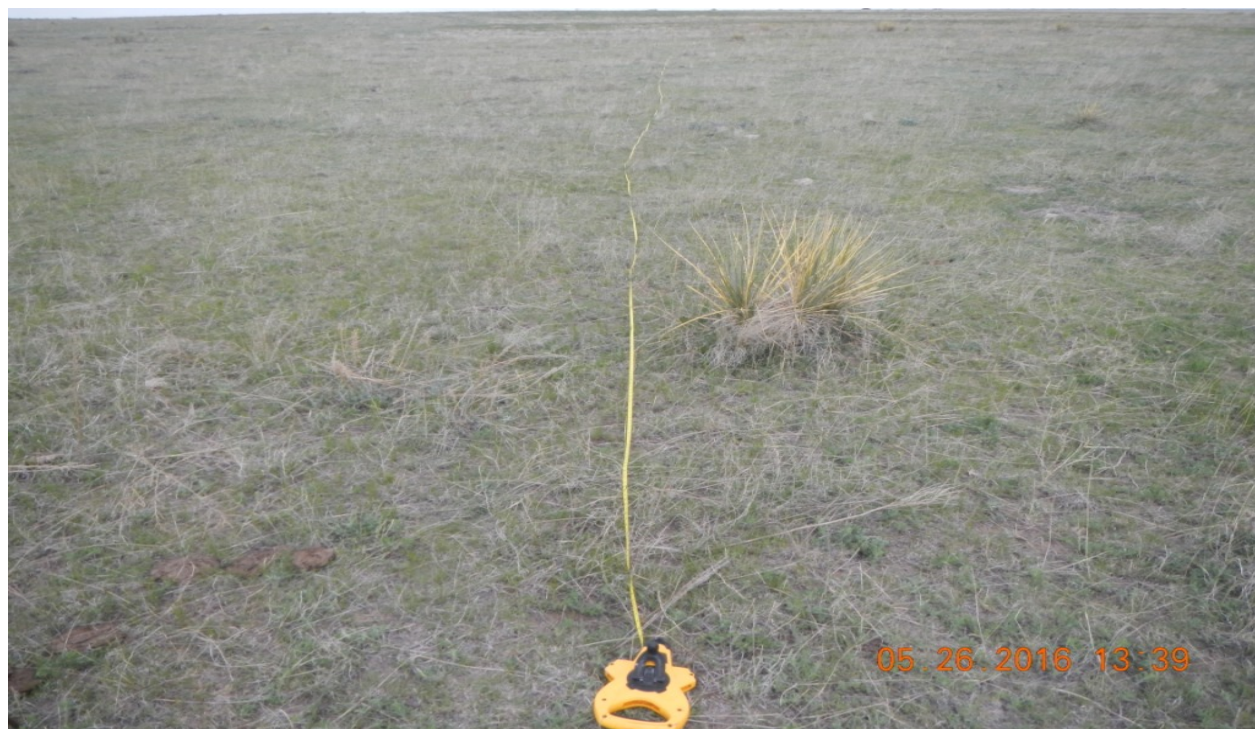
photo 10: End of transect facing northeast at the reference area.
