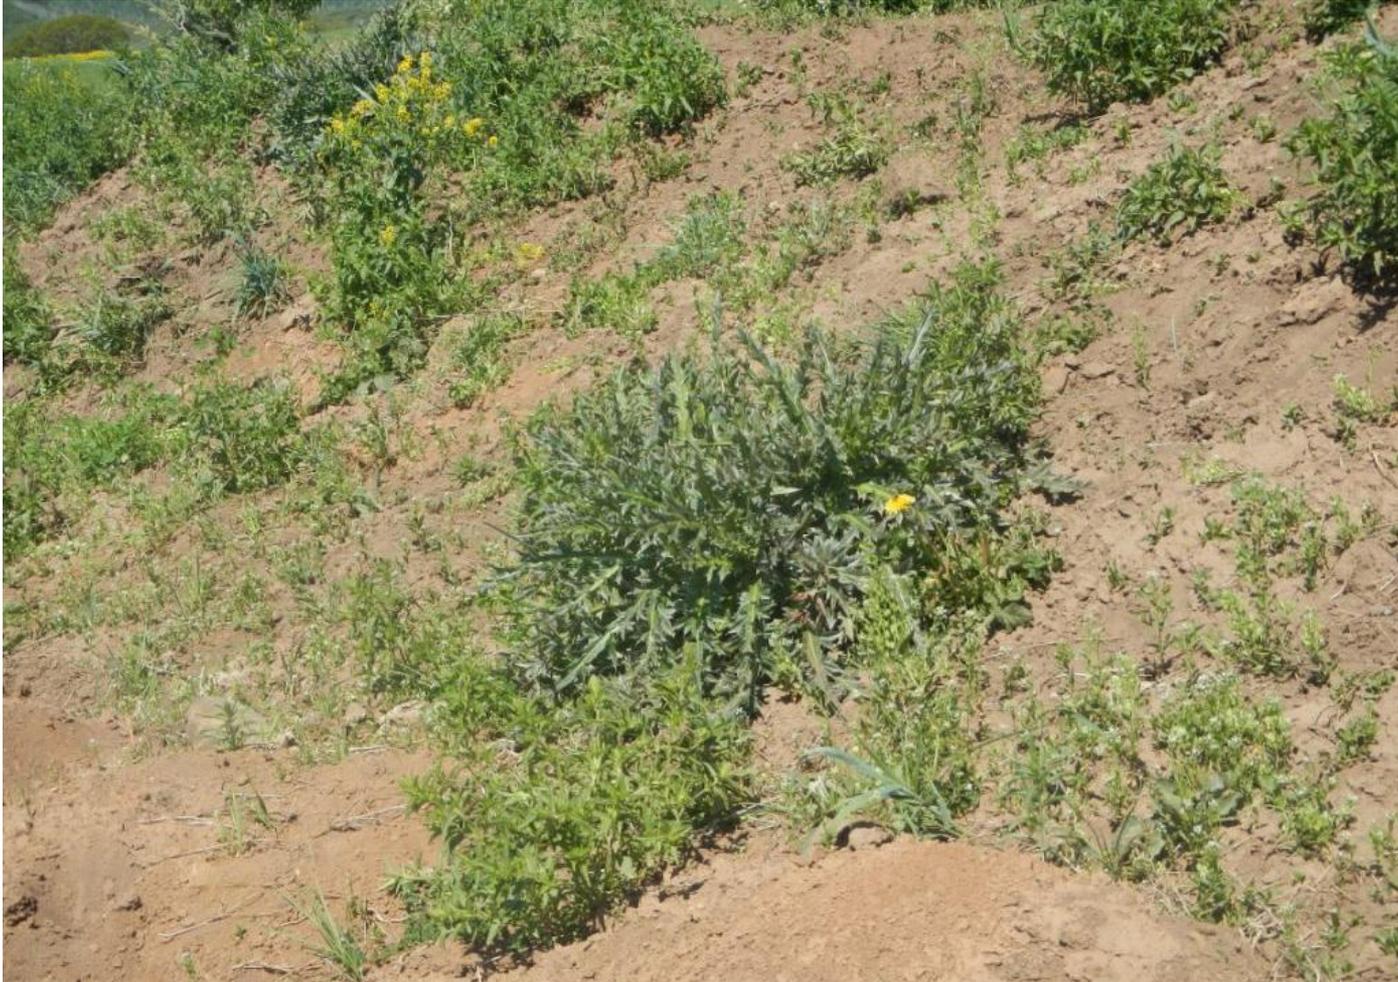
Photo 1. View of musk thistles (*Carduus nutans*) in the northern portion of the project area.

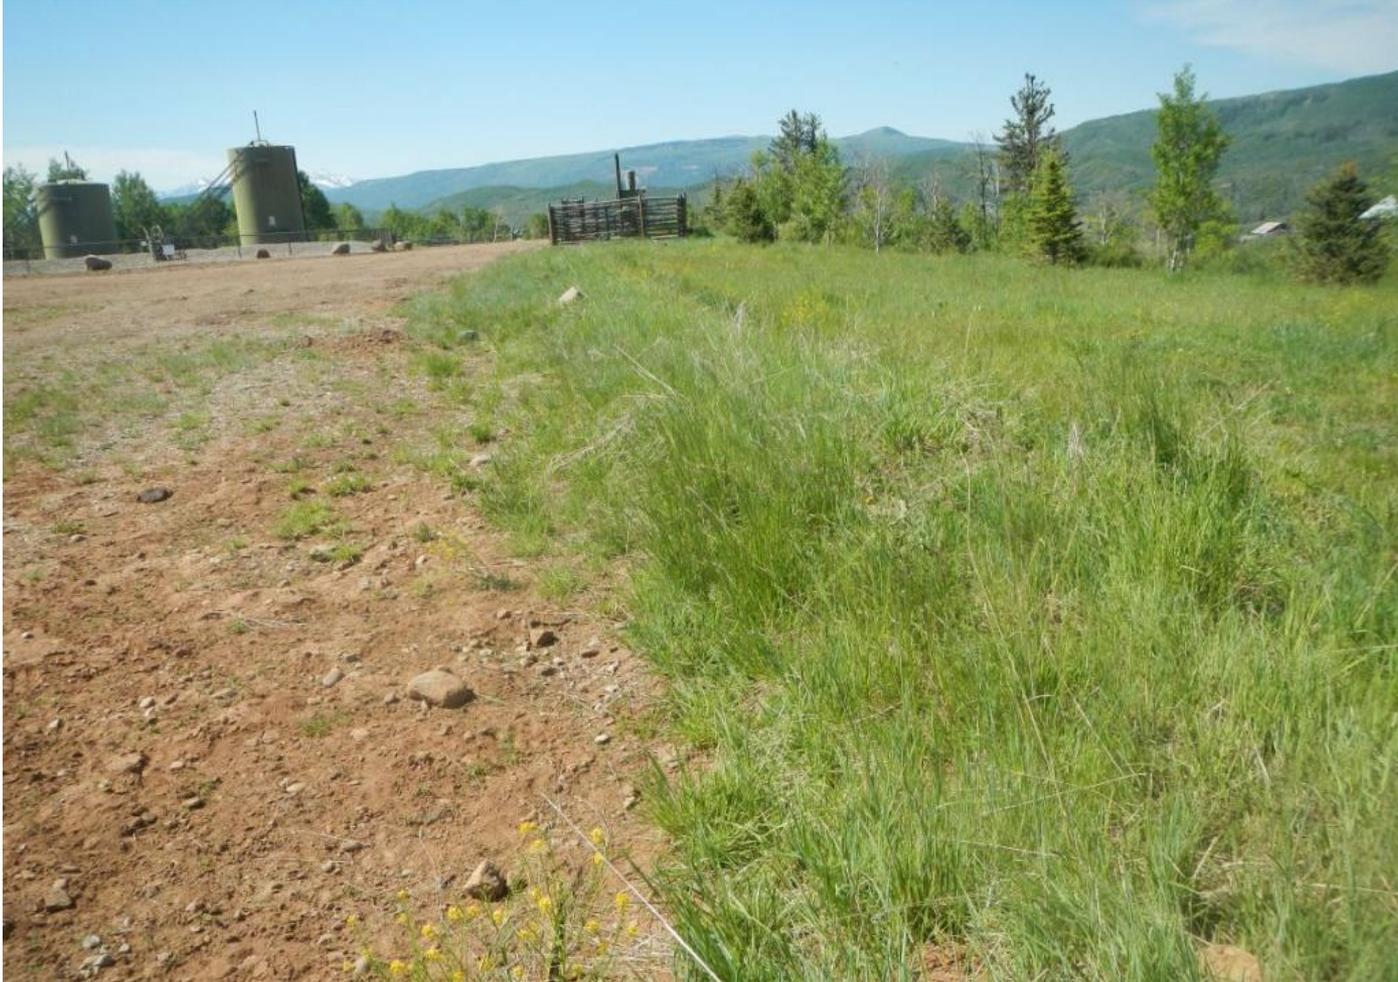
Photo 2. View of the western portion of the project area from the northwestern corner facing southward.

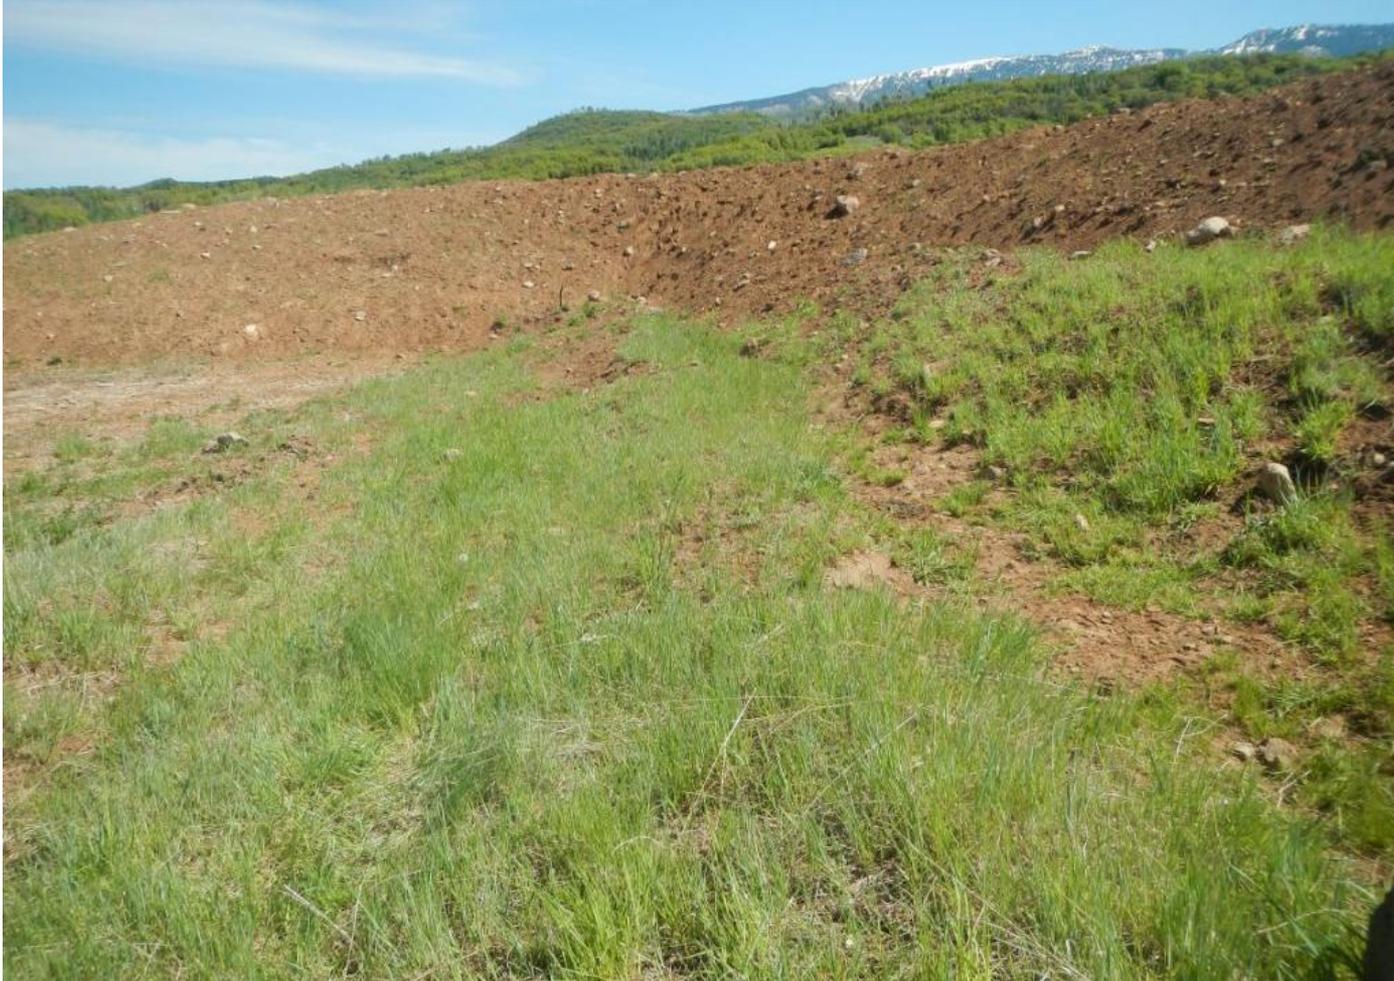
Photo 3. View of the northeastern portion of the project area from the eastern edge facing northward. Revegetation is progressing on the flat well pad surface, thin corner revegetation on soil stockpiles.

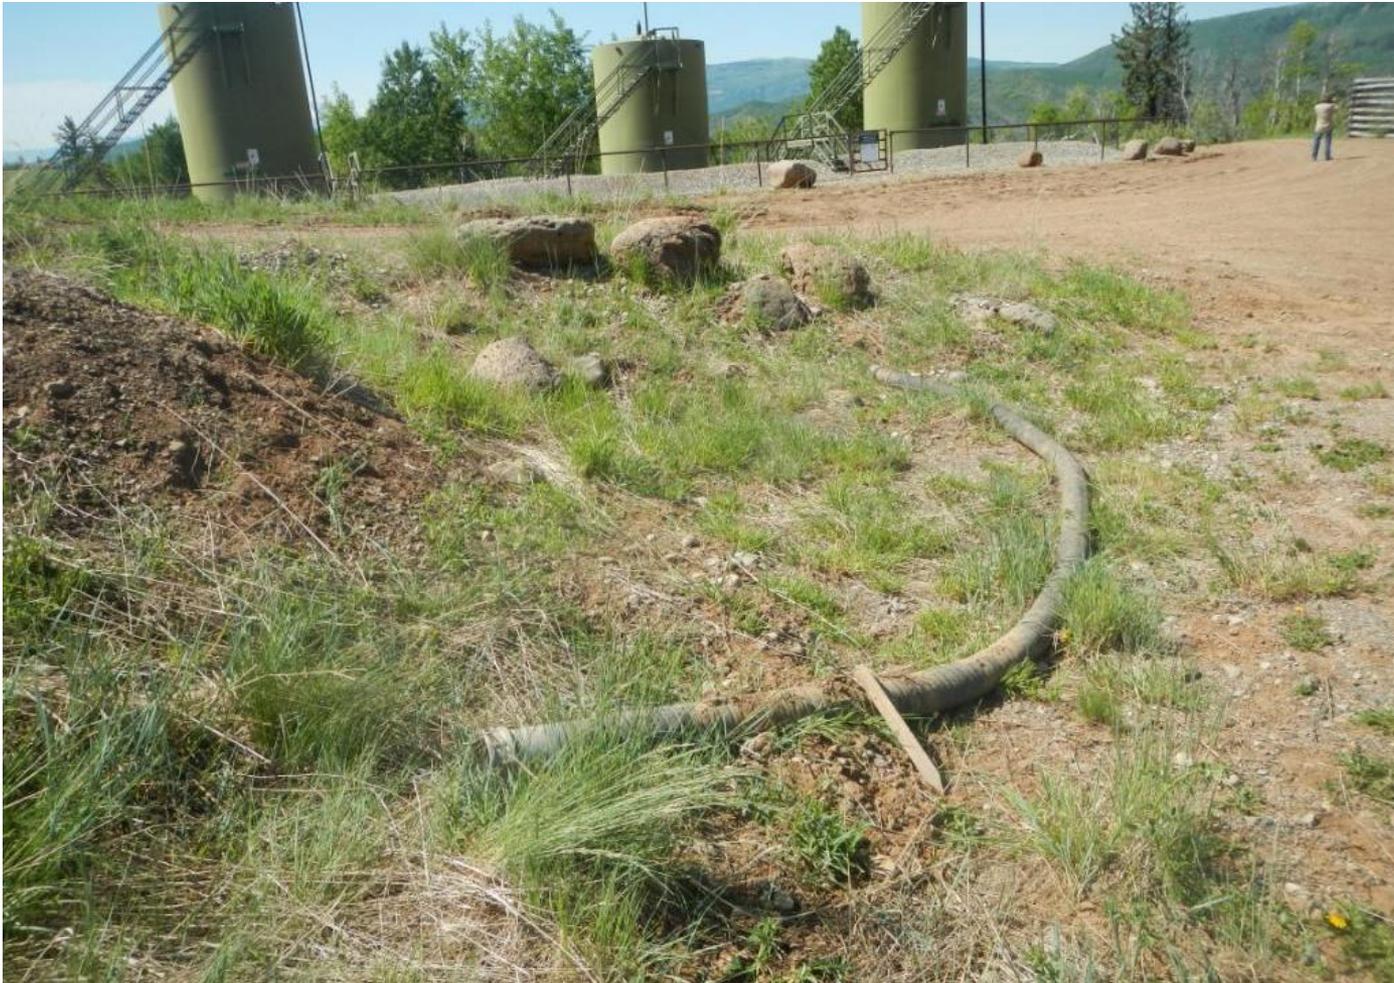
Photo 4. View of the southeastern portion of the project area from the eastern edge facing southward. Unused pipe and wood stake need to be removed.

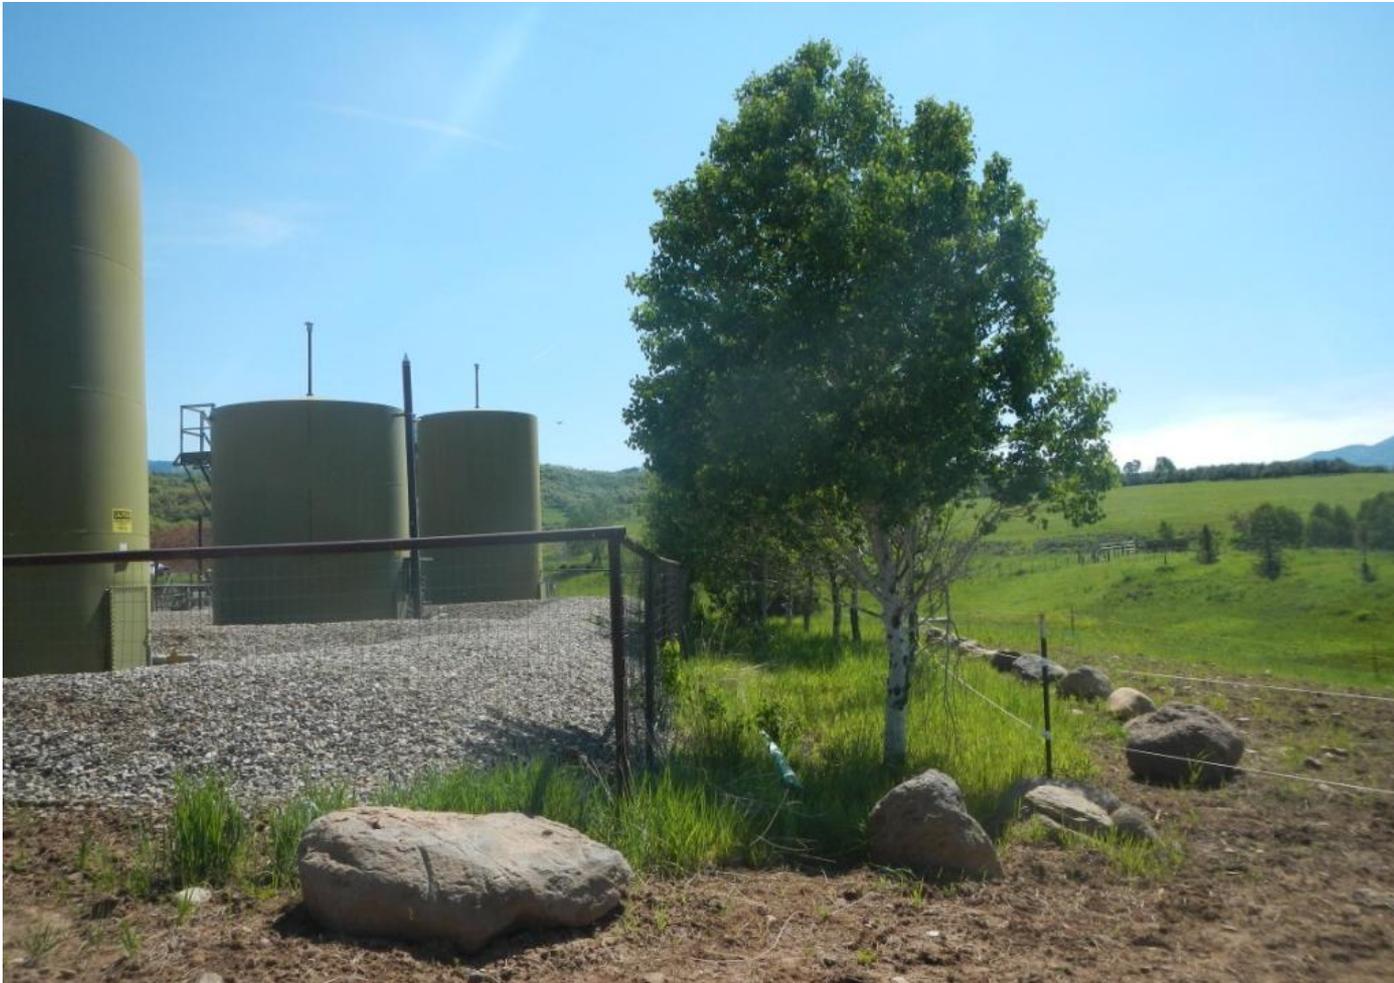
Photo 5. View of the southern portion of the project area from the southwestern corner facing eastward. Good grass revegetation here. It appears that aspen trees were planted along southern project border.
