Iles Investment CO 1-23

Inspection# 673403285

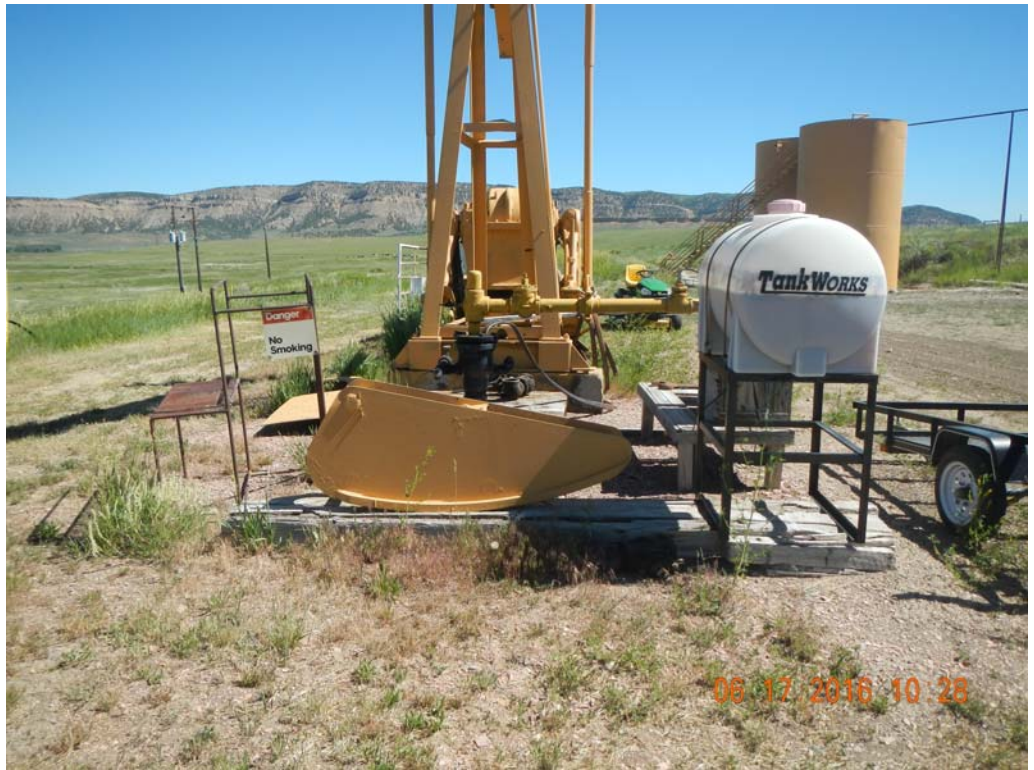
No wellhead sign.

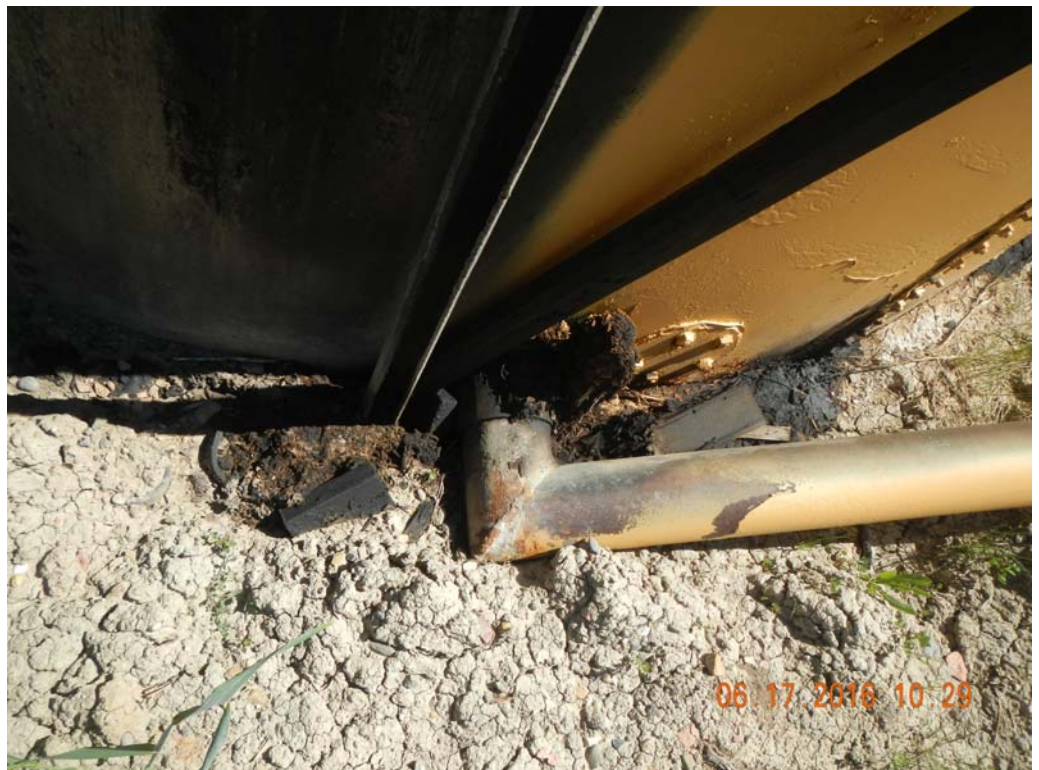
Stained soil from leak at tank base.

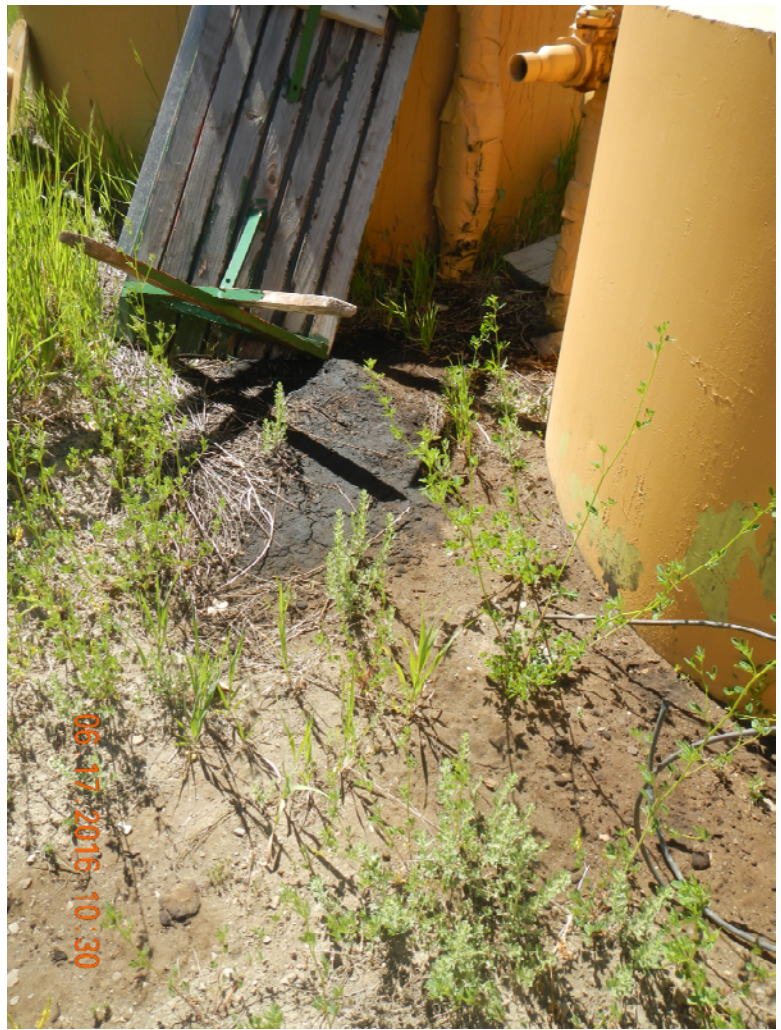
Stained soil from leak at tank base.

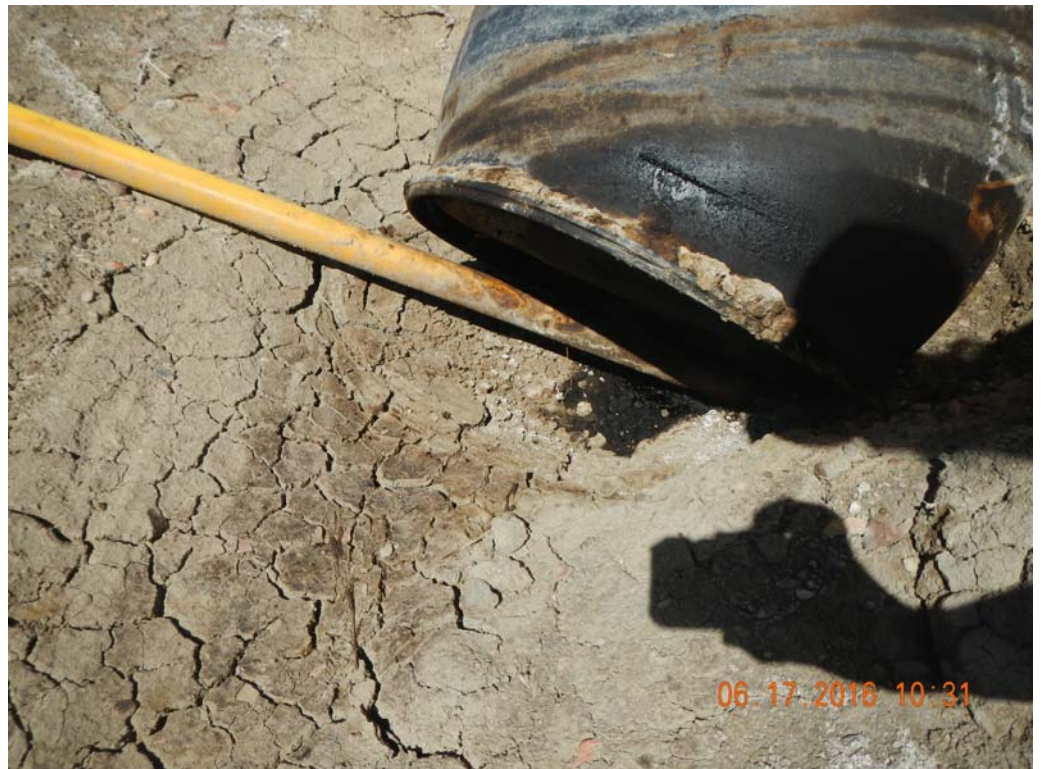
Stained soil below bucket below leak at tank loadout.

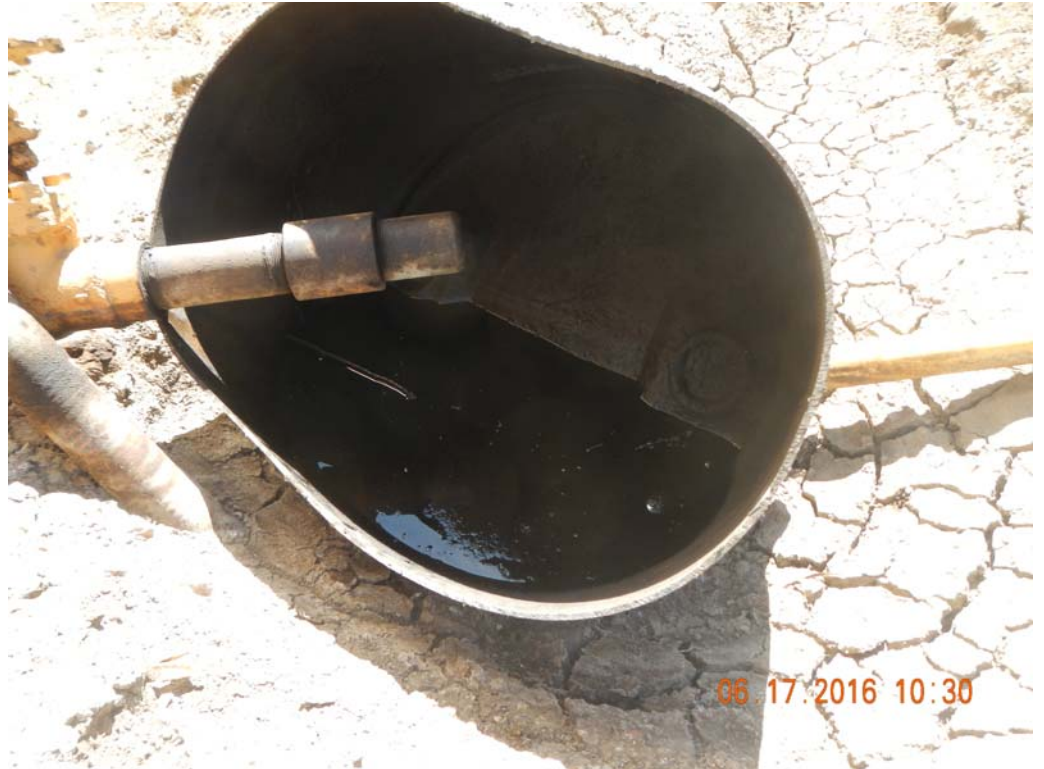
Fluid in bucket
approximately 1 inch from
overflowing.

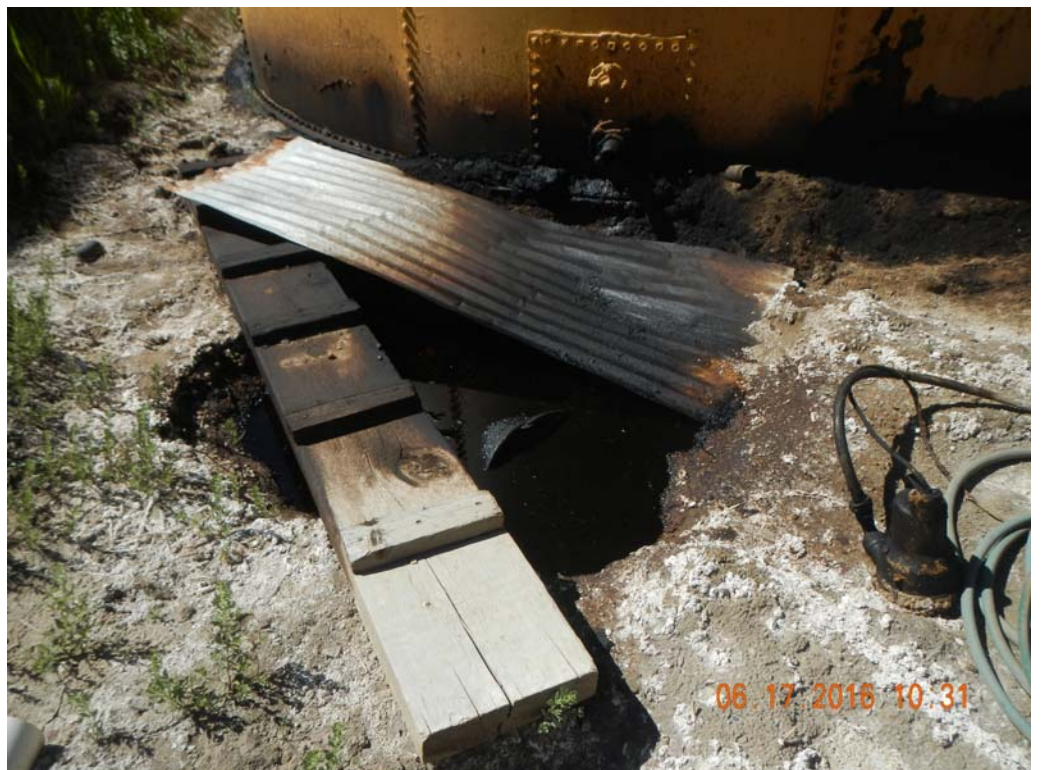
Stained soil and fluid from
leak at tank base.

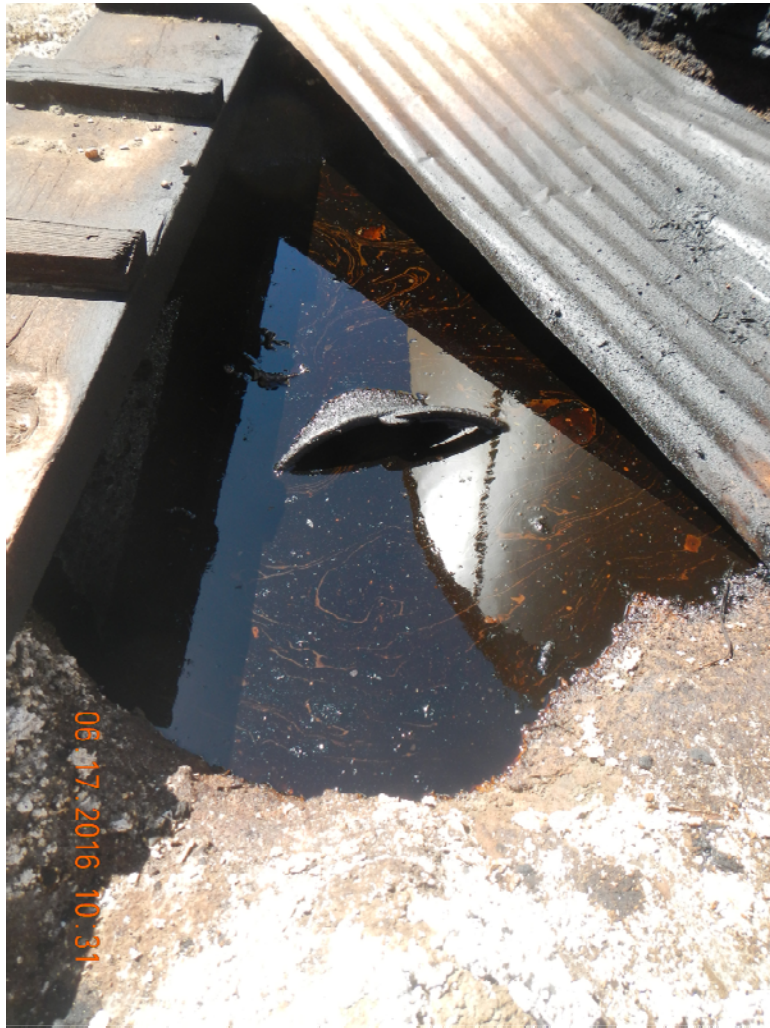
Close up of fluid at tank base.

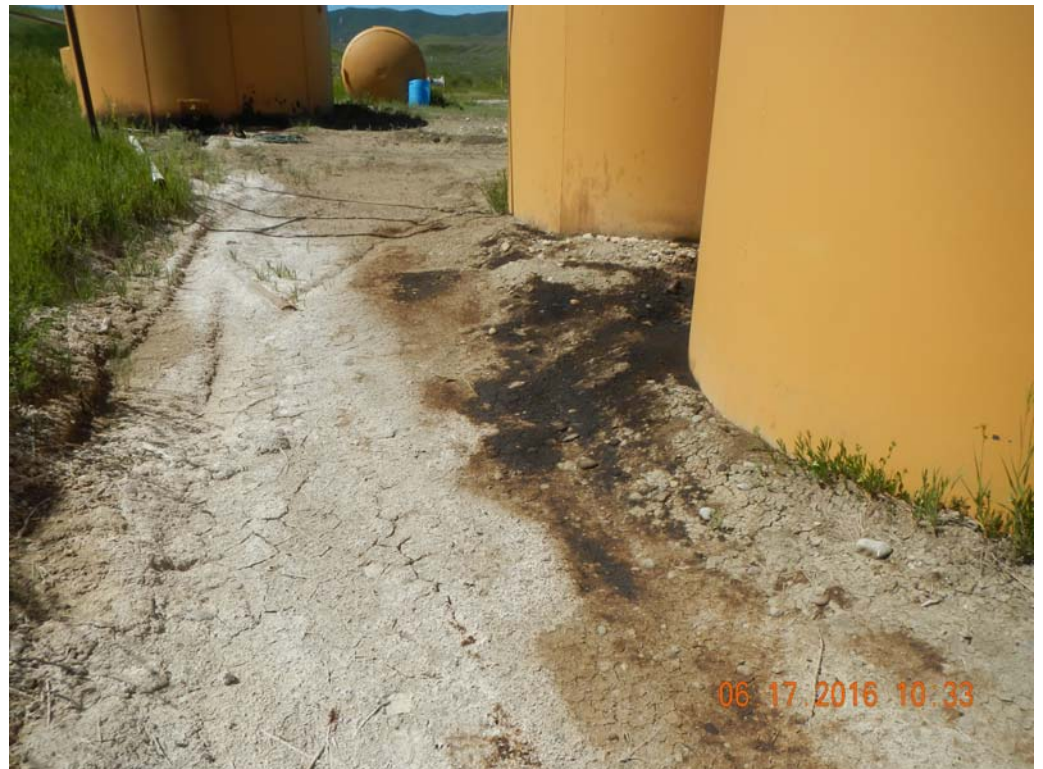
Stained soil at tank bases.

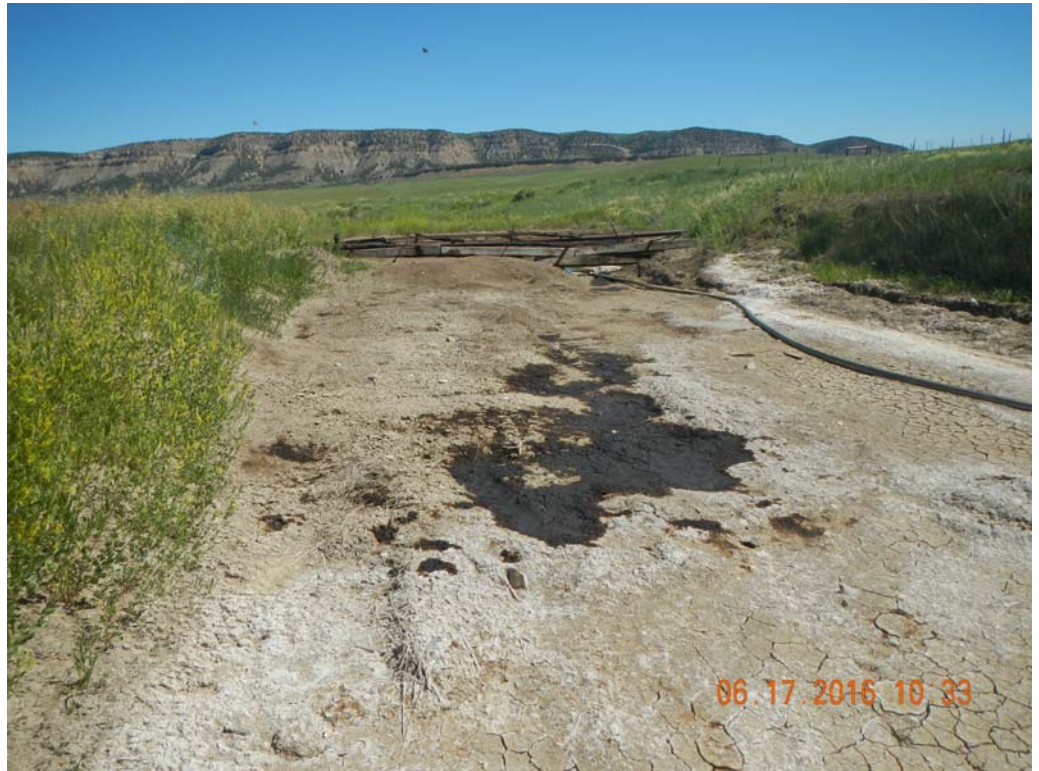
Stained soil between tanks and pit.

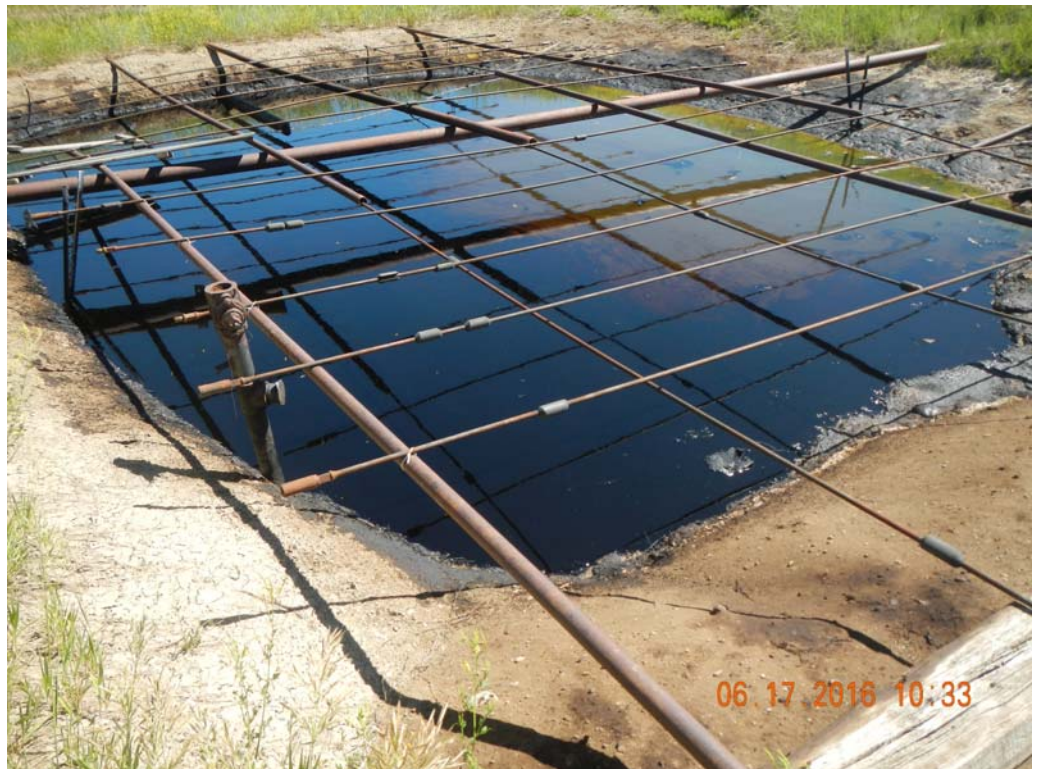
Pit without net. Water and product present in pit. 2 feet of freeboard not present.

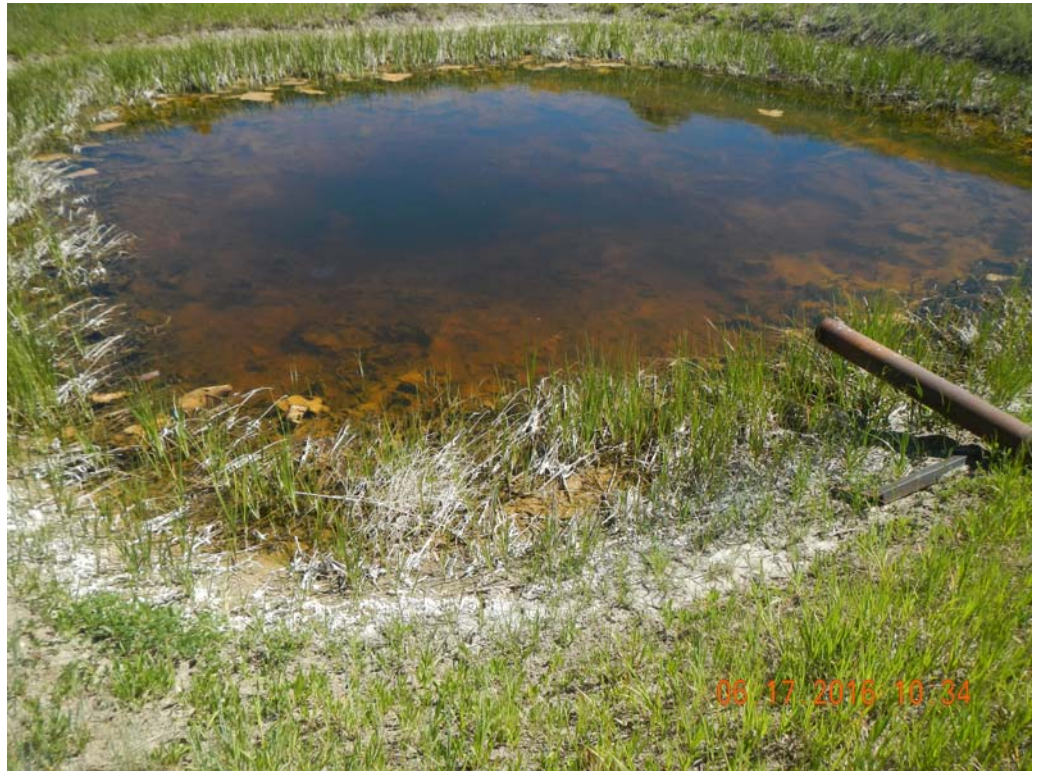
Pond adjacent to pit with multiple sheen spots observed.

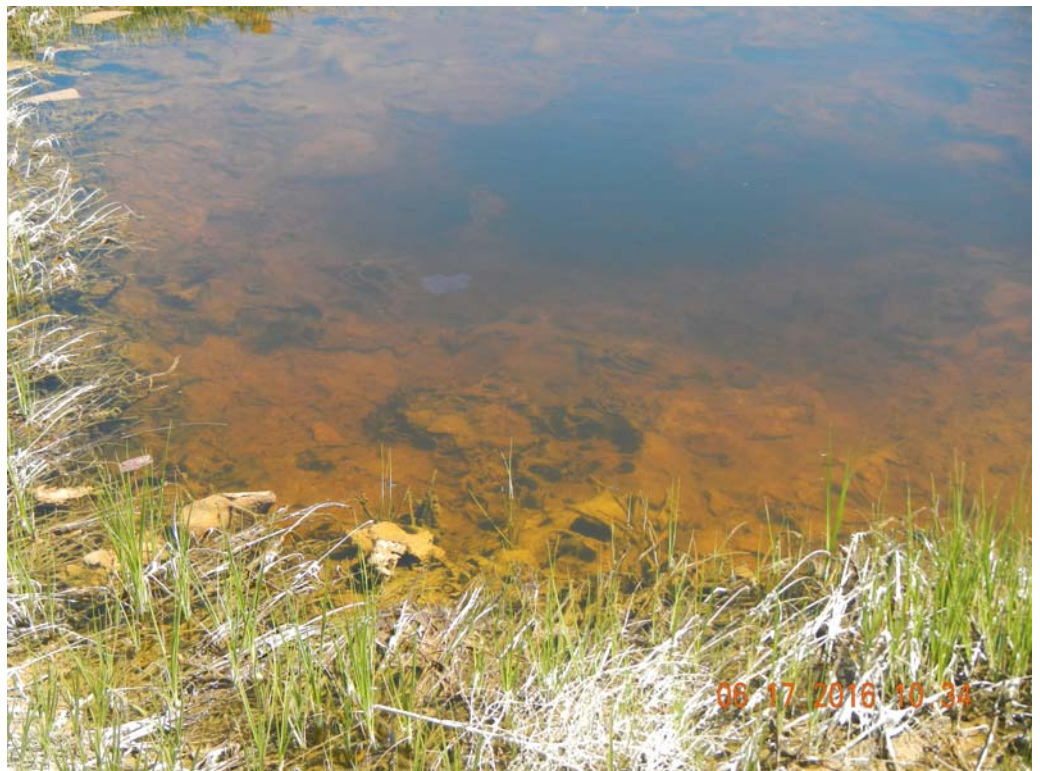
Close up of one sheen spot.

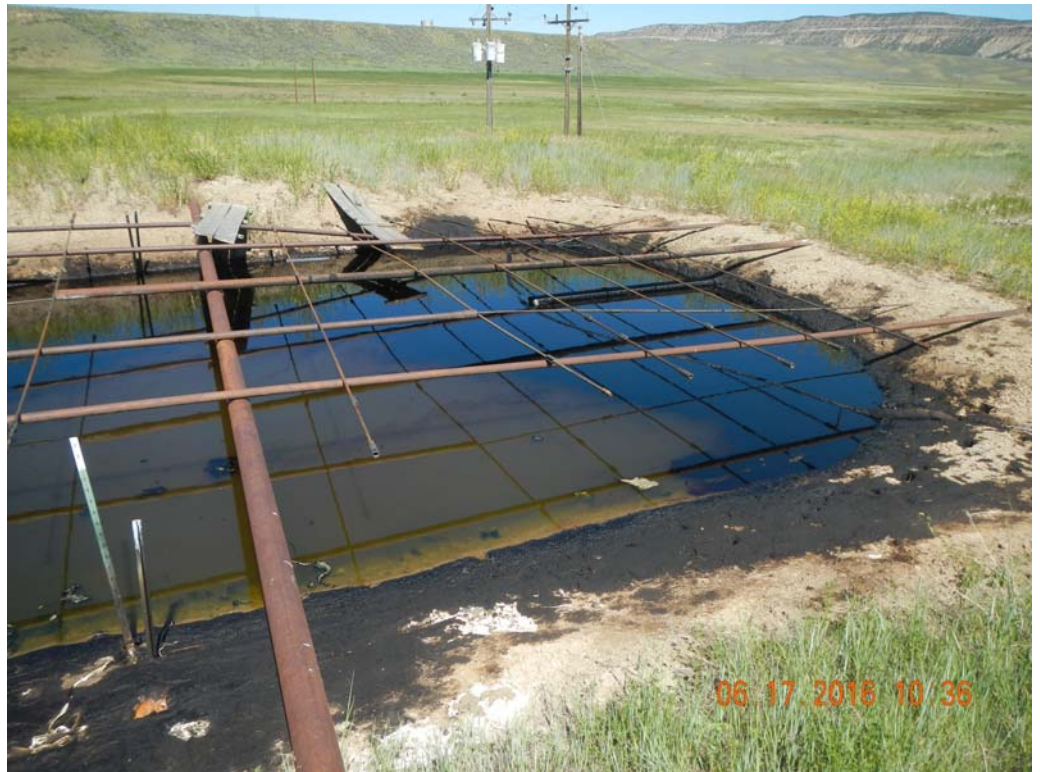
Pit without netting and without 2 feet of freeboard. Drainage ditch and stream visible in background.

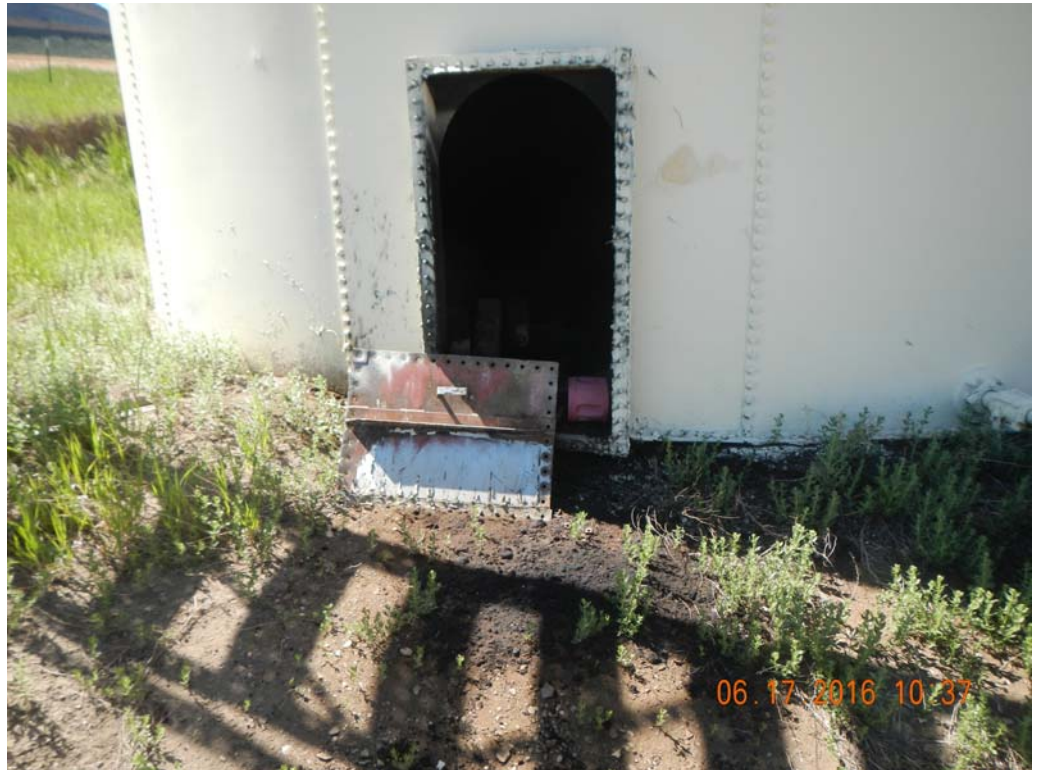
Stained soil at base of tank.
No tank label.

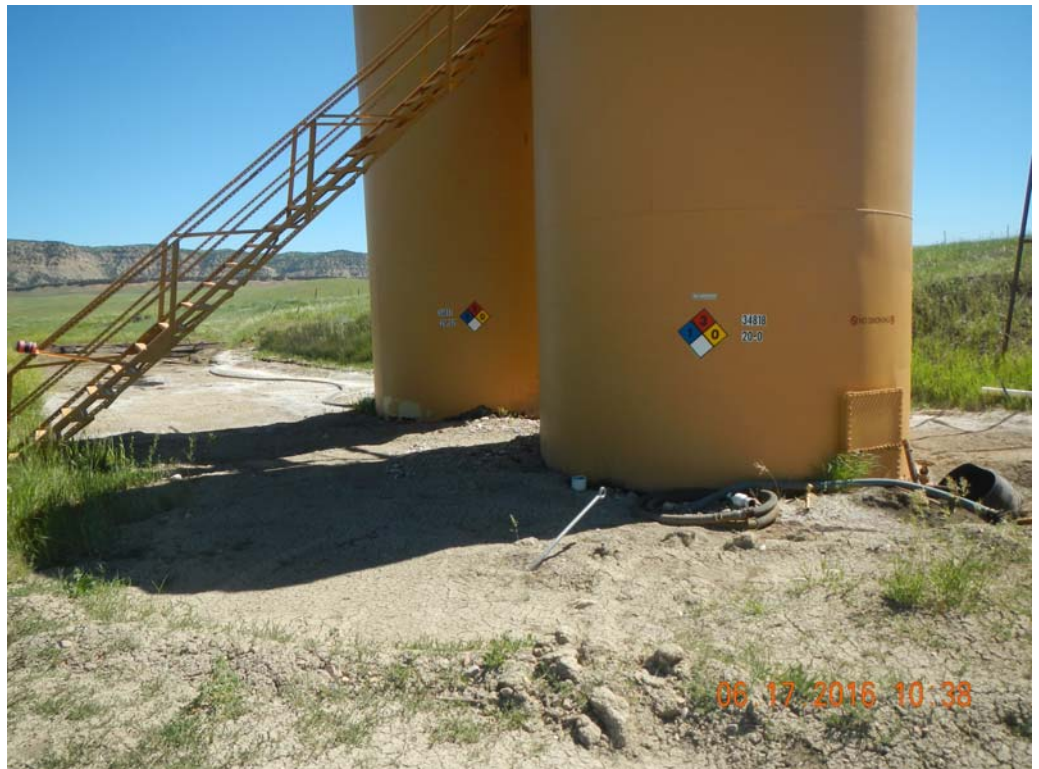
Incomplete tank labels.
