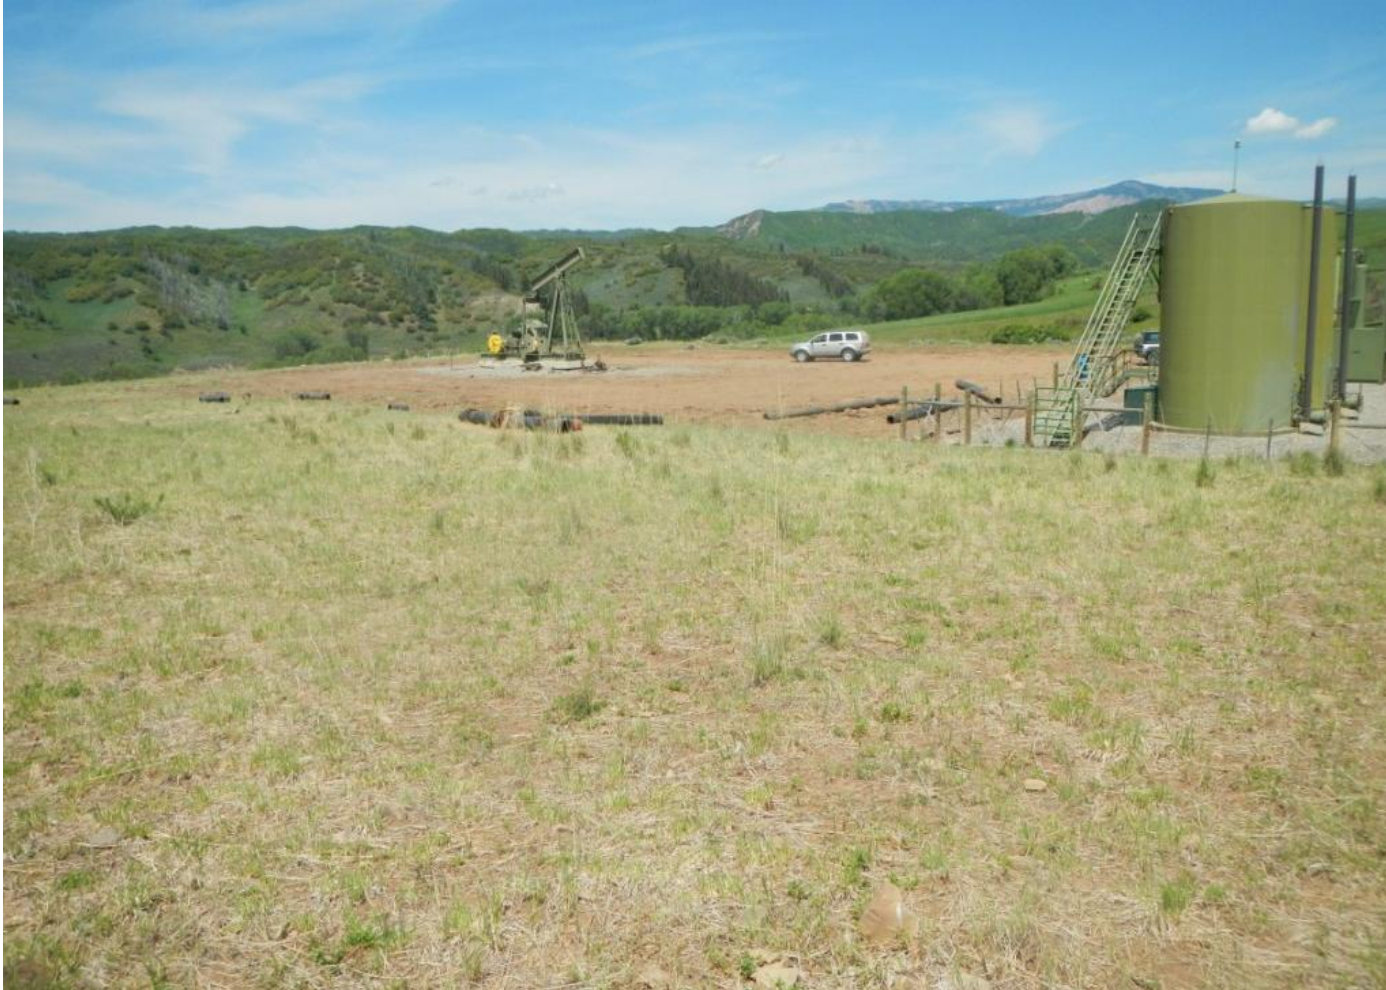
Photo 1. View of the project area from the southeastern corner facing center. Revegetation is progressing and is largely comprised of grazed grasses and shrubs such as western wheatgrass (*Pascopyrum smithii*) and big sagebrush (*Artemisia tridentata*).

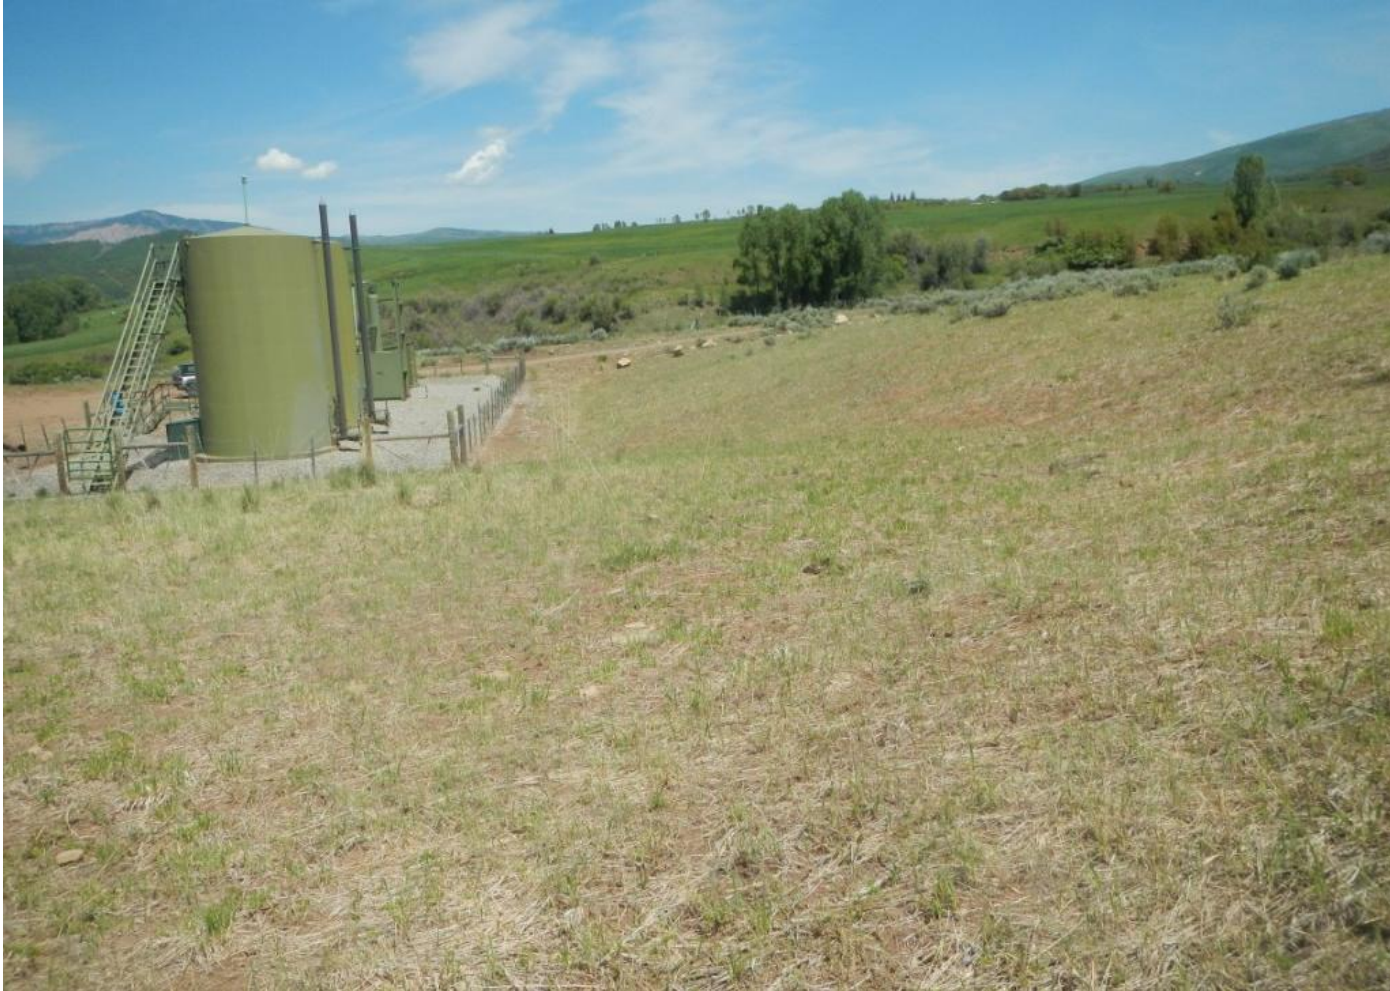
Photo 2. View of the eastern portion of the project area from the southeastern corner facing northward.

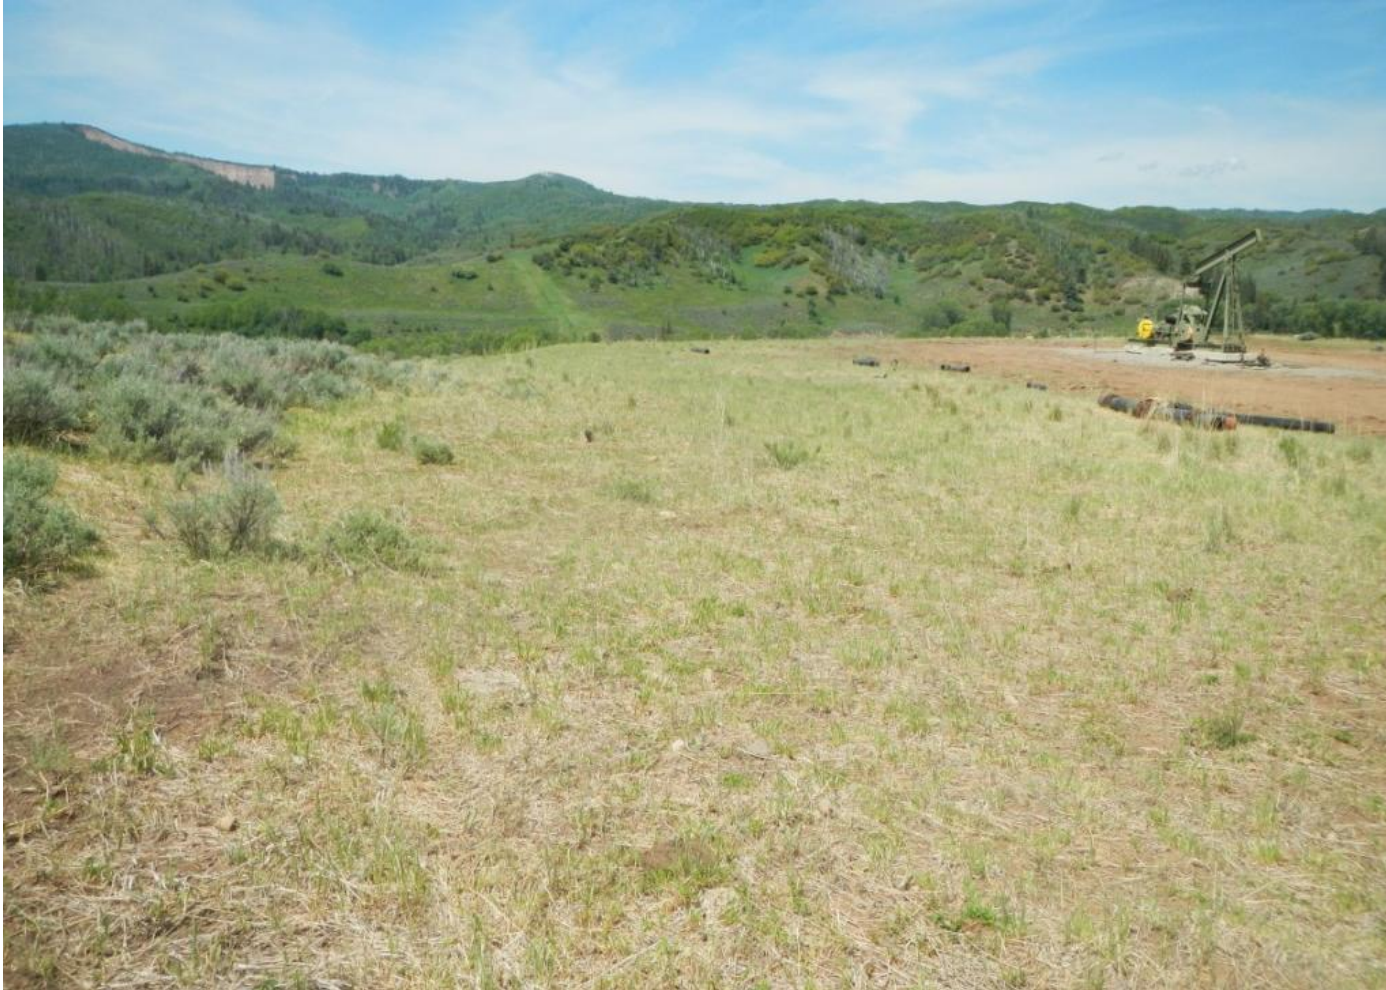
Photo 3. View of the southern portion of the project area from the southeastern corner facing southwestward.

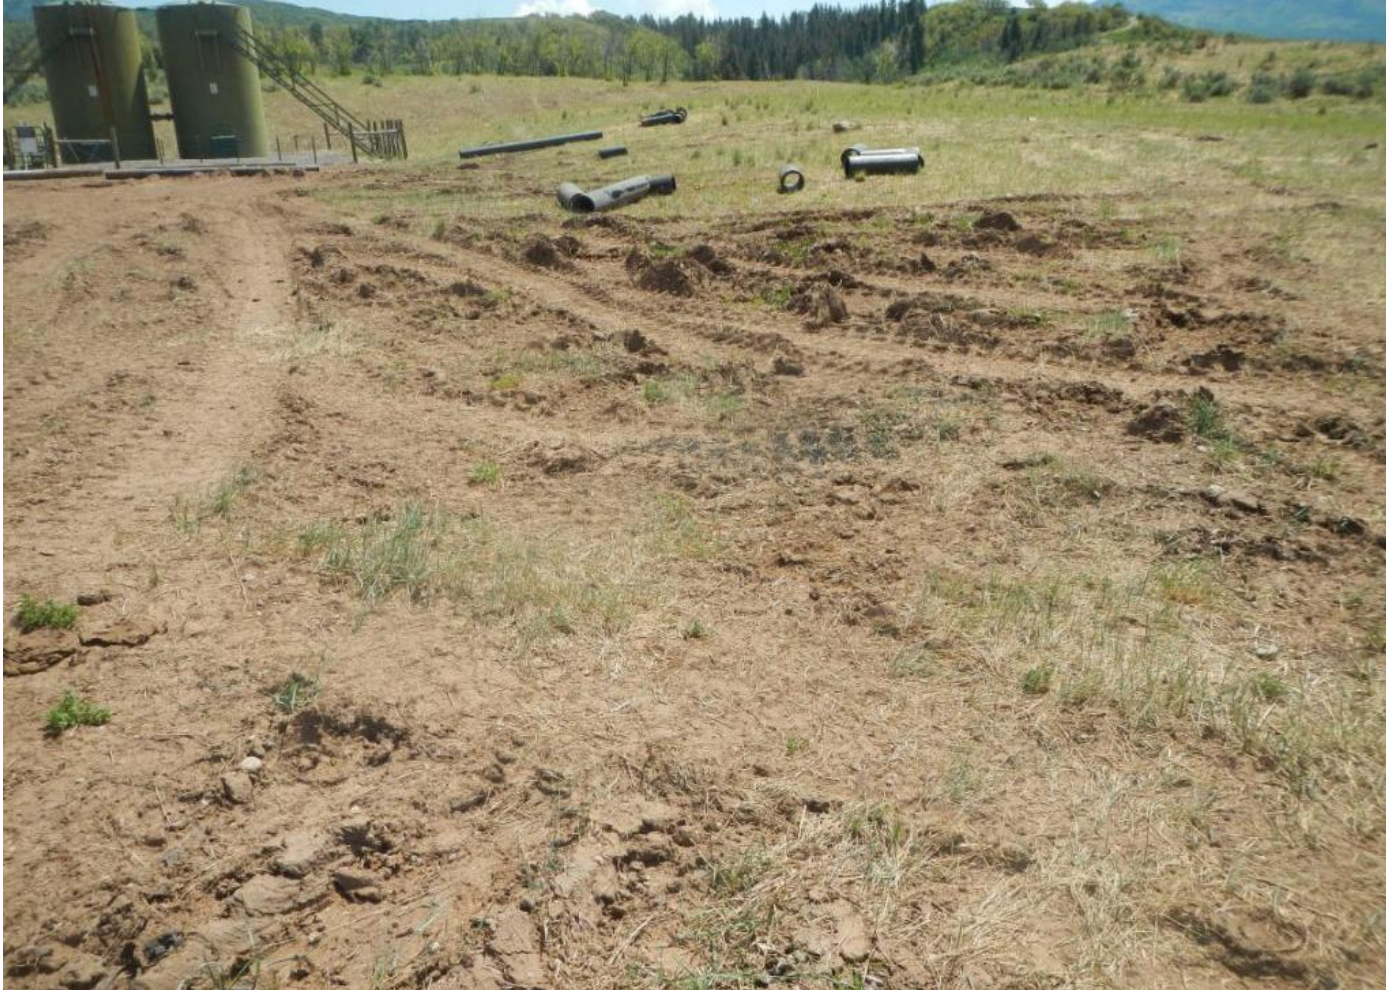
Photo 4. View of tire tracks, disturbed vegetation, and pipe debris in the southern portion of the project area. Tracked portions of the interim reclamation need to be seeded and reclaimed. Pipe and other debris needs to be removed.

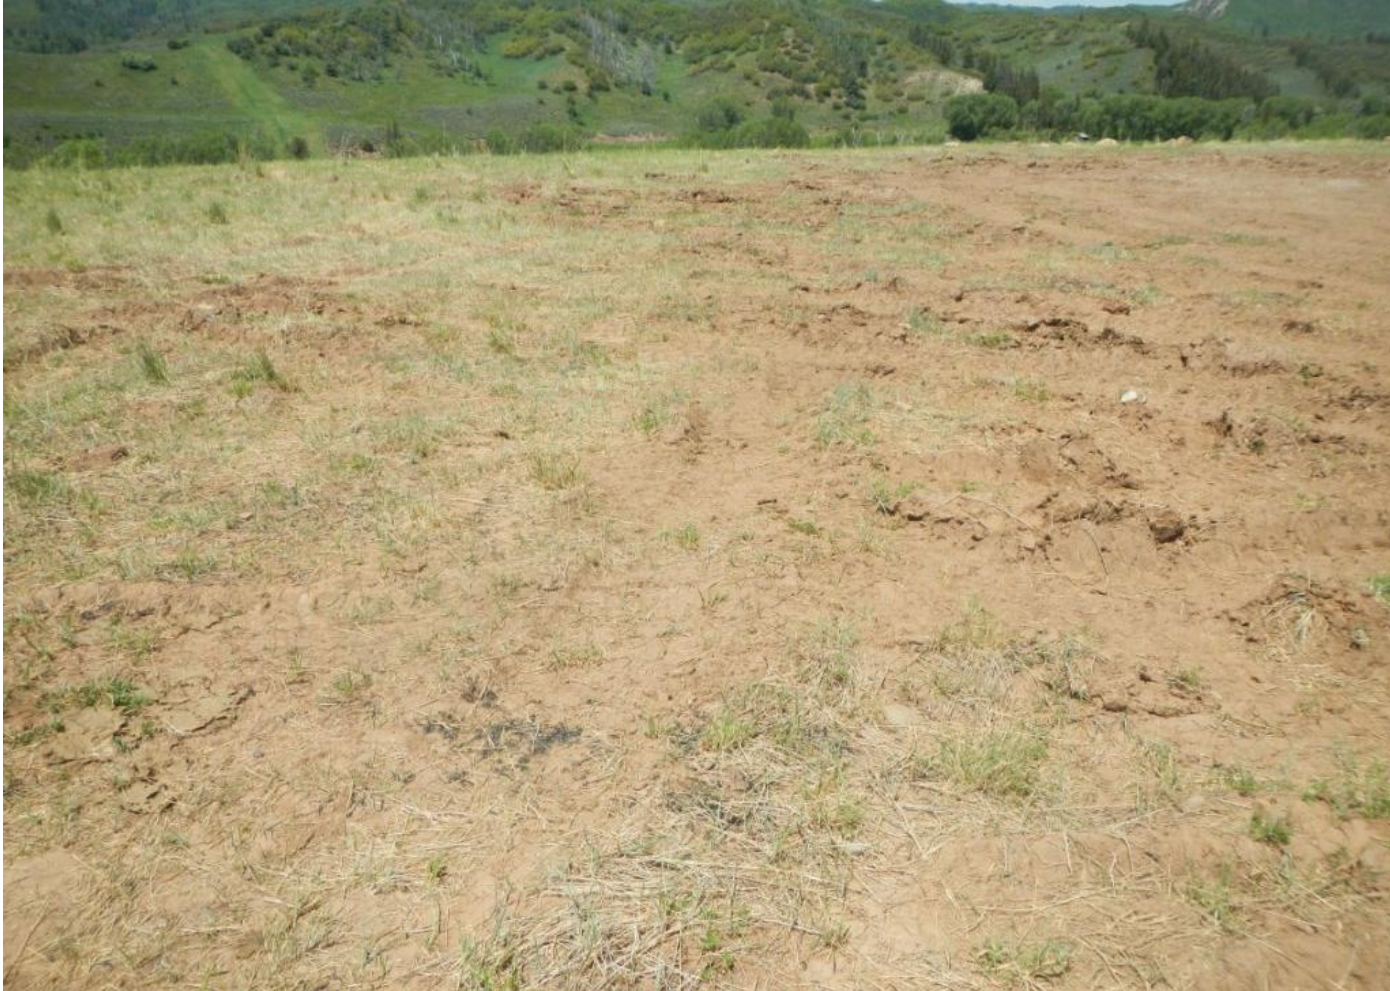
Photo 5. View of vehicle tracking in the western portion of the interim reclamation area that needs to be reclaimed.
