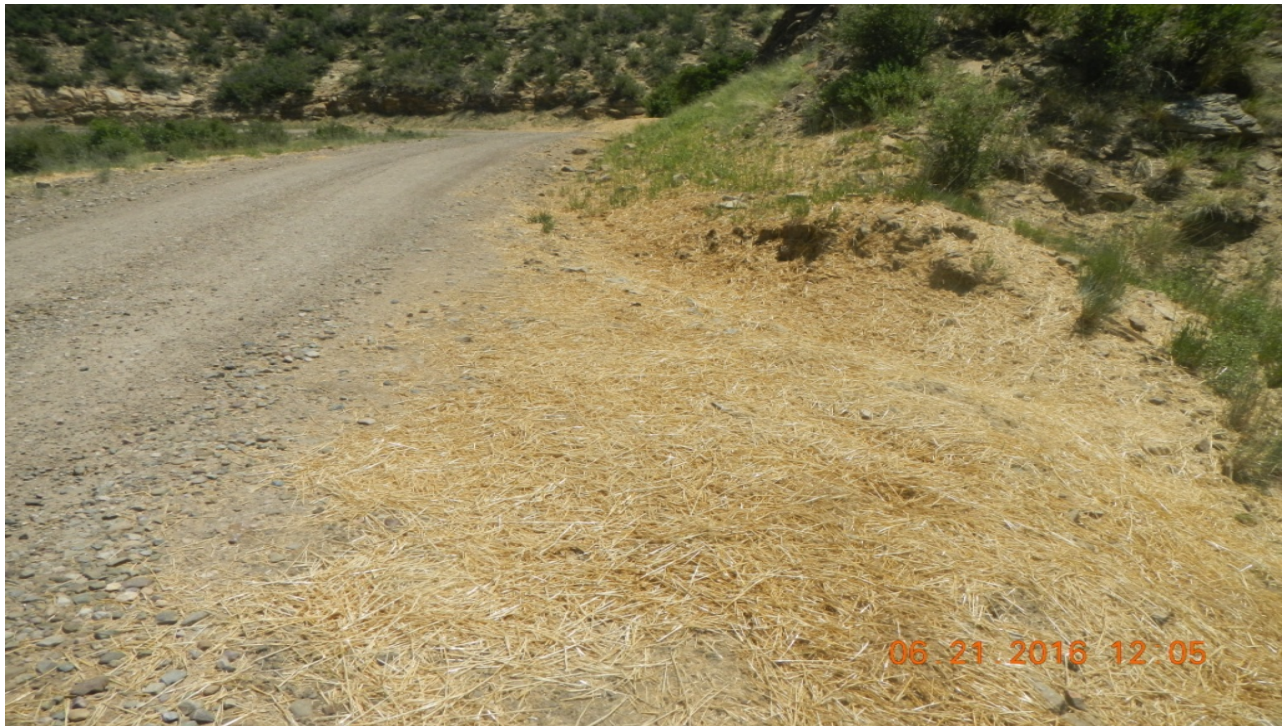
photo 1: Stormwater improvements have been performed along the access since the previous inspection.

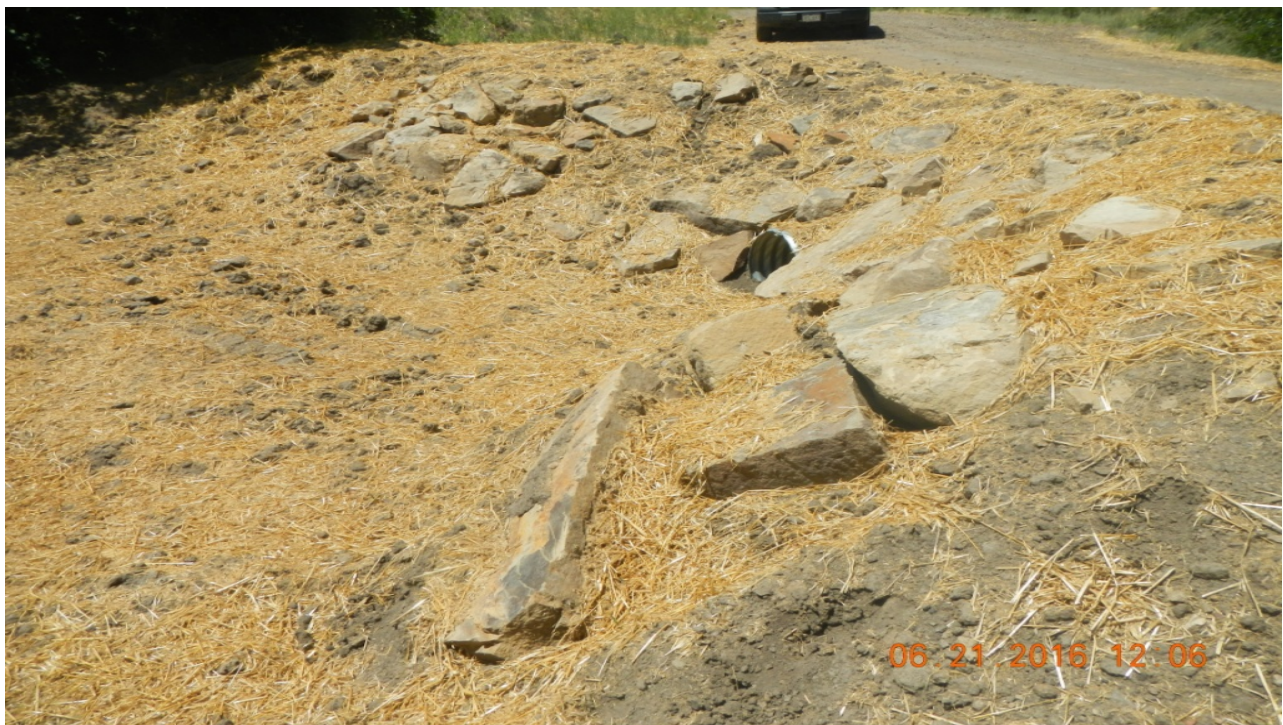
photo 2: Sediment has been cleaned out of culvert along the access road.

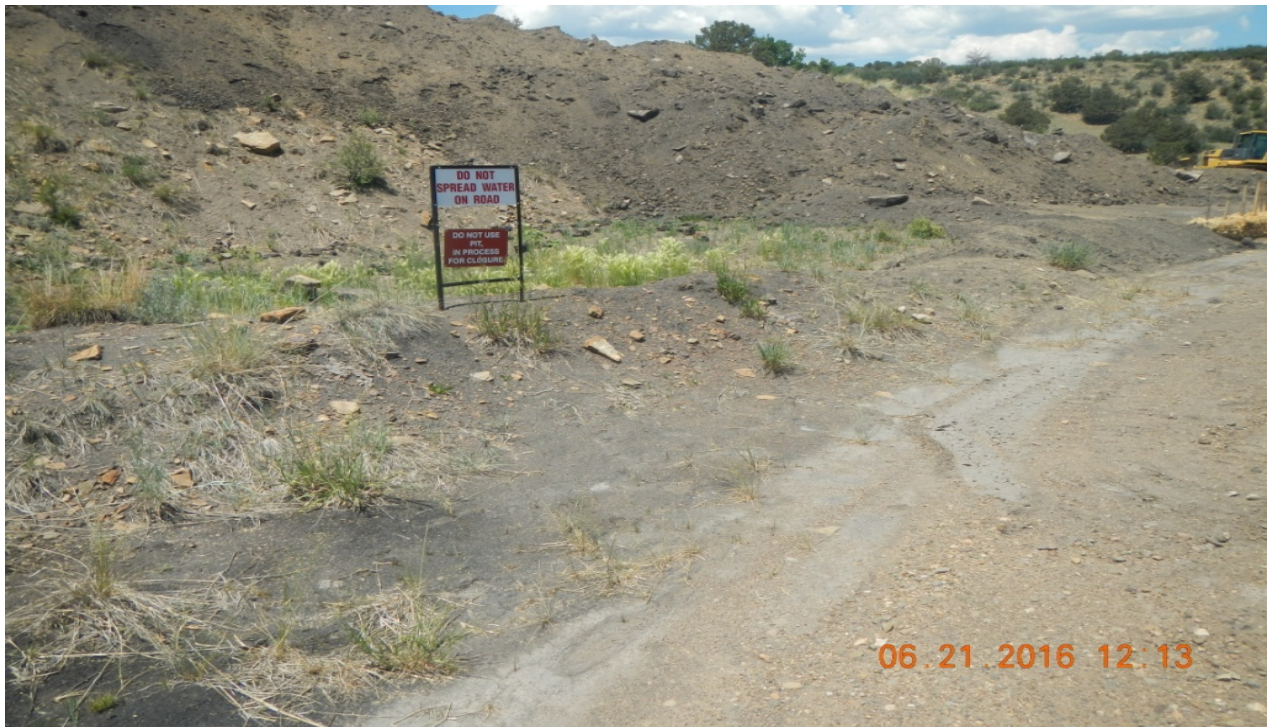
photo 6: Facing southwest toward the pit. Sign has been placed for pit closure.
