Jones 1-11

Inspection# 673403301

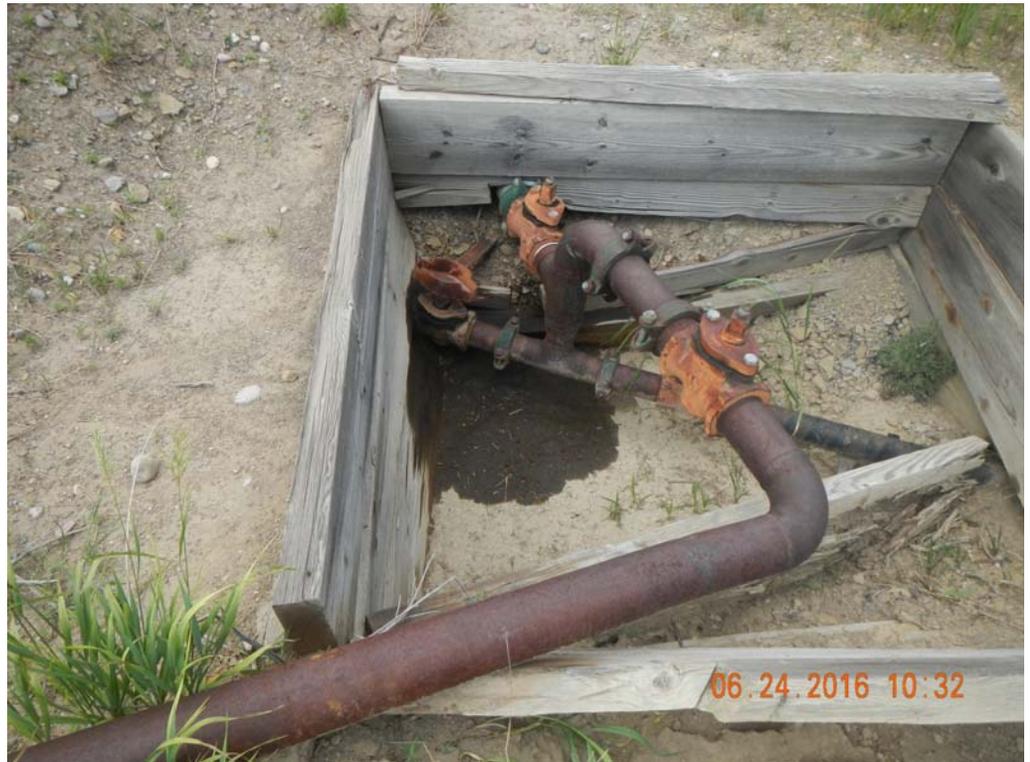
Stained soil at flowline connection below crude oil tank in pump jack area.

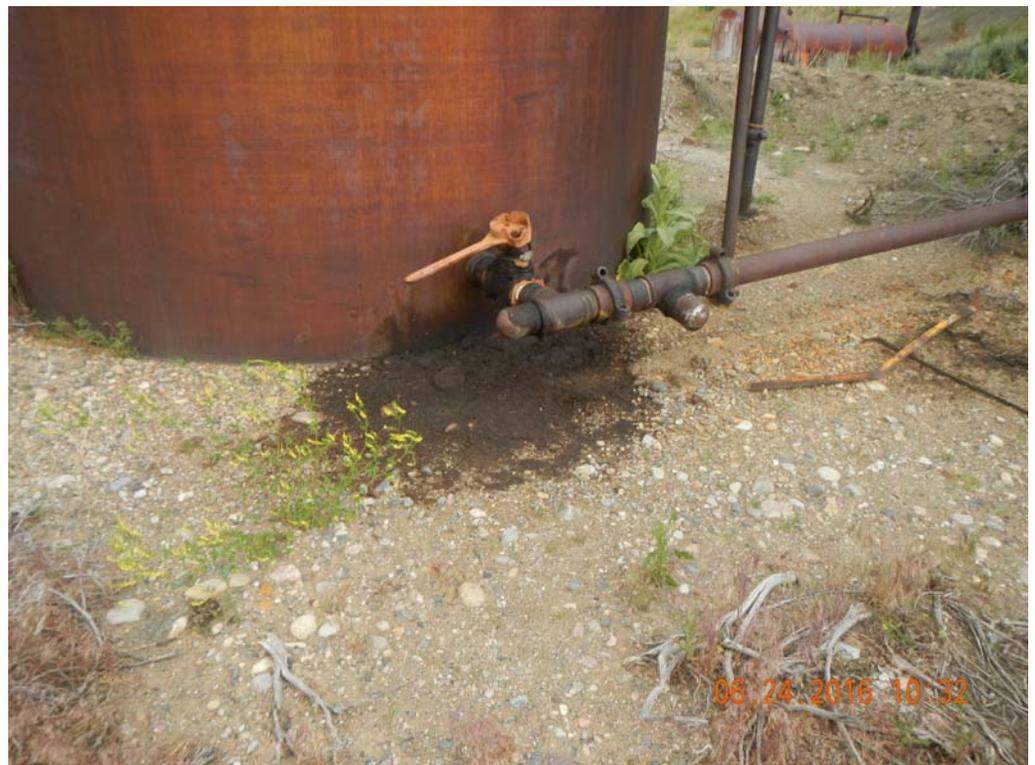
Stained soil at base of tank.

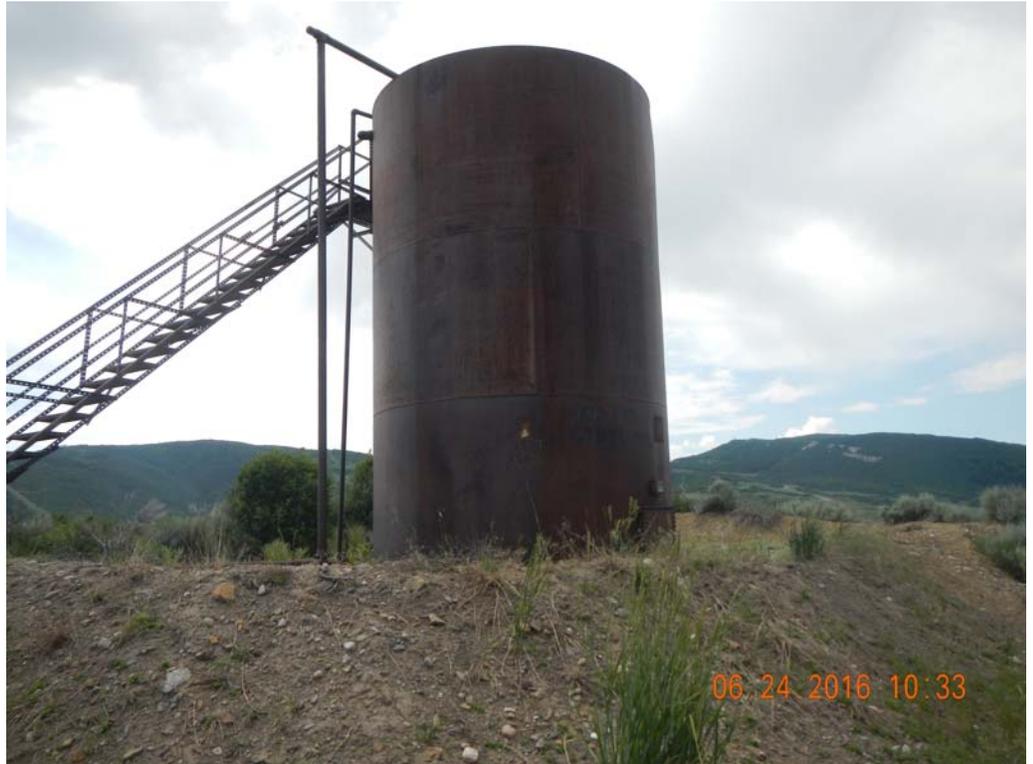
No NFPA diamond on tank.

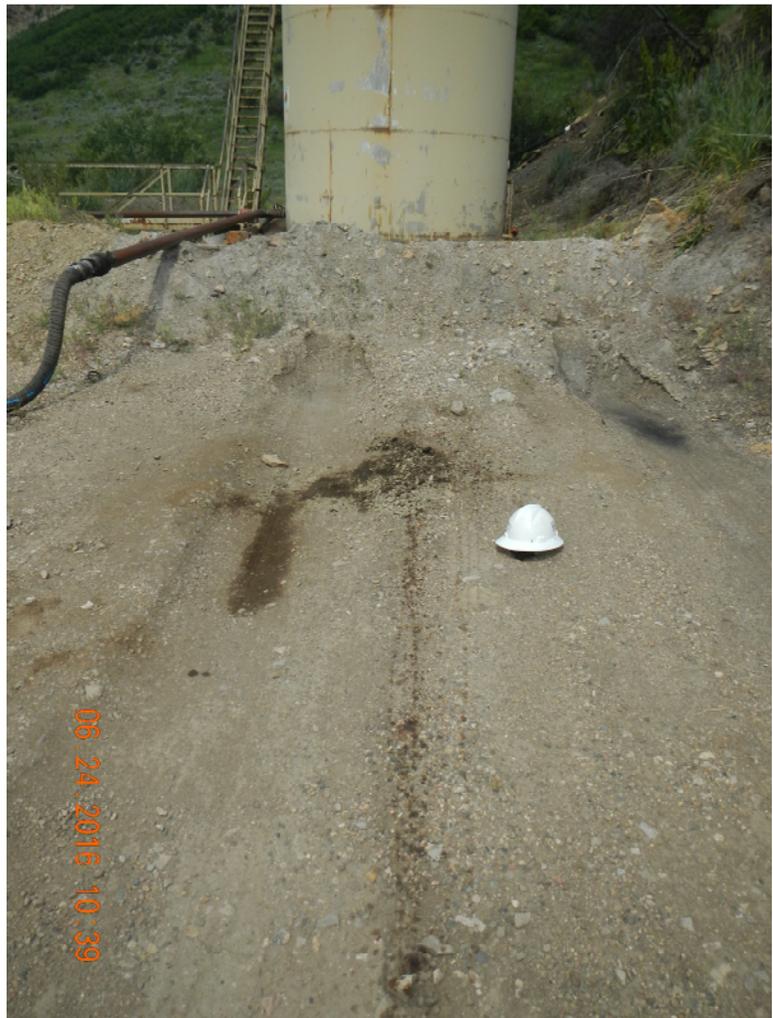
Stained soil outside tank berm.

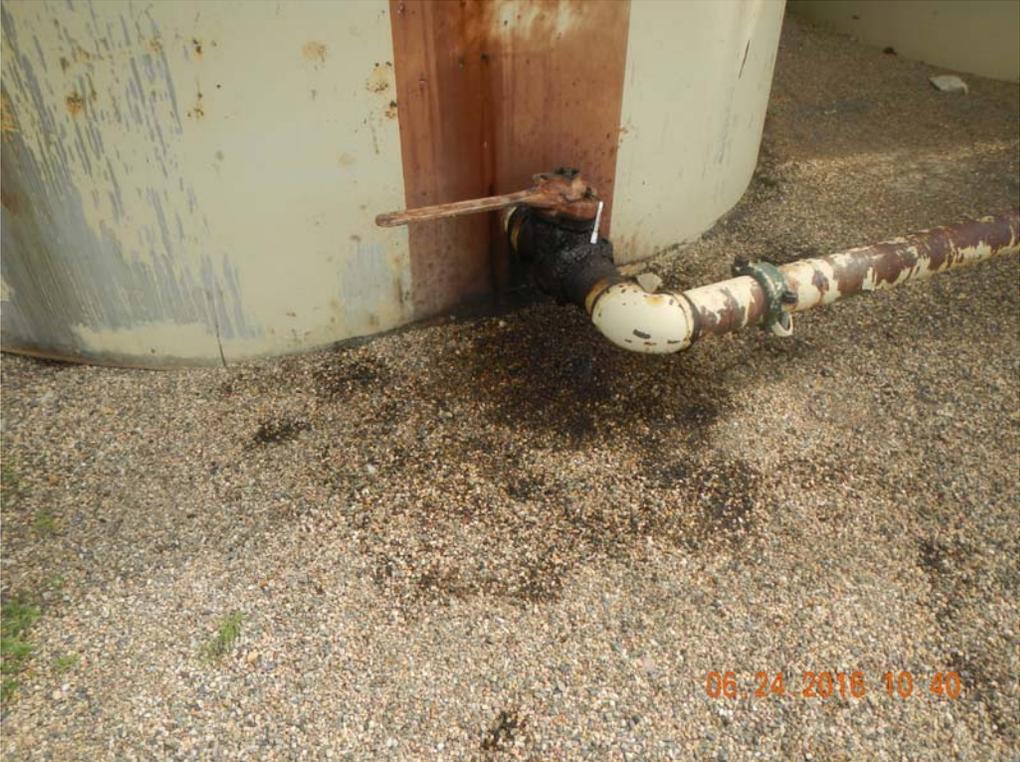
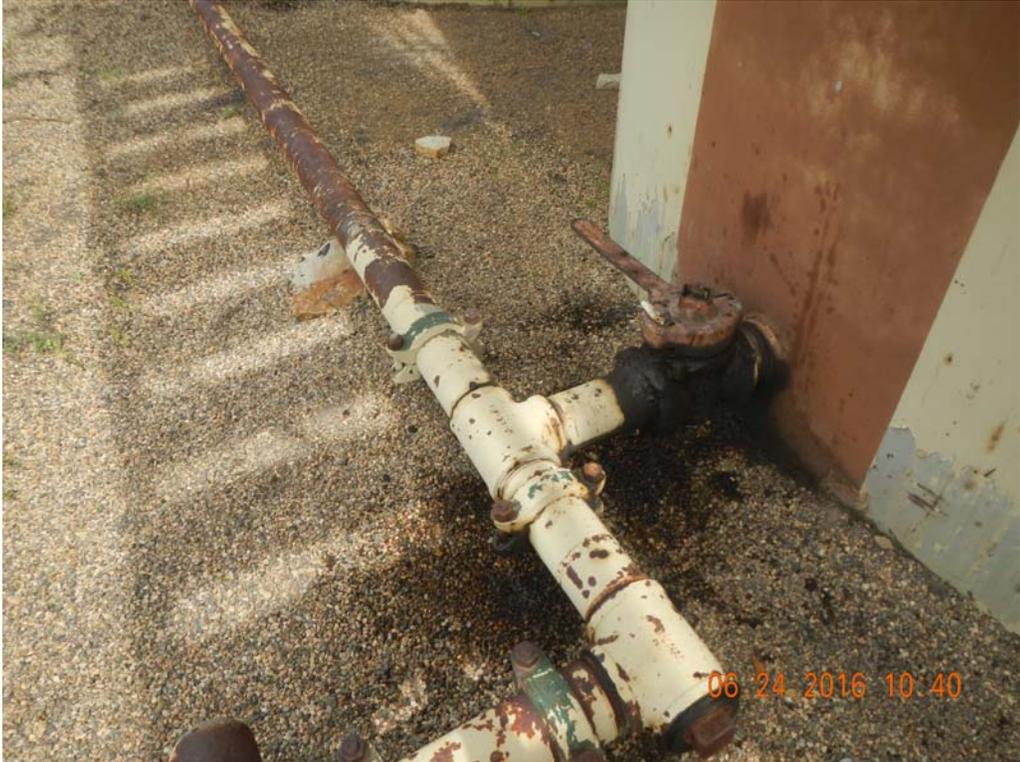
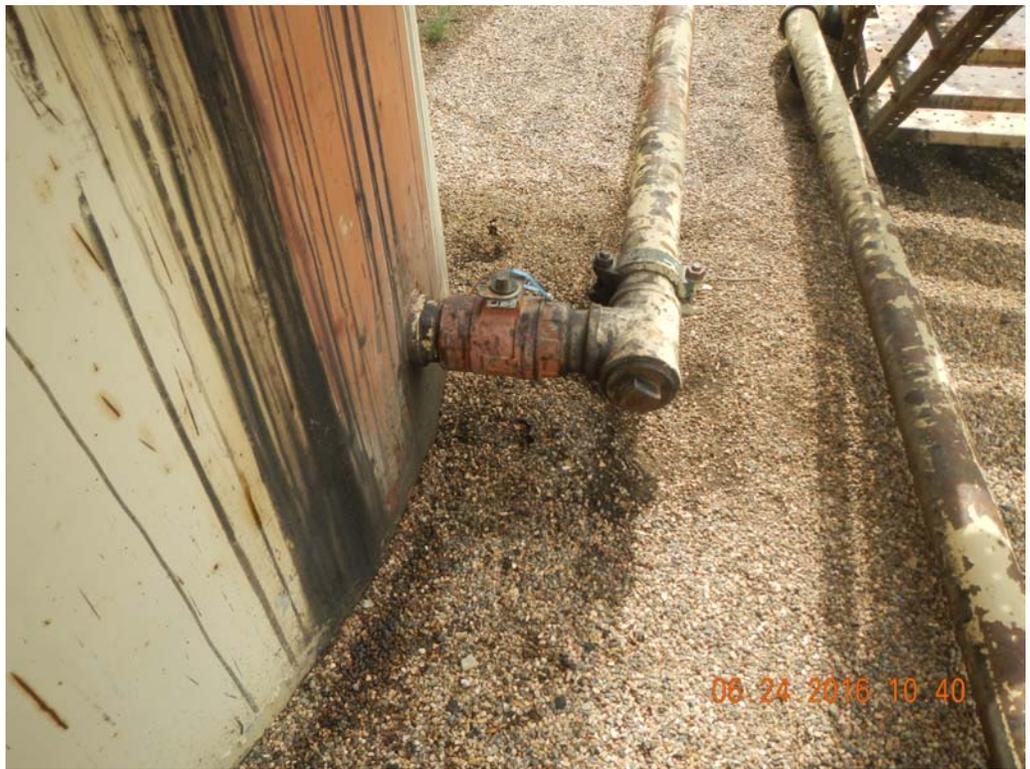
Stained soil at tank base.

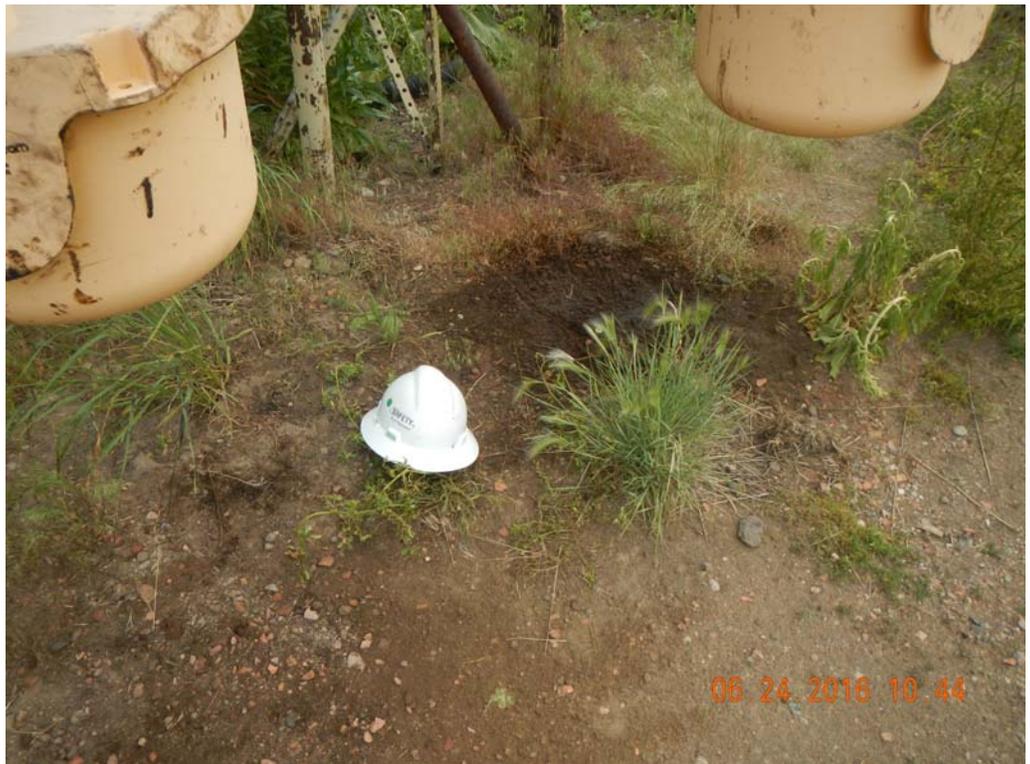
Stained soil at loadout
outside of berm.
