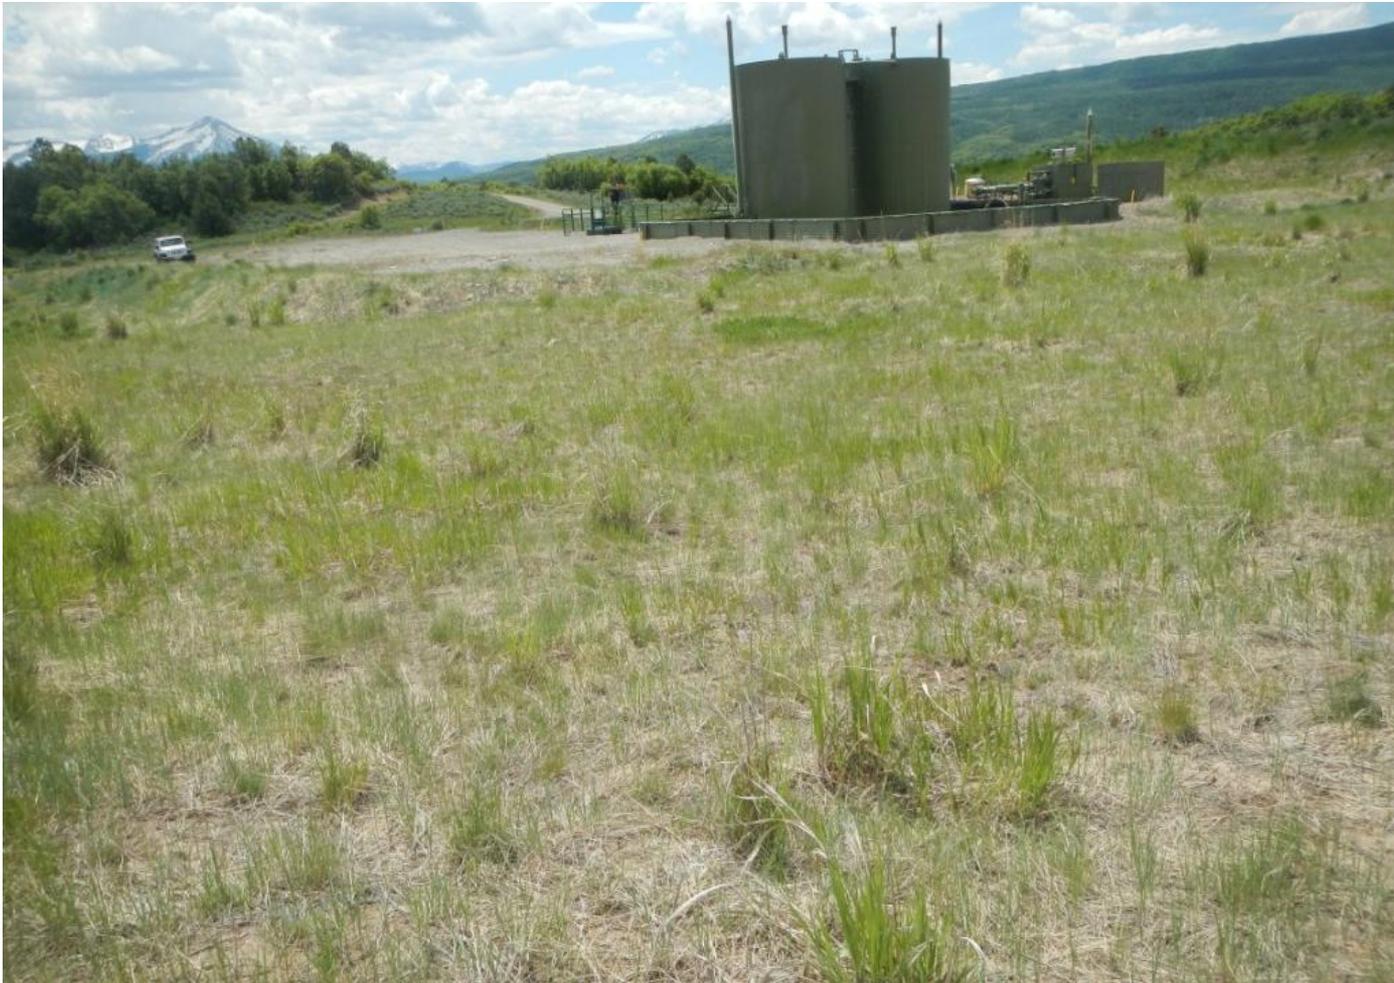
Photo 1. View of the project area from the northern corner facing center. Areas no longer needed for production are revegetating with grasses such as smooth brome (*Bromus inermis*), fescue (*Festuca* sp.), dropseed (*Sporobolus cryptandrus*), and western wheatgrass (*Pascopyrum smithii*).

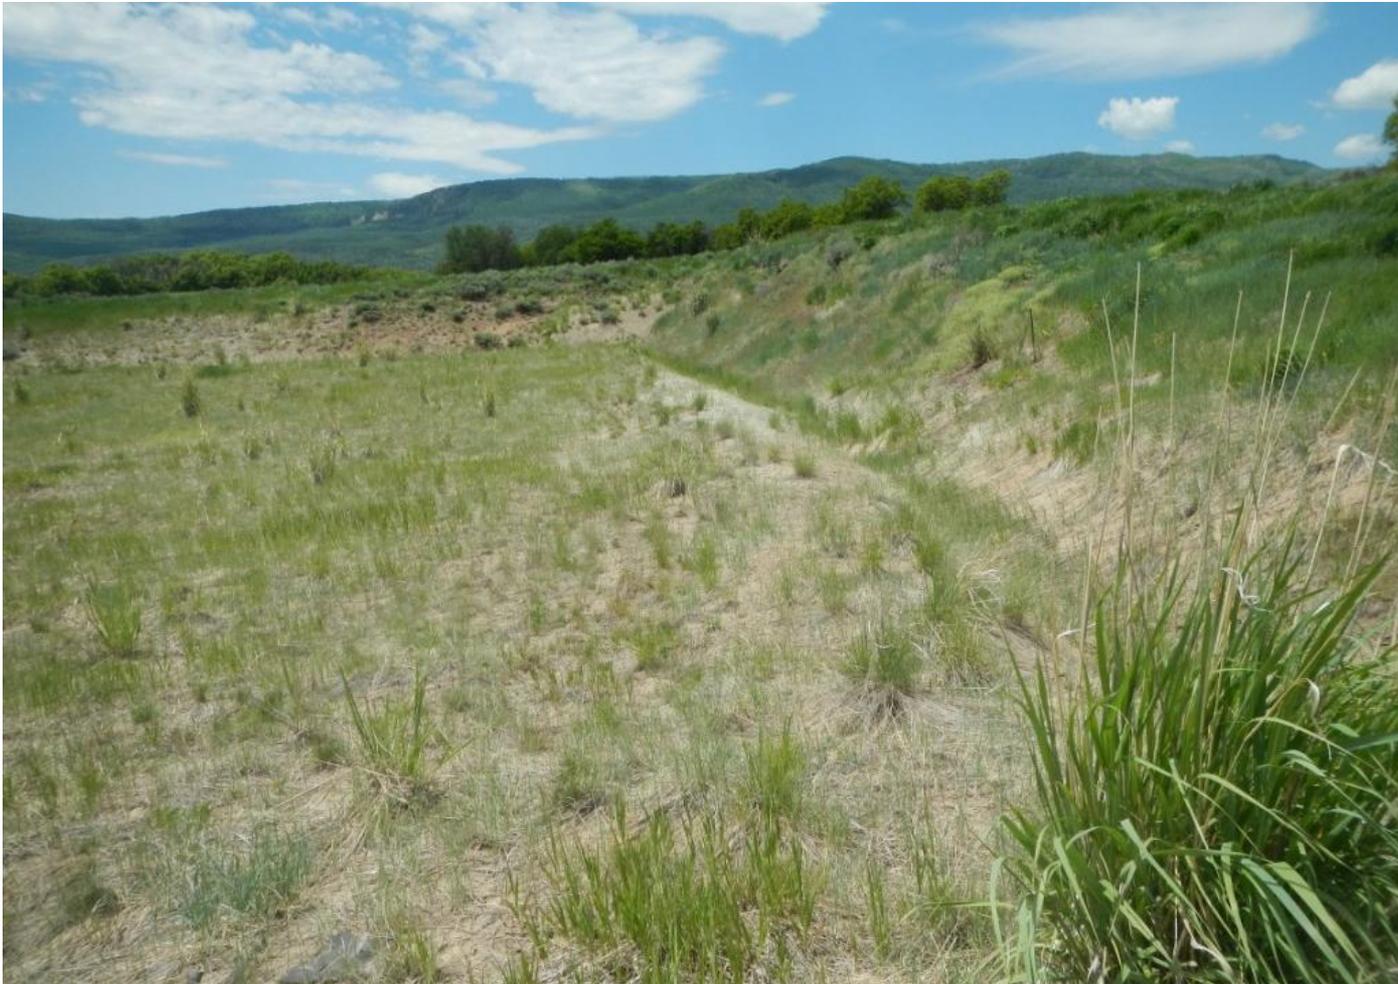
Photo 2. View of the northwestern portion of the project area from the northern corner facing southwestward.

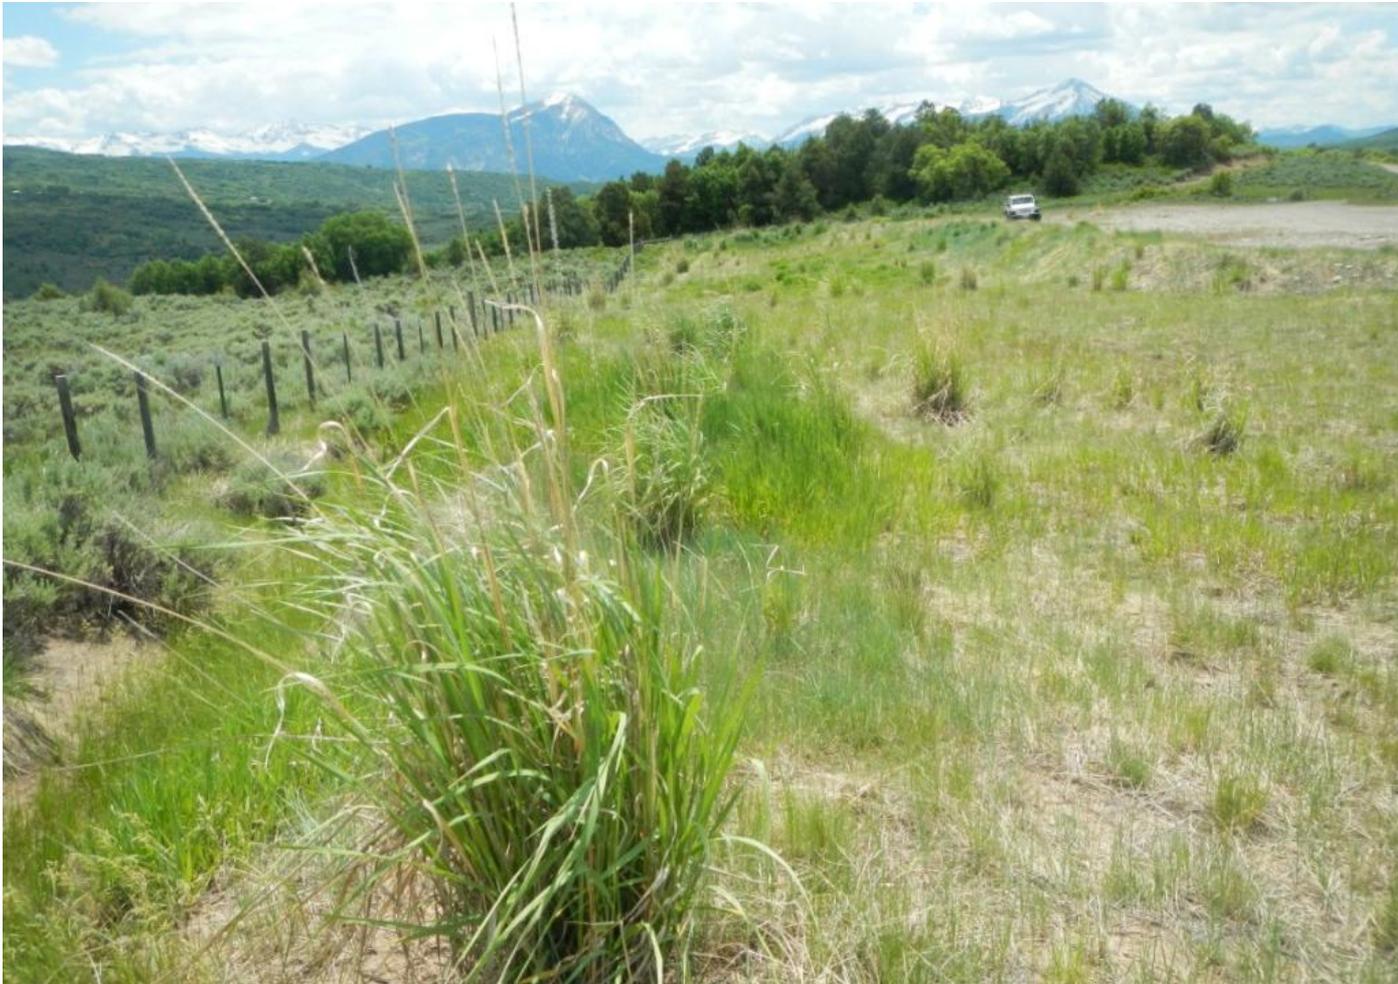
Photo 3. View of the northeastern portion of the project area from the northern corner facing southeastward. Sleepy grass (*Achnatherum robustum*) is growing in the foreground.

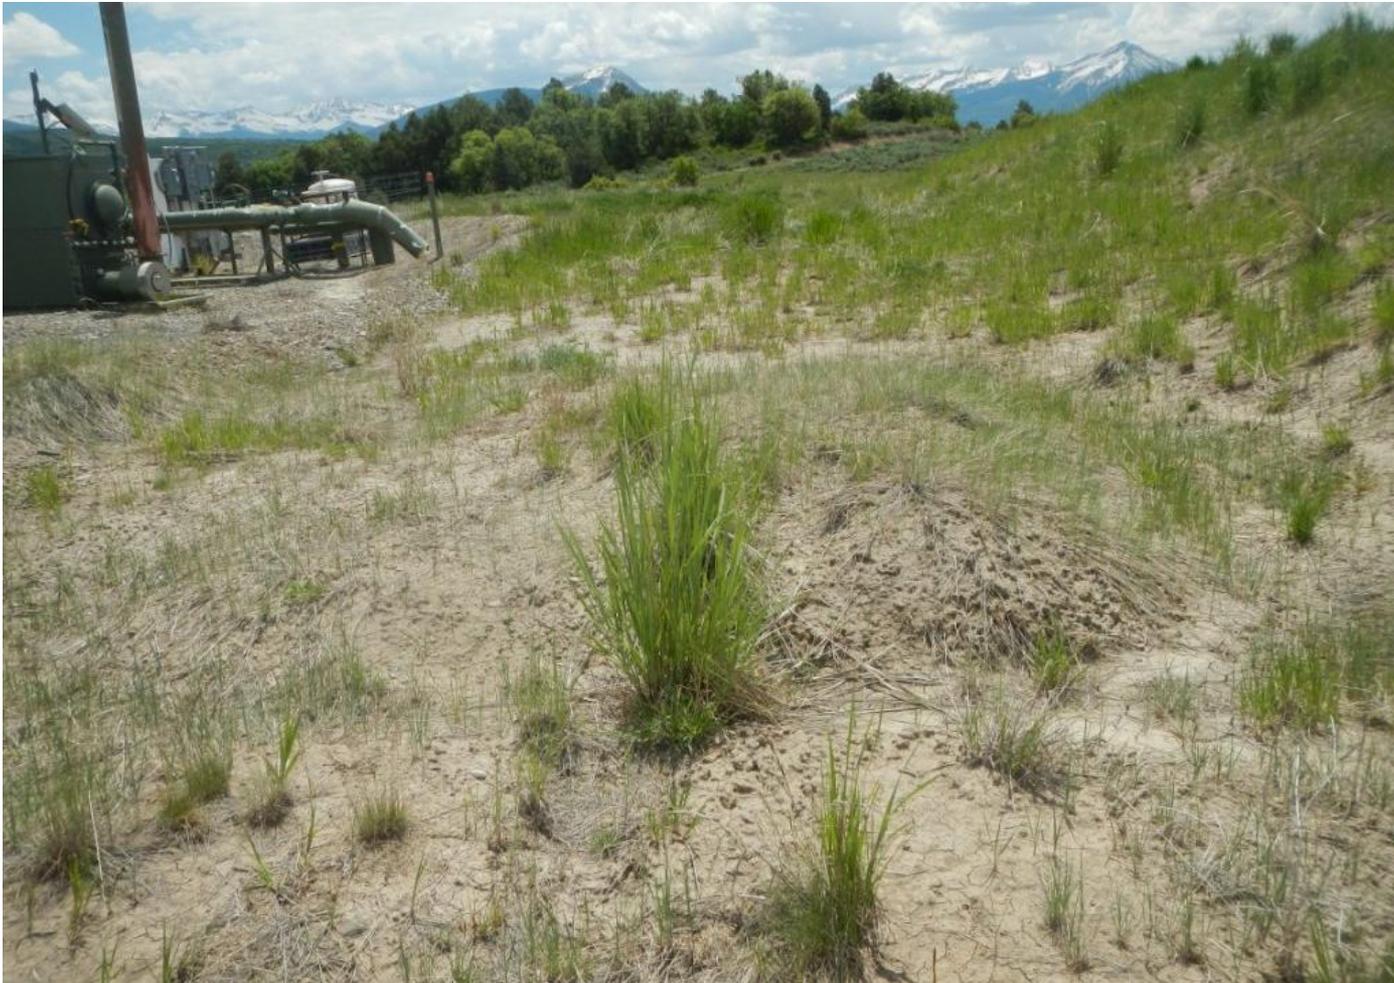
Photo 4. View of the southwestern portion of the project area from the northwestern corner facing southeastward.

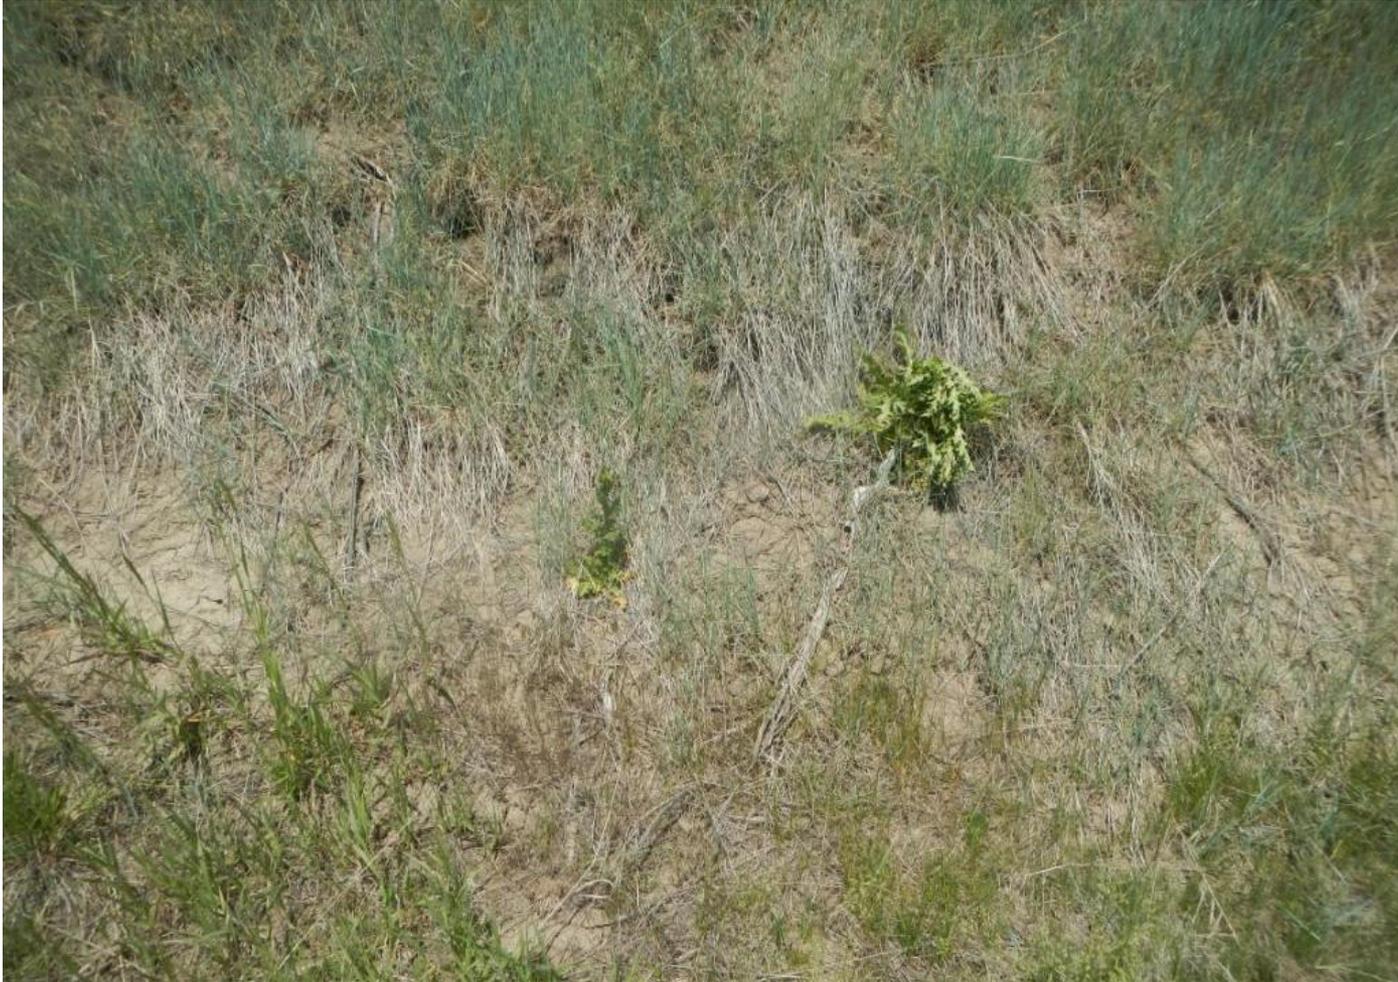
Photo 5. View of wilting musk thistles (*Carduus nutans*) that appear to have recently been treated with herbicide.

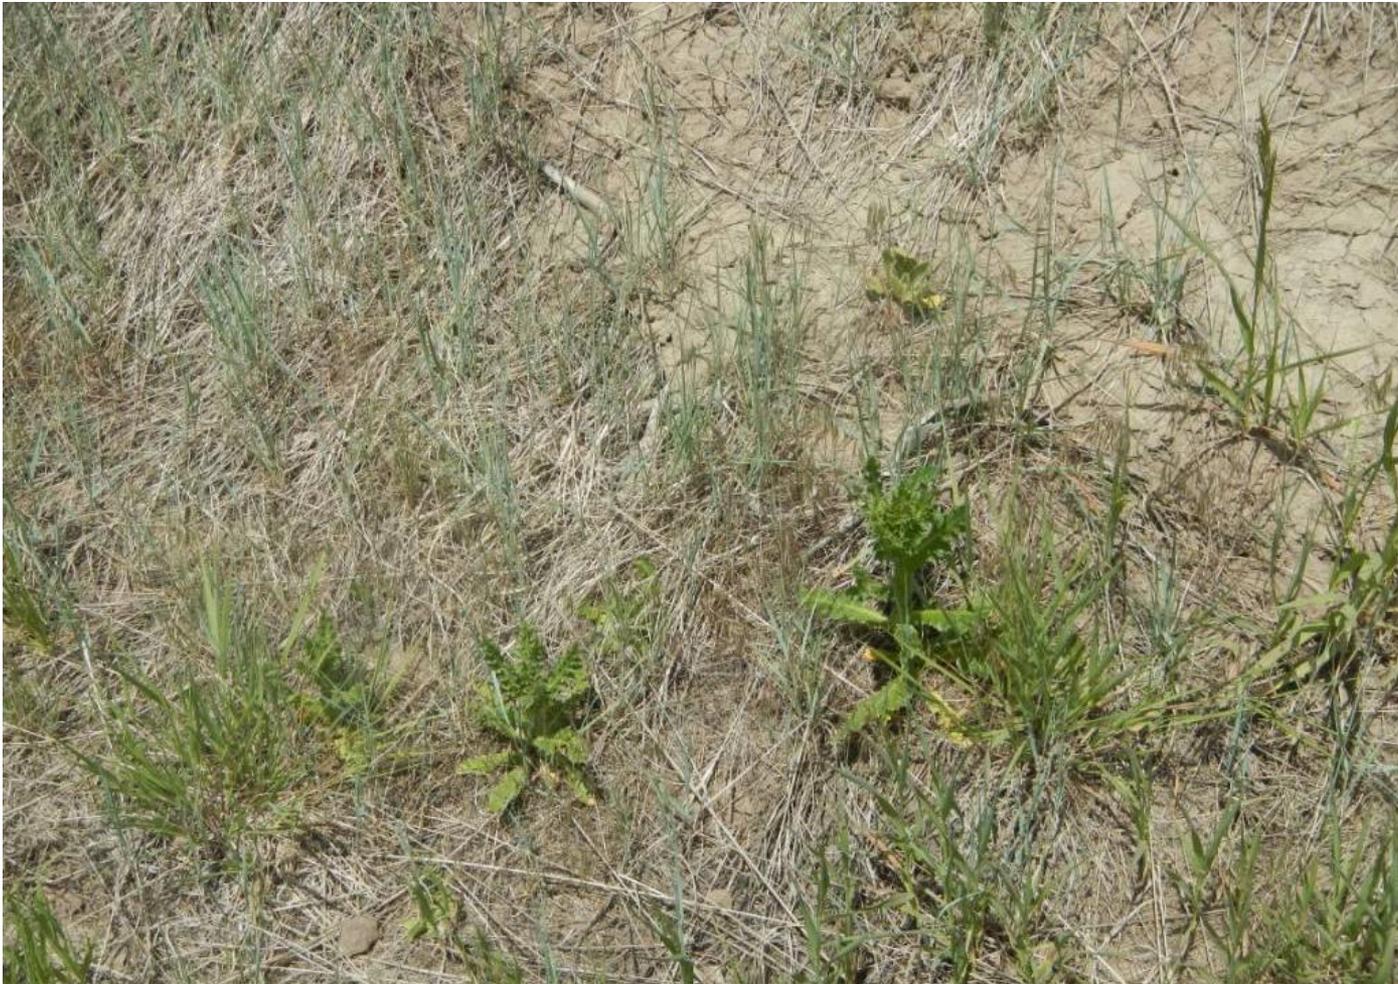
Photo 6. View of Canada thistle (*Cirsium arvense*) that do not appear to have been treated during recent herbicide treatment.

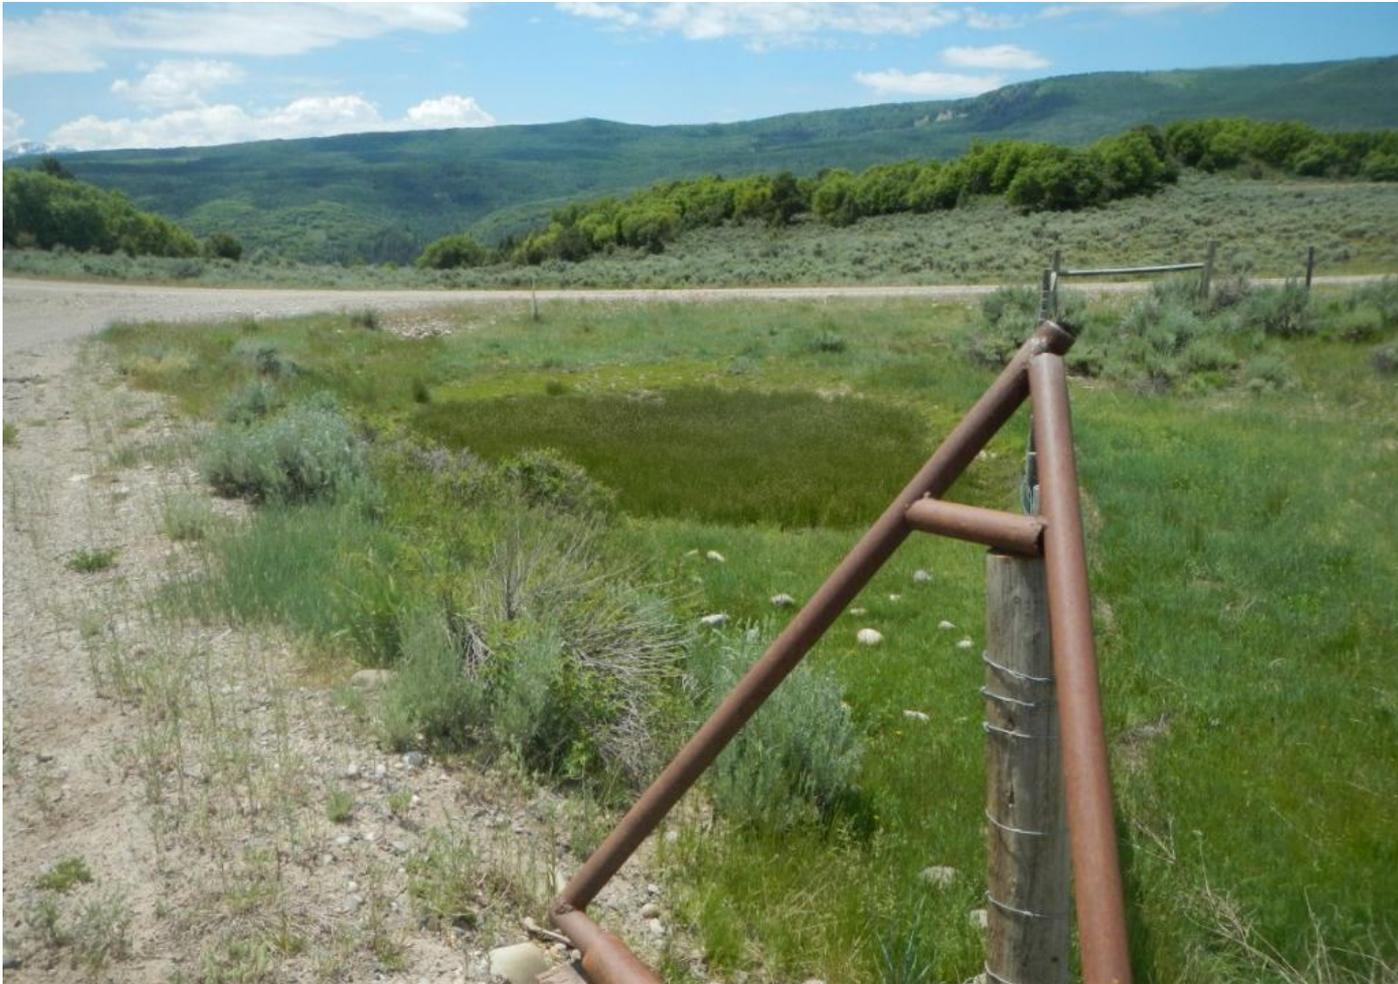
Photo 7. View of silt trap in southern portion of the project area that appears stabilized and functional.

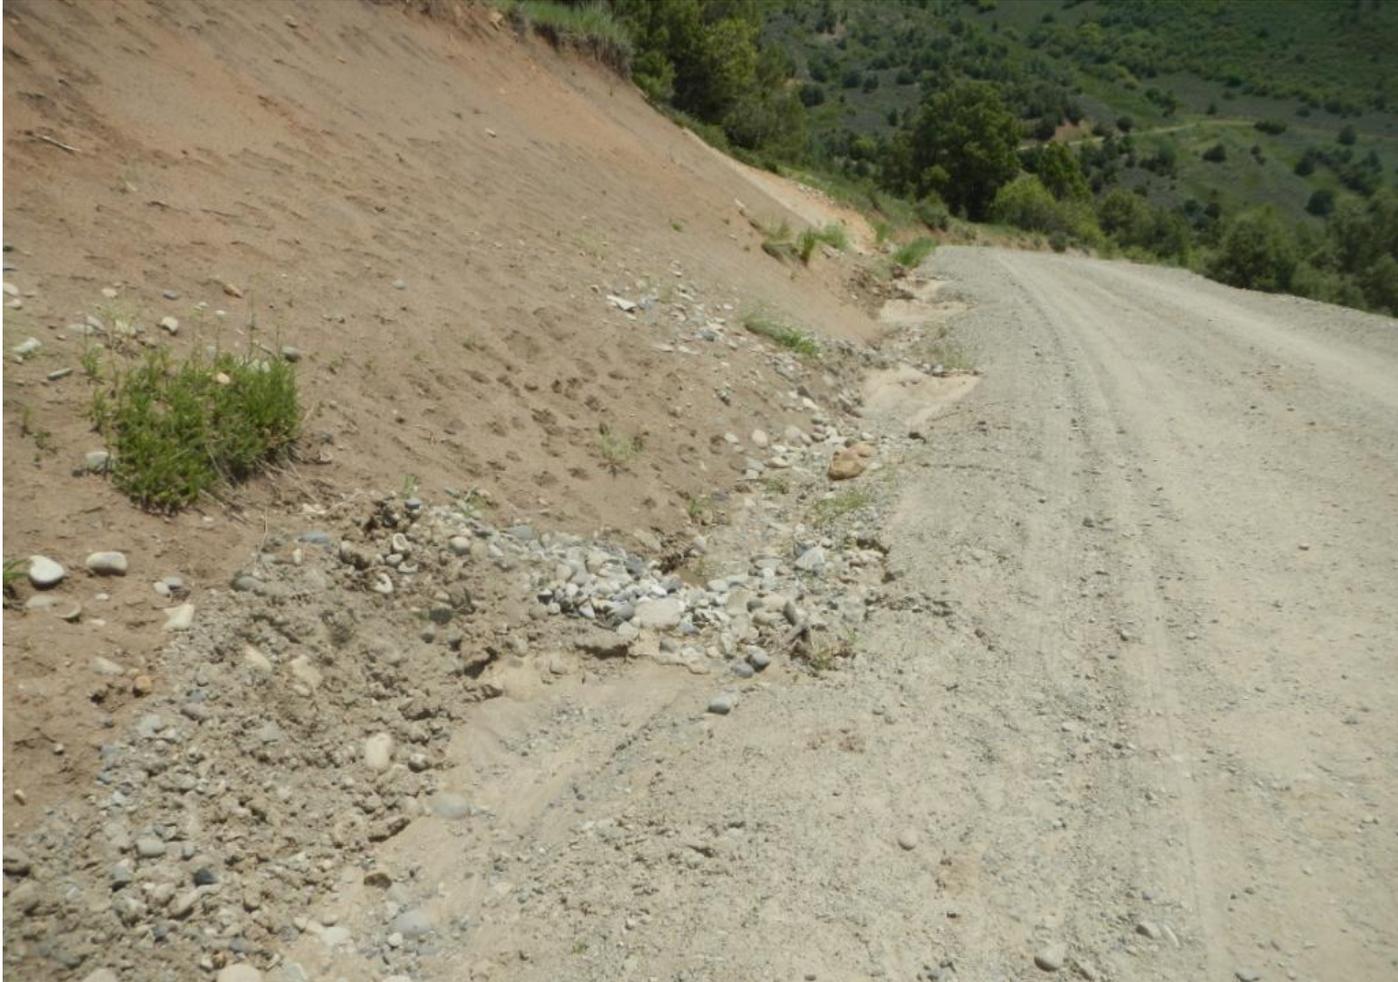
Photo 8. View of cobble check dams along steep section of access road. These appear to be properly sized and spaced. Sediment accumulation needs to be cleaned.

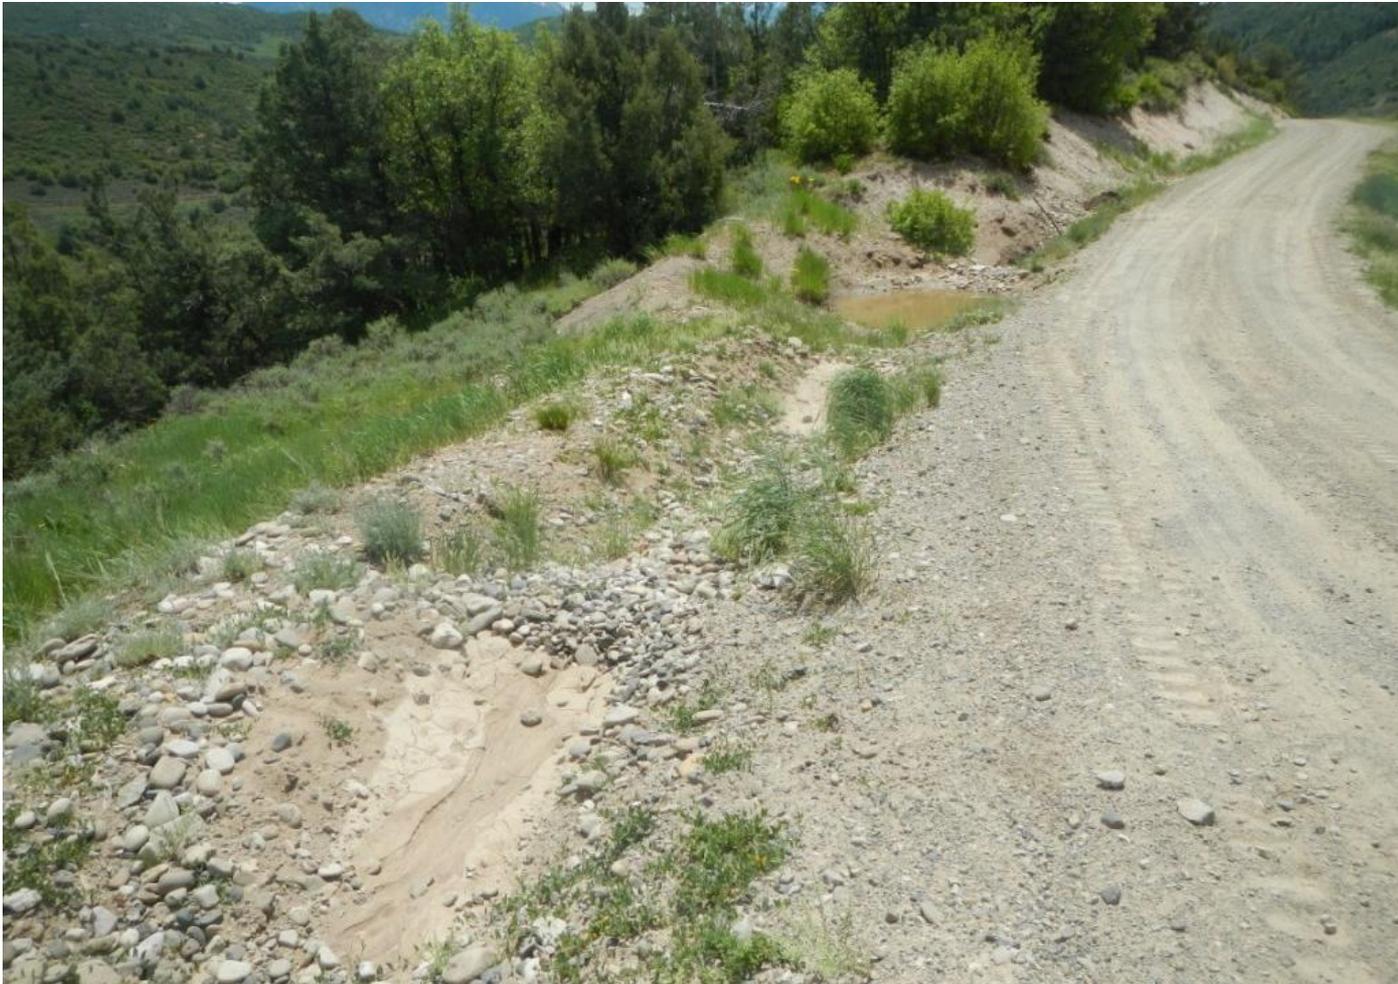
Photo 9. View of silt traps and culvert entrance along access road that appear to be functioning.

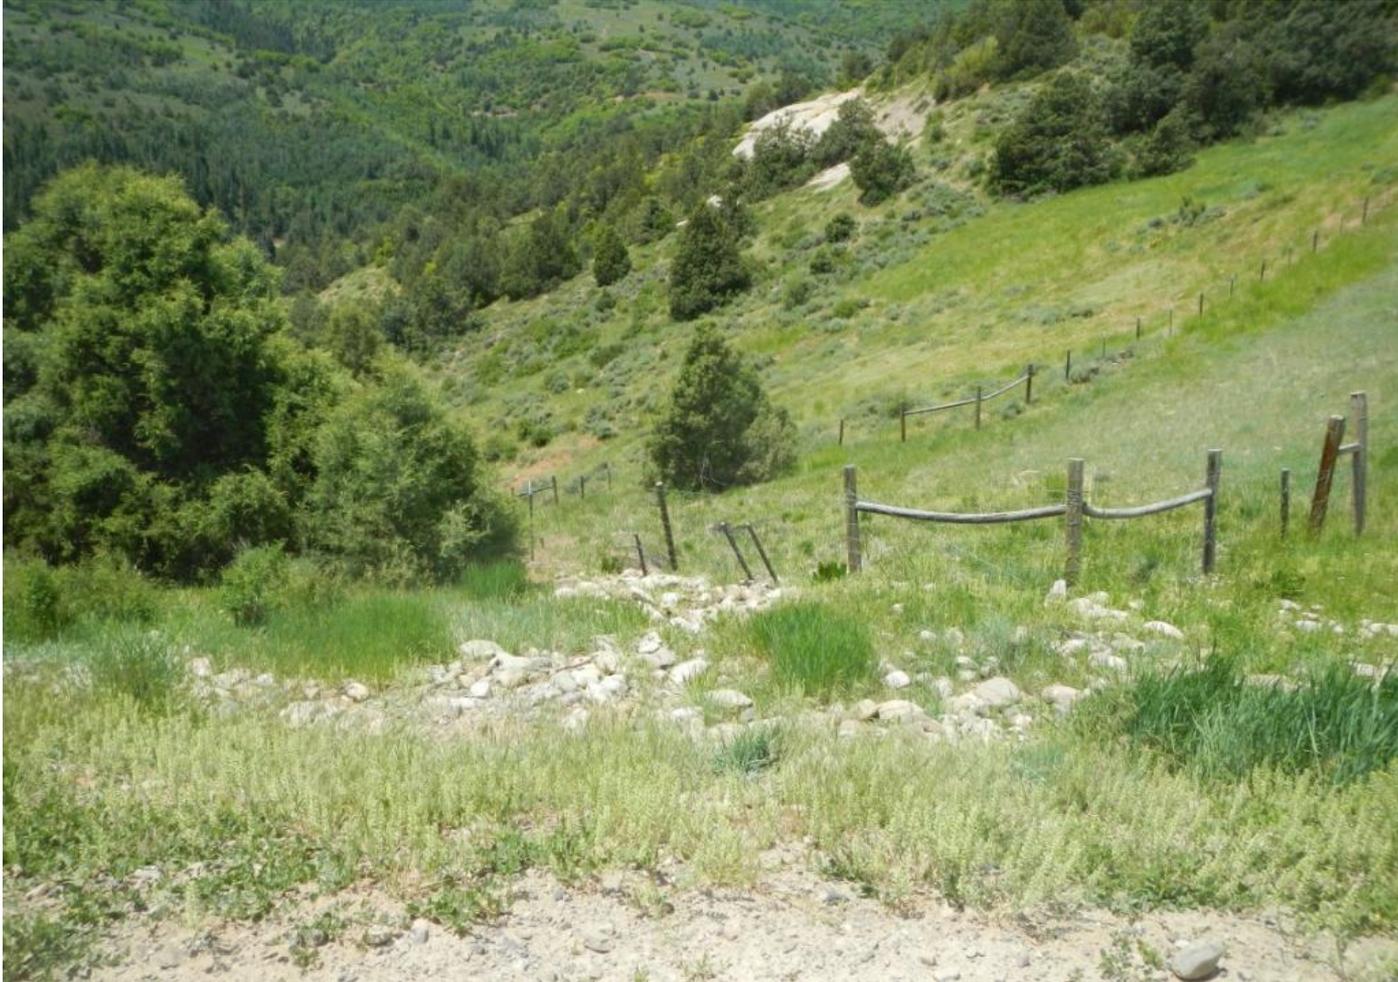
Photo 10. View of culvert outlet along access road draining westward. Outlet drain is armored and is stabilized at this time.

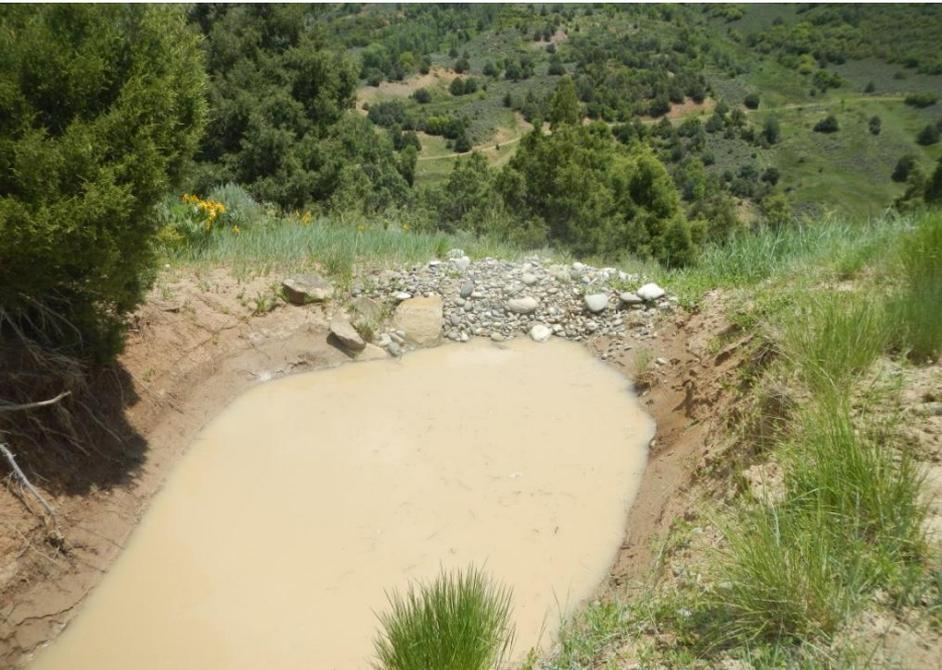
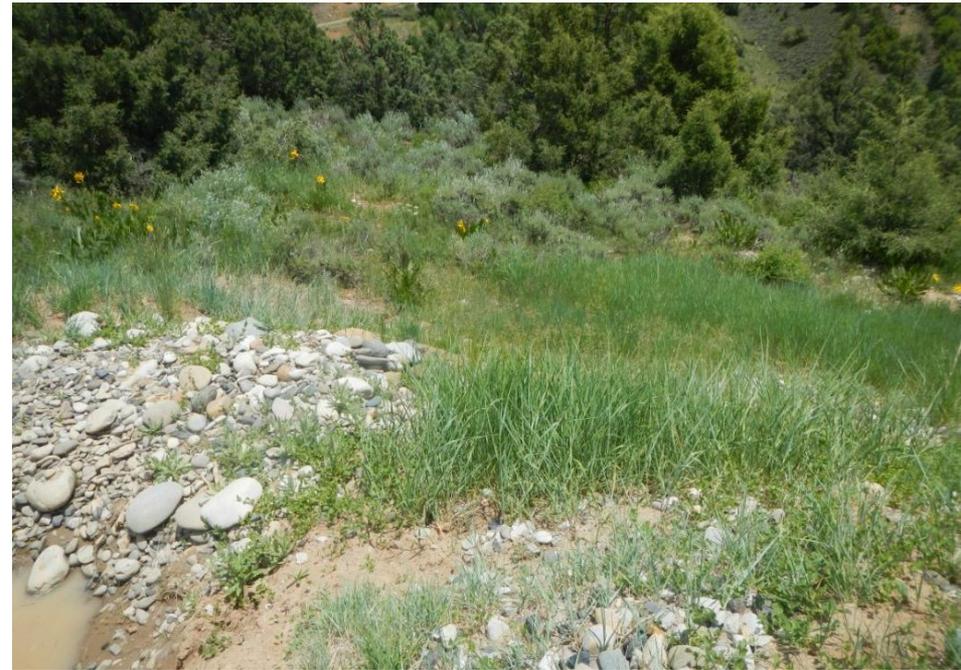
Photos 11 and 12. View of silt trap (on left) at turnout along access road. Photo on right shows silt trap overflow point that is stabilized at this time.

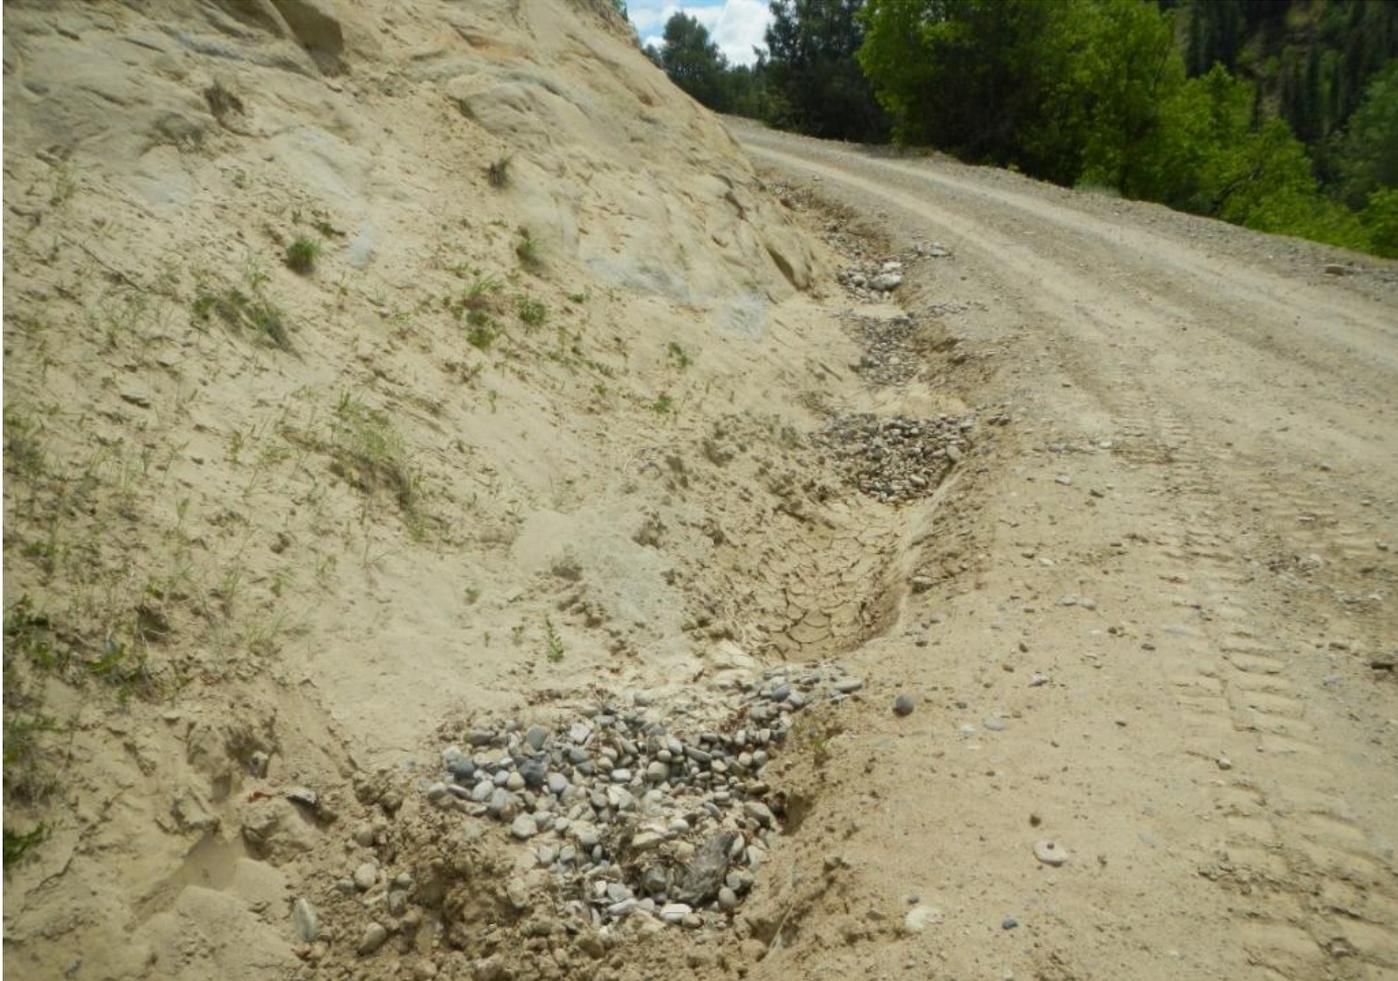
Photo 13. View of more cobble check dams near the bottom of the access road. These appear to be properly sized and spaced and will require frequent maintenance for silt accumulation.
