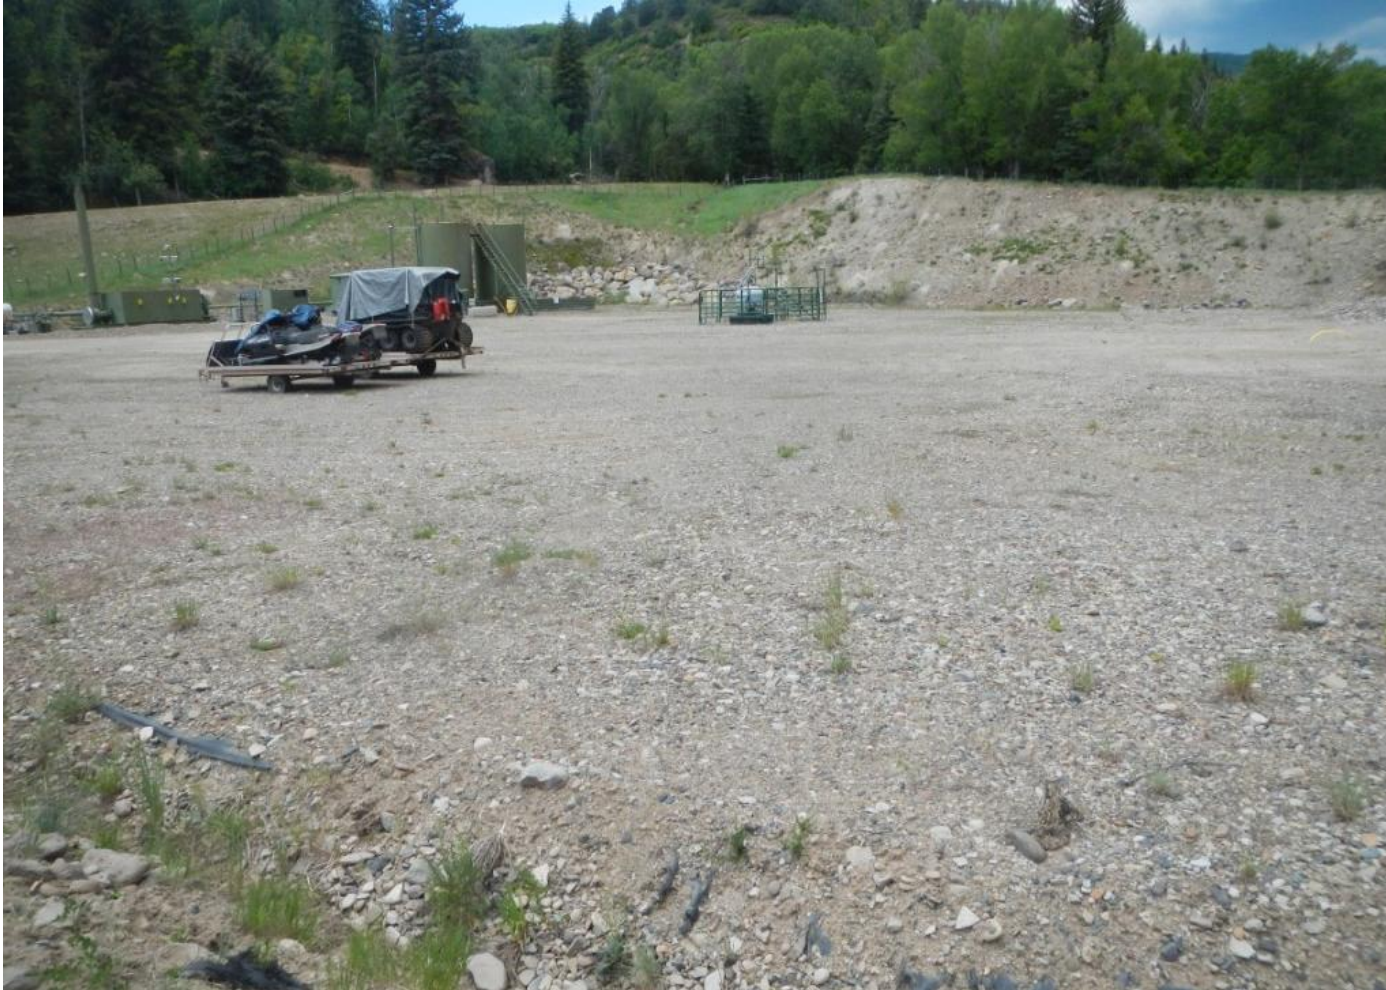
Photo 1. View of the project area from the northeastern corner facing center. Location needs interim reclamation.

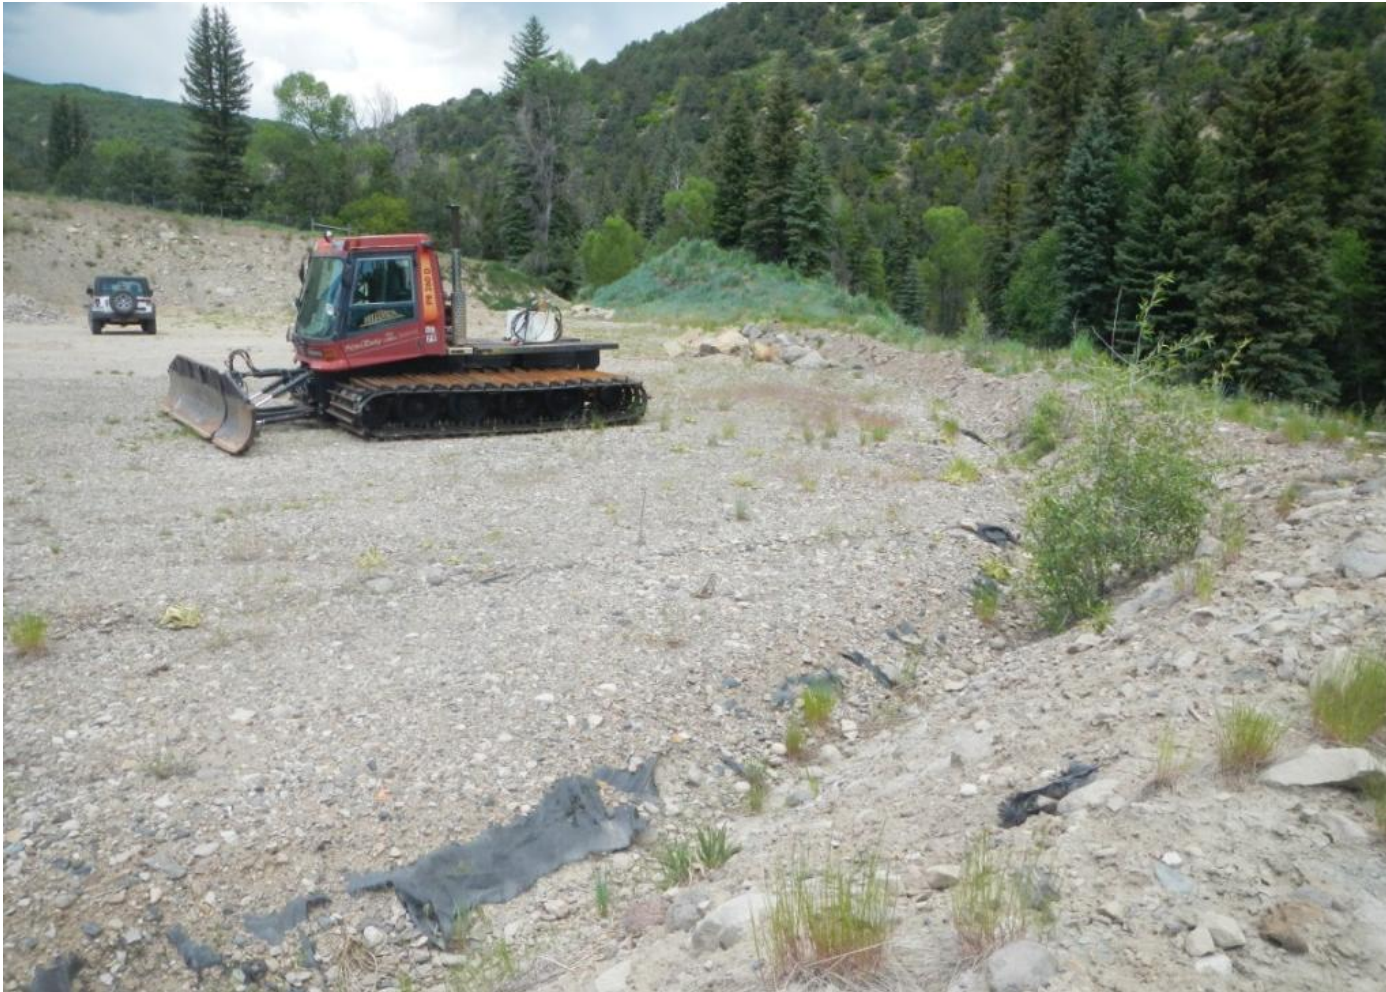
Photo 2. View of the northern portion of the project area from the northeastern corner facing westward. It appears that vegetated topsoil stockpile is in the northwestern corner.

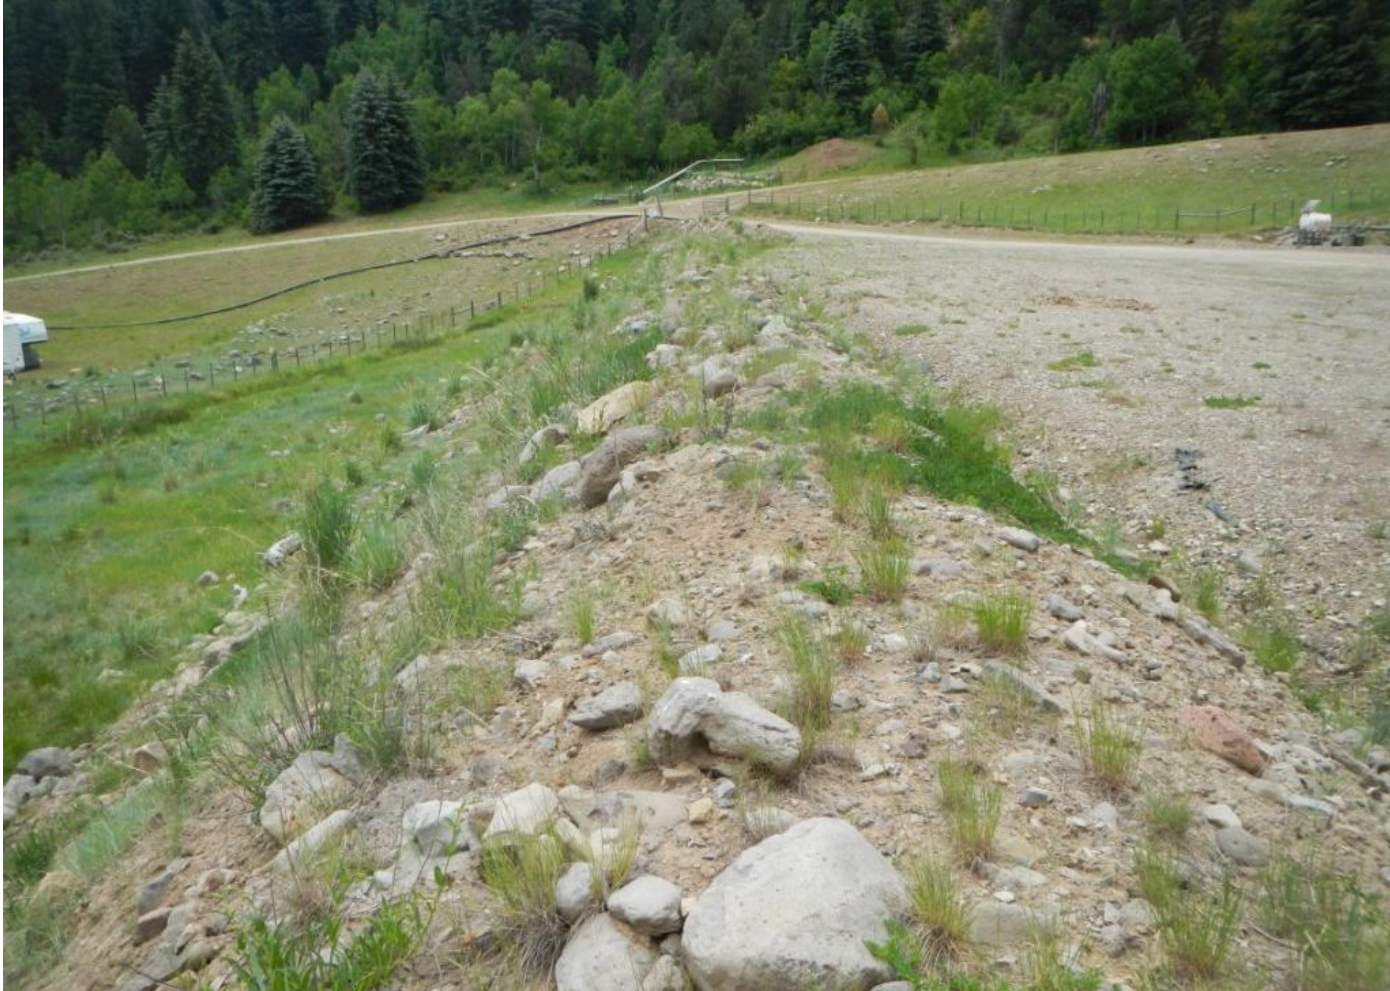
Photo 3. View of the eastern portion of the project area from the northeastern corner facing southward.

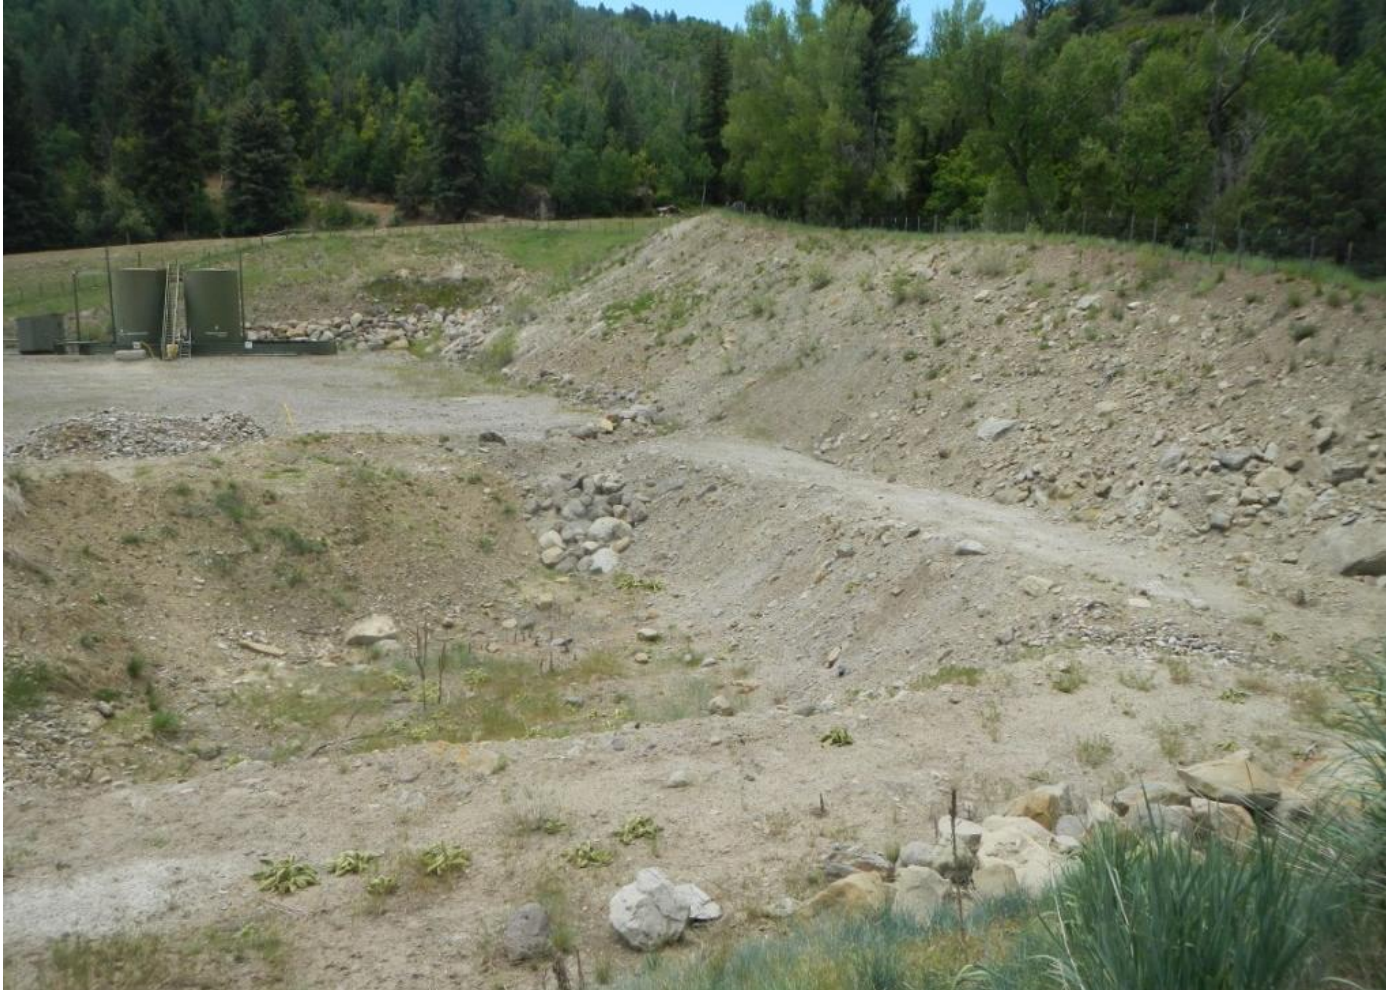
Photo 4. View of the western portion of the project area from the northwestern corner facing southward. It appears that old pit is being used as a large silt trap at this time.

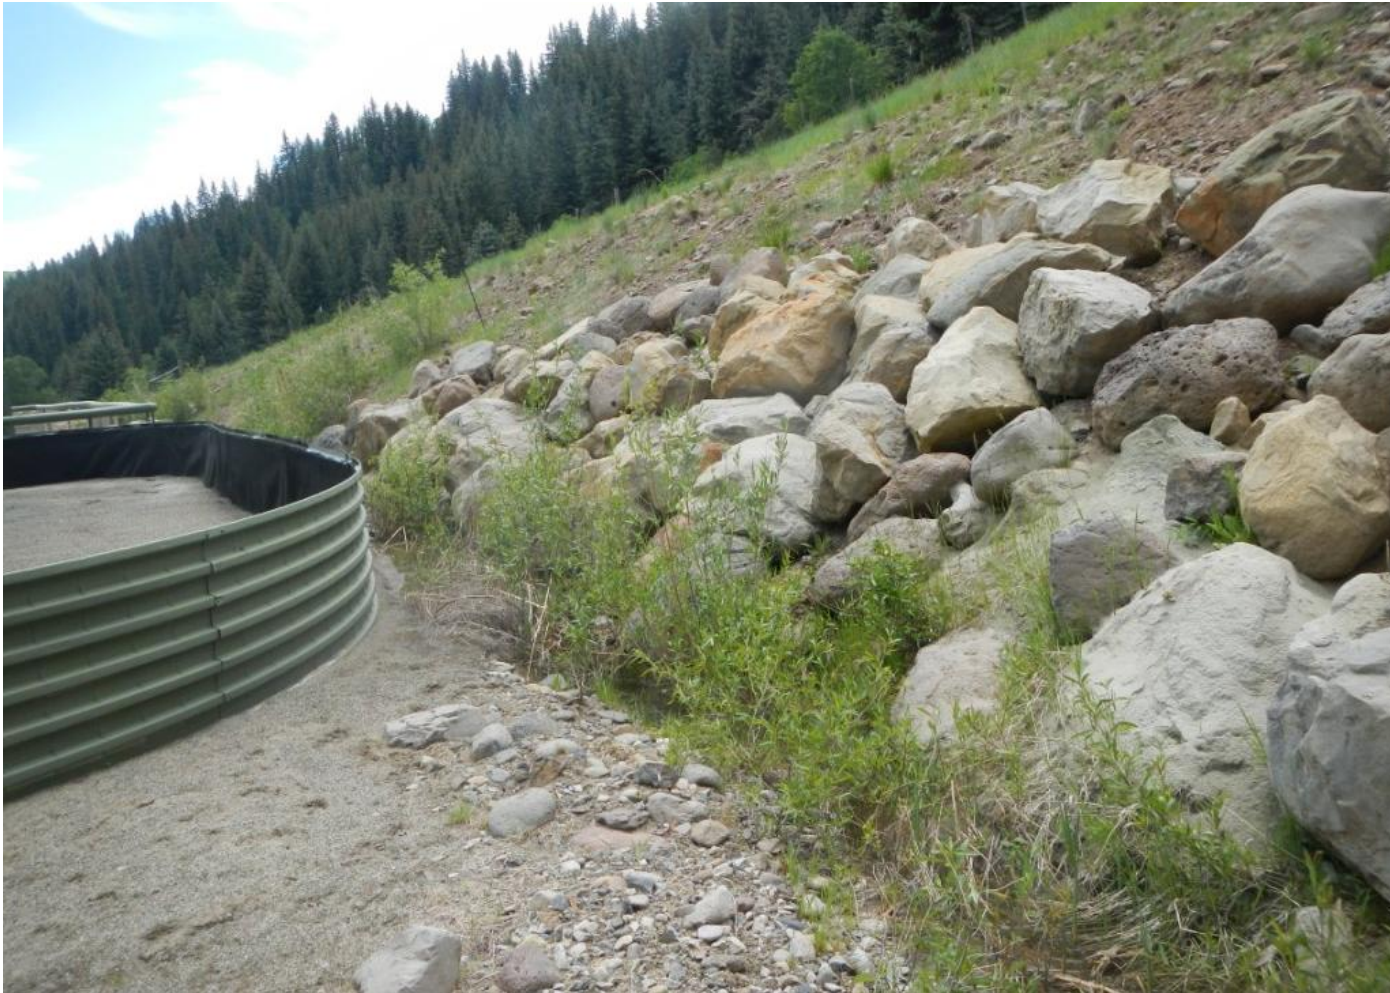
Photo 5. View of the southern portion of the project area from the southwestern corner facing eastward.

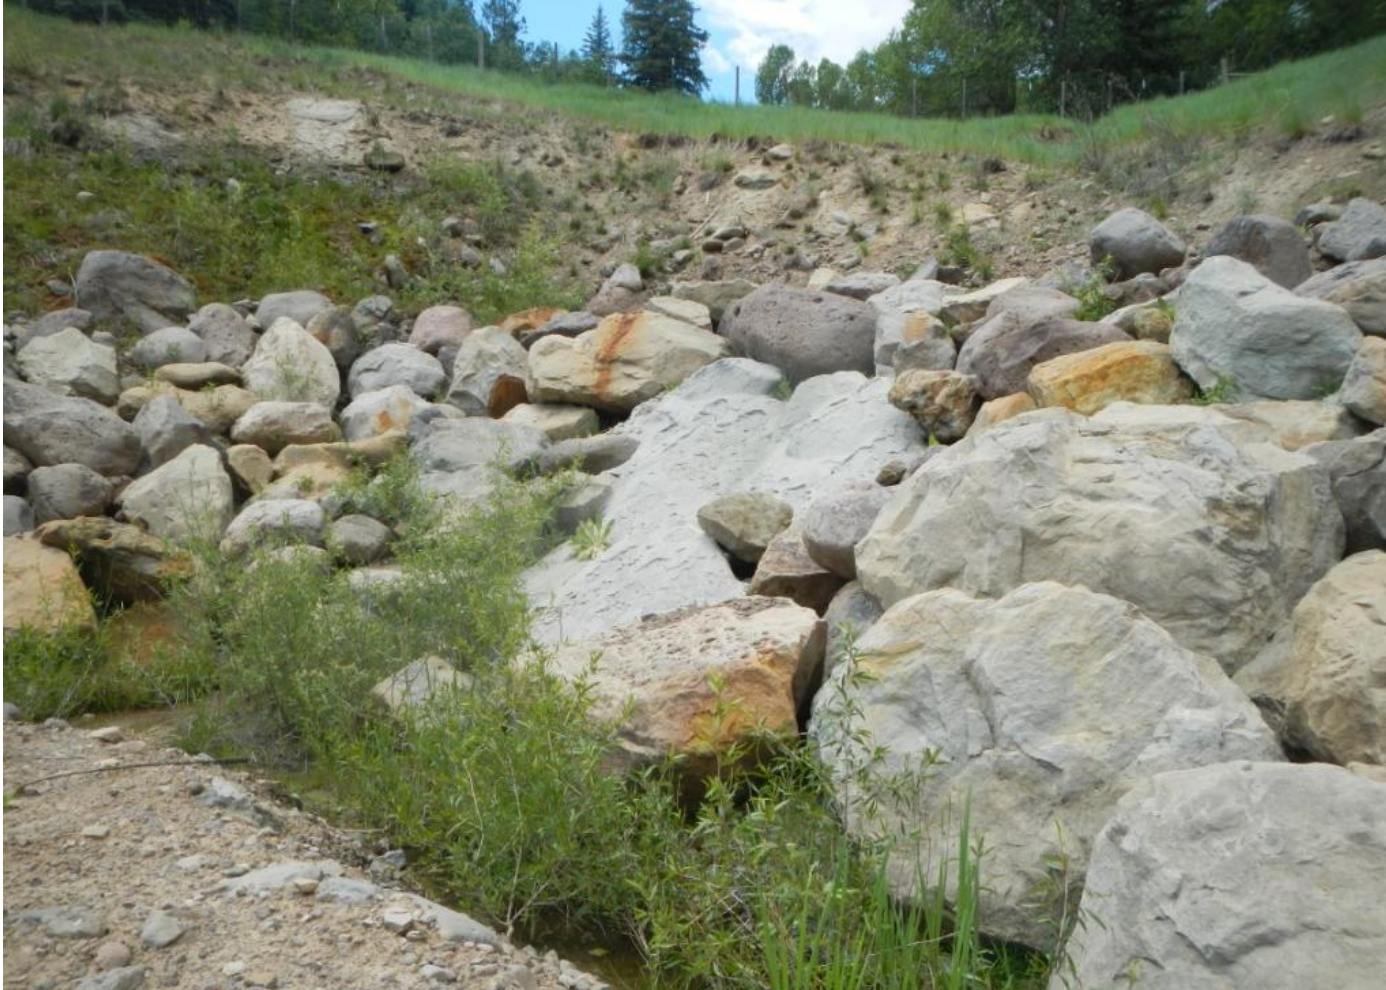
Photo 6. View of the southwestern corner of the project area facing up-slope. Large boulders are being used to stabilize slope. Water is emerging from cut-slope.

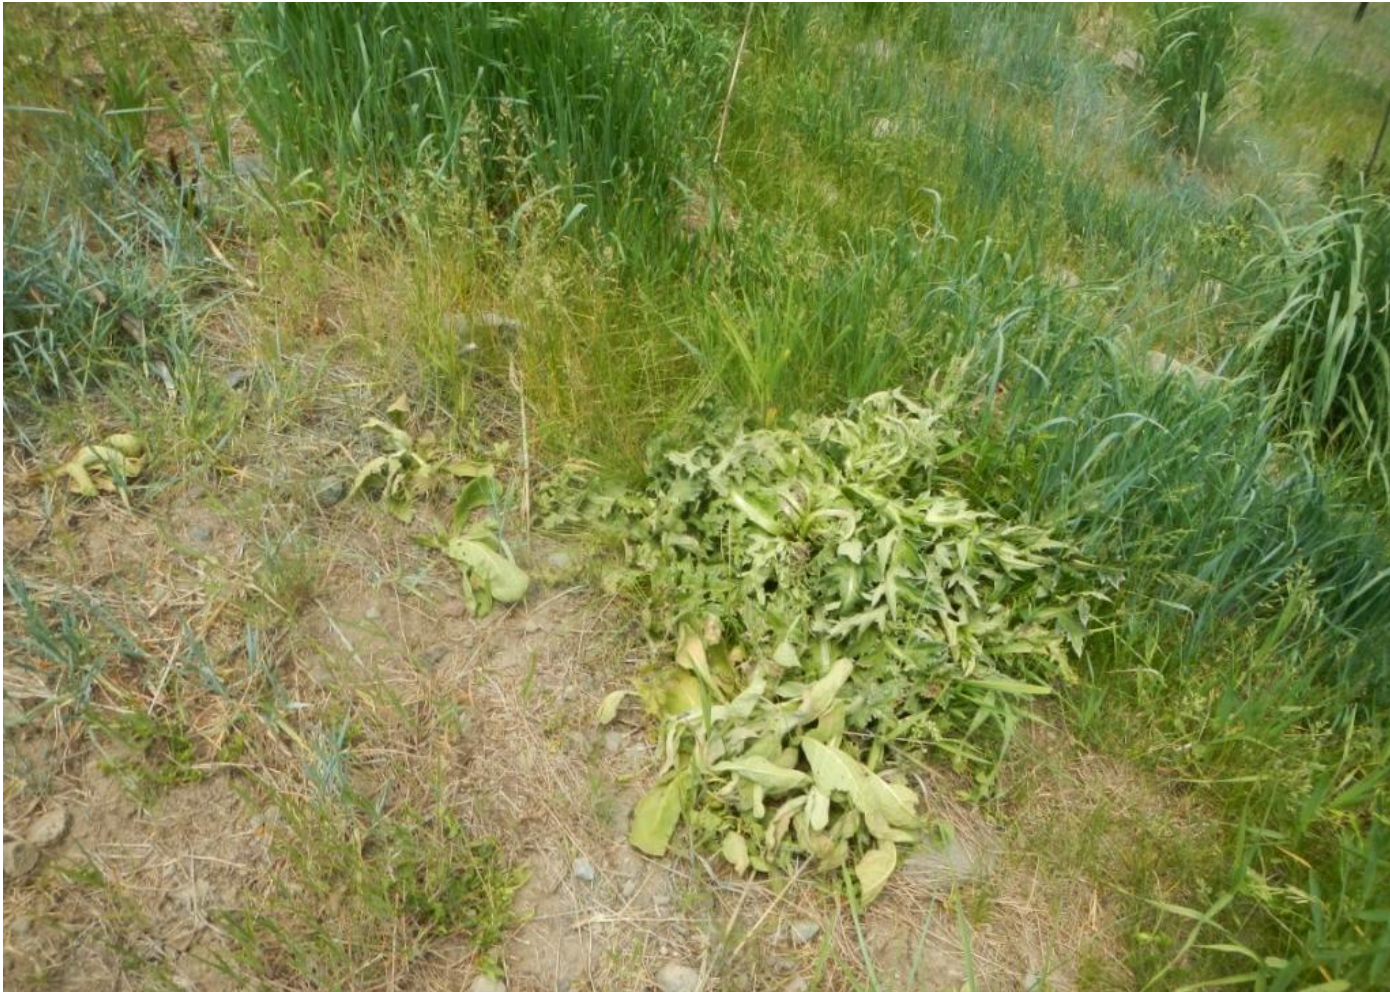
Photo 7. View of wilted musk thistle appear to have been recently treated with herbicide.
