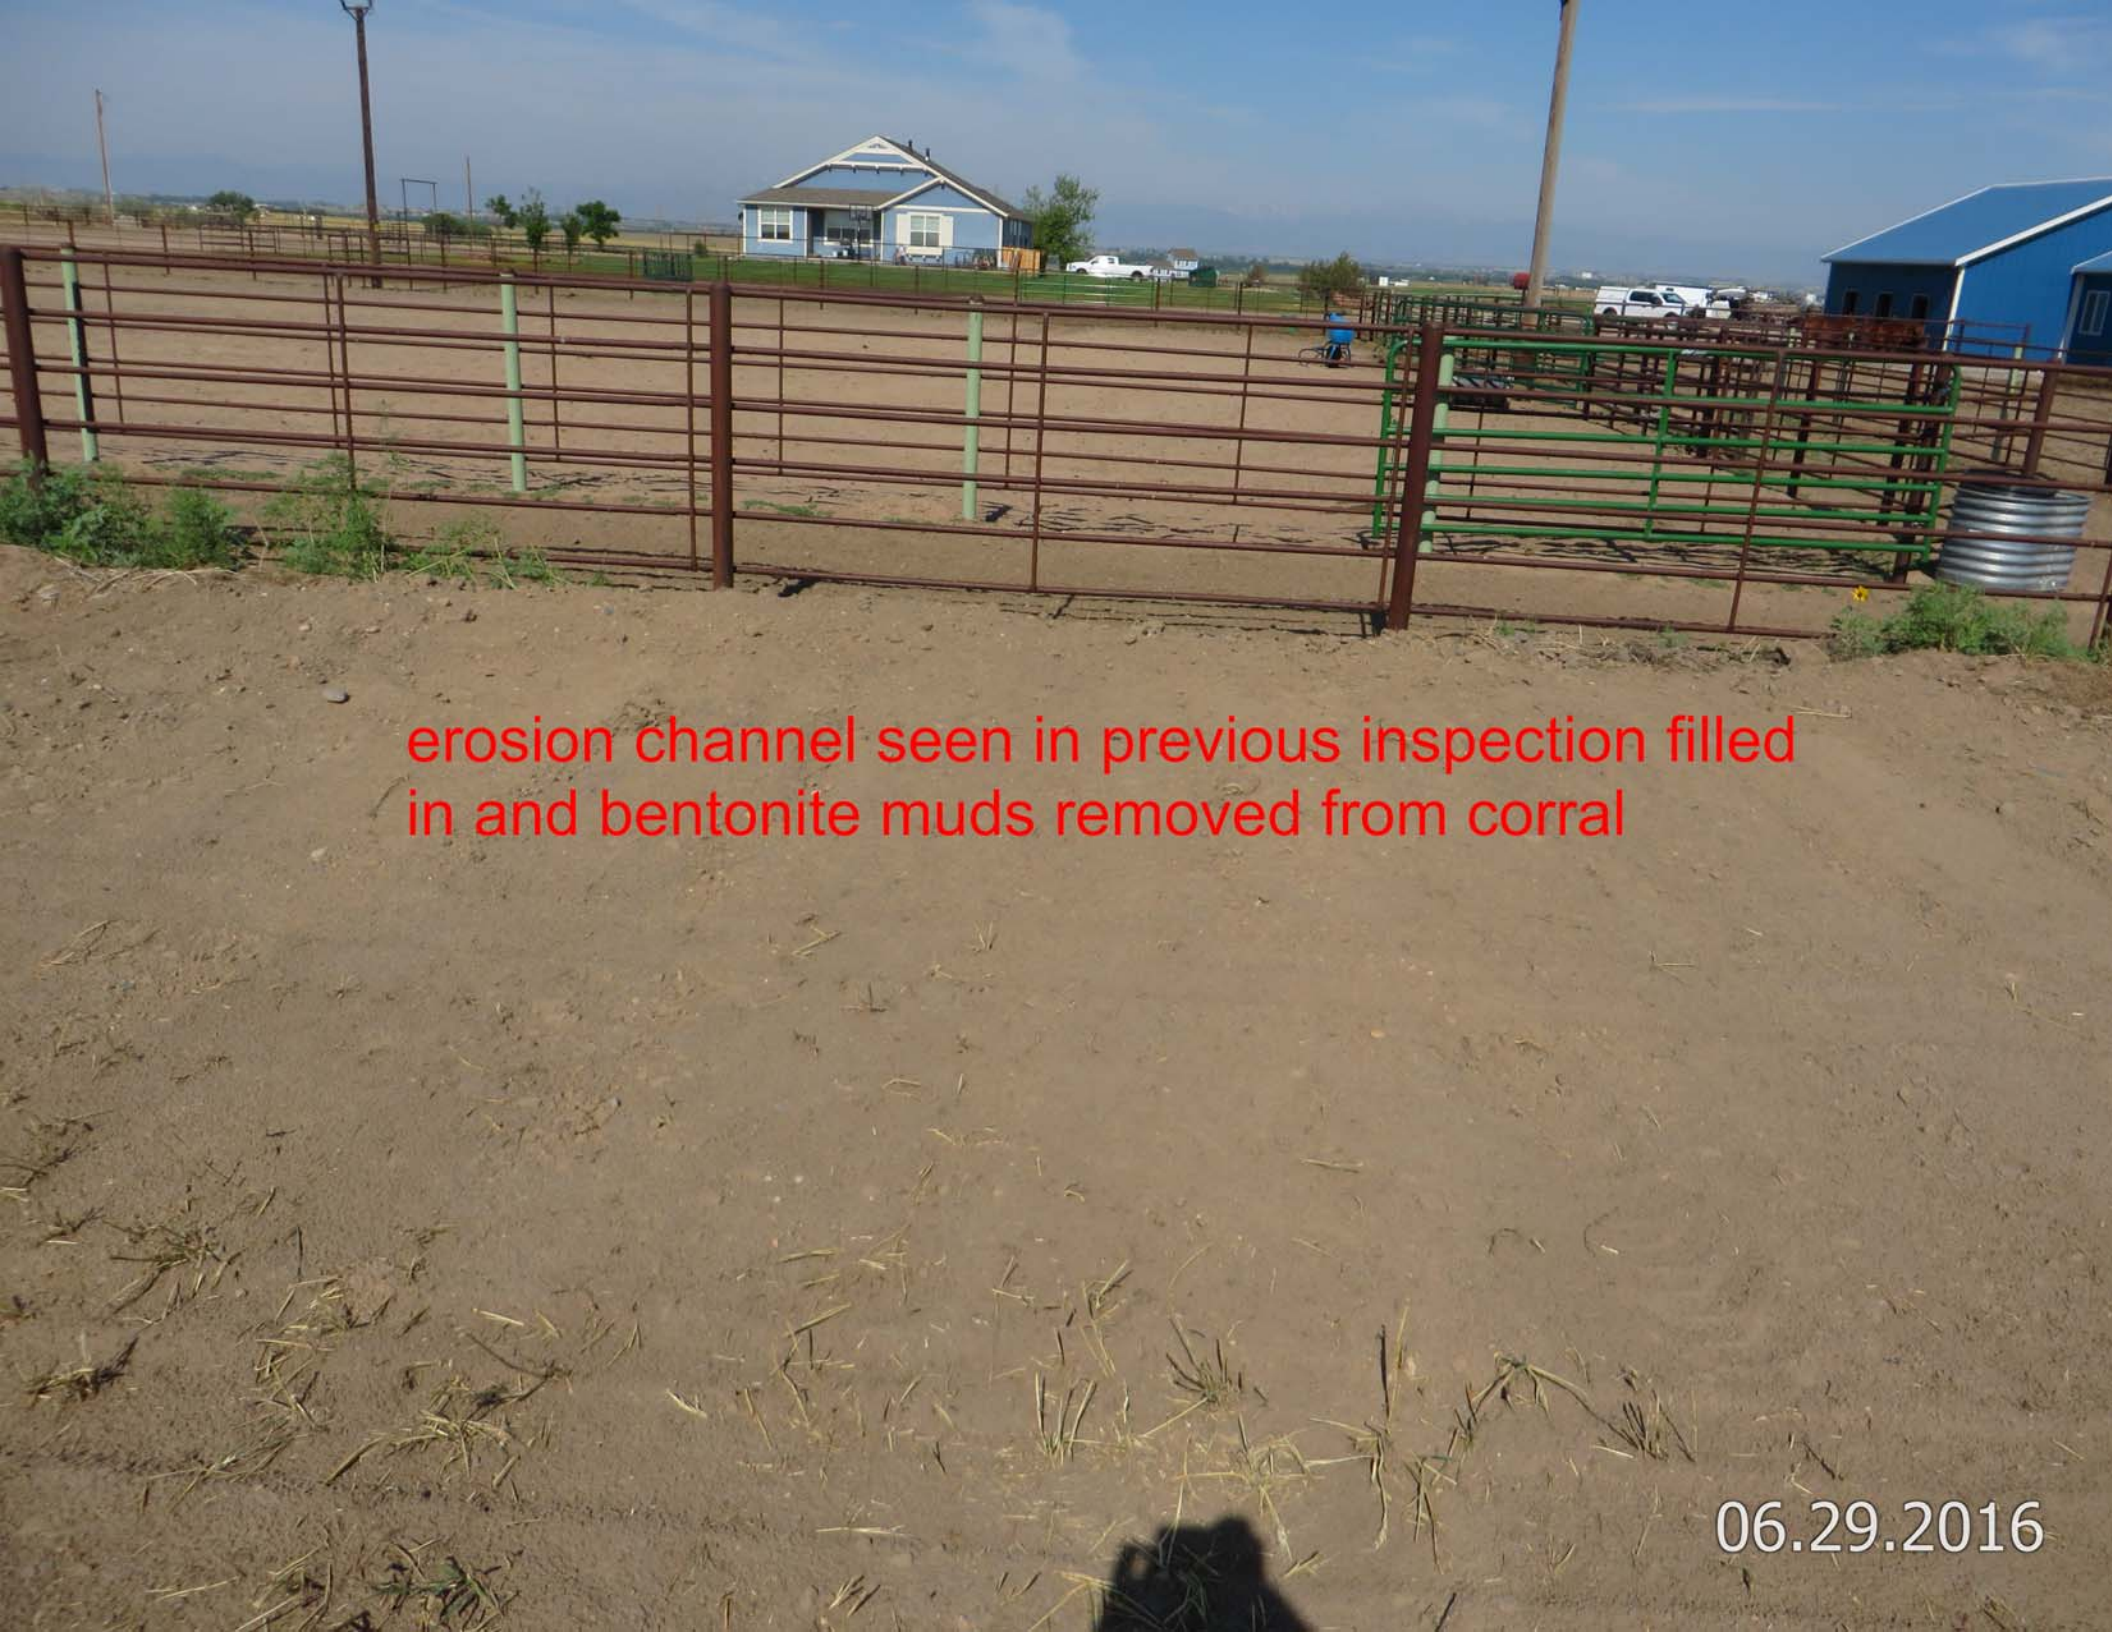
06.29.2016

erosion channel seen in previous inspection filled in and bentonite muds removed from corral
