Final Reclamation Inspection

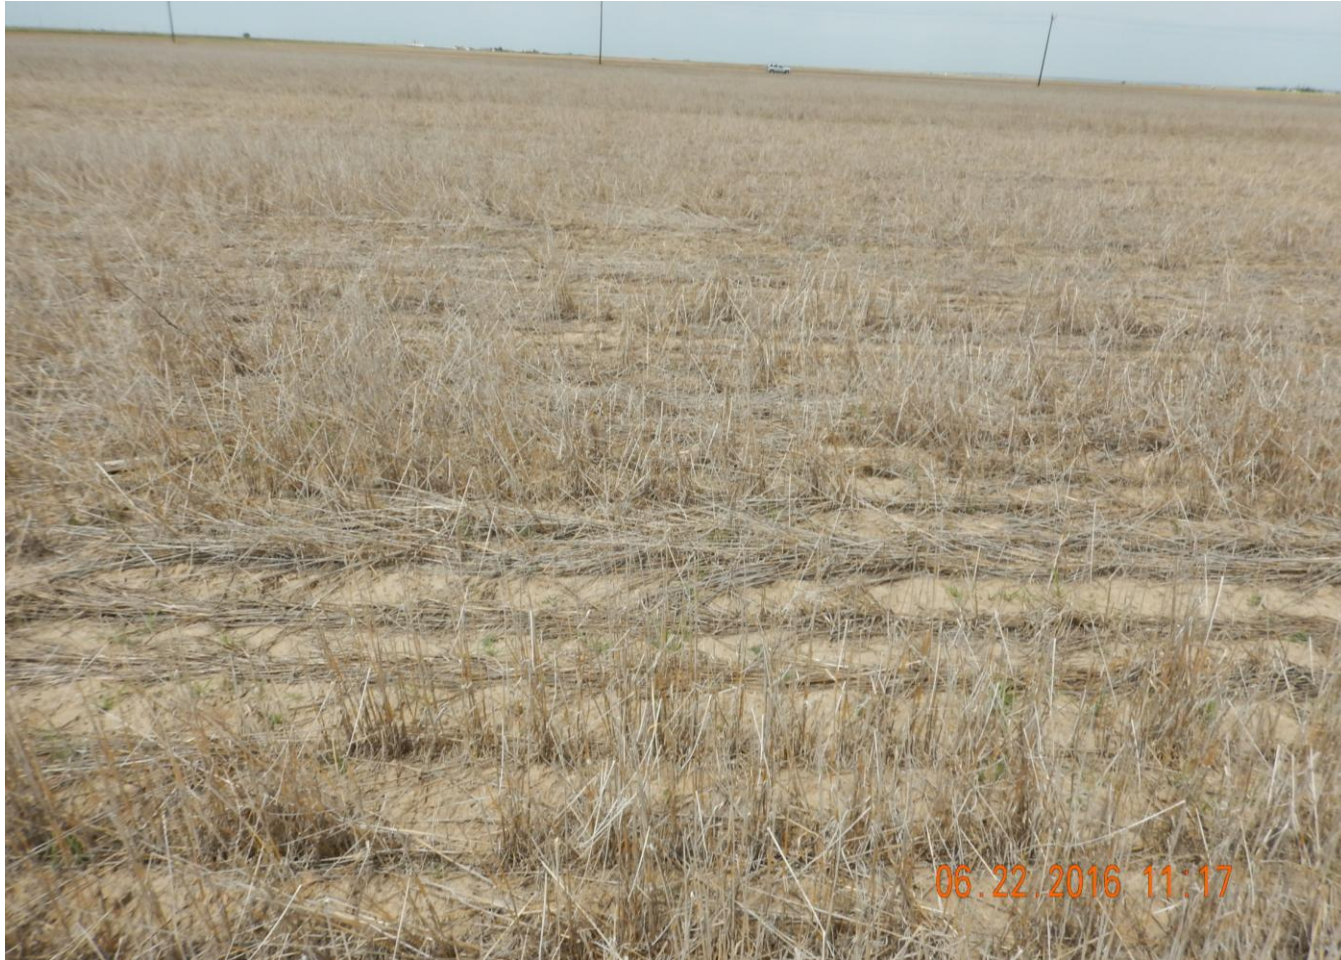
Photo 1. Photo taken from center of location, facing West. No evidence of disturbance. Uniform vegetative growth throughout location.

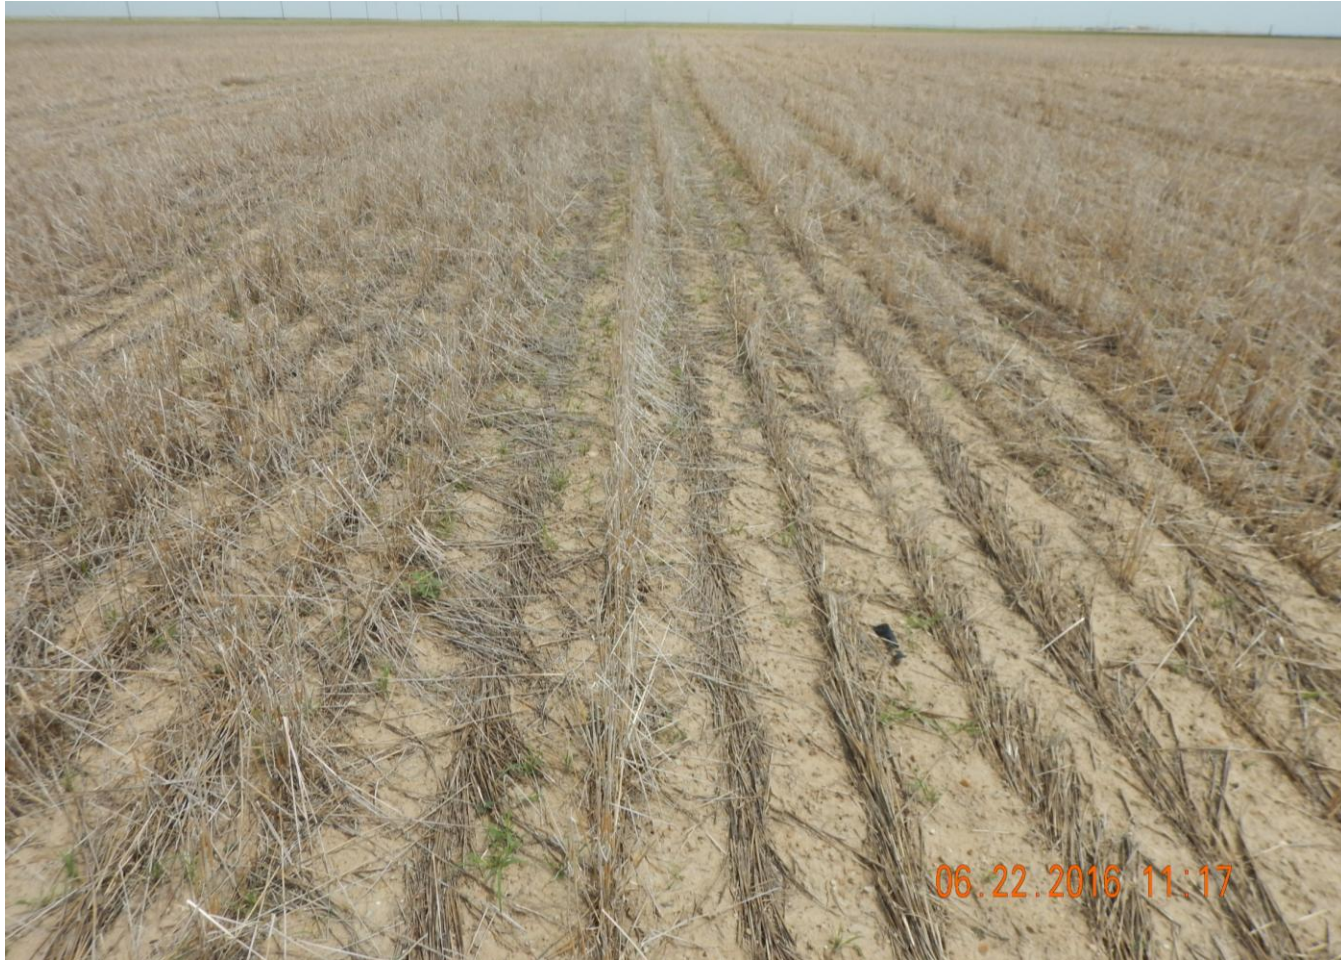
Photo 2. Photo taken from center of location, facing North. No evidence of disturbance. Uniform vegetative growth throughout location.

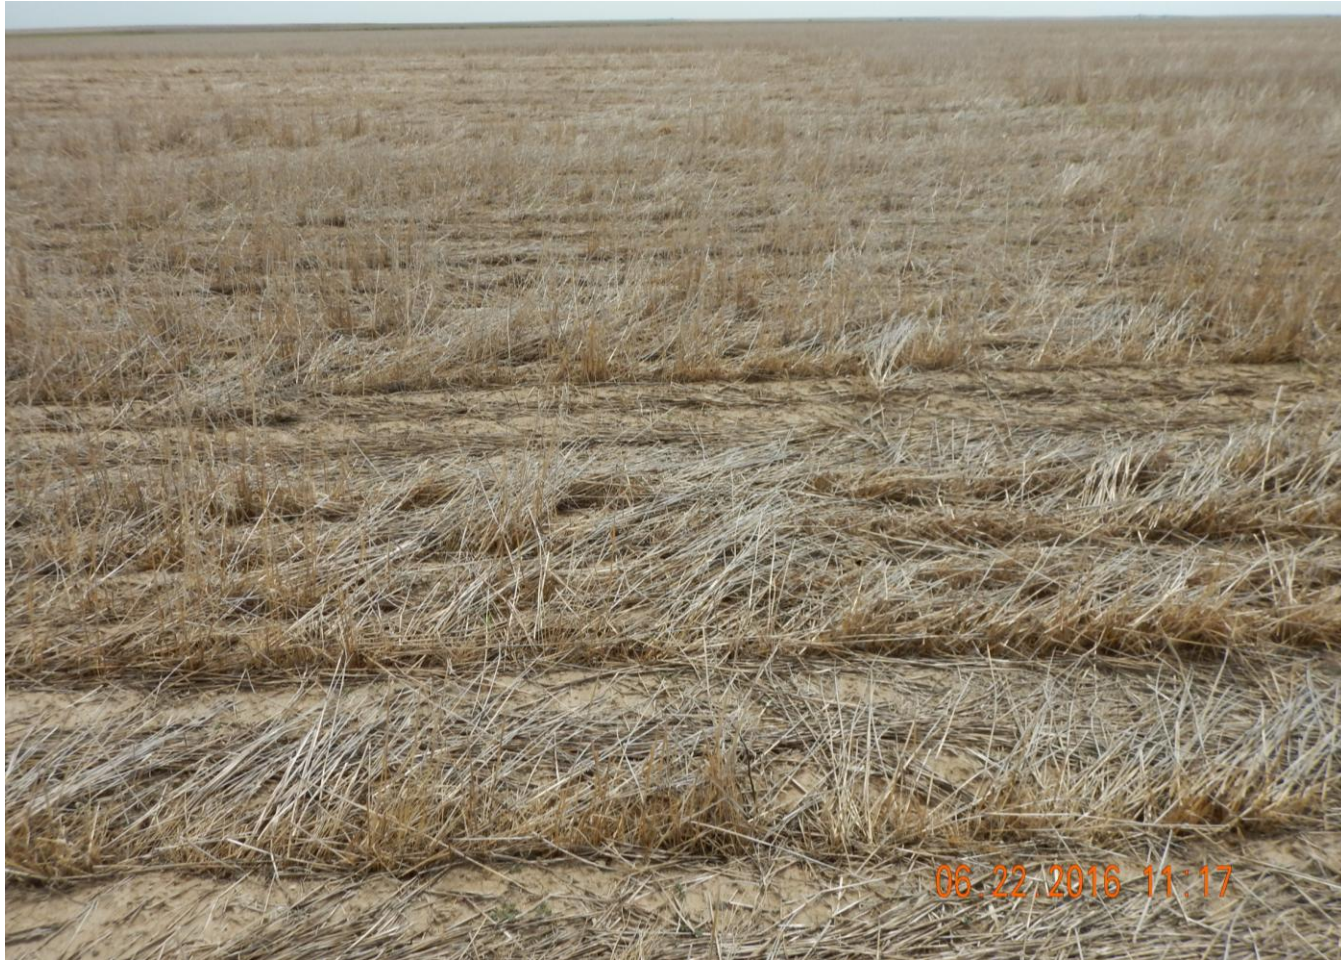
Photo 3. Photo taken from center of location, facing East. No evidence of disturbance. Uniform vegetative growth throughout location.

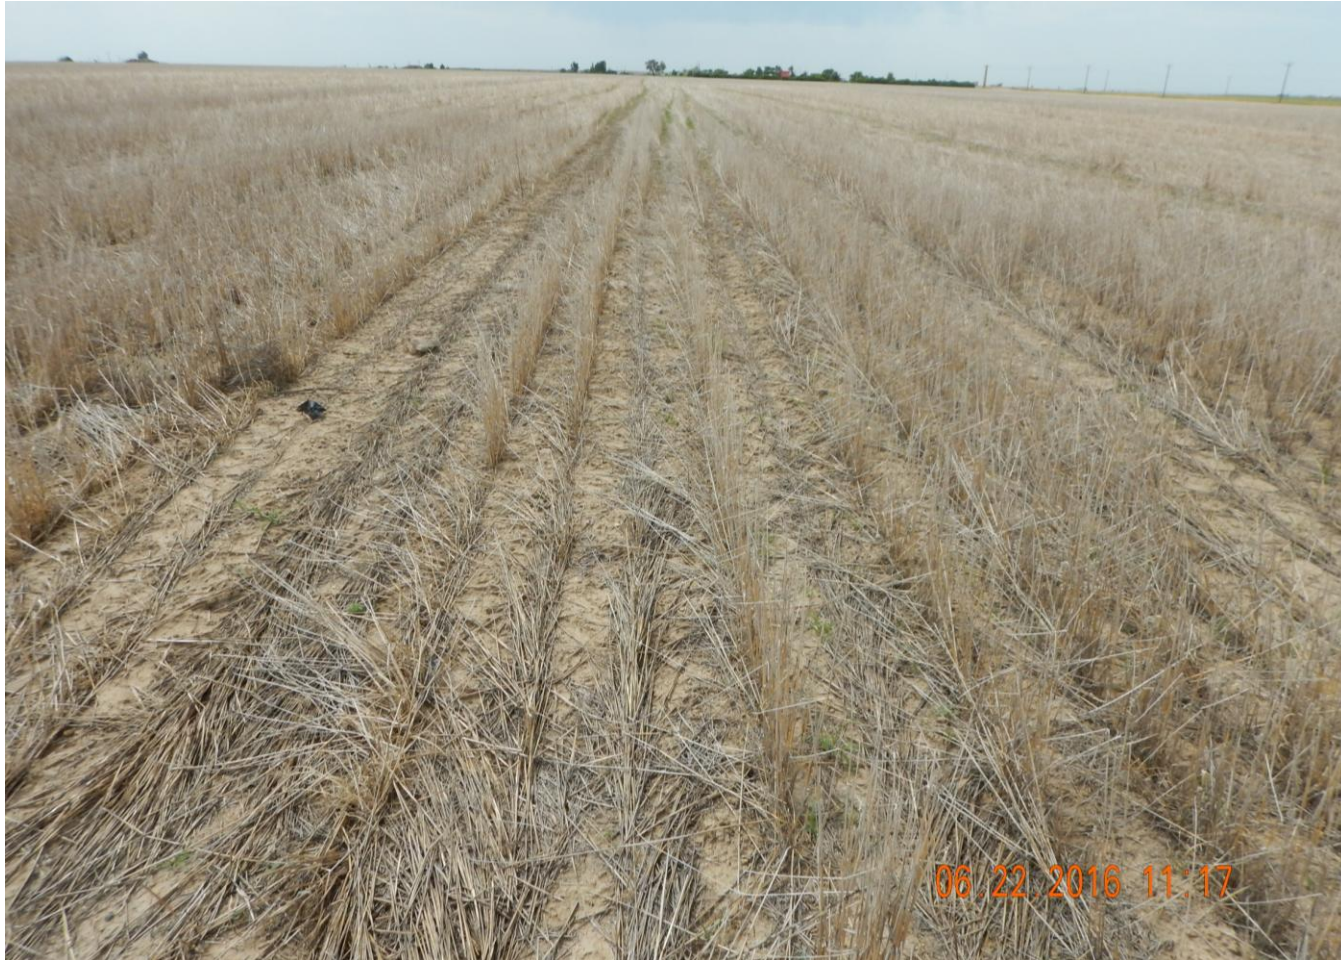
Photo 4. Photo taken from center of location, facing South. No evidence of disturbance. Uniform vegetative growth throughout location.

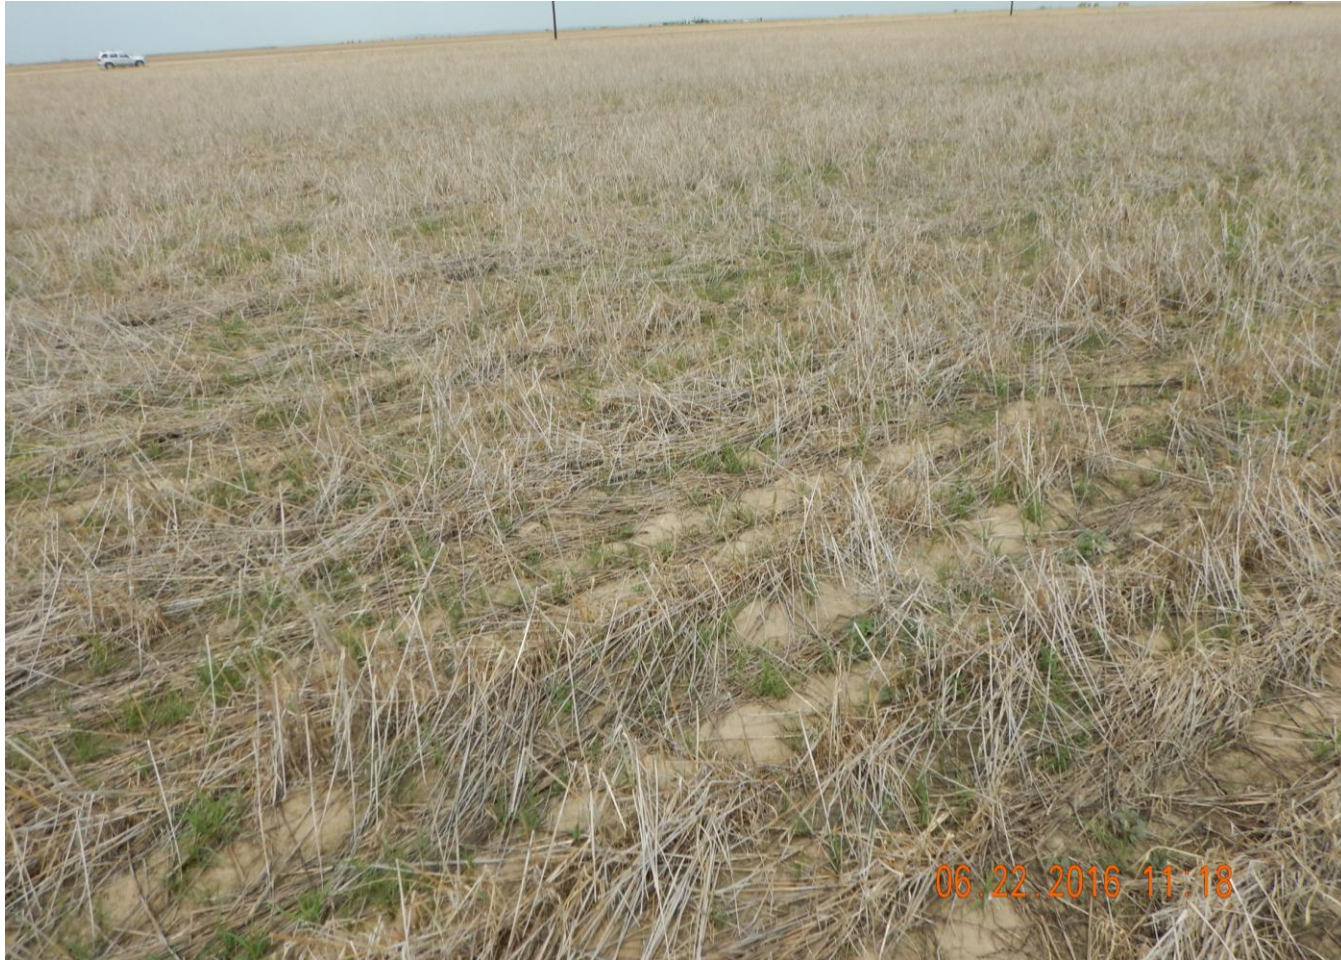
Photo 5. Reference photo taken east of location, facing South. Location appears to be reflective of the reference area.
