Construction Inspection

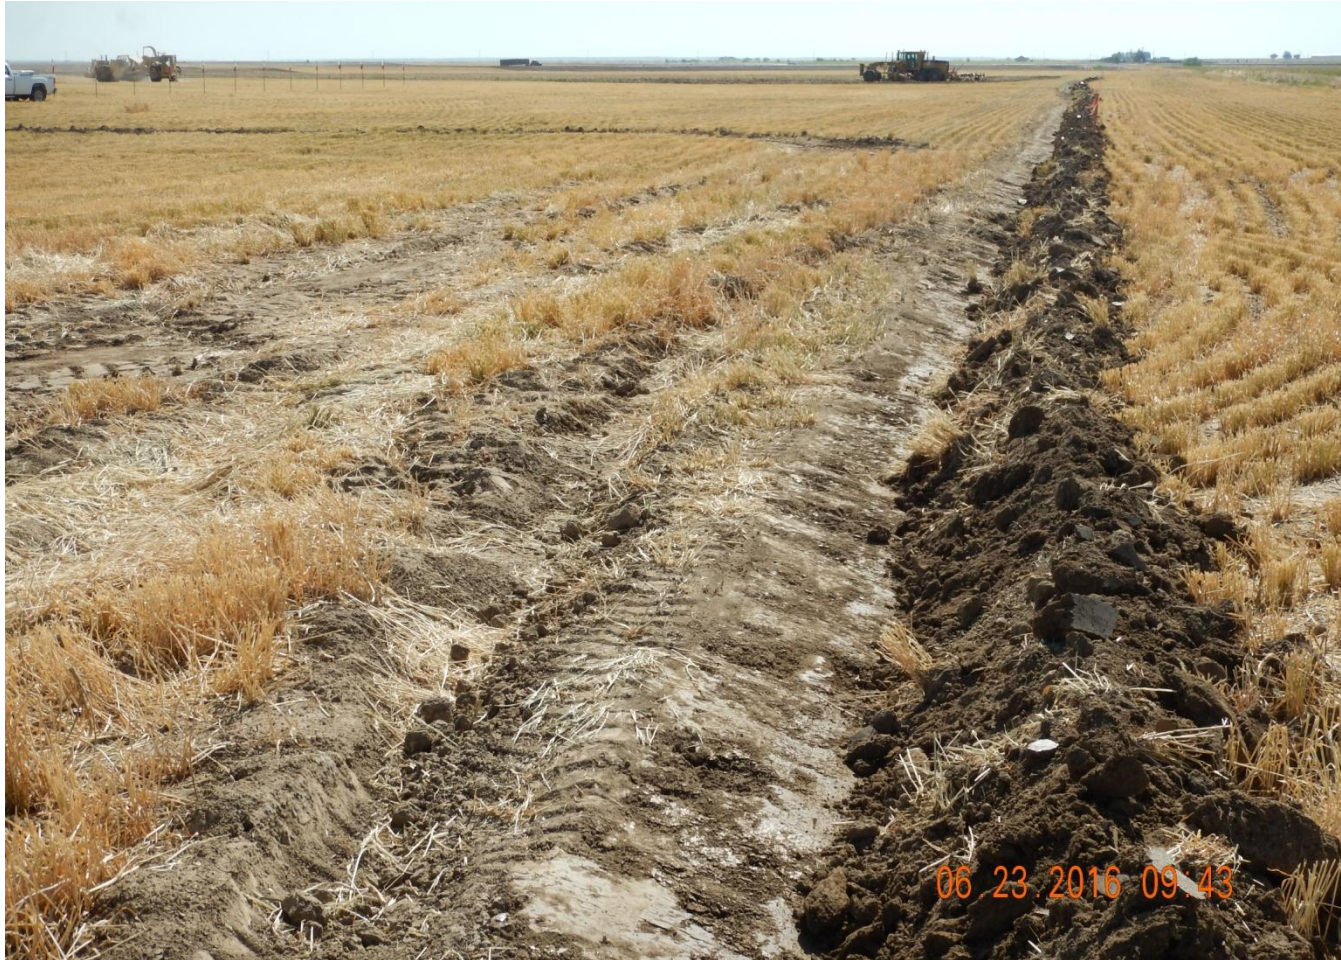
Photo 1. Photo taken from southwest location, facing East. BMP installed around perimeter of location. Operator said berms will be compacted and BMP would be finished on eastern side once landowner moves equipment.

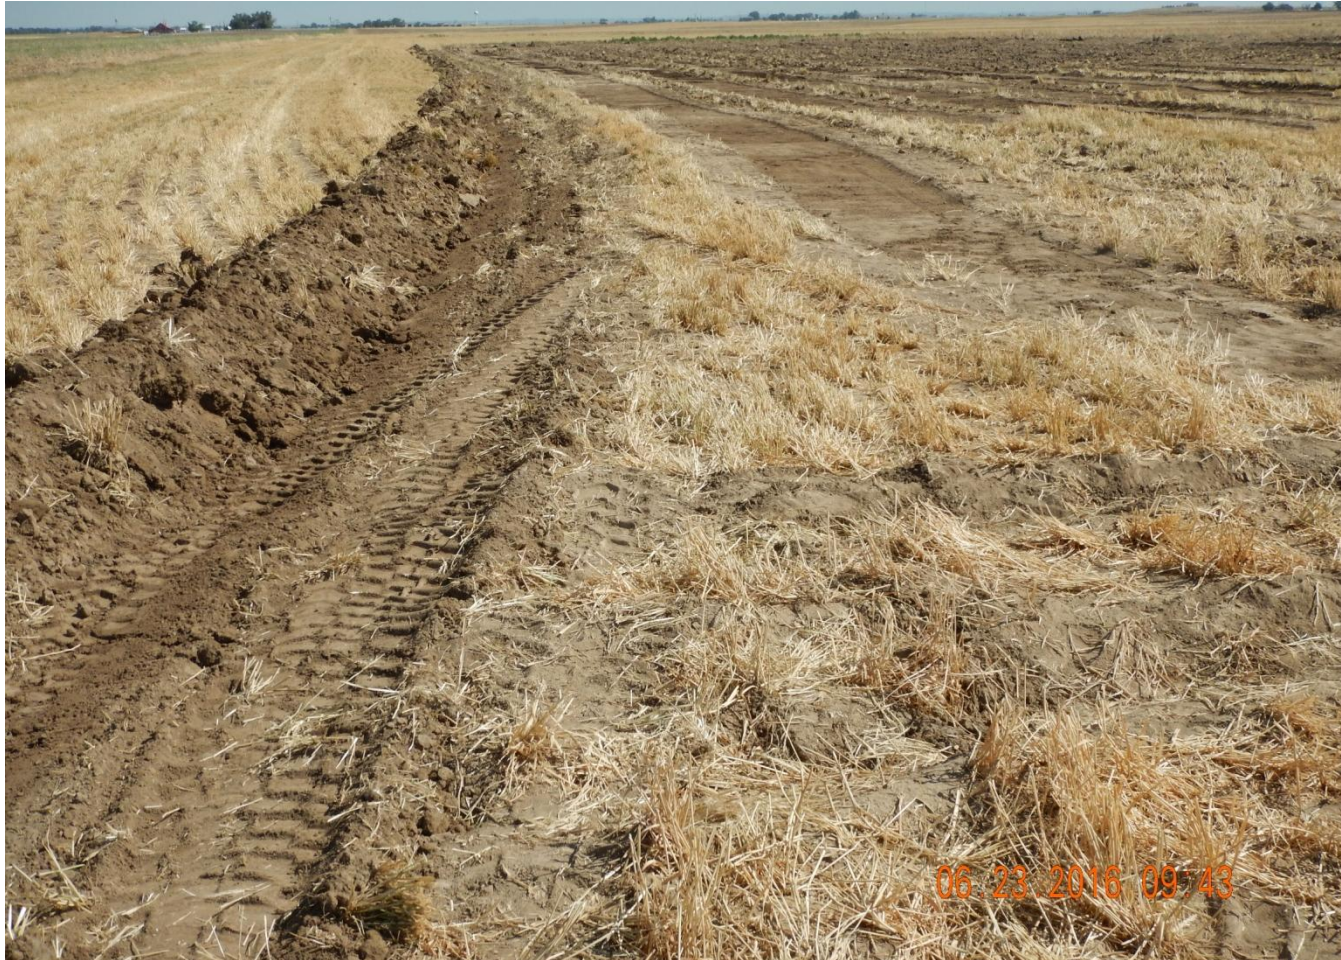
Photo 2. Photo taken from southwest location, facing North. BMP installed around perimeter of location. Operator said berms will be compacted and BMP would be finished on eastern side once landowner moves equipment.

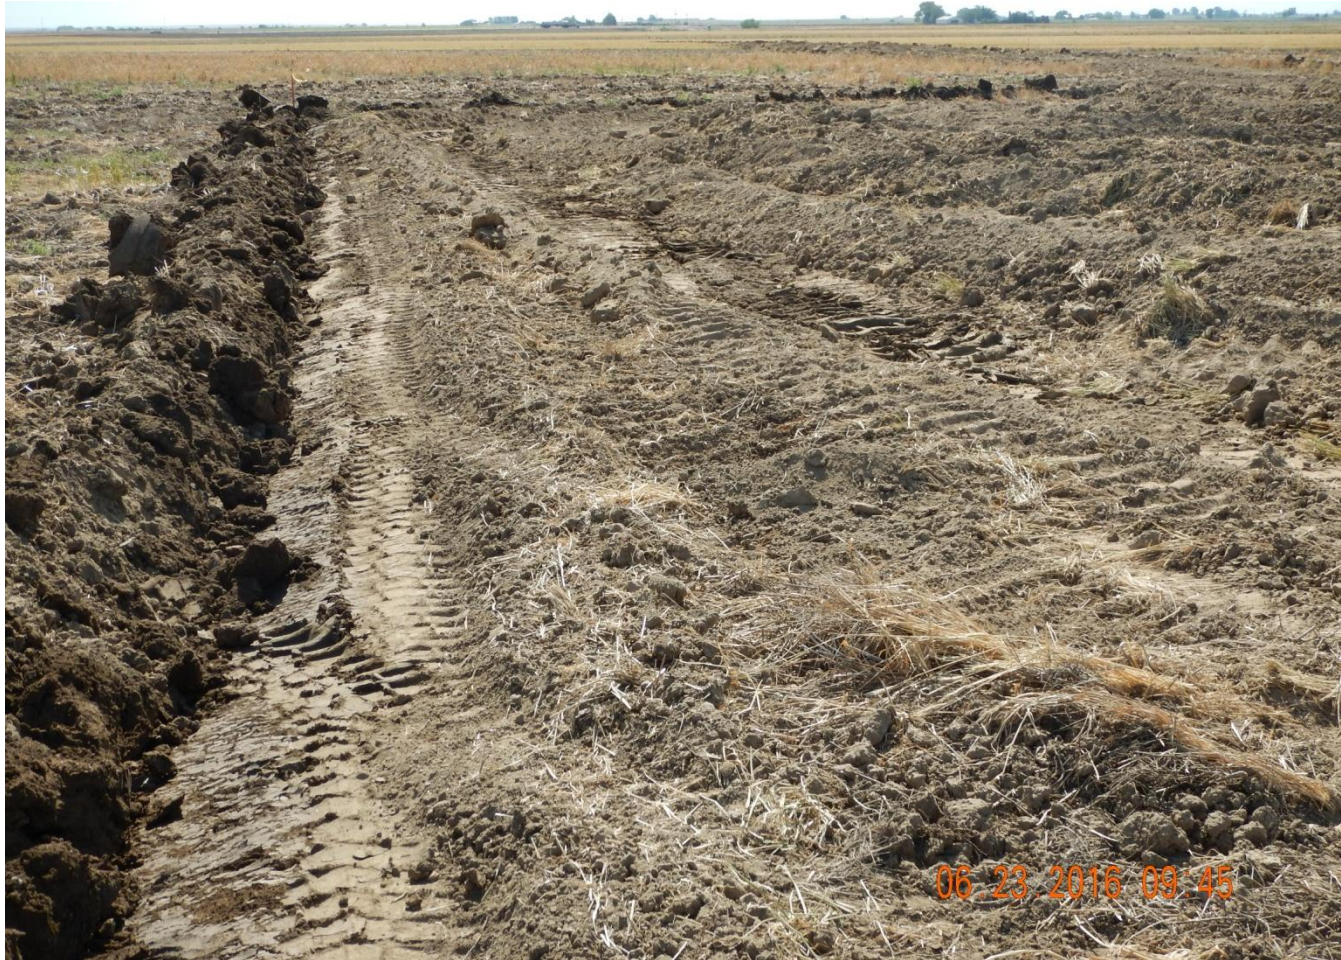
Photo 3. Photo taken from northwest location, facing East. BMP installed around perimeter of location. Operator said berms will be compacted and BMP would be finished on eastern side once landowner moves equipment.

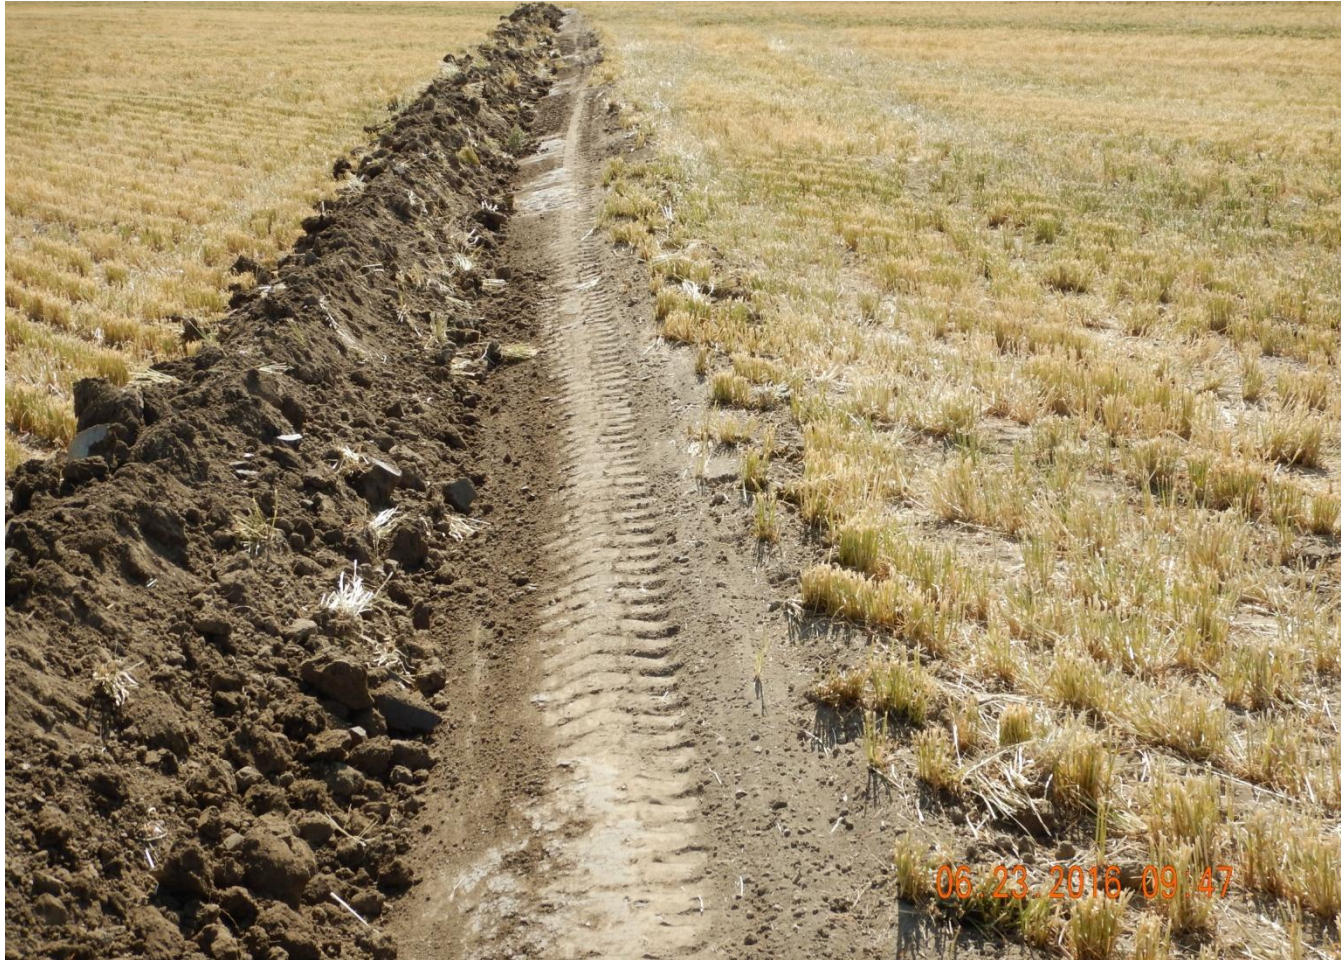
Photo 4. Photo taken from northern location, facing East. BMP installed around perimeter of location. Operator said berms will be compacted and BMP would be finished on eastern side once landowner moves equipment.

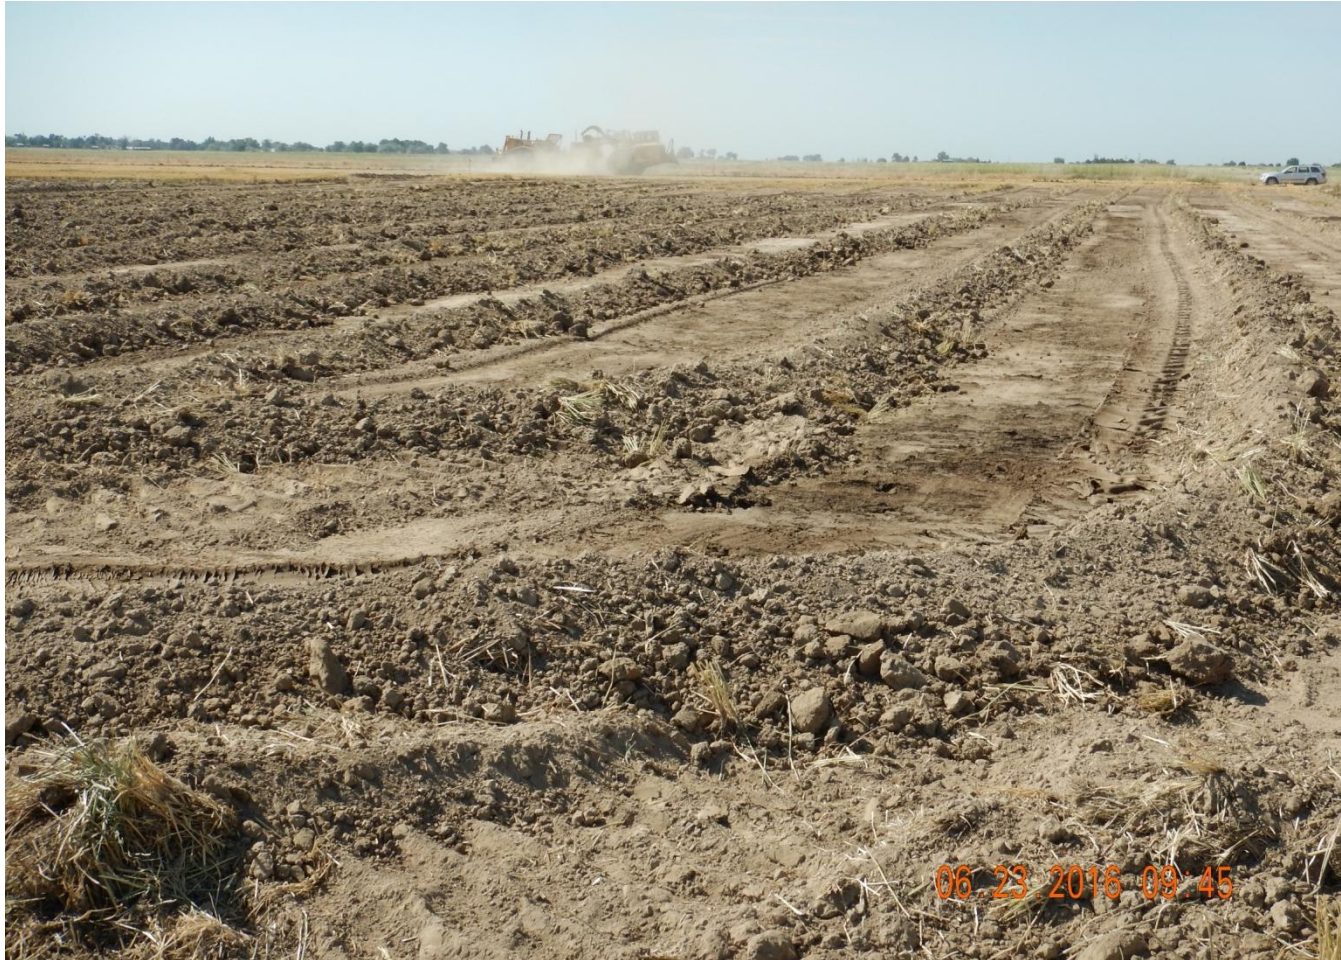
Photo 5. Photo taken from northern location, facing South. Topsoil salvage in process.
