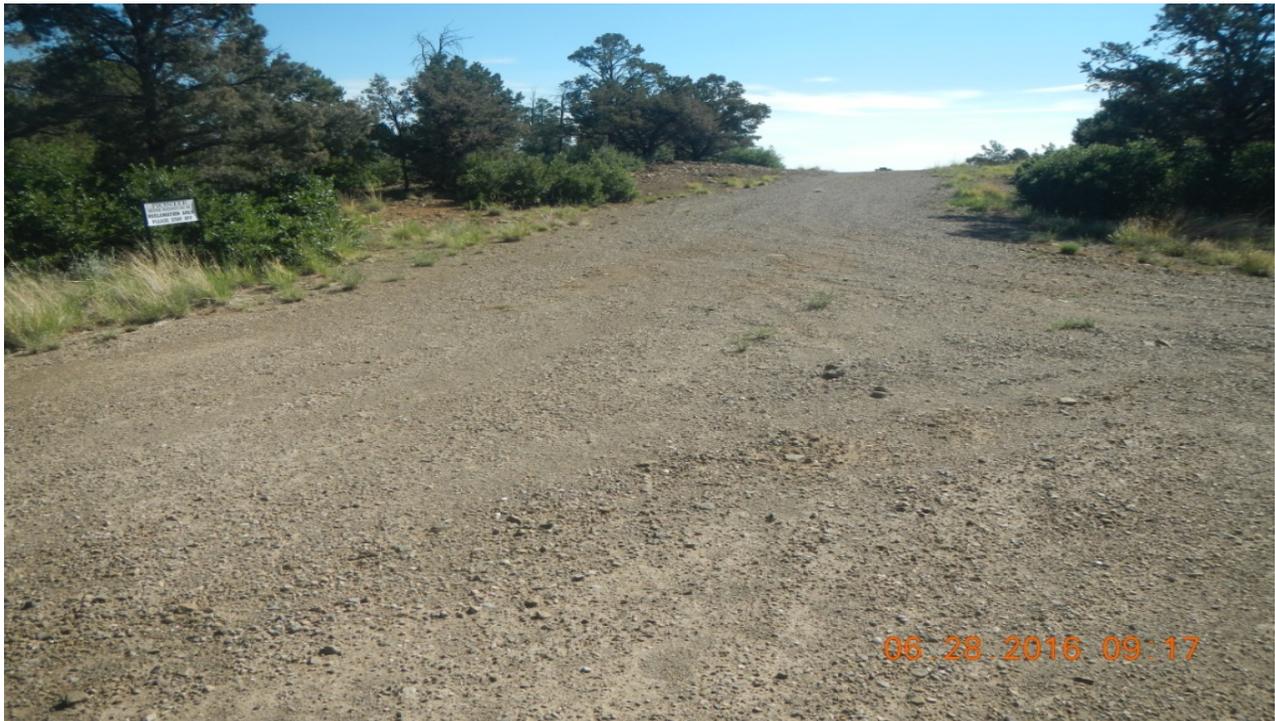
photo 1: Facing northeast toward the beginning of the access road.

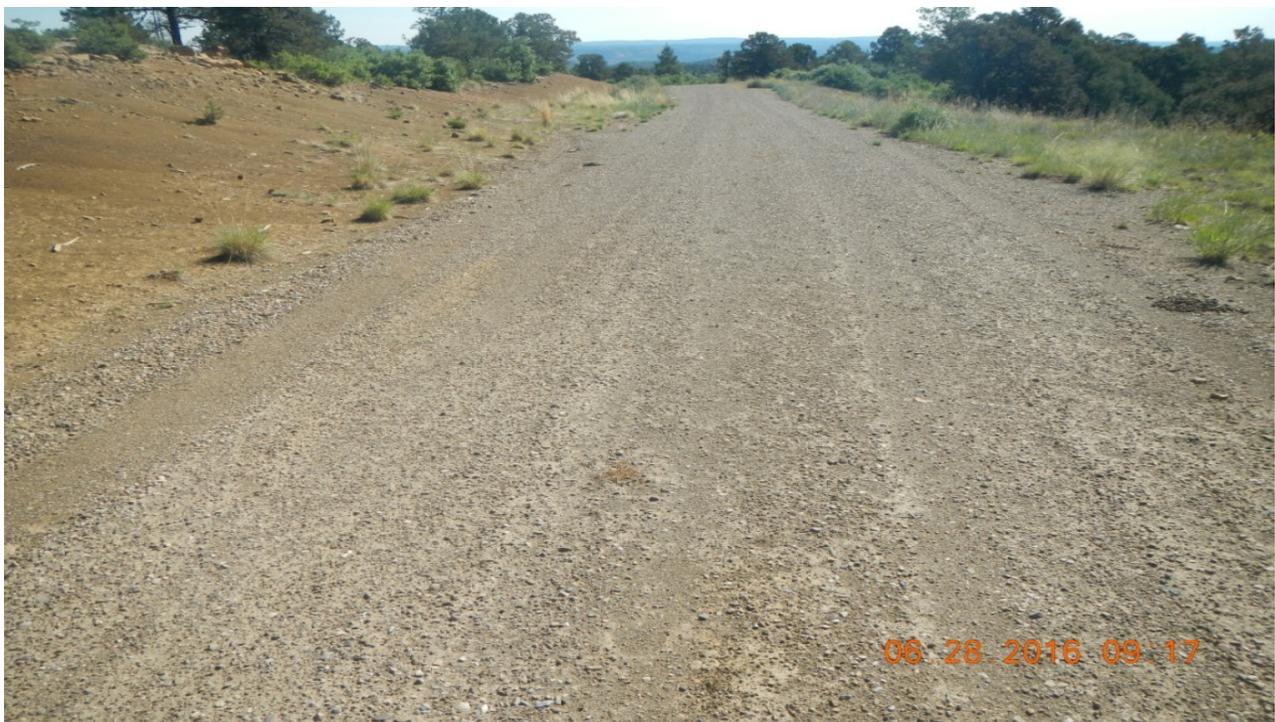
photo 2: Facing northeast along the access road.

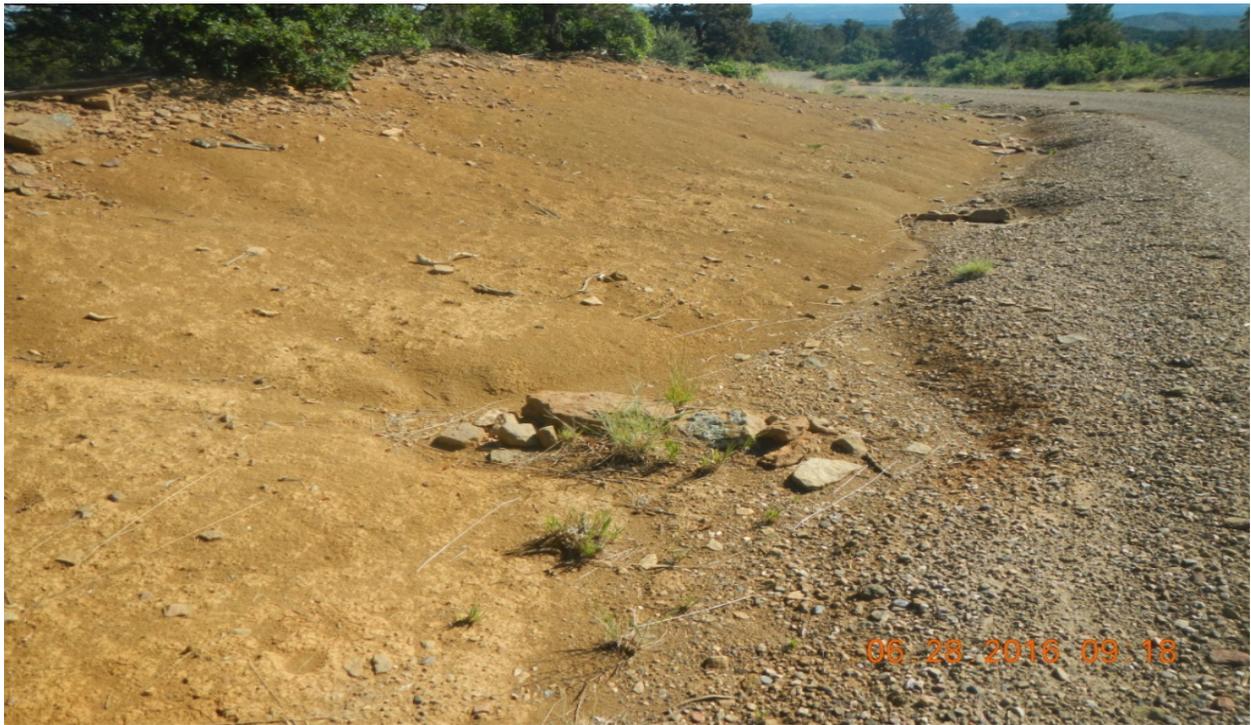
photo 3: Facing toward the side of the access road which is not stabilized with vegetation. What appears to be rock check dams have not been maintained.

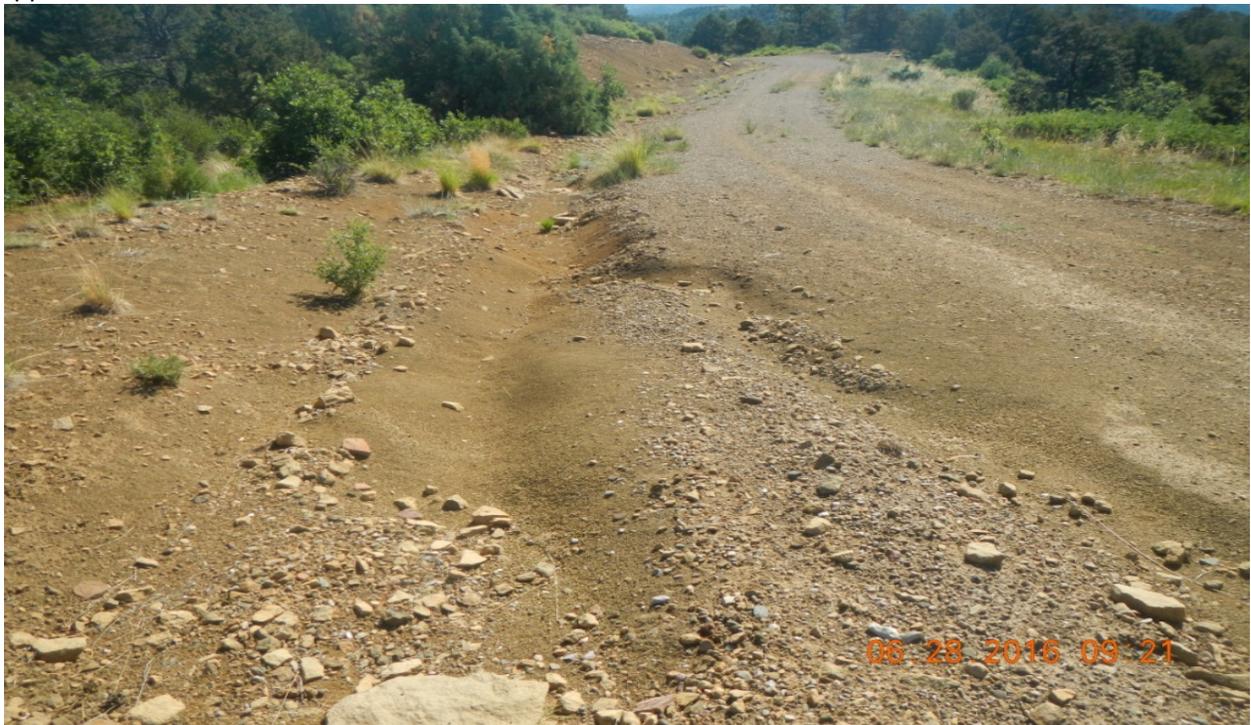
photo 4: Facing northeast along the access road. There are signs of erosion shown in the photo.

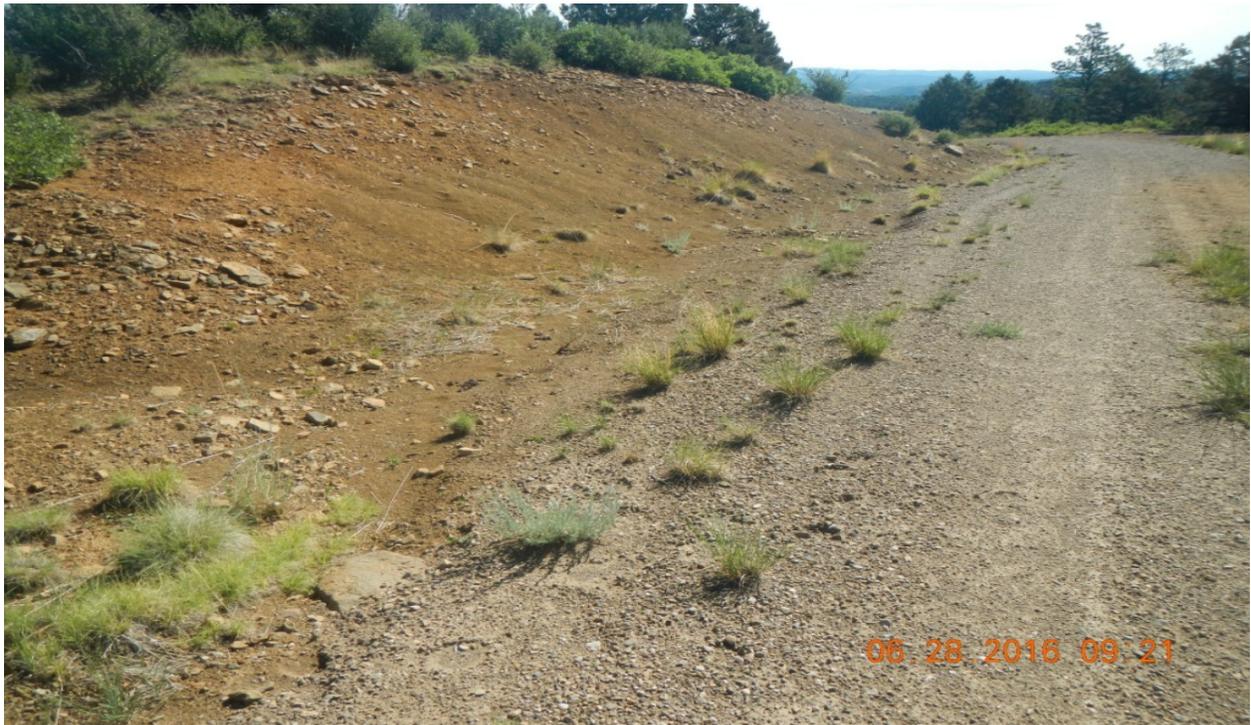
photo 5: The cut side along the access road does not have vegetation establishment.

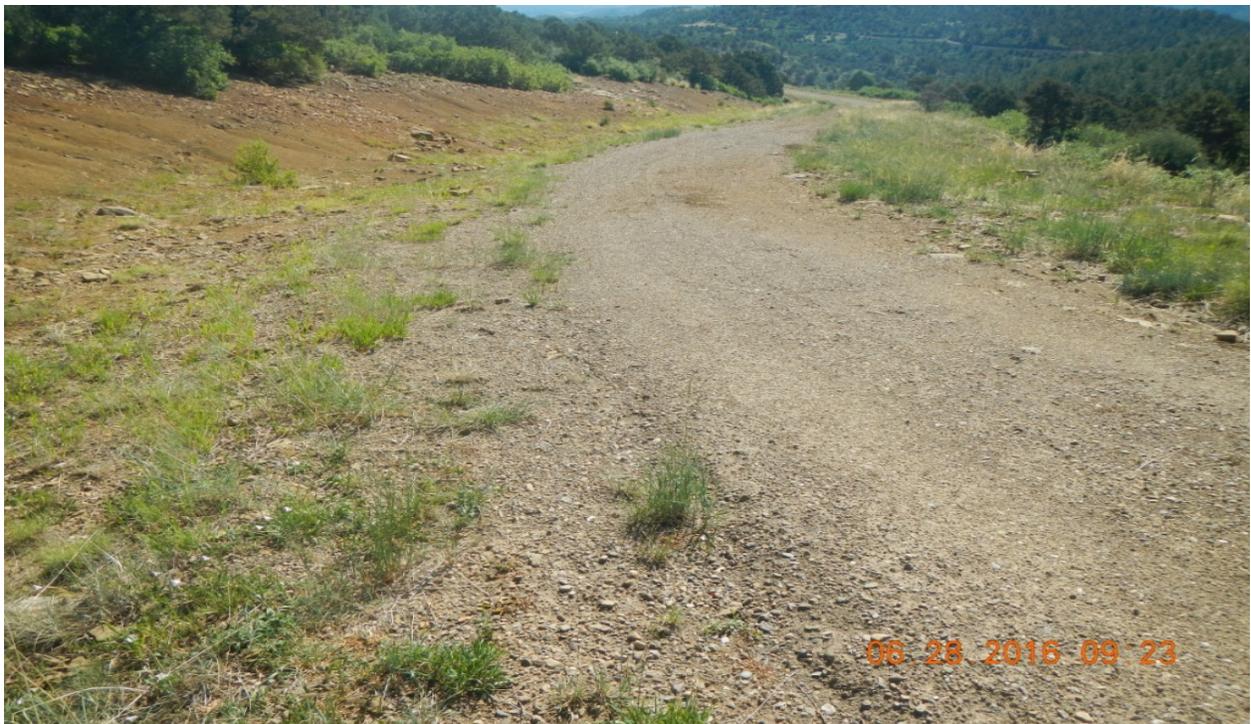
photo 6: Facing northeast further along the access road.

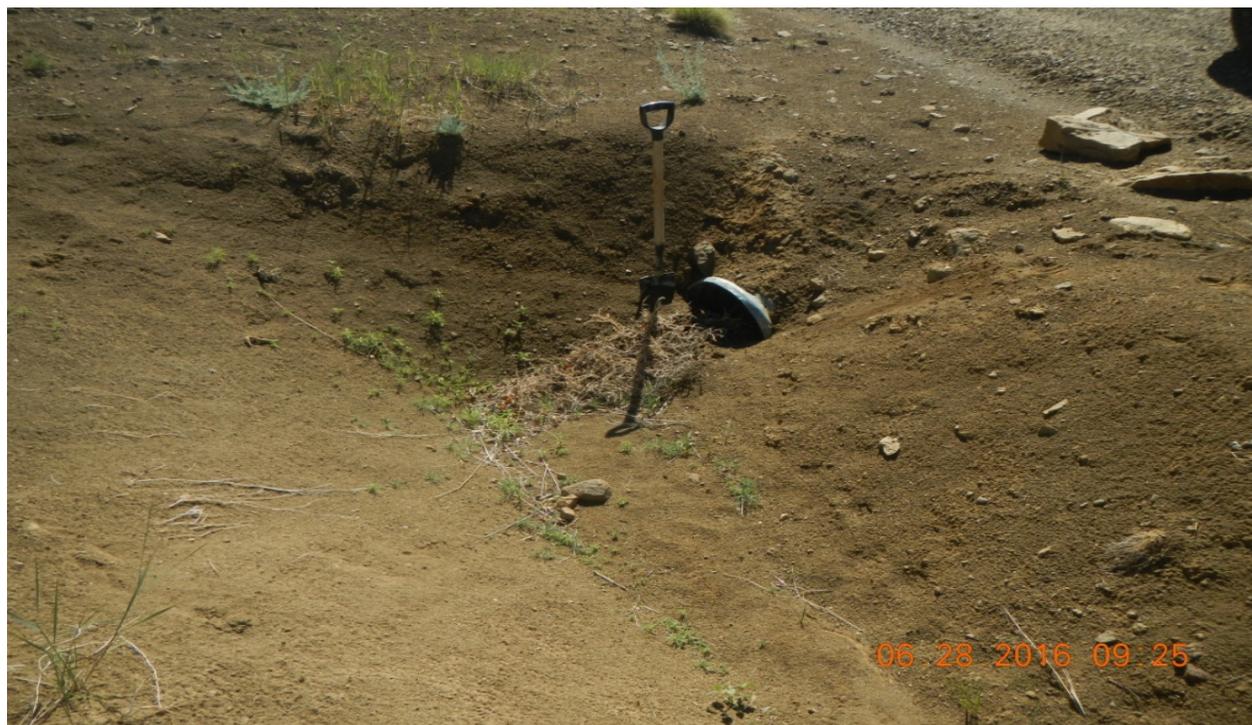
photo 7: A culvert is approximately half full of sediment. (Lat/Long: 37.089,-104.83053)

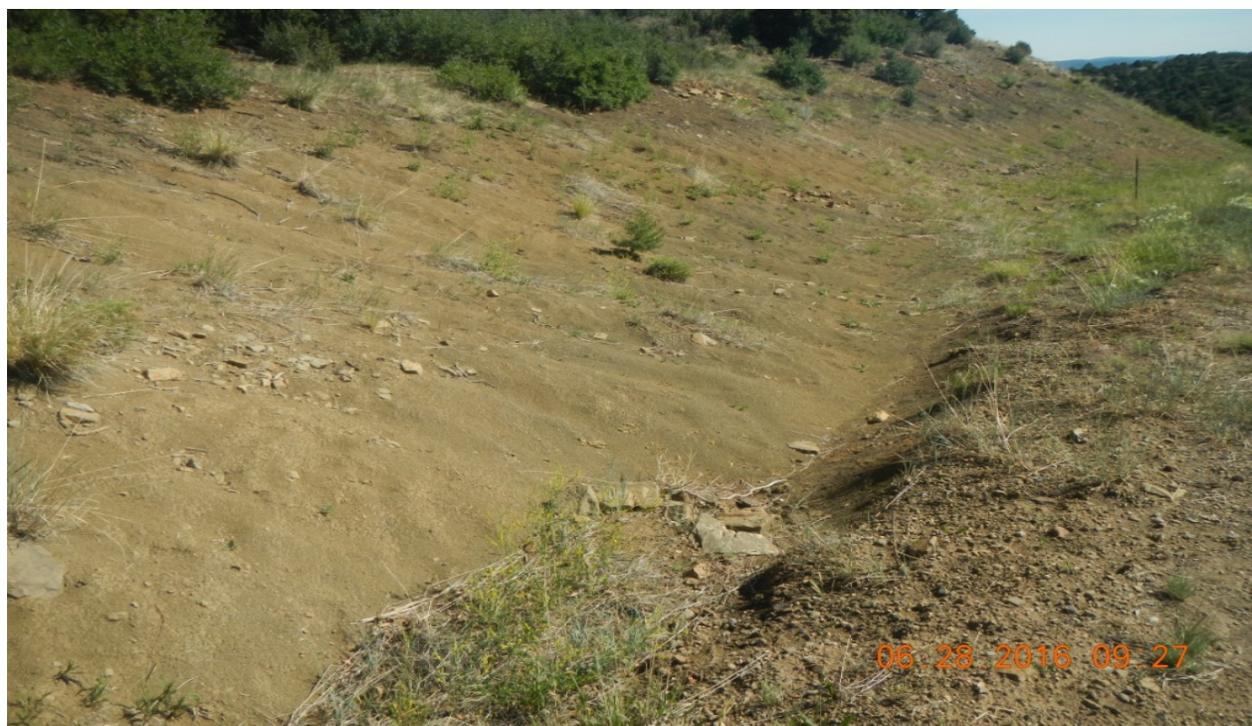
photo 8: Facing along the side of the access road. Vegetation is not well established.

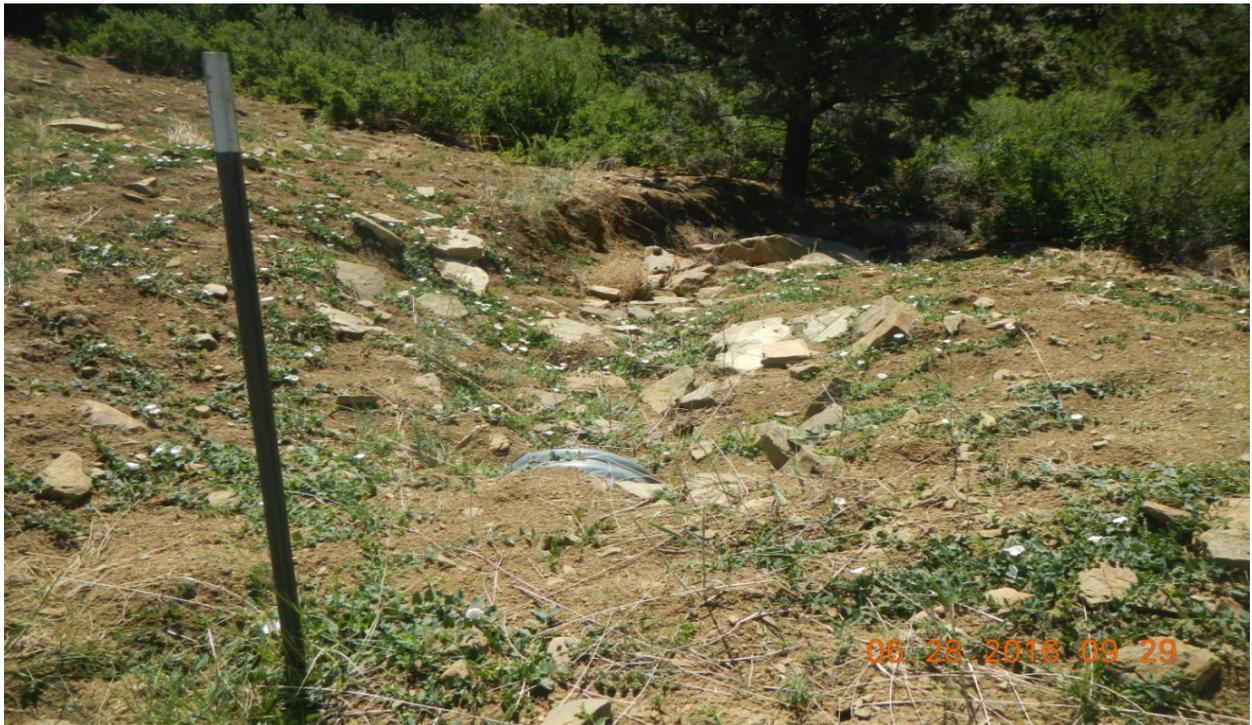
photo 9: There are signs of erosion on the outlet of the culvert. No stormwater outlet protection.

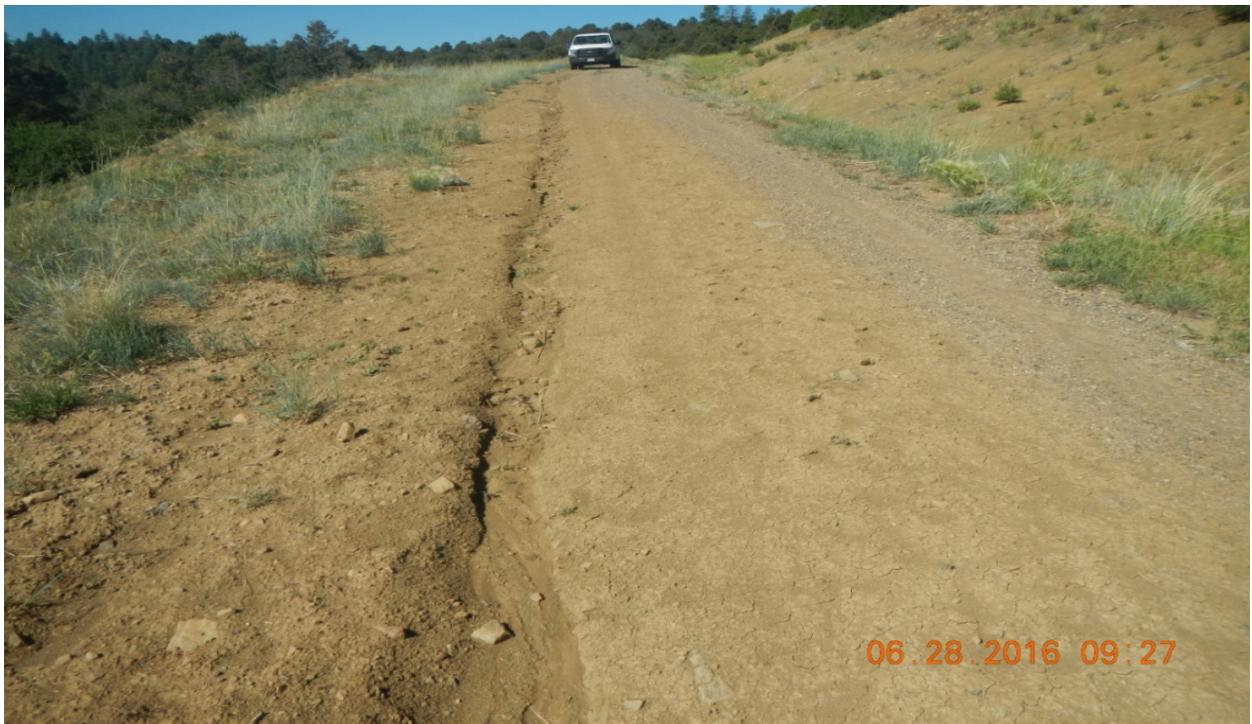
photo 10: Facing back toward the southwest along the access road. Signs of erosion are shown along the road.

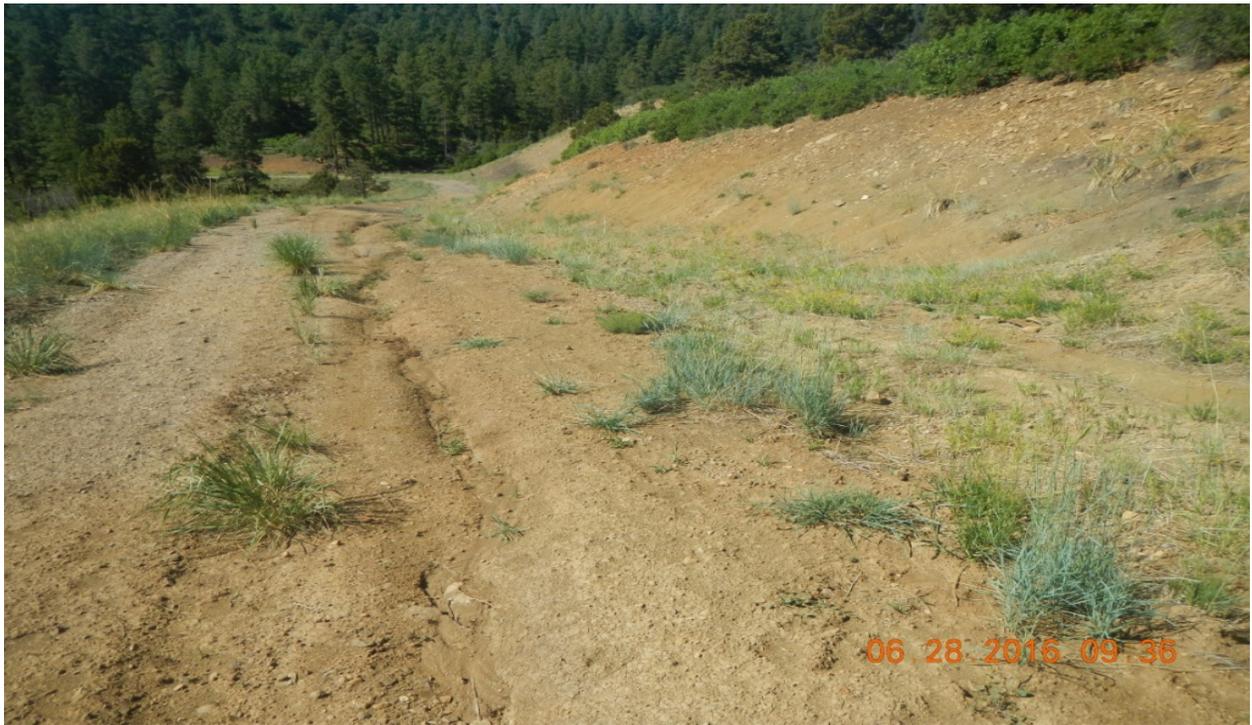
photo 11: Facing southeast along the access road. Vegetation is not established along the cut slope of the road.

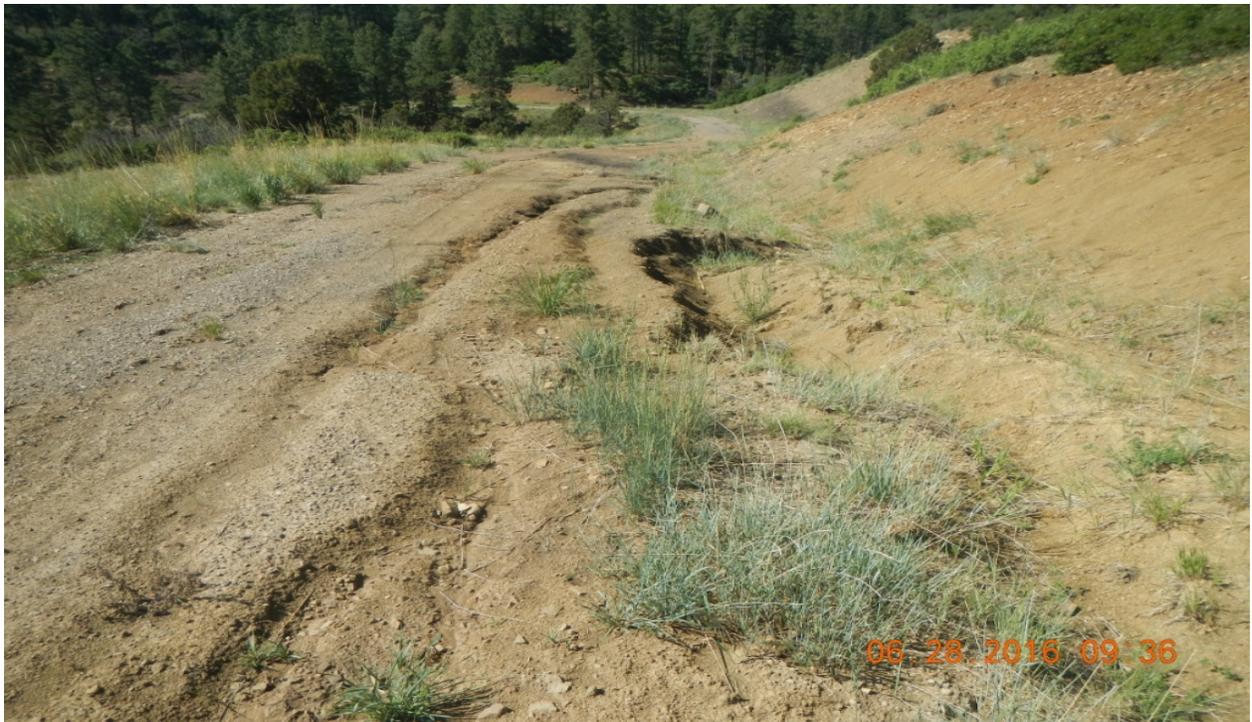
photo 12: Facing southeast along the access road. Erosion channels have developed along the road.

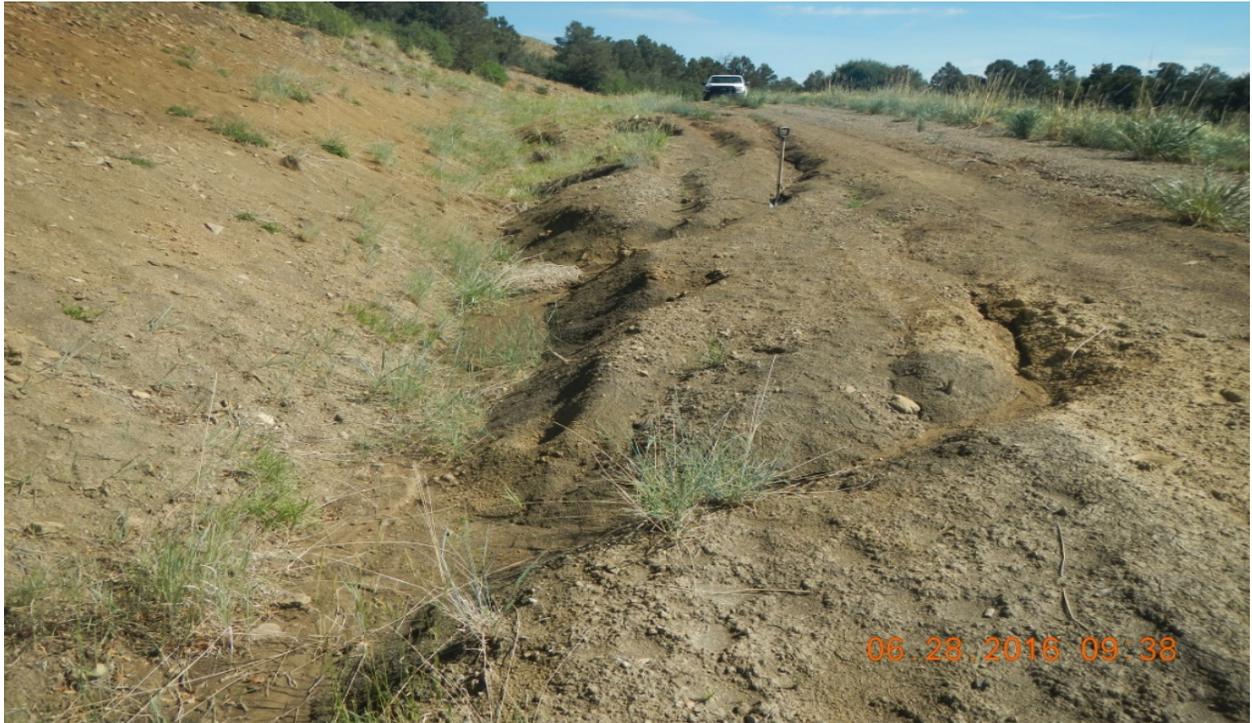
photo 13: Facing back toward the northwest along the access road.

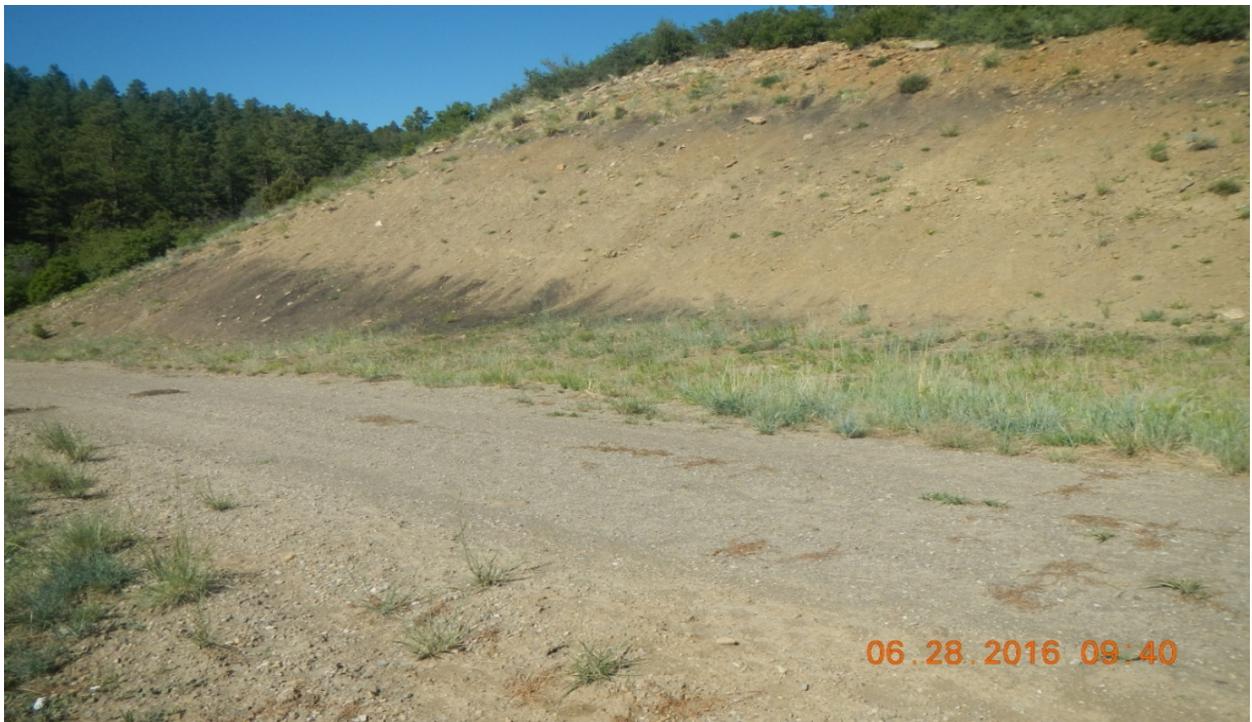
photo 14: Facing toward the cut side along the access road which is not adequately stabilized with vegetation.

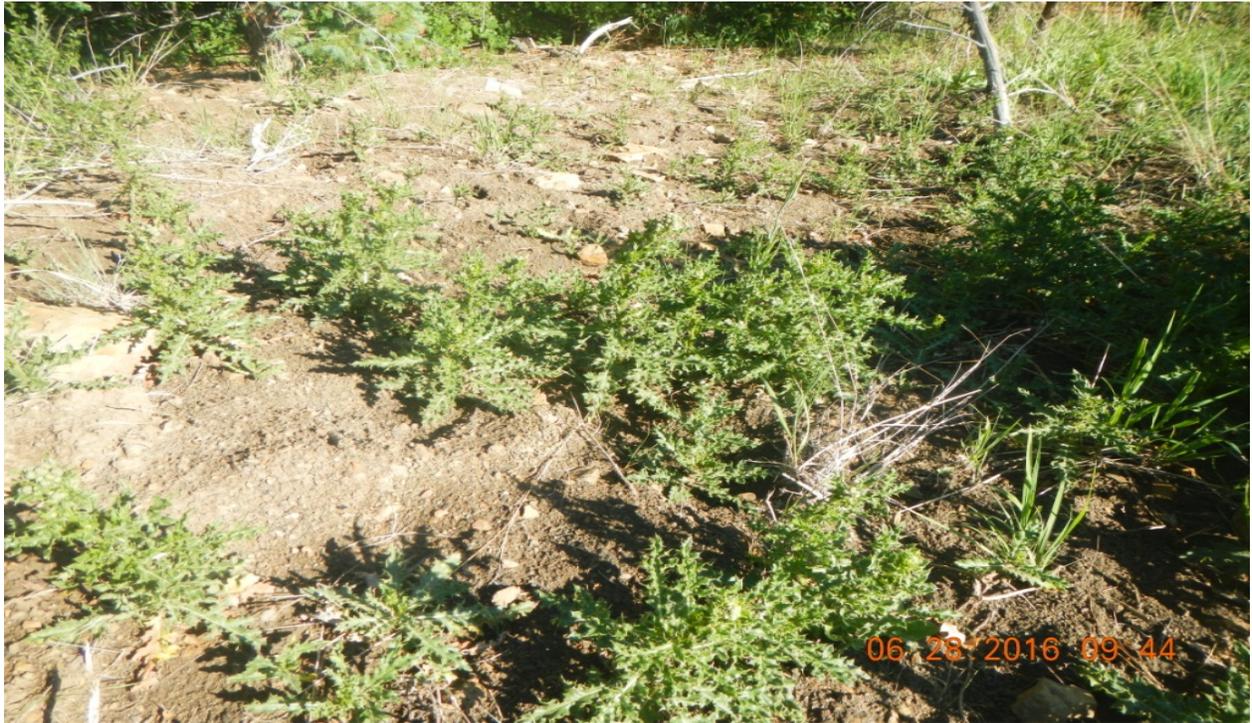
photo 15: Noxious weeds (List B Canada thistle and Houndstongue) found along the access road.
(Lat/Long: 37.08861,-104.82819)

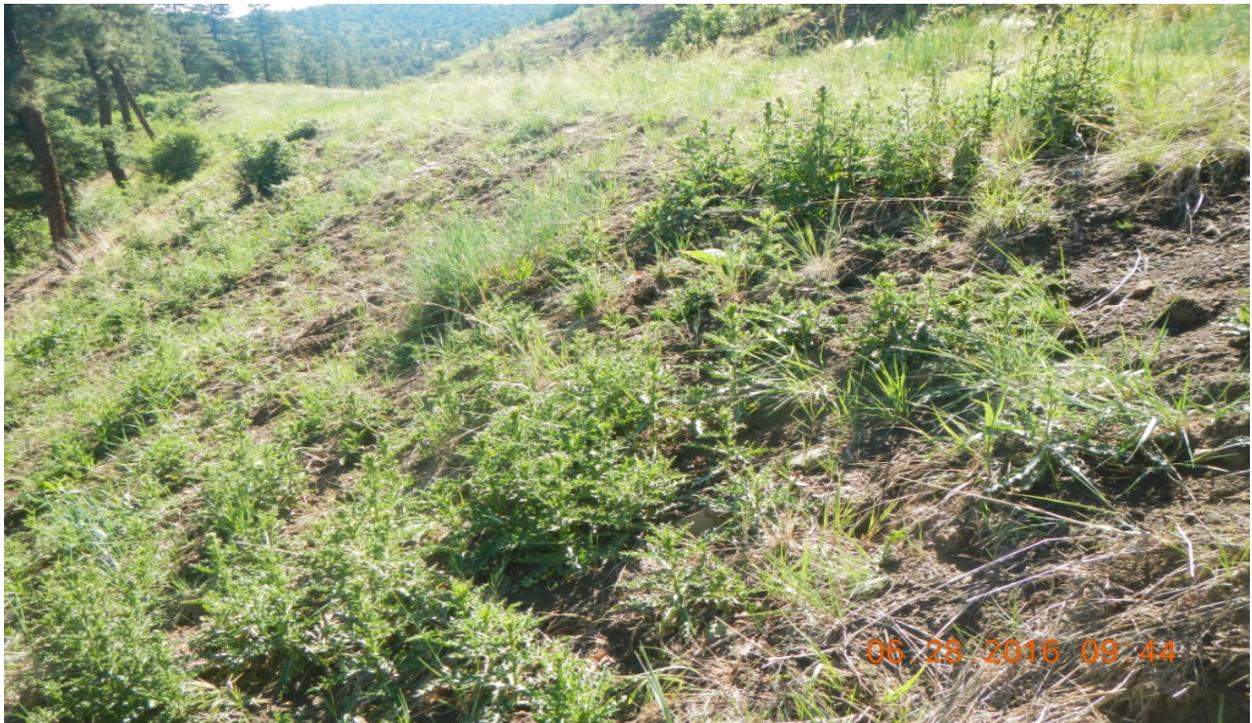
photo 16: Noxious weeds (List B Canada thistle and Houndstongue) found along the access road.
(Lat/Long: 37.08861,-104.82819)

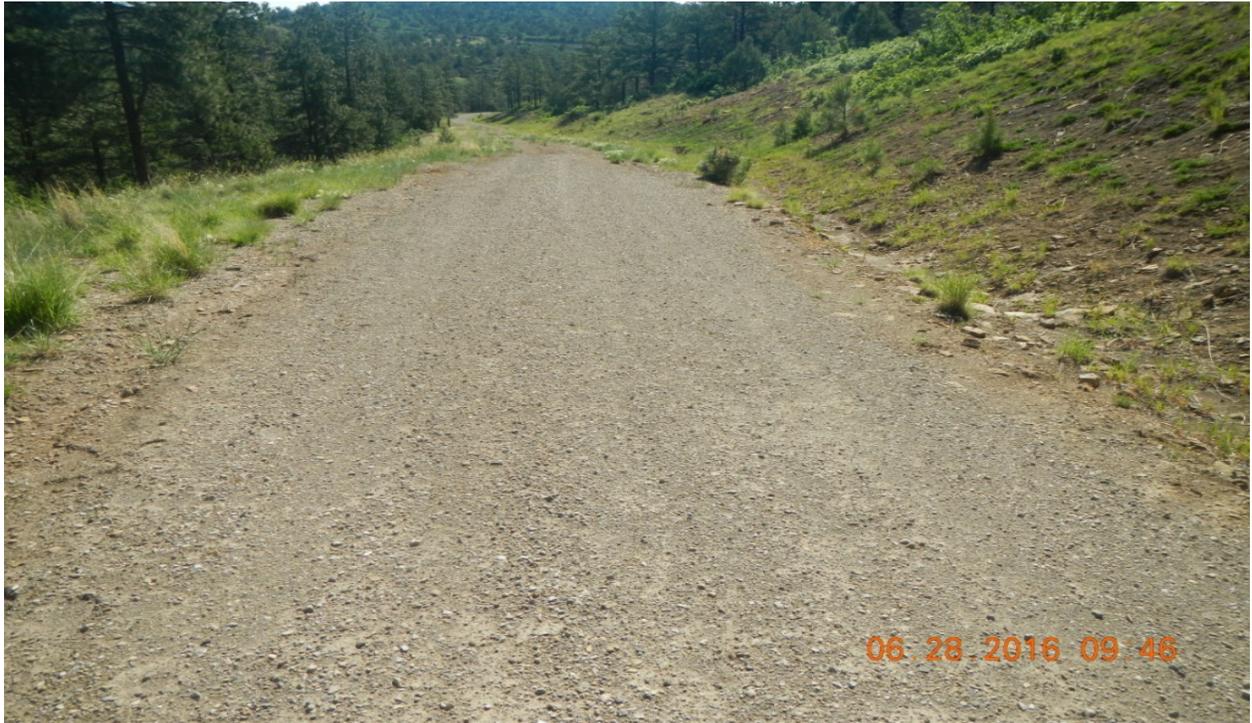
photo 17: Facing northeast along the access road toward the location.

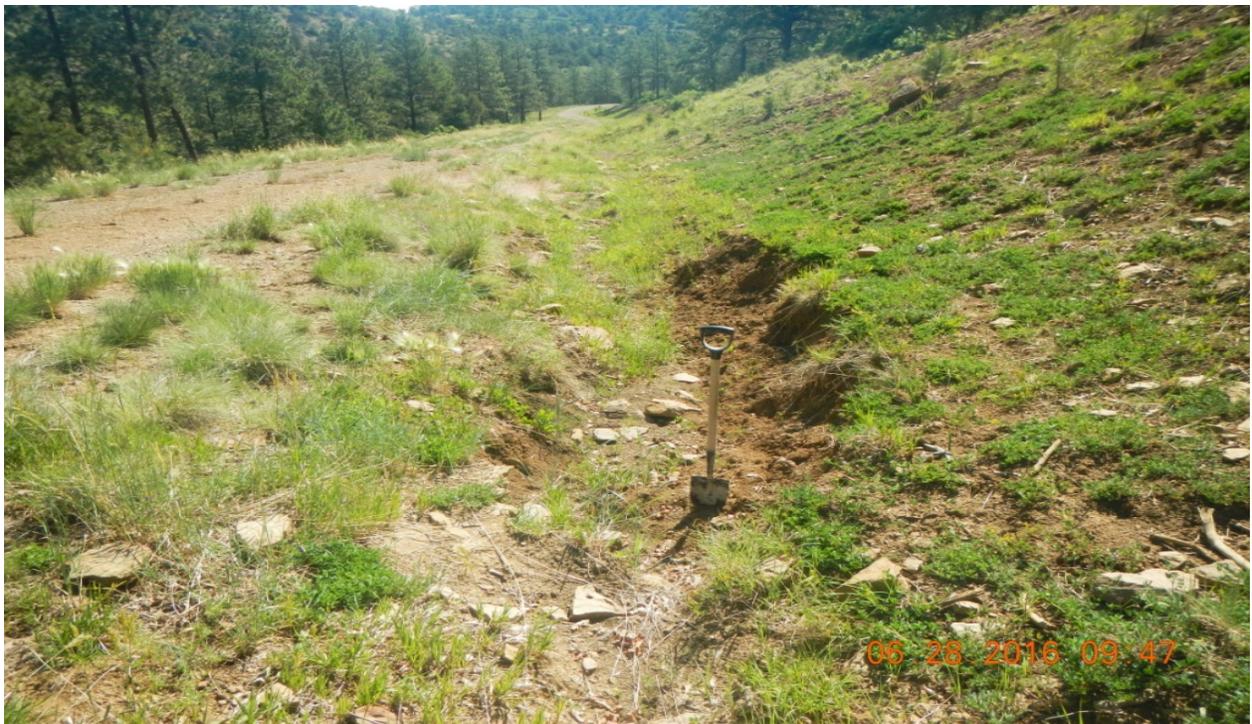
photo 18: Area of erosion noticed along the access road.

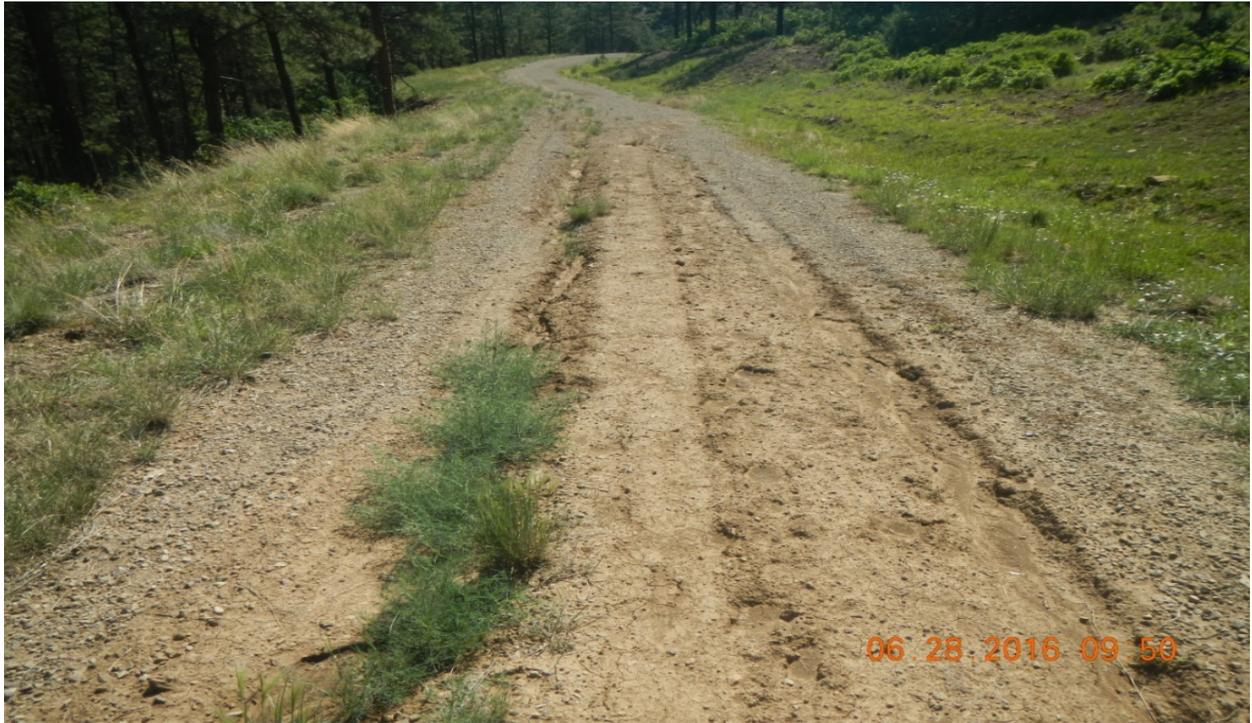
photo 19: Facing northeast along the access road. Signs of erosion can be seen along the access road.

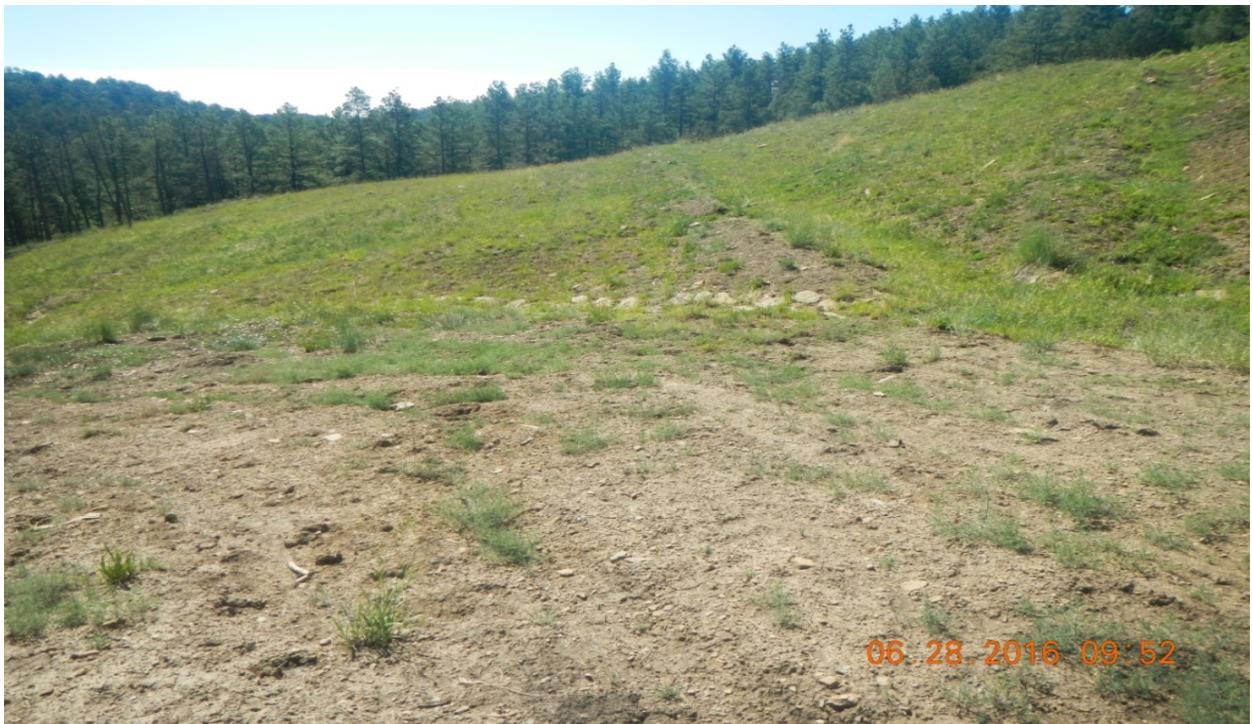
photo 20: End of the access road facing east toward the location.

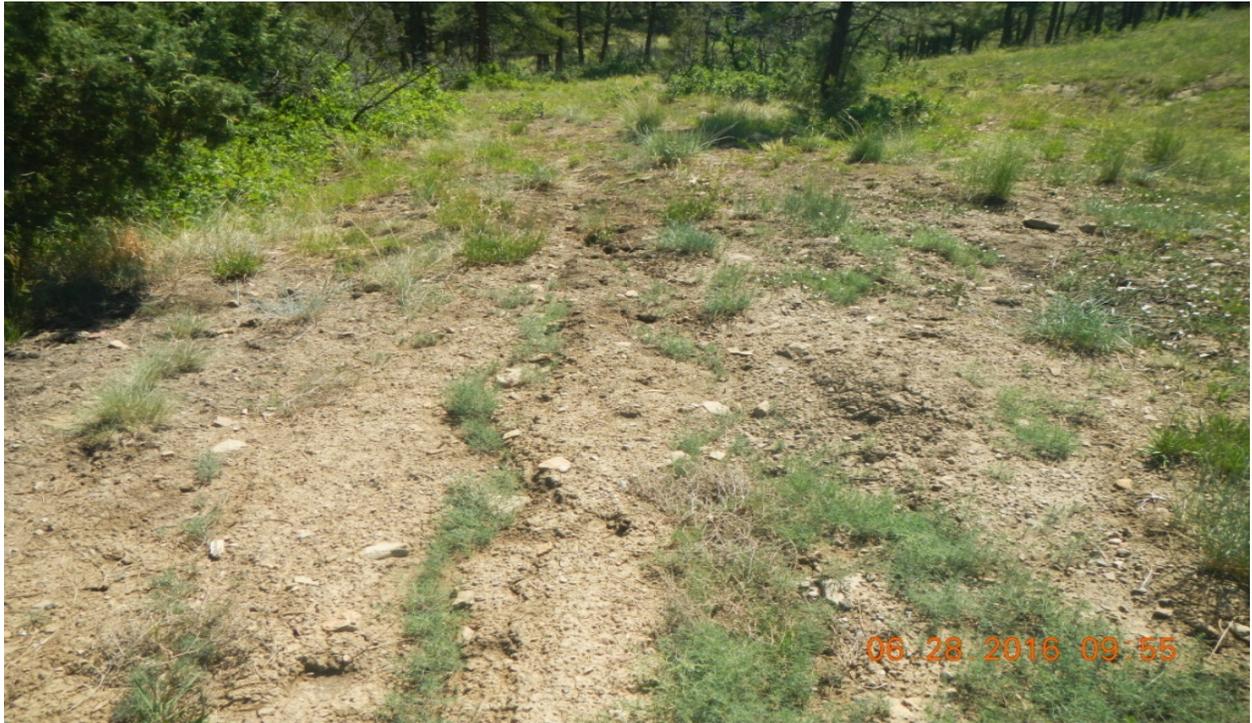
photo 21: End of the access road facing northeast. Signs of erosion were noticed in this area.

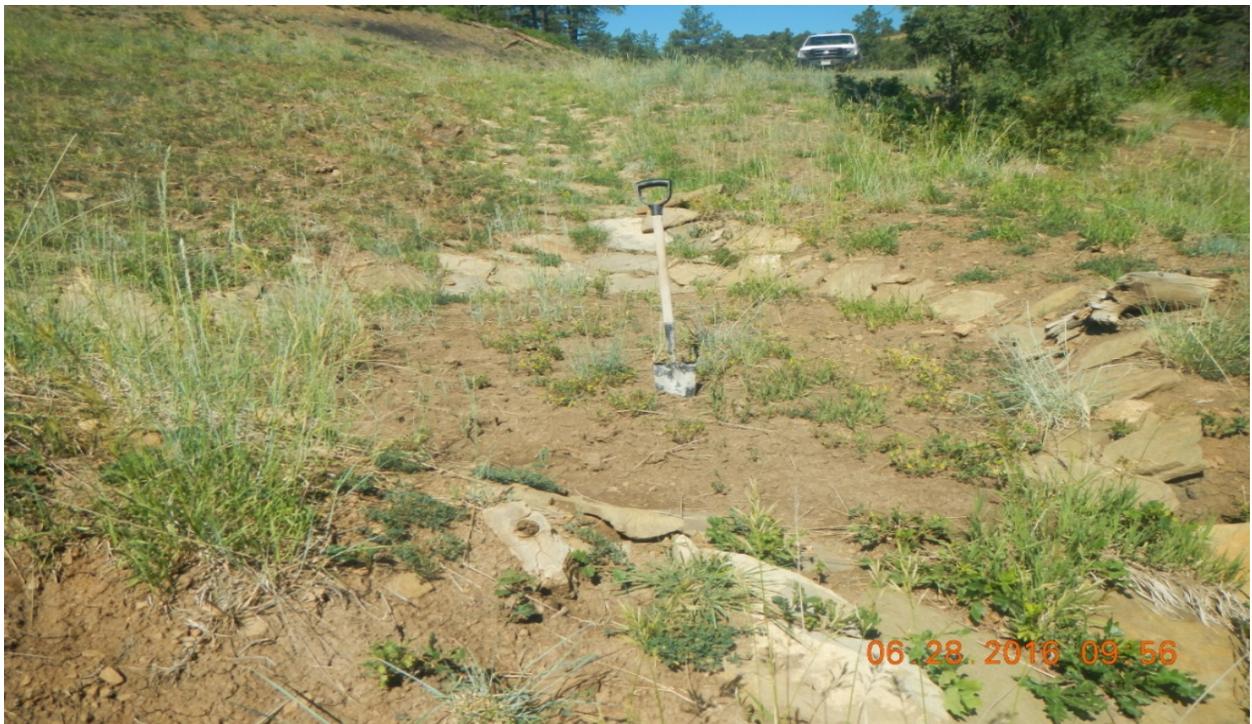
photo 22: There were two sediment traps at the north and northeast side of the location which are full of sediment as shown in this photo.

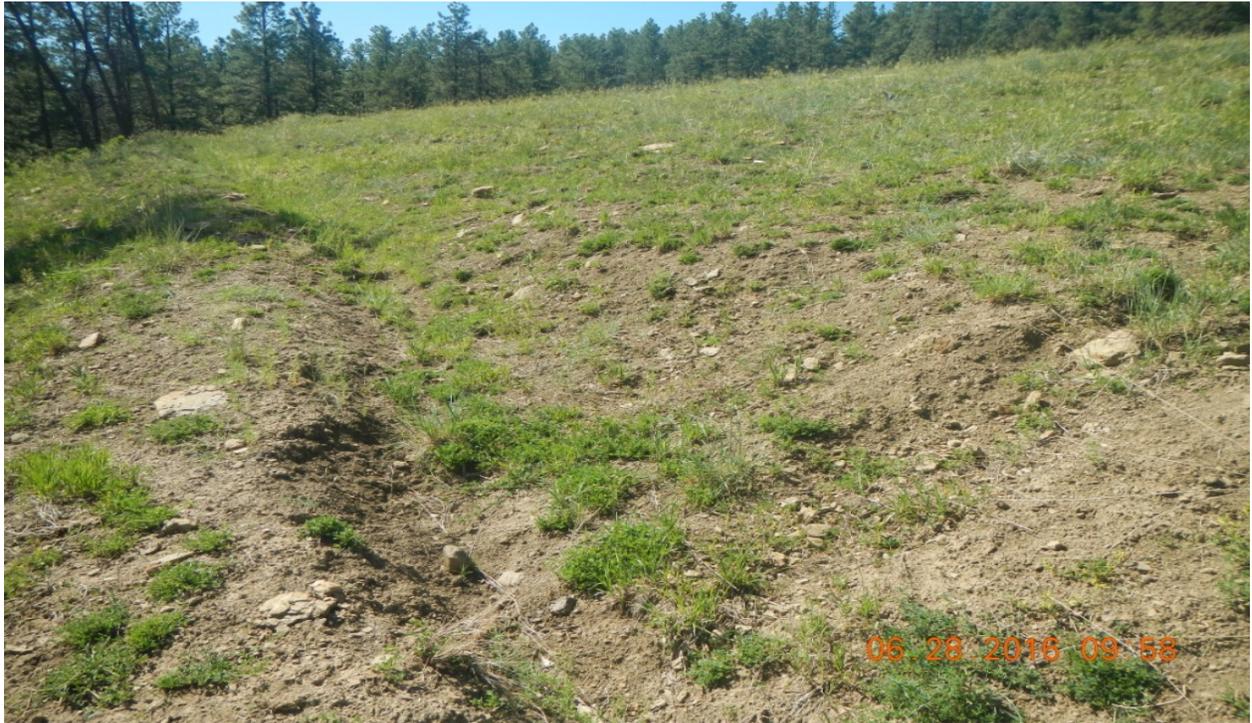
photo 23: North side of the location facing southeast.

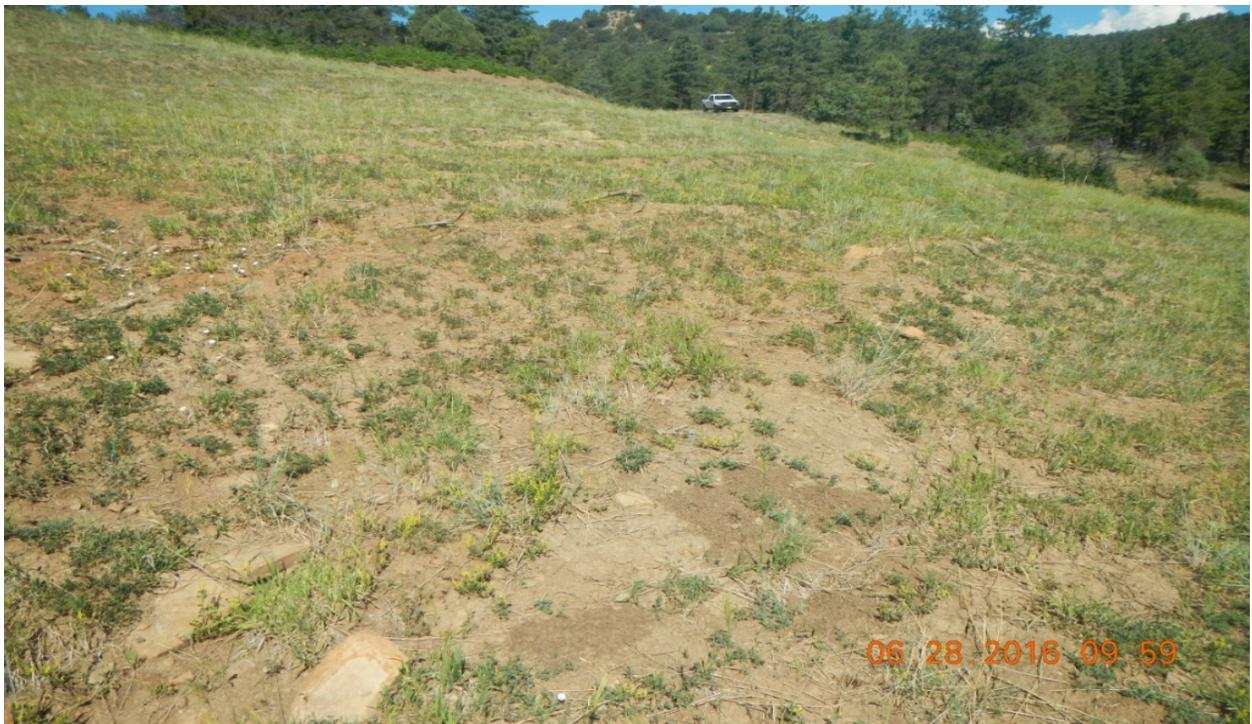
photo 24: East side of the location facing west.

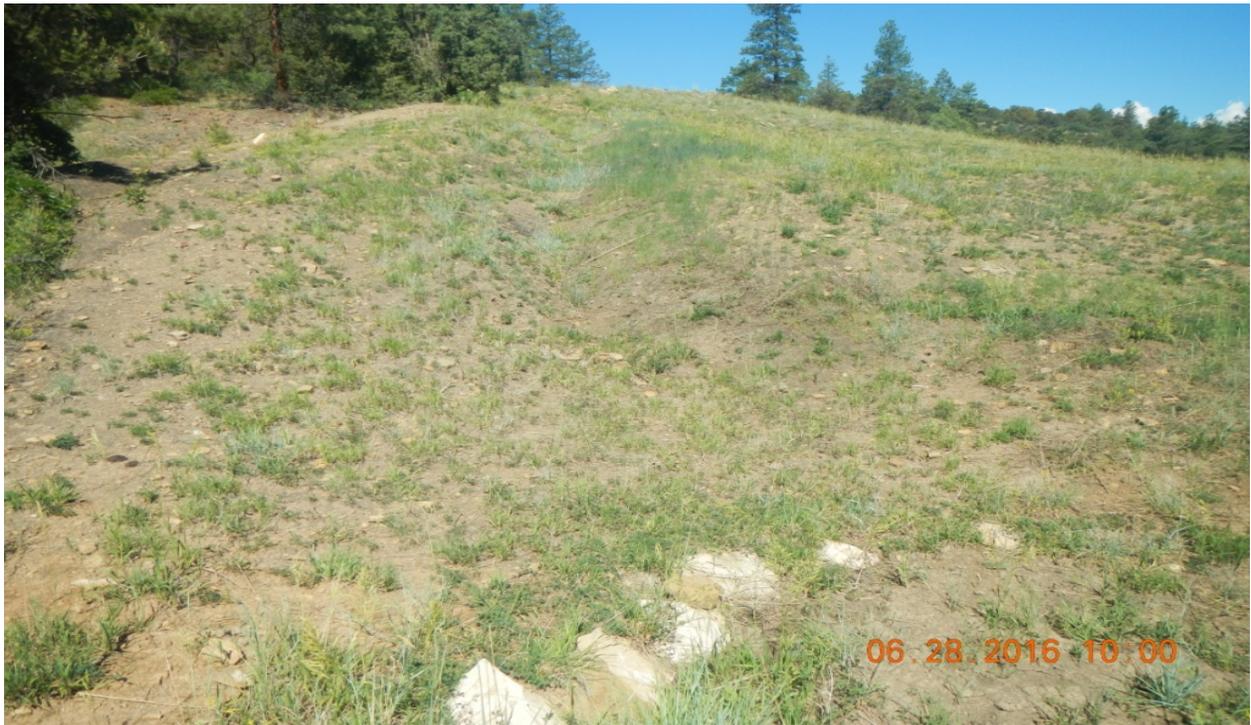
photo 25: East side of the location facing southwest.
