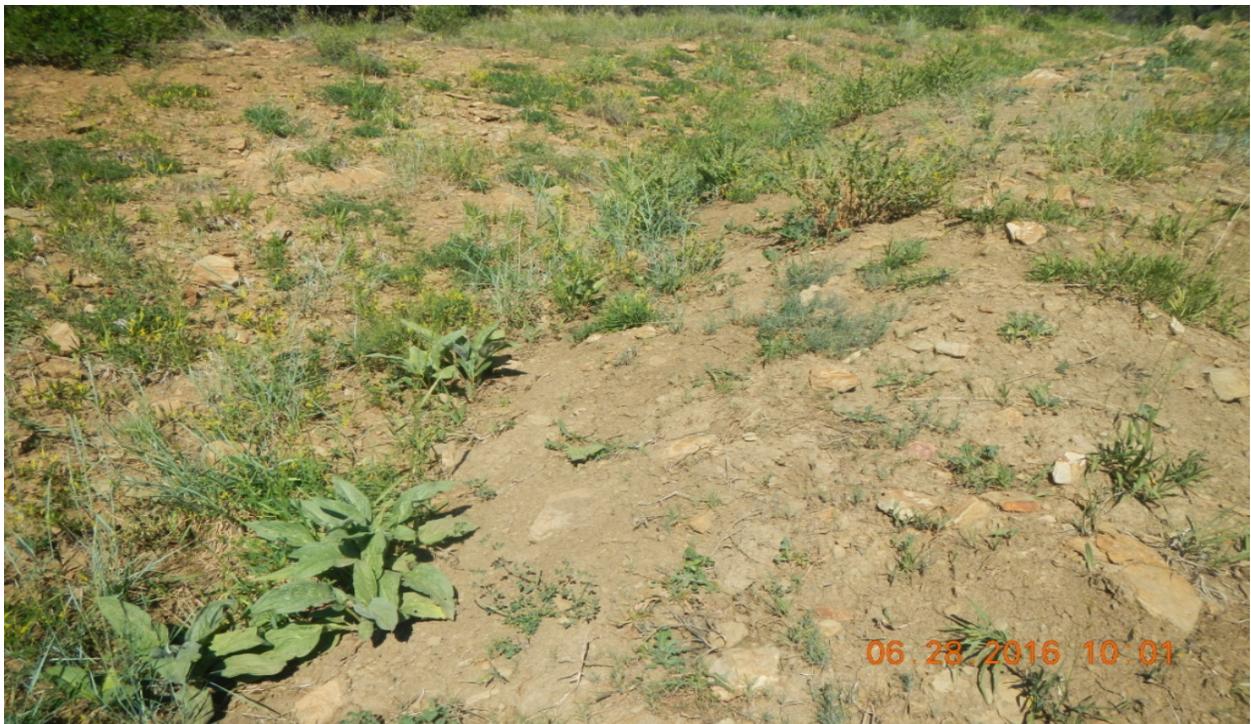
photo 26: There are noxious weeds (List B Houndstongue, Bull thistle, and Musk thistle) found along the south side of the location. The Houndstongue has developed seed.

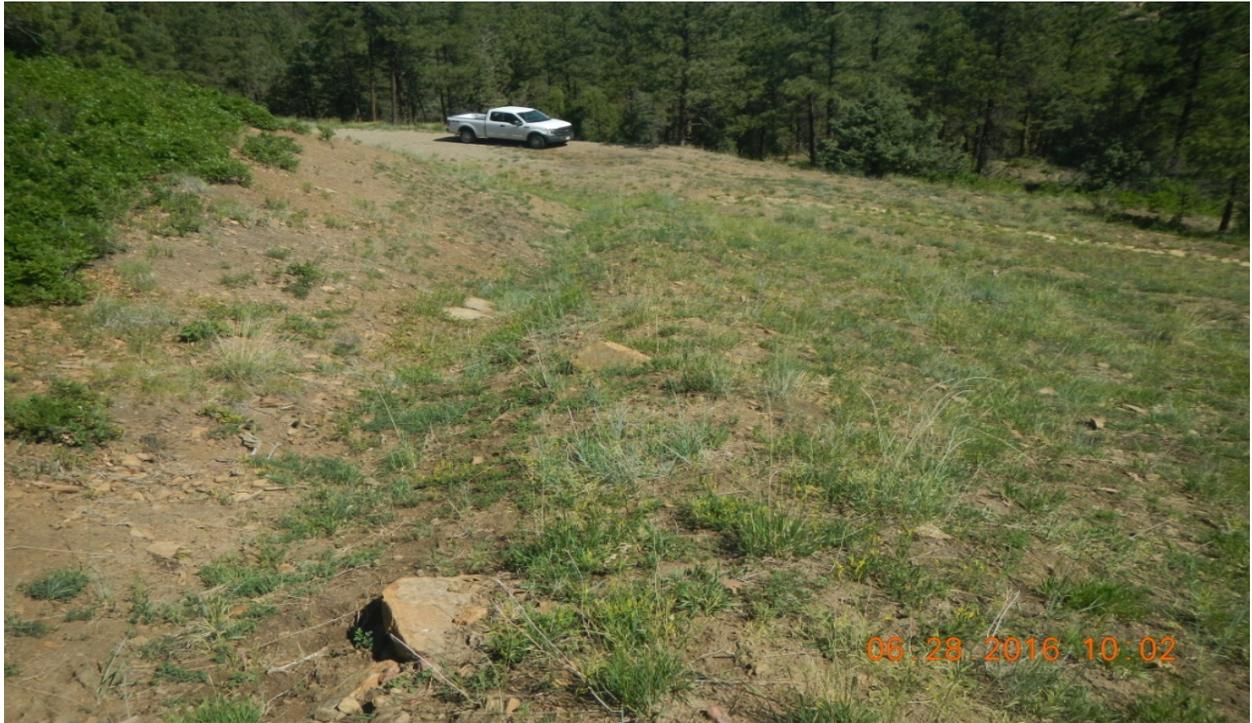
photo 27: South side of the location facing northwest.

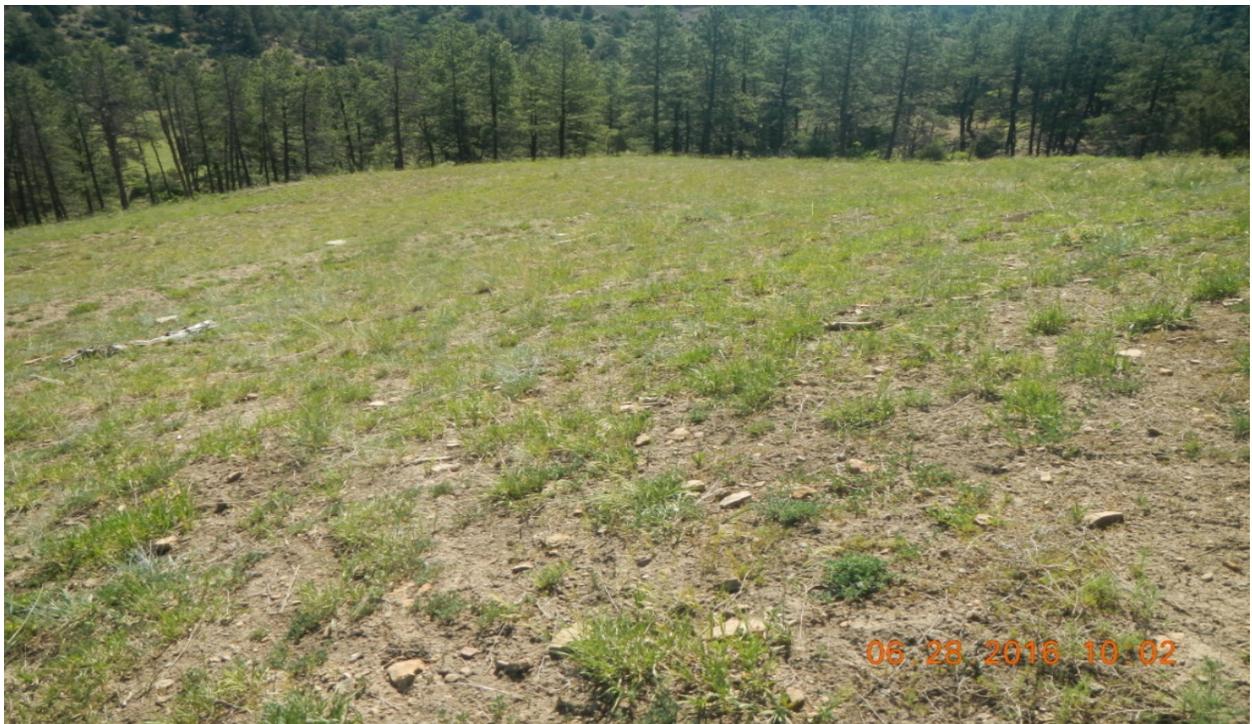
photo 28: Southwest side facing northeast..

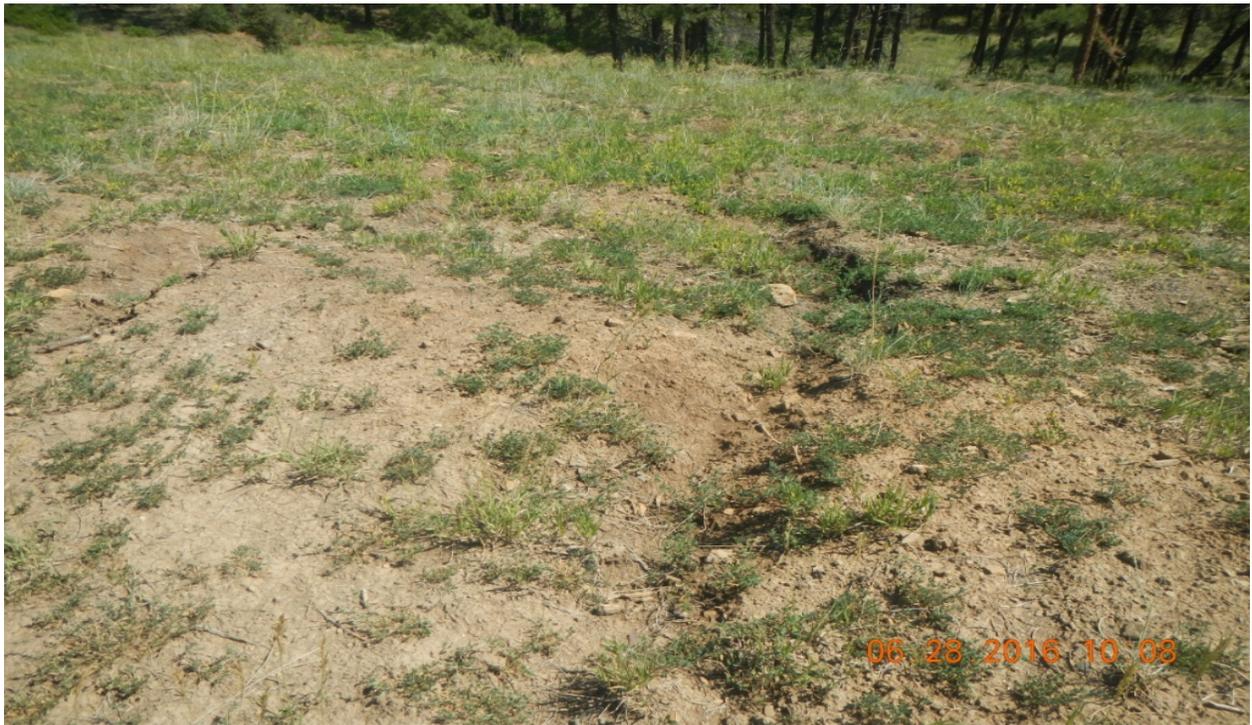
photo 29: There were signs of erosion at the location.

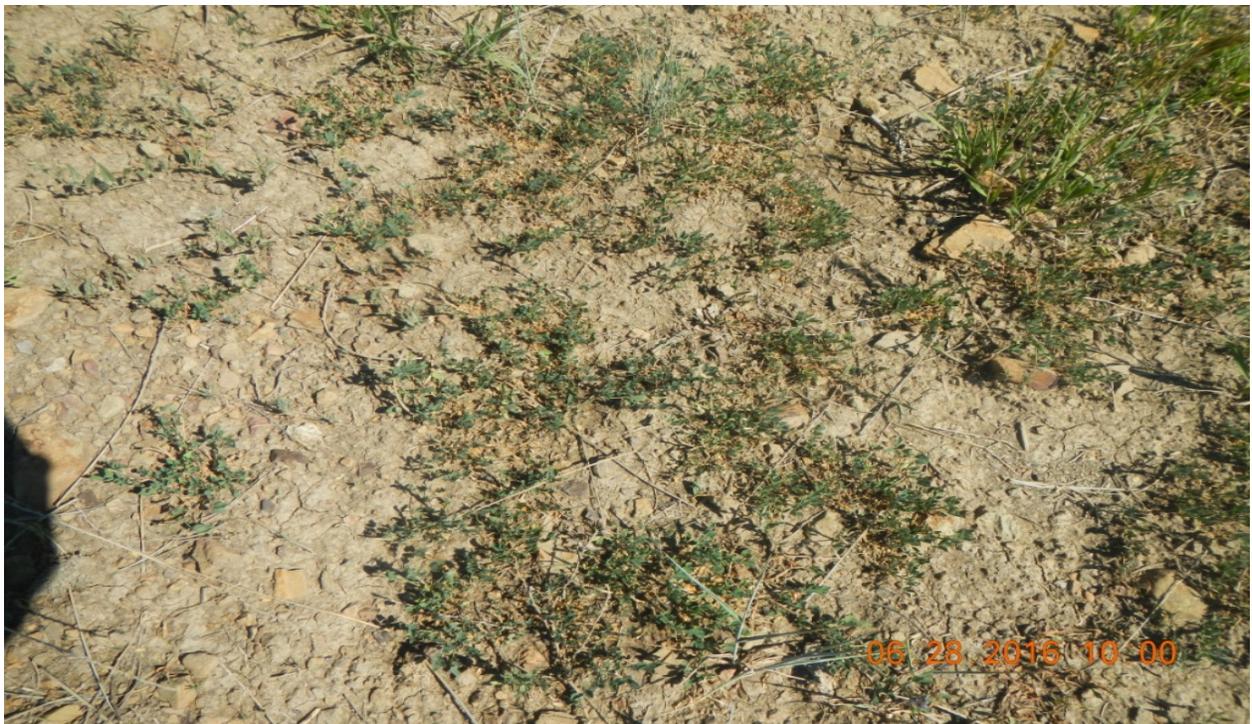
photo 30: View of the vegetation cover at the location. The photo shows mostly alfalfa growth which does not appear to be growing well.
