May 13, 2016

Inspection Photos: Silver Orphan API#081-06682

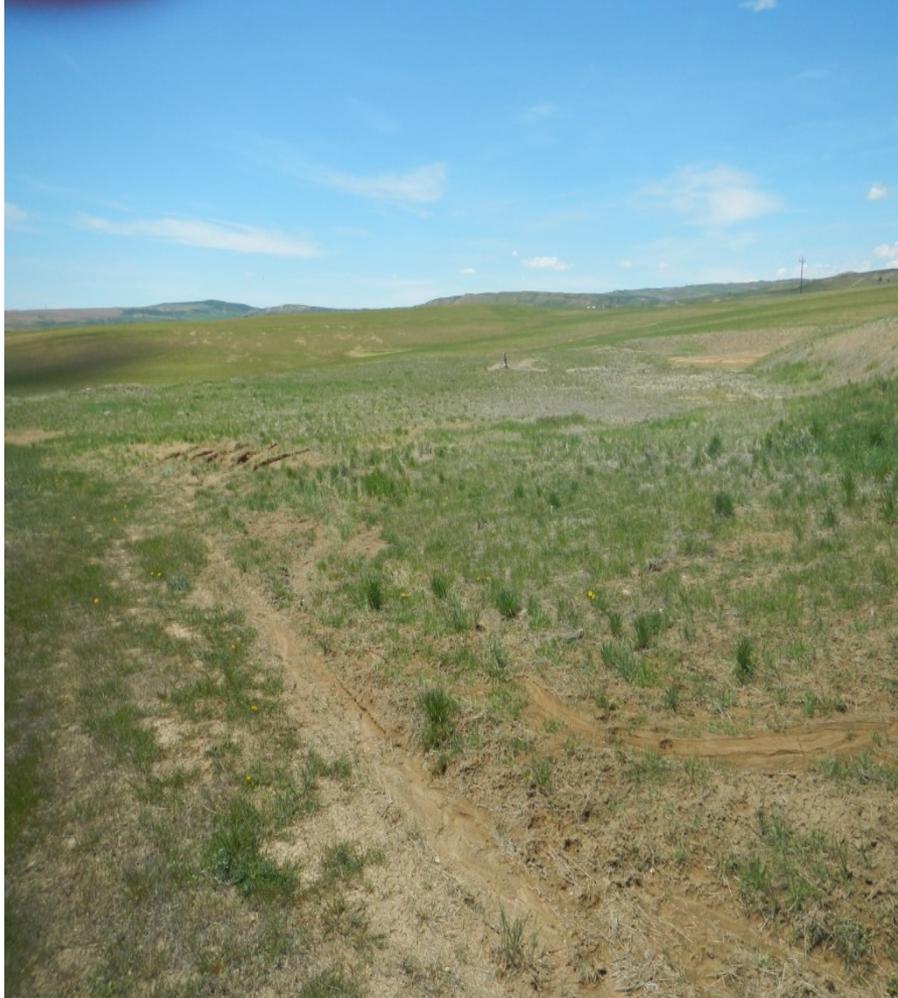
Photo#1:

View SE over Location.

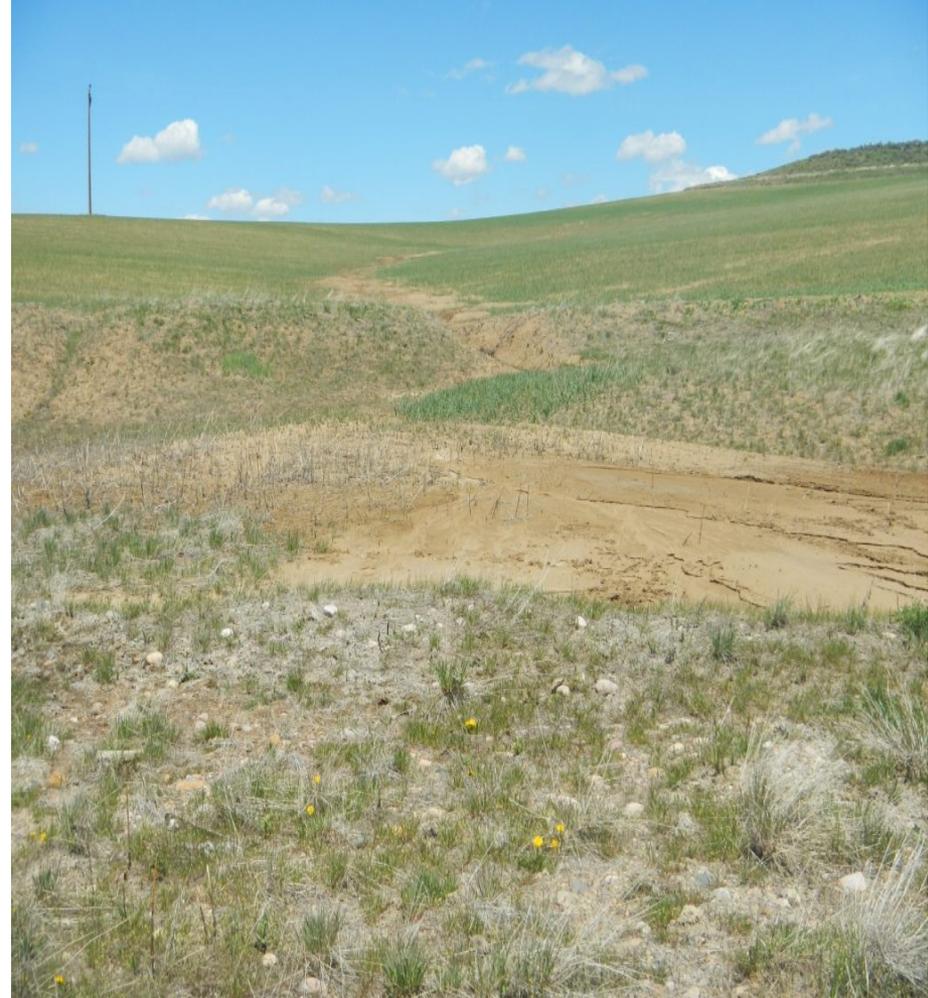
Photo#2:

Sediment Run-on from Crop Ground at NW Corner of Location..

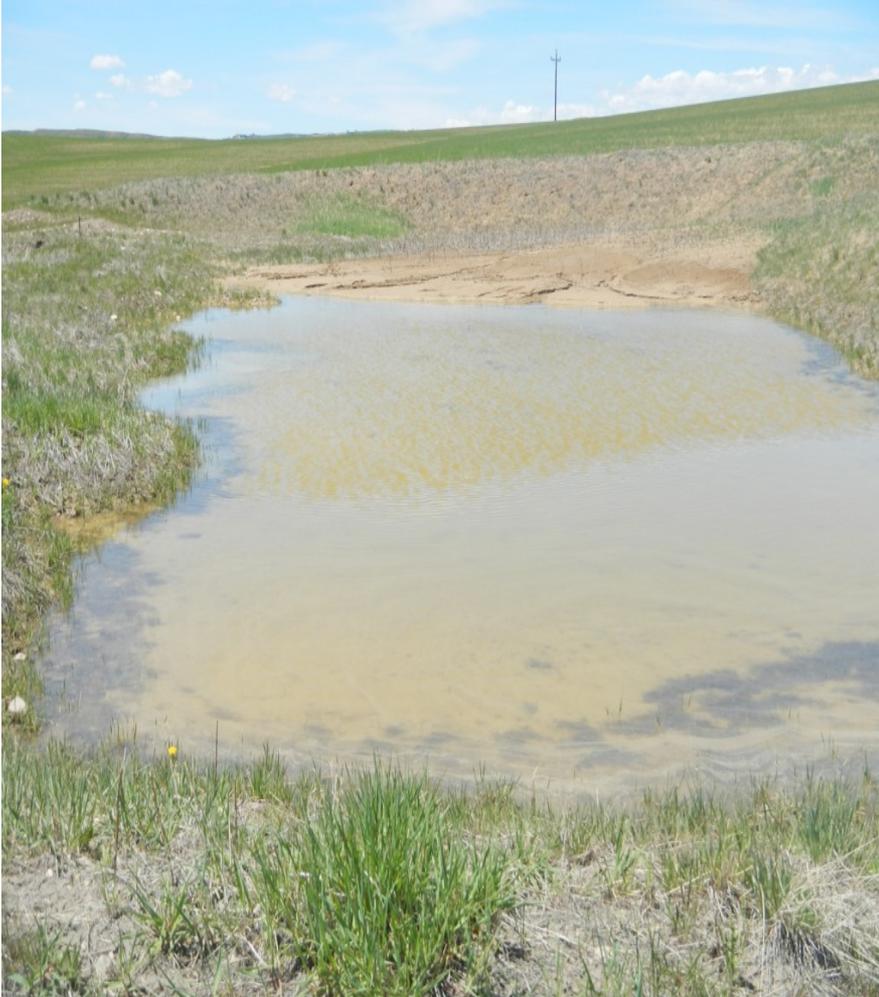
Photo#3:

Drainage Containment / Pit Area?

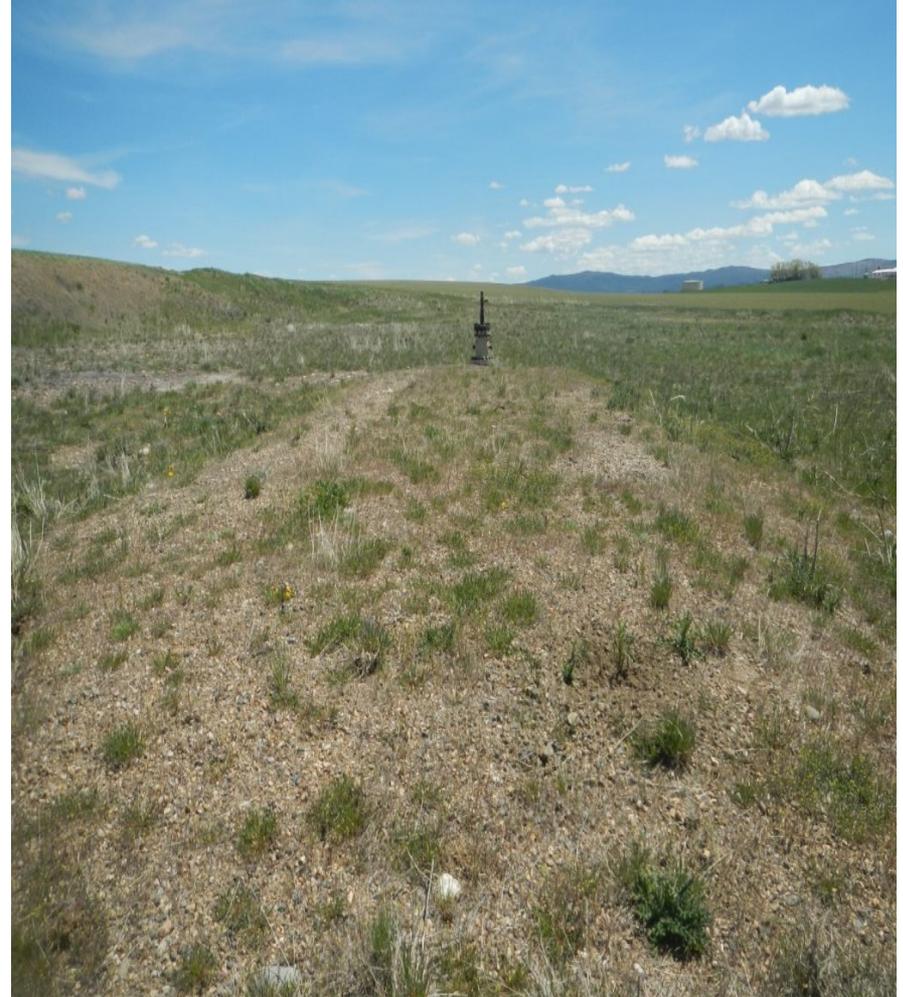
Photo#4:

Raised Well Head / Facility Area

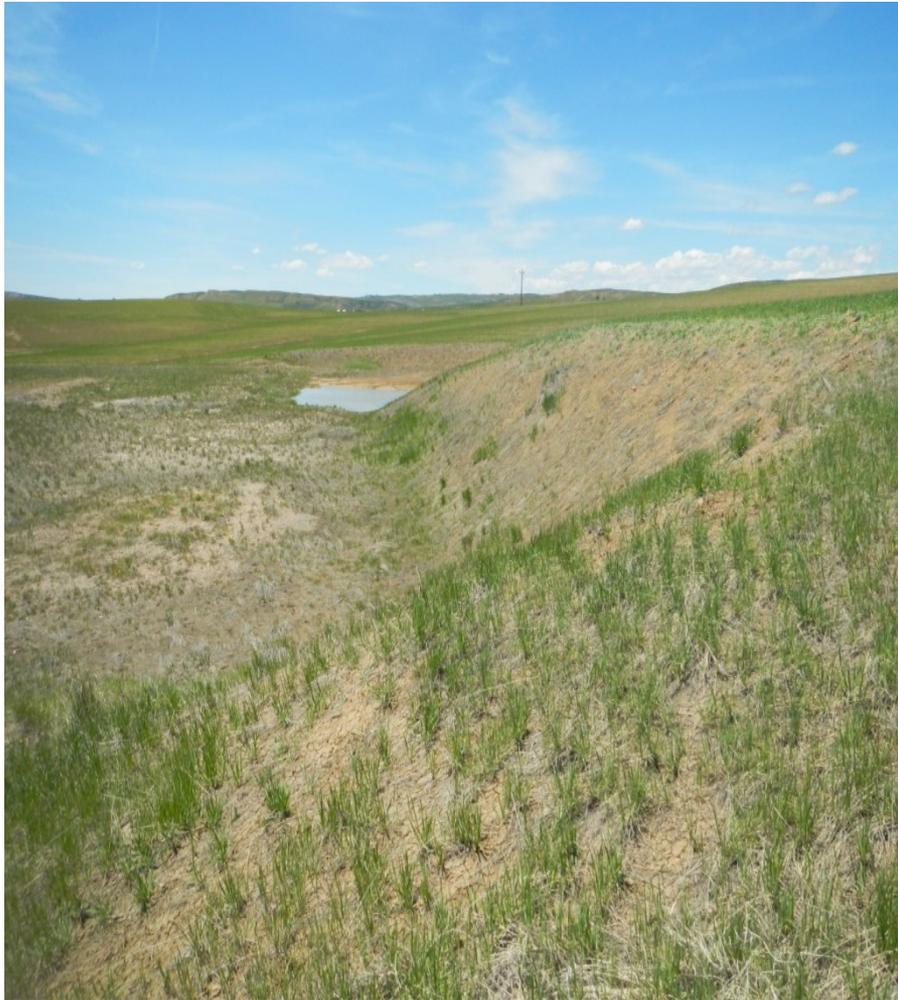
Photo#5:

View of Cut Slope from NE corner of Location.

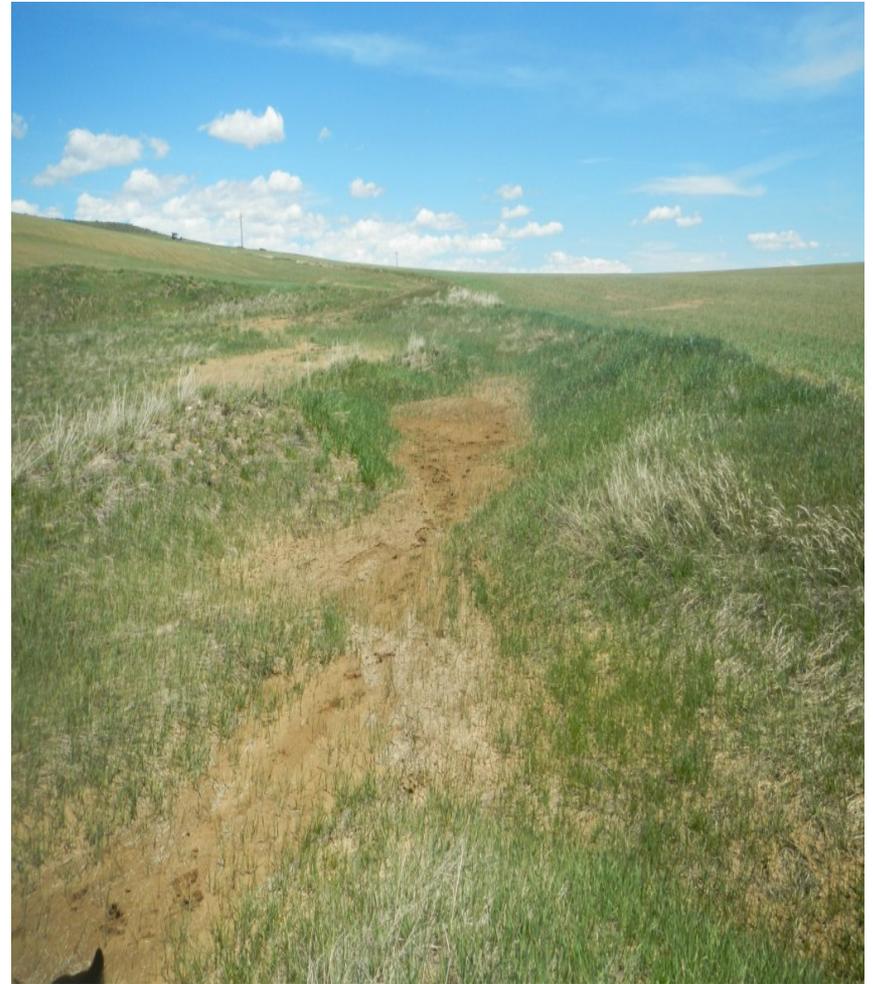
Photo#6:

Fill Slope containing Run-on from Crop ground.

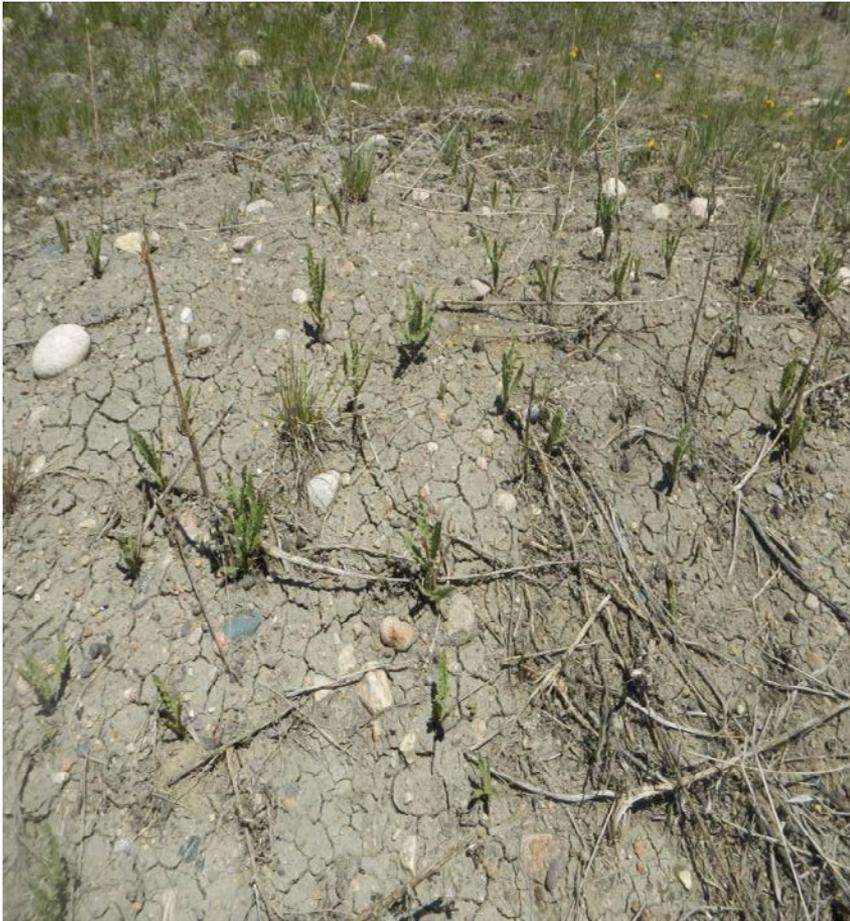
Photo#7:

Thistle Rosettes Emerging across Location

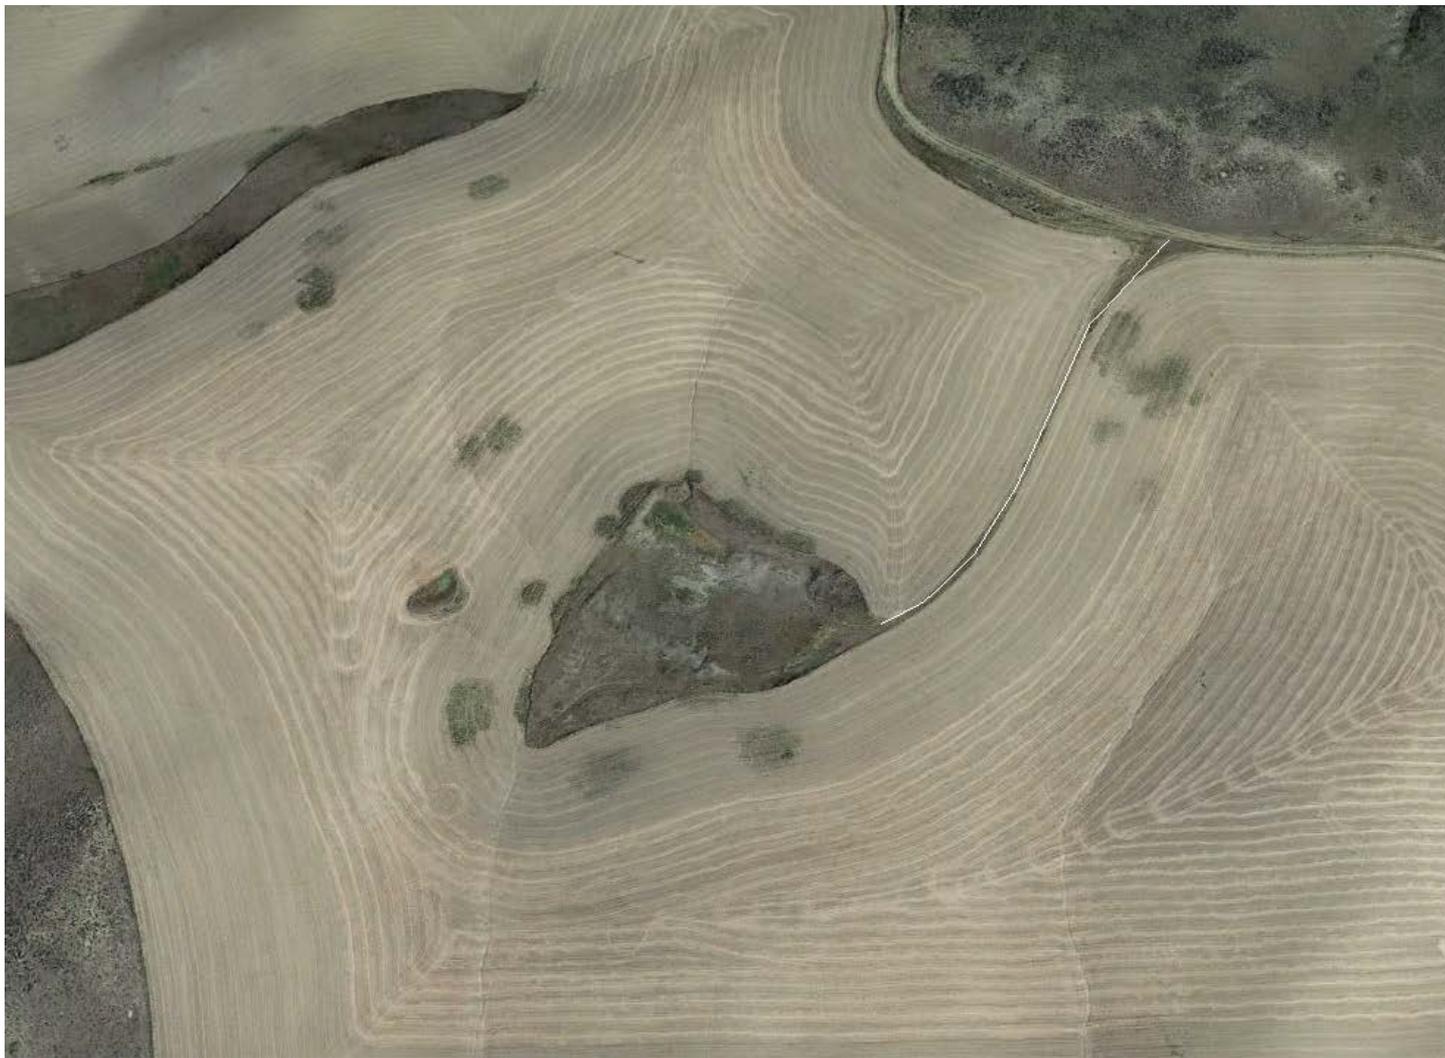
Silver Location surrounded by Crop Ground
