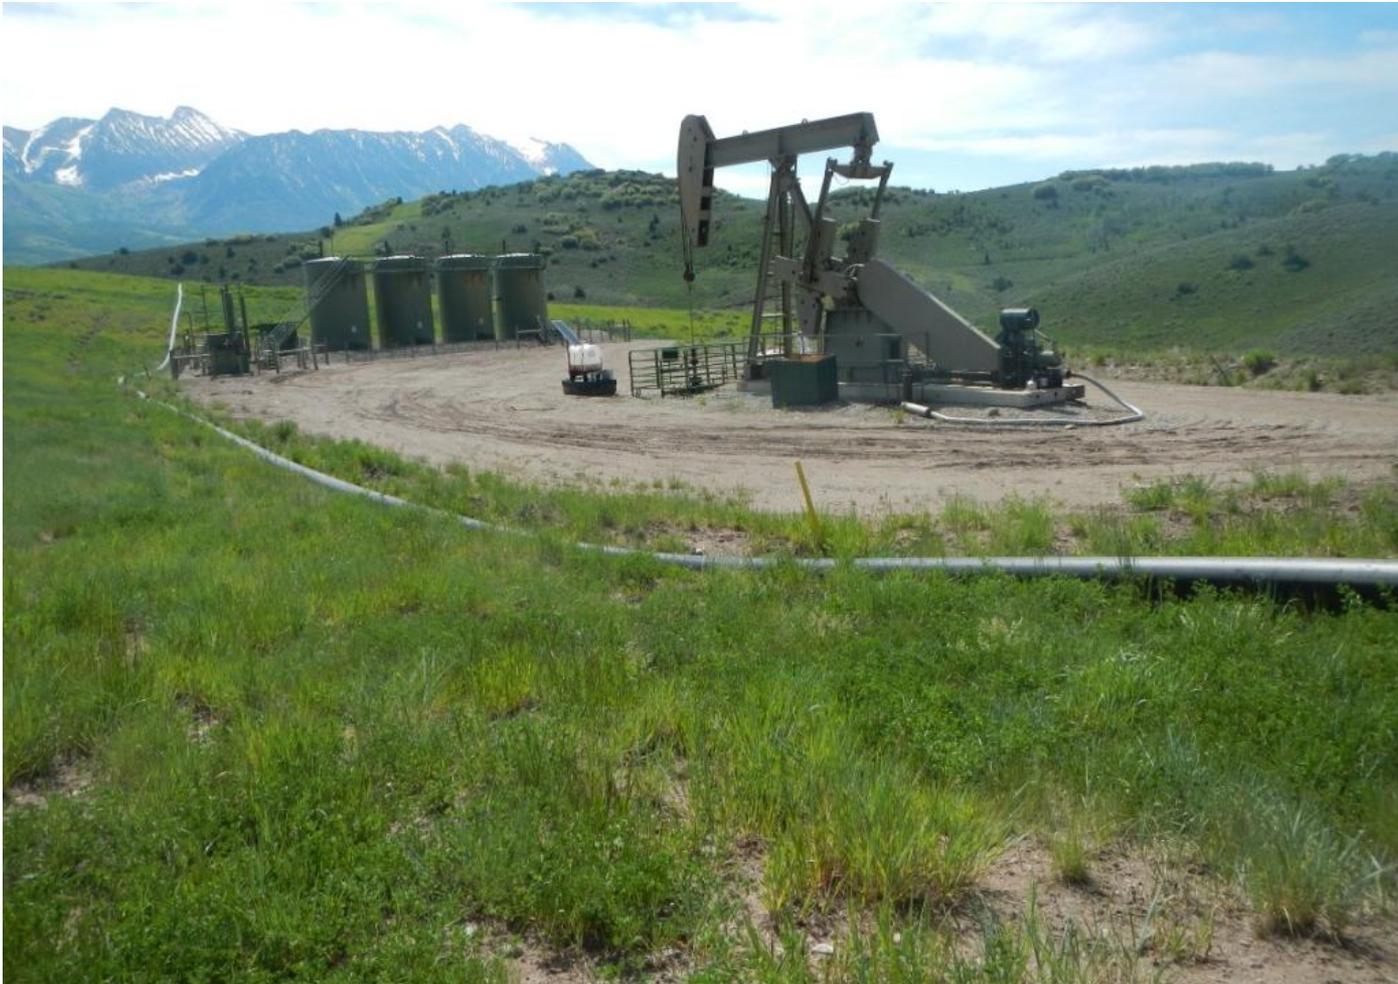
Photo 1. View of the project area from the northwestern corner facing center.

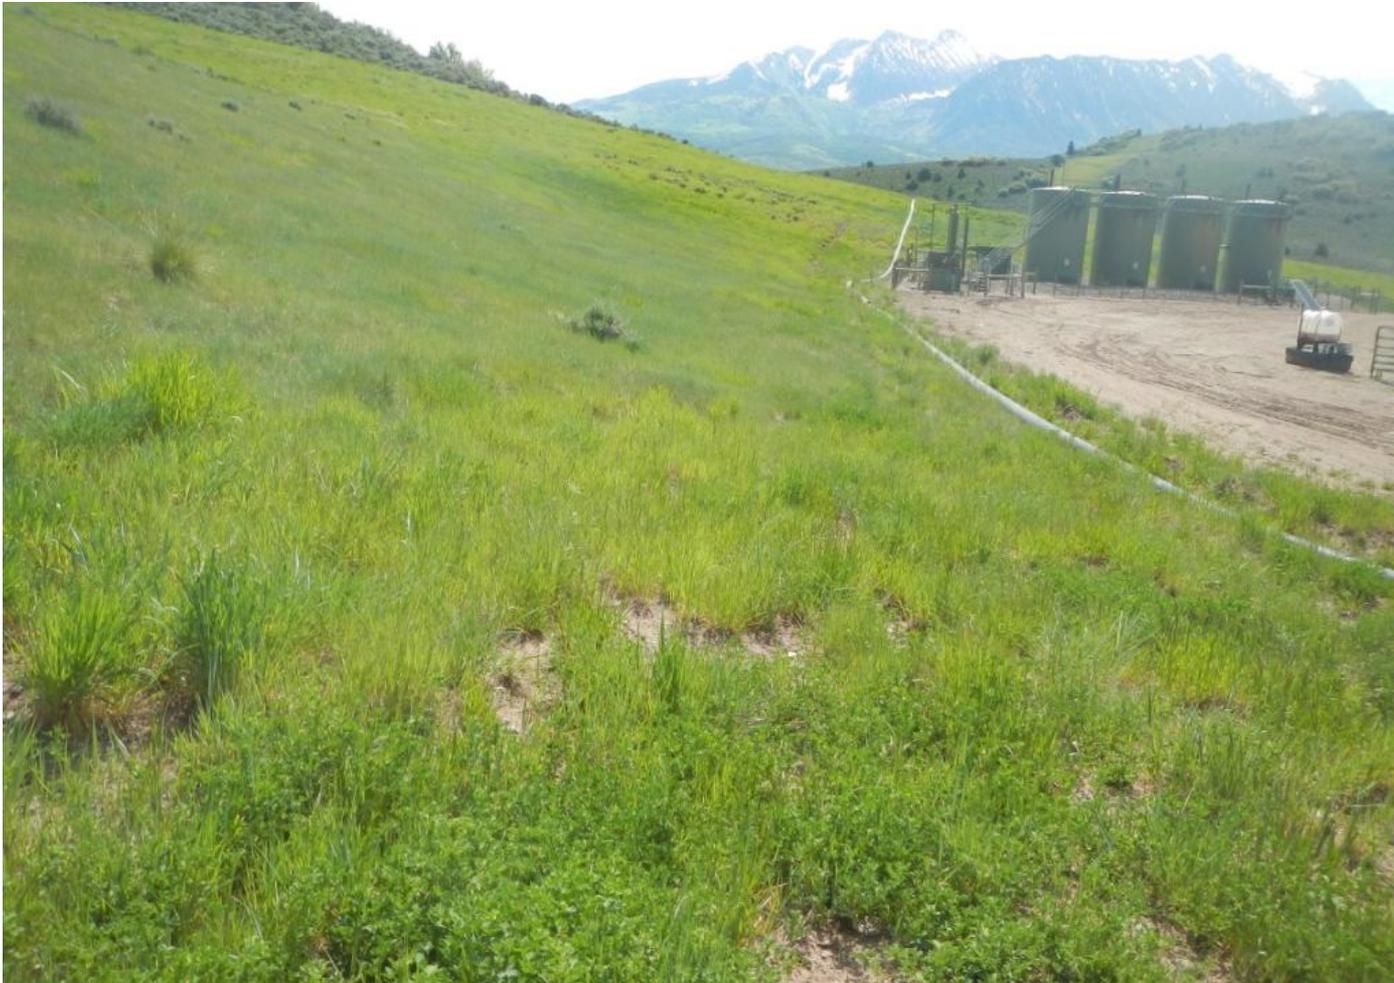
Photo 2. View of the northern portion of the project area from the northwestern corner facing eastward. Revegetation is established on the slope and dominated by smooth brome (*Bromus inermis*) and western wheatgrass (*Pascopyrum smithii*) with scattered forbs such as yellow clover (*Melilotus officinalis*) and yarrow (*Achillea millefolium*).

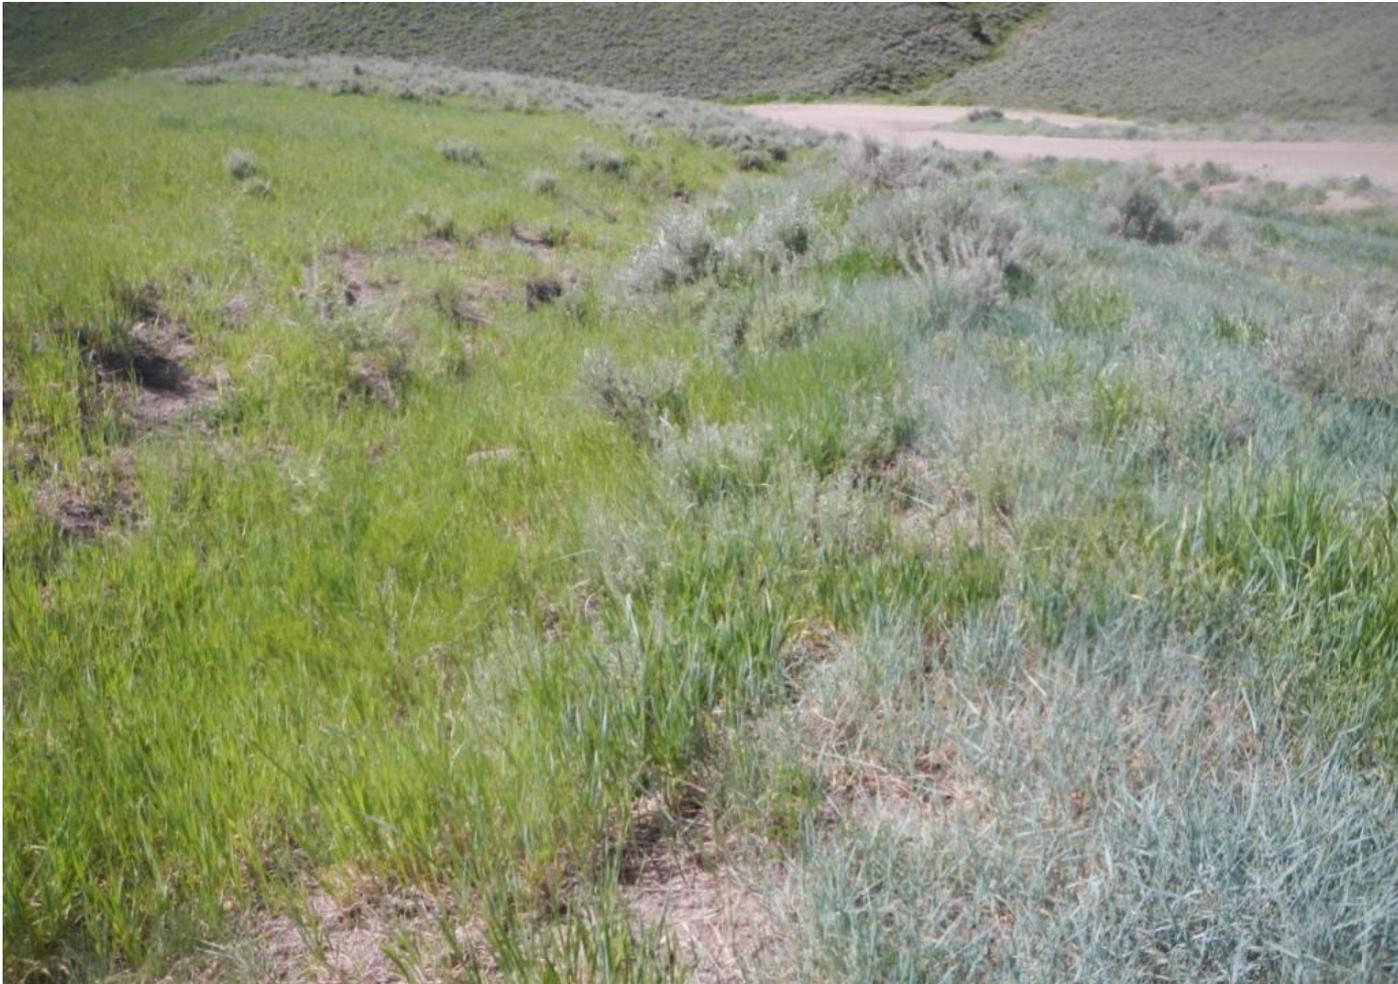
Photo 3. View of the eastern portion of the project area from the northeastern corner facing southward.

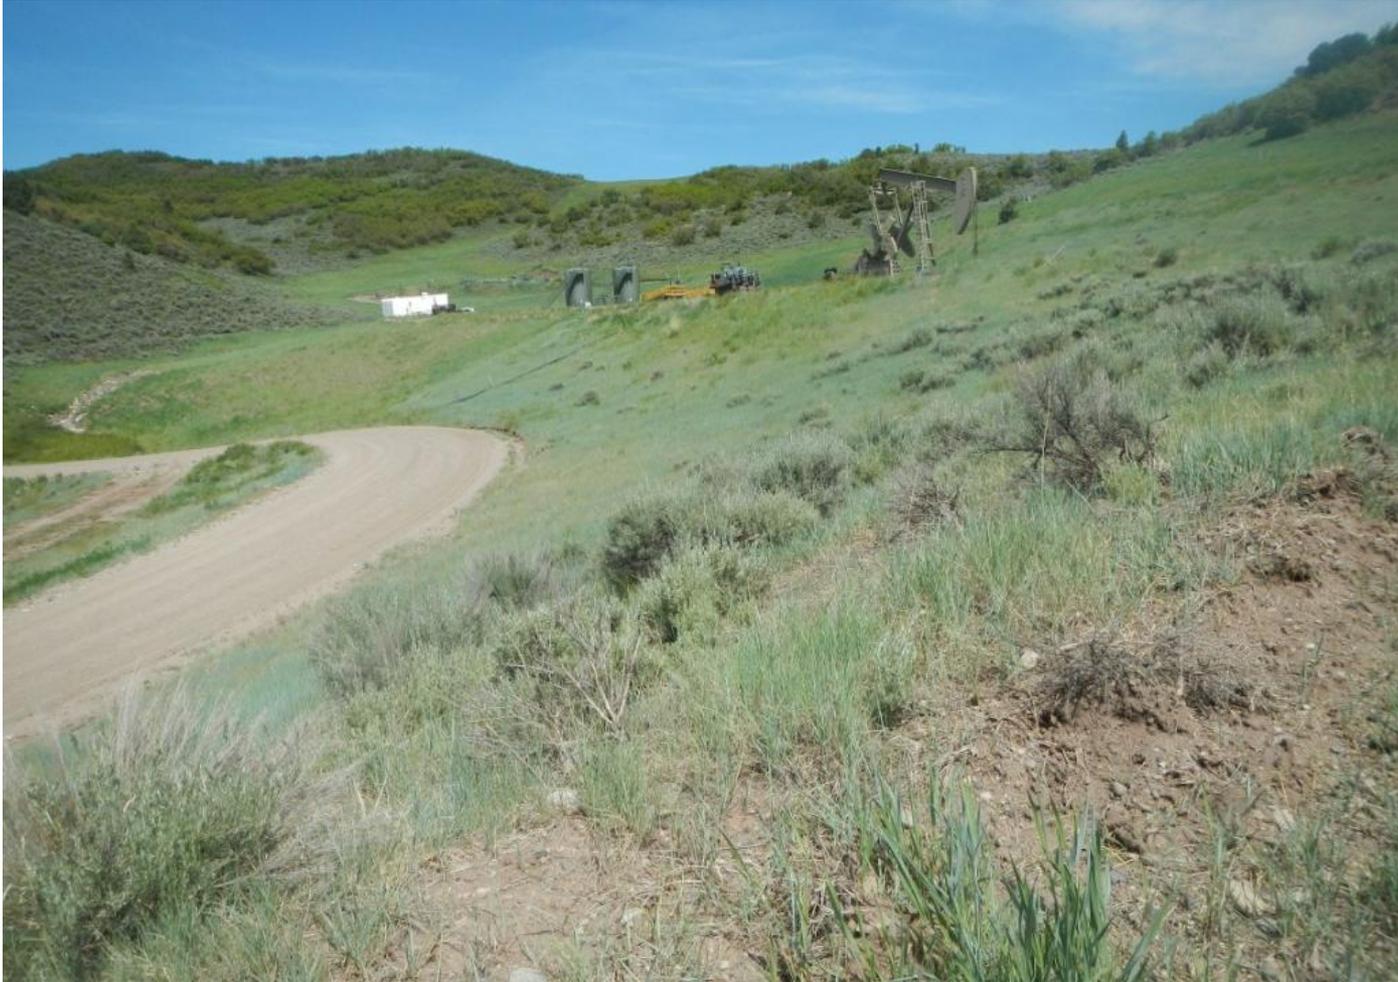
Photo 4. View of the southern portion of the project area from the access road entrance.

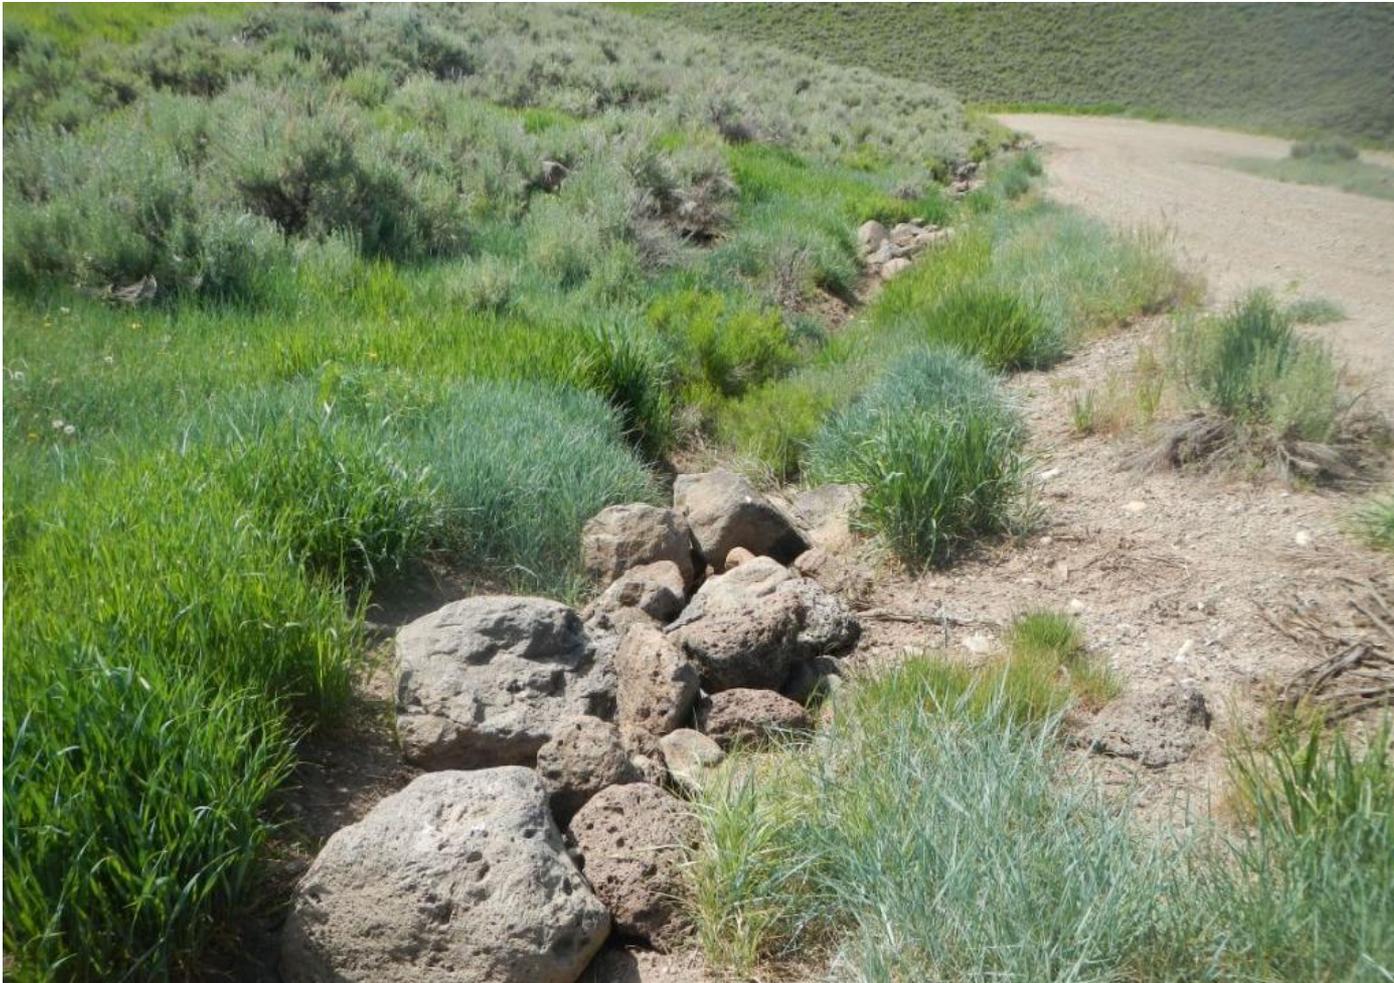
Photo 5. View of roadside ditch along access road from well pad facing toward entrance. Rock check dams are being used to de-energize flows.

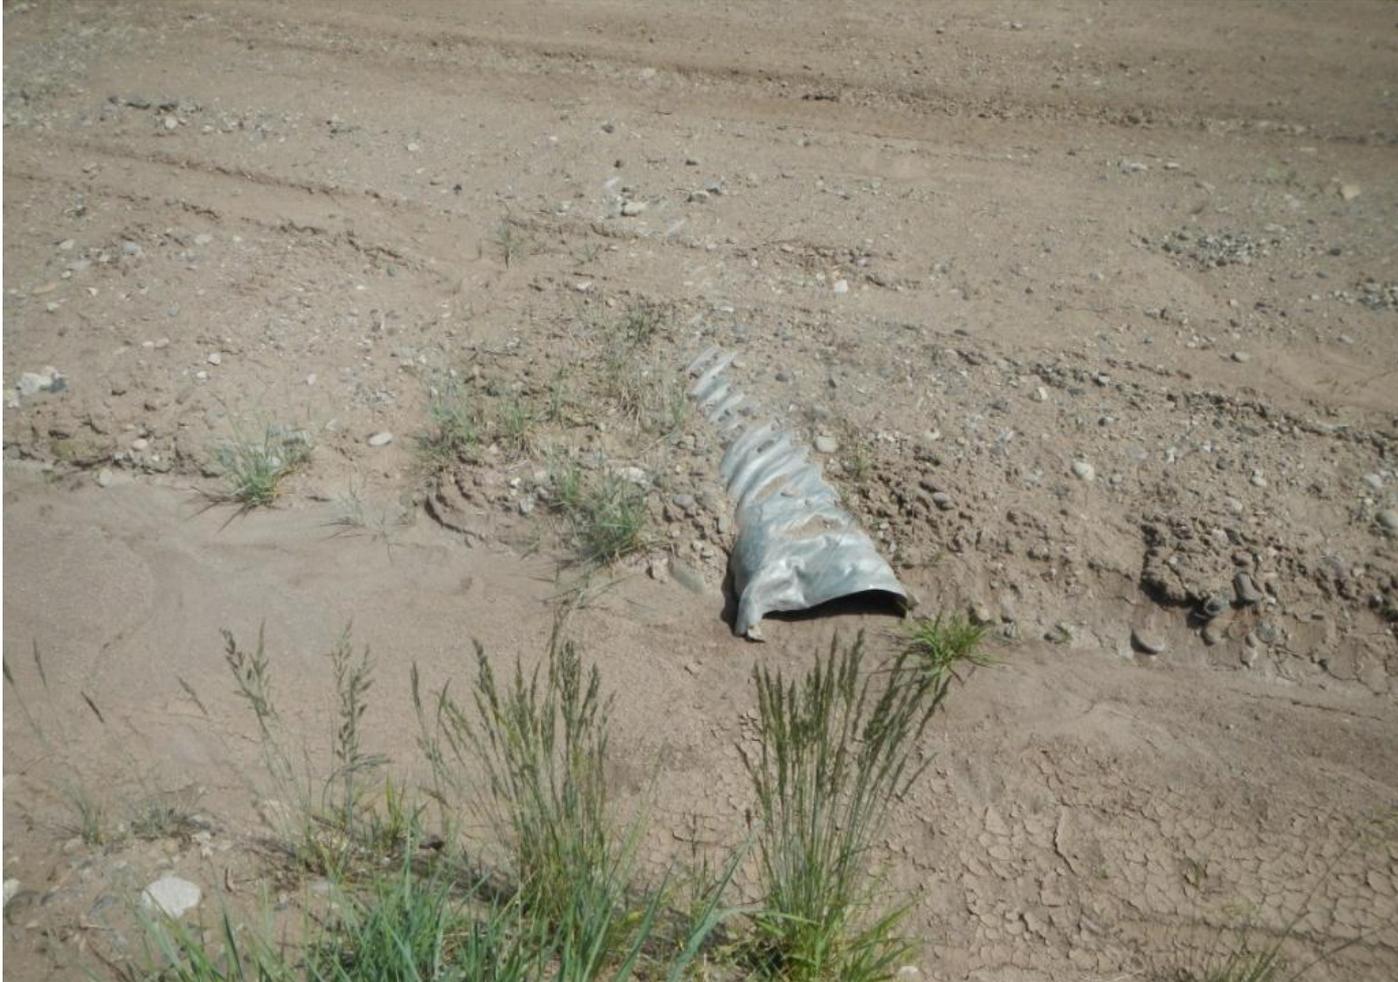
Photo 6. View of culvert at the entrance to the access road that is damaged and full of sediment. Culvert needs maintenance and repair.
