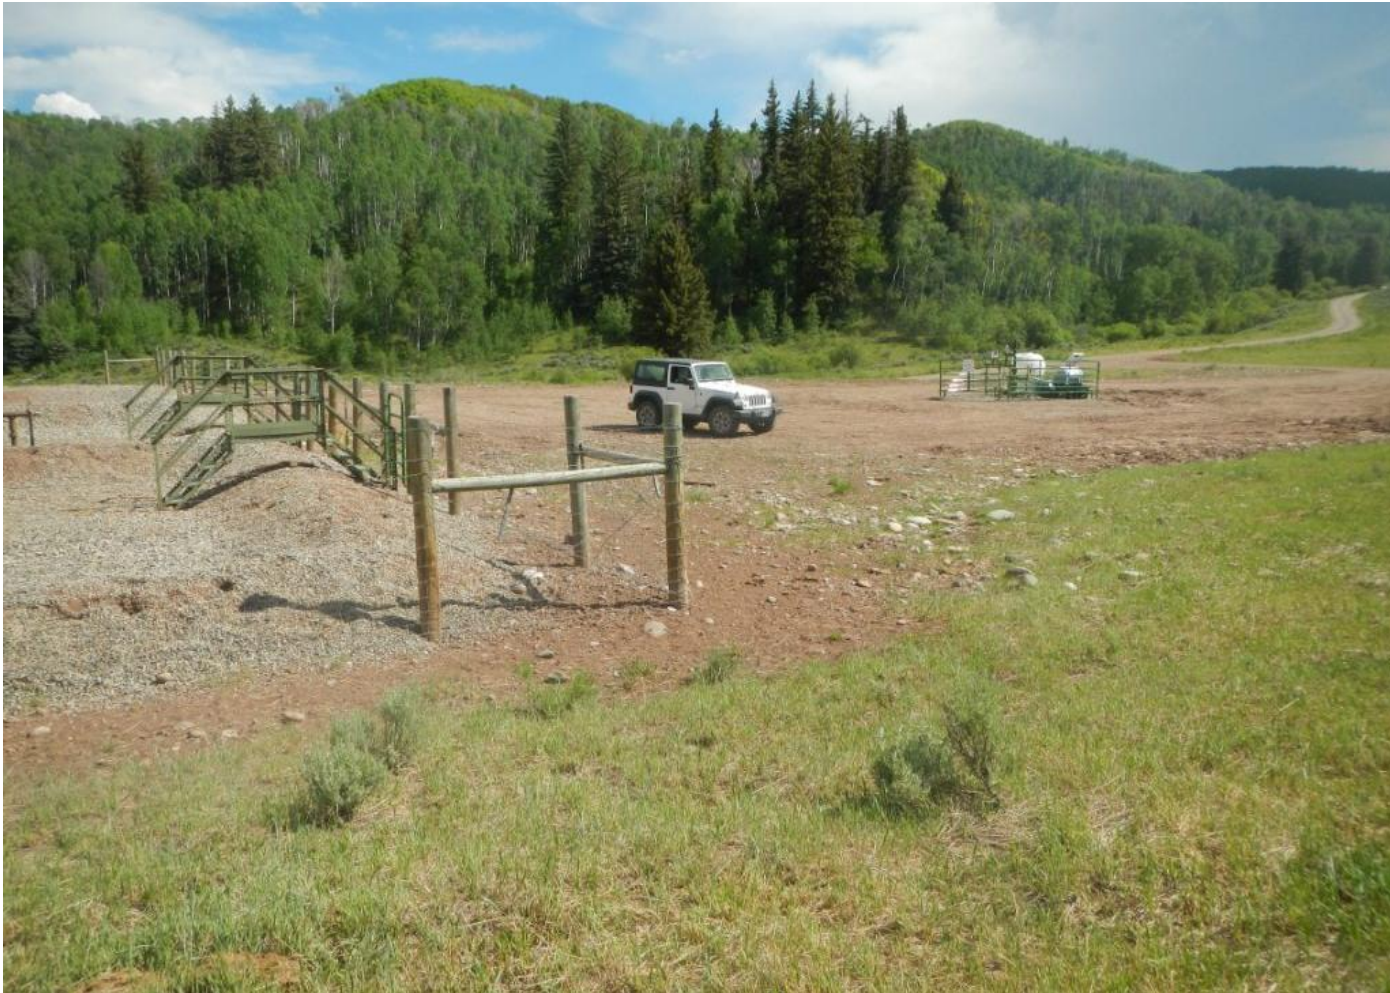
Photo 1. View of the project area from the northern corner facing center.

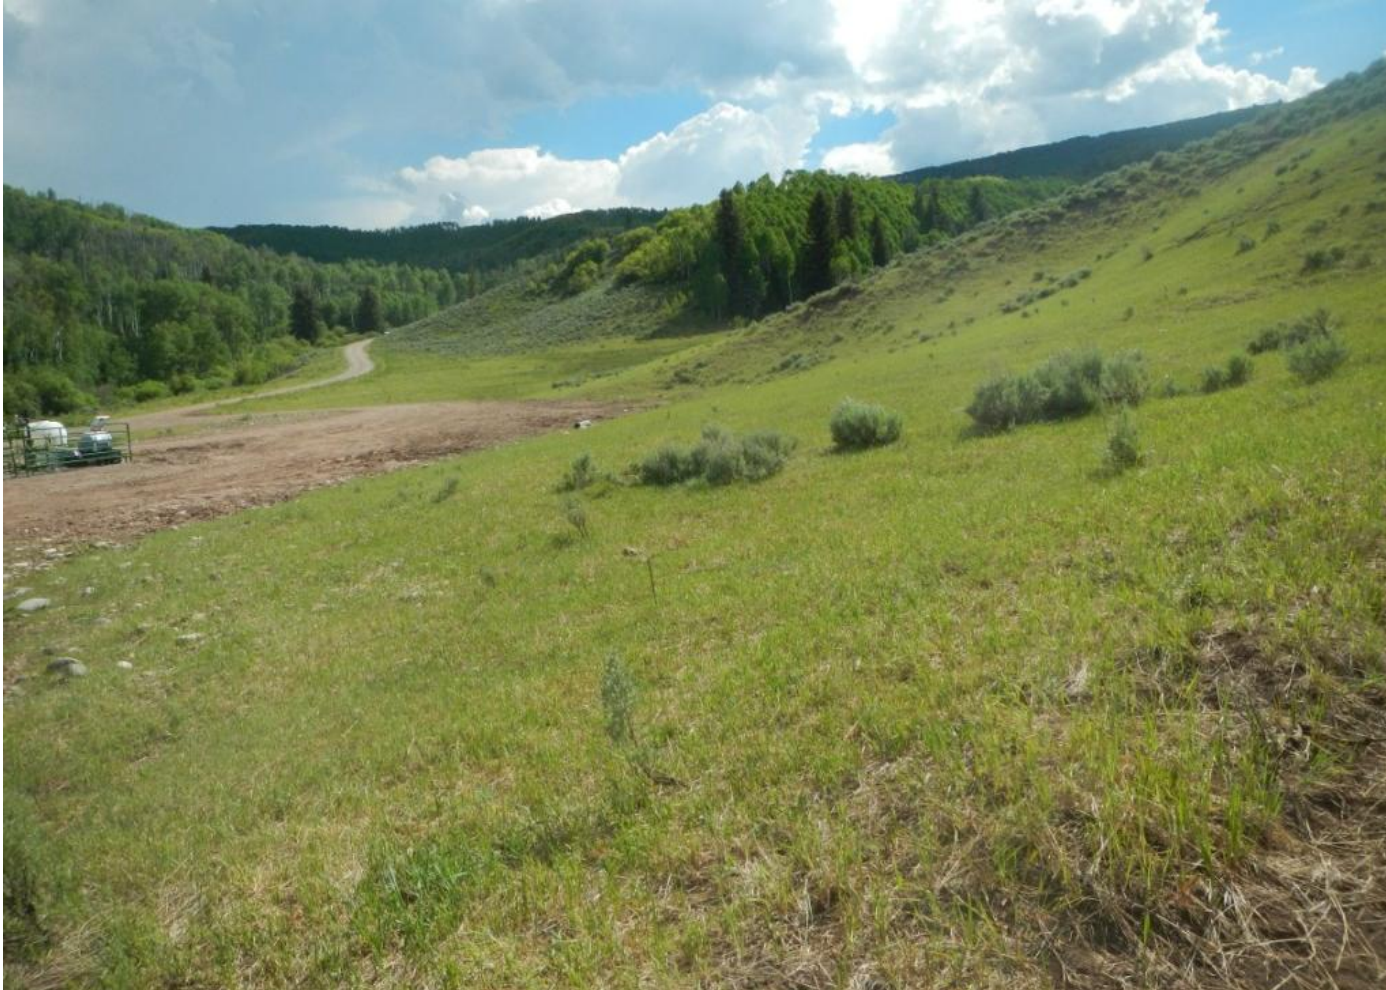
Photo 2. View of the northwestern portion of the project area from the northern corner facing southwestward. Revegetation is progressing, dominated by grazed grasses and scattered sagebrush (*Artemisia tridentata*).

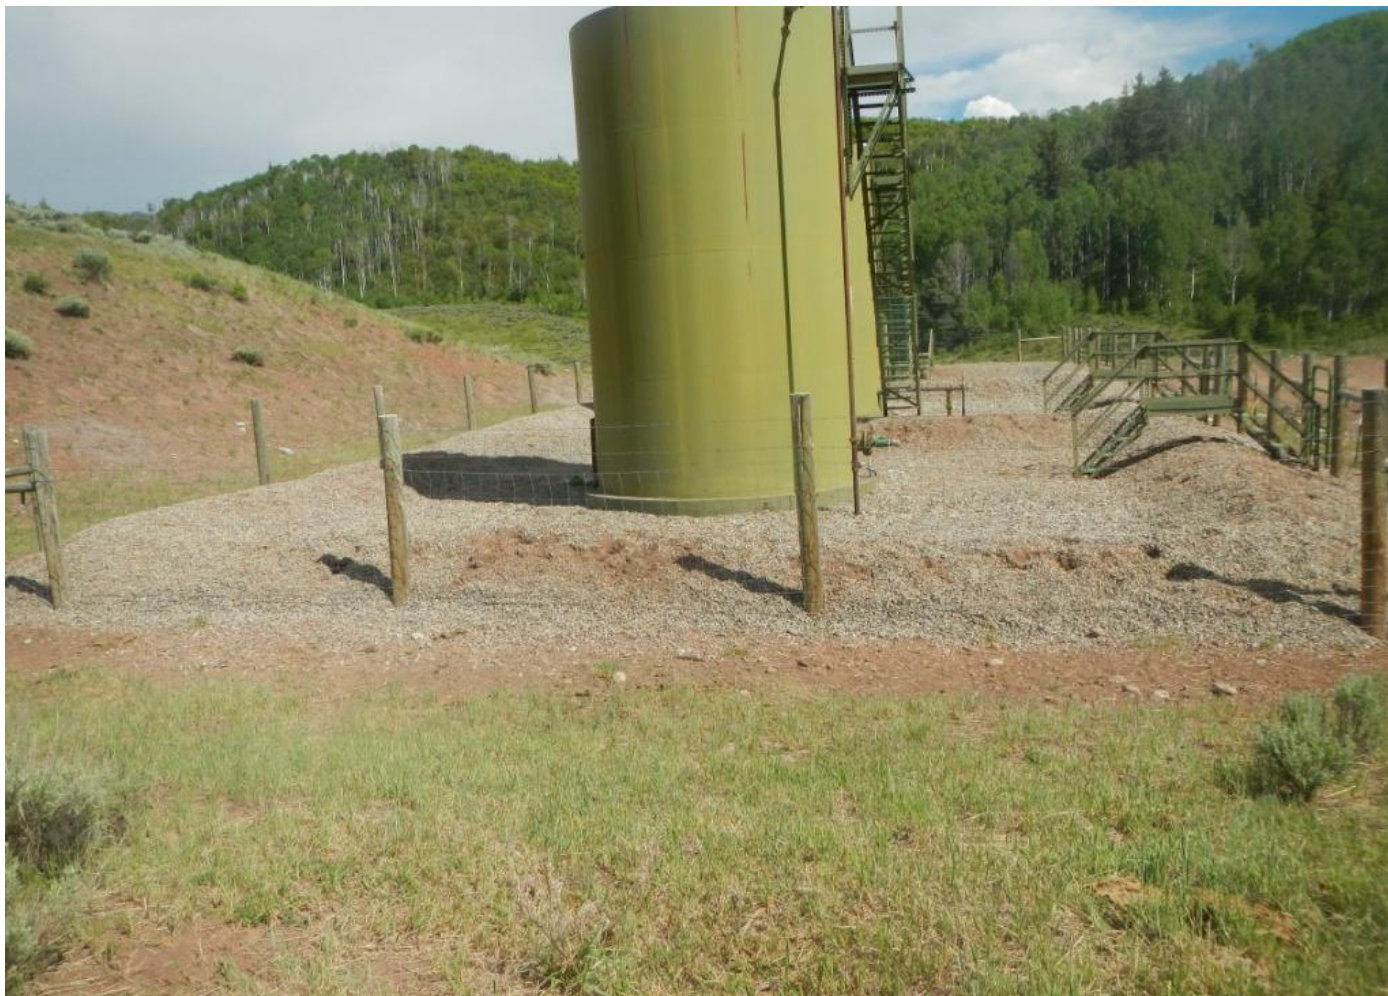
Photo 3. View of the eastern portion of the project area from the northern corner facing southward.

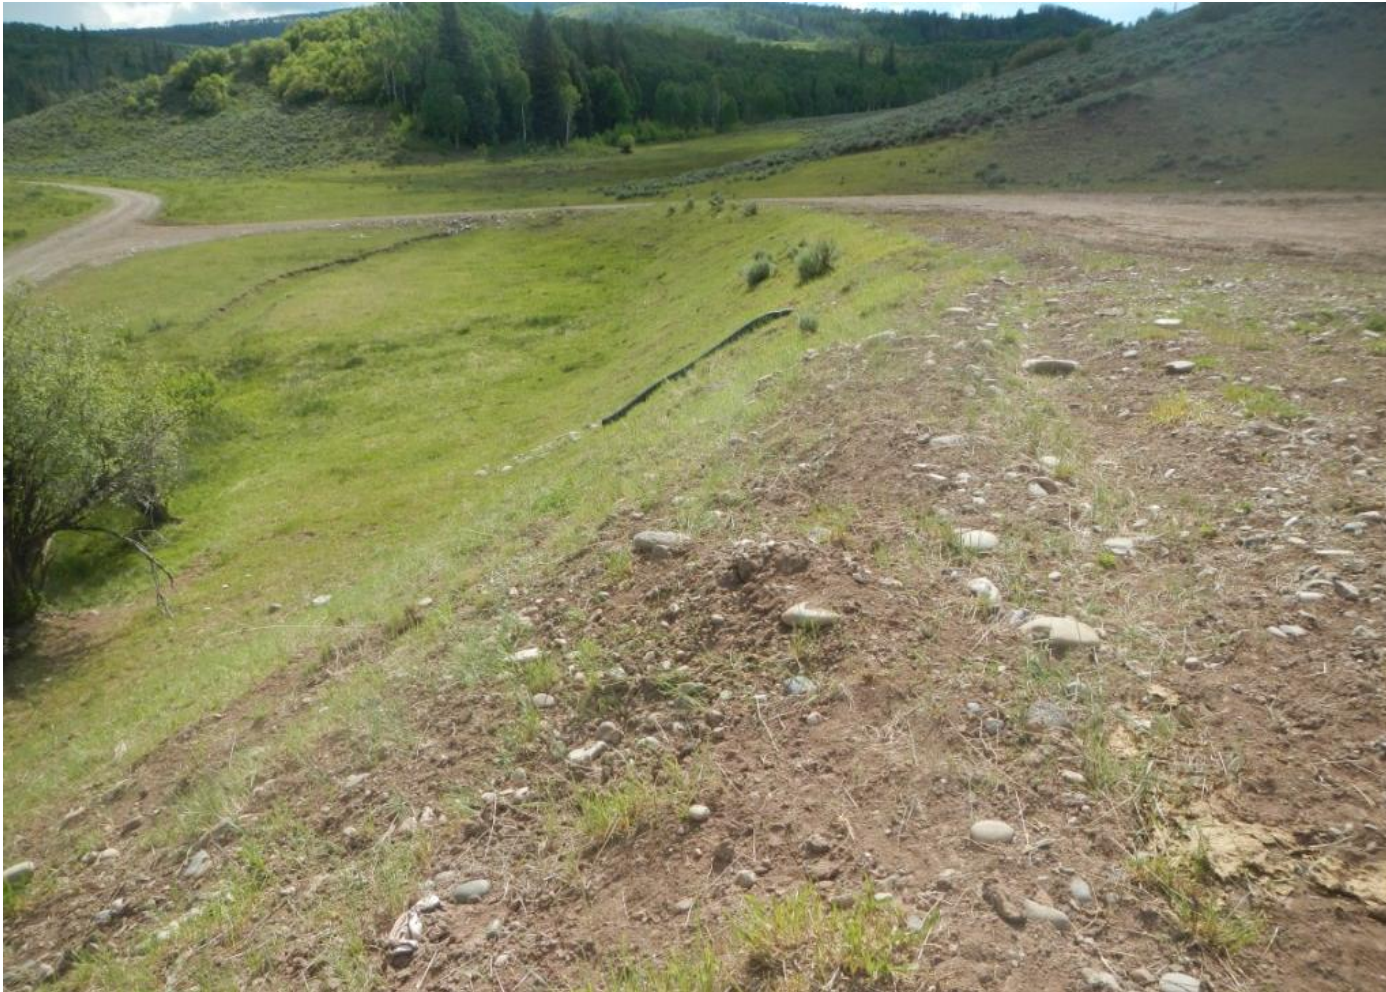
Photo 4. View of the southern portion of the project area from the southeastern edge facing westward. Stormwater flows in this portion of the well pad are diverted through black piping and armored outlet and flows from the access road are diverted along vegetated swale in background.

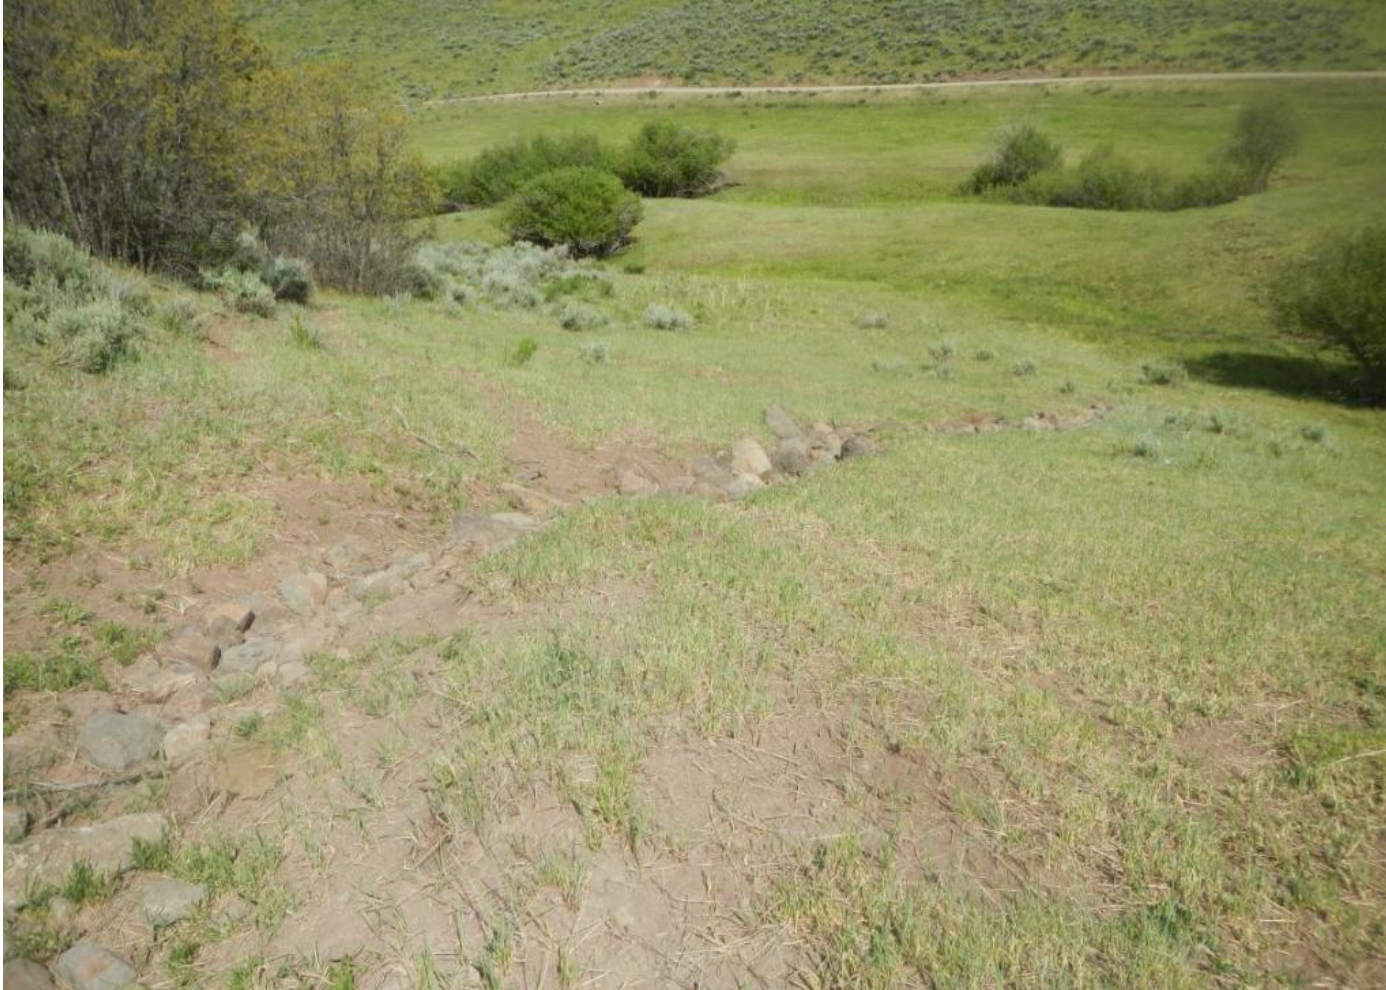
Photo 5. View of area where concentrated stormwater flows off of the southeastern corner of the well pad. Channel is armored and appears stabilized at this time.

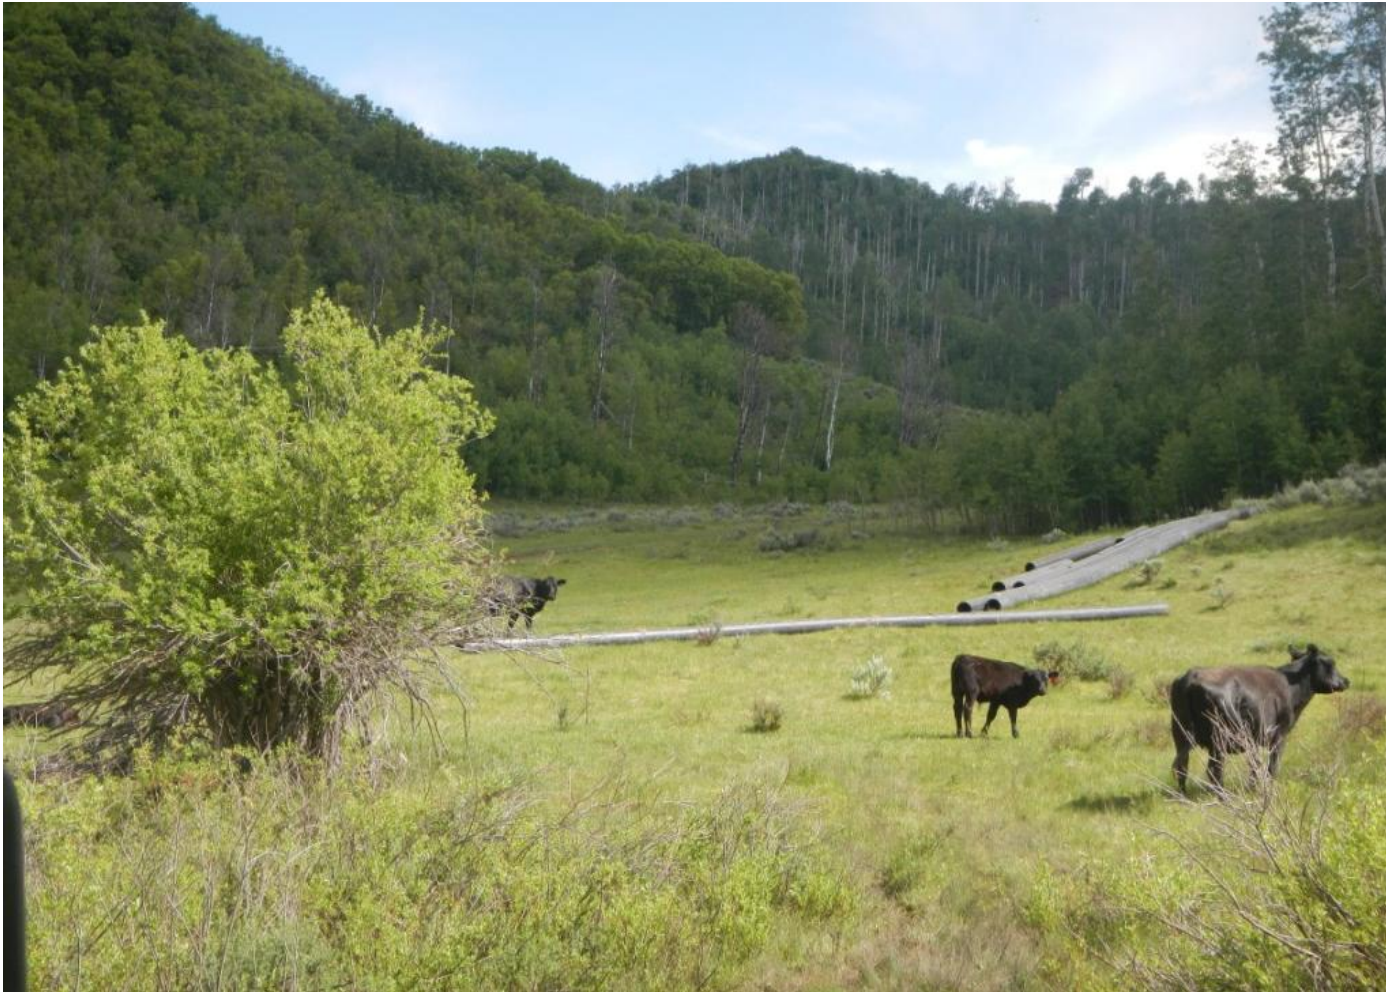
Photo 6. View of unused pipe that sitting in rangeland southwest of project area that needs to be removed.

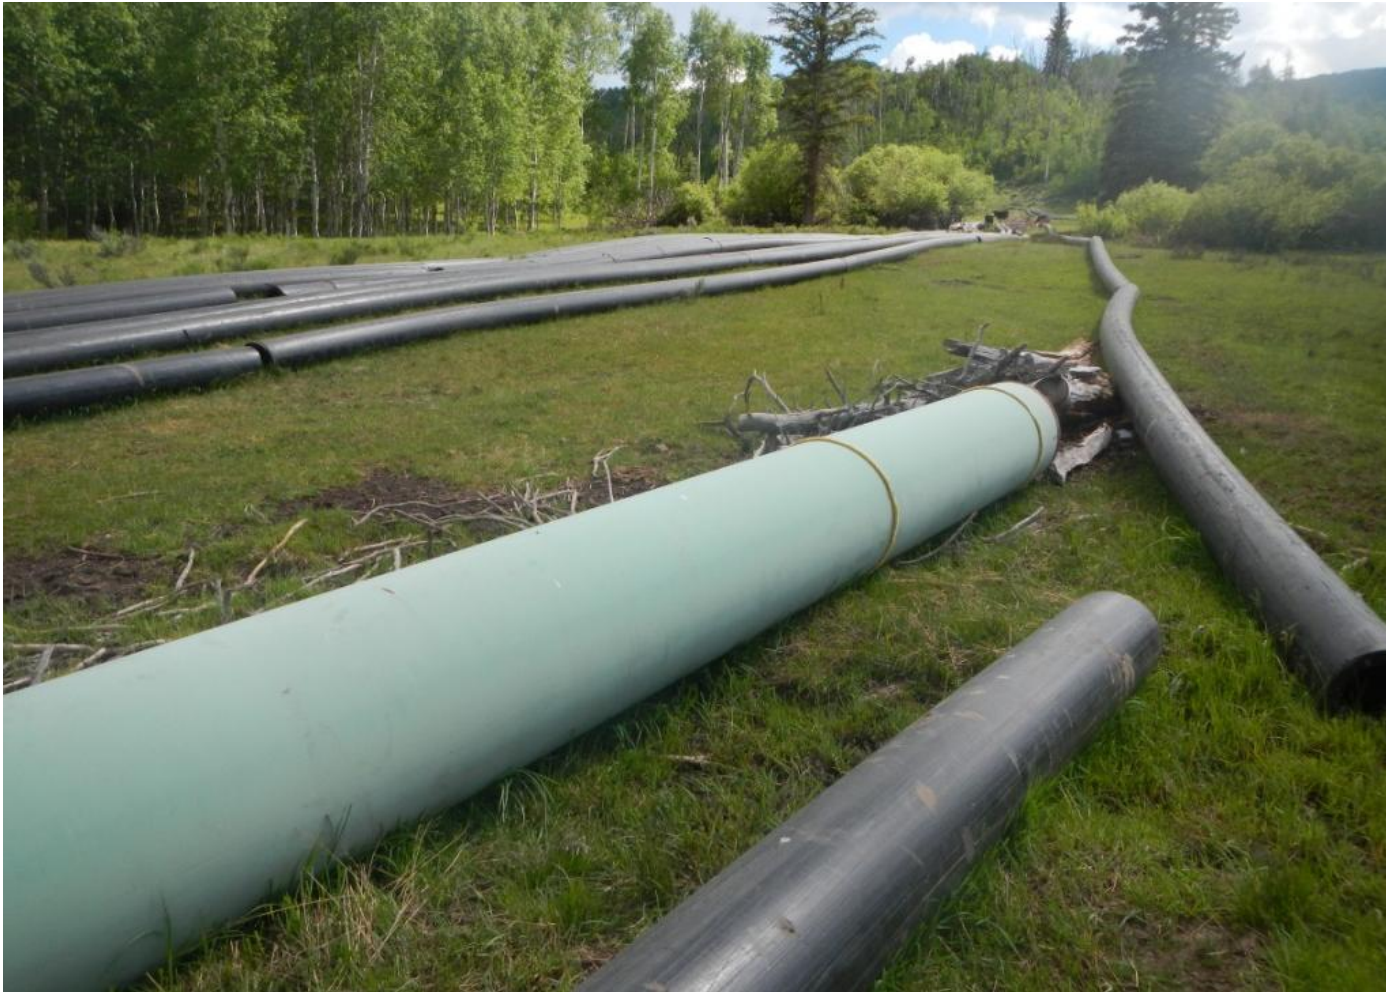
Photo 7. View of more unused pipe, southwest of the well pad that needs to be removed.

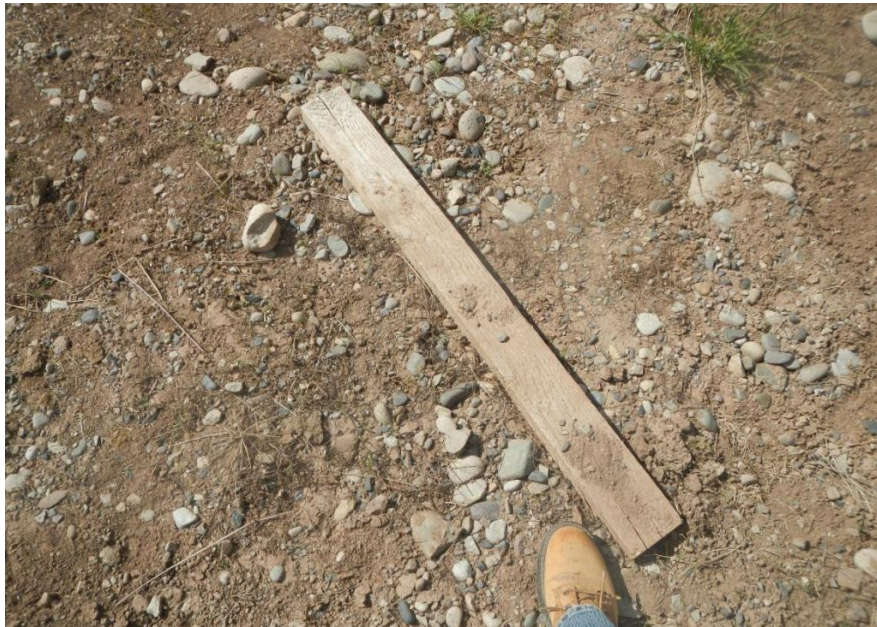
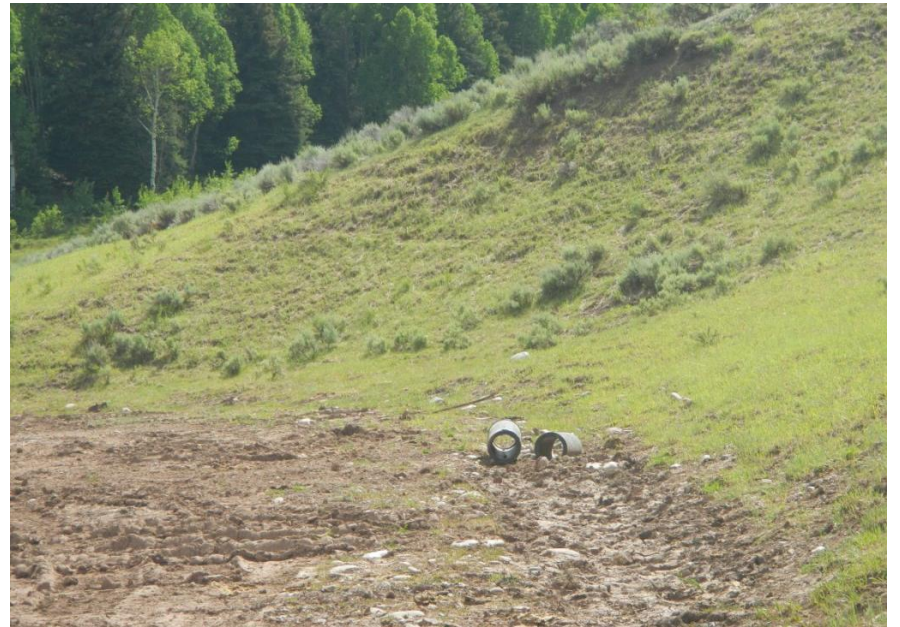
Photos 8 and 9. View of debris on the well pad that needs to be removed.
