Final Reclamation Inspection

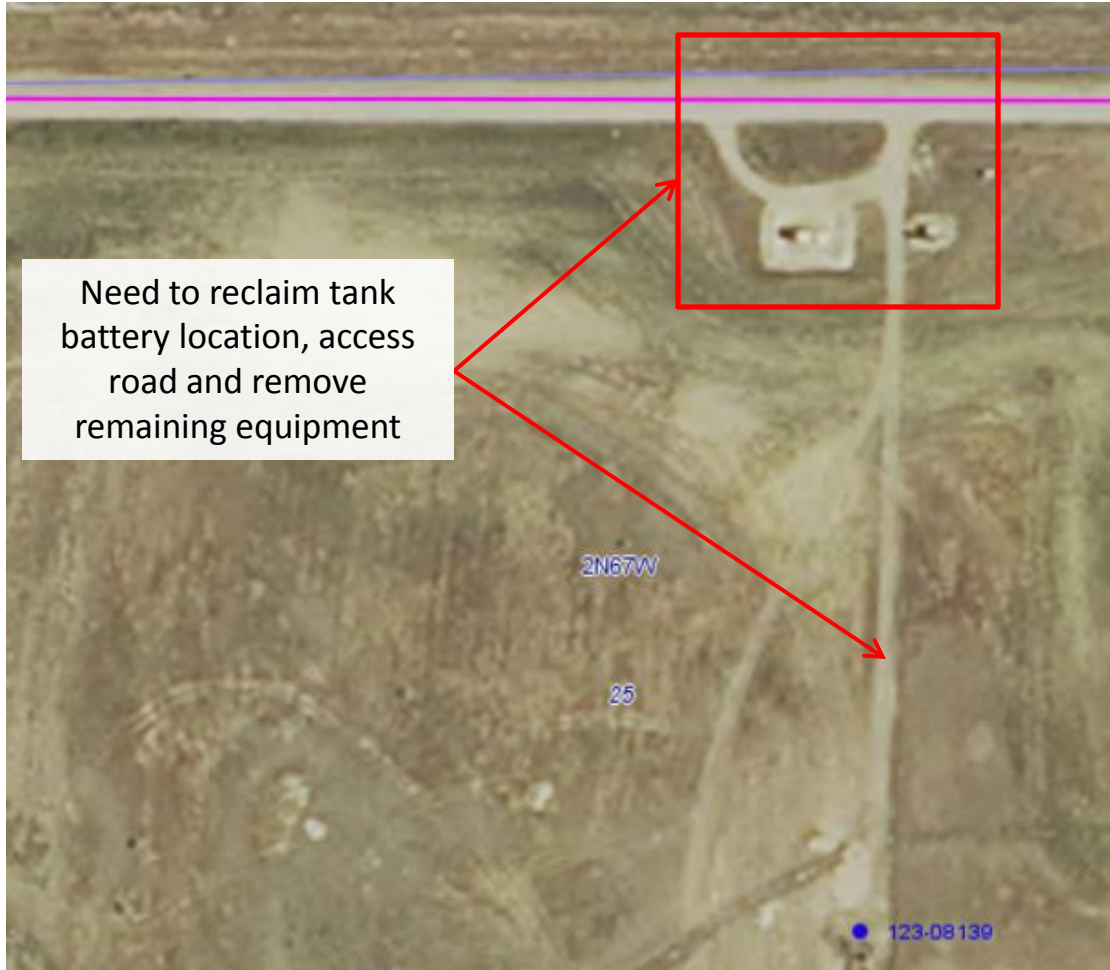
Photo 1. Aerial imagery taken 2013 using COGCC GISOnline, illustrating areas that still have not been reclaimed per Rule 1004.

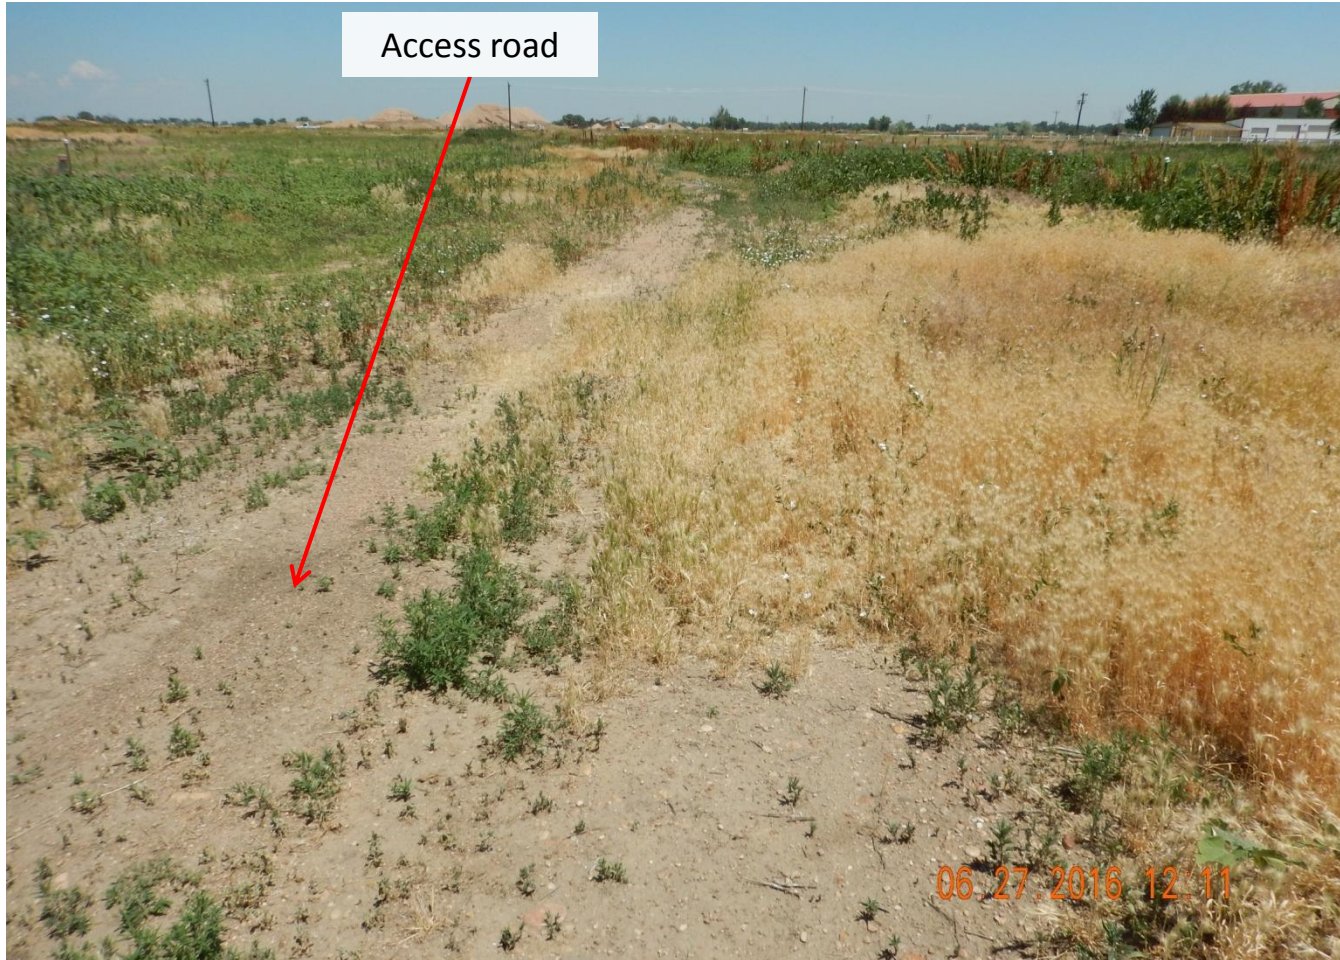
Photo 2. Photo taken from the well location, facing North. Access road needs to be reclaimed per Rule 1004.

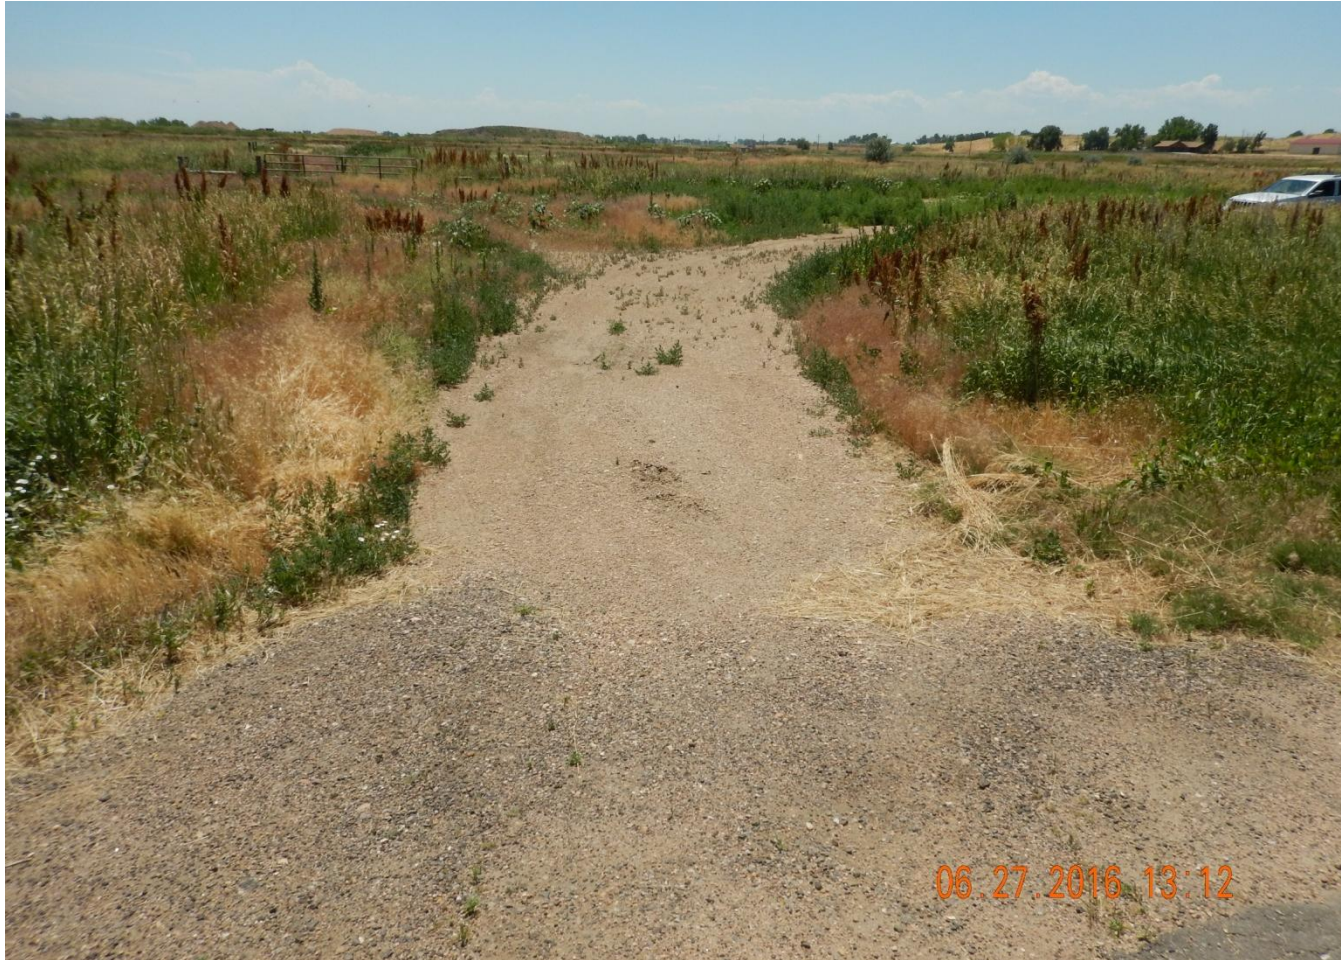
Photo 3. Photo taken from the eastern entrance of the tank battery location off CR 18, facing South. Need to reclaim location per Rule 1004.

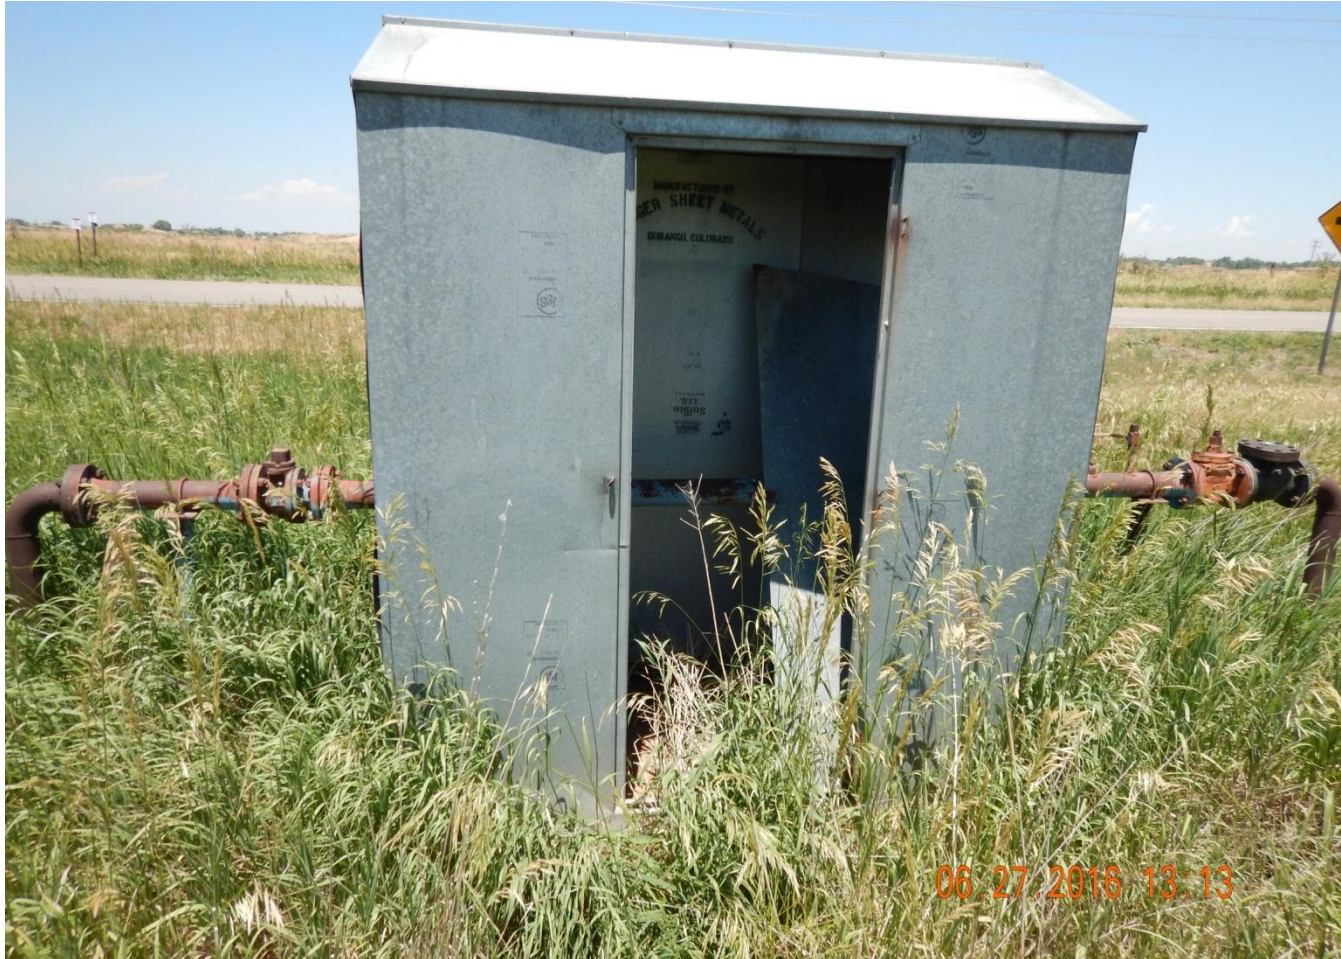
Photo 4. Photo taken from the eastern tank battery location. Equipment still remains and needs to be removed per Rule 1004.

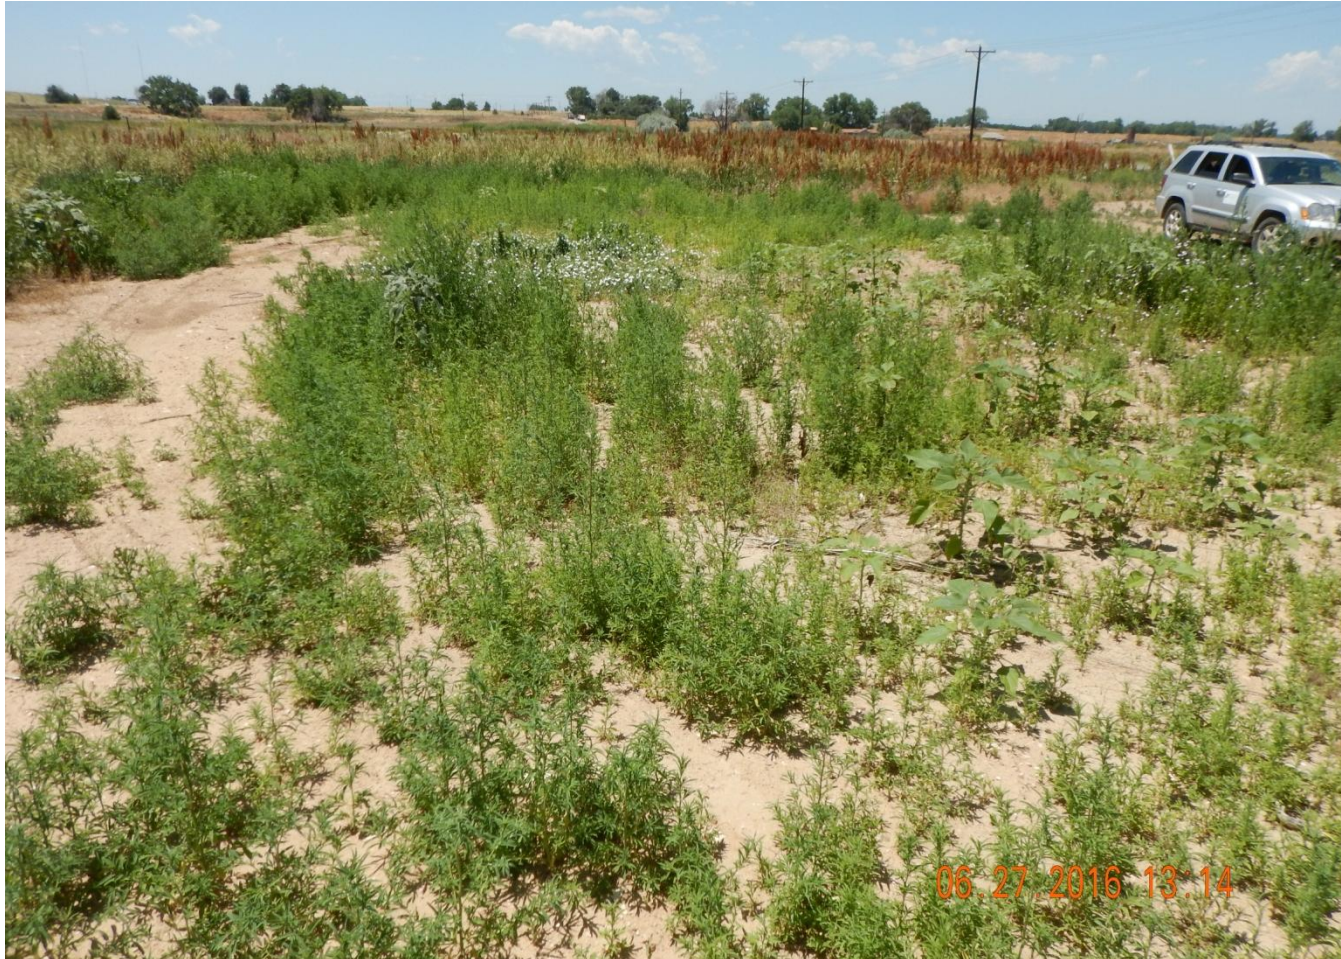
Photo 5. Photo taken from the northern tank battery location, facing West. Need to reclaim location per Rule 1004.

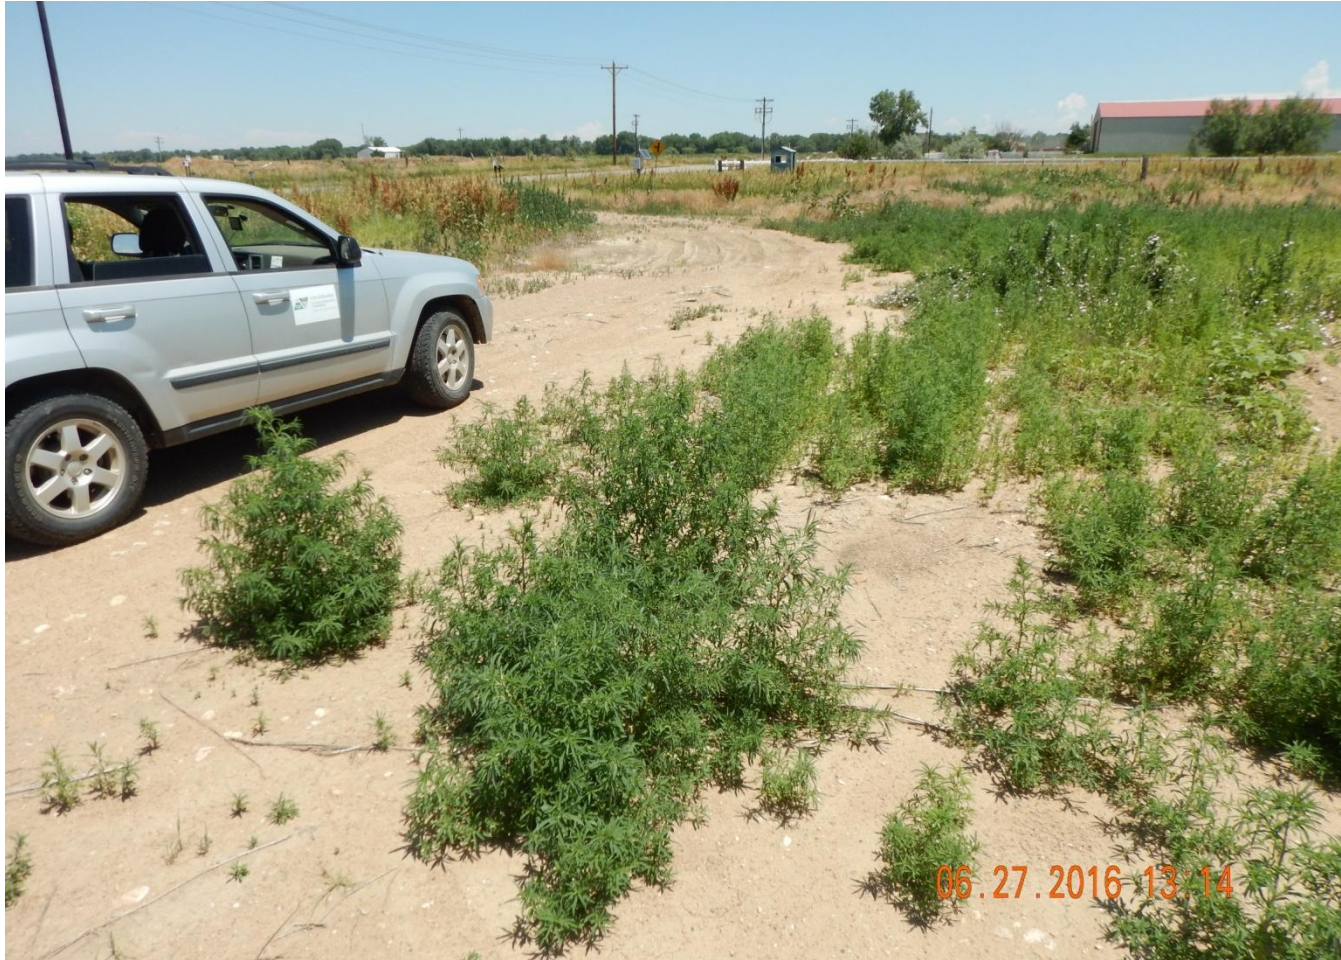
Photo 6. Photo taken from the northern tank battery location, facing East. Need to reclaim location per Rule 1004.

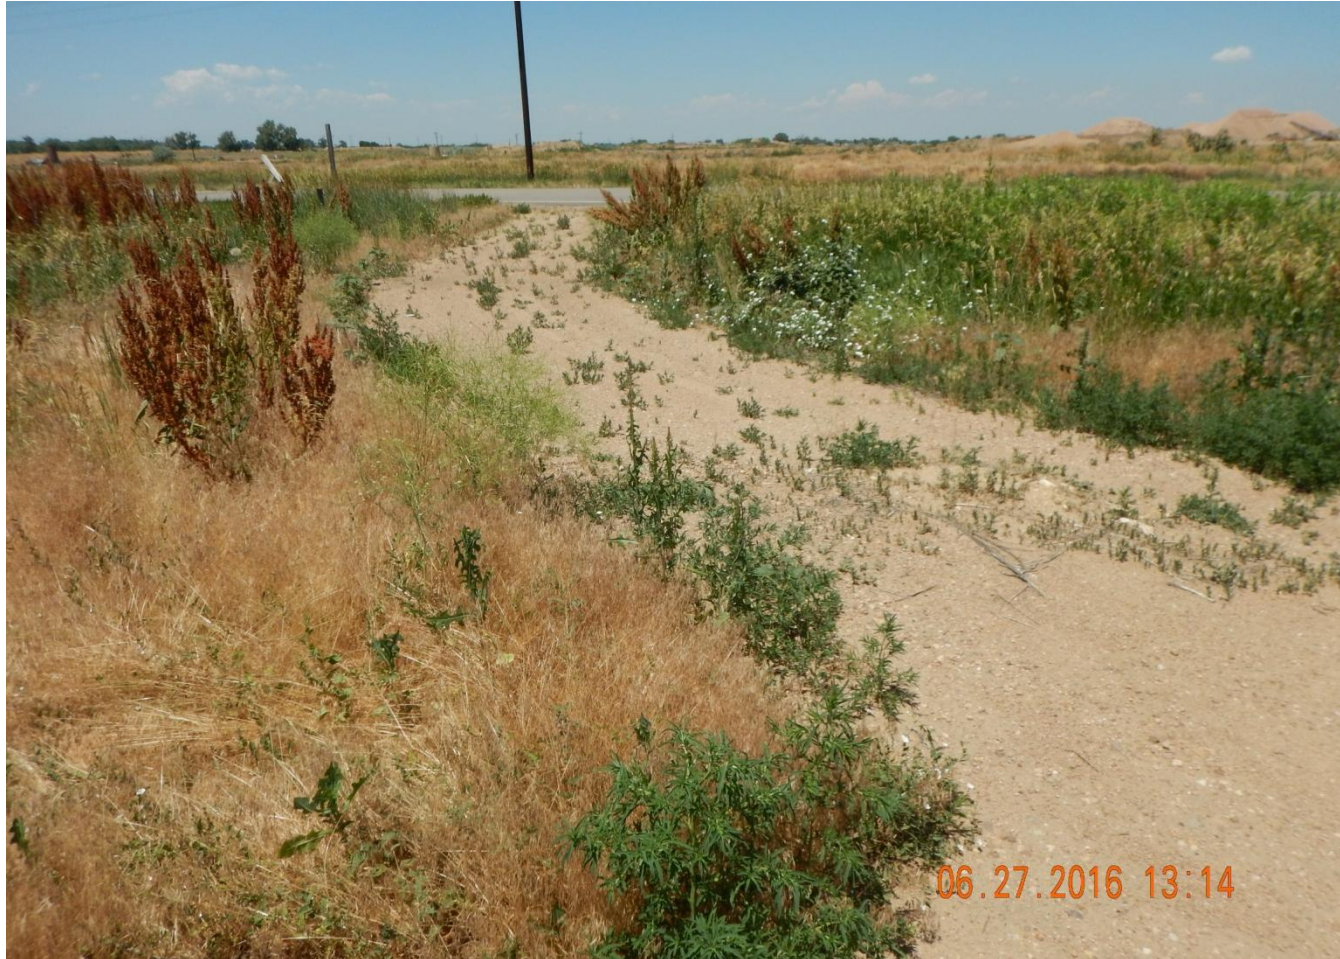
Photo 7. Photo taken of the western entrance of the tank battery location off CR 18, facing North. Need to reclaim location per Rule 1004.

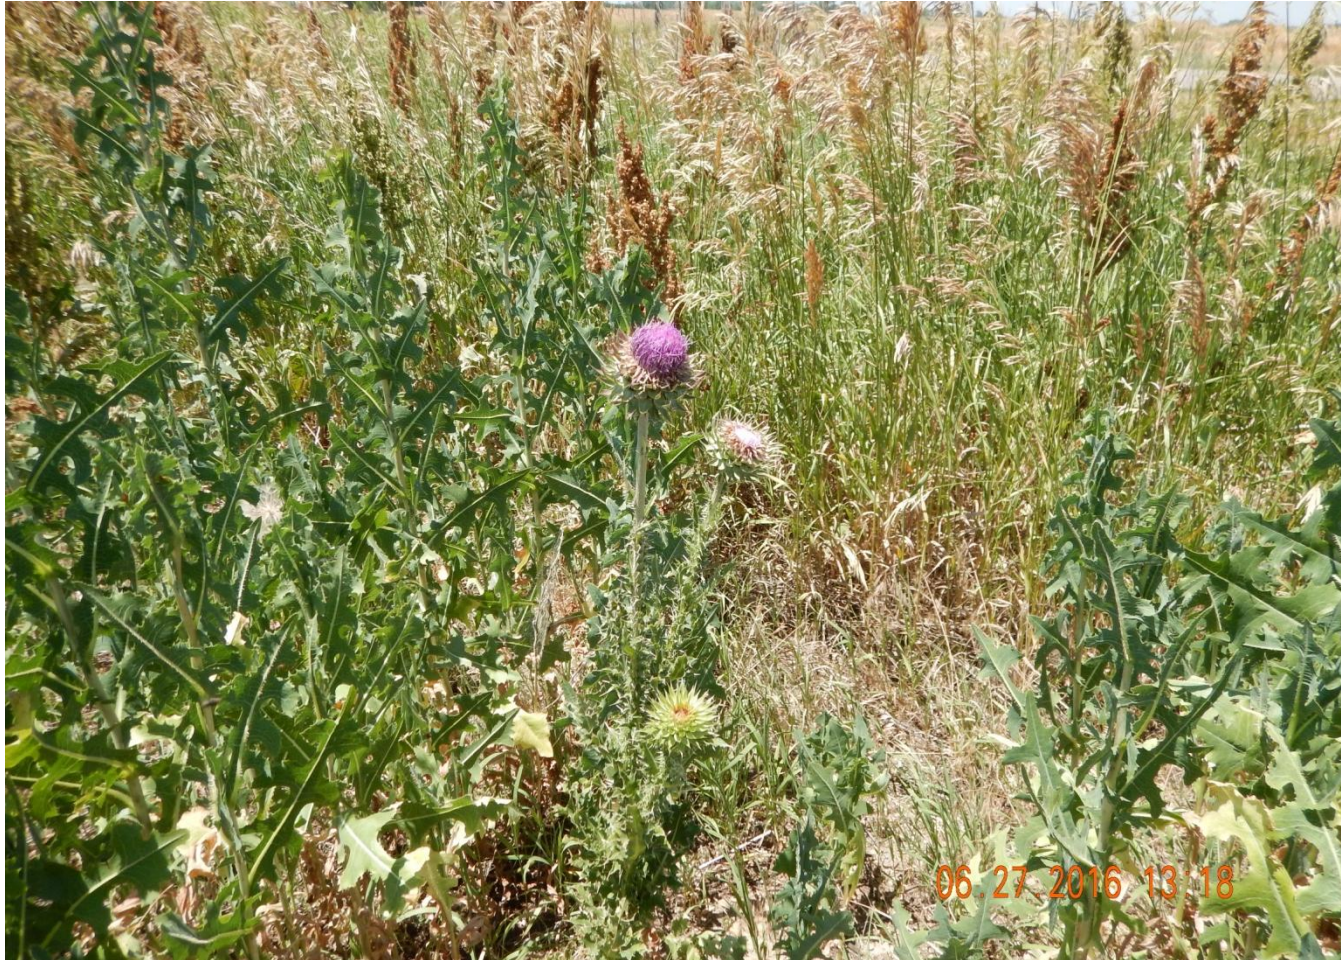
Photo 8. Photo taken of a List B Colorado Noxious weed species, (*Carduus nutans*). Needs to be removed per Rule 1004.
