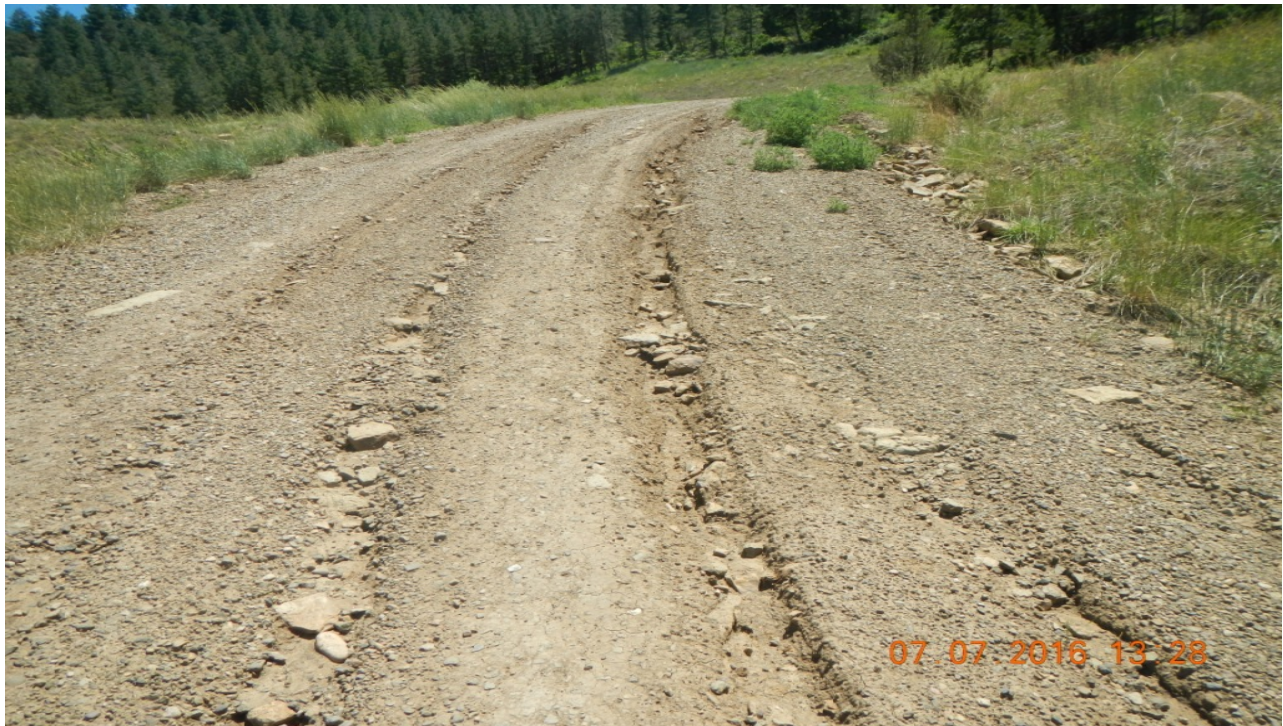
photo 1: Access road near the location is showing signs of erosion.

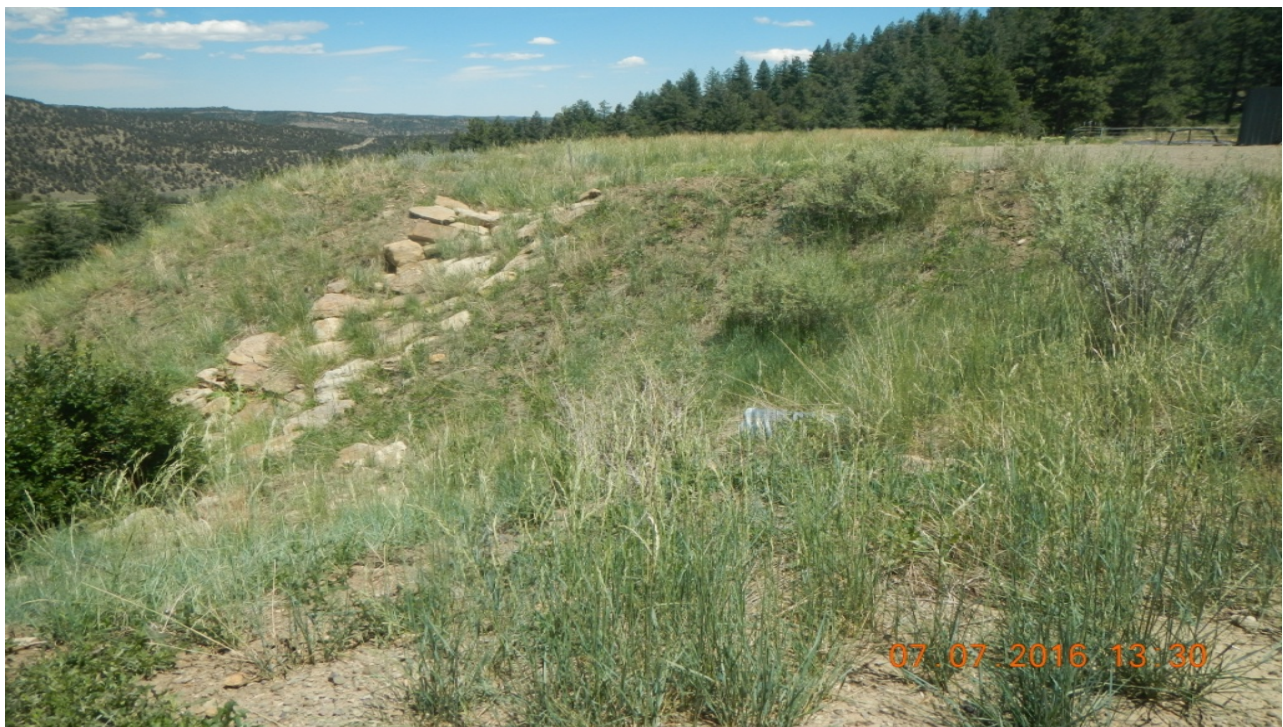
photo 2: Facing east toward the north side of the pad.

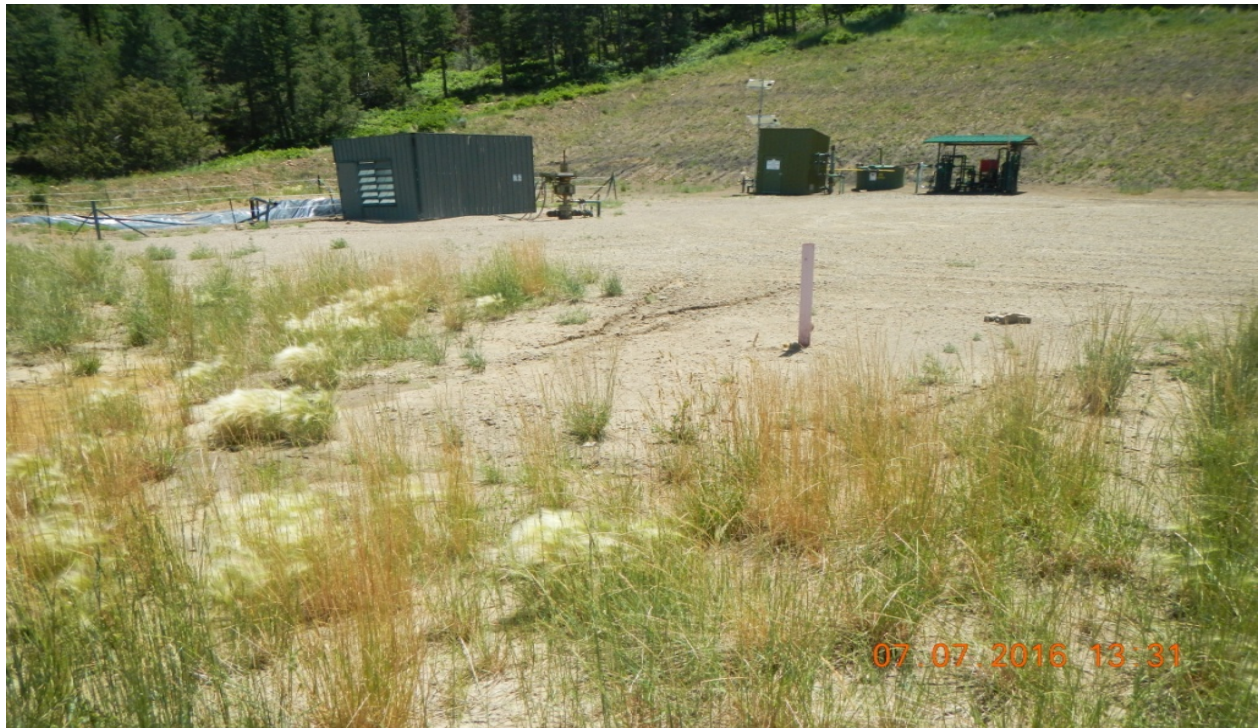
photo 3: North side of the location facing south.

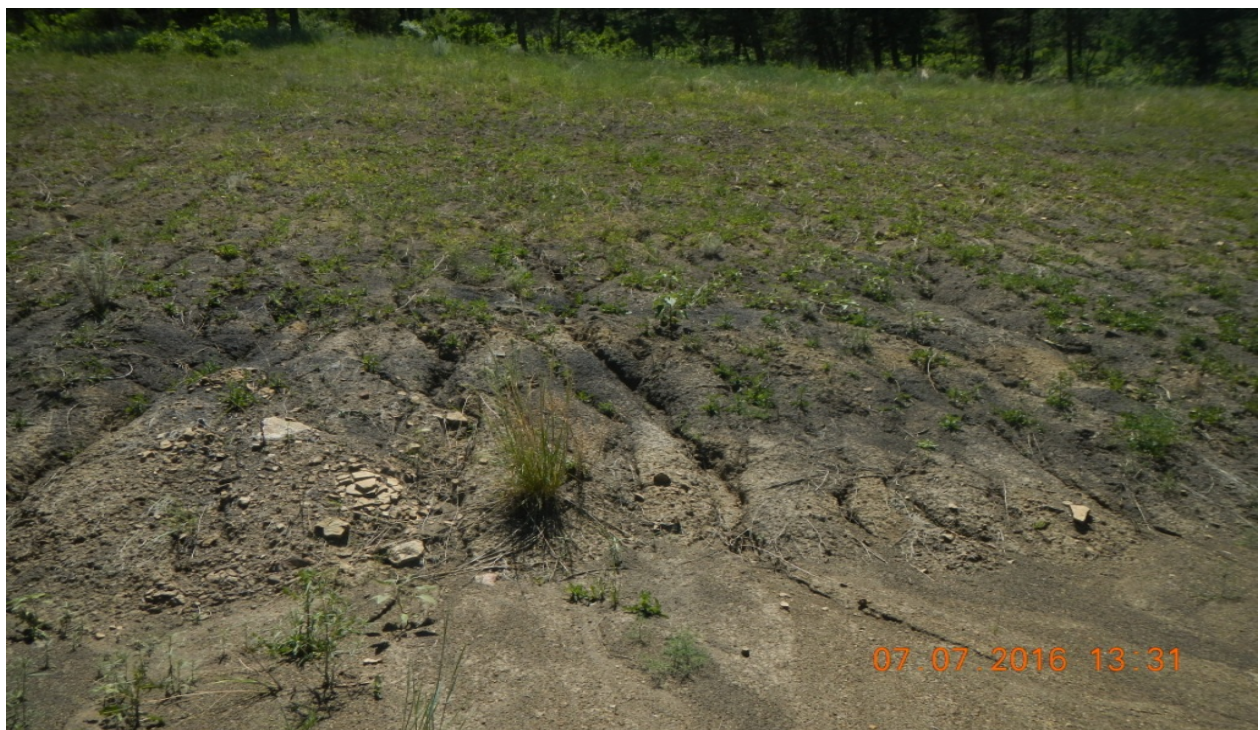
photo 4: The south slope is not stabilized and there is signs of erosion from stormwater runoff.

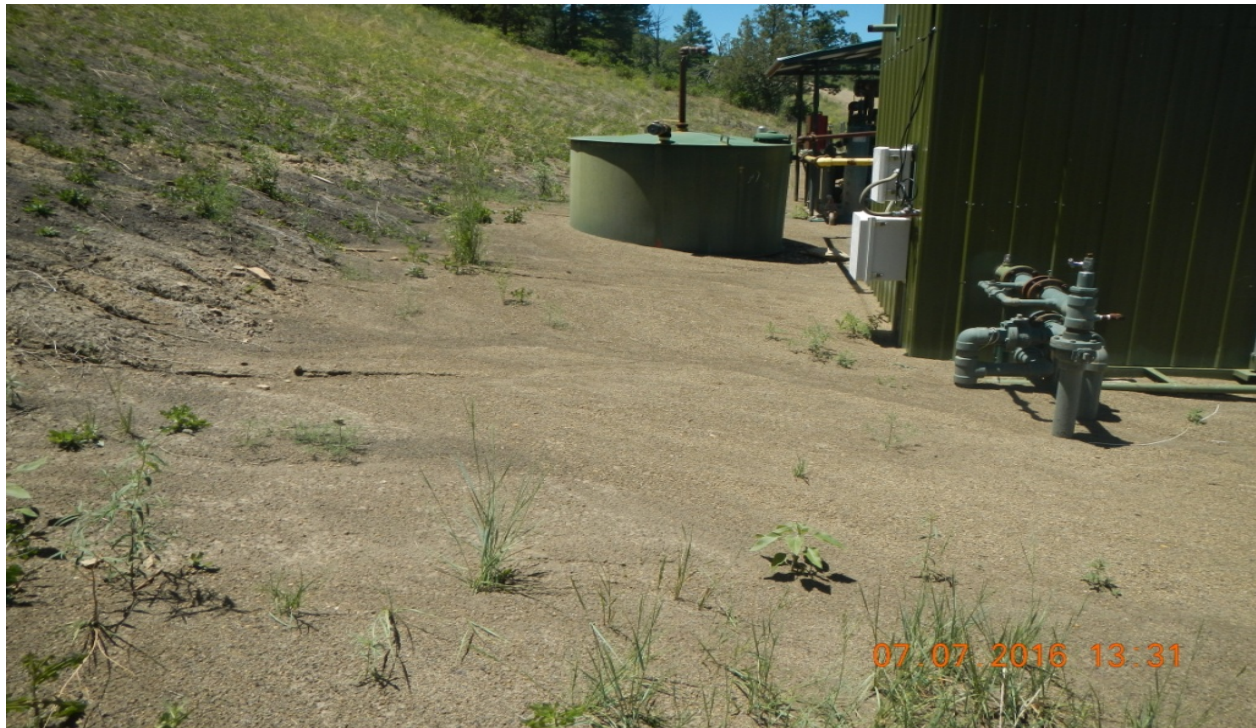
photo 5: Sediment is being deposited near the equipment along the south side of the location.

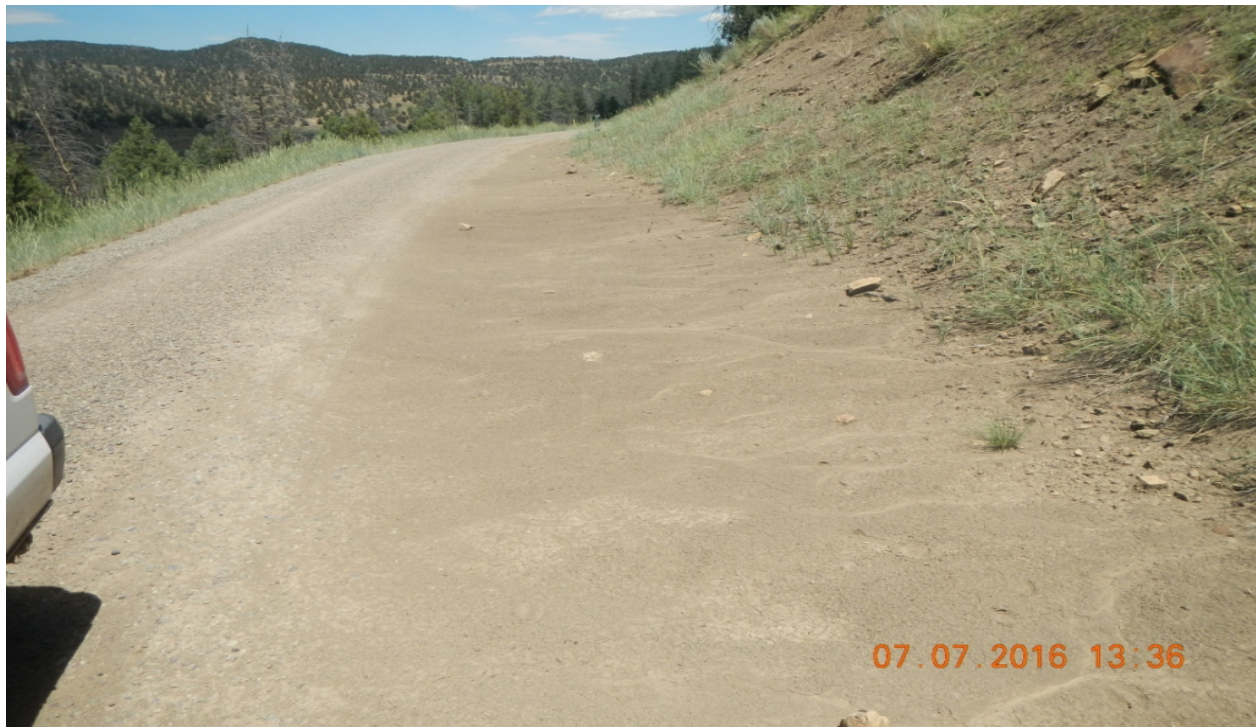
photo 6: Along the main access road (37.137,-104.897) there is signs of sediment migration onto the access road.
