Spetter 5-8

Inspection# 673403396

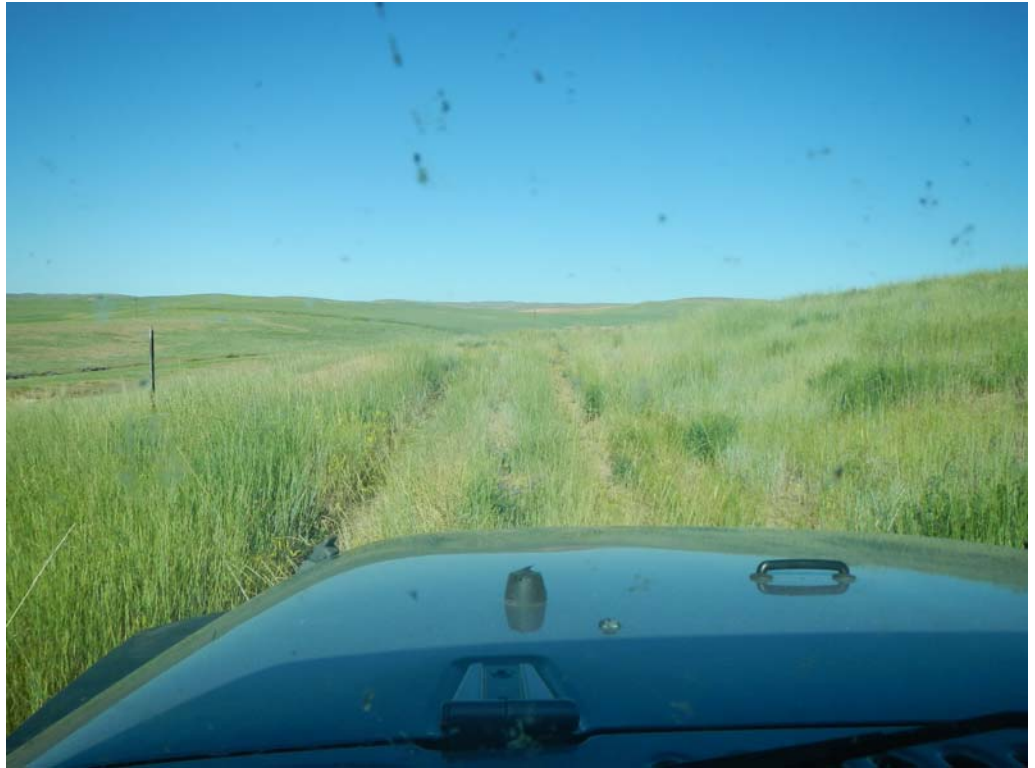
Access road overgrown and difficult to locate.

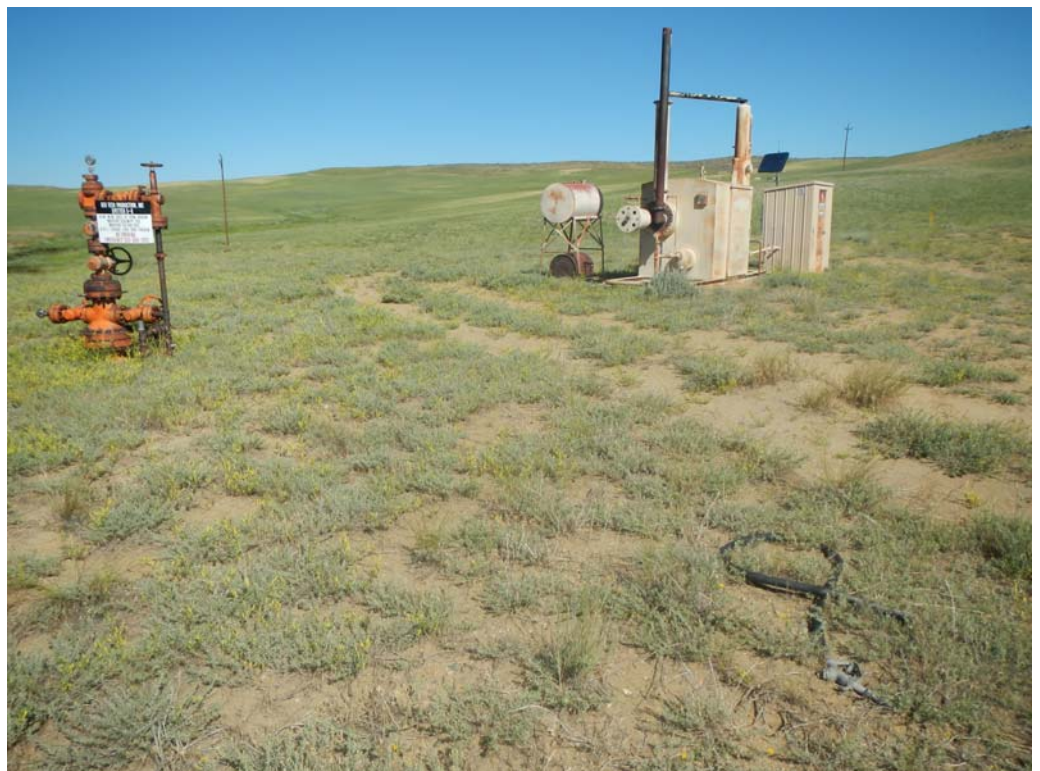
Fueling hose in foreground, no wildlife protection on exhaust in background. Storage without containment on left of separator.

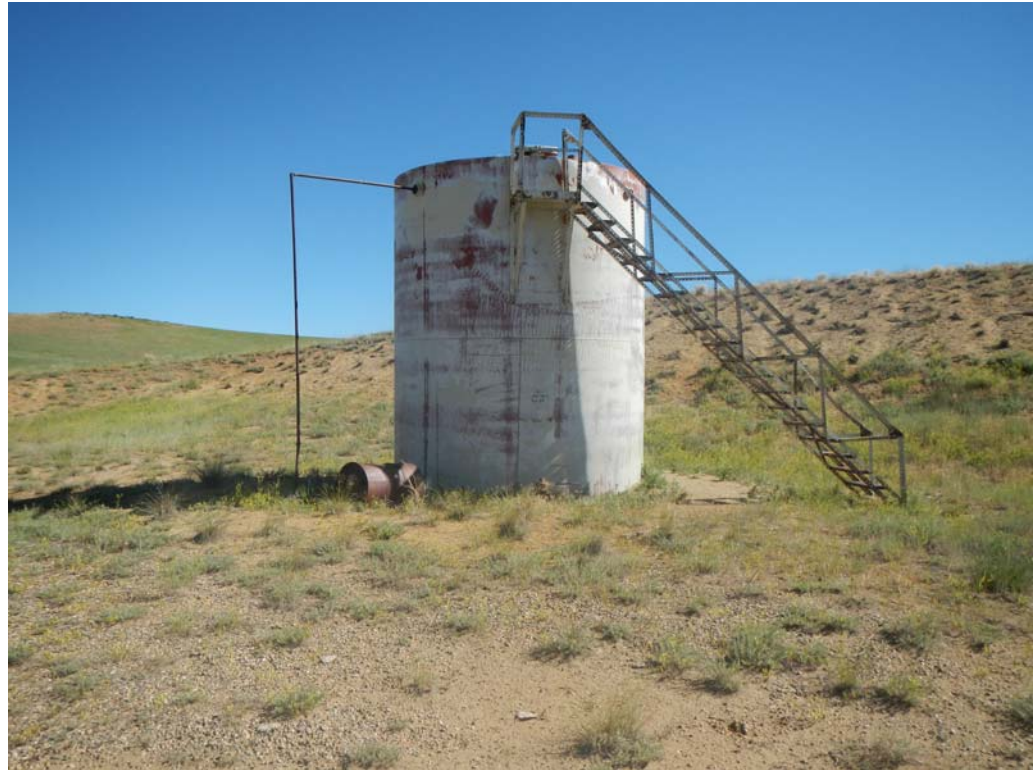
No battery sign. No tank label. No berm.

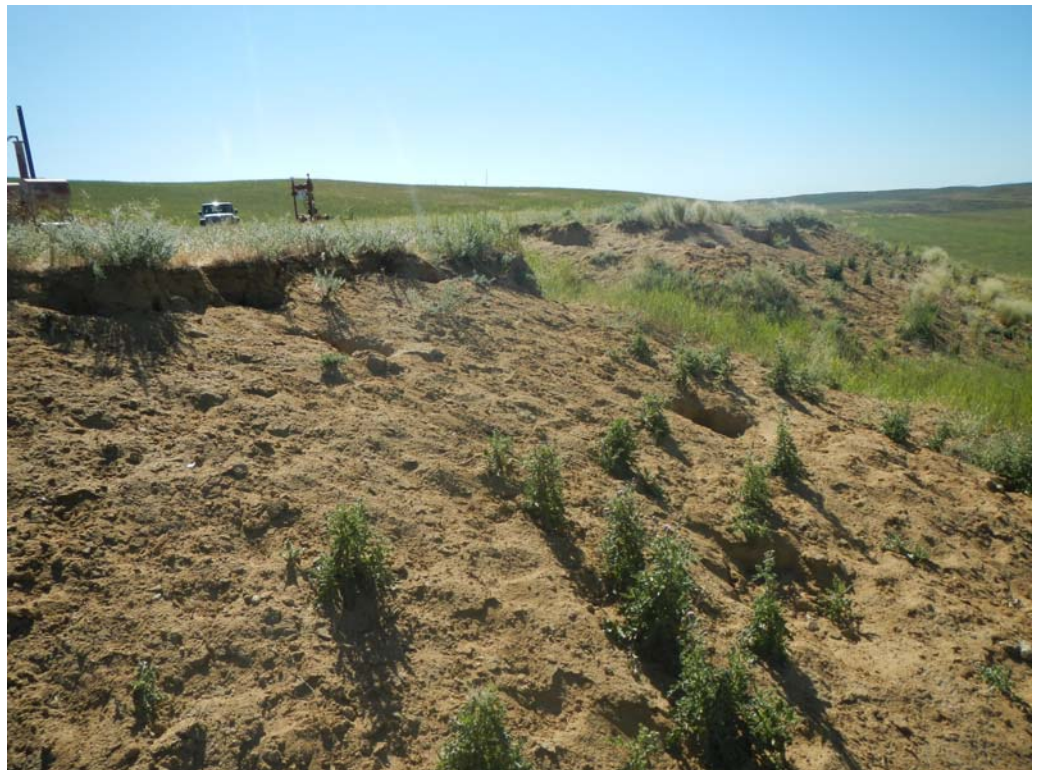
List B noxious weeds in disturbed area on west of location created by erosion gully (1 of 2) seen in background. Unmarked deadmen at top of slope.

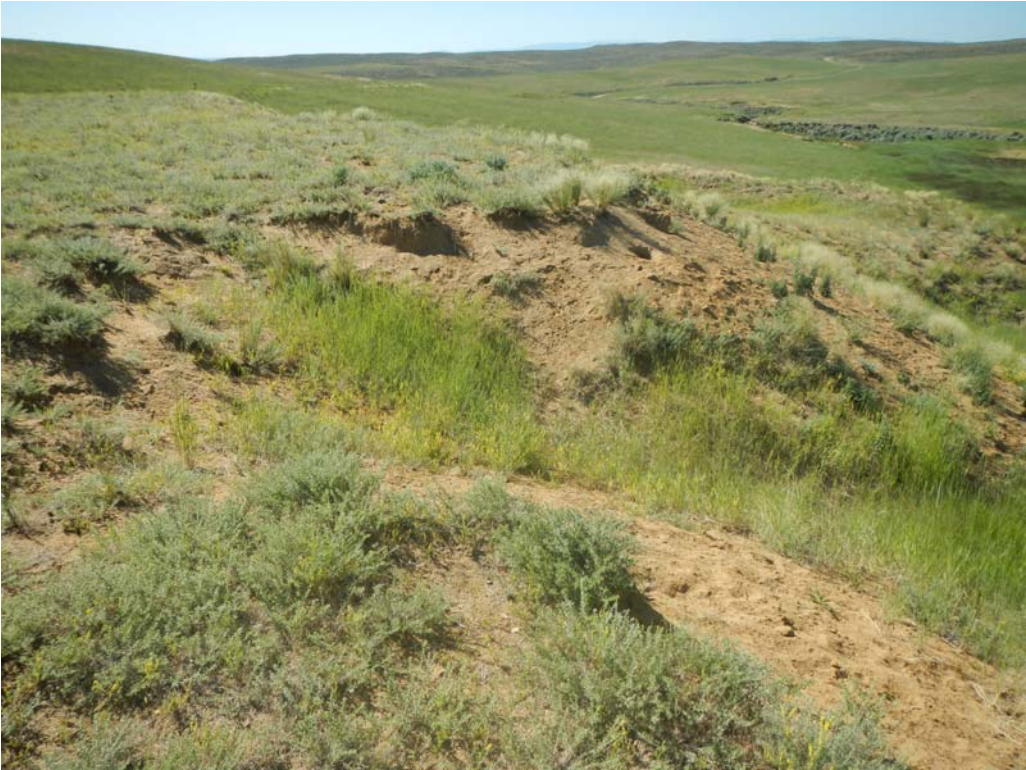
Erosion gully (2 of 2) on west side of location.

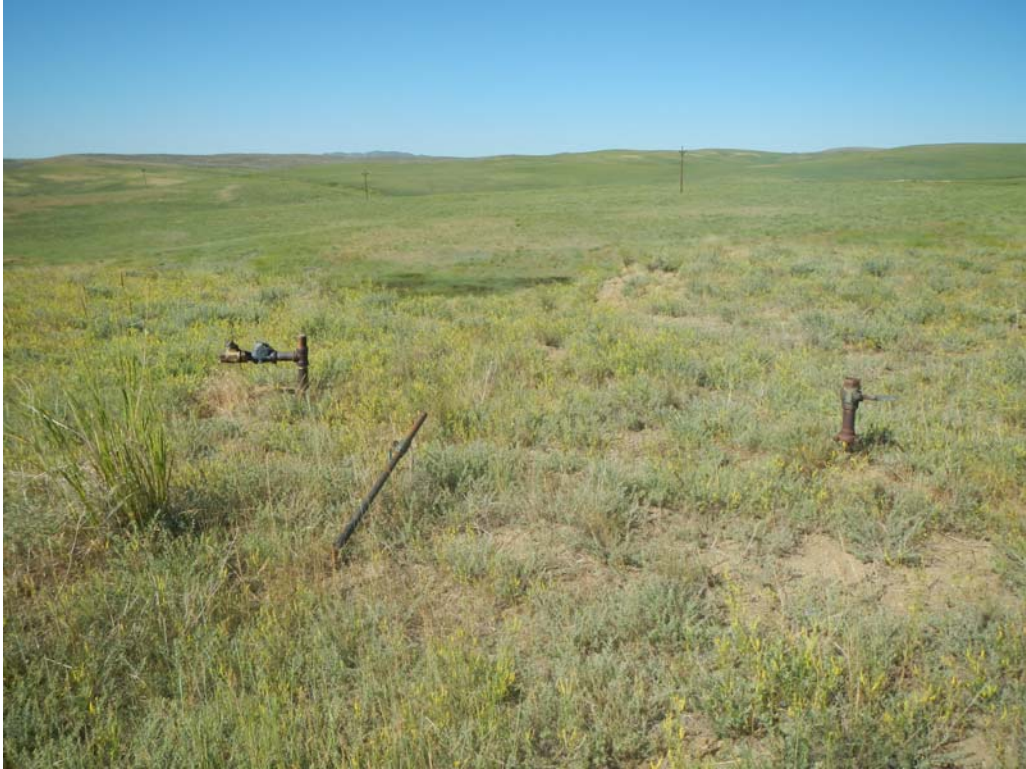
Pipe risers.
