Federal 6-25

Inspection# 673403397

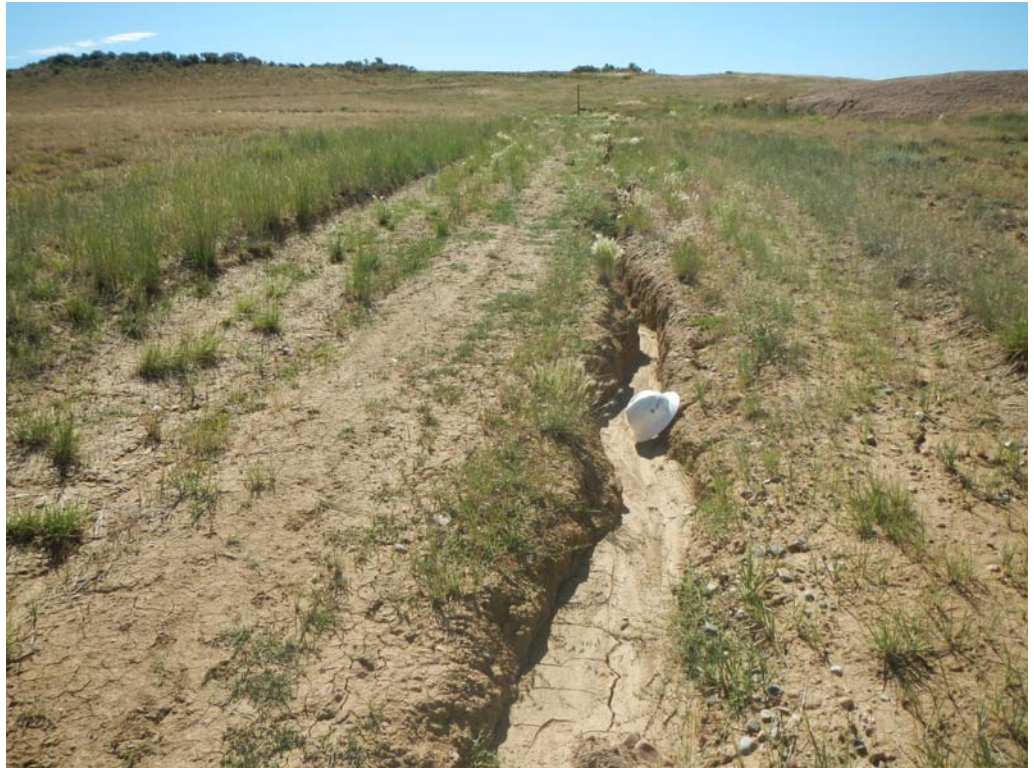
Ruts in access road.

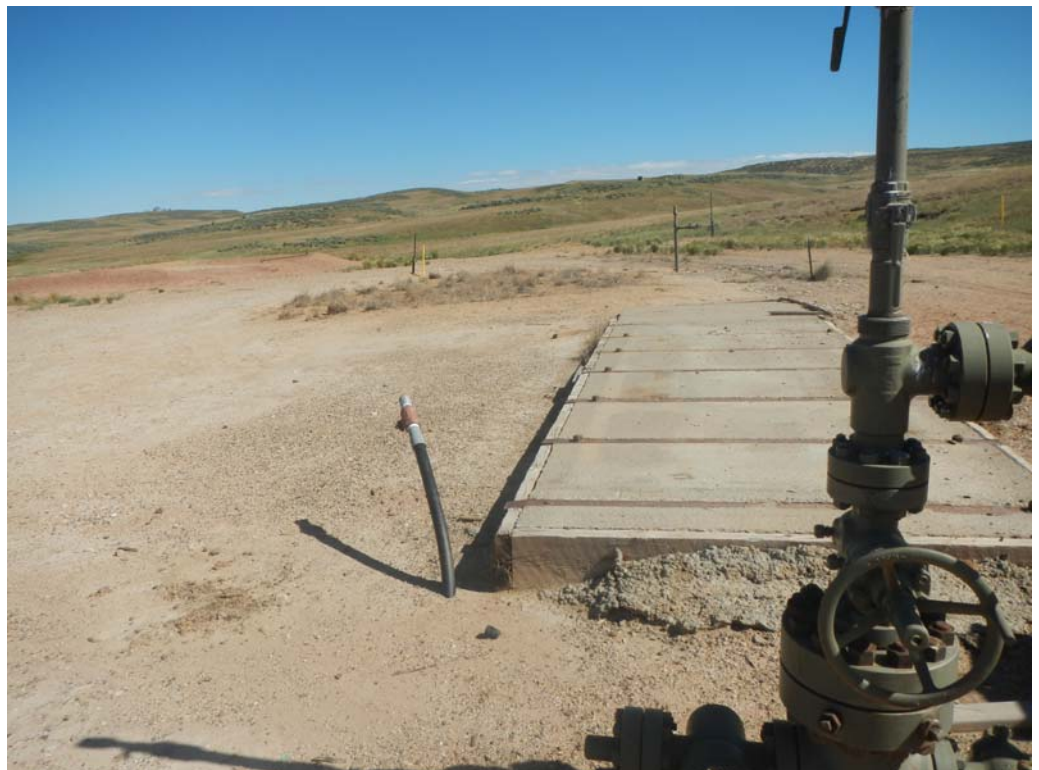
Pump jack base on location.

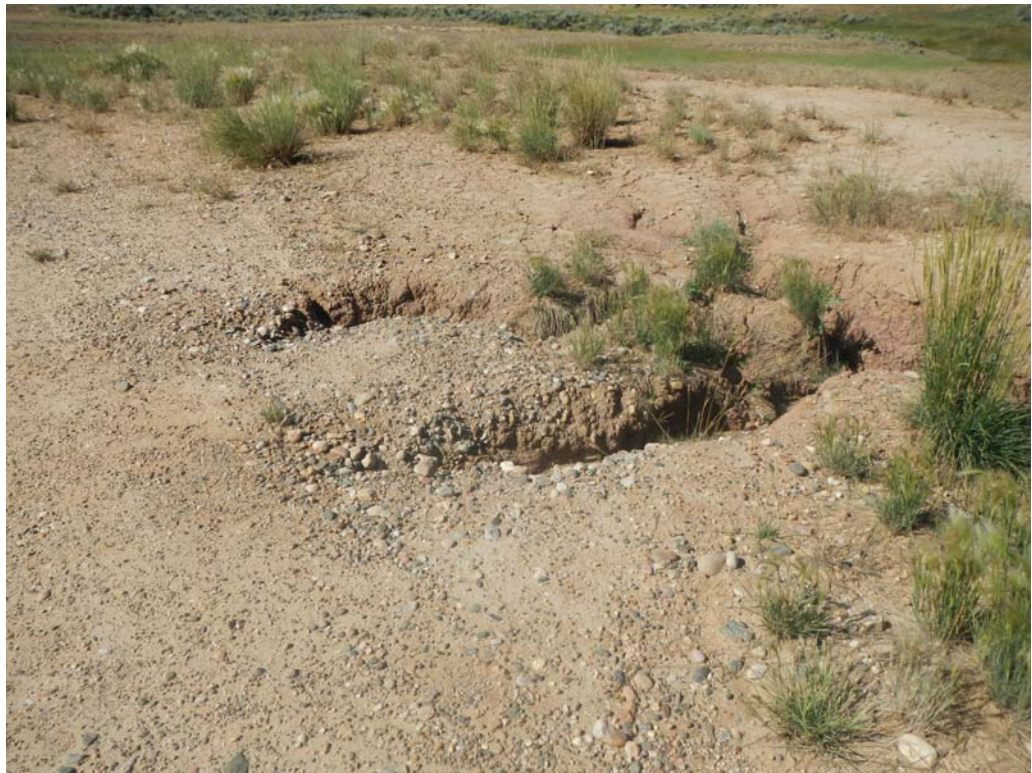
Beginning of erosion gully off location.

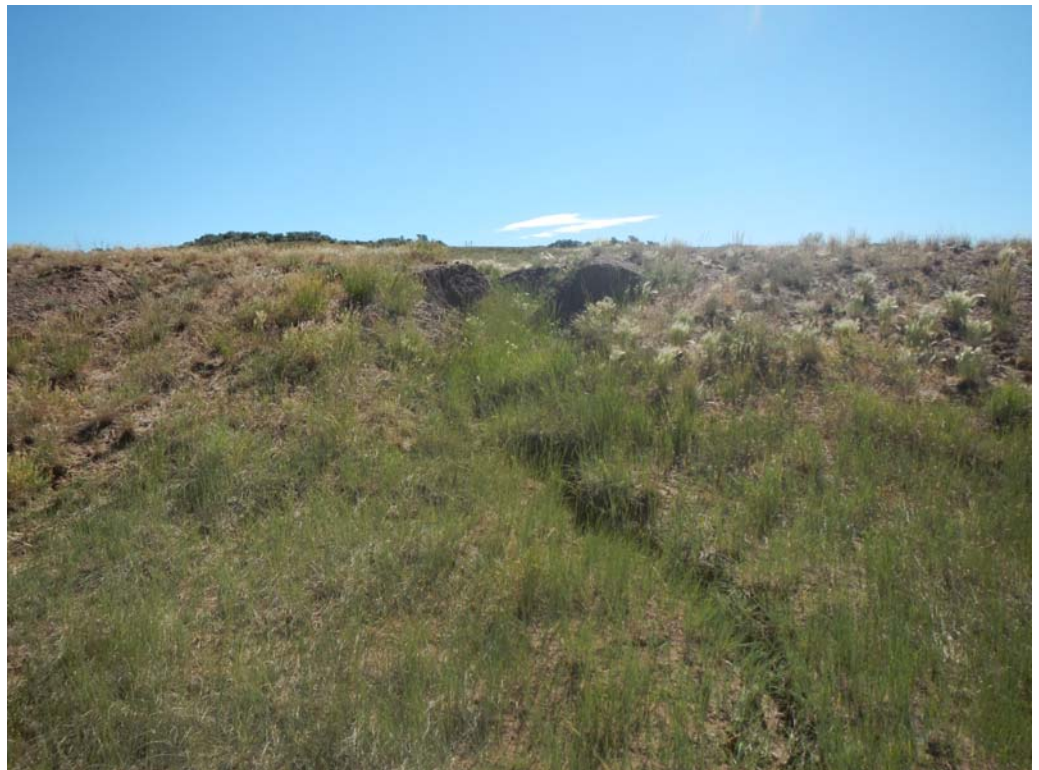
Looking up gully back towards location.
