Final Reclamation Inspection

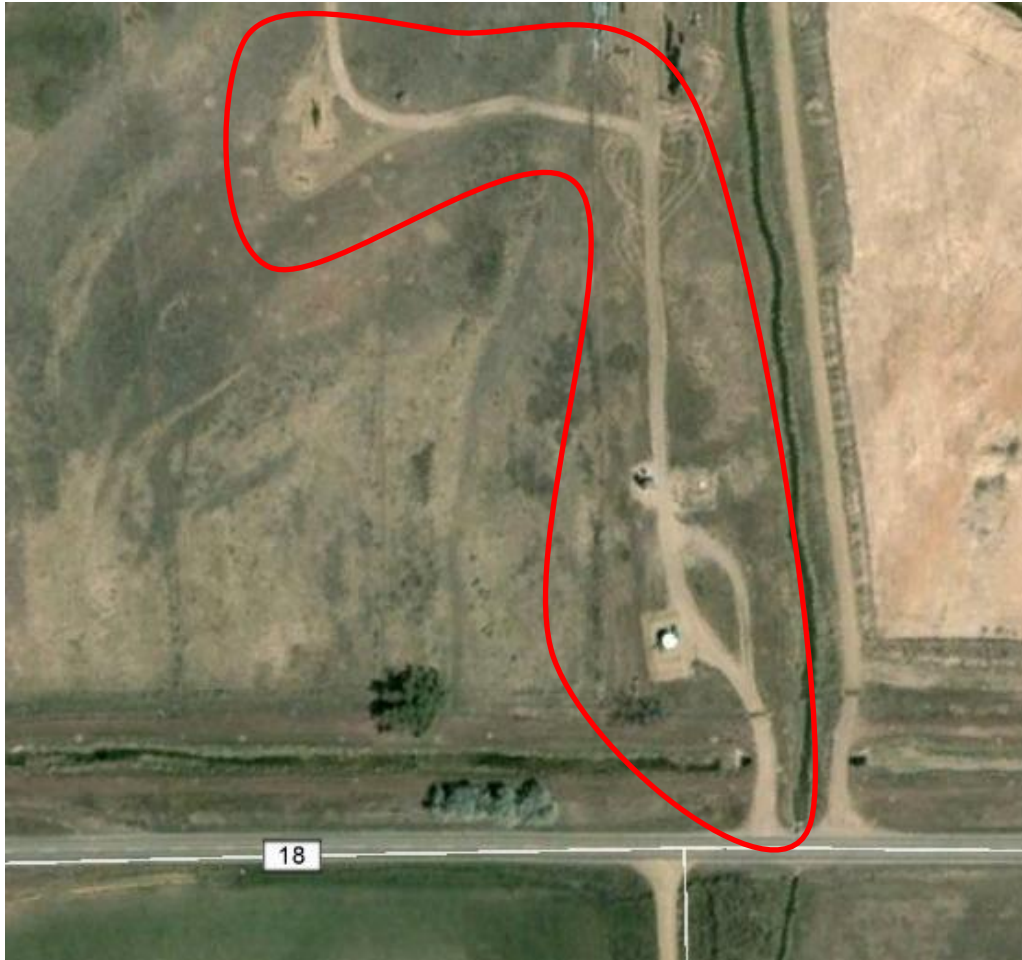
Photo 1. Aerial imagery from 5/3/2006 illustrating total areas that have not been reclaimed per Rule 1004 (highlighted in red).

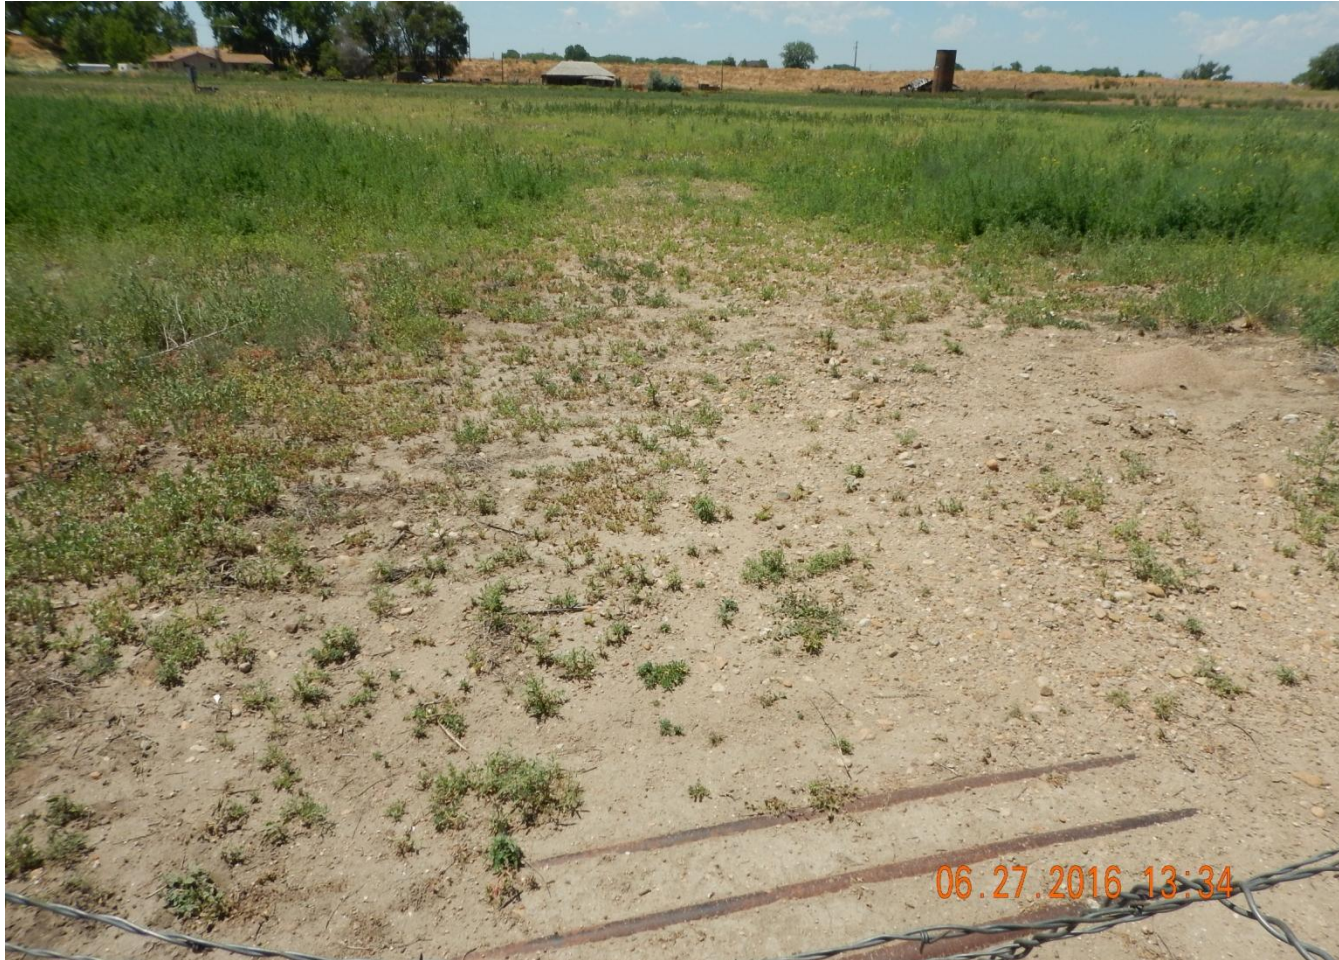
Photo 2. Photo taken north of tank battery location, facing West towards well location. Access road needs to be reclaimed per Rule 1004.

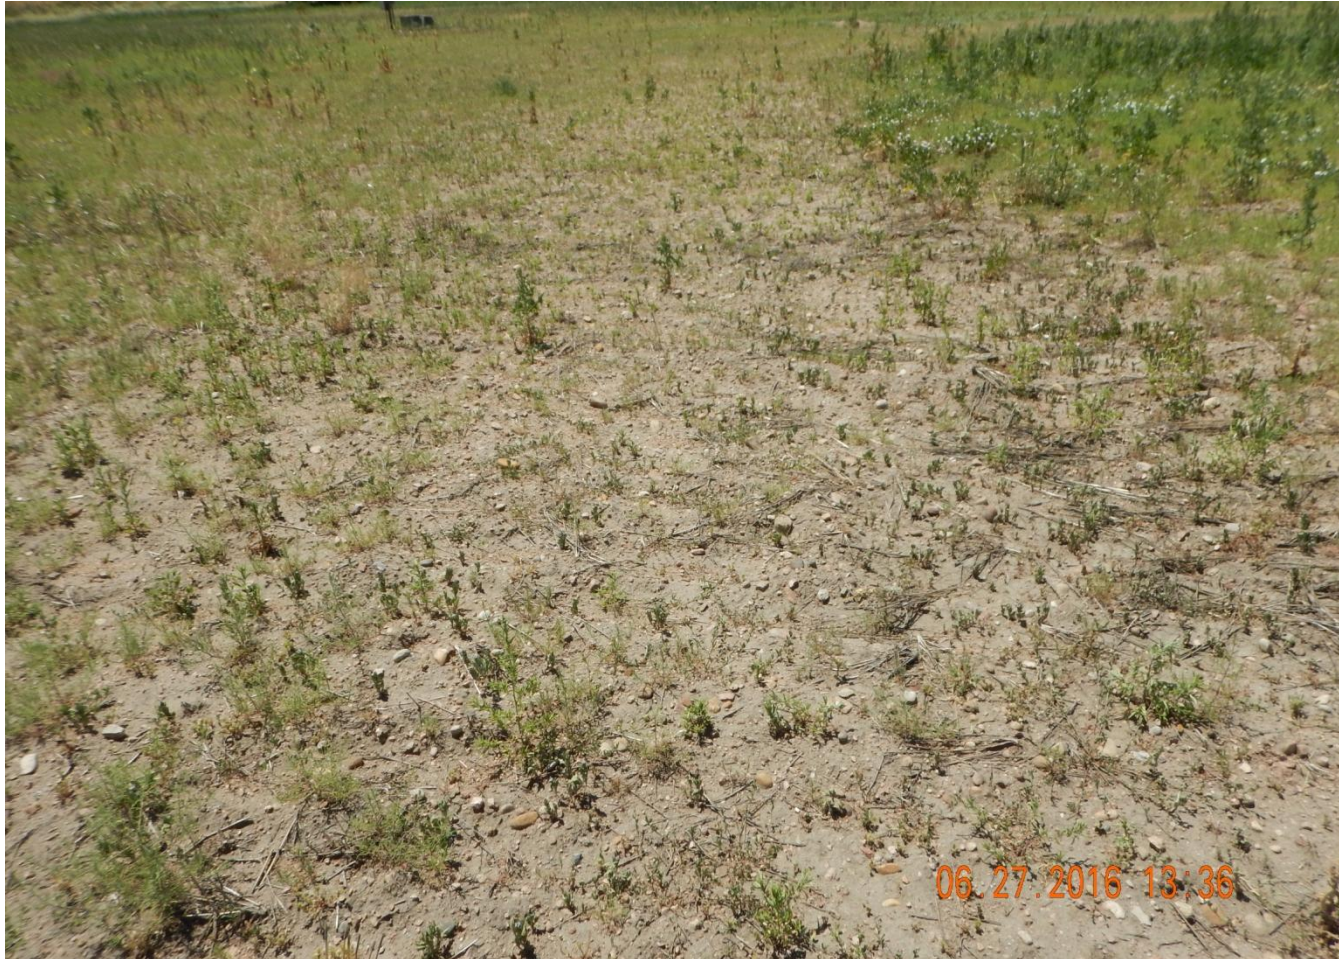
Photo 3. Photo taken from well location, facing West. Need to reclaim location per Rule 1004. A seeding attempt was made but gravel was not removed preventing proper vegetative establishment.

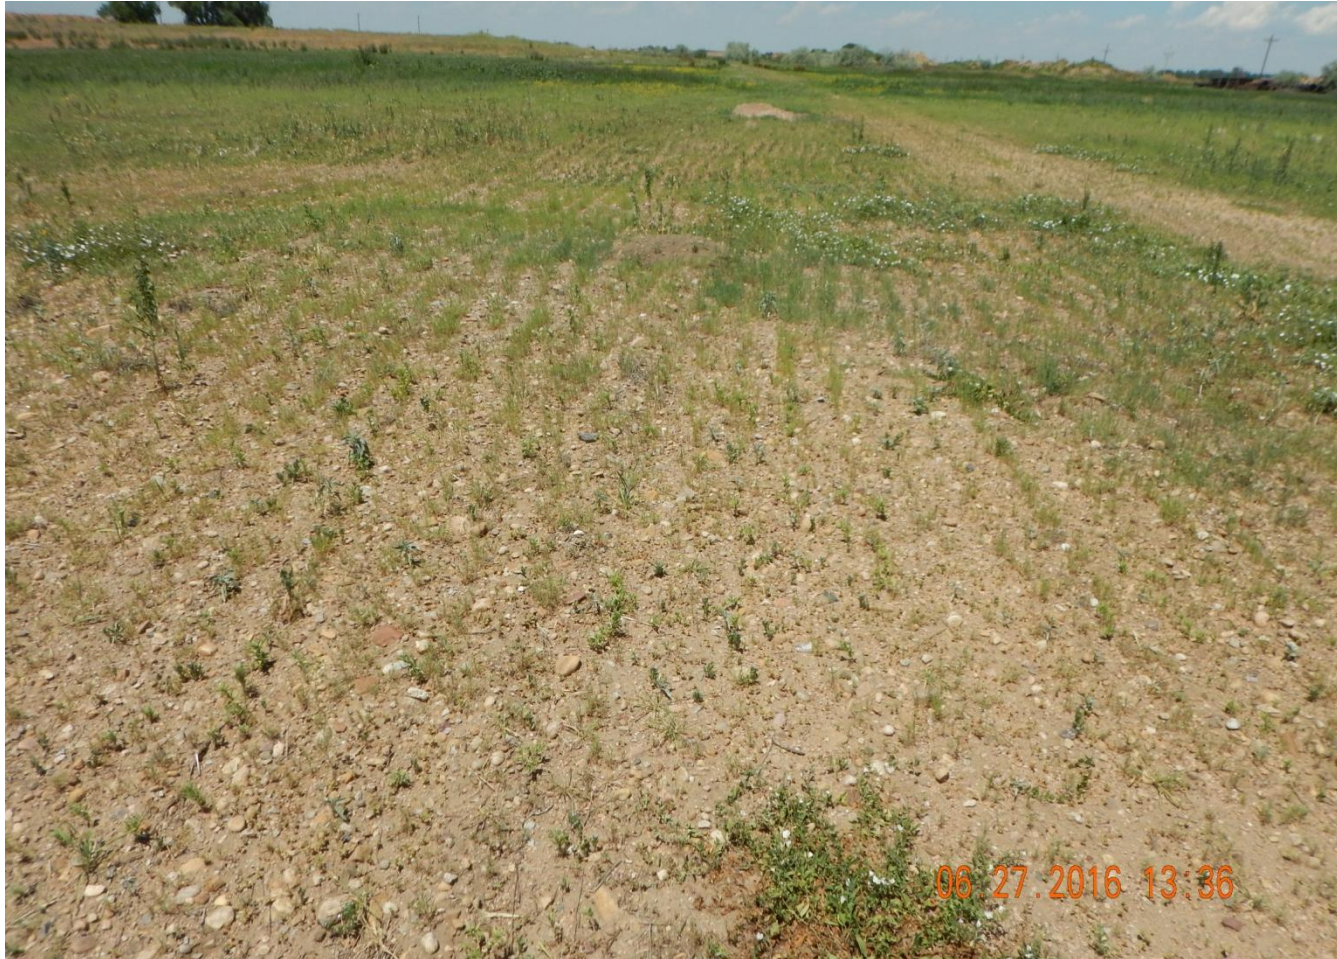
Photo 4. Photo taken from well location, facing North. Need to reclaim location per Rule 1004. A seeding attempt was made but gravel was not removed preventing proper vegetative establishment.

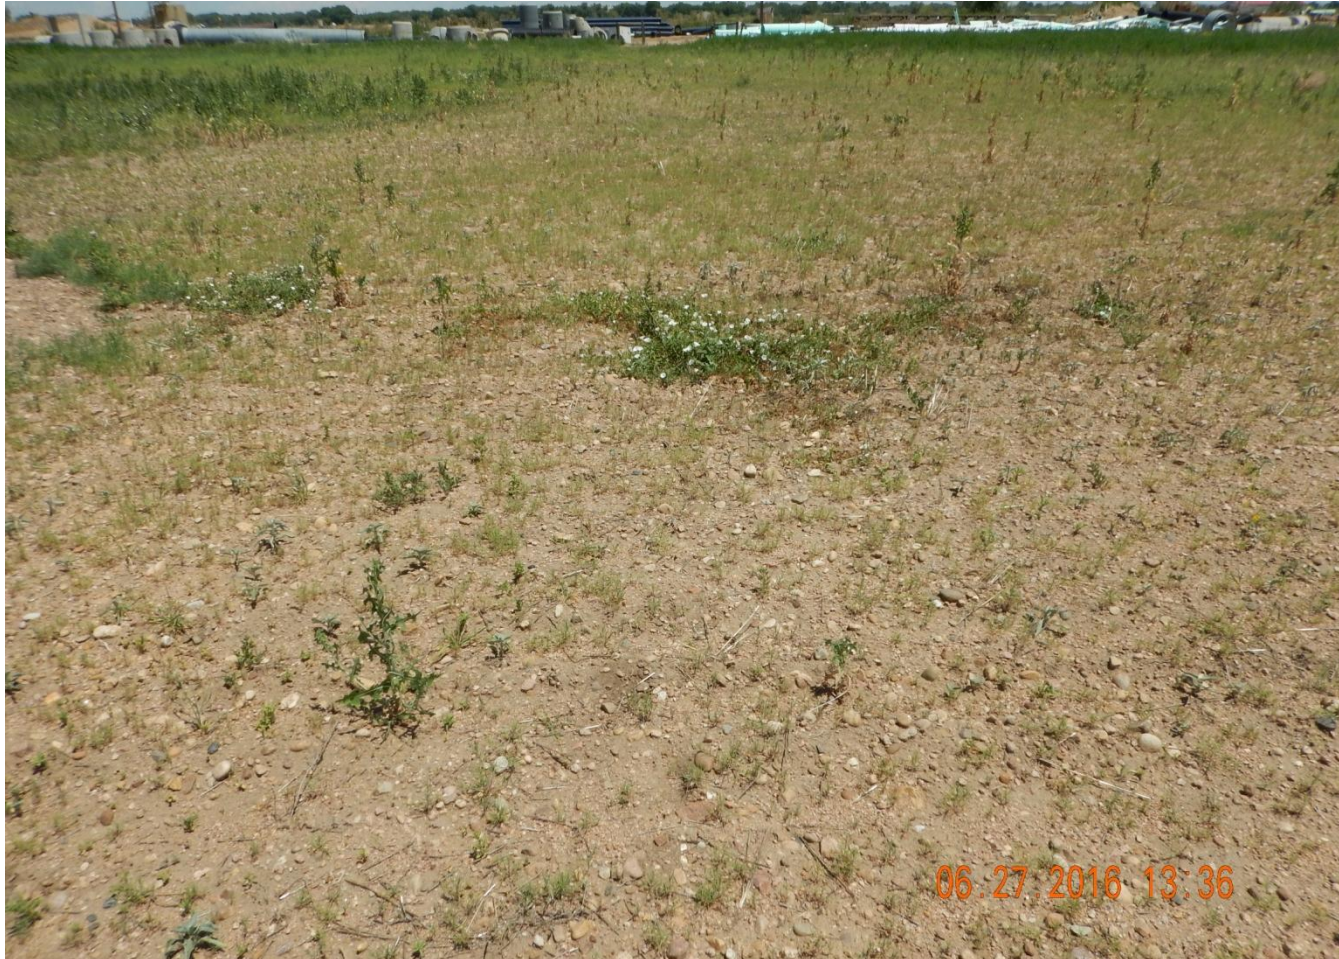
Photo 5. Photo taken from well location, facing East. Need to reclaim location per Rule 1004. A seeding attempt was made but gravel was not removed preventing proper vegetative establishment.

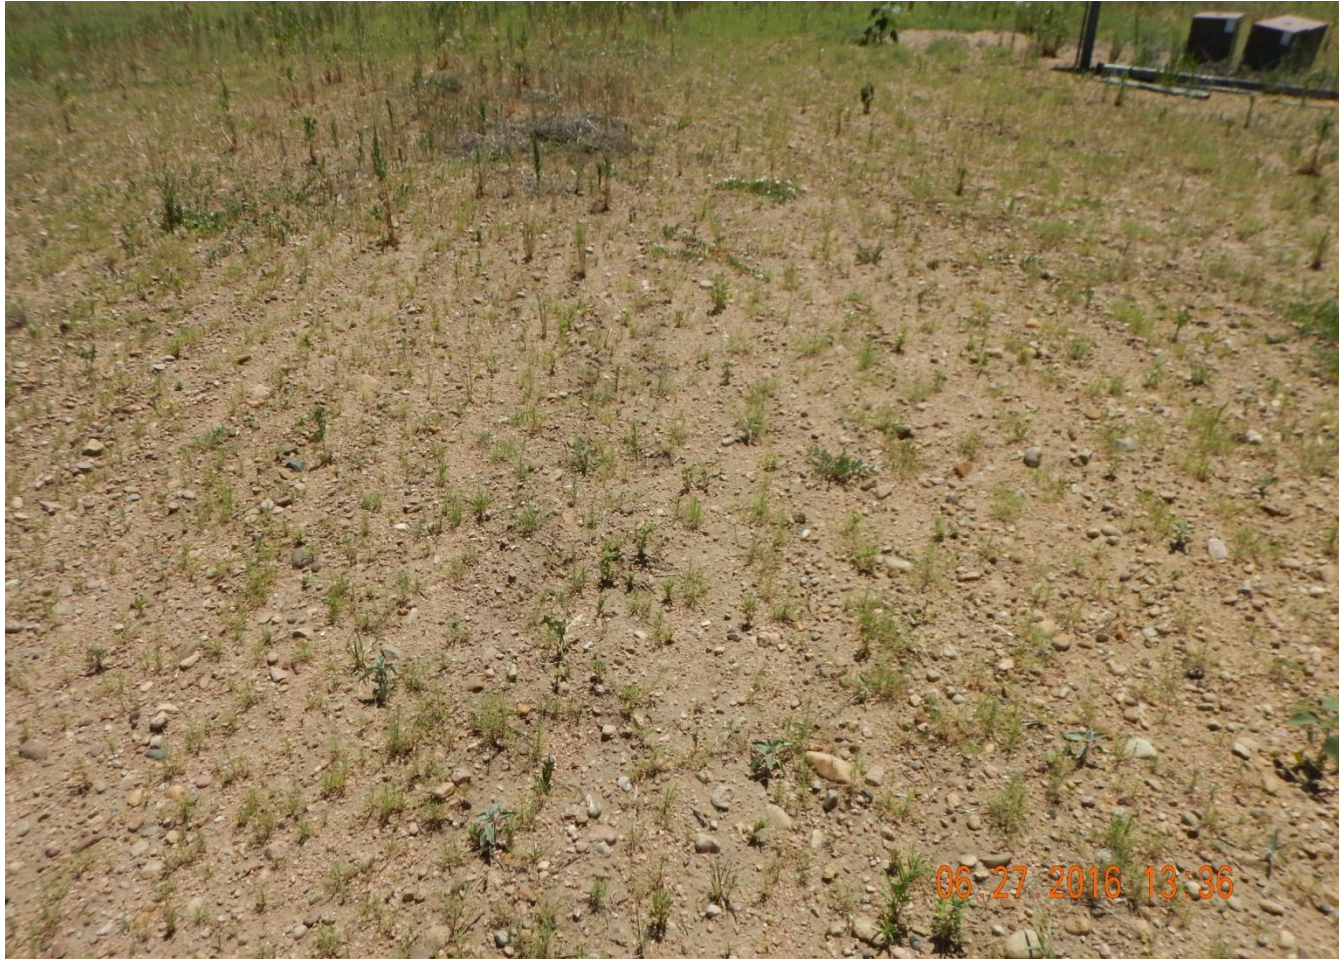
Photo 6. Photo taken from well location, facing South. Need to reclaim location per Rule 1004. A seeding attempt was made but gravel was not removed preventing proper vegetative establishment.

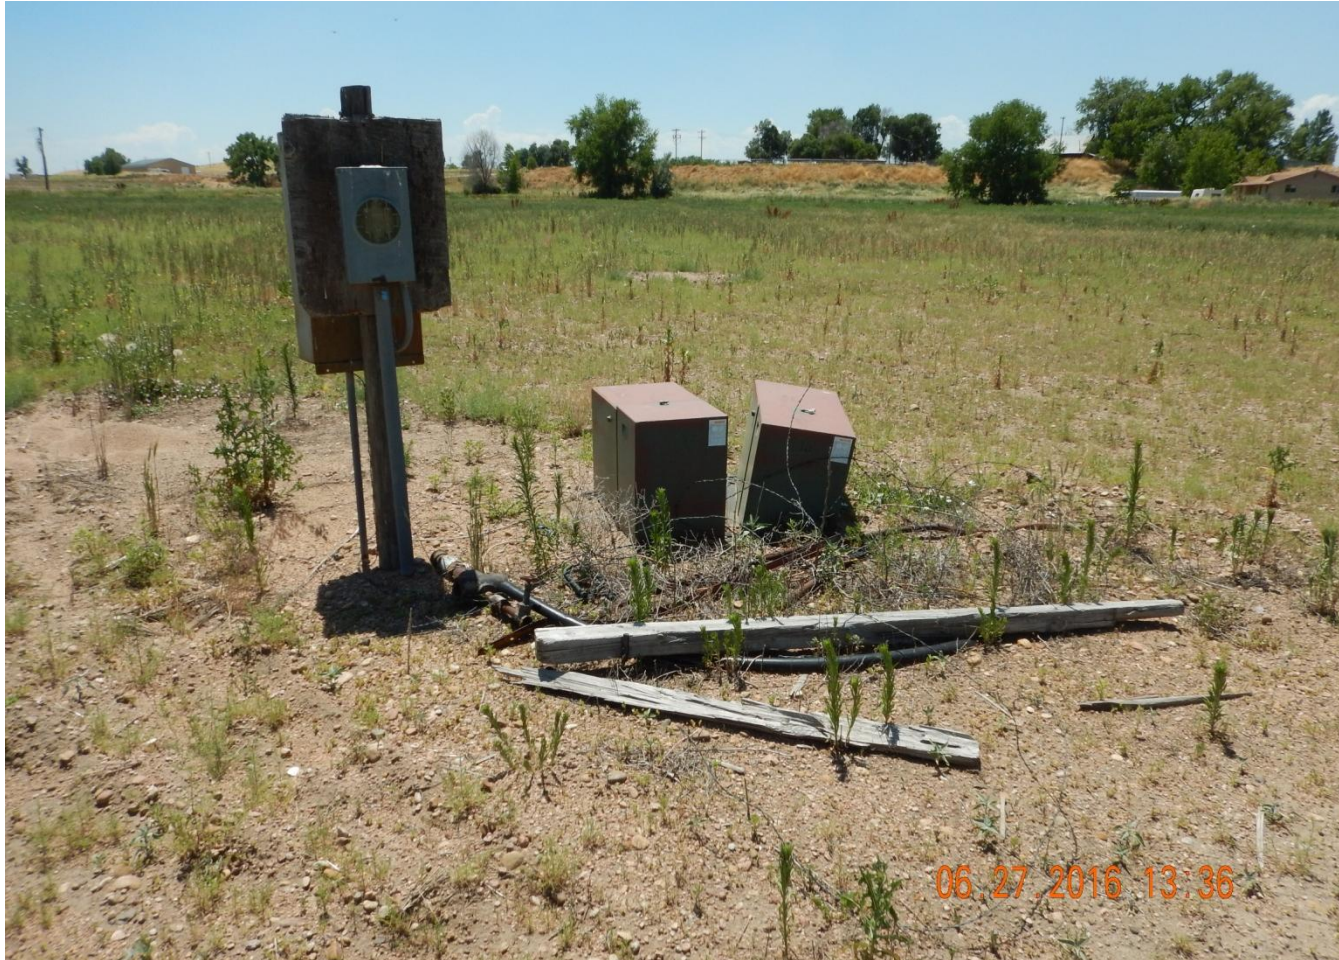
Photo 7. Photo taken from well location illustrating equipment and debris that still remains and needs to be removed per Rule 1004.
