Interim Reclamation Inspection

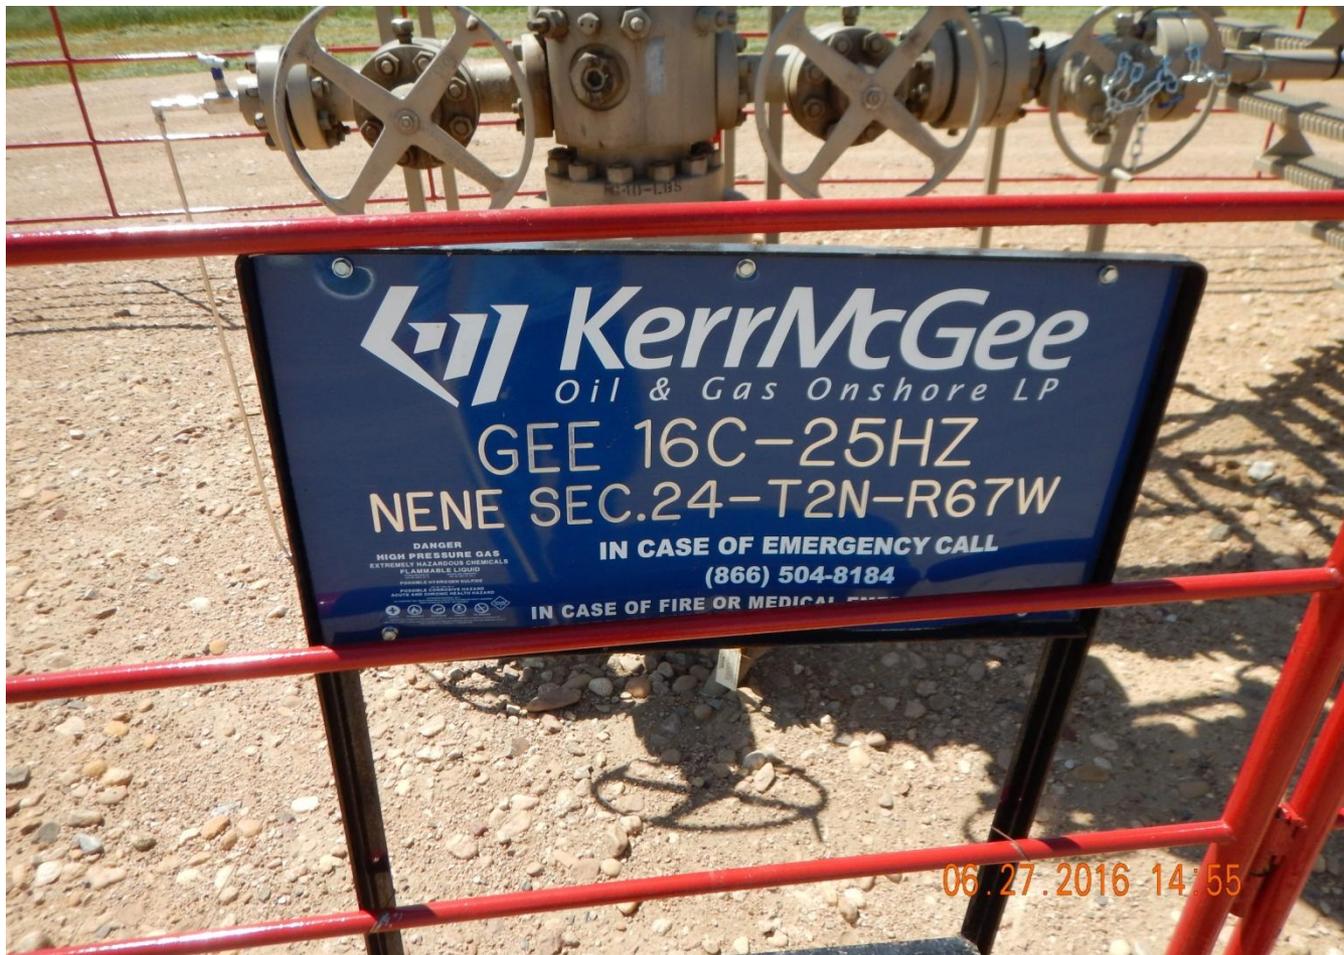
Photo 1. Photo taken of Producing Well, API #123-39236.

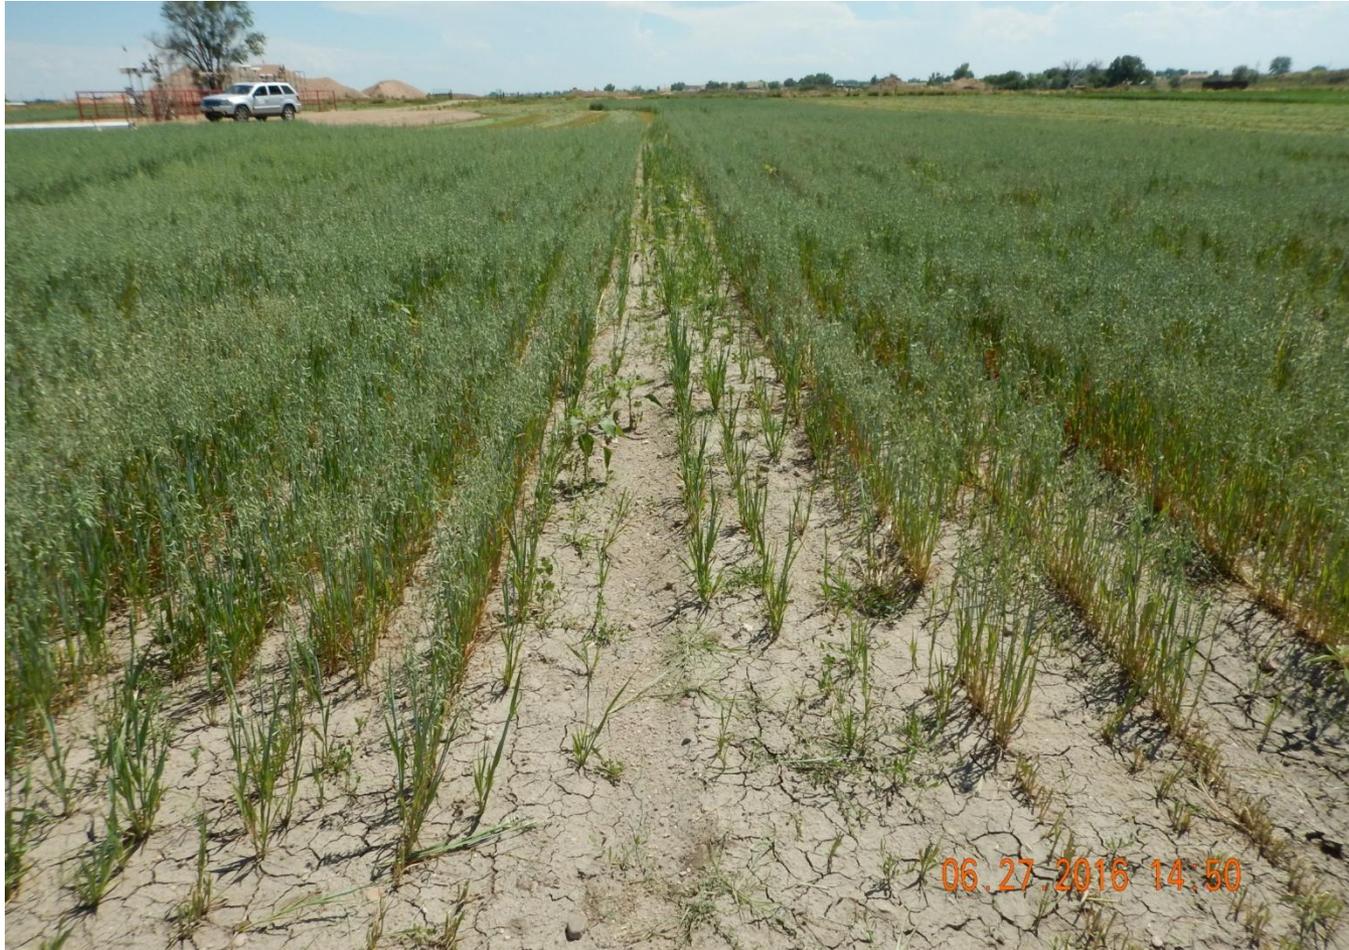
Photo 2. Photo taken from northwest location, facing South. Interim reclamation areas are not representative of reference areas as illustrated in this photo. Bare soil and inconsistent growth are apparent throughout interim areas.

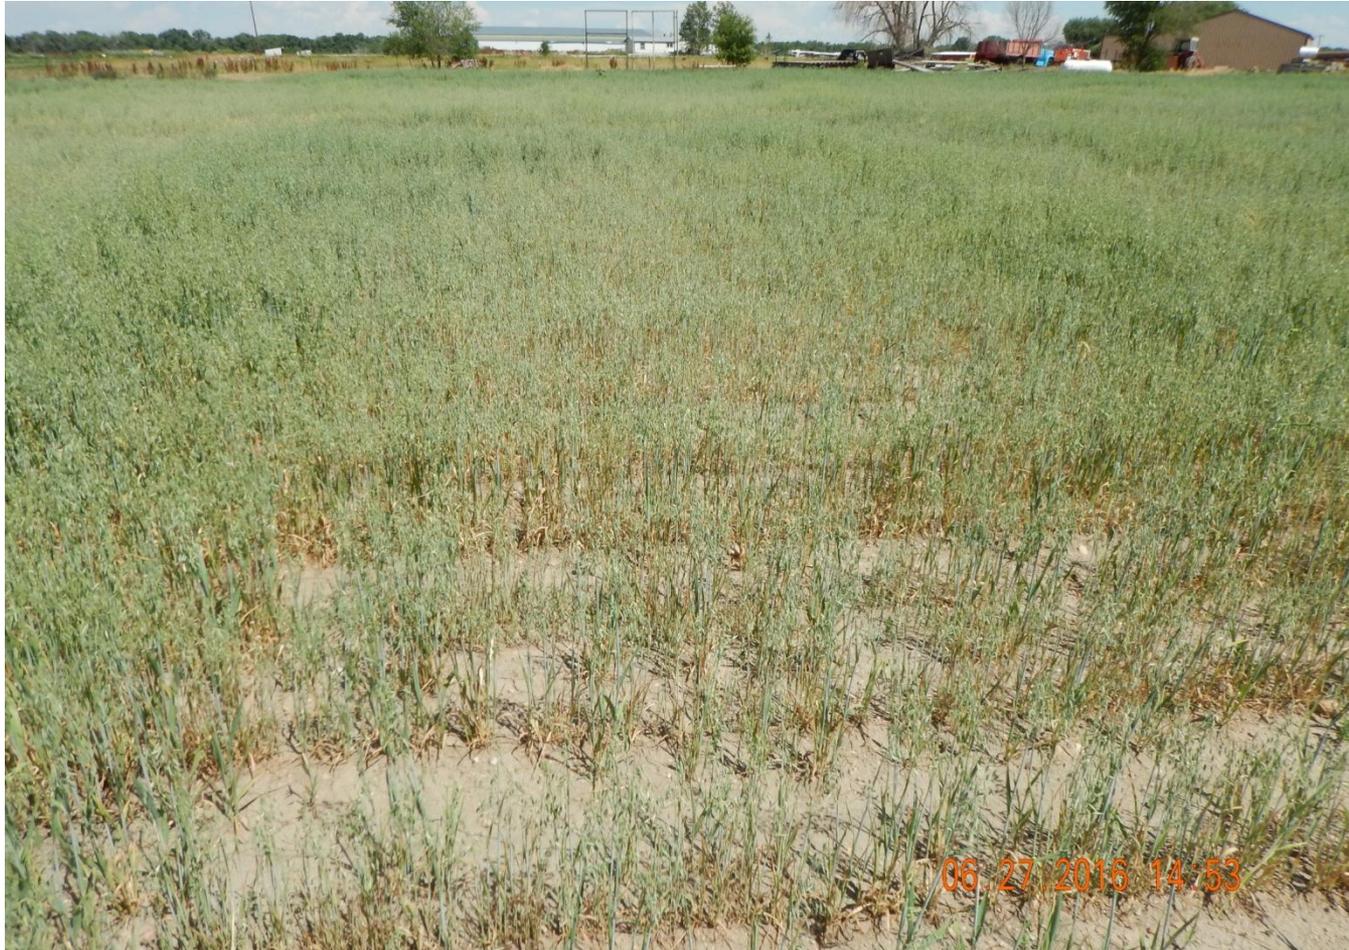
Photo 3. Photo taken from northern location, facing East. Interim reclamation areas are not representative of reference areas as illustrated in this photo. Bare soil and inconsistent growth are apparent throughout interim areas.

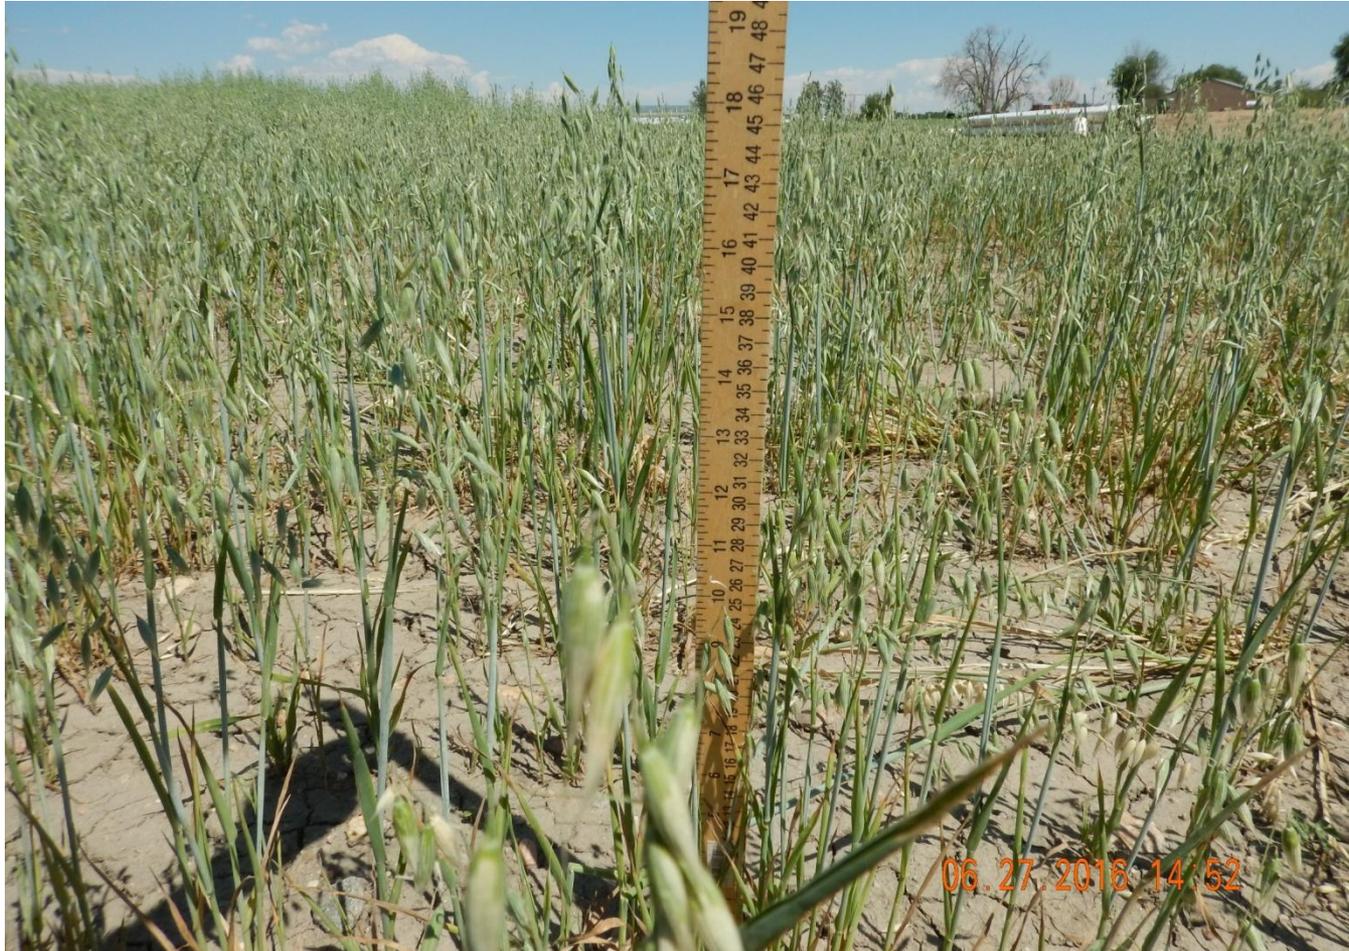
Photo 4. Photo measurement taken from previous photo. Crop height is about 19" in this approximate location.

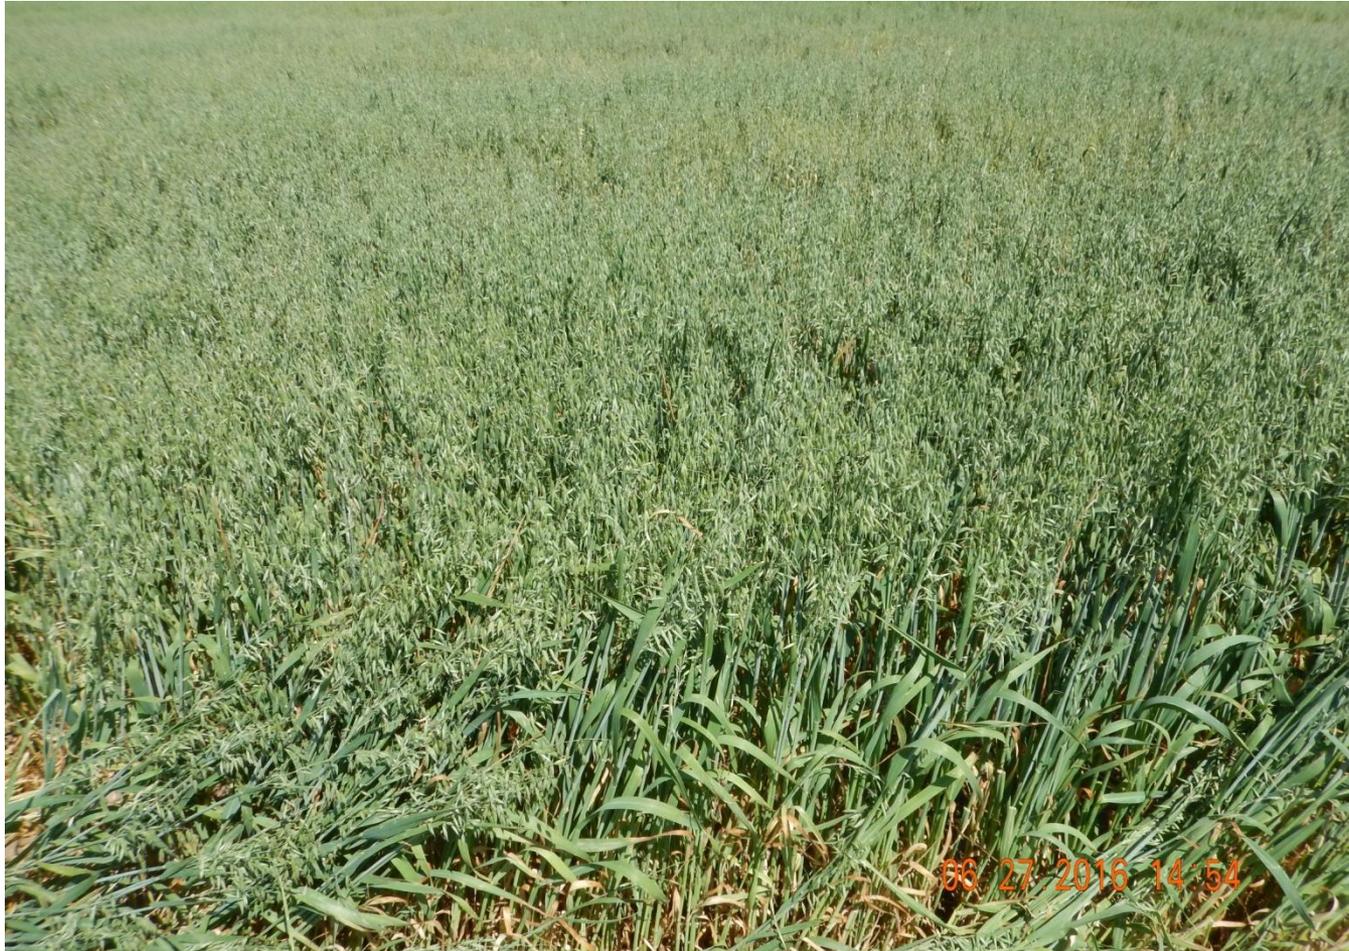
Photo 5. Reference photo taken from southwest location, illustrating crop density is much higher and crop height is much higher- refer to following photo.

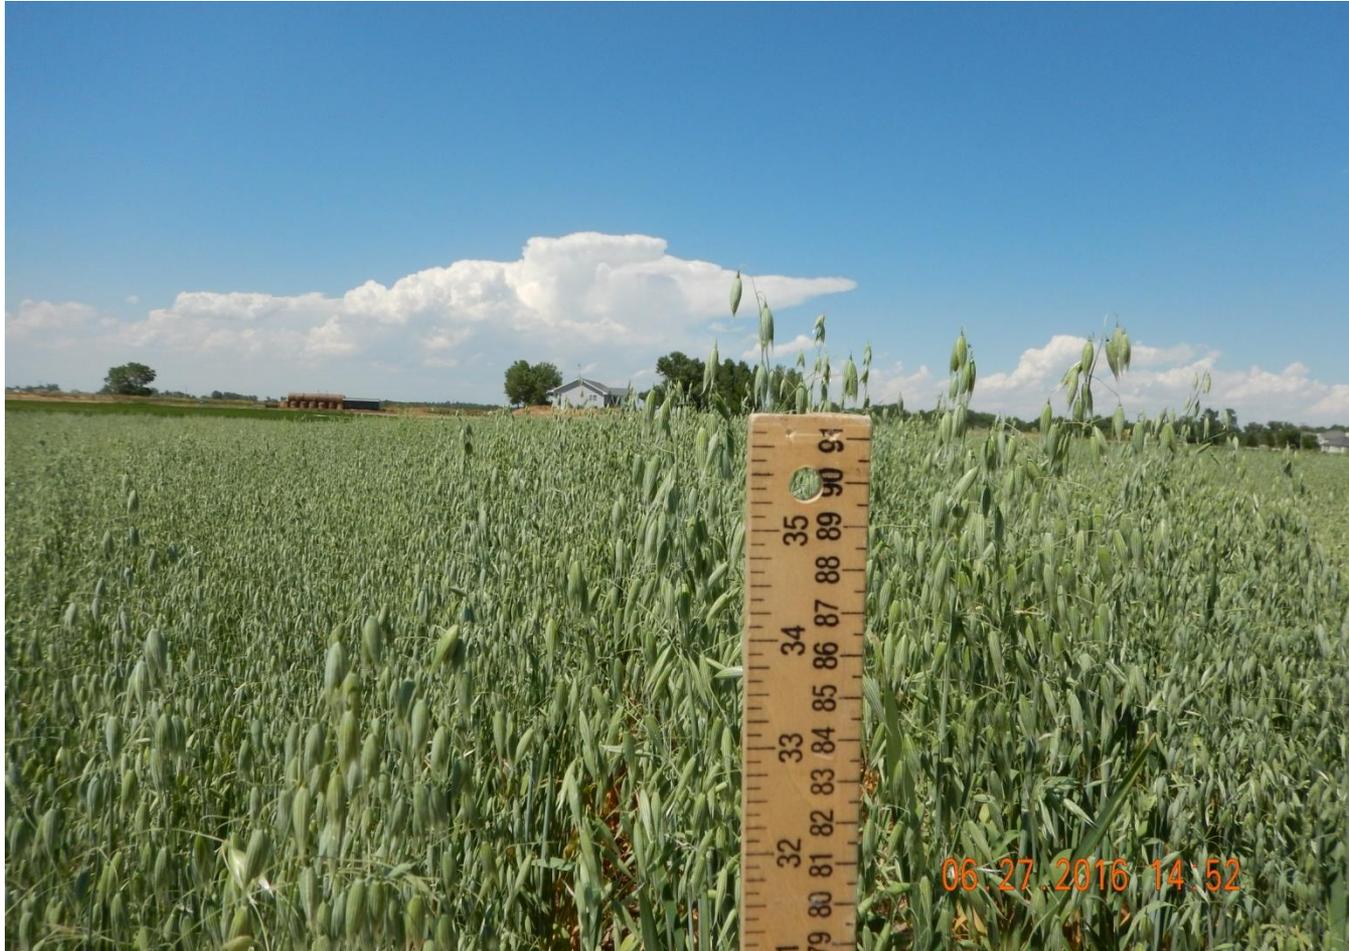
Photo 6. Photo measurement taken from previous photo. Crop height is about 36-37" in this approximate location which is not reflective of the entire interim area.
